CONTAINMENT DEBRIS WALKDOWN PACKAGE WATTS BAR N. P. UNIT 1

WALKDOWN PACKAGE NO. WB1-DWD-005A SHEET 1 OF 3

COMMENTS
	REACTOR COOLANT INTERIM LEG (CROSSOVER LEG)
	* TVA CONTRACT NO. 93NNS-75645C

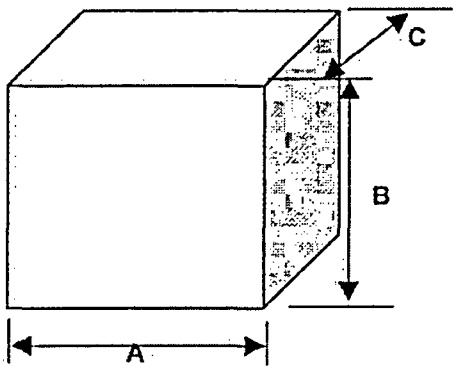
AREA 06 3M-M20C RADIANT SHIELD CALCULATION
JB-293-4557-B AND JB-293-6347-A

SURFACE AREA CALCULATION OF JUNCTION BOX JB-293-4557-B (SIZE: 12X14X6)

TOTAL INSULATION VOLUME FOR TWO BOXES (CU FT) =	0.516

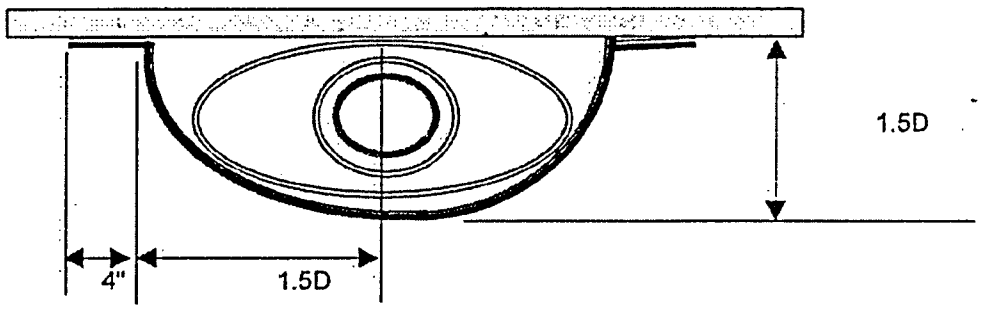
AREA 06 3M-M20C RADIANT SHIELD CALCULATION
AREA 06- 3M-M20C RADIANT SHIELD CALCULATION
1" DIAMETER CONDUIT (OUTSIDE DIA = 1.315")
1 1/2" DIA. CONDUIT (OUTSIDE DIA = 1.9")
2" DIAMETER CONDUIT (OUTSIDE DIA. = 2.375")
3 LAYERS 3M-M20C FOR CONDUIT PER NOTE 1A DRAWING 1-47W243-6
DETAIL C-8 AND NOTE 6 DRAWING 1-47W243-8 SPECIFIES 3 LAYERS WRAP.

D=DIAMETER OF CONDUIT IN IN"
FIRST LAYER TIGHTLY AROUND CONDUIT
SECOND LAYER IS 1.5D DIAMTER CIRCLEX1.2
THIRD LAYER IS 1.5D RADIUS HALF CIRCLE + 8"

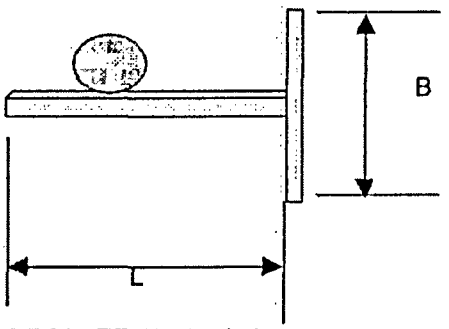
AREA 06 3M-M20C RADIANT SHIELD CALCULATION

ASSUME A=12" WITH 2x2 SQ TUBE, BASE PLATE SIZE = 9x9
TWO LAYERS OF 3M FIRE BARRIER M20C FOR SUPPORT
COVER BASE PLATE 6" ALL AROUND.

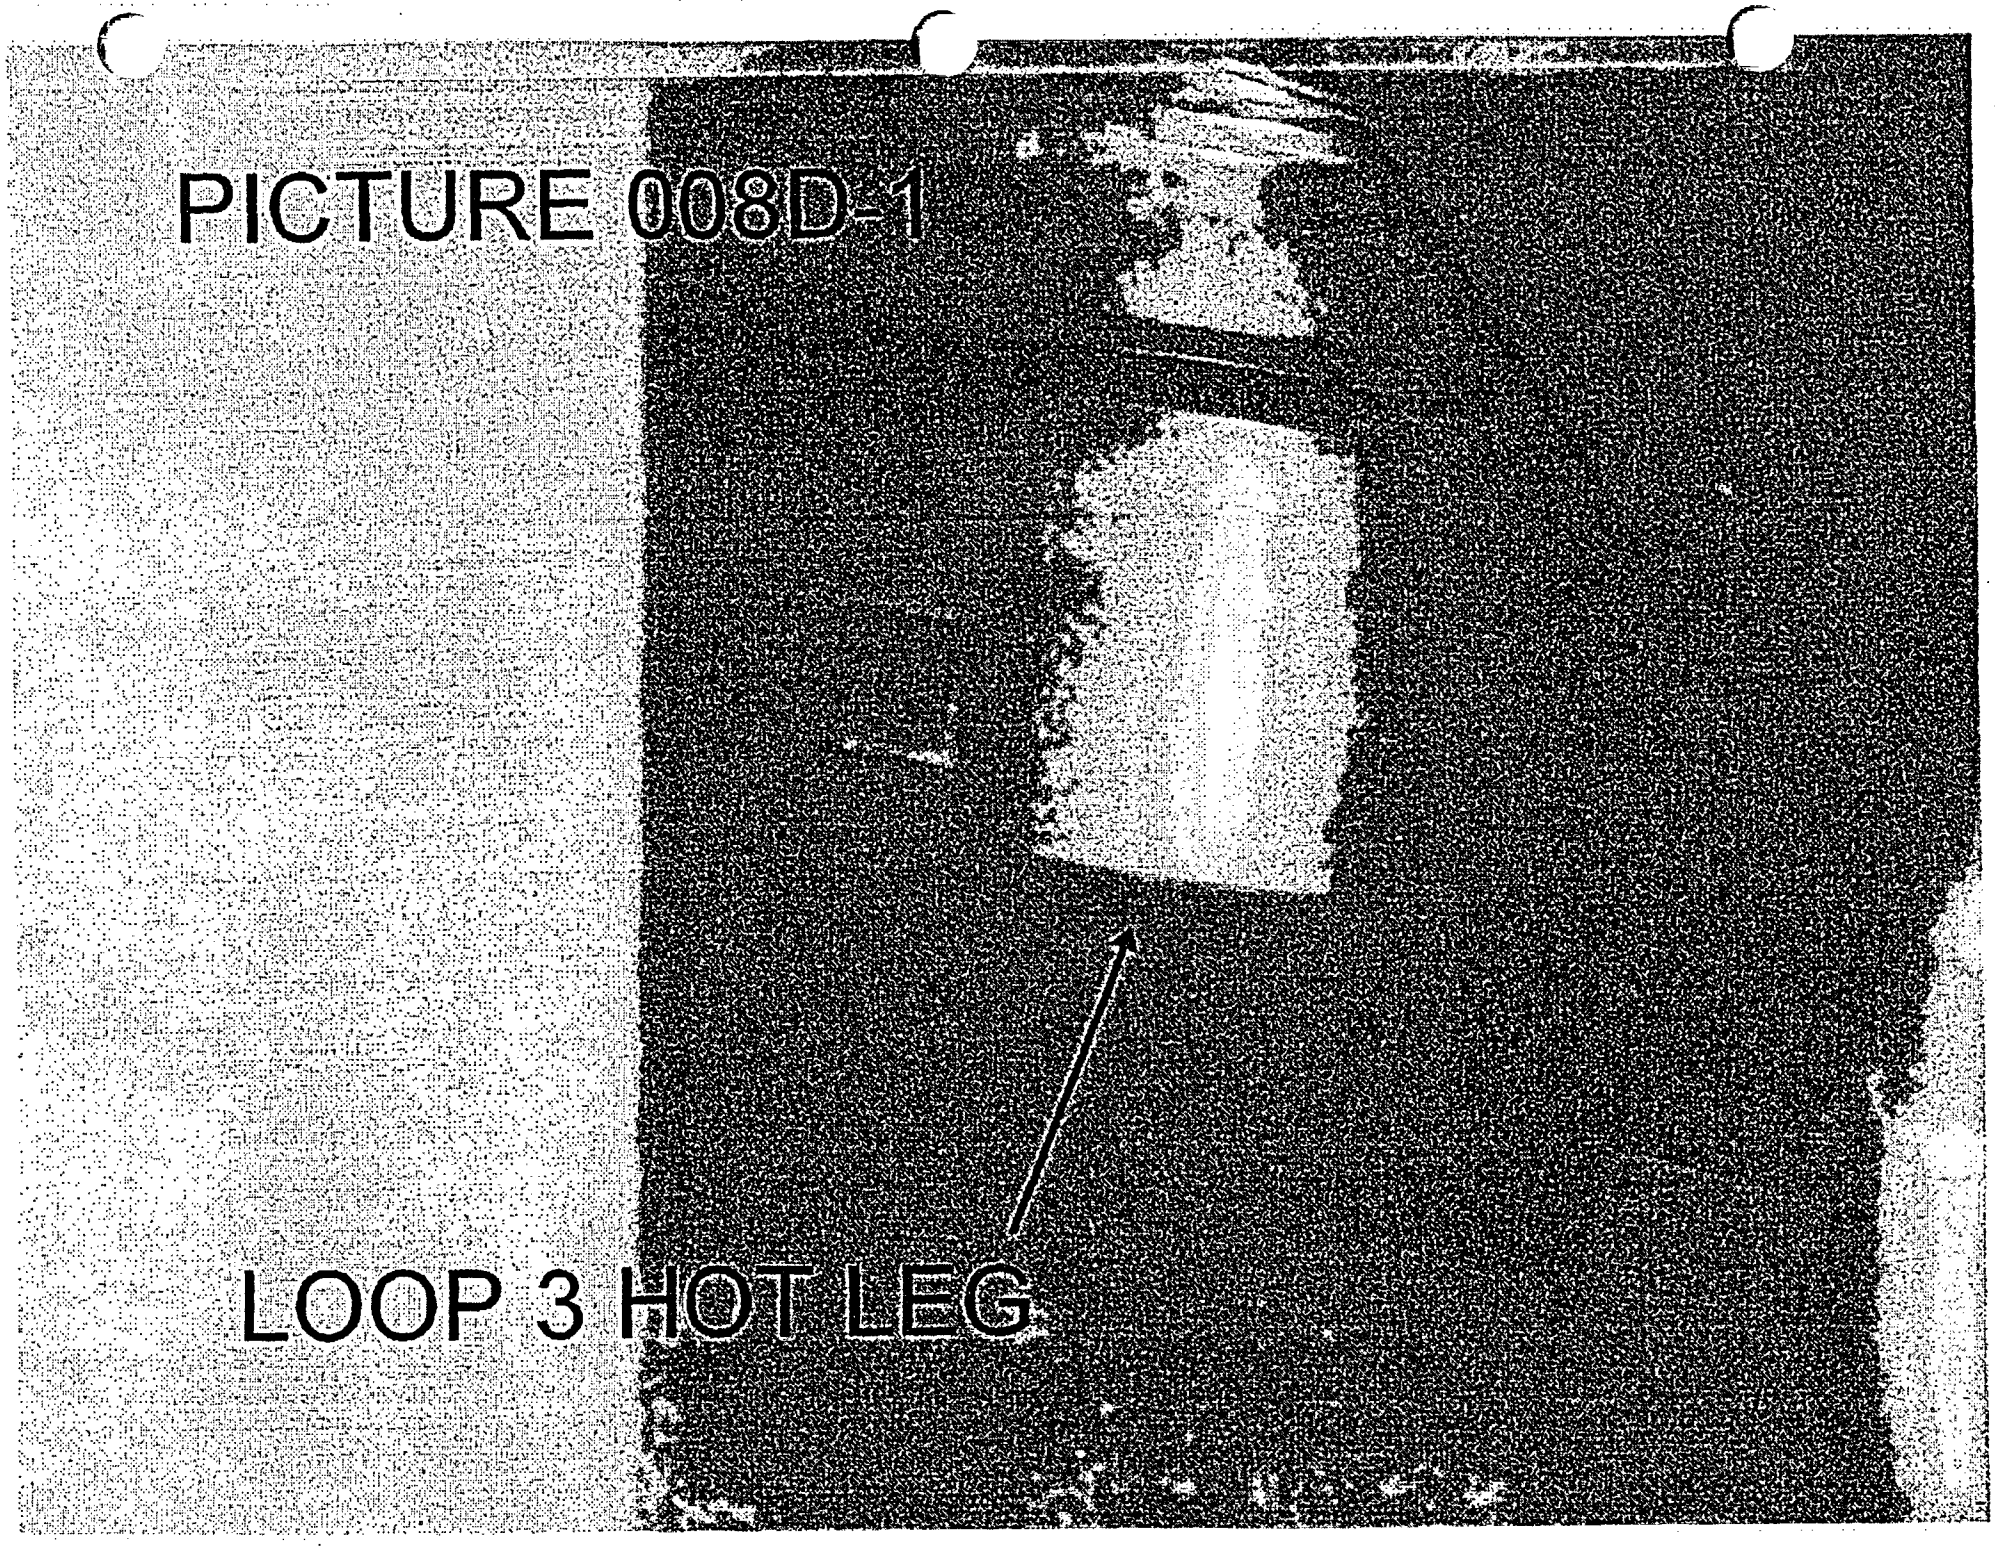
PICTURE 008D-1
LOOP 3 HOT LEG
