University of Missouri
Pickard Hall
Characterization Report
Gamma Scans / Soil Samples

CHASE Environmental Group

Building: Pickard Hall	Outside Grounds	Page: G.1 of G.3

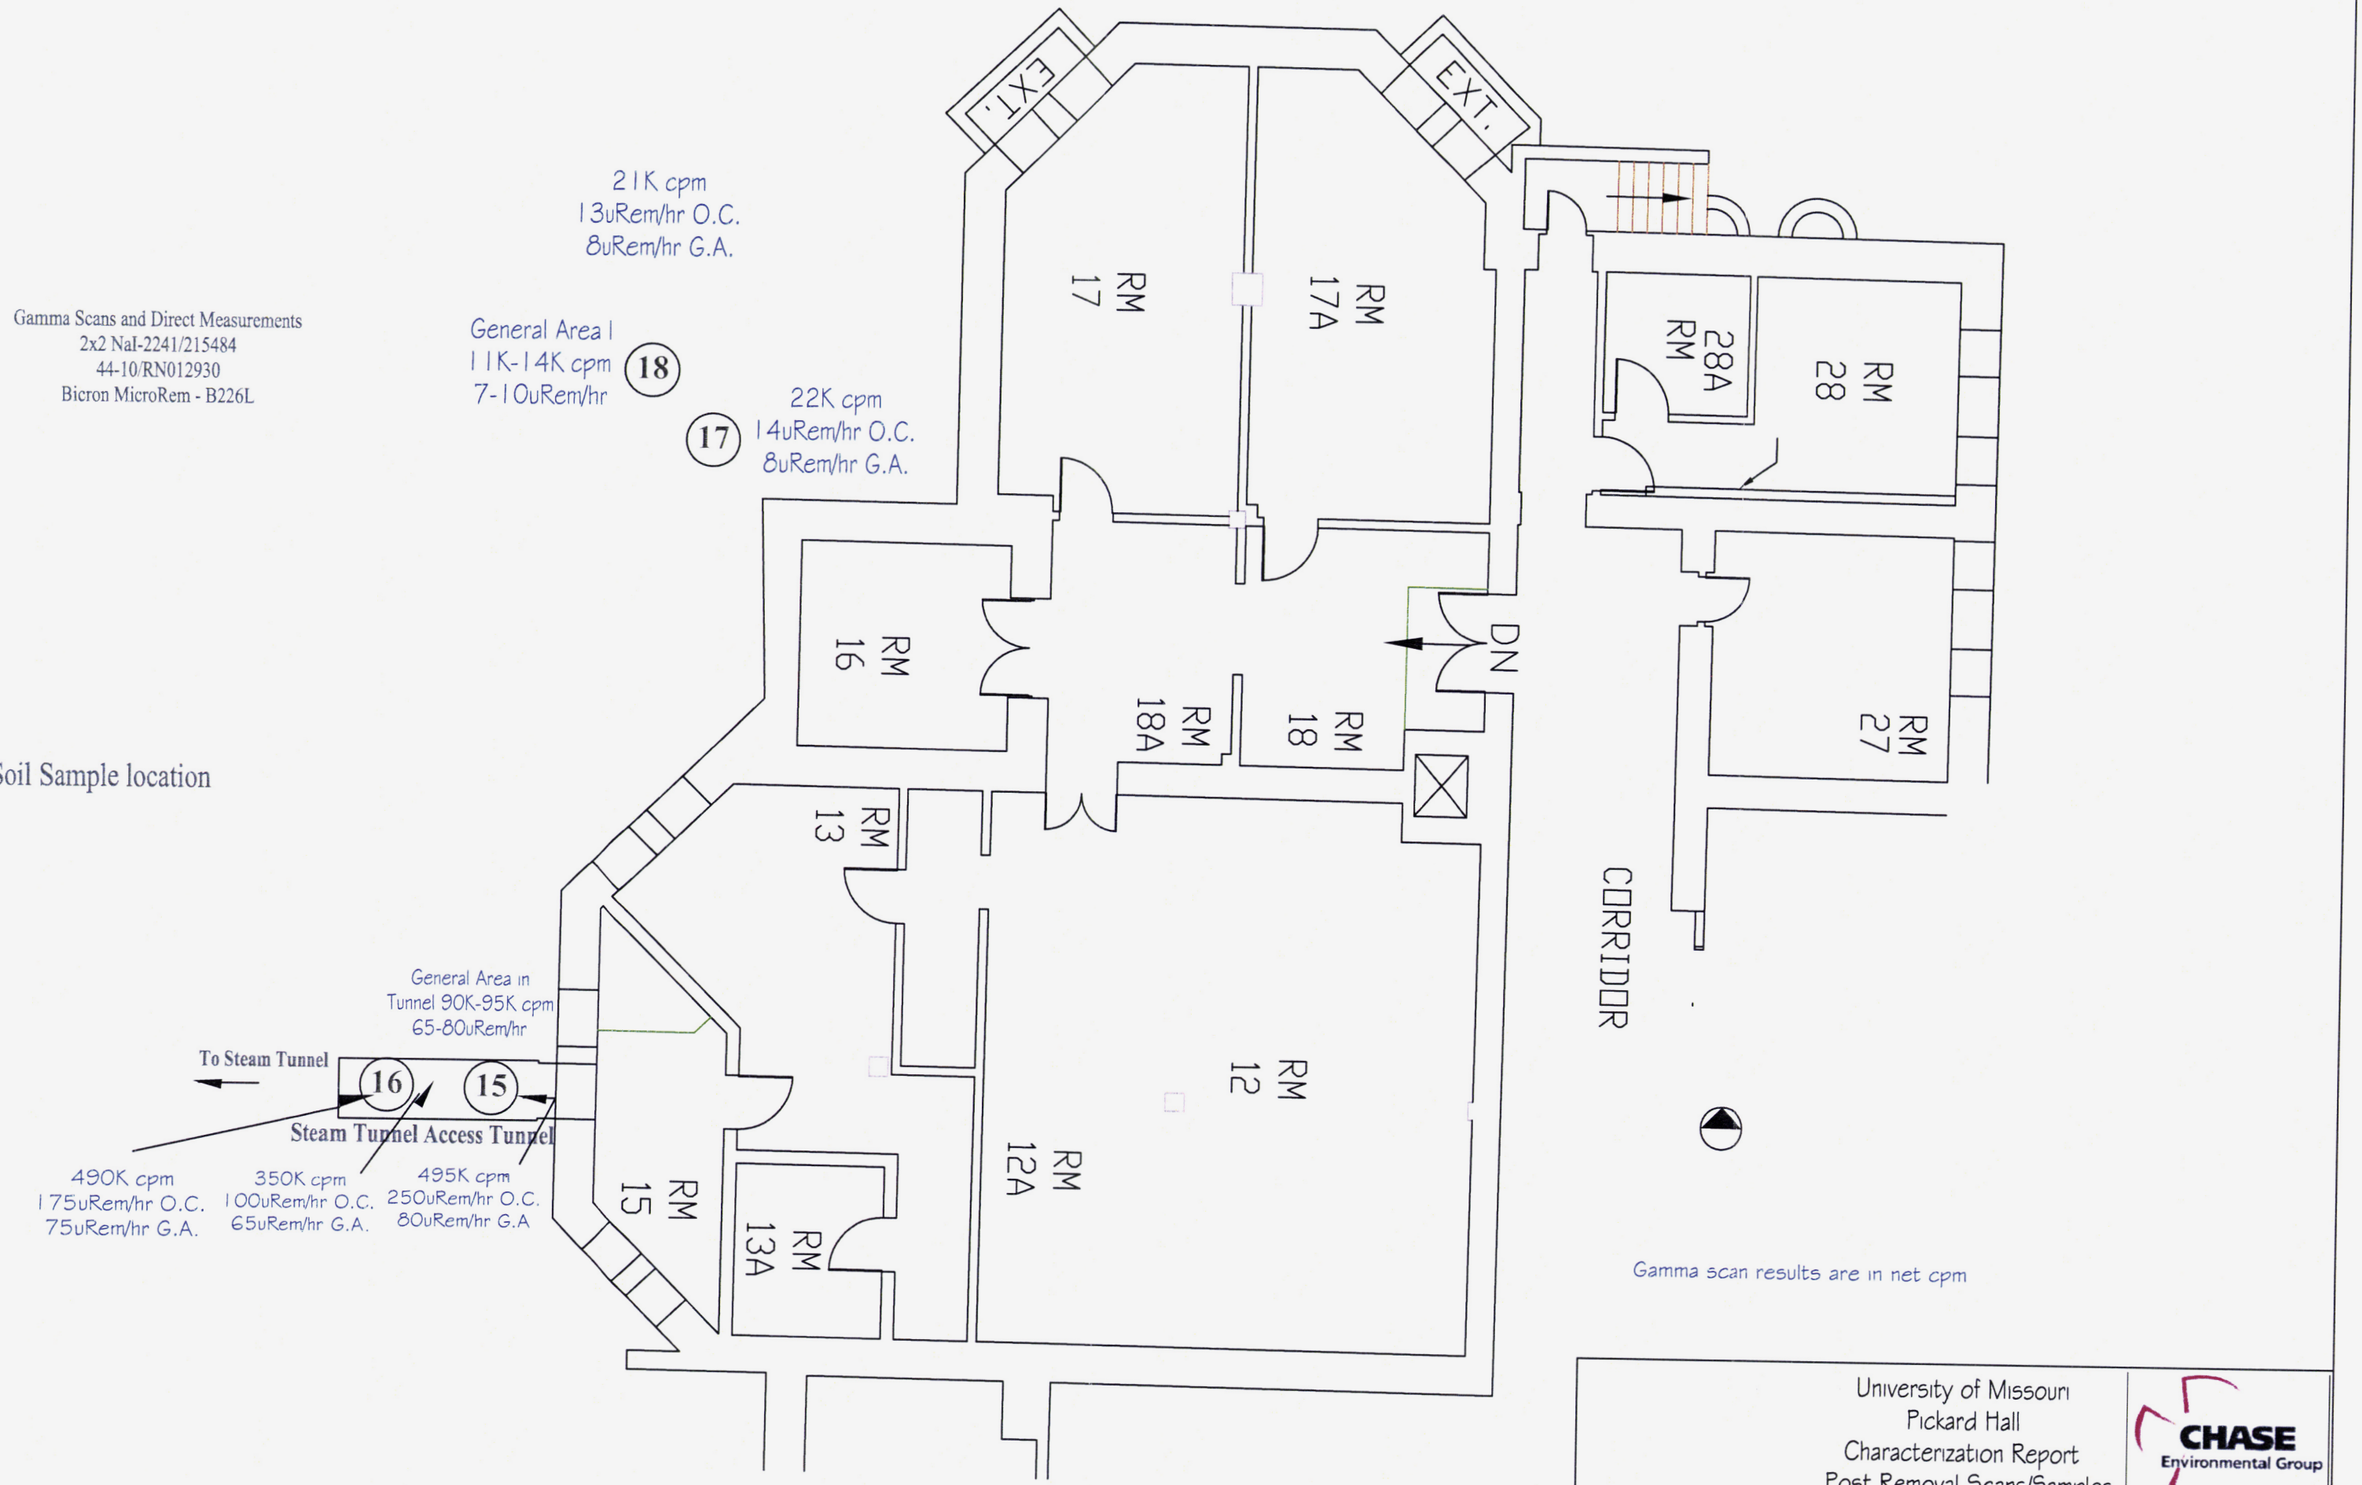
Building: Pickard Hall	Elevation: Tunnel/Grounds	Page: G.2 of G.3

Inaccessible
Due to Landscaping
