SUBJECT: PUBLIC MEETING CONDUCTED ON JANUARY 13, 2000

Plant Incident Report 1999-2650

*Unplanned descent of Unit 1
Reactor Coolant Pump Motor 1-03*

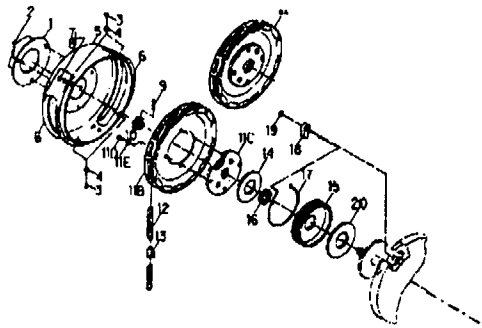
HANDWHEEL SIDE ASSEMBLY

- **Improper re-assembly of the hoist after a site re-build left the spindle unit gear teeth partly engaged. Subsequent usage resulted in the spindle unit working its way out of the gear assembly until thread engagement was lost.**

Spindle unit
Set screw
Load shaft
