**1999 Annual Site Inspection
and Monitoring Report for
Uranium Mill Tailings Radiation
Control Act Title I Disposal Sites**

January 2000

Long-Term Surveillance and Maintenance Program

1999 Annual Report

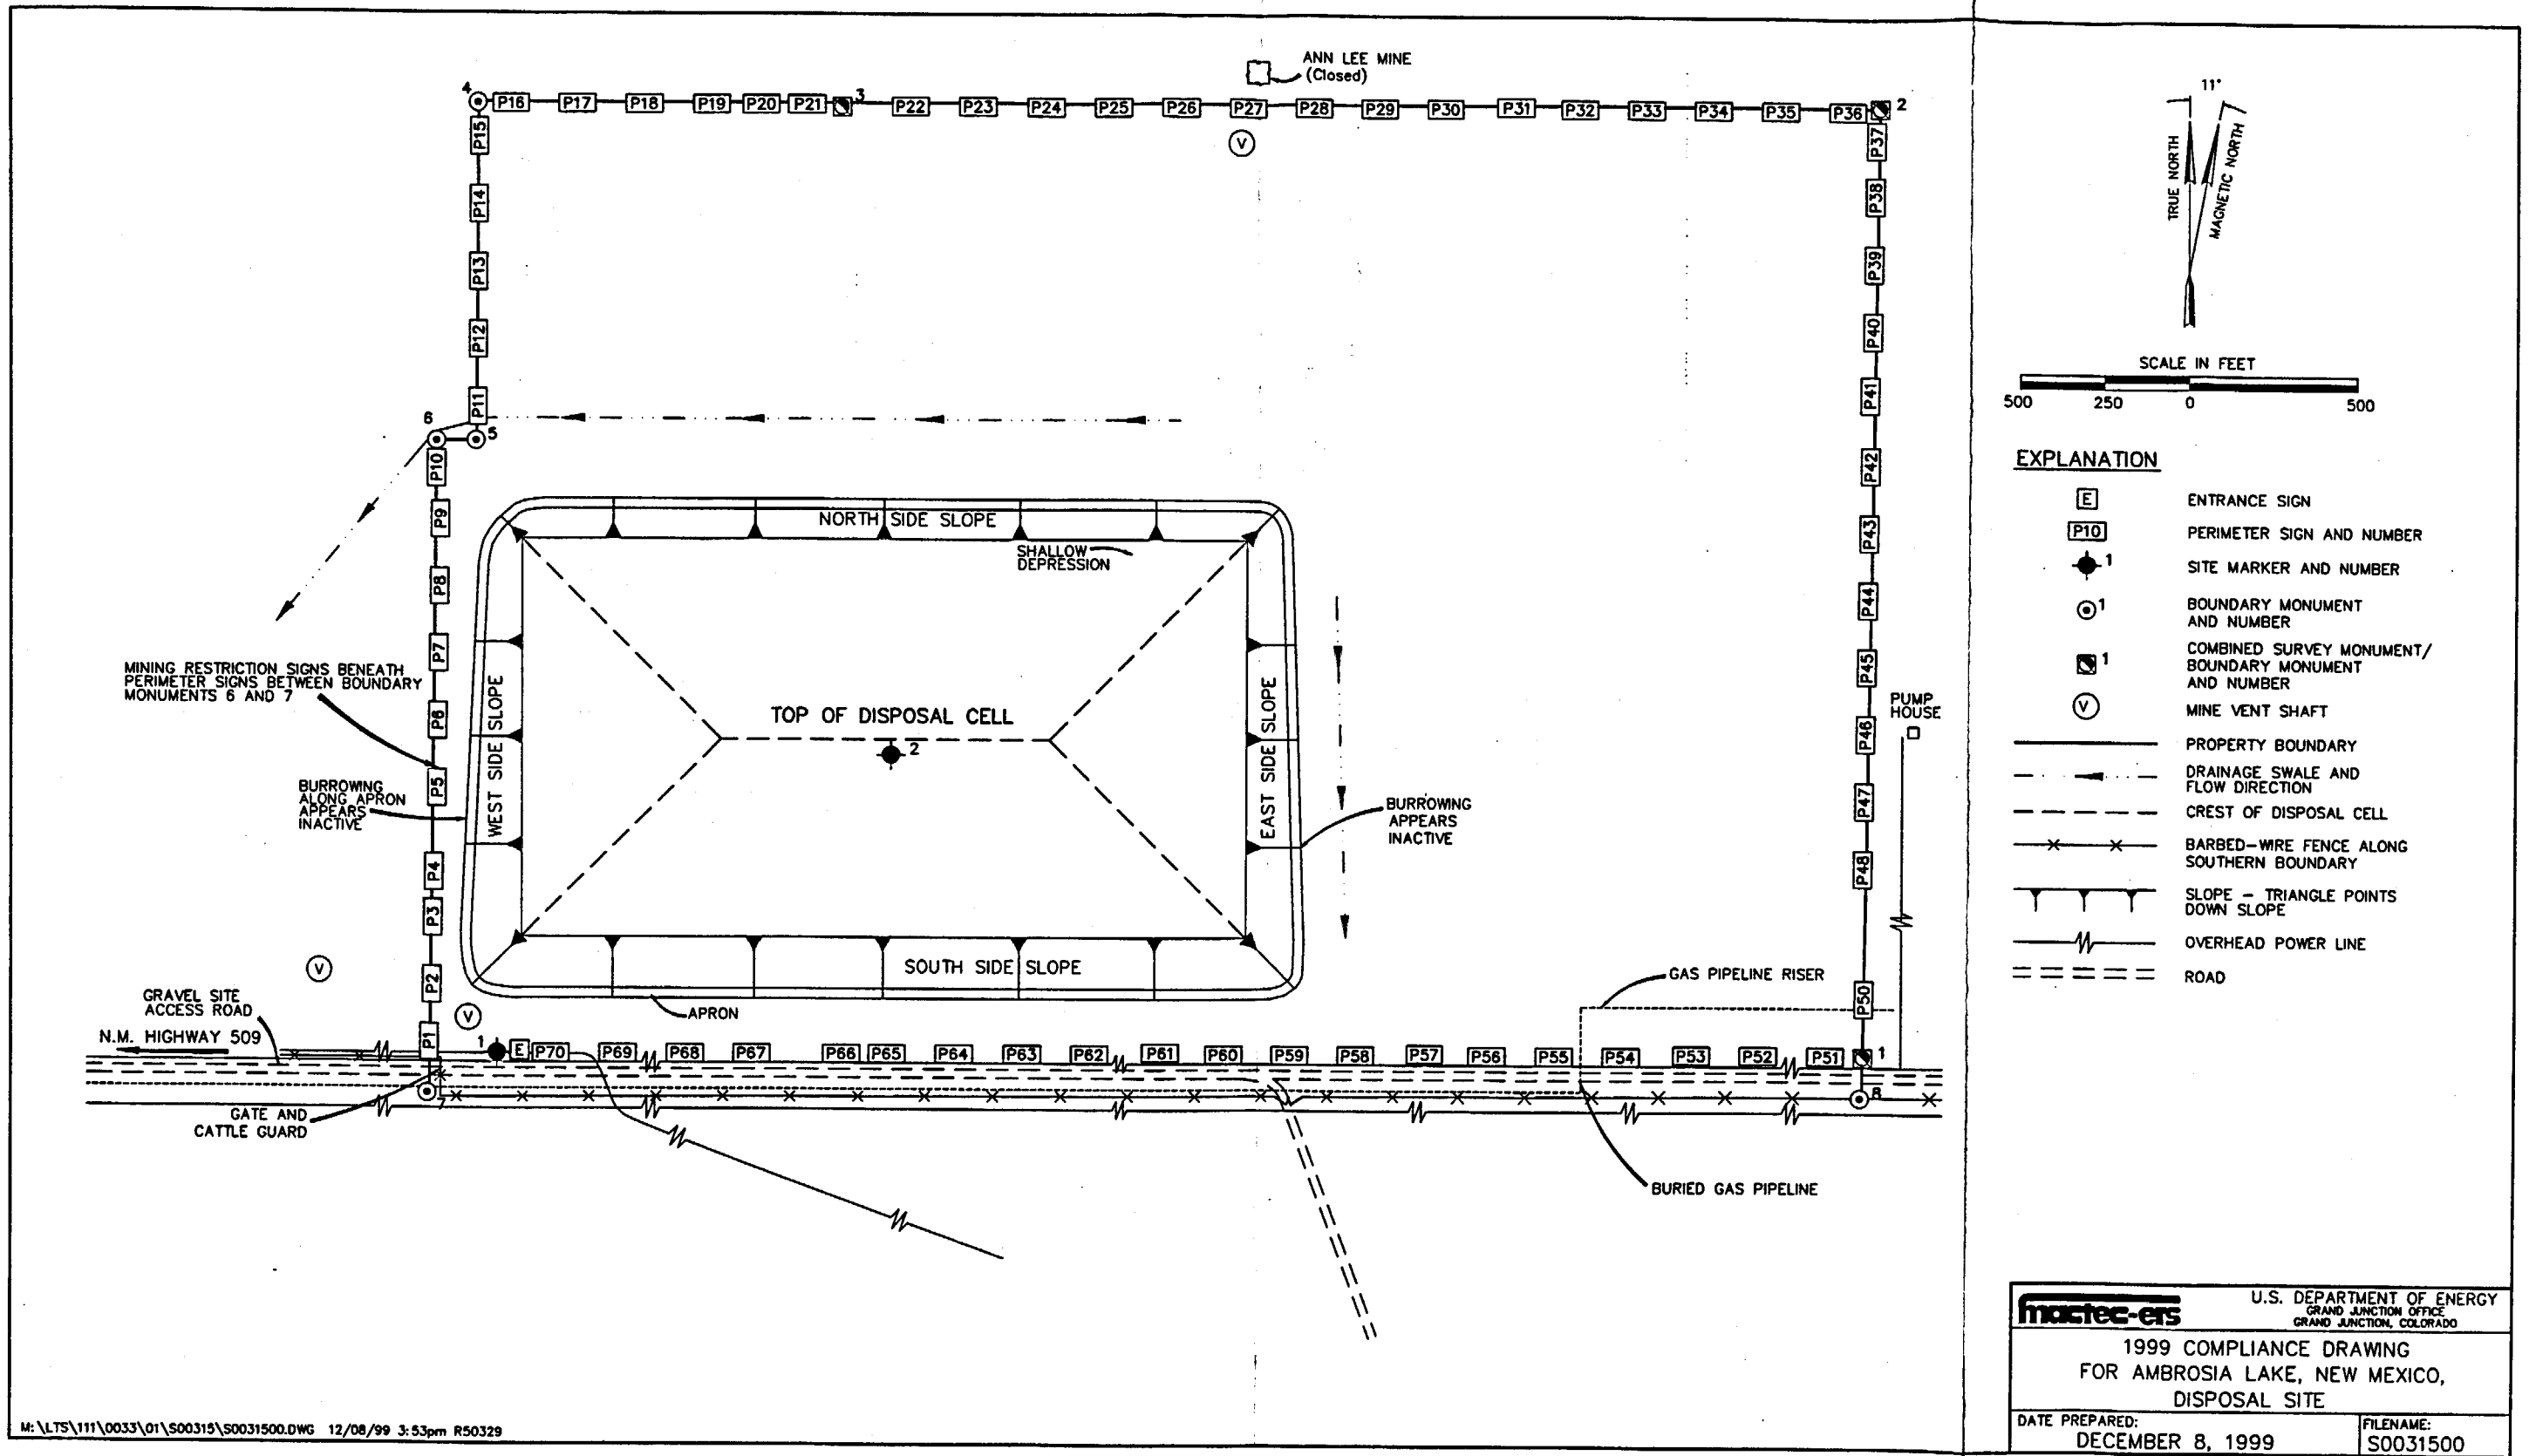
Figure AMB-1. 1999 Compliance Drawings for Ambrosia Lake, New Mexico, Disposal Site

Top of Disposal Cell. For the most part, the top of the disposal cell was in excellent condition. There was no evidence of cracking, slumping, or erosion. There is a shallow depression around the displacement monument, DM-4, at the northeast corner of the disposal cell. This depression was discovered during the 1997 inspection but now appears unchanged. It is believed to be an artifact of final grading before the riprap was laid down. The depression is no longer considered significant, although it will be monitored from year to year.

Annual weeds on top of the disposal cell were withered and dead. The plants are probably *Kochia* that dried out and died before reaching maturity and producing seeds. The plants appear to grow where the riprap is thin or filled with fine-grained materials, an artifact of installation. The fine-grained material (sand and dirt) apparently retains moisture and provides a rooting medium. The weeds, so far, are not a problem because they die while still immature.

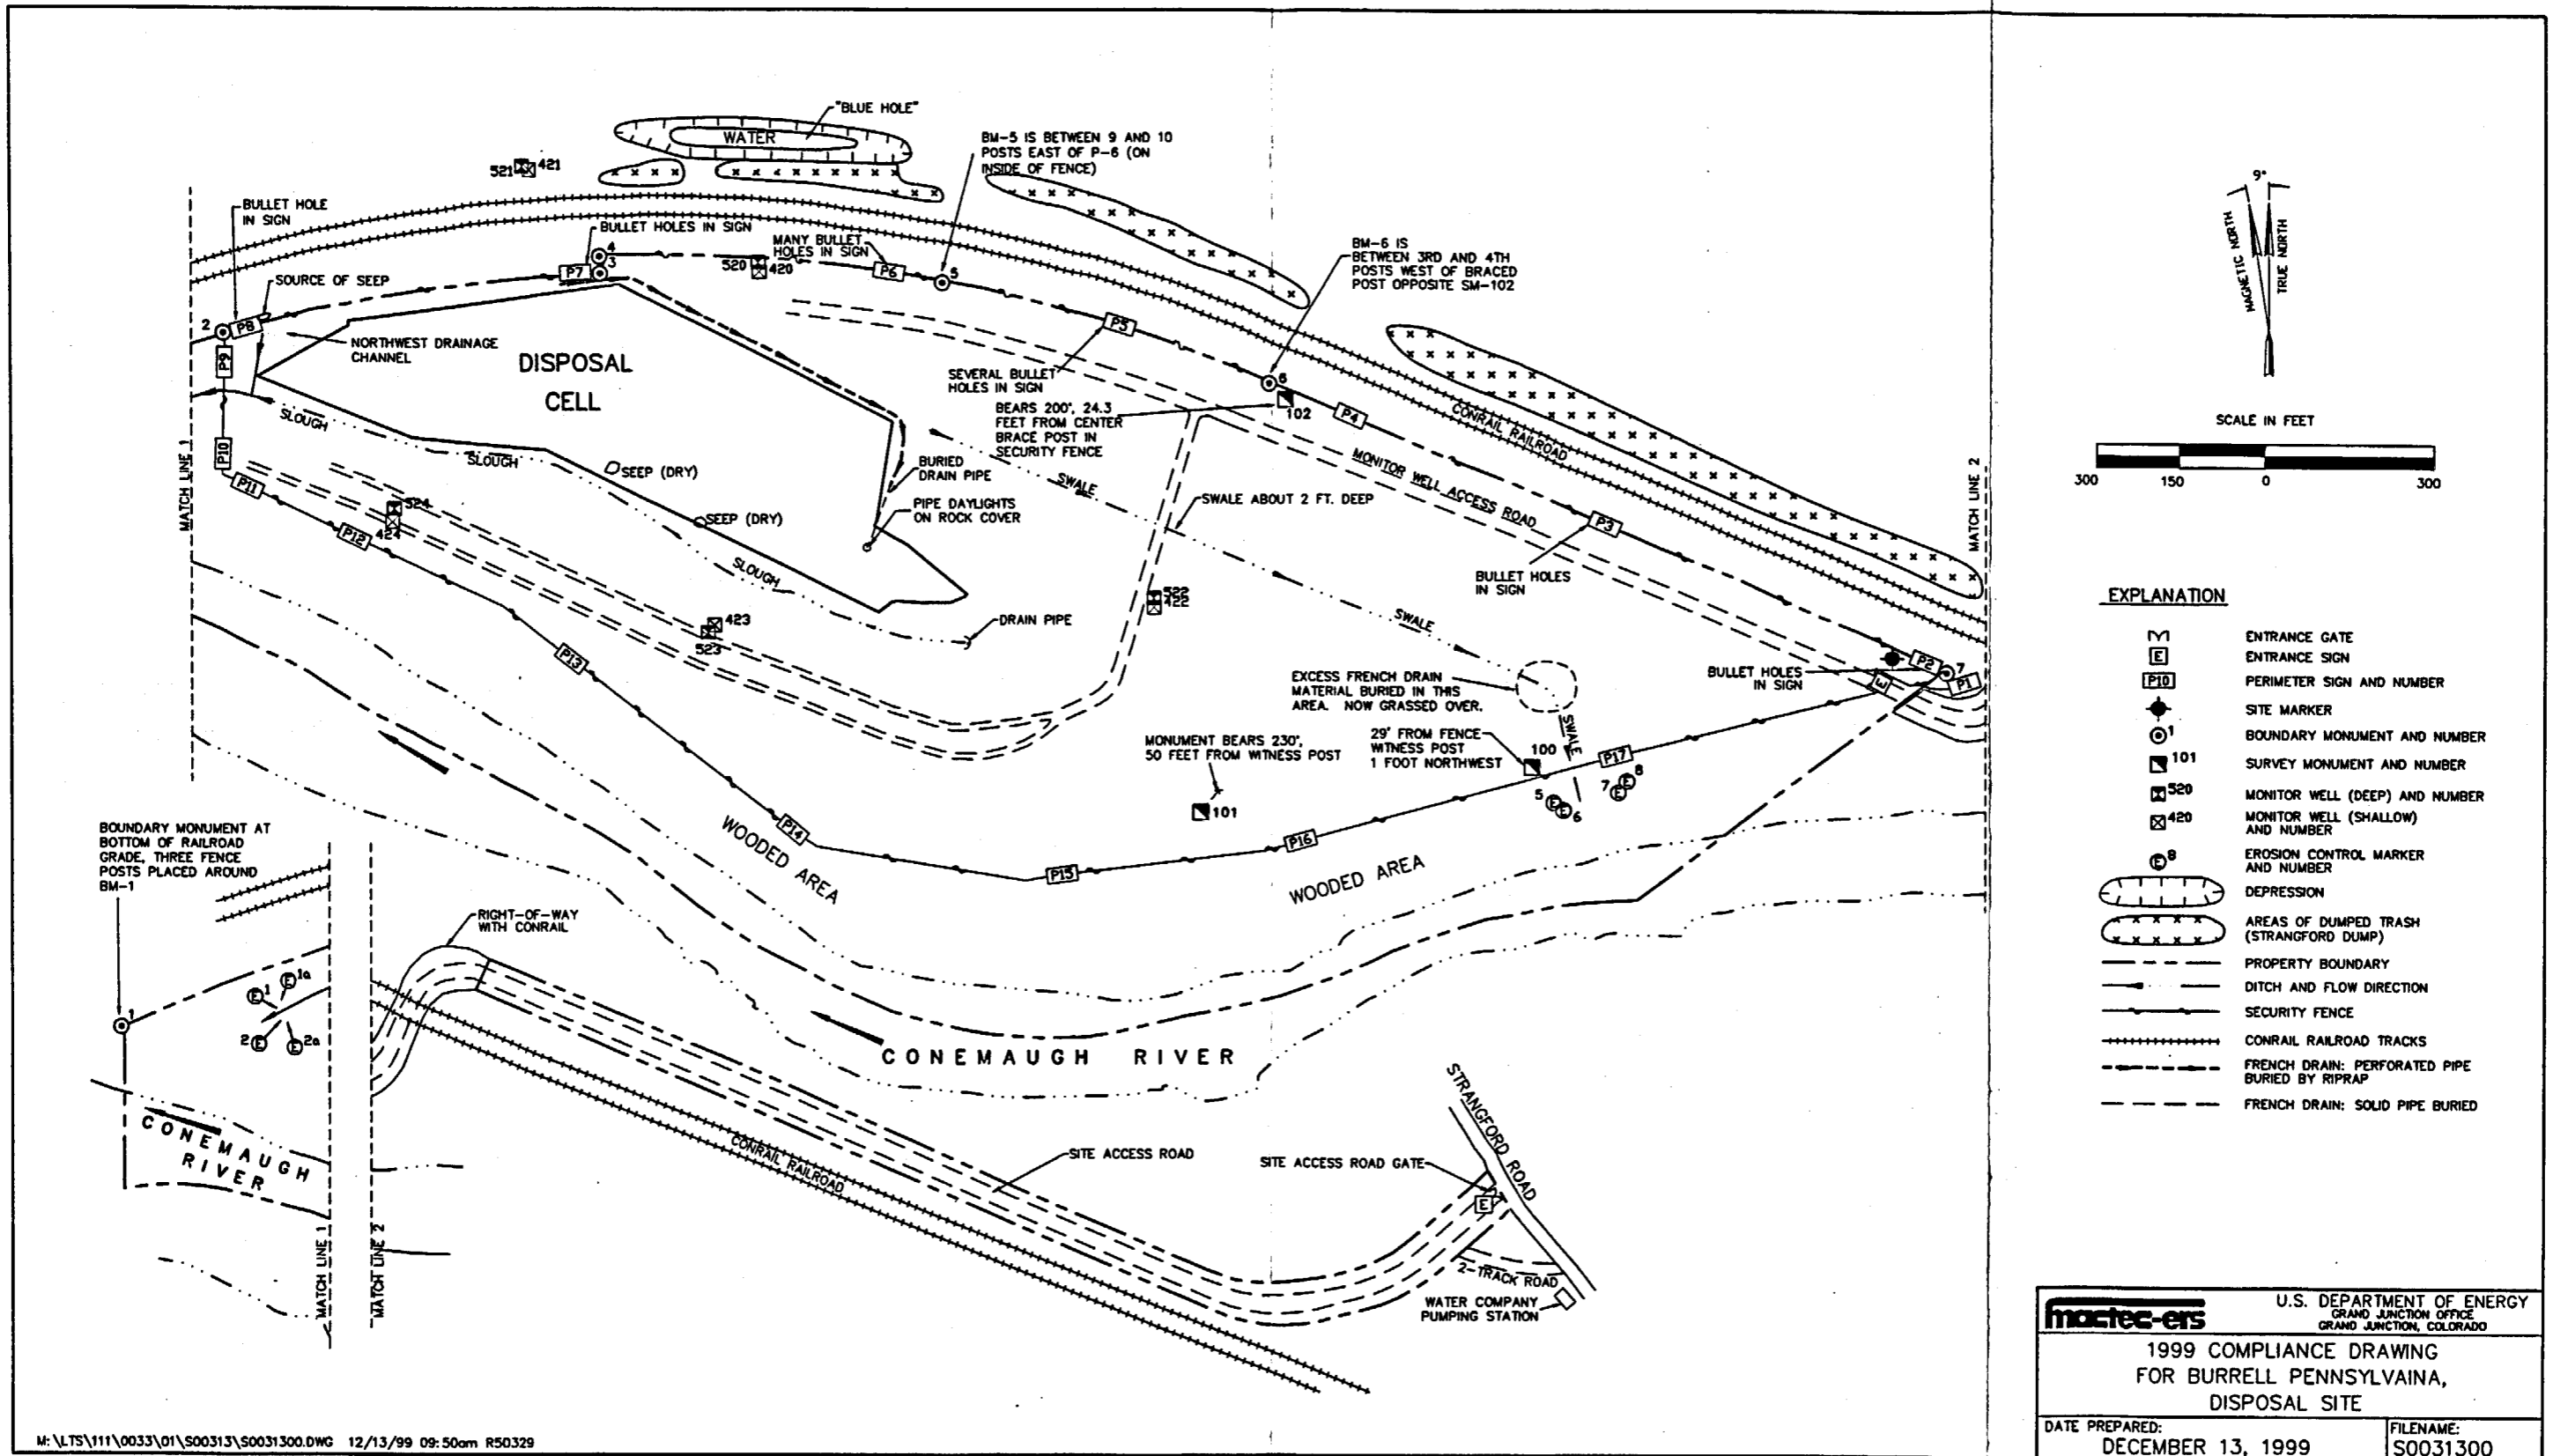
Figure BUR-1. 1999 Compliance Drawings for Burrell, Pennsylvania, Disposal Site

Trees and shrubs have established aggressively on the disposal cell. With the exception of a 0.5-acre test plot on the south side slope of the disposal cell, DOE has sprayed the vegetation on the disposal cell several times, most recently in July 1998. That spraying resulted in a thorough kill; however, (1) there is abundant dead woody plant material on the disposal cell, and (2) trees

and bushes are beginning to reappear because of a virtually infinite seed supply from wooded areas surrounding the disposal cell.

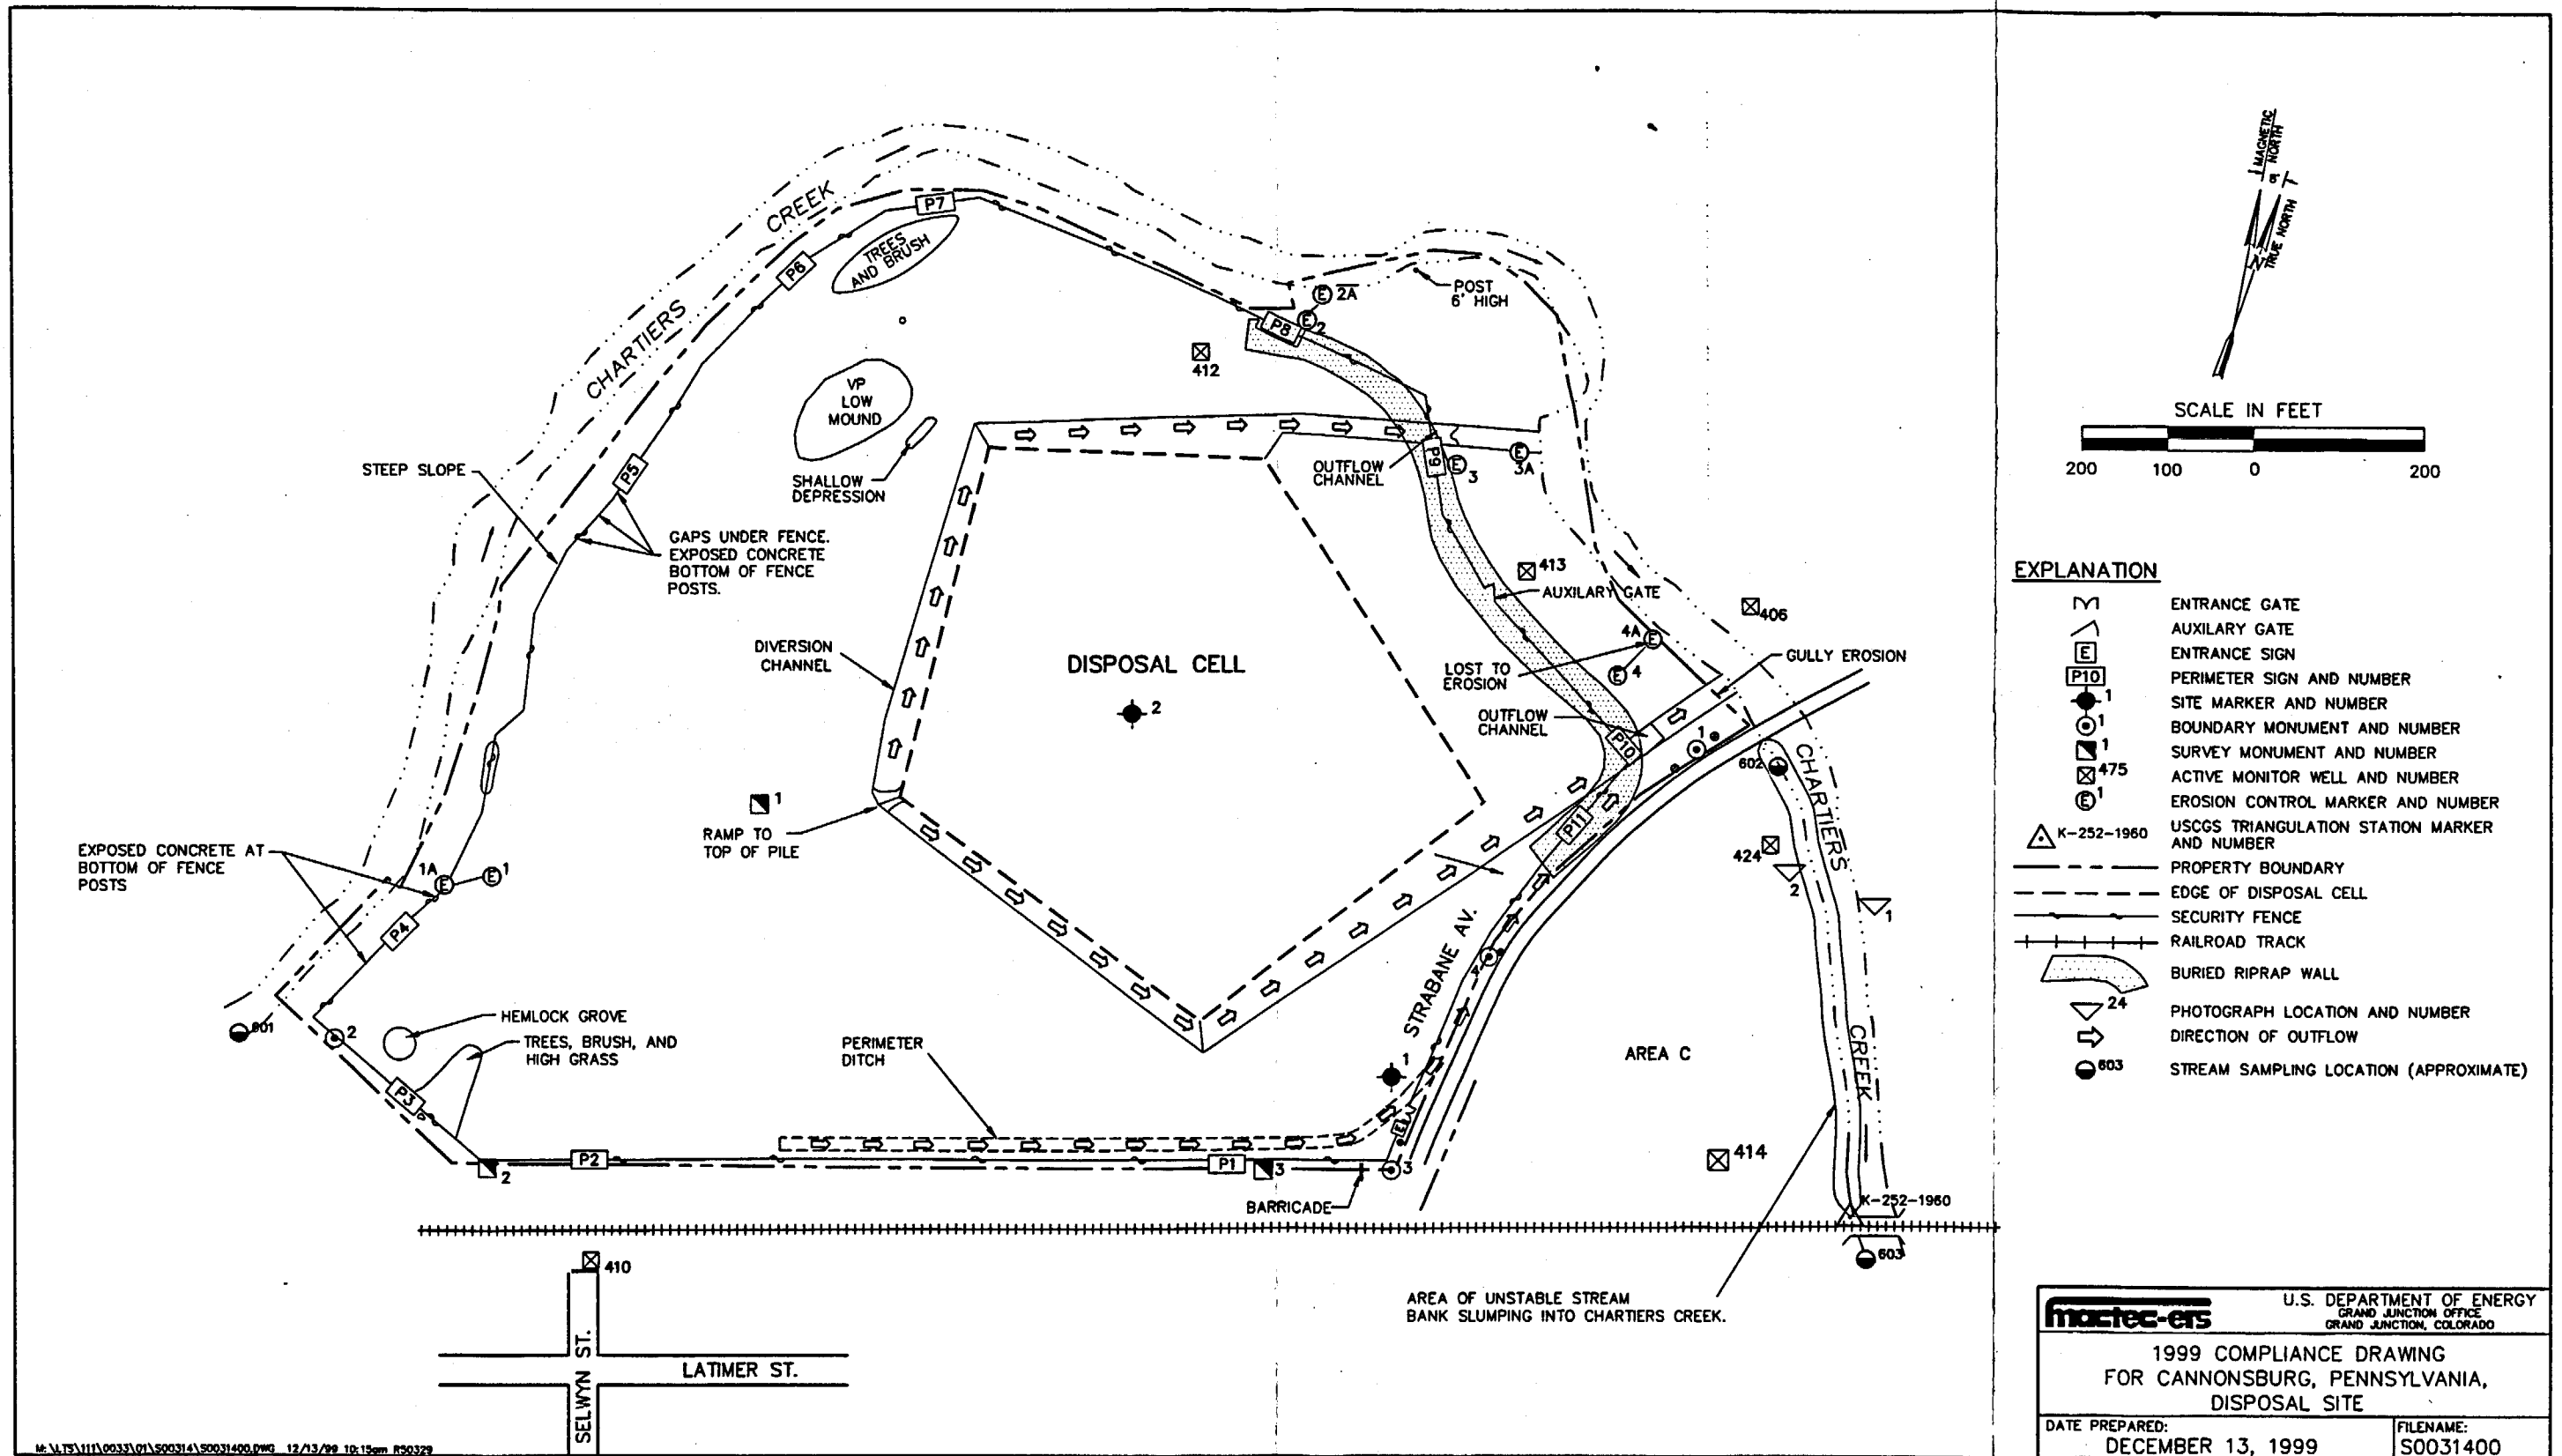
Figure CAN-1. 1999 Compliance Drawings for Canonsburg, Pennsylvania, Disposal Site

Disposal Cell. The disposal cell is grass-covered and in excellent condition. The grass is mowed and mulched annually, most recently in August 1999. There was no animal activity or evidence of erosion, settlement, slumping, or other indication of instability.

Grassed Area Surrounding the Disposal Cell. The thick grass that covers the disposal cell also covers the area surrounding the disposal cell and extends beyond the security fence to the creek, from ECM-2 eastward to the Strabane Avenue bridge. The grass, mowed and mulched annually, is in excellent condition.

There are several groves of large trees and bushes in this transect. Beginning in 1994, dead trees and branches have been removed periodically from these groves. The entire area inside the fence is now park-like and well kept. Trees and branches in these groves and from along the fence line (see below) will continue to be removed as necessary.

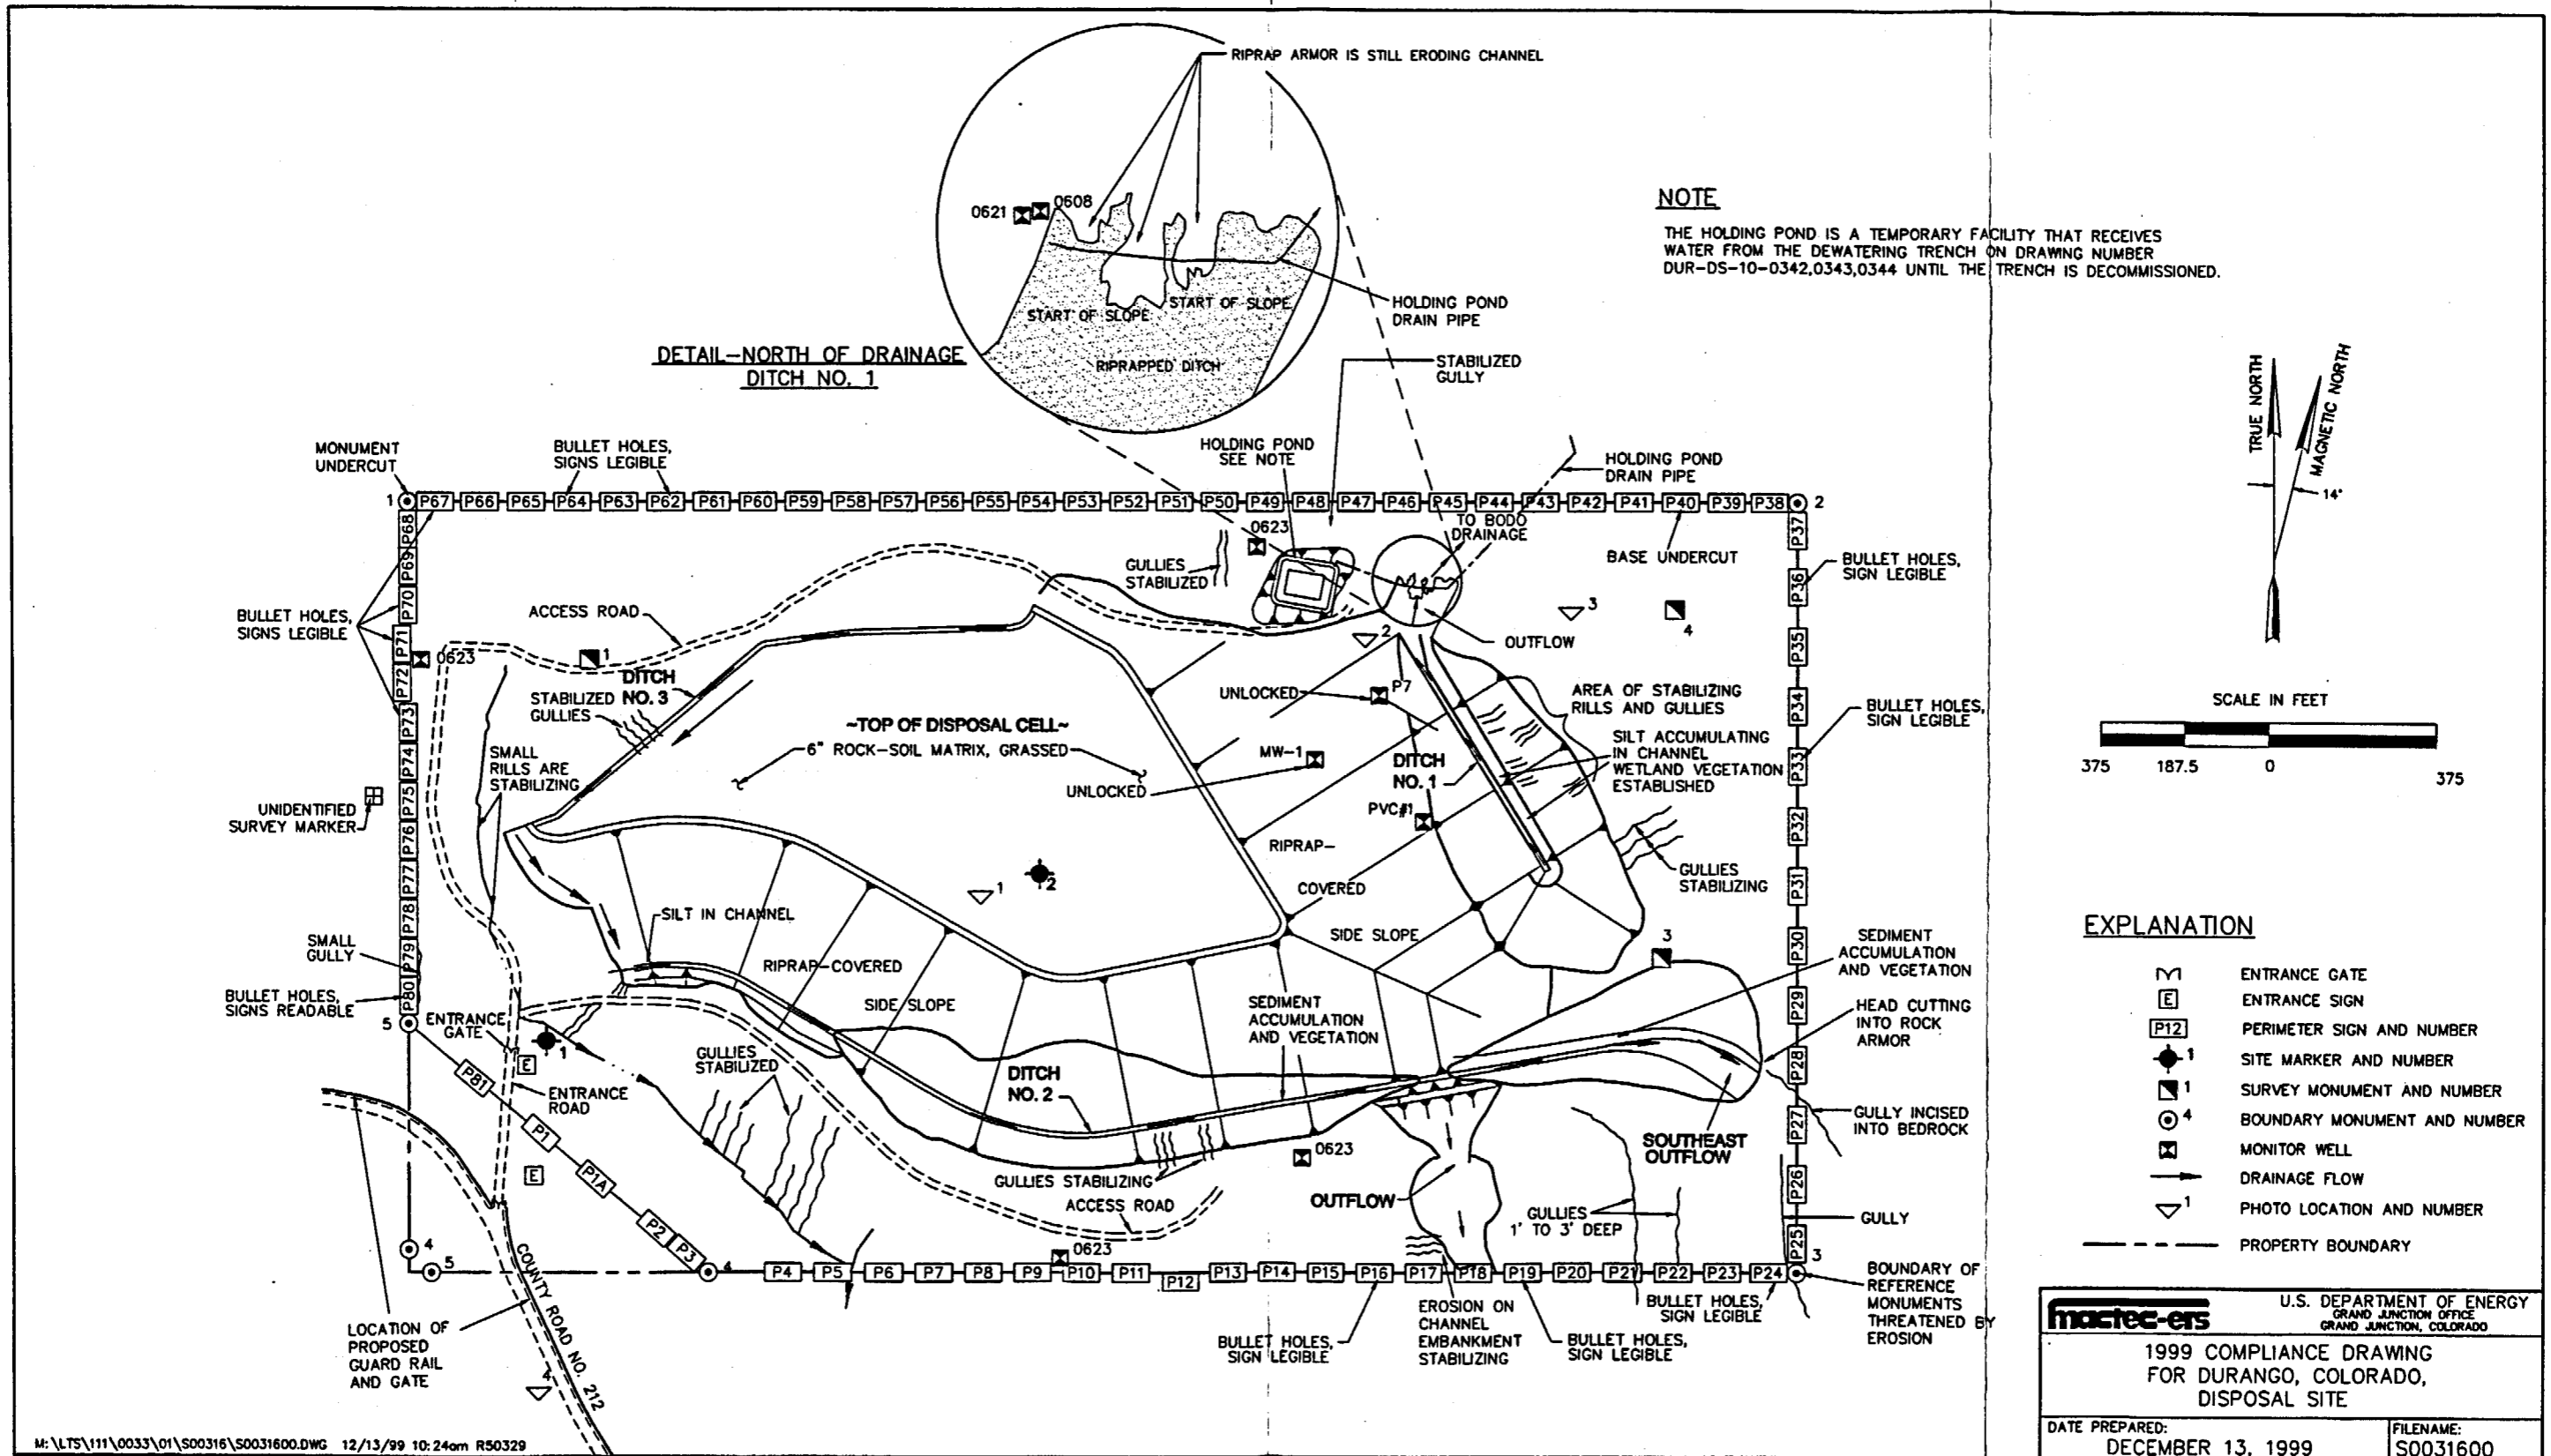
Figure DUR-1. 1999 Compliance Drawings for Durango, Colorado, Disposal Site

In 1998, inspectors reported that vegetation on the top of the disposal cell had changed significantly. Yellow sweetclover dominated the plant community; and perennial grasses, once well-established, appeared stressed or dead. Inspectors suggested that this might be a response to changes in the soil water and nutrient status. This year, however, after spring rains, inspectors found perennial grasses healthy and restored (DUR PL-1). Very little sweetclover was present on top of the disposal cell. The vigor of the perennial grasses appears to be moisture dependent.

Rabbitbrush and four-wing saltbush, both deep-rooted shrubs, grow near the east end of the top slope. Occasional rabbitbrush and willow grow along the edge of the top slope. Because they are few, deep-rooted plants do not currently threaten the performance of the cover. However, given that the number of shrubs and trees is likely to increase, the effects of these deep-rooted plants on the long-term performance of the cover warrants evaluation. This evaluation is currently underway by the DOE's Long-Term Performance Monitoring and Cover Assessment Project.

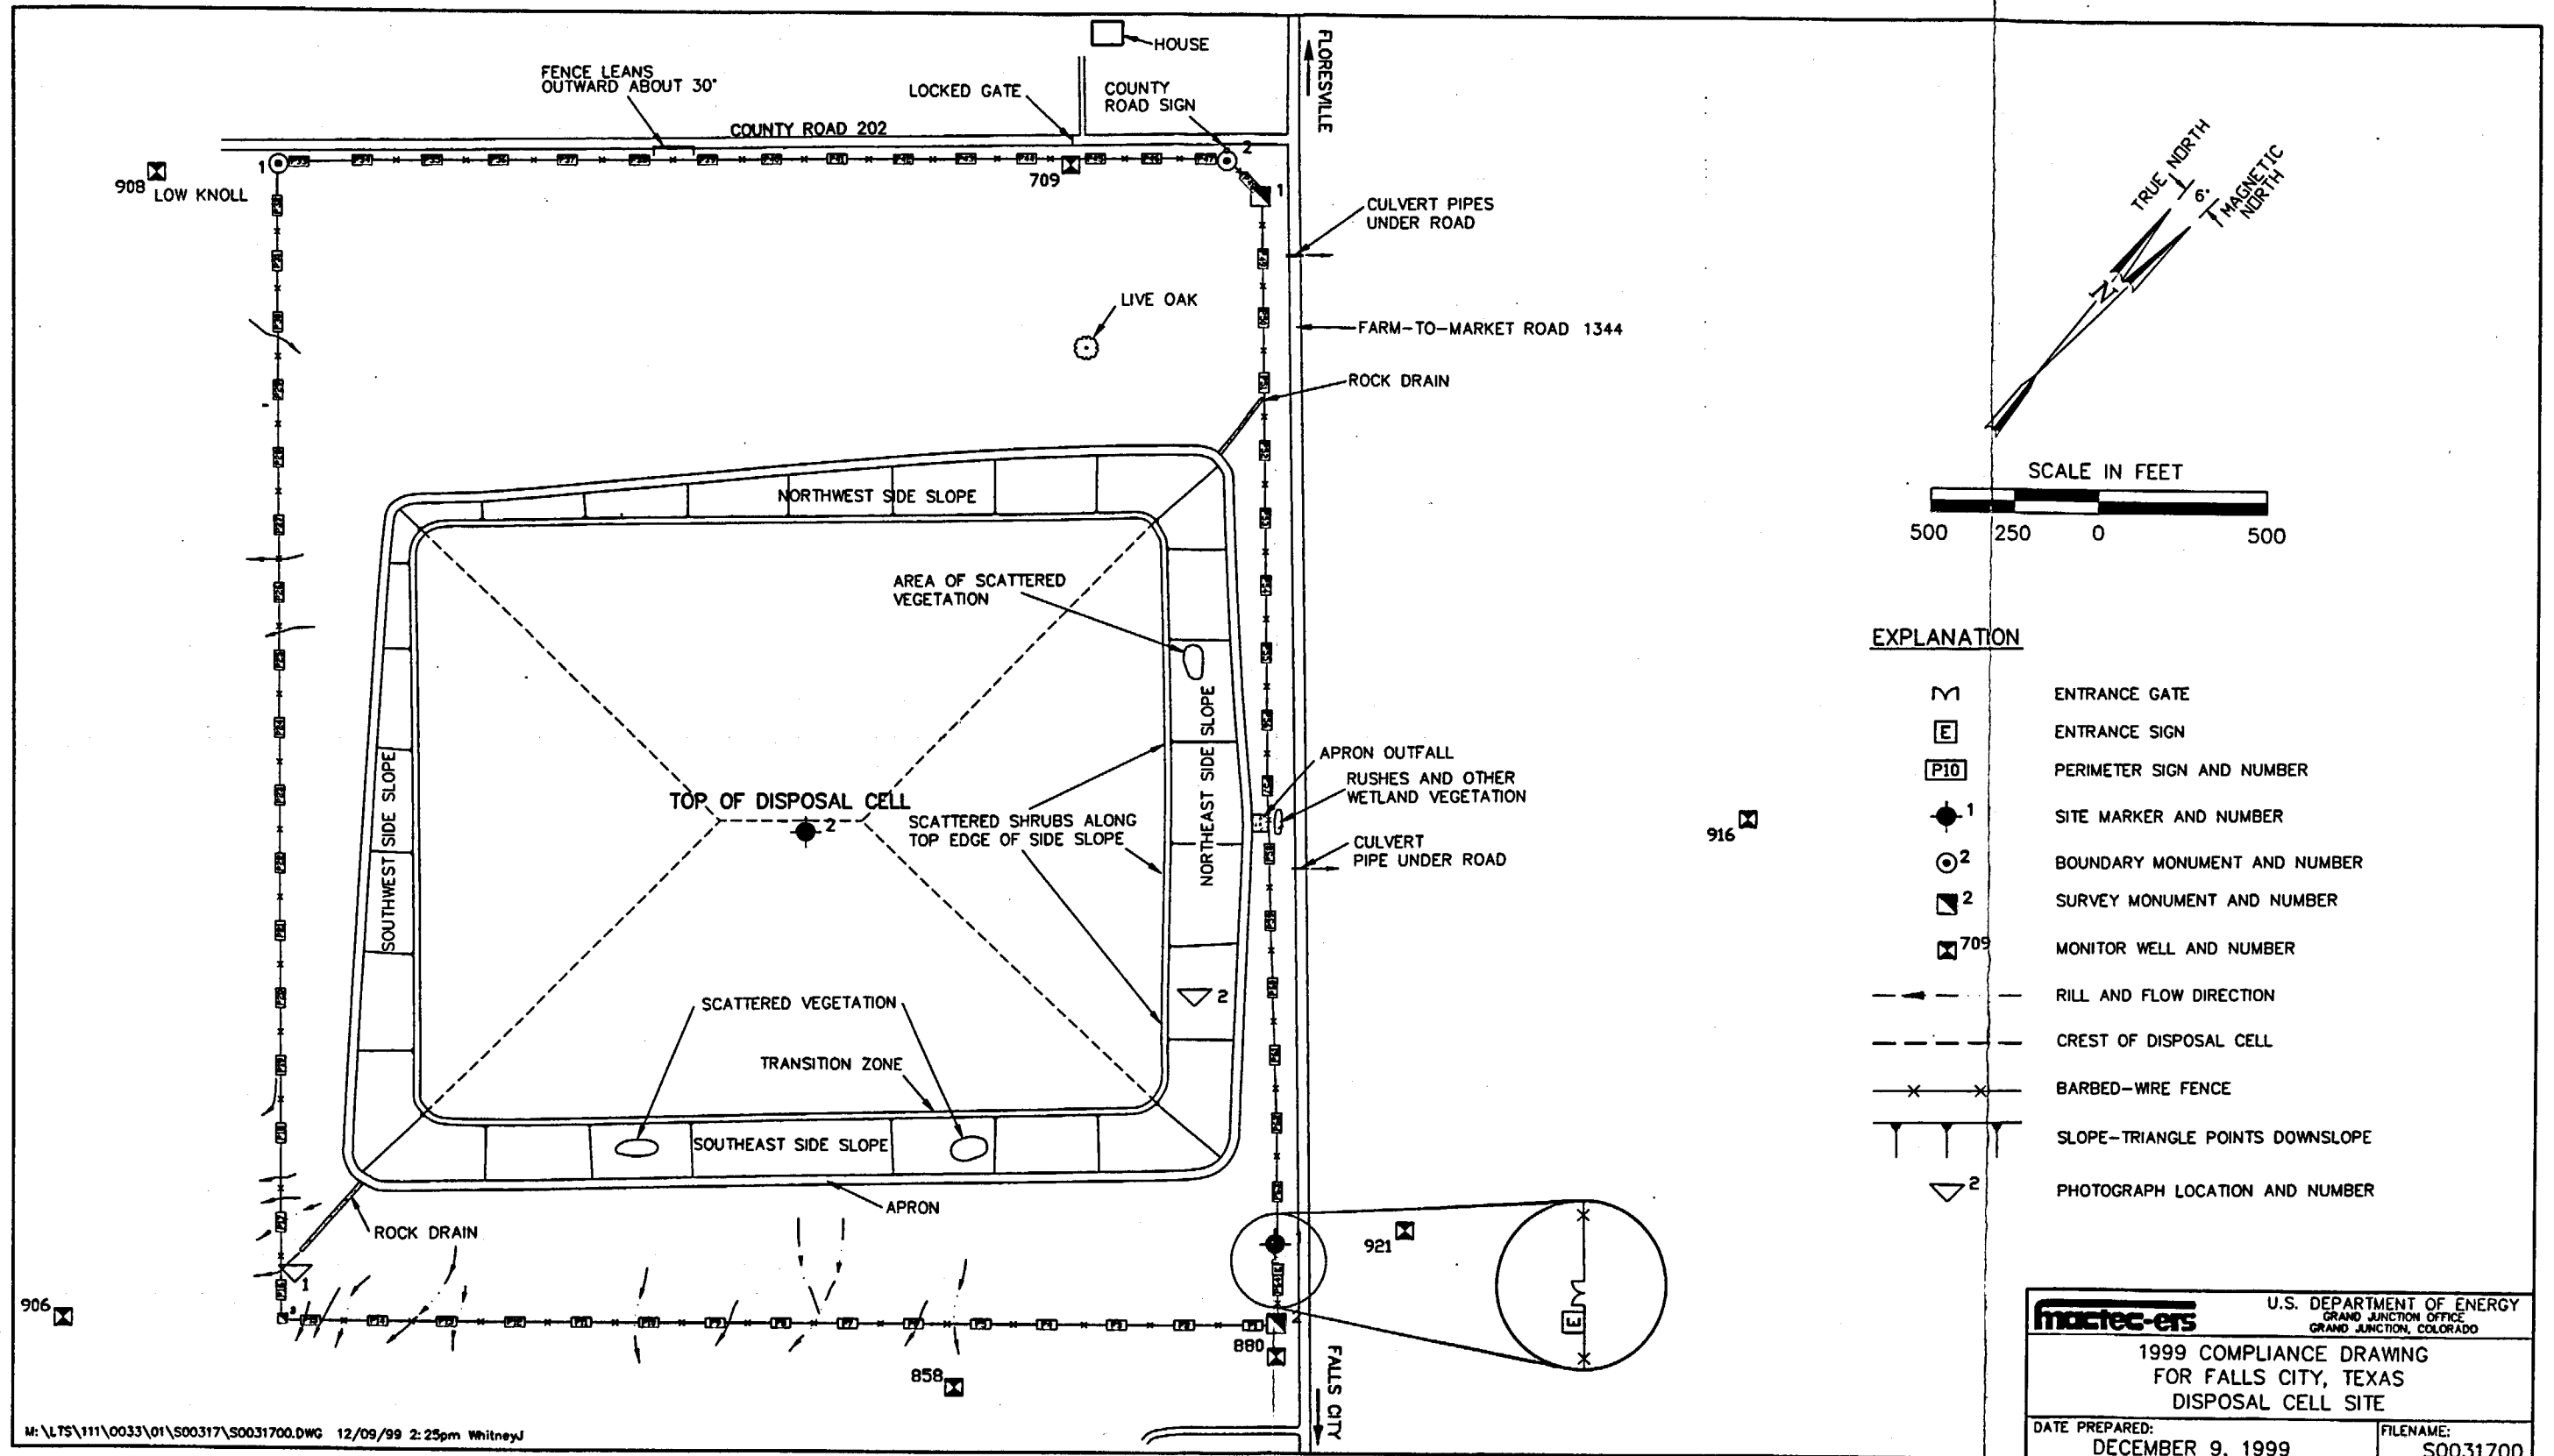
Figure FCT-1. 1999 Compliance Drawings for Falls City, Texas, Disposal Site

Small scattered trees and bushes, including greasewood, "upland willow," Palo Verde, and possibly others, are beginning to grow in the rock on the side slopes. Greasewood, and similar species, are concerns because they are deep-rooted. Inspectors used a systemic herbicide (Roundup) on the shrubs during the 1999 inspection and expect to do so during future inspections.

There are no trees on top of the disposal cell or in grassed areas immediately adjacent to the disposal cell. Grass cutting appears to effectively control these plants. Unfortunately, the riprap-covered side slopes of the disposal cell can not be cut.
