**1999 Annual Site Inspection
and Monitoring Report for
Uranium Mill Tailings Radiation
Control Act Title I Disposal Sites**

January 2000

Long-Term Surveillance and Maintenance Program

1999 Annual Report

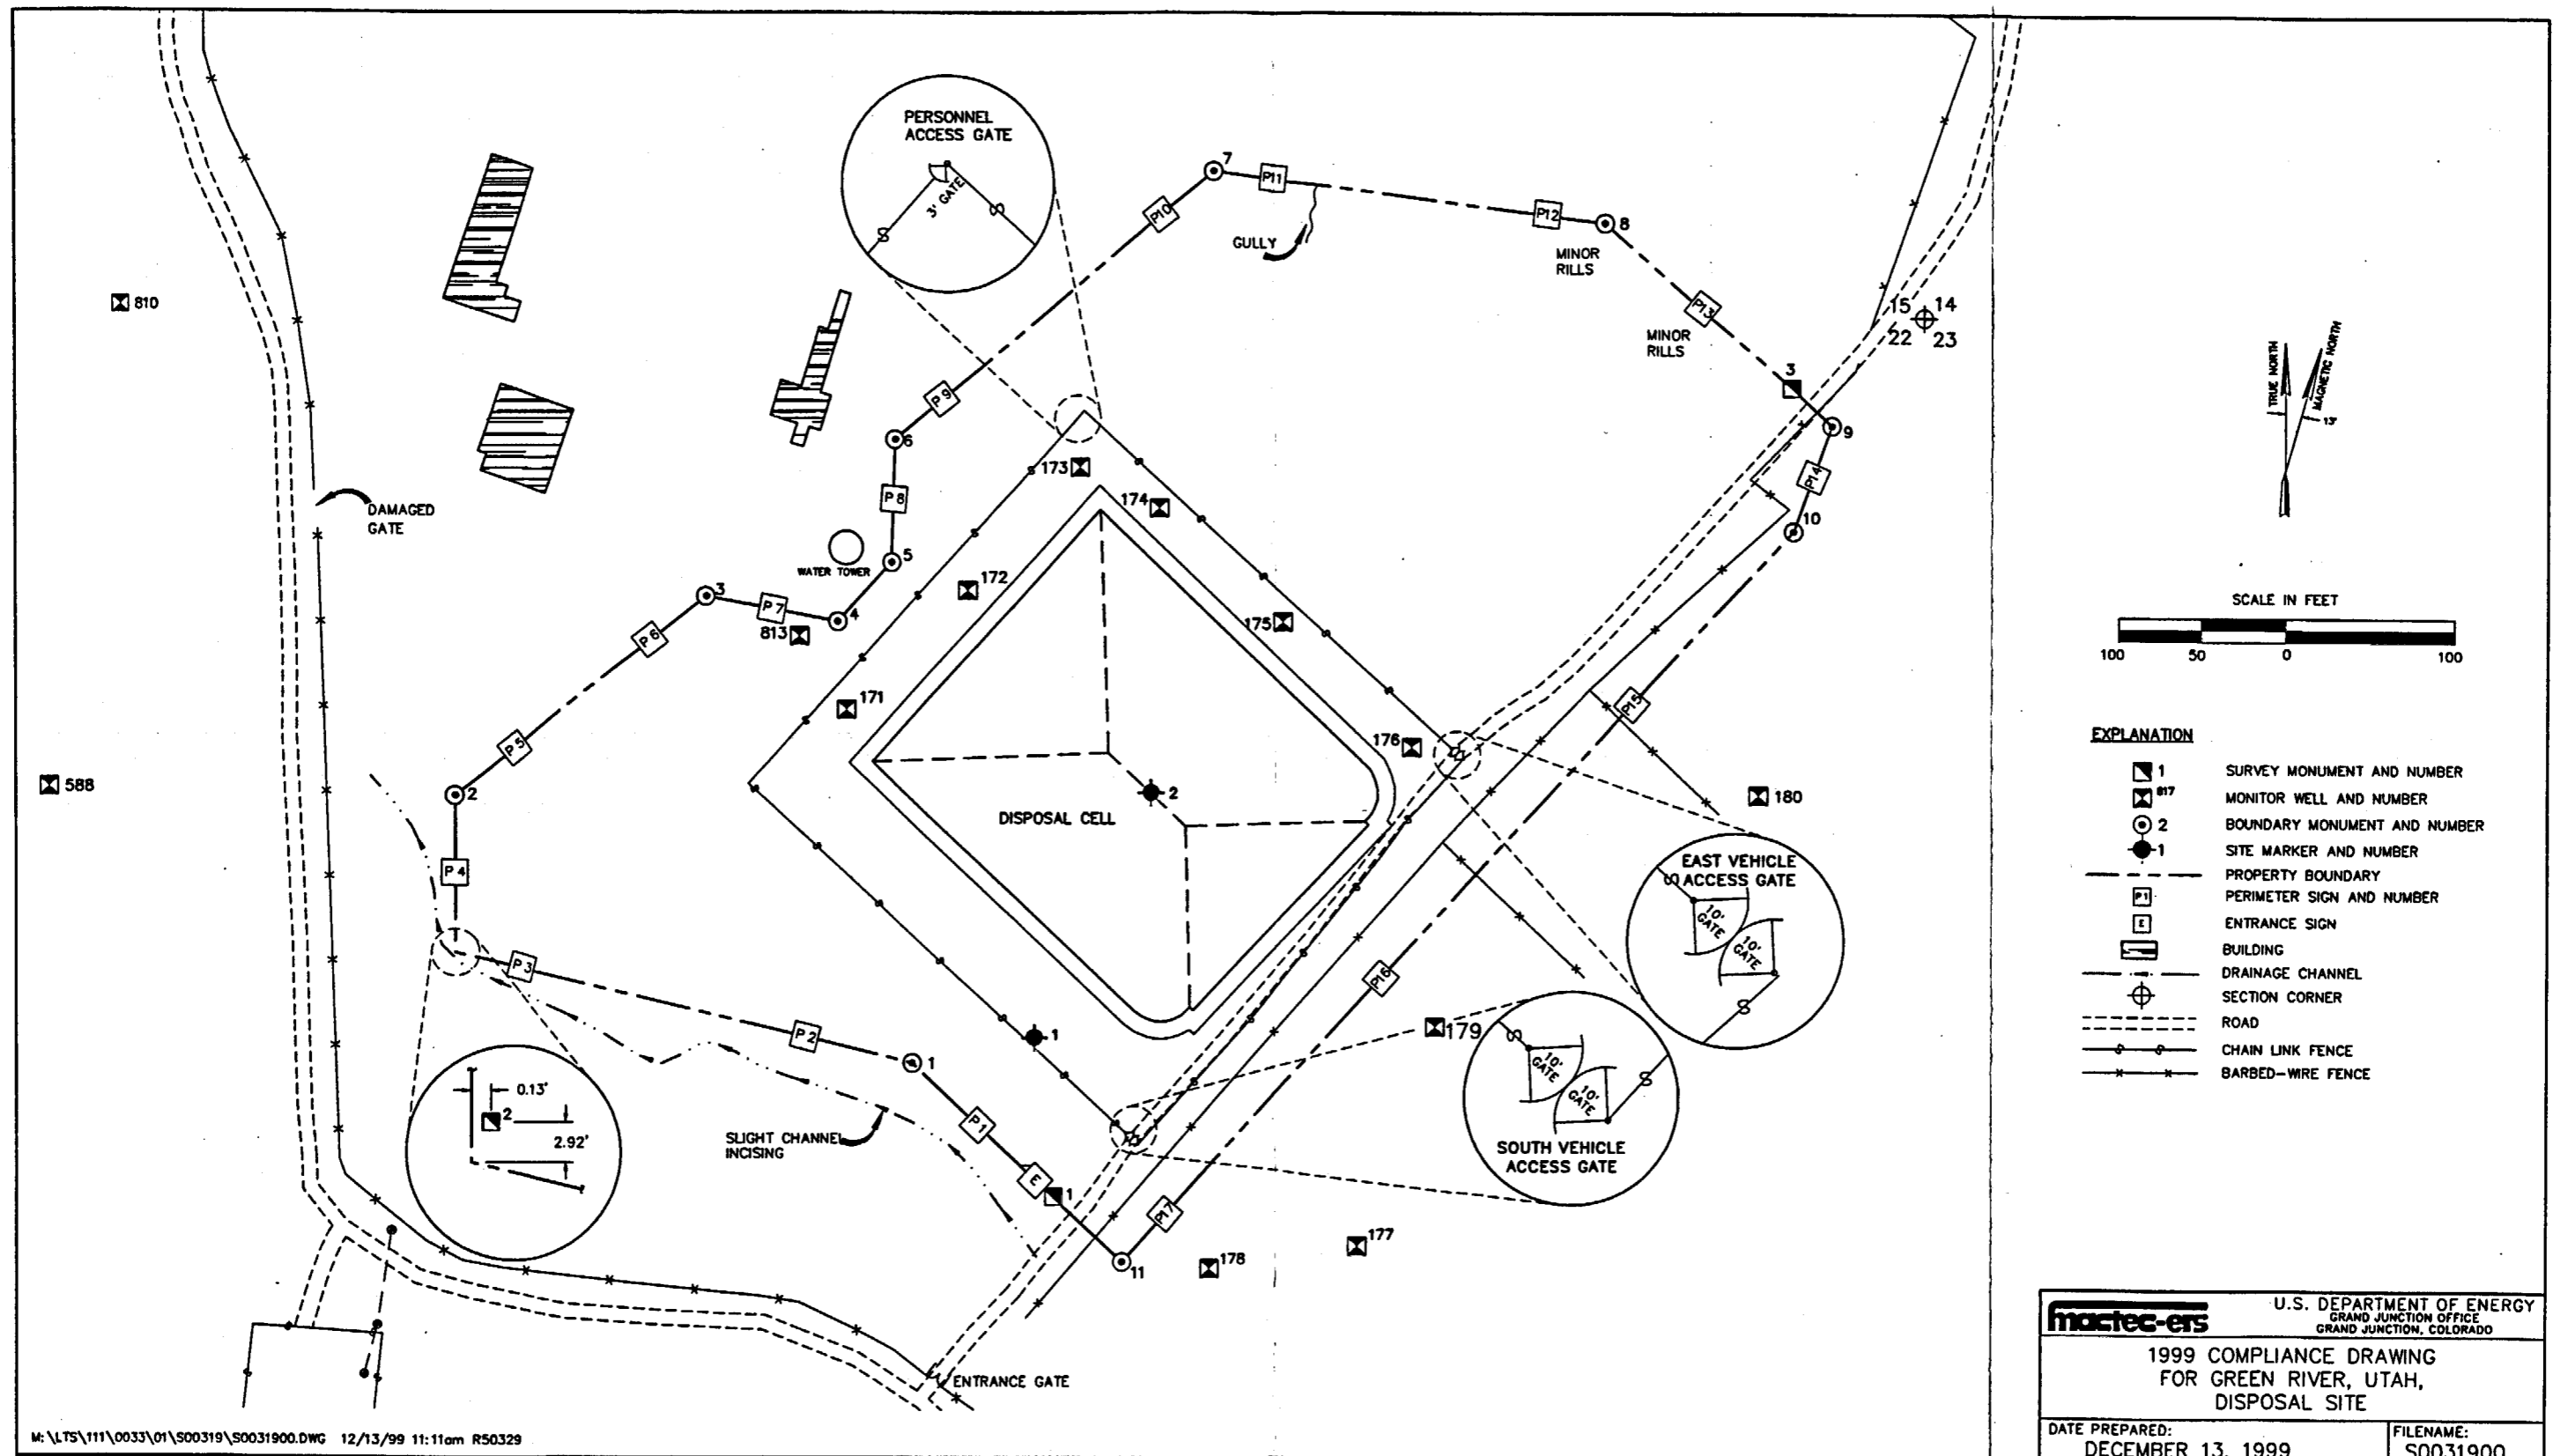
Figure GRN-1. 1999 Compliance Drawings for Green River, Utah, Disposal Site

Rill and gully erosion noted during previous inspections on the hillside northeast of the disposal cell in the area between BM-7 and SM-3 does not appear to be active. New vegetation is establishing in the bottom of the gully southeast of BM-7. This hillside is outside the DOE security fence and can be accessed by the public. No recent tracks were seen by inspectors this year. However, the installation of the security fence so close to the disposal cell leaves large portions of the site unsecured and unprotected.

Outlying Areas. The area extending outward from the site for a distance of 0.25 mile was observed for signs of erosion, development, or other disturbance that might affect site security or integrity. Areas of erosion noted during previous inspections include the natural drainage southwest of the site, several rills near survey marker SM-2, and gullies northwest of the water tower. Erosion in these areas appears unchanged from previous inspections and monitoring will continue.

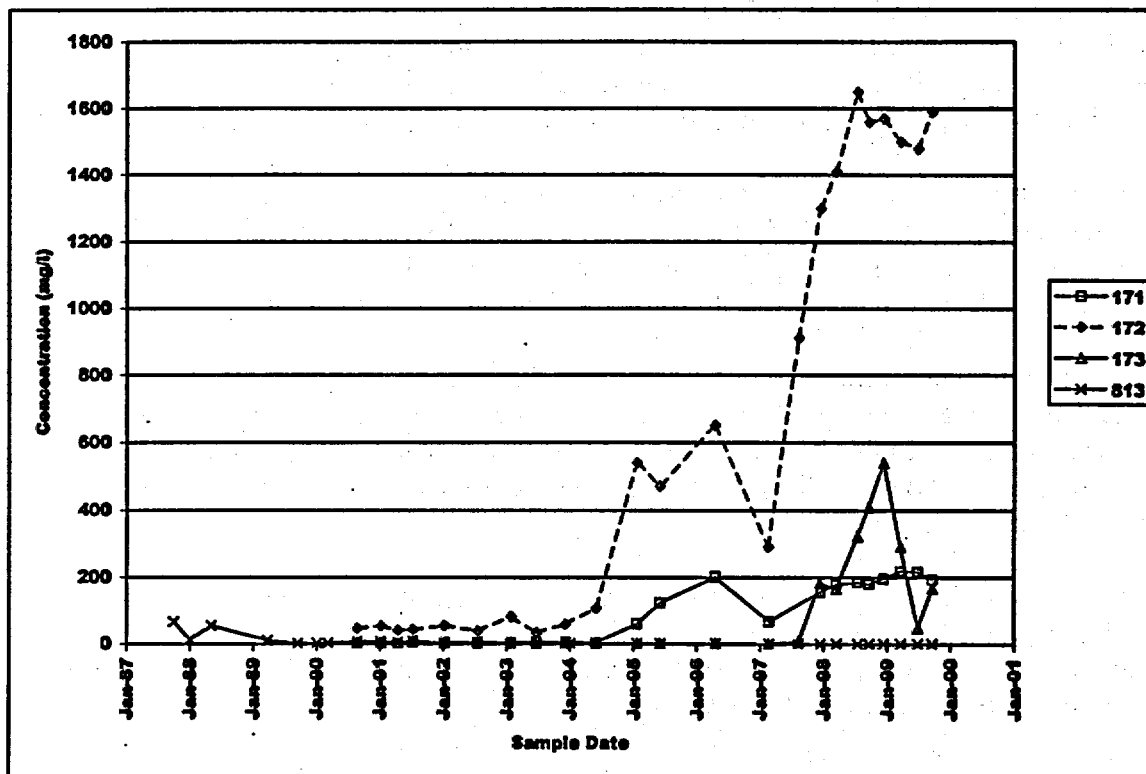
Figure GRN-2. Nitrate Concentrations at the Green River, Utah, Disposal Site

In the past year, nitrate concentrations have generally decreased in MW-172 and MW-173, after rising in recent years. Further monitoring may be necessary to determine if these trends continue. The nitrate concentration in MW-171 remains essentially unchanged. The nitrate concentration remains near the laboratory detection limit in MW-813.

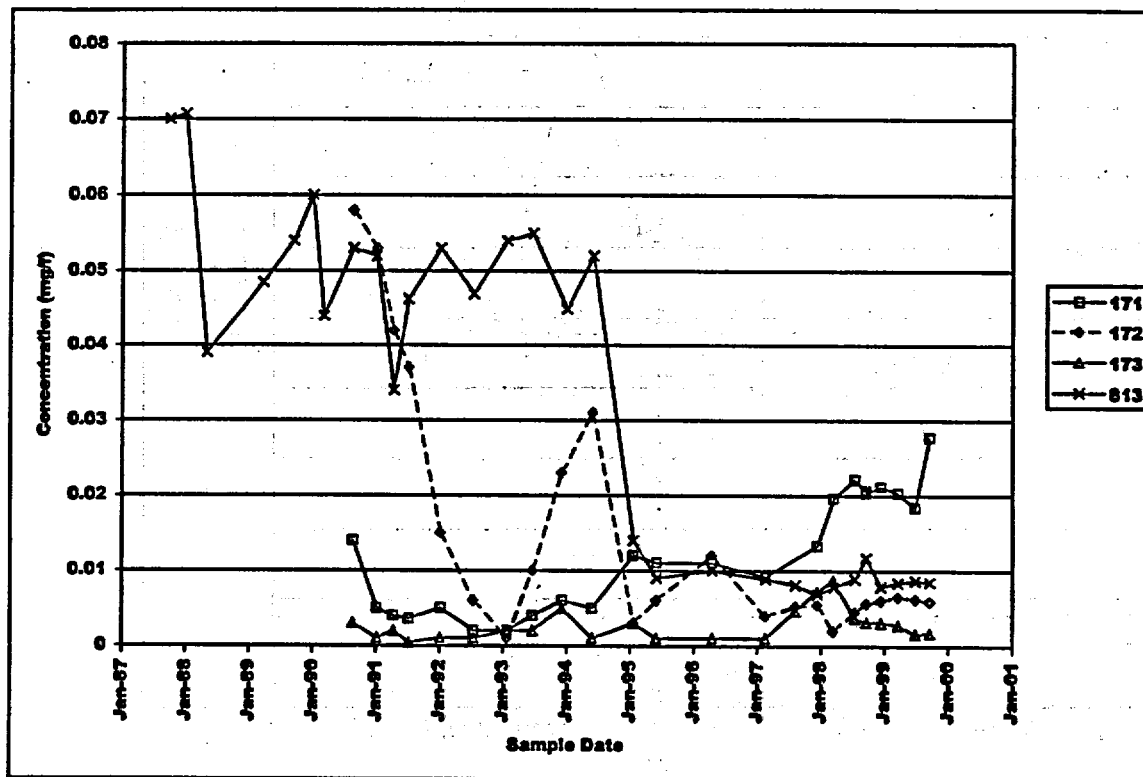
Figure GRN-3. Uranium Concentrations at the Green River, Utah, Disposal Site

Uranium. The standard for uranium was not exceeded in any POC well sample collected in 1998, nor has it ever been exceeded at a POC well since the disposal cell was constructed in 1989 (Figure GRN-3).

Concentrations of uranium at MW-171 increased from when postconstruction monitoring began until July 1998 and have remained generally constant since then. The concentrations of uranium in 1999 samples from MW-171 average about one-half the standard. Uranium concentrations in MW-172 trended lower between 1990 and March 1998, after which time the uranium concentration has consistently been approximately 0.006 mg/L. At MW-173, concentrations have typically been below or slightly above the detection limit and no trend is apparent. A five-fold decrease in uranium concentration occurred at MW-813 from June 1994 through January 1995. Levels have since stabilized at about 0.01 mg/L.

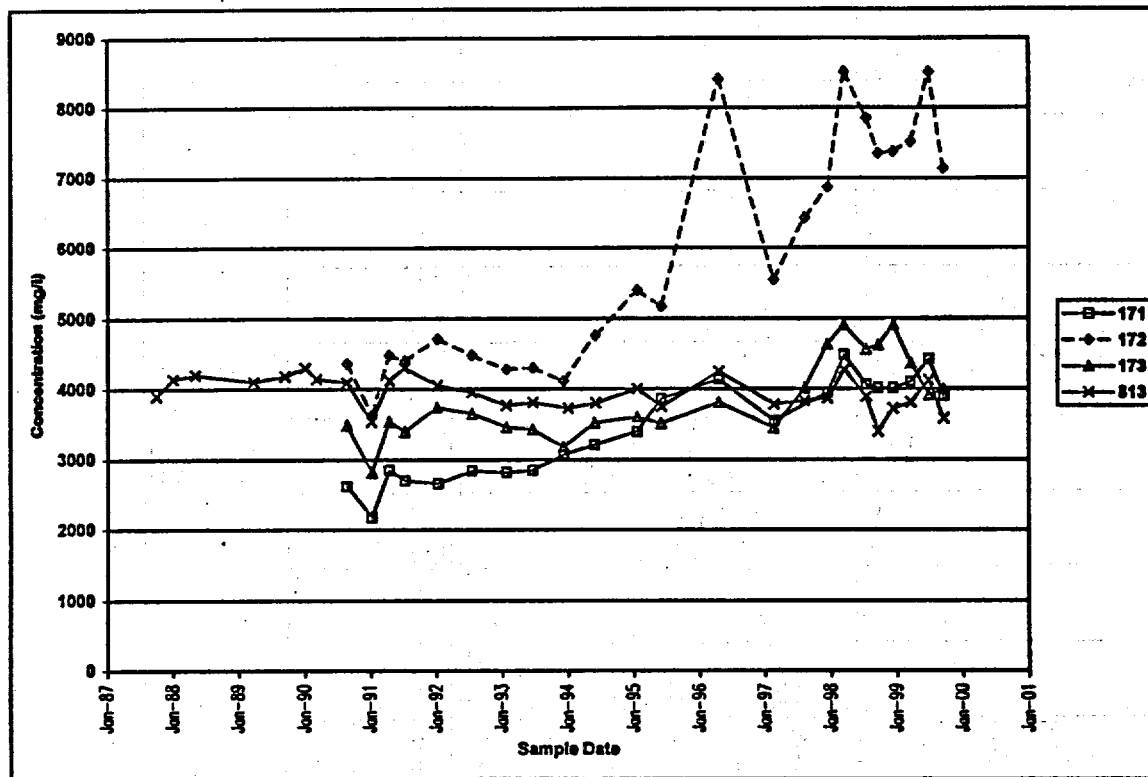
Figure GRN-4. Sulfate Concentrations at the Green River, Utah, Disposal Site

Sulfate. Sulfate concentrations exceeded the proposed standard in each sample collected in 1999 at MW-171 and MW-172, and exceeded the proposed standard for December 1998 and March 1999 at MW-173 (Figure GRN-4). The proposed standard was not exceeded in any sample from MW-813 in 1999, nor since monitoring began at this well in 1987.

Sulfate concentrations at MW-171 and MW-172 have generally increased since sampling began at these wells in August 1990. The proposed standard was exceeded in each sample collected since January 1995. Sulfate concentrations in samples from MW-173 ranged from approximately 3,500 mg/L to 4,500 mg/L between 1990 and February 1997, after which time

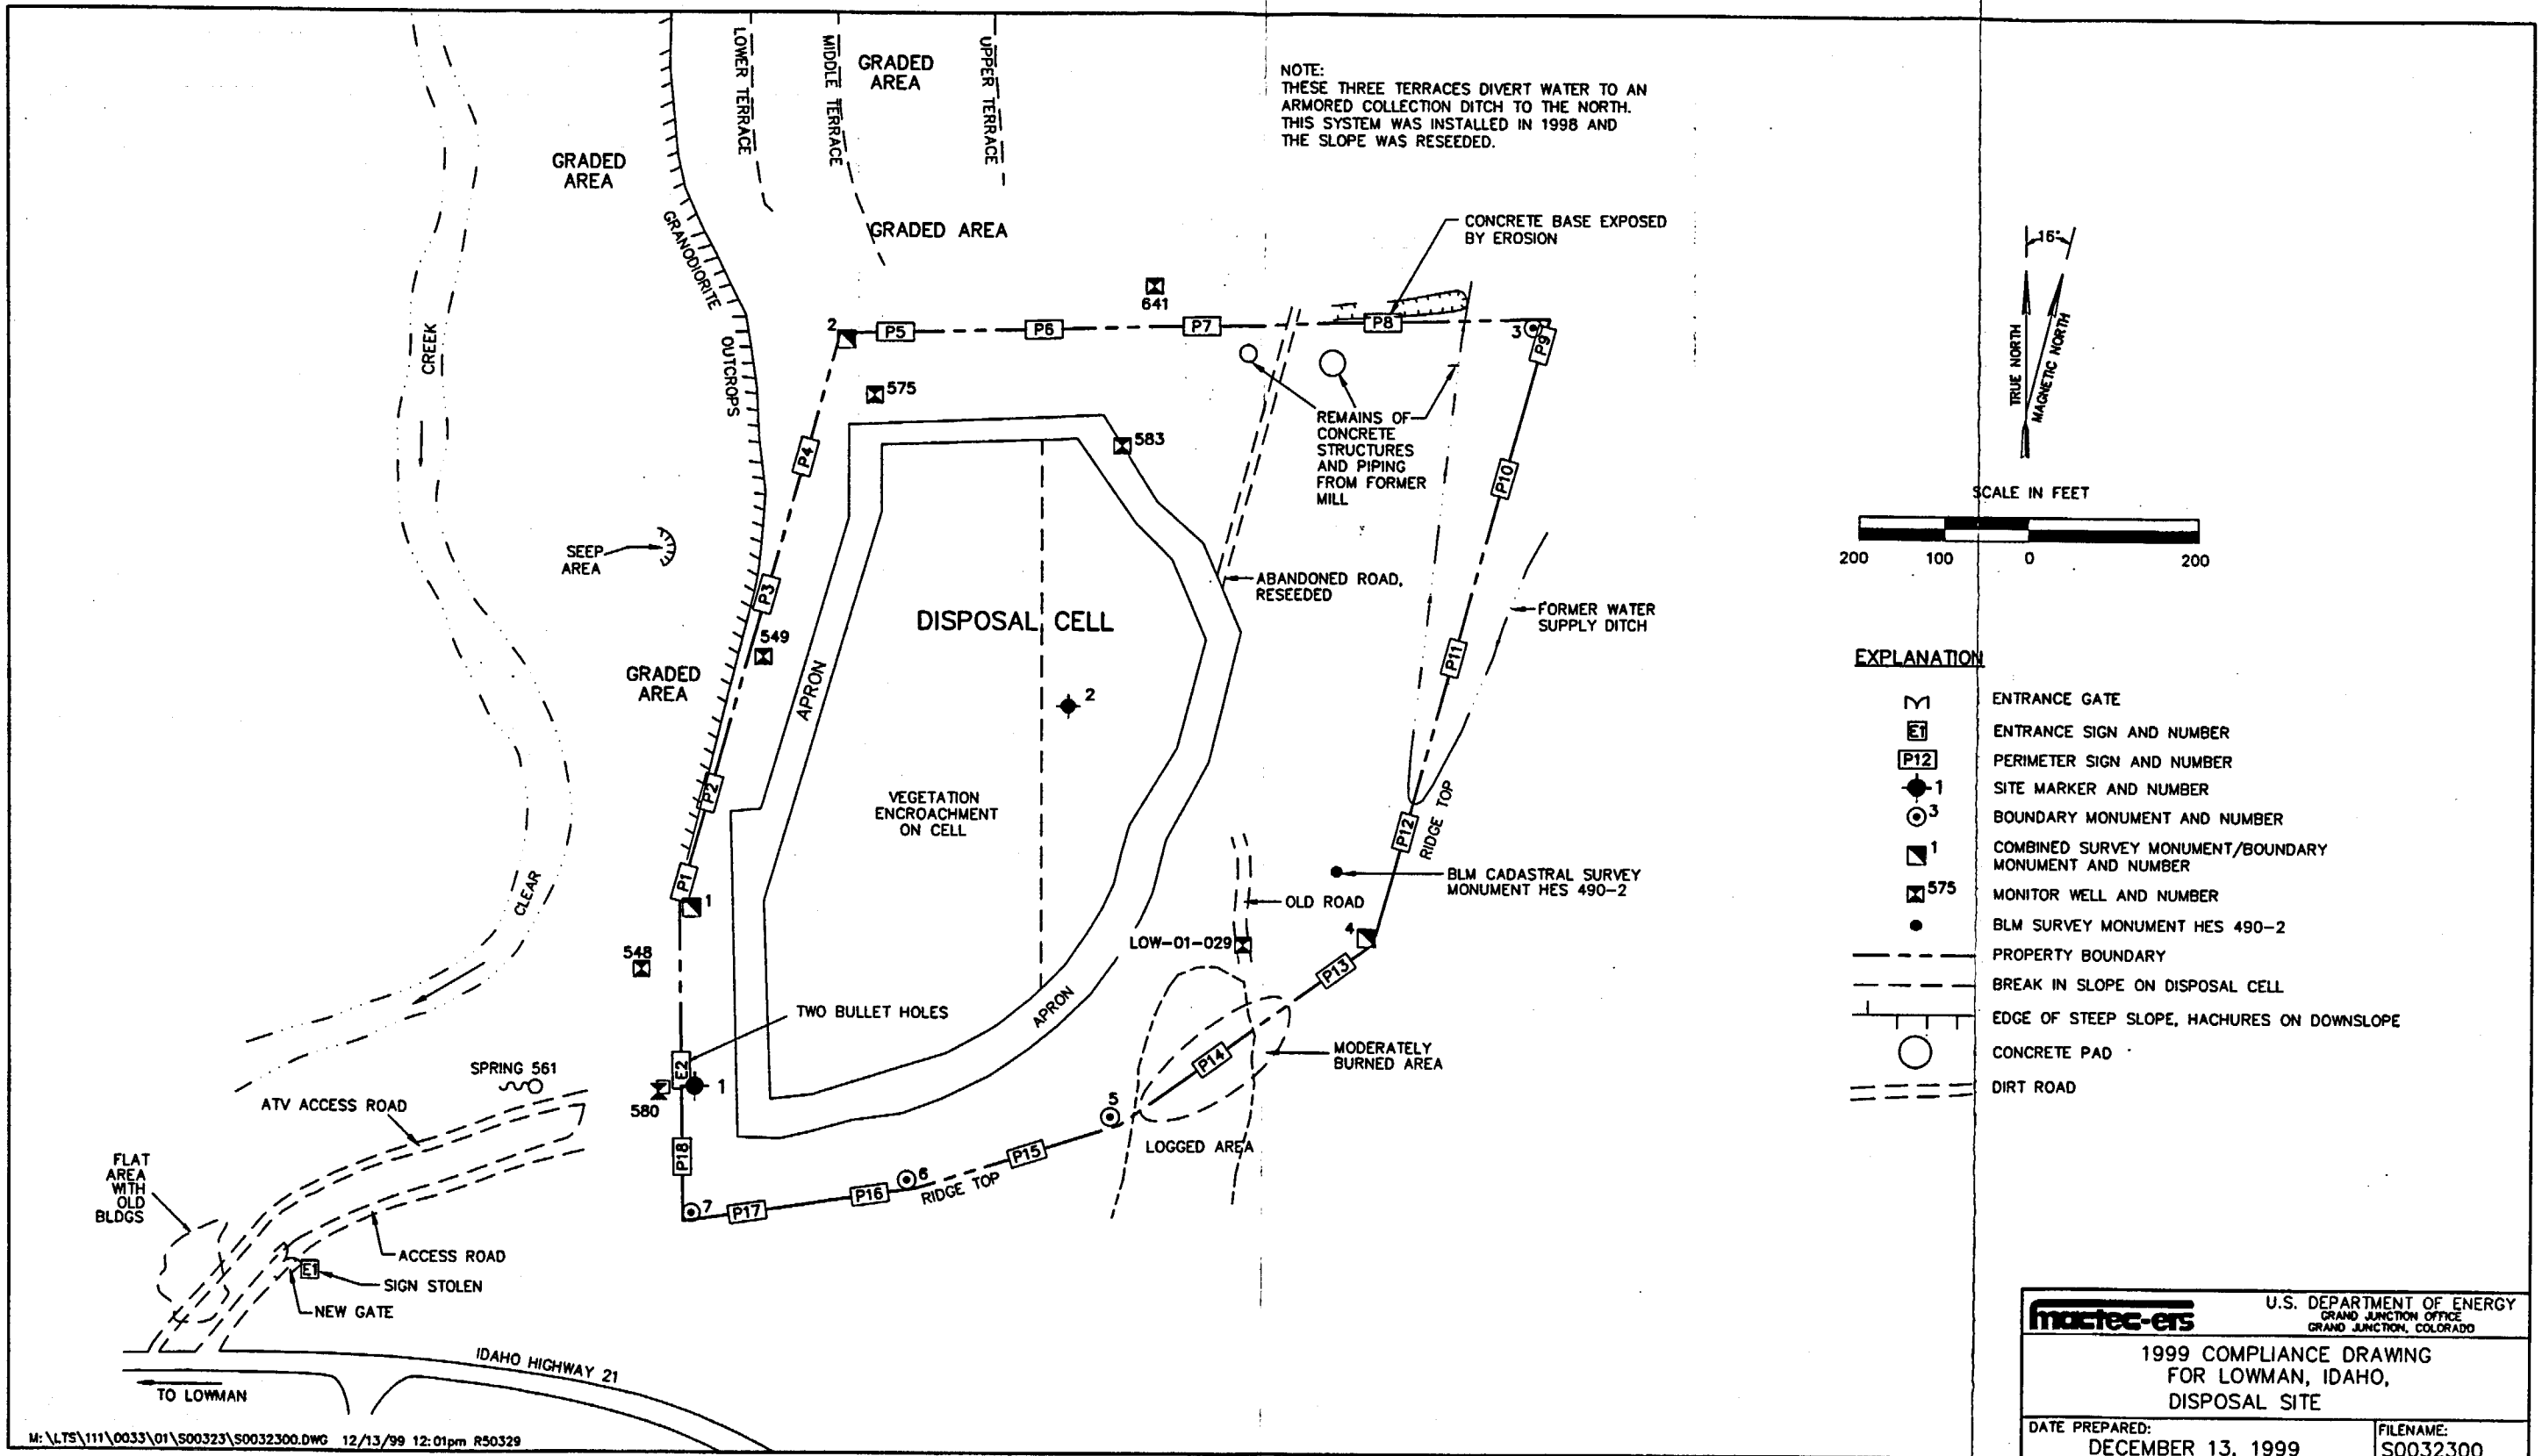
Figure LOW-1. 1999 Compliance Drawings for Lowman, Idaho, Disposal Site

Encroachment of vegetation (biointrusion) on the top and side slopes of the disposal cell is increasing. Ponderosa pine is the most noticeable species. Some of these trees are now more than 4 feet tall. Other species include redosier dogwood, whortleberry, Norway cinquefoil, common mullein, and thistle. The long-term effect of these plants on the integrity of the disposal cell should be evaluated to determine if vegetation control is required to preserve cell integrity.

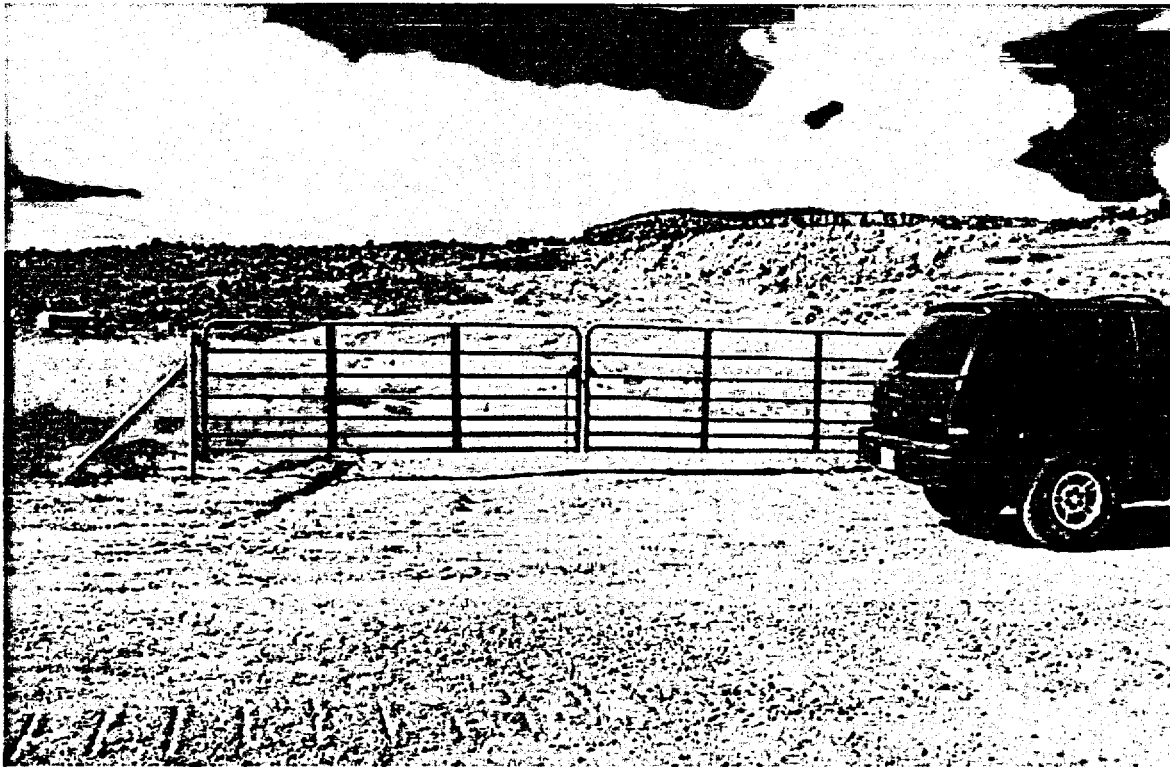
NAT/99. PL-1. Entrance Gate

The access road, gate, entrance sign, and all perimeter signs are new and in excellent condition.

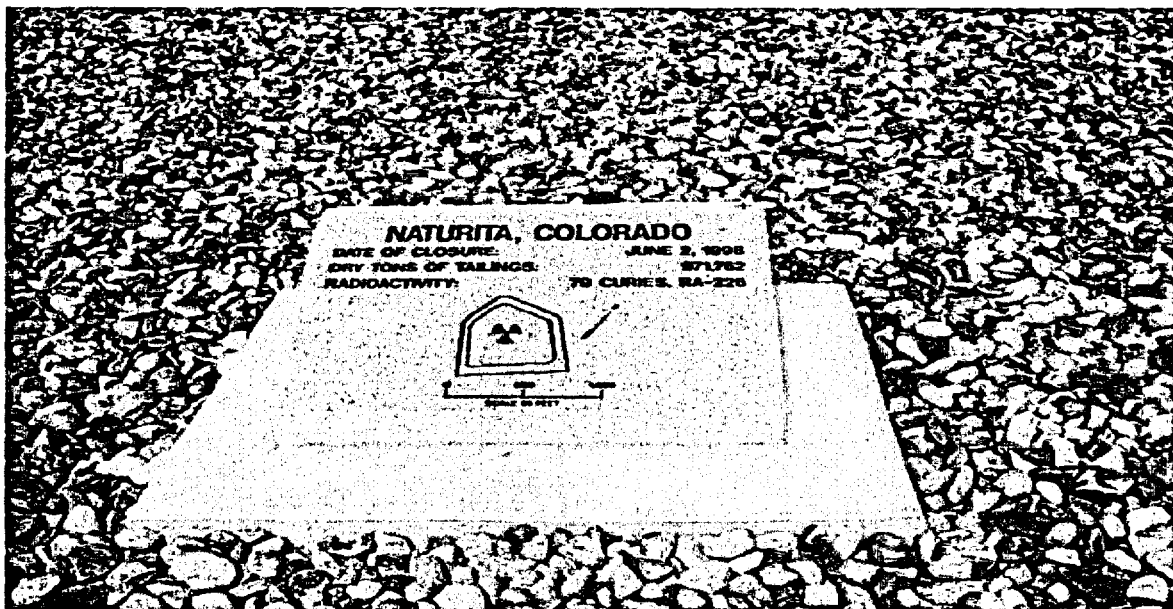
NAT/99. PL-2. Site Marker SMK-2 on Top Slope

Site Markers, Survey and Boundary Monuments Two granite site markers (SMKs) identify the Naturita site. SMK-1 is set just inside and left of the entrance gate, and SMK-2 (NAT PL-2) is located on the disposal cell in the south-central portion of the top slope. Both markers were undisturbed and in good condition.

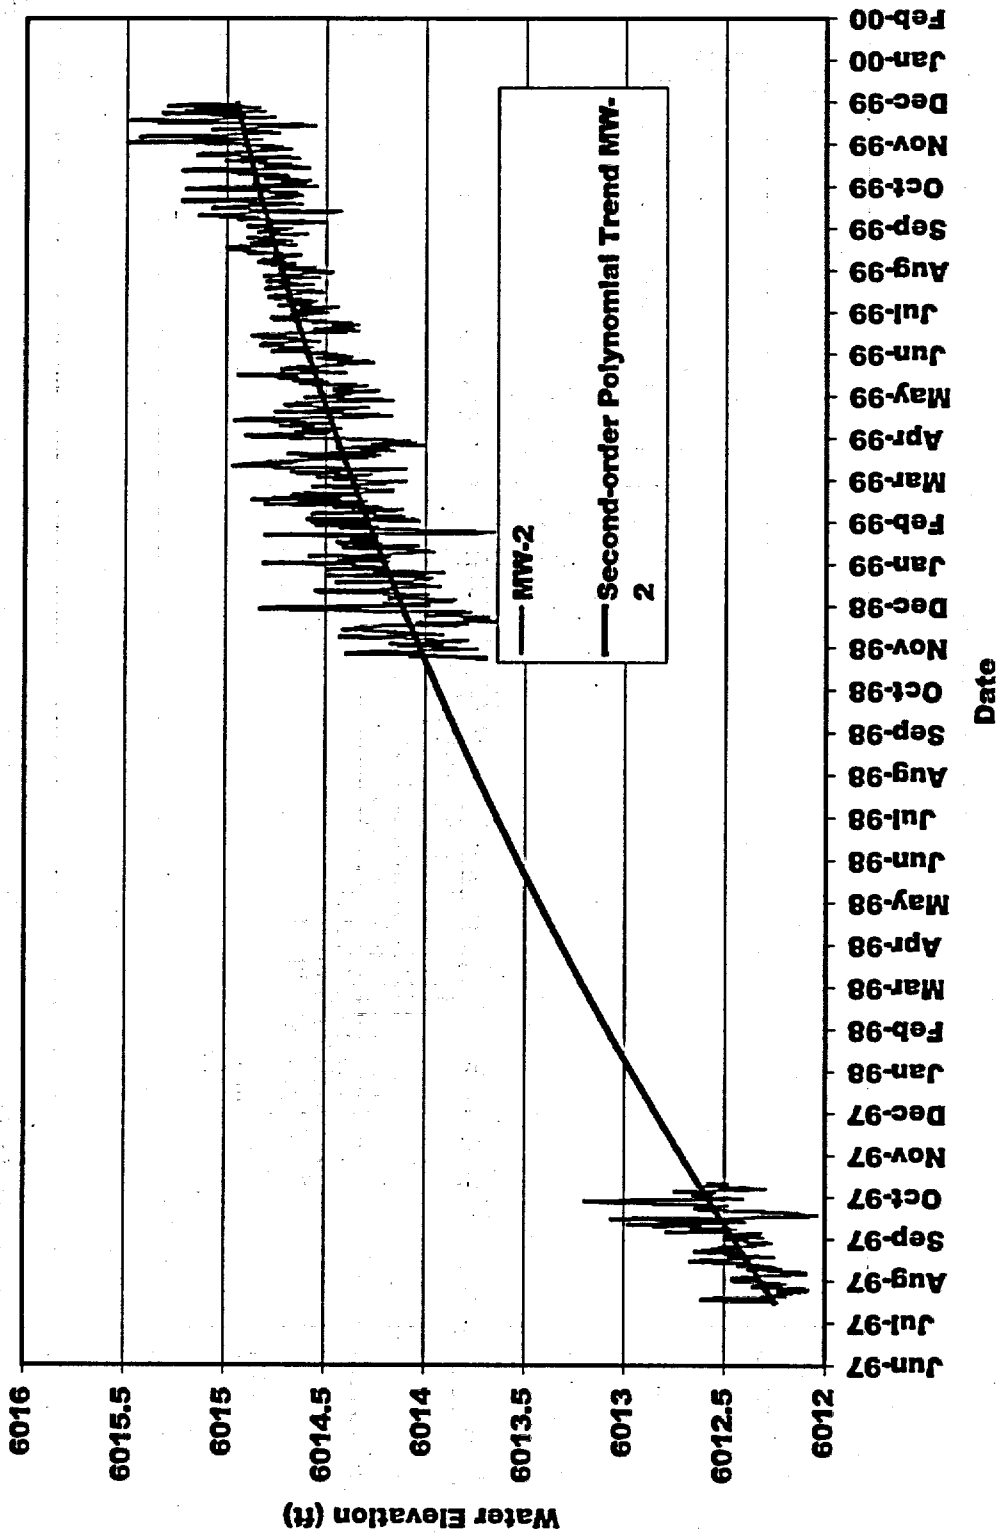
Figure RFL-2. Datalogger Information from MW-2 at Rifle, Colorado, Disposal Site

Results of monitoring since August 1997 are shown in the accompanying figures RFL-2, RFL-3, and RFL-4. The data from MW-2 are incomplete because of a datalogger that shut down (Figure RFL-2). The datalogger in this standpipe was replaced in October 1998. The data for MW-3 are continuous (Figure RFL-3). Data from the two standpipes overlay, so DOE considers the second standpipe, MW-2, redundant or backup to MW-3 (Figure RFL-4).

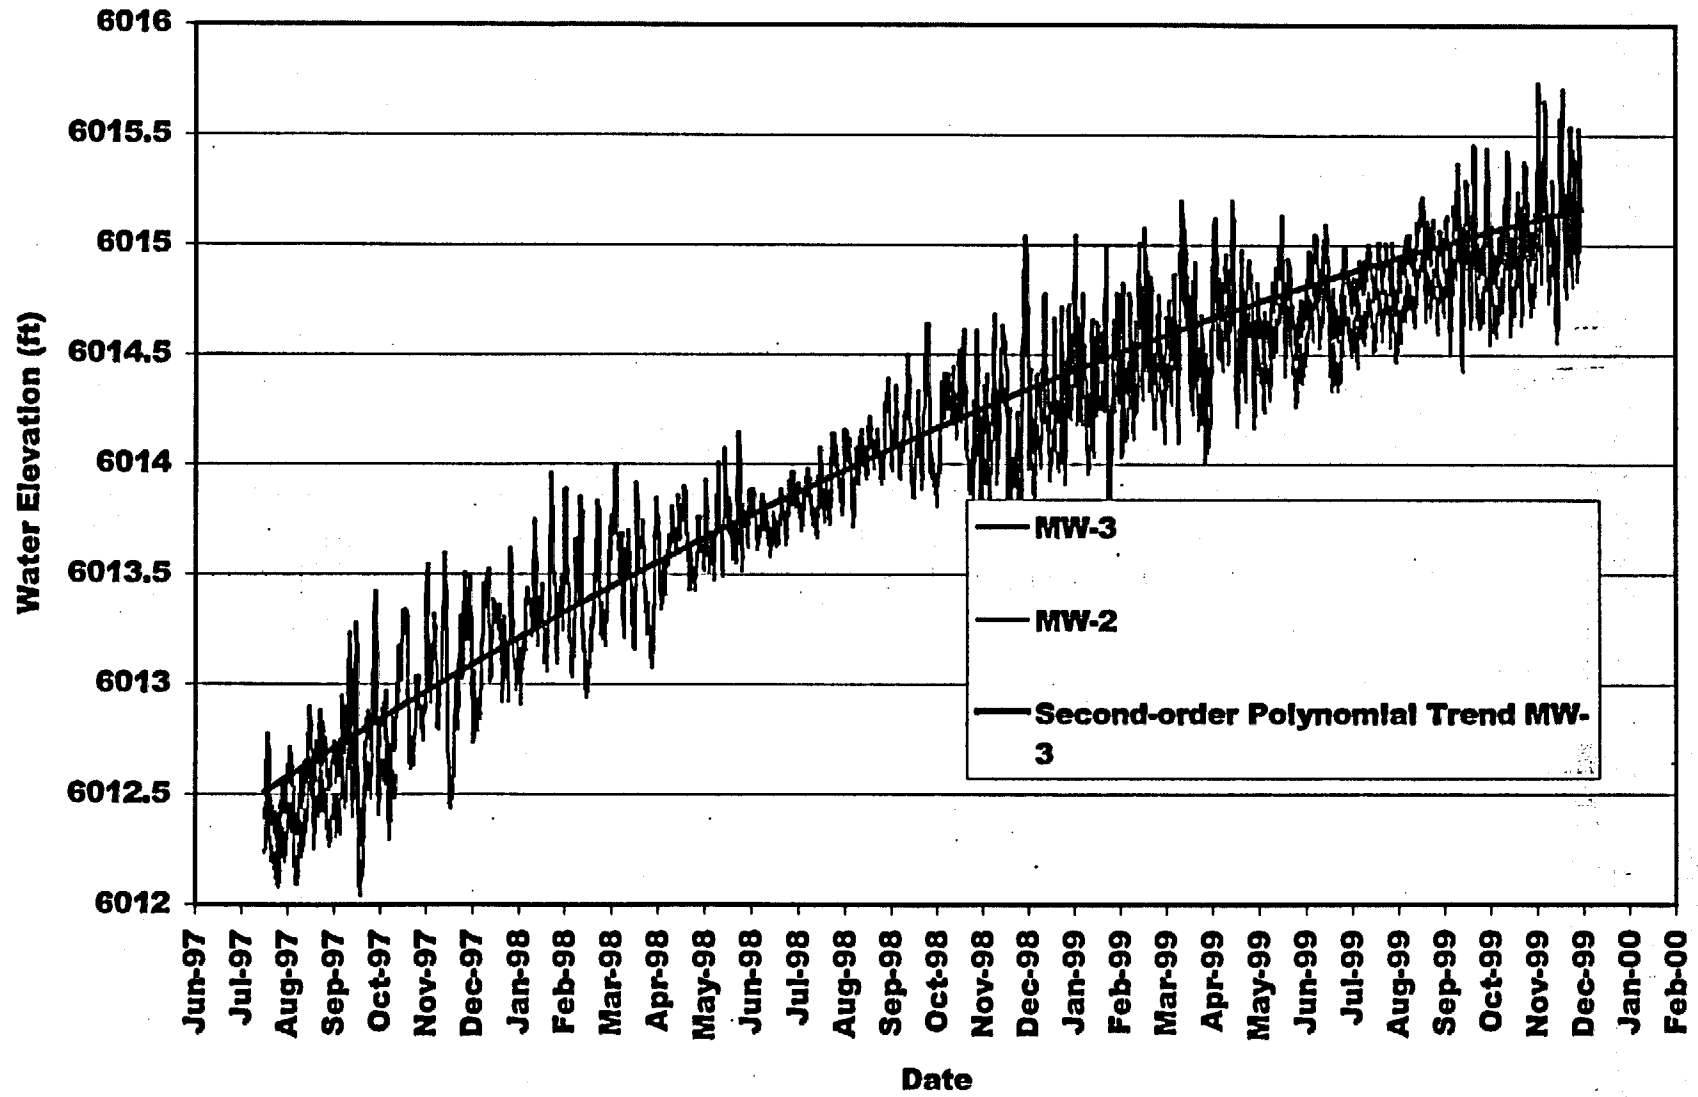
Figure RFL-4. Datalogger Information from MW-2 and MW-3 at Rifle, Colorado, Disposal Site

Superimposed on the data in each of the figures is a solid line that represents a second-order polynomial trend or fit for the data. An apparent flattening of the trend line is apparent from about the third quarter of 1998 on (Figure RFL-4). This trend line suggests that water levels will not significantly exceed the elevation of 6,015 feet, which is less than the action level elevation at 6,016 feet. DOE will continue to monitor water levels by downloading data loggers in the two standpipes on a quarterly basis.
