**Sherwood Uranium Mill Project
TECHNICAL EVALUATION REPORT**

Monitoring and Stabilization Plan Supplement

February 2000

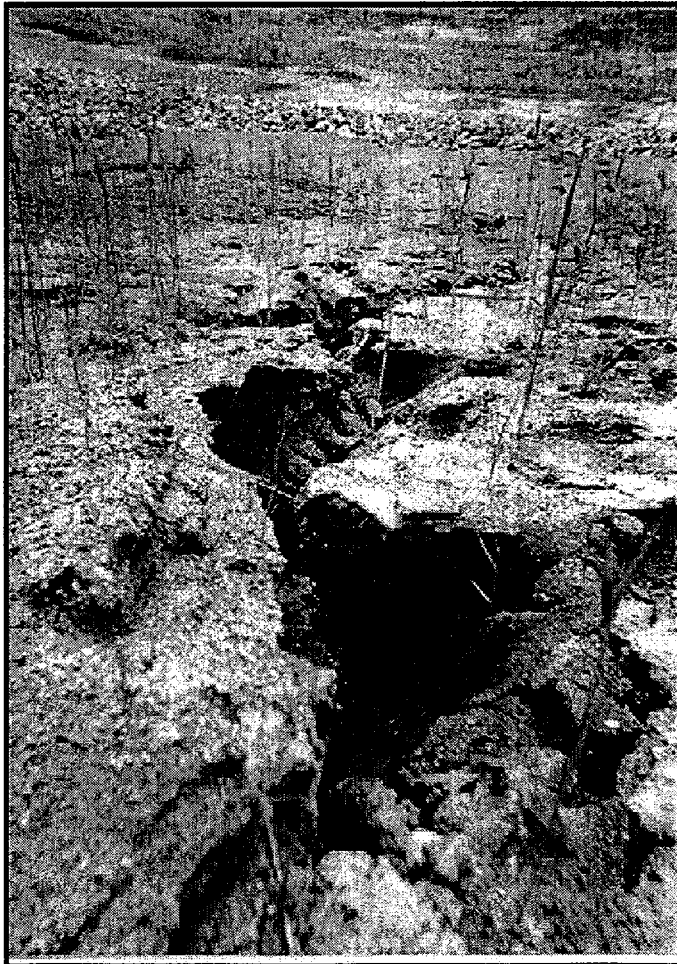
Left: Location 5, Looking SE from midway of margin slope (down slope), erosion in rills, with local depth to approximately 2 feet. (location of soil sample).

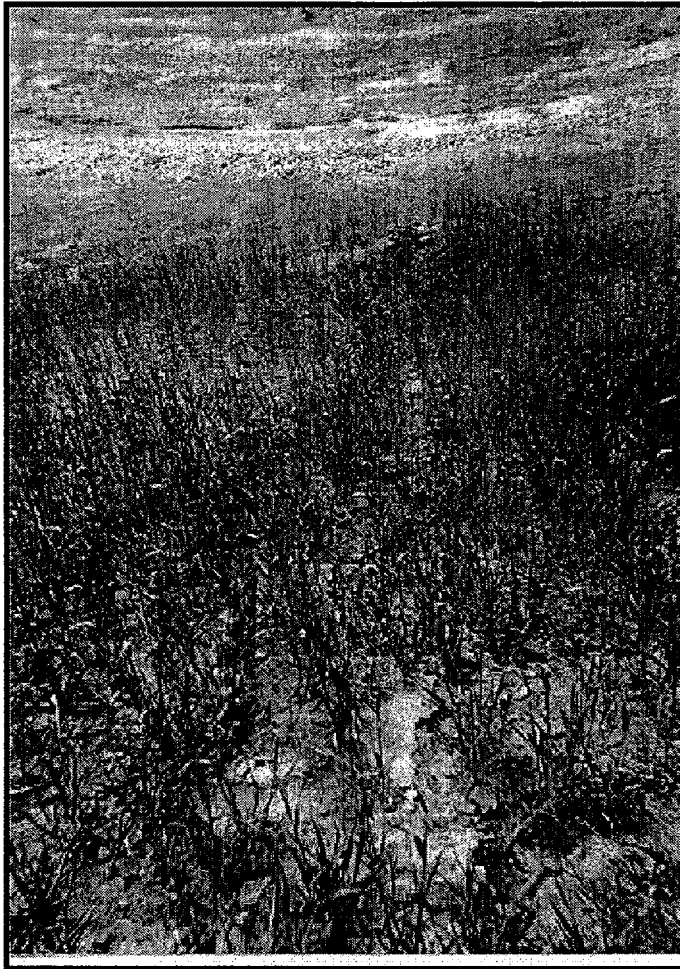
Left: Location 6, looking SE from top of margin slope (down slope), erosion in rills with local depth to 6 inches, consistent from top of slope to bottom, significant vegetation from top of slope to midslope.

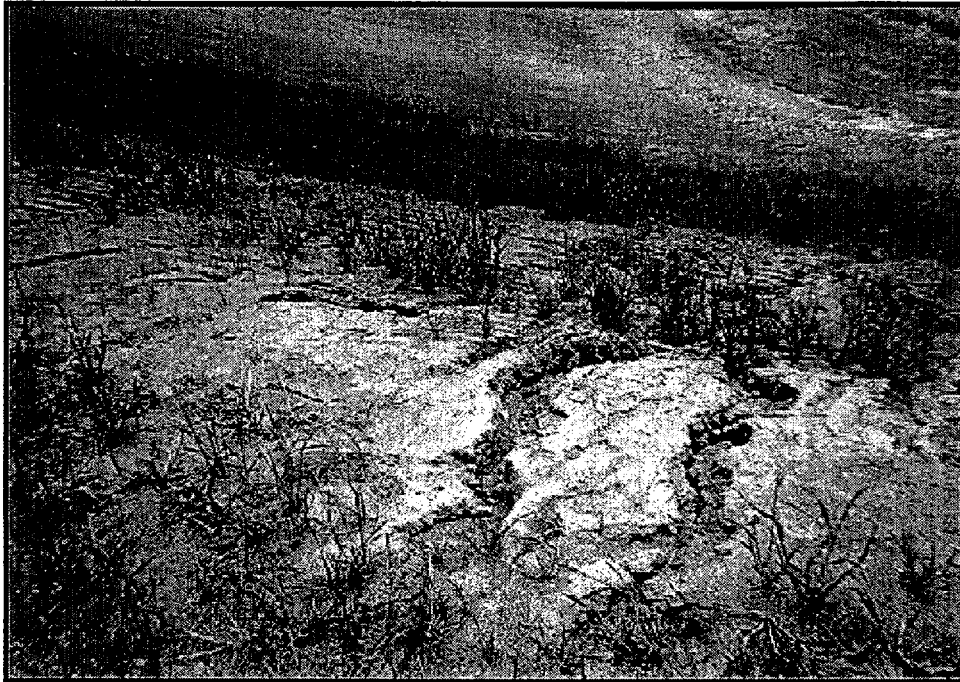
Top: Location 6, looking ^E from top of margin (down slope), erosion in rills with local depth to 6 inches, erosion starting at slope transition from top of dike, significant vegetation.

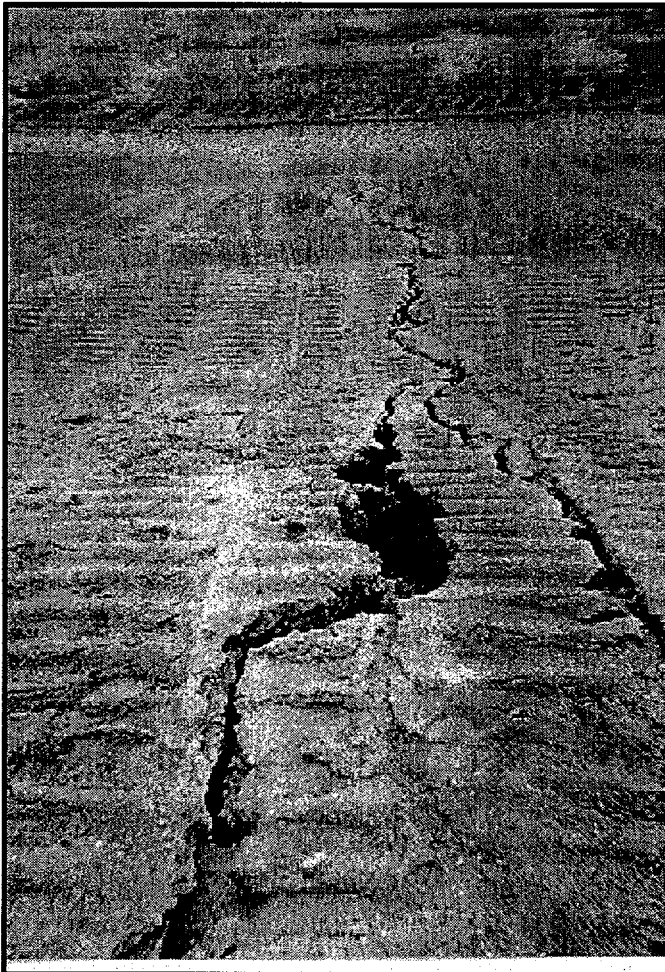
Bottom: Location 7, looking ^E from top of margin (down slope), erosion in rills about every 6 to 12 feet along slope to 6 inches.

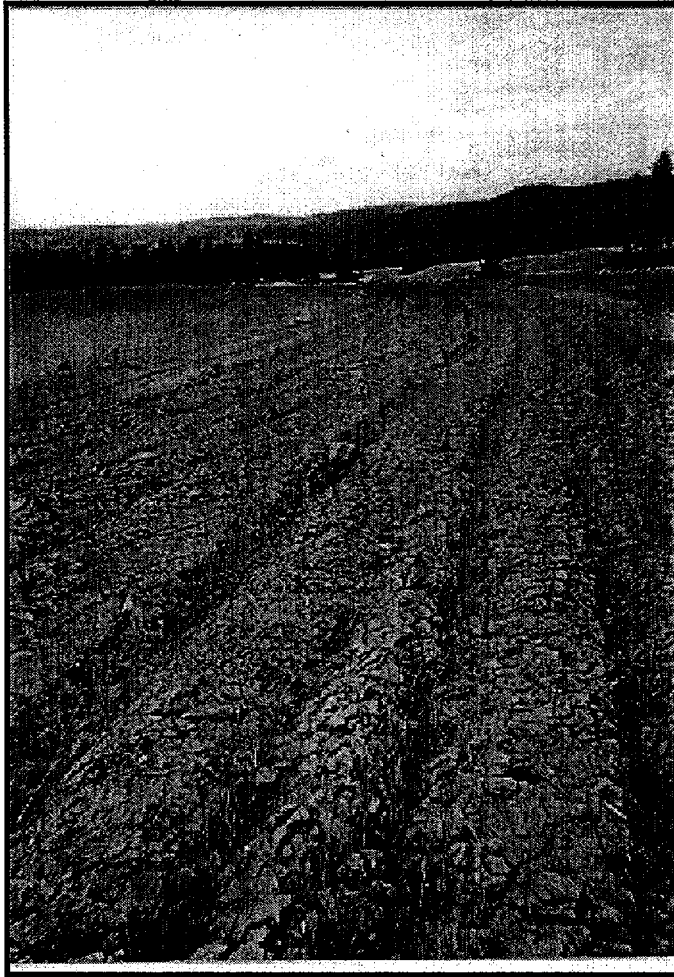
Left: Location 8, looking SE from transition of top of dike to bench above impoundment, erosion in-line with pattern from apparent ripping operation (previous vehicle access road).

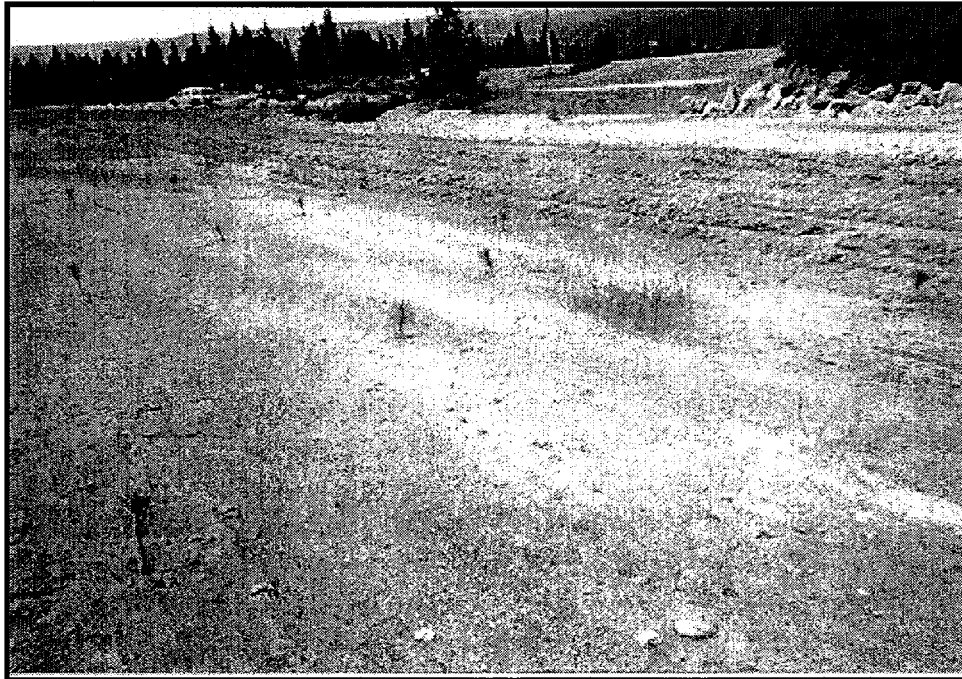
Bottom: Location 9, looking SW from bench and previous vehicle access from NW borrow source, erosion protection and culvert for truck shop vehicle access road, in background.

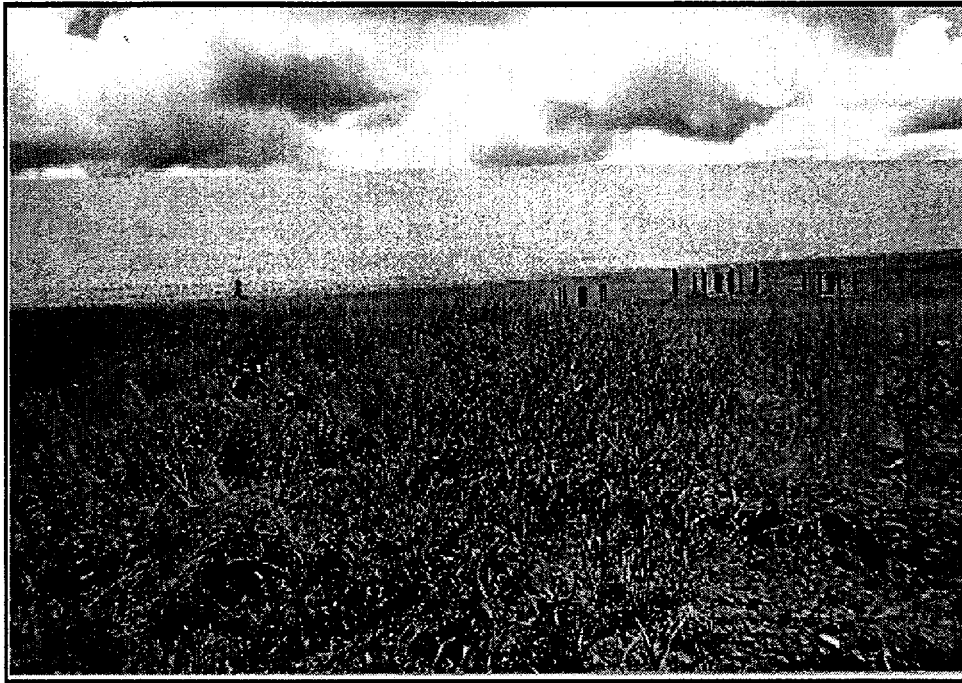
Location 17, looking NE from monitoring well bench, downslope on left, Impoundment dam in background.

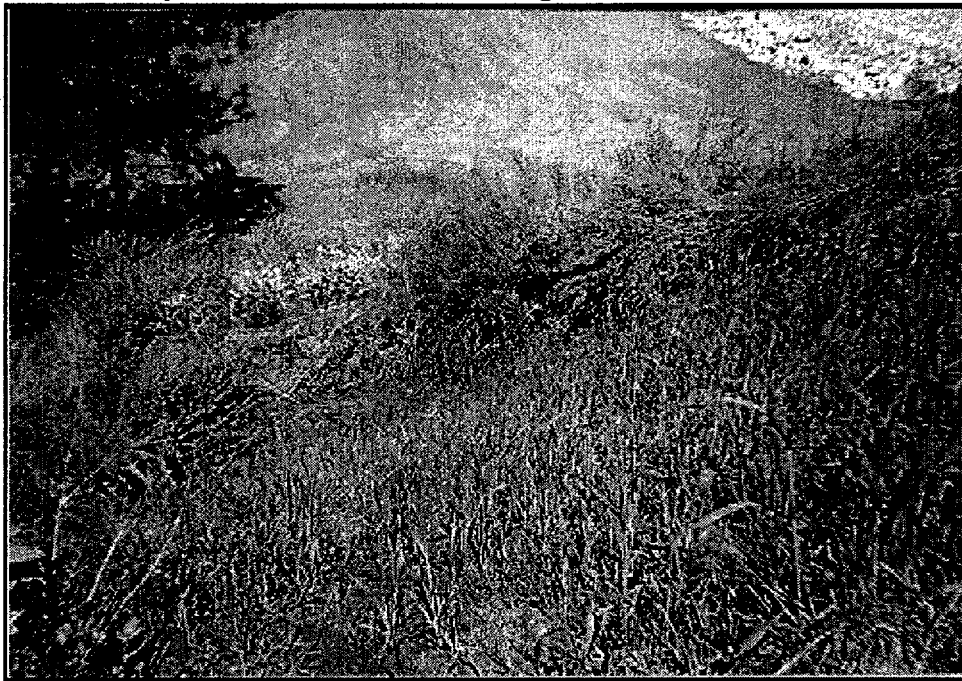
Location 17, looking ^{NW}~~NE~~ from monitoring well bench toward downslope in foreground, bottom of Impoundment dam outslope and natural drainage.

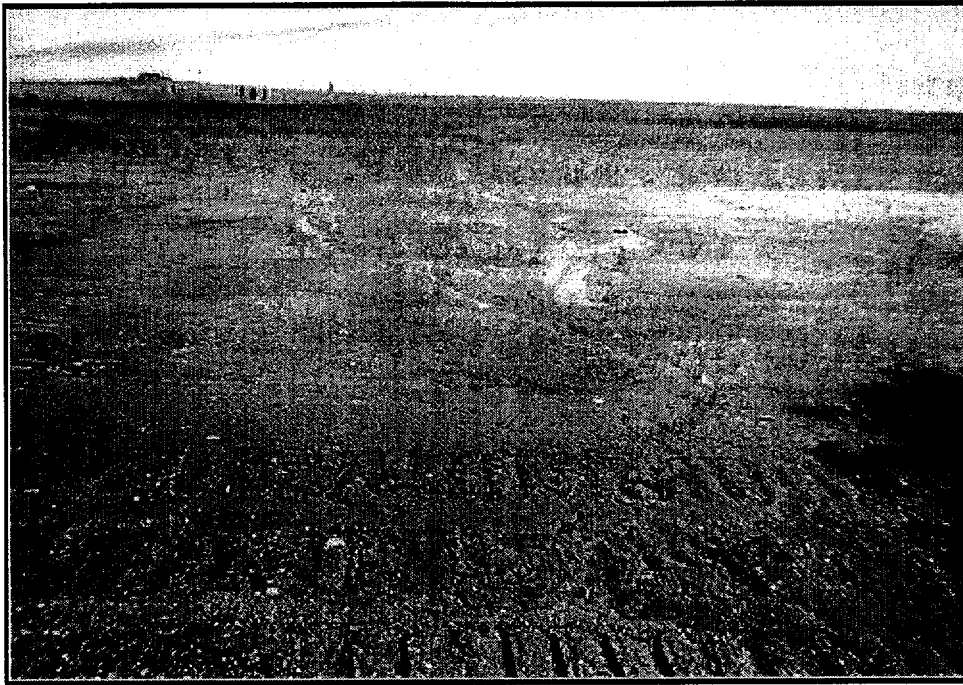
Location 18, looking NW from monitoring well bench, shallow erosion in foreground, wells and impoundment dam in background.

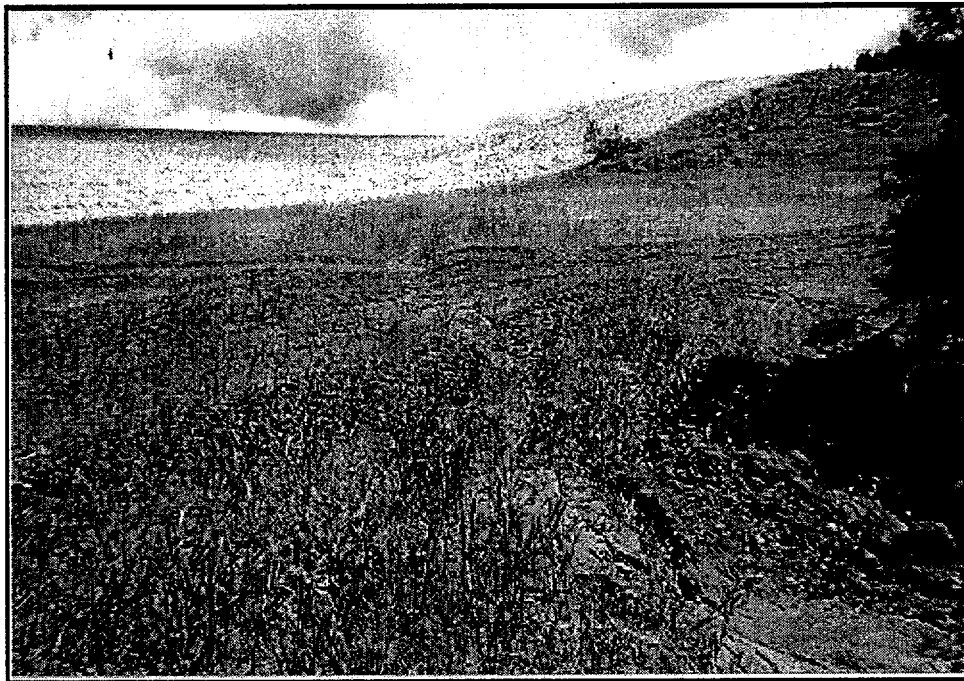
Location 18, looking NE from monitoring well bench, shallow erosion in foreground, impoundment dam in background.

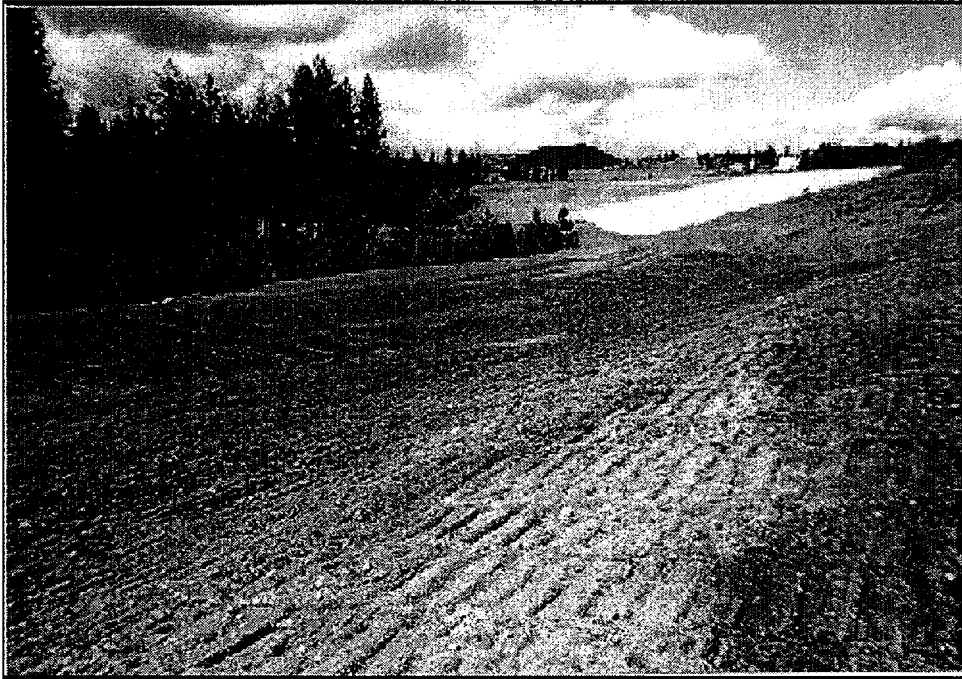
Location 19, looking NW from NE portion of impoundment swale toward dam face, rolling benches in foreground, showing rework from early spring erosion.

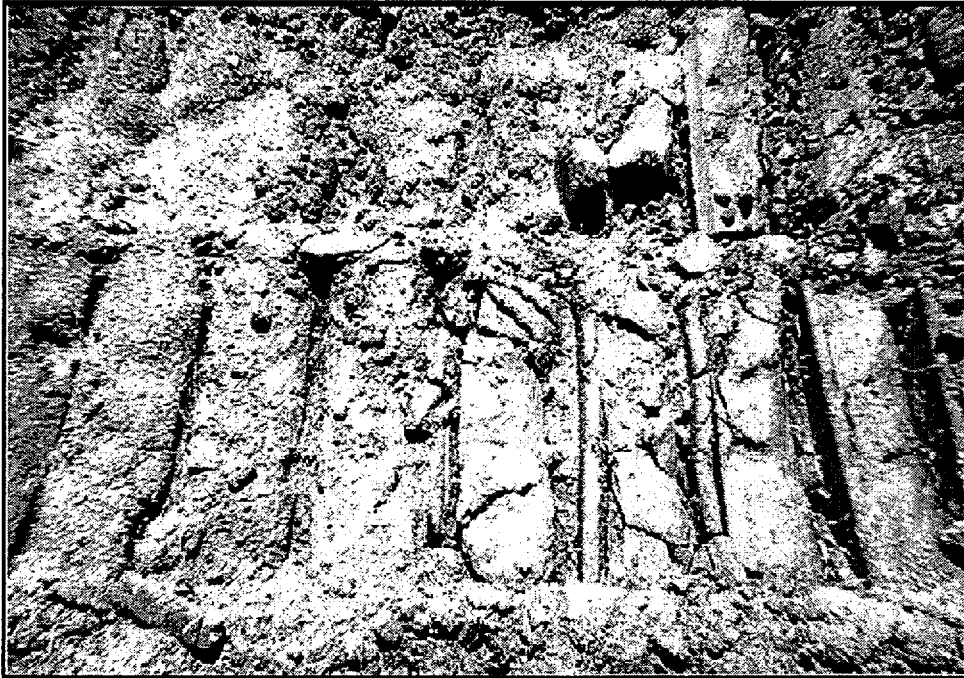
Location 20, looking down at cat tracks showing rework from early spring erosion and vegetation recovery.

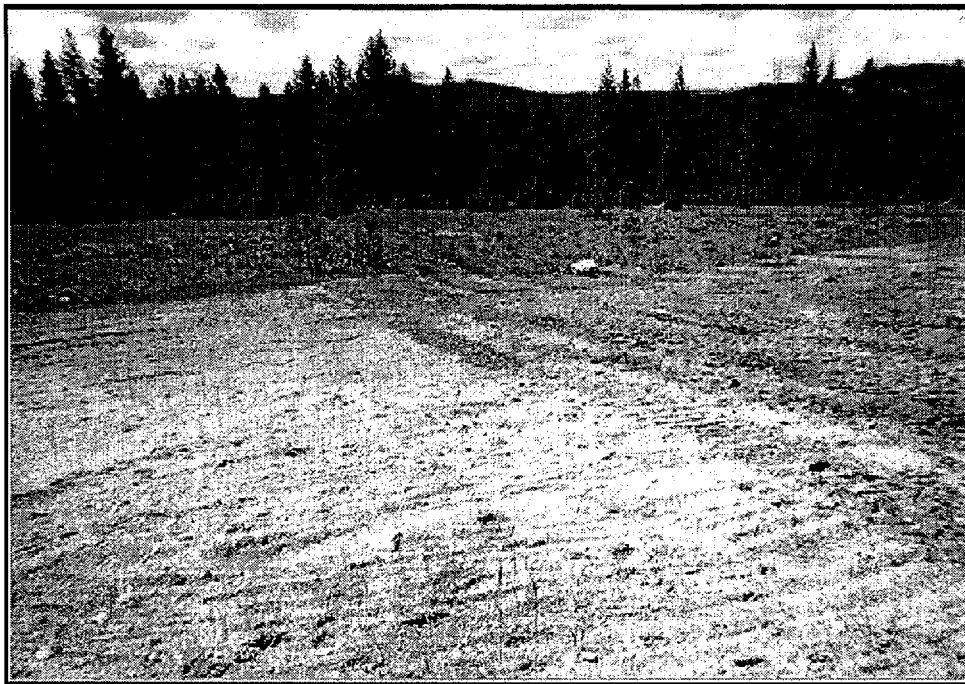
Location 21, looking S showing rework from early spring erosion and transition to natural vegetation.

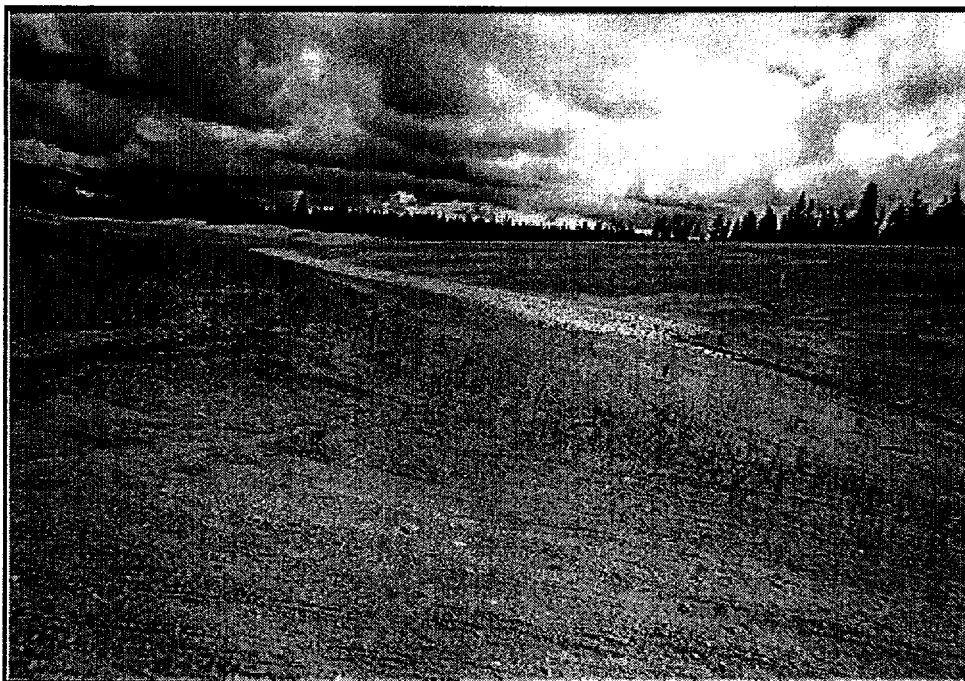
Location 21, looking N showing ending section of diversion dike and margin toe rock protection. Some erosion is evident parallel to toe.

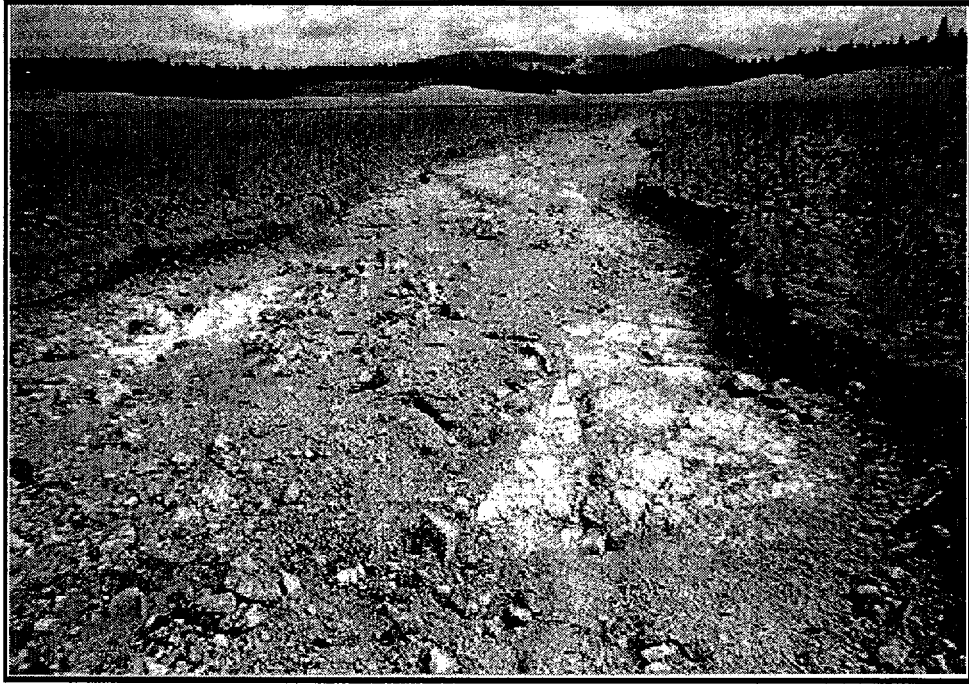
Location 22, looking N from swale outfall (up slope) showing erosion to about 1 foot and local underlying rock and bedrock outcrops.

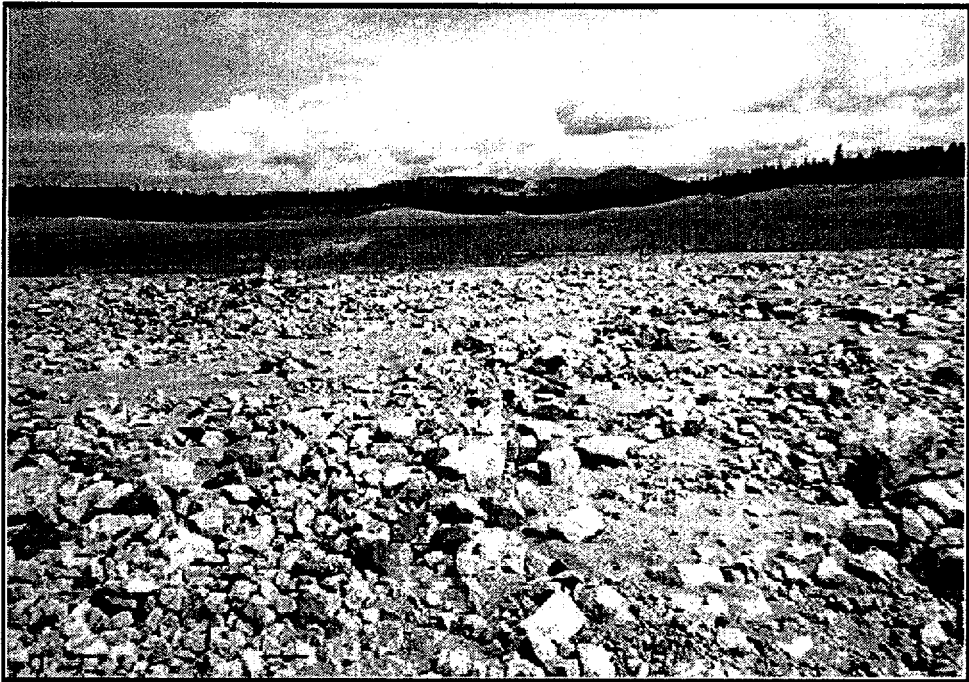
Location 22, looking S toward swale rock protection, showing soil deposition from upstream erosion (see photo above).

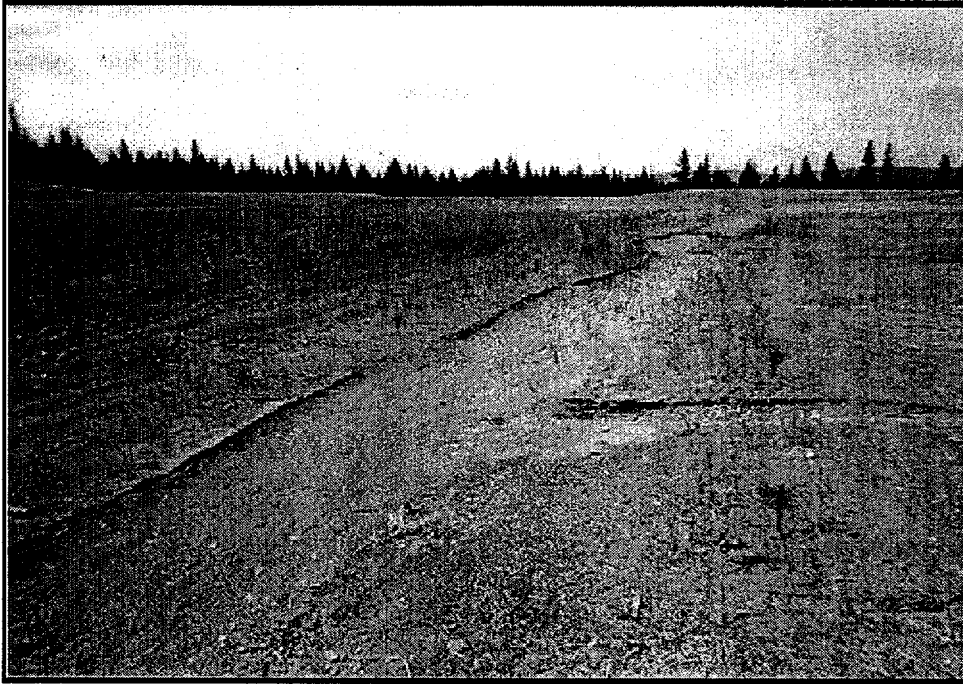
Location 23, looking S showing erosion from upstream of swale. Main channel is from N., side channel is from E (impoundment surface), depths to 4 inches.

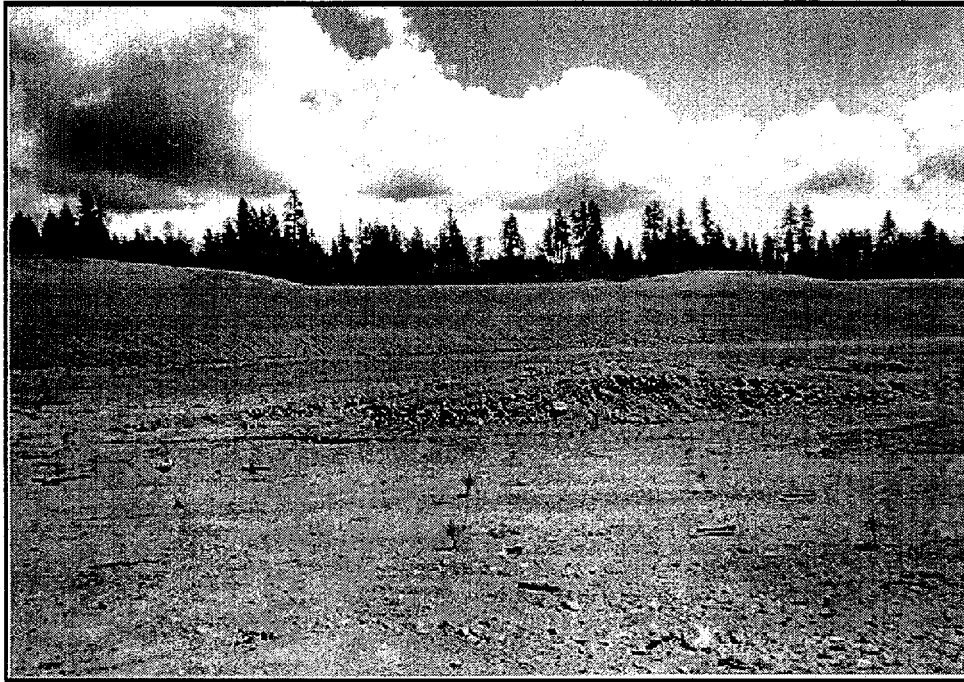
Location 29, looking ESE showing rock area (bedrock) in foreground and east dike margin in background (notice small rills).

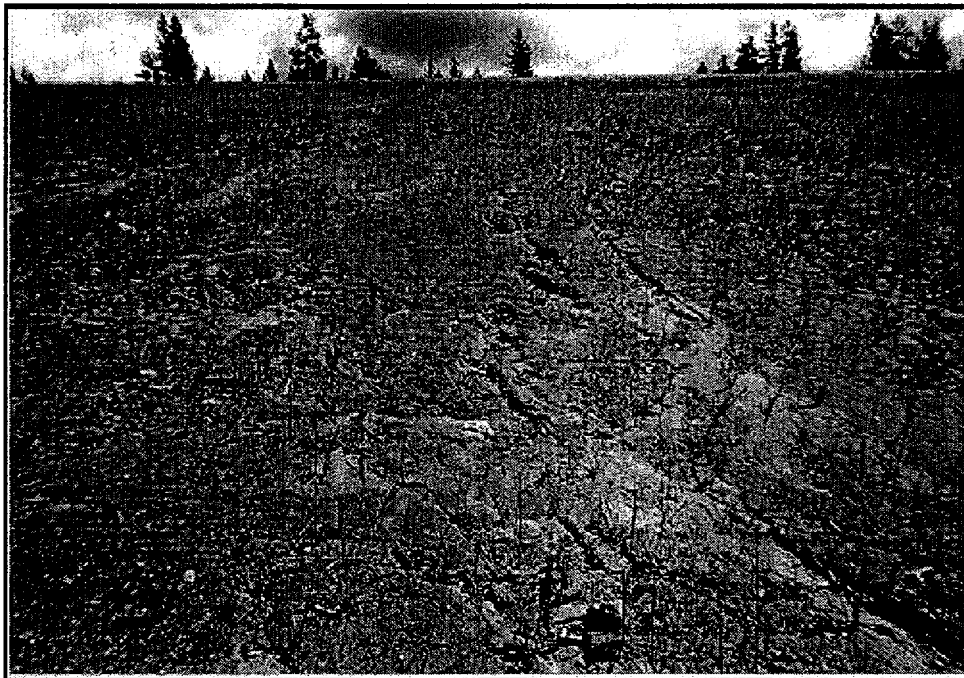
Location 30, looking E from base of dike margin (up slope) showing small rills, to 4 inches deep.

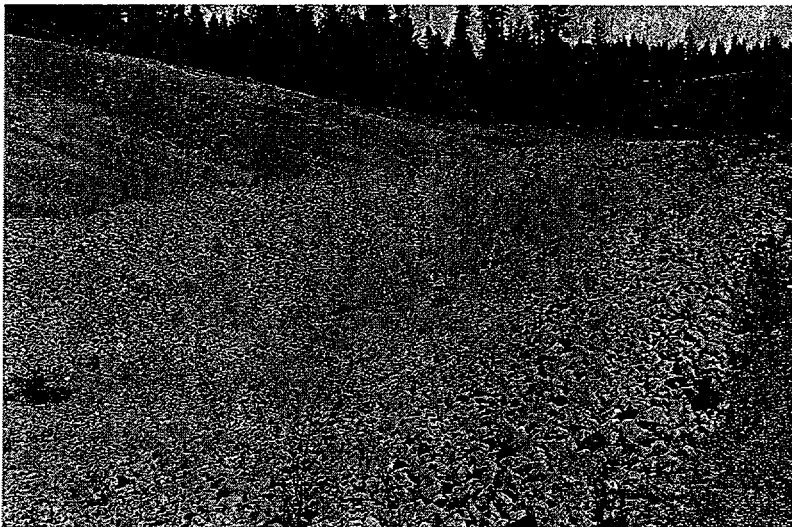
Photo 1.

The riprap associated with diversion ditch is largely made up of competent quartz monzonite. Photo taken of eastside of the diversion ditch.

Most of the riprap is composed of competent quartz monzonite with a small fraction of basalt mixed in. The amount of basalt varies from place to place, and estimated to be less than ten per cent of the total placed rock. (Photo 1.) Only a very minor fraction of the rock showed visual deterioration and did not break with repeated blows by the sledge hammer. The quartz monzonite rocks that showed deterioration by crumbling or fracturing were rocks containing a

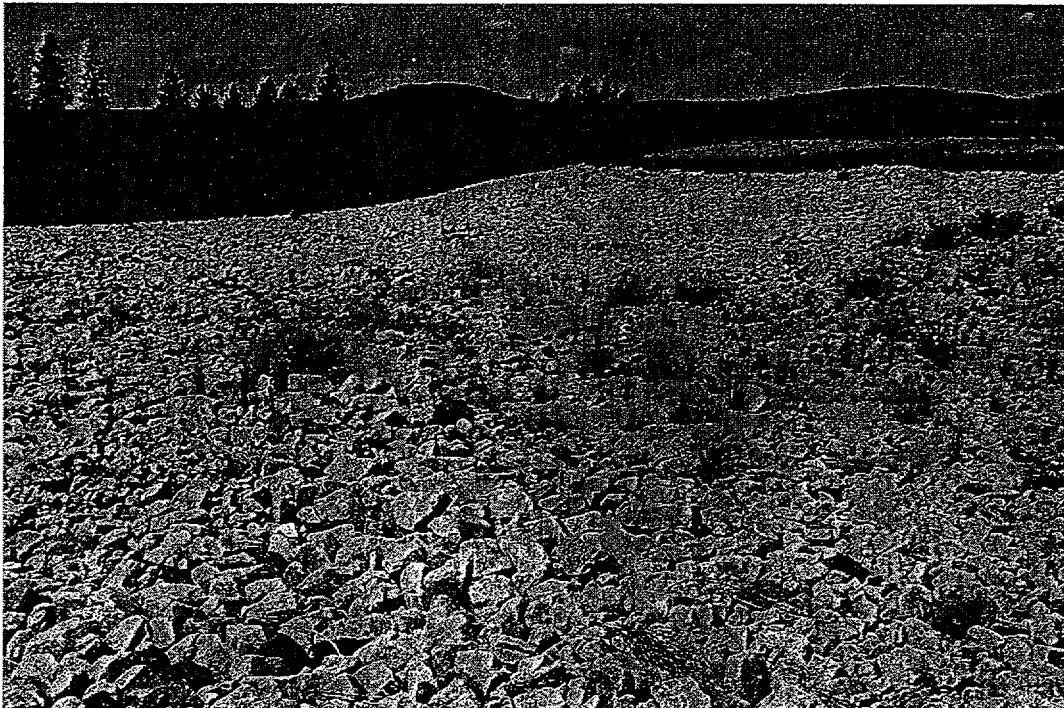
Photo 6.

There is an area of the riprap at the top of the swale where fines have washed in from the cover surface since construction was completed. The fines conceal the rock underneath that was placed during construction. (Photos 6 and 7)

View of the top of the outlet swale (taken from the east, looking west) where fines have washed into the riprap from the cover surface. The riprap has not been disturbed.

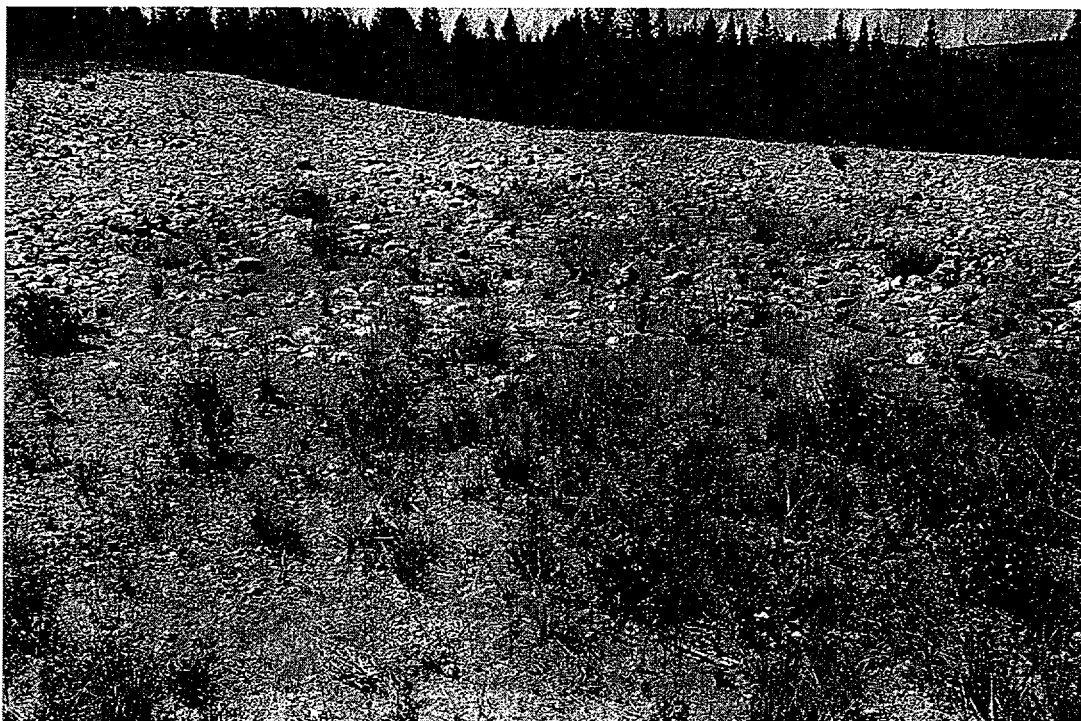
Photo 7.

View from edge of cover surface (looking south) showing extent of fines that have washed onto the swale. The riprap has not been disturbed underneath.

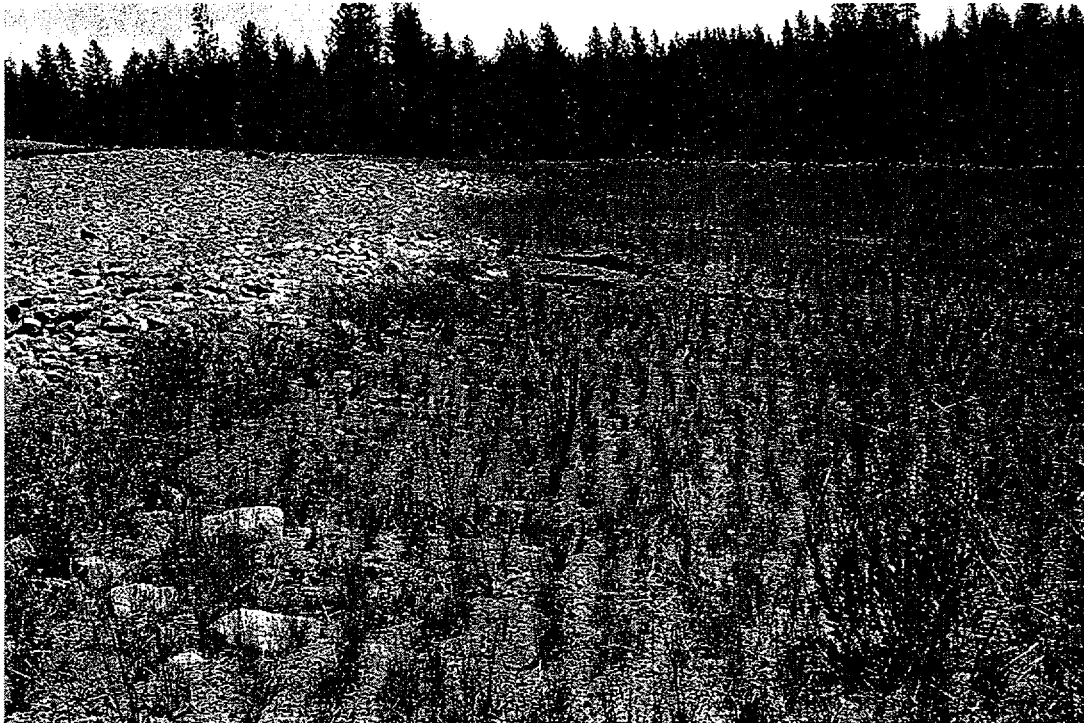
Photo 8.

The entire cover outlet swale is underlain by quartz monzonite bedrock. Approximately one foot of topsoil was placed on top of the bedrock at the toe of the riprap. Two major gullies are present at the toe. (Photo 8.)

Toe of the outlet swale where gullies have developed. The photo was taken on the west side looking toward the east along the toe.

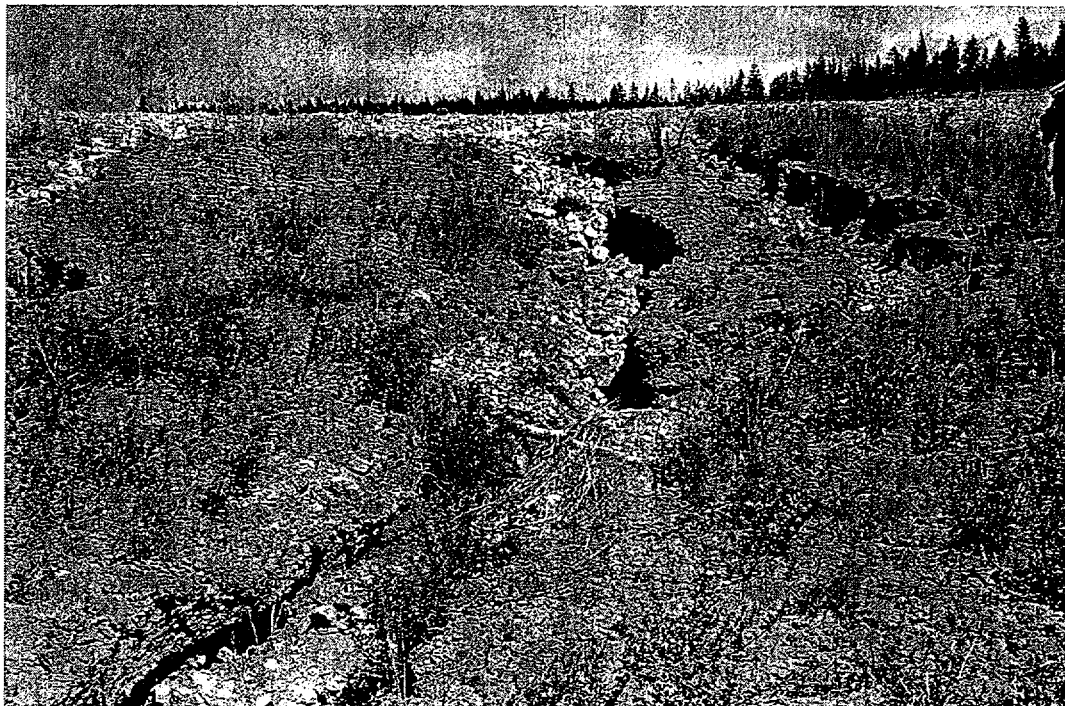
Photo 9.

The topsoil has been removed by erosion in the gullies exposing the quartz monzonite bedrock underneath. (Photo 9 and 10.)

Photo shows where silty topsoil has been eroded away, exposing the quartz monzonite bedrock underneath.

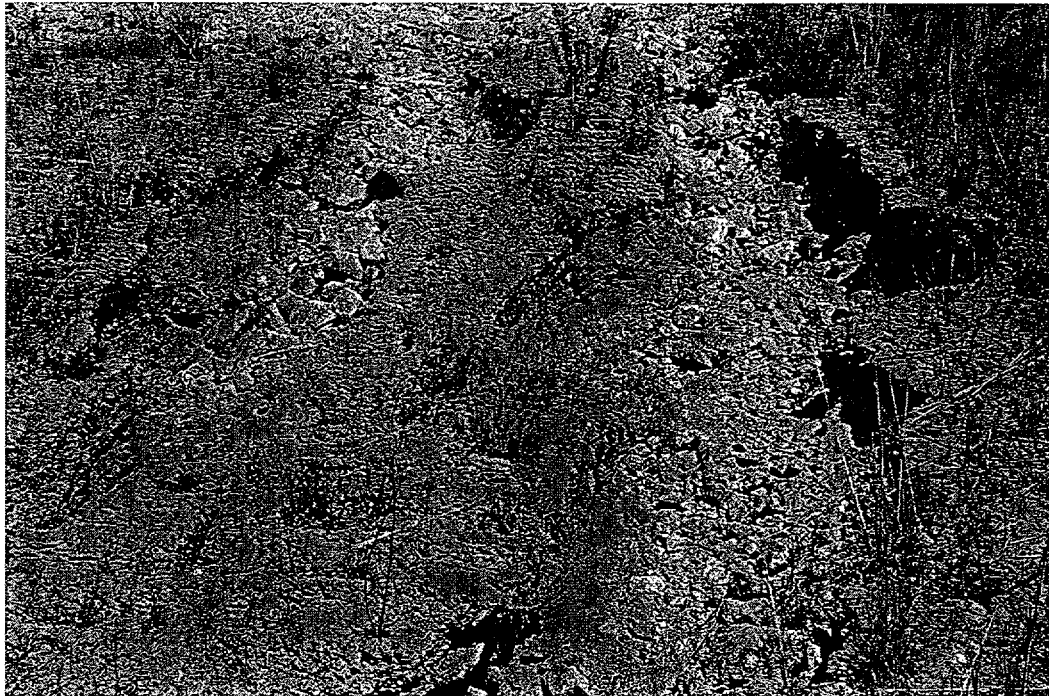
Photo 10.

Close-up view of the eroded topsoil and exposed quartz monzonite bedrock at the toe of the outlet swale.

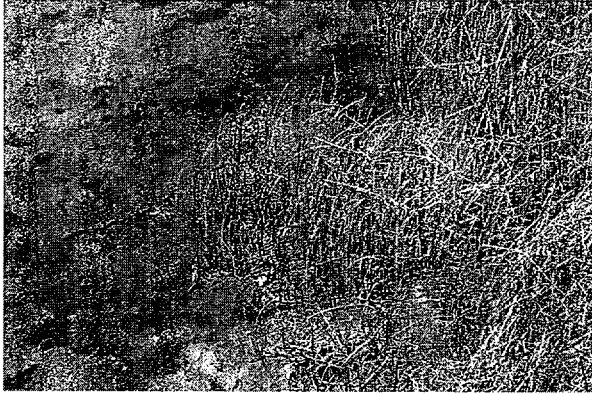
Re-vegetation (seeding) of the pond area occurred in the fall of 1998 and is progressing well, showing an estimated 20 to 40 percent vegetation coverage of the pond surface by the beginning of August 1999. See photographs of pond vegetation.

Close up of pond vegetation.
Photograph taken August 5, 1999.

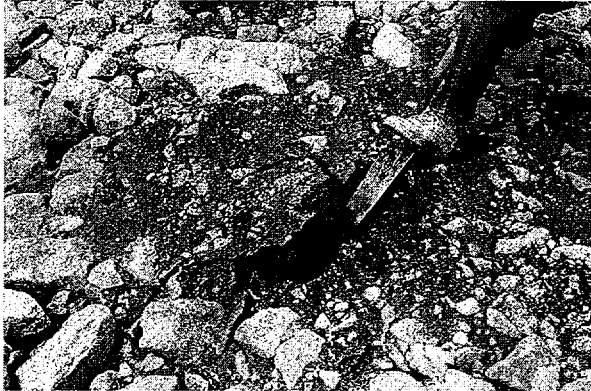
To date, rock placed during construction has not moved or shown any potential structural instabilities. (Insert P-60, 78, 86, 99, 108)

Some deposition of silty soils has encroached into the rock covers. However, the rock has not moved.

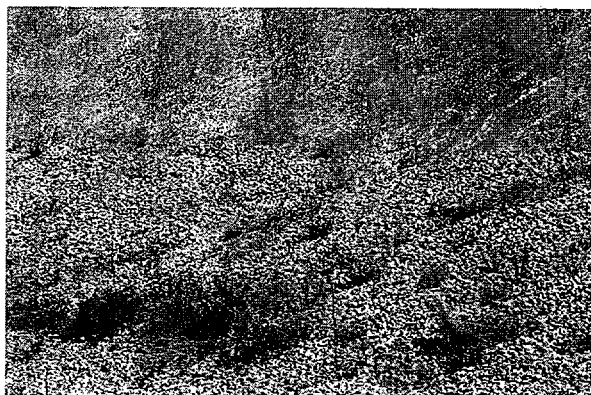
Erosional effects observed during inspections performed between construction completion and this storm versus erosional features seen after this storm indicate that a local thunderstorm of moderate intensity has caused additional rilling and soil deposition.

An hourly-reporting hydrograph, located just east of the reclamation site, indicated a peak intensity of 0.43 inches per hour for an 11-hour storm of 0.86 inches total accumulation.

Photograph is of the same general area, taken after the thunderstorm. Notice the increase in soil erosion and deposition in the rock.

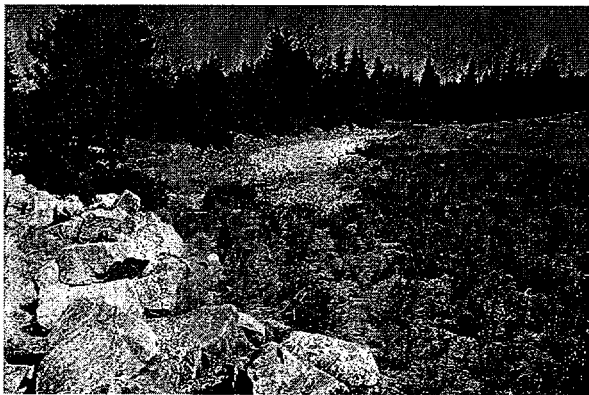
Photograph is taken from the access roadway up the rock protected drainage channel, looking northwest. Large rock in the foreground is adjacent to the road. A culvert (not seen at middle left of photograph) allows runoff to cross under the road.

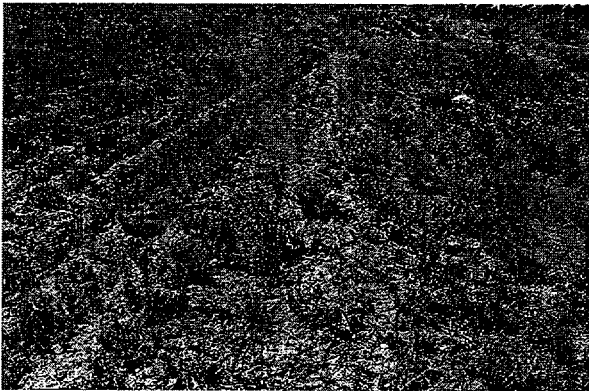
Photograph is taken about 50 feet to the east of the photograph above showing the ditching and channeling in the area. Ditches have eroded slightly in alignment with the ripping operation performed during construction. Channels direct runoff away from the drainage and culvert.

Surface water flow and soil erosion are occurring away from the constructed channel and culvert due to local ditching from construction effects. During construction, the area was compacted due to construction traffic and was subsequently ripped with a CAT-mounted deep ripping tool. Surface water flow has since followed this ripping pattern and not flowed into the channel and culvert as expected.

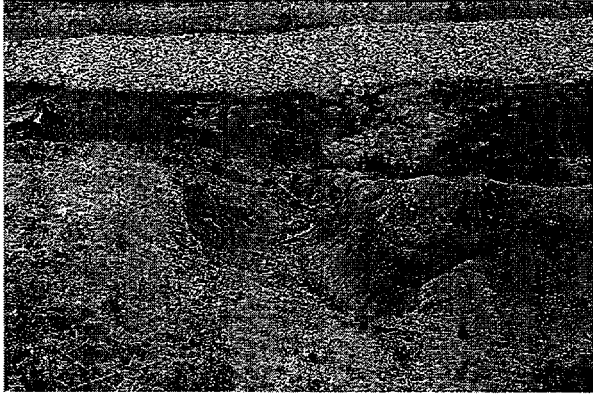
Photograph is of the gully formed at the base of the hillside north of the northwest section of the diversion channel. The gully has formed where the bench overflowed and eventually cut a gully. Silt from the hillside rills and the gully area have deposited in the diversion channel.

The constructed bench has had the effect of concentrating the surface water flow from the hillside, thus inducing the production of a gully and silty soil deposition in the diversion channel.

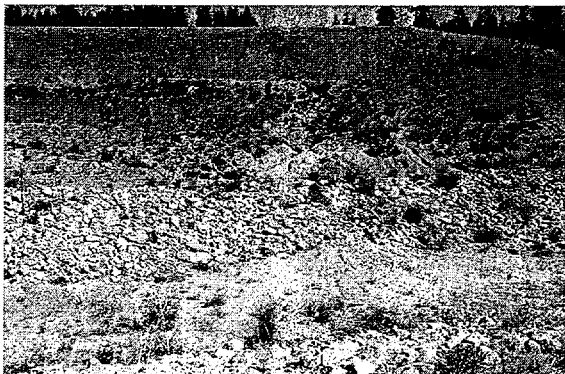
Silty soil has accumulated in the diversion channel. The accumulation has increased over the past two years, including the July 17th thunderstorm event. This accumulation is likely to continue until the up-gradient soils are stabilized. (See Question 2.)

Photograph shows soil deposition in the diversion channel in the foreground and gully in the upper middle of the frame. The background shows the re-vegetated hillside producing the runoff. Note the area of the diversion channel covered with soil. Soil is approximately 3 feet deep at the deepest location.

There is some question that, if the accumulated soil is allowed to remain or continue to accumulate in the channel, it may interfere with the required flow capacity of the diversion channel. It may therefore be warranted that the accumulation of silty soil is removed, or re-distributed, to no longer interfere. It may also be necessary to address Question 2 to limit or eliminate the source of silty soil accumulation. See photograph below of soil deposition in the northwest section of the diversion channel.

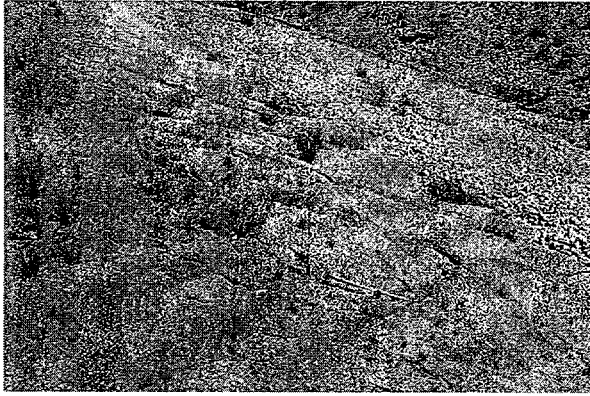
This photograph is of the area between the diversion channel rock slope and the margin. This area is only about 20 feet in length, but shows rilling in spots.

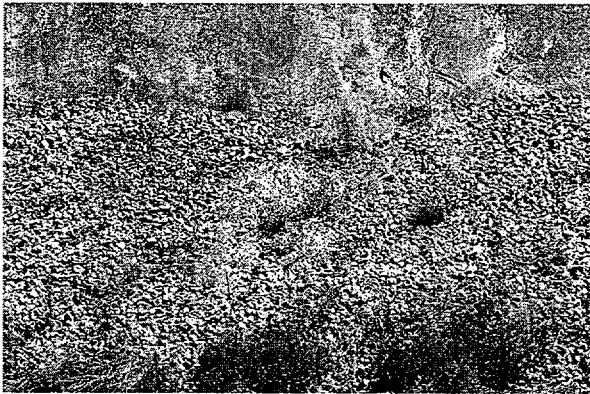
This photograph is of the east diversion area showing soil rills and soil deposition encroaching into the rock slope. Vegetation is establishing in the diversion channel rock slopes and bottom. Vegetation is generally absent on soil slopes.

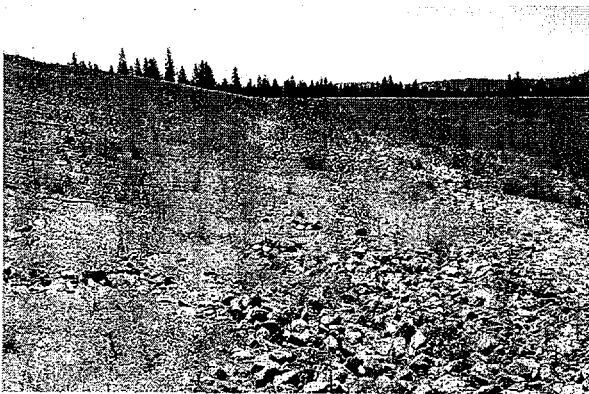
Photograph is of the same general area as above, showing the toe of the margin slope and the soil deposition into the rock toe.

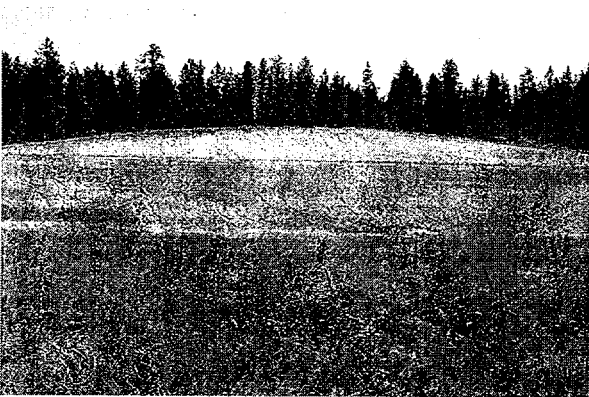
The recent thunderstorm event has caused additional erosion that indicates that the area is not yet stable. Past experience indicates that the recent rill production may self-heal.

Photograph is on the east margin in the distance. Rills are evident in the margin slope surface. Foreground shows the impoundment cover vegetation.

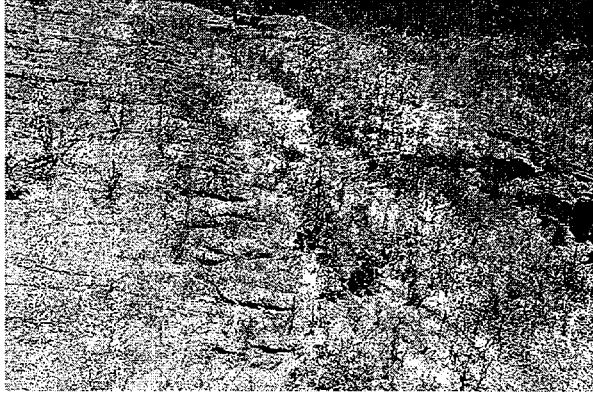
Photograph is of the southeastern extent of the bench shown above. A gully formed at the end of this bench. The bench has recently overflowed and begun cutting a second gully.

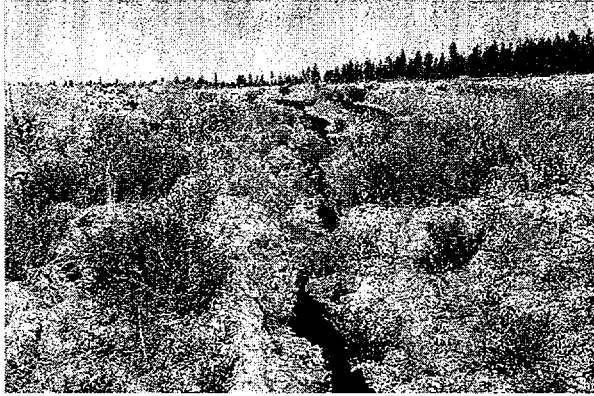
Photograph is of soil apron erosion down-stream of the impoundment swale. Soil apron material has high silt content in this area and is highly erosional. Gully shown is approximately 2 feet deep to quartz monzonite sub-grade by approximately 2 to 3 feet wide.

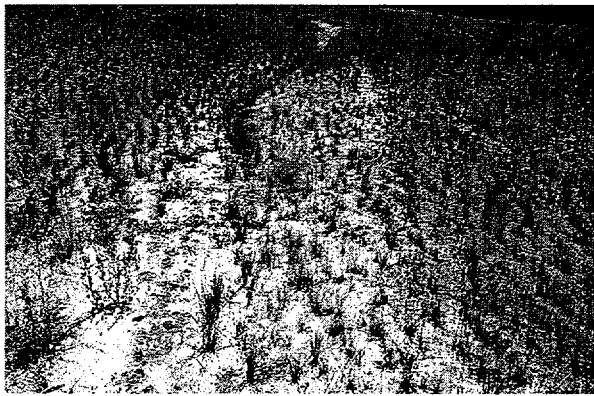
Photograph is of bench just down-stream of the soil apron, shown above. The bench has received some deposition in the foreground. In the background, the bench has begun cutting approximately one foot deep by one to two feet wide.

With moderate runoff from the swale, the first bench is likely to be breached; thus producing concentrated flow, gulying, and deposition of silt in the shallow capacity of the second bench. This would then repeat in due course and produce a gully effect down-slope from the swale through the two benches.
