**Sherwood Uranium Mill Project
TECHNICAL EVALUATION REPORT**

Monitoring and Stabilization Plan Supplement

February 2000

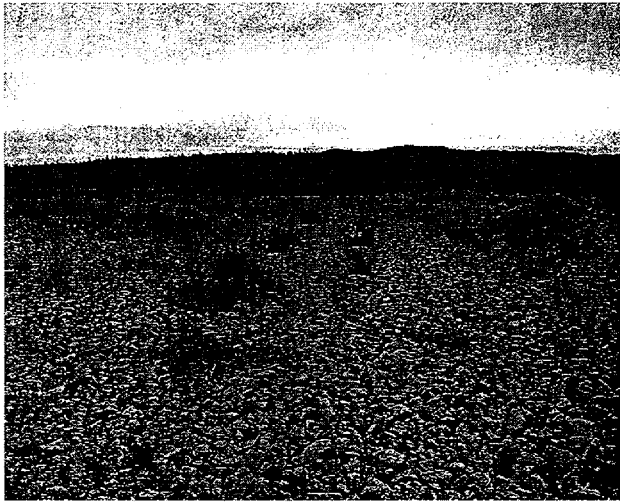
The inspection commenced at the highest portion of the diversion channel. The D₅₀ rock size at this location is 3 inch. The thickness of the layer was found to be at least 6 inches. The rock at

this location was found to be adequately sized and well graded (e.g., no areas/bands of smaller rock). The picture below shows this uppermost point of the diversion channel.

Picture 1: Looking downstream at the uppermost end of diversion channel

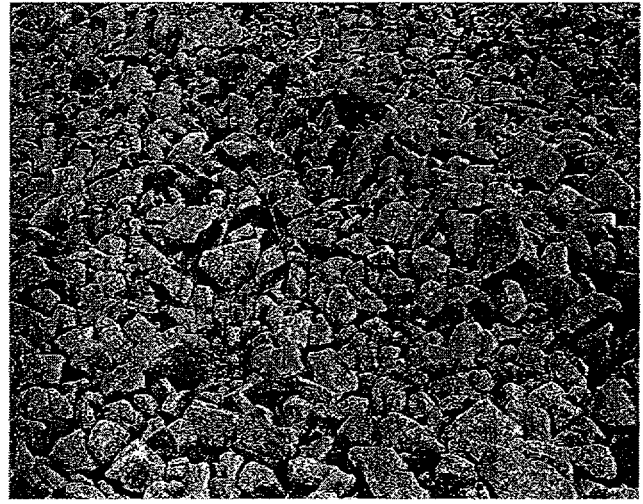
Picture 2: Ridges and valleys from construction

Ridges and valleys were noted on the sloped walls of the diversion channel. The bulldozer used to push the rock up the walls of the diversion channel apparently causes these “waves”. The valleys resulted from the compaction offered by the tracks of the bulldozer. The ridges were apparently caused by the lack of any compaction. This ridging and valley effect is called “construction traffic effects” in this report. This effect was noted most often where smaller rock ($D_{50} = 3$ inch) was placed. While the ridges were generally found to be parallel to the channel centerline in the western portion of the diversion channel, in the eastern sections of the channel the ridges were found to be perpendicular to the channel centerline. Picture 2 (above) and other pictures elsewhere in this report attempt to show the ridges and valleys.

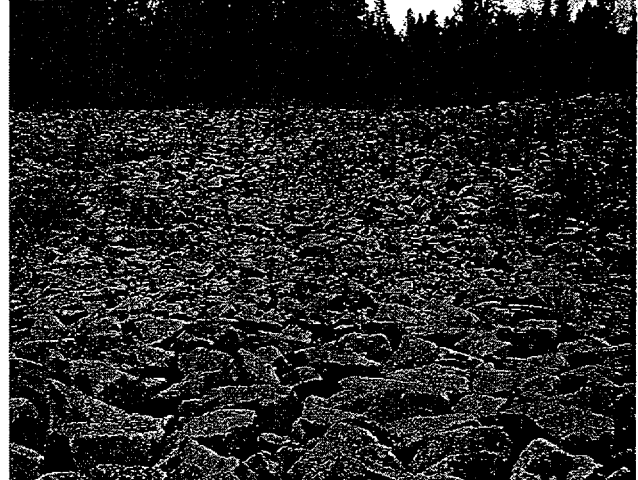
Picture 19: looking up Confluence C

Picture 19 is taken looking up Confluence C. Many different sizes of riprap are also visible. Near the center of picture 19, it appears that there is an area of only small rock. This area was investigated and recorded in picture 20 (below).

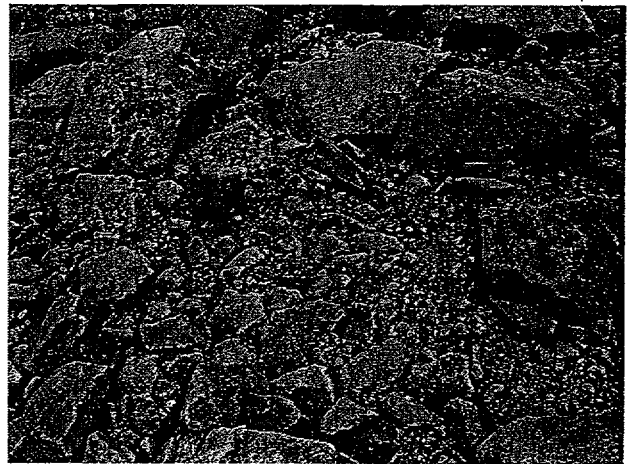
Continuing the inspection downstream from Confluence C, silting and riprap voids were visible as shown in pictures 21 and 22. In over 90% of the void areas, vegetation is growing.

Picture 22: voids in rip-rap layer

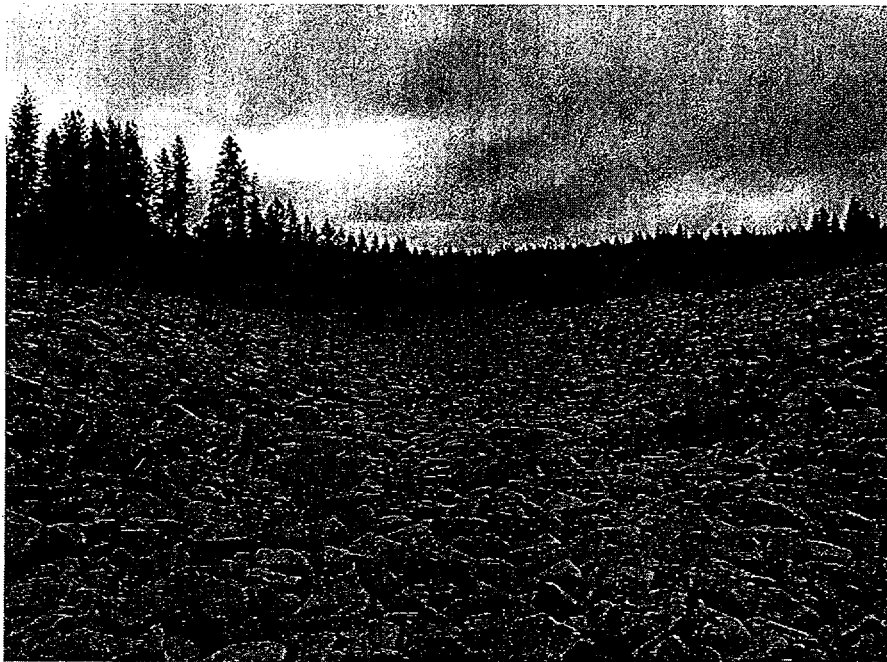
As shown in picture 21, beyond the silt area is a bend in the channel to the left. Picture 23 shows the diversion channel layout after that bend. Construction traffic effects are minimal and the riprap is larger (e.g., $D_{50} = 6$ inch).

Picture 23: diversion upstream of Confluence D

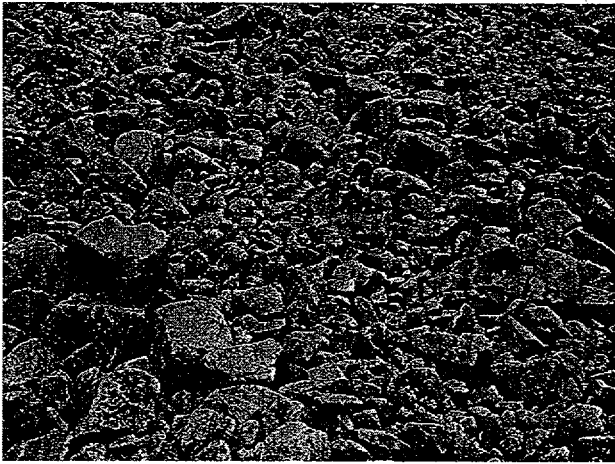
Near the far end of the leg shown in picture 23, a valley of smaller rock sitting atop bigger rock was found. The surface is uneven which corresponds to the bottom of the channel. This area of the channel was blasted during construction due to heavy equipment being unable to excavate the hillside. Picture 24 shows the valley of smaller rock.

Picture 24: about 200 feet upstream of Confluence D

Valley of smaller rock atop bigger rock

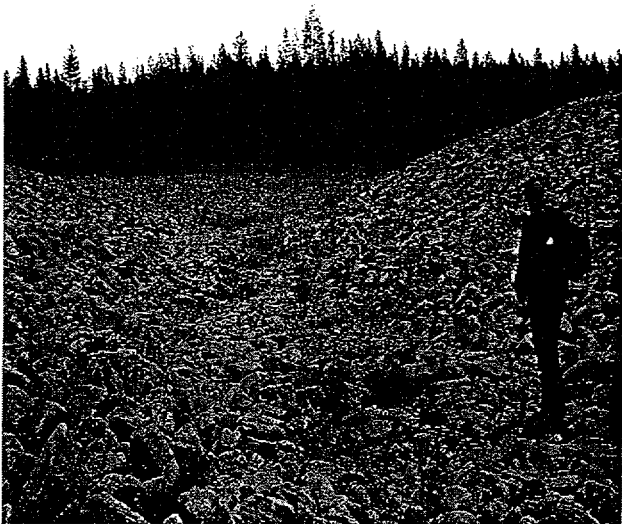
At Station 53+00 (about 150 feet upstream of Confluence D), a diversion channel low spot was characterized. The area was approximately 10 ft². Picture 25 shows the spot. Vegetation was also seen in this area.

Picture 25: low spot in diversion channel

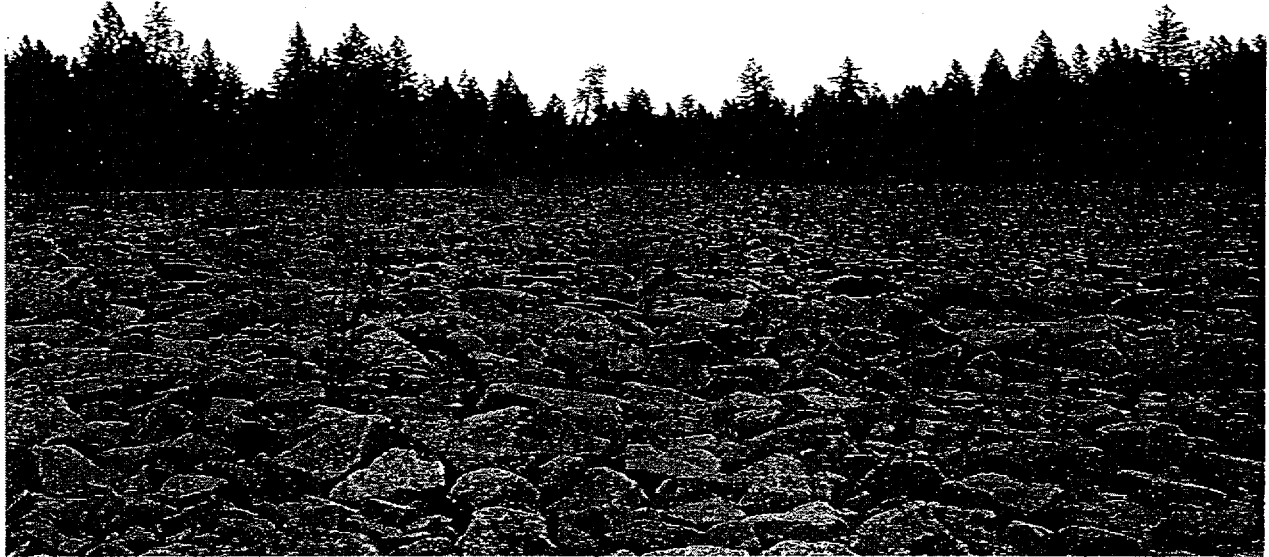
As can be seen in the distance of picture 25, Confluence D was the next major portion of the diversion channel reviewed. Confluence D was found to have construction traffic effects

Picture 27: Confluence D (taken from SW corner of confluence)

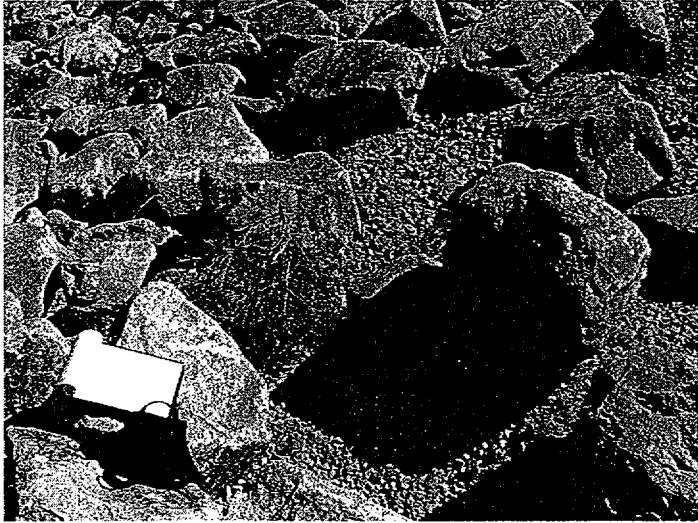
While the inspection revealed only minor rock placement irregularities when looking at the small 3-inch rock, the larger rock had some voids as is shown in picture 29. The voids were intermittent in the placement of the larger (e.g., 15-inch) rock and characteristically lacked the smaller rock sizes.

Picture 29: upper riprap edge of inner diversion channel wall at Confluence E.

Filter material is clearly visible through the voids in riprap layer.

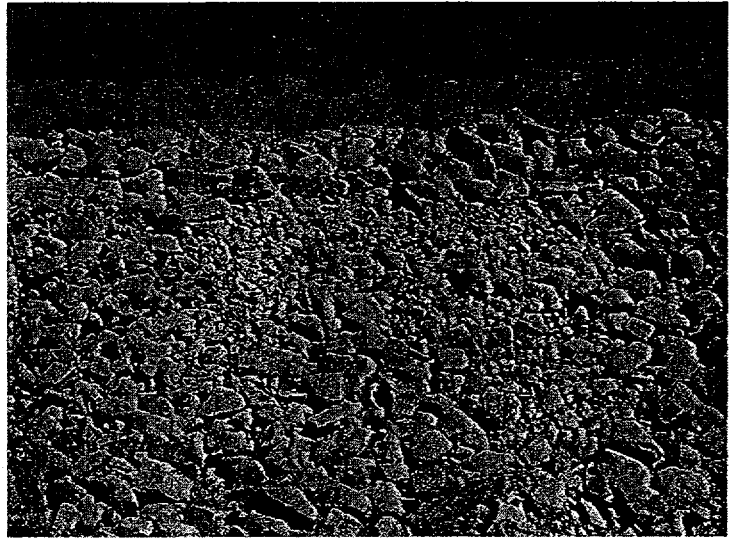
Picture 33: illusory area of poor grading

Picture 33 shows how these areas with segregated rock sizes may be misleading. The affected area (center top of picture) appears to be the result of the bulldozer catching some of the filter layer beneath the riprap and mixing the filter with the riprap during placement.

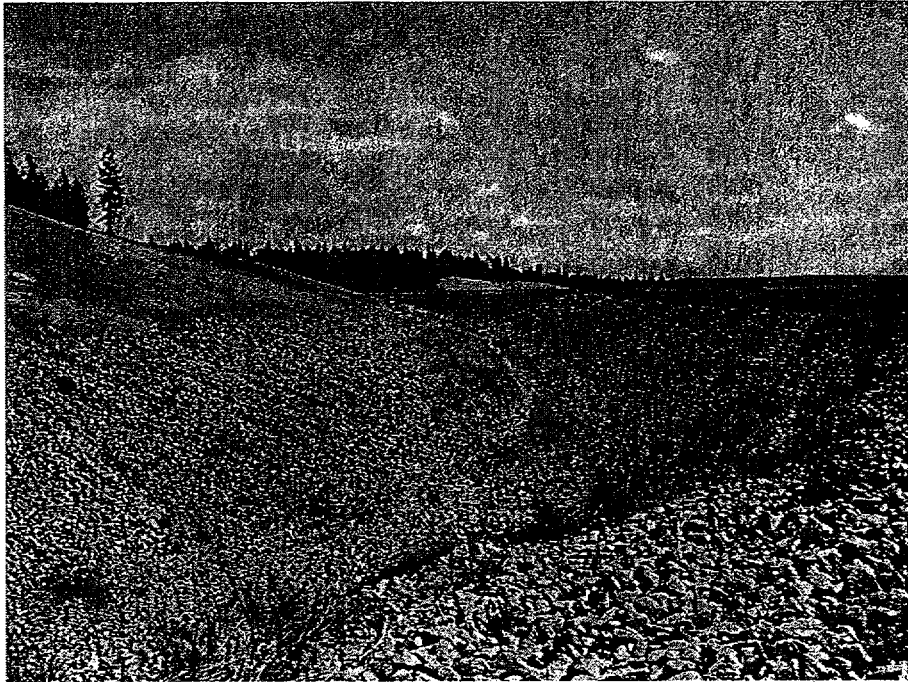
Picture 34 shows the diversion channel between Confluence E1 and Confluence F. It is apparent that a bulldozer was used to move the rock up the slope of the diversion channel walls. In the picture below, ridges can be seen on the outer (left-hand) wall. In most cases, the ridges in the eastern legs of the diversion channel are perpendicular to the channel centerline, but there are occasional stretches where rock was pushed up the slope at angles less than 90° to centerline.

Picture 34: Looking downstream towards Confluence F.

The water in the channel is from a spring intersected during construction.

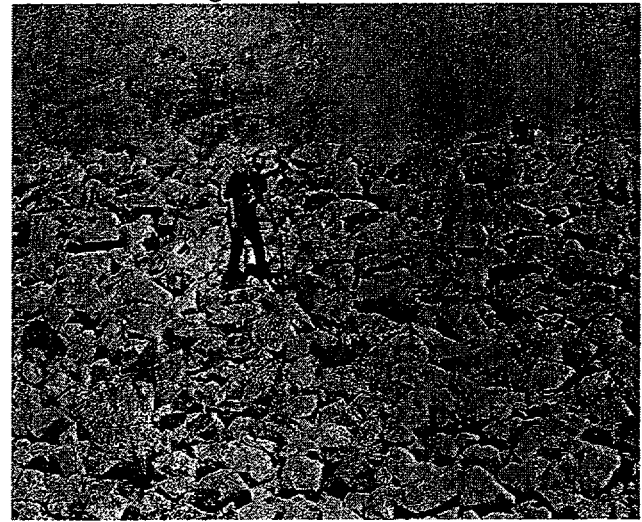
Picture 36: Voids in Confluence F riprap

Picture 36 shows the larger riprap sizes used in the confluences. The filter layer was visible in a few small ($< 5 \text{ ft}^2$) areas. Voiding is a small percentage of the total area of the confluence.

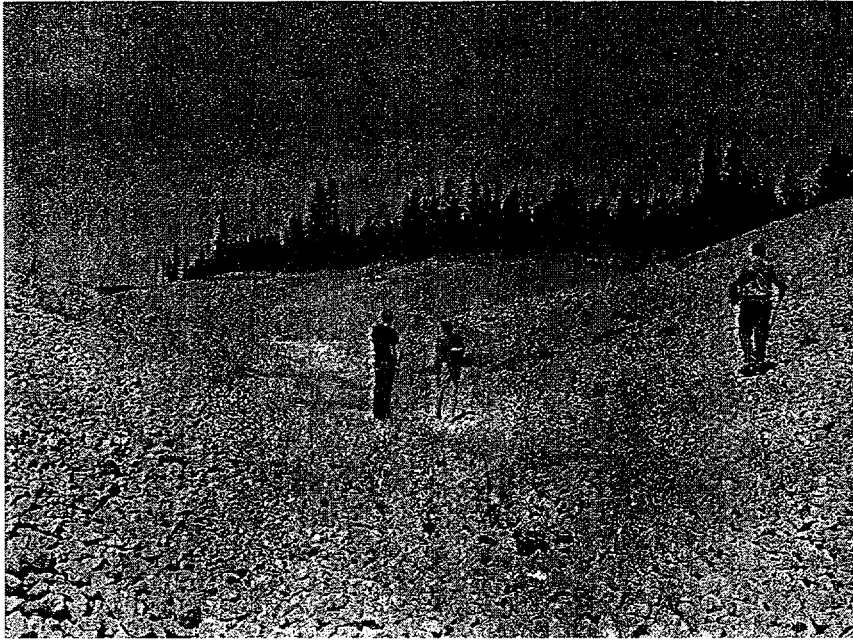
At station 19+36 (upstream edge of Confluence G), well-graded 3-inch rock was evident. Construction traffic effects were noted on the slopes of the diversion channel. The ridges prominent in the traffic effects were perpendicular to the centerline of the channel. Picture 41 shows the channel from this point looking upstream to Confluence F2.

Picture 41: looking up the channel from station 19+36 toward Confluence F2.

Well graded 3 inch rock is characteristic of the rock in the diversion channel.

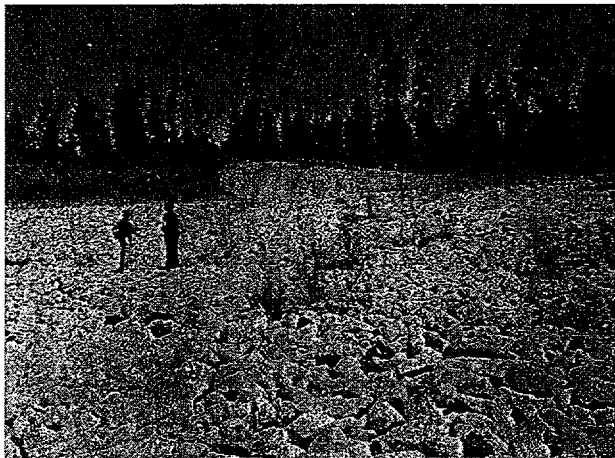
Picture 42: Confluence G

The last major intersection within the diversion channel is Confluence G. Picture 42 and 43 show the layout within the boundaries of Confluence G.

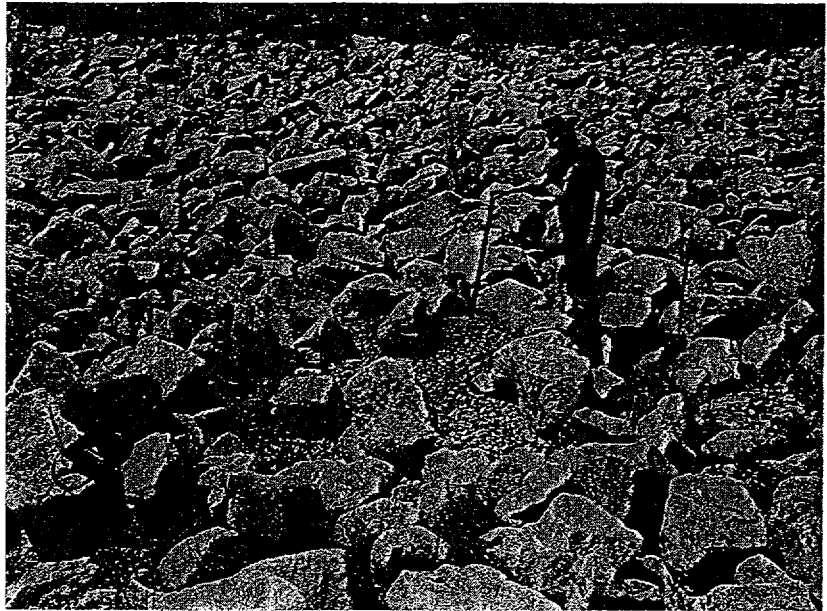
Picture 44: approximately 10 ft² of voiding in the riprap layer in an otherwise good placement area at Station 15+79.

At Station 15+79 a 10 foot by 15 foot area found void of riprap. This area is located along the centerline of the diversion channel at the downstream transition from large ($D_{50} = 15$ inch) riprap used in Confluence G to the smaller ($D_{50} = 3$ inch) riprap used for most of the diversion channel. Picture 45 shows this area.

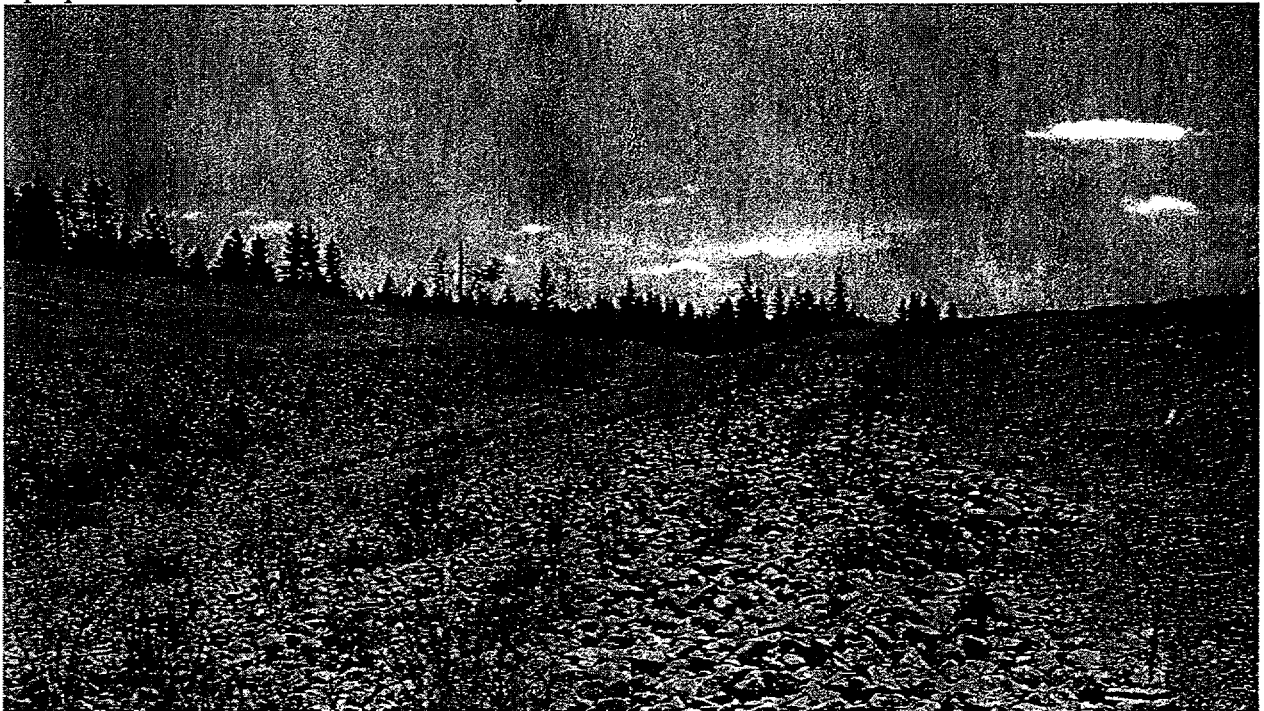
Picture 48, taken from the top of the inner wall, shows the remaining portion of the diversion channel to the outlet. The outlet is approximately 1100 feet downstream from the point where this picture was taken. There are no remaining confluences in this portion of the channel. The riprap is 3-inch rock in a 6-inch thick layer.

Picture 48: looking toward the diversion channel outlet

At the time of this inspection, the diversion channel was less than three (3) years old. In this short time vegetation has pioneered the diversion channel. Along with the various grass species that have become established in the diversion channel, several species of trees can be seen.

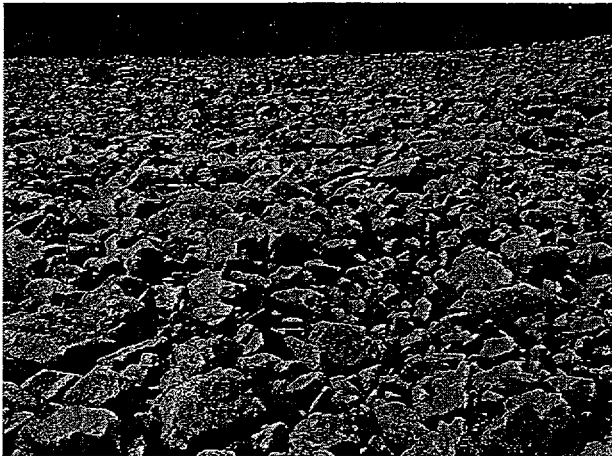
Picture 51: looking south across swale

As is indicated in pictures 51 and 52, the swale is generally well graded riprap with some basalt visible. Several areas were examined for thickness and found to be acceptable. In one area of apparent segregation of riprap (picture 53, below), only 3 inch rock is visible. However, when the area was dug out, larger rock was discovered beneath. In essence the voids created by using large rock are being filled with the smaller rocks that are part of the gradation requirements. The interlocking feature of the various rock sizes serves to enhance the structural stability of the surface.

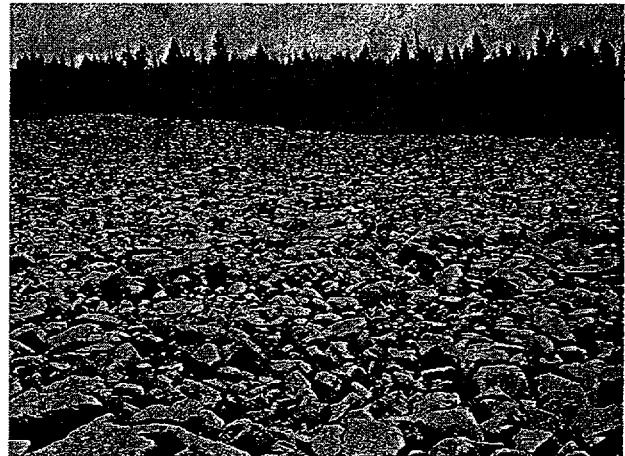
Picture 52: looking easterly across the swale

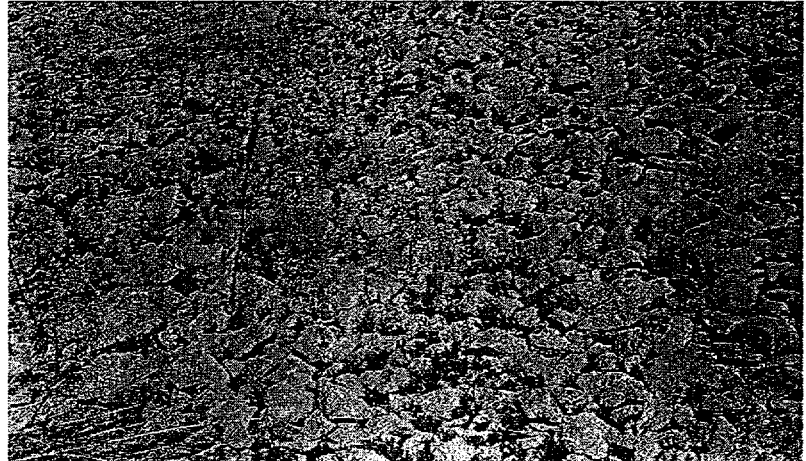
In other areas on the main embankment, small trees were found to be growing.

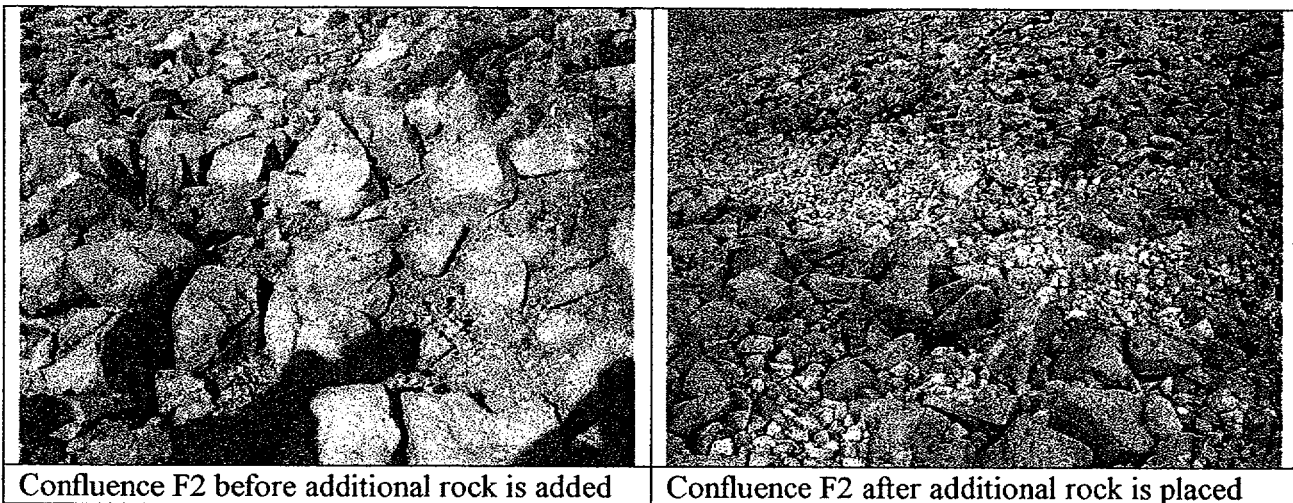
Confluence F2 before additional rock is added

At Confluences "E", "E1", "F", and "F2" rock was placed into the riprap voids via the front-end loader. The front-end loader was able to reach placement voids approximately 3/4 way up the 3:1 diversion channel walls. In areas that the front-end loader could not reach without causing excessive damage to the channel walls, rock was hand-moved from nearby areas that had appropriate sized rock and excess quantities. This technique proved most efficient at the seams of the confluence and the upper edge of the confluence walls.

Confluence F2 after additional rock is placed

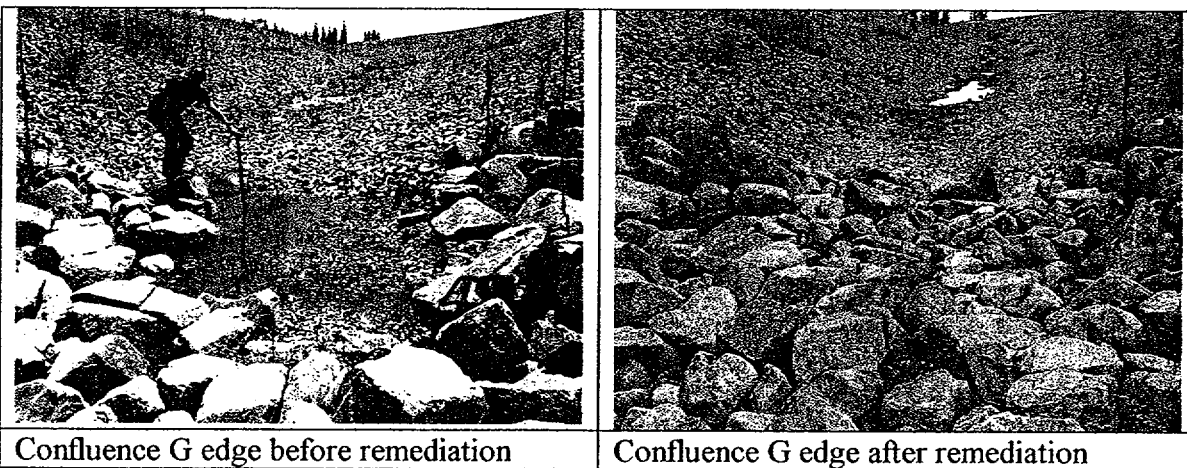
The portions of the channel that required the most intensive effort were the confluences. Of particular concern was the downstream edge of Confluence "G" where apparently only filter was placed in an area about 10 ft by 15 ft.

Confluence G edge before remediation

At Confluence "G", the voids with filter material visible received additional rock to cover the filter to the proper depth. At the downstream edge of this confluence, large (d_{50} = 10-15 inch) rock was placed at this location. Since the stockpile rock was only 3 inch, the rock used for this 150-ft² area was scavenged from other locations within the channel that had excess rock. Over half of the rock necessary to remediate this location was obtained just upstream of Confluence "E". (See pictures below)

Confluence G edge after remediation

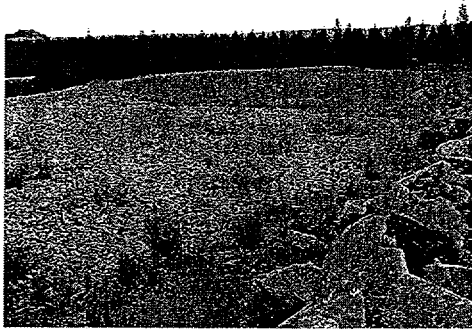
Before

Issue 1 is an area near the access roadway that is collecting runoff from a small watershed (about an acre) that has produced some small rills. Construction in this area is to direct the surface water flow down an existing channel area. Work in the area opened up the channel to about 1 foot deep by 8 feet wide. See photos for before and after conditions. This work enhances the surface water flow path away from a potential for surface water flow into and possible erosion of the west groin area of the dam. Work performed met design requirements.¹

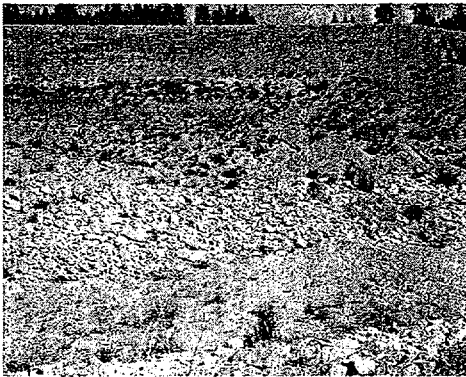
Before

Issues 2 and 3 are in the northwest section of the diversion channel where silt has encroached into the channel from an up-gradient re-vegetated slope. This up-gradient slope area contained a source of borrow top soils. The area was reclaimed, re-contoured and re-vegetated in 1996. The up-gradient slope still shows some rill erosion and produces some silt during storm events.

Near the bottom of the slope, but above the channel, there was a constructed bench directing surface water flow to the south and away from the diversion channel. This bench filled with sediment, overflowed, produced a small gully (Issue 3), and deposited silt in the channel. This gully and the silt from the slope have produced concentrated silt deposition in the channel (Issue 2). This silt has deposited in a classic fan pattern where the surface water encountered rock (riprap) on the side of the channel, and the channel bottom with its shallow gradient slope.

Approximately 3 feet (maximum depth) of silt was found in the diversion channel bottom. The department's interest was to stabilize the area, and reduce the long-term potential for silt deposition accumulation that might reduce the diversion channel flow capacity.

Issue 2 correction was to re-distribute silt in the channel to about 1 foot or less thickness above the rock, thus reducing the amount of diversion channel flow capacity reduction. This was accomplished by moving the accumulated silt down stream reducing silt deposition thickness. This work was defined by memo instruction and inspected in the as-built condition. See photos showing the before and after condition. Work performed met design requirements.¹

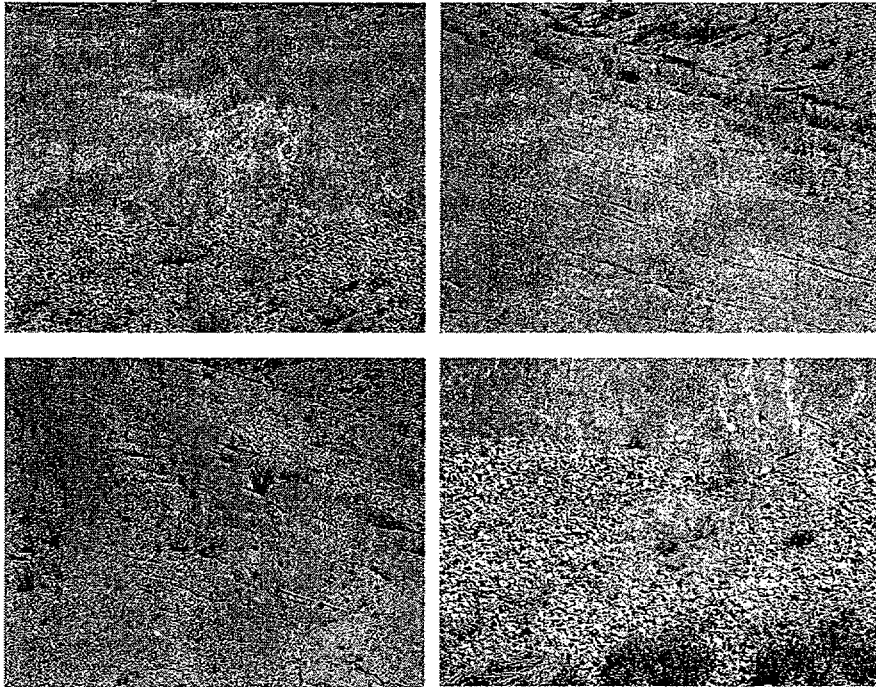
Examples of Diversion Channel Side Slope Rill Erosion

The outside side slopes are longer (20 to 100 feet) slopes between the diversion channel rock placement and the outside, undisturbed area of the site. This area shows longer and wider rills and has caused more silt deposition in the channel (compared with the inside slopes). Outside slopes were not enhanced with topsoil placement or seeding. They are therefore showing slow re-vegetation. The erosion is in rills of depth from 2 to 6 inches in places and widths of a few inches. The rills are parallel to each other and separated by a few feet. The rills appear to be limited in depth by the greater structural capacity of the sub-surface soils, thus flaring in width, rather than depth as they progress down-slope.

Soil erosion and diversion channel capacity analysis¹ prepared by Western Nuclear Inc.'s engineering consultant indicates that the constructed diversion channel geometry is capable of accepting large amounts of soil sedimentation without interfering with the design flow of the diversion channel. Although re-vegetation is slow on the side slopes, and rill erosion is still occurring, side slopes are expected to stabilize like the surrounding terrain over time and before large amounts of silt could accumulate in the diversion channel to cause interference of design flow capacity. Silt accumulation is observable but very much less than the design allowance. See photos below for a general indication of the existing conditions. See the referenced analysis for a quantification of the allowance for sedimentation in the diversion channel.¹

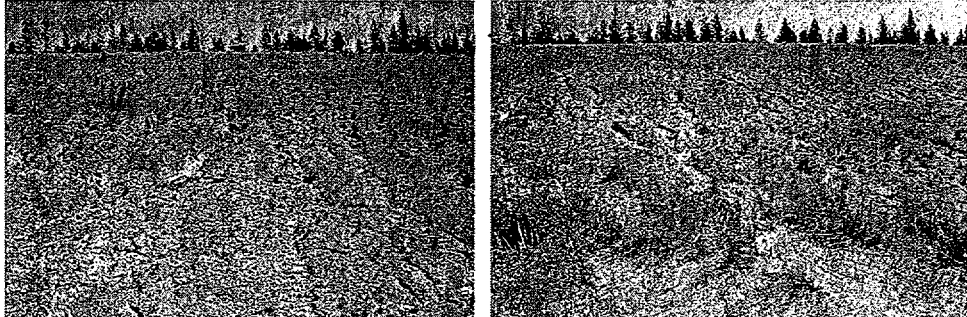
Examples of Margin Slope Rill Erosion

Issue 5 relates to rill erosion potential on the margins between the margin berm and the impoundment. This area is about 75 to 150 feet long down-slope with slopes from 3H:1V (33%) to 5H:1V (20%). The area is covered with placed topsoil 6 to 12 inches thick over the cut constructed margin berm. Most of the sub-grade is weathered monzonite. Some sub-grade material is alluvial soil generally located adjacent to diversion channel confluences. Rills are present in some margin areas and are typically 2 to 6 inches deep. Re-vegetation of the margins has progressed and produced vegetation that has stabilized many of the early (just after construction) erosion areas. Many rills remain and re-vegetation has not completely stabilized the margin slopes.

Vegetation remains in the early succession stage with good growth of grasses. Shrub plants are now present in small size and will improve the erosion protection of these slopes over time. There is still a potential for rill erosion to expand and for sedimentation to continue, especially during major storm events. Over time, the erosion protection afforded by vegetation and natural weather hardening of the exposed surfaces will increase surface stability. Soon, margin side slopes will be stable for expected (high probability) storm events. Rill erosion may then be expected only during major (low probability) storm events. Later, margin side slopes will further stabilize so that rill erosion will be minimized even for major storm events.

Observation of natural side slopes in undisturbed areas adjacent to post-construction areas shows very little erosion or potential for sedimentation. Therefore, the long-term expectation is for rill erosion and sedimentation to cease.

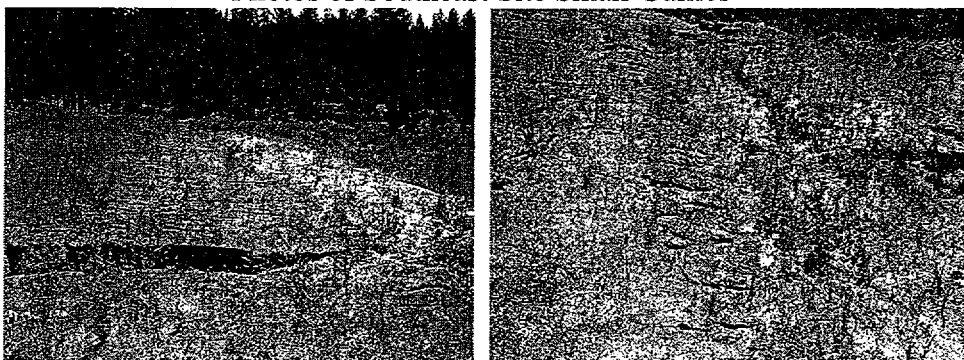
Photos of Southeast Site Small Gullies

Issue 6 is an area on the southeast edge of the impoundment site. It is quite distant from impounded tailings (several hundred feet). There is a small watershed area (less than 5 acres) of the disturbed area between the swale outfall and the diversion channel outfall that slopes toward the south. This area has produced some concentrated surface water flow to the south and formation of small gullies. There is a constructed bench at the southern extent of this disturbed area that has further concentrated the surface water flow. This bench has filled with sediment, overtopped and produced small gullies.

The total effect, especially considering the distance to impounded tailings or significant structures, and the small size of the gullies, is not significant to performance of the site. See photo of area described.

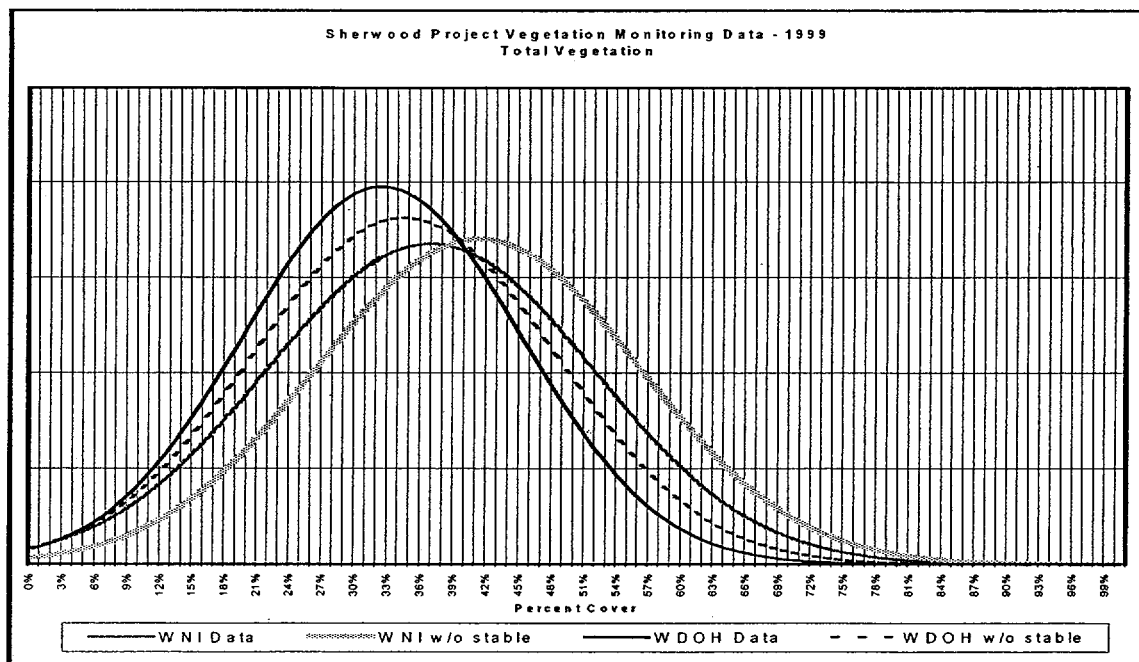
Comparison of the sample data for the four cases indicates that the results for the four cases are not statistically different at approximately the 95% confidence interval. In addition, the Deep Soils data indicates better performance than the Full Sample data, but not markedly. Evaluation of individual sample data points shows that considerable vegetation prevails on the areas of the margin where quartz monzonite bedrock is found. See the probability distribution below for the four samples for a visual representation of the individual sample data.

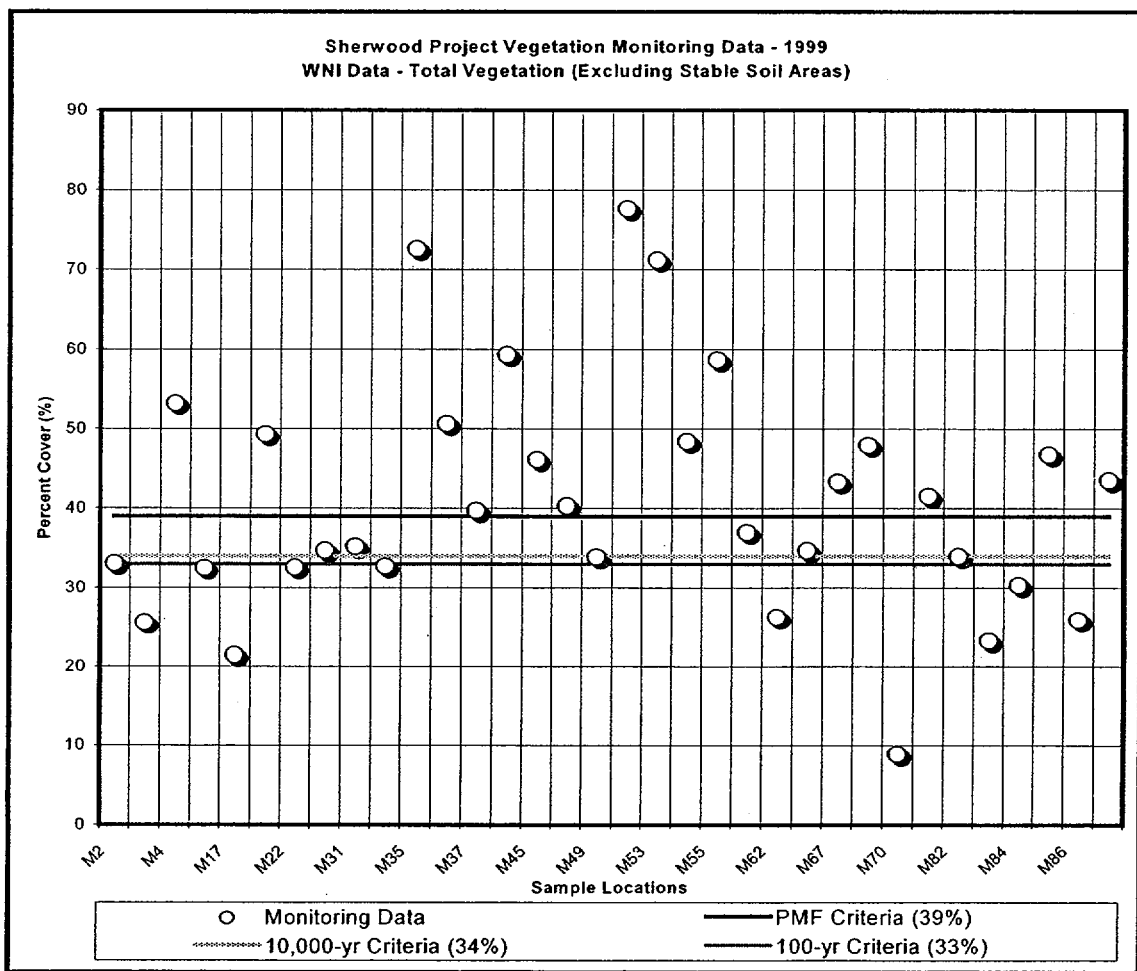
Sample data for Western Nuclear, Inc.'s Deep Soil sample set has been charted for percent cover indicated at each sample location. In addition, the 39% (PMF – 1 in 1,000,000-year storm event criteria), the 34% (1 in 10,000-year storm event criteria) and the 33% (1 in 100-year storm event criteria) criterion bars are also shown. As can be seen below, most sample points exceed the 33% and 34% cover criteria, and a majority of sampling points exceeds the 39% cover criteria.

While it may be apparent by viewing the chart that there may be some likelihood that some erosion may occur, it is not likely to be widespread, cover large areas, or be of a concern for causing major damage that would require re-construction. (There is considerable vegetation productivity variability by sample location.) Only unlikely events (greater than 1 in 10,000-yr storm events) are likely to cause major damage.

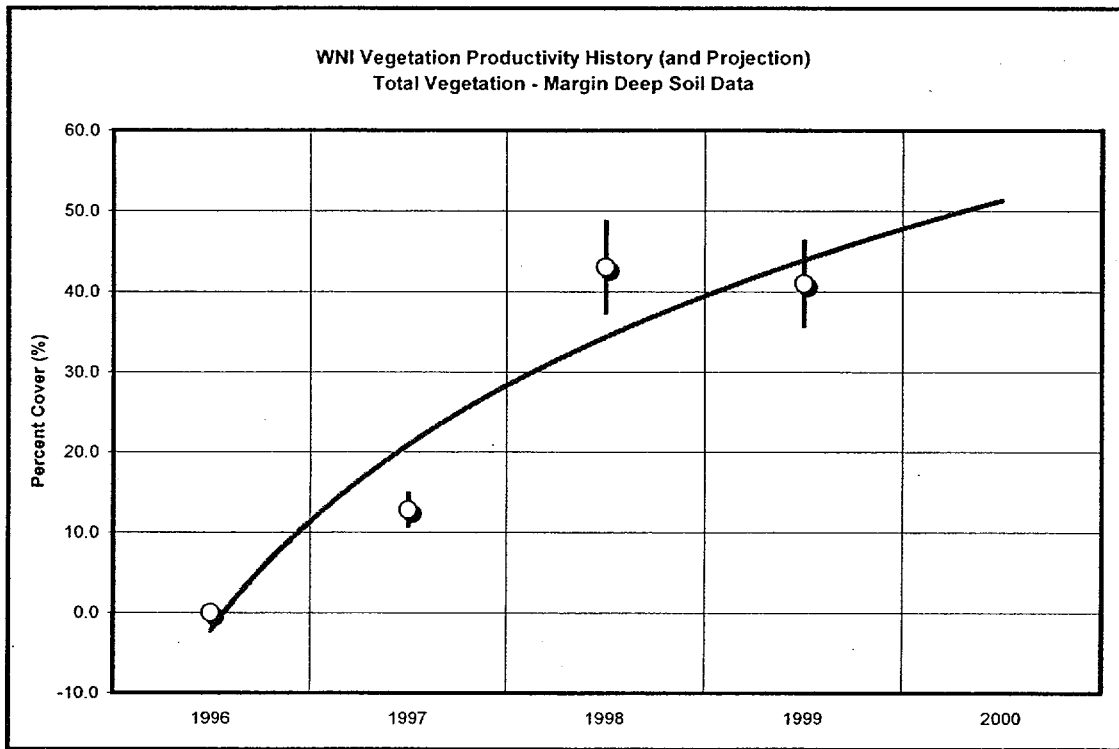
In the longer-term, the site is expected to increase in vegetation productivity and attain relative structural stability from erosion similar to the surrounding areas of the site. In the following chart, the historical data is plotted over the past 4 years for total vegetation on the margin areas for deep soil samples. The mean and 95% confidence interval are shown for each year, as well as a logarithmic fit line that projects vegetation productivity progression into the 2000 season. (Reclamation construction occurred in 1996 indicating a 0 percent cover for that year.) See the following chart for a visual presentation of the history and projections for vegetation productivity.

Although there is variation in vegetative cover from year to year, the trend is for continued improvement and projections of percent cover in the range of 50 percent by the summer of 2000.

There is an apparent higher performance in 1998 compared to 1999 data. It appears that a predominance of sweet clover (a biennial species) has skewed the results somewhat. Sweet clover has a peak performance in the second, fourth, and even years after planting. The odd years will eventually fill in. Therefore, it is expected that year 2000 results will again increase. WNI and department staff observed this affect.
