Attention: Mr. Nick Jackiw R-3 38-42697

Subject: Reference Telcon on 4/21/82 at 4:26 p.m.
Between Nick Jackiw of NRC and Rick Haisler,
Manager, Quality Assurance of BPS

Subject: BPS Generators Provided for Nuclear Standby Service -
Alternator to Spider Rotor Torque Value Discrepancies,
Hope Creek Alternator S/N 700510R2

SUBJECT POTENTIAL FAILURE IN DIESEL GENERATOR SETS

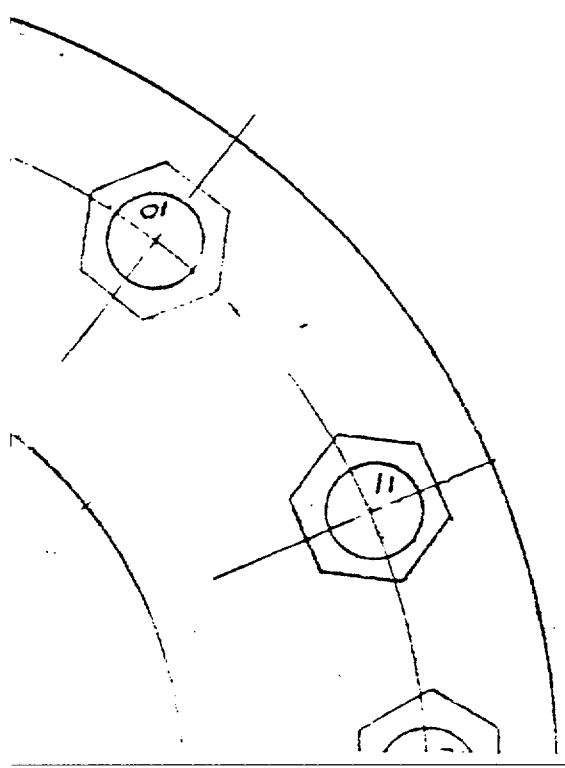
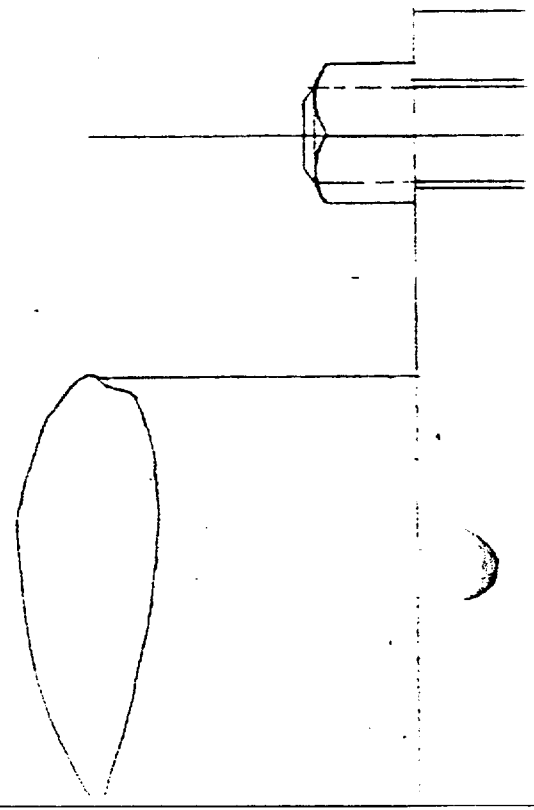
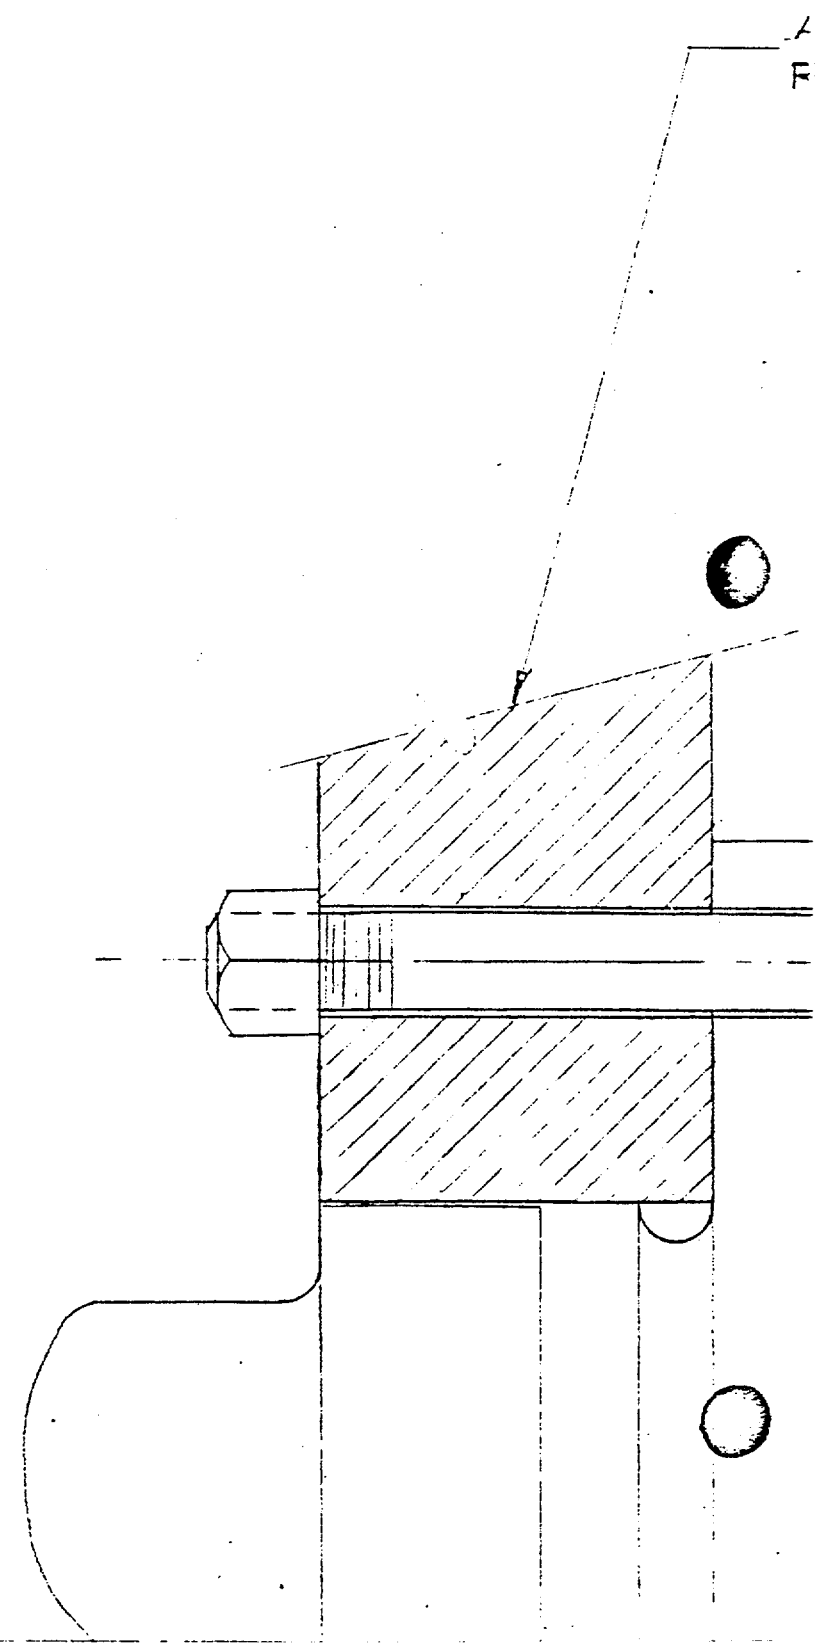
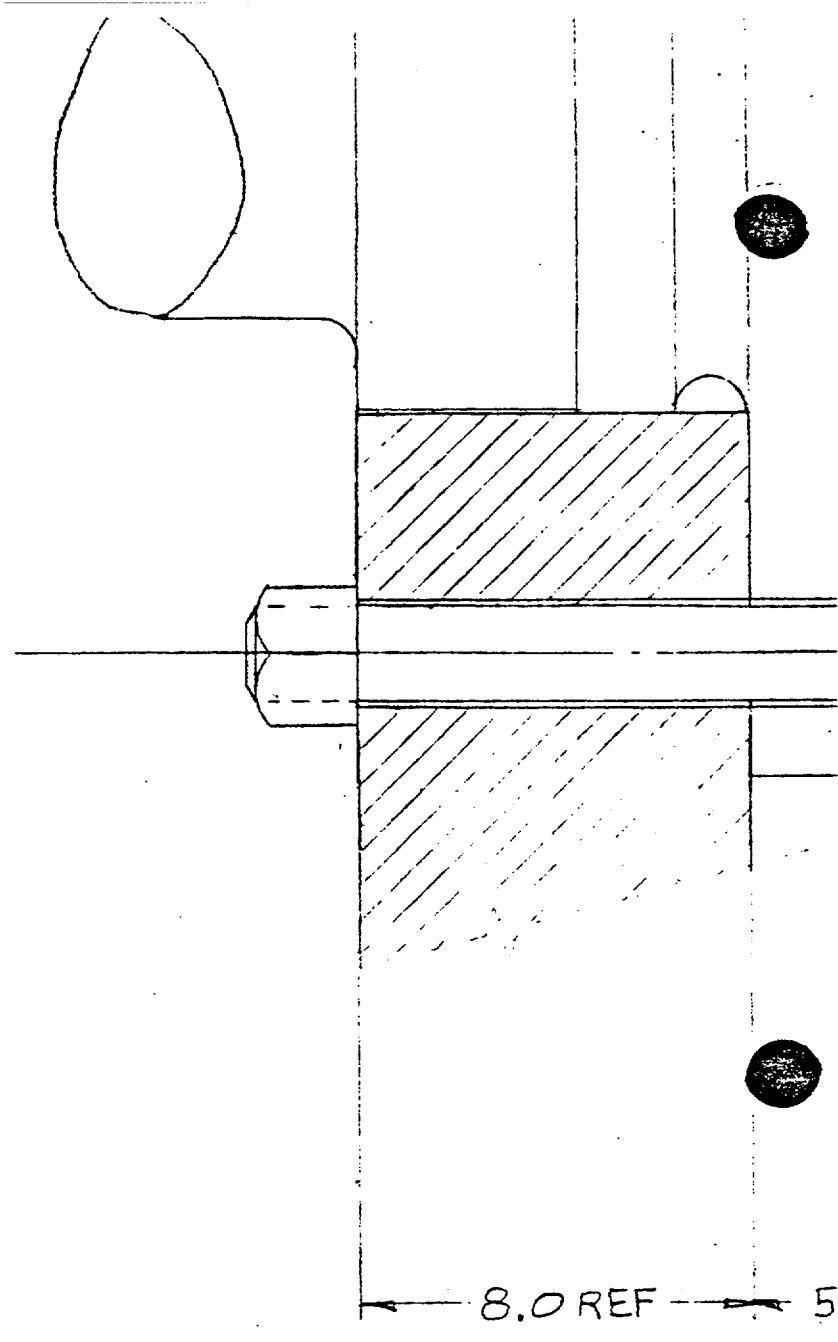
The application of this stud/nut design is shown on Colt Industries Drawing Number 11871439 Attachment (2) submitted for your information.
