REPORT TO CONGRESS
ON
ABNORMAL OCCURRENCES
FISCAL YEAR 2002

March 2003

Office of Nuclear Regulatory Research
United States Nuclear Regulatory Commission
Washington, DC 20555-0001

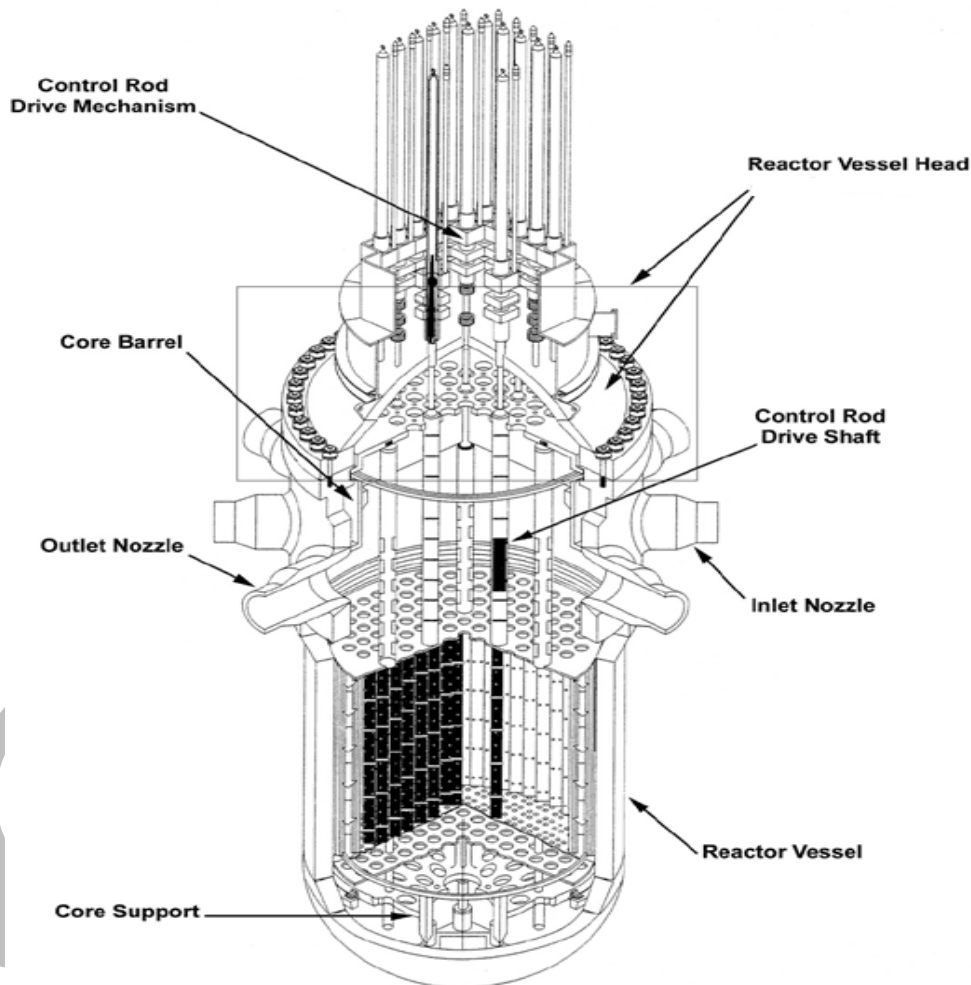
Figure 1. Typical Pressurized Water Reactor (PWR)

Nature and Probable Consequences — On February 16, 2002, the Davis-Besse facility began its 13th refueling outage, which included inspections of the control rod drive mechanism (CRDM) nozzles in accordance with NRC Bulletin 2001-01, "Circumferential Cracking of Reactor Pressure Vessel Head Penetration Nozzles," issued on August 3, 2001. These nozzles penetrate through the reactor pressure vessel (RPV) head and are attached by welds. Nozzle cracking was first discovered in the industry in the late 1980s. The concern with cracking is the potential loss of control rod drive function (rod ejection) and the resultant loss of coolant accident (LOCA) should the cracks reach a critical size and orientation. Also of concern is the potential for the reactor coolant to leak through small cracks in CRDM nozzles and cause boric acid corrosion of the RPV head. The RPV head is an integral part of the reactor coolant pressure boundary (Figure 1) and loss of its integrity can likewise result in a LOCA.
