**EXAMINATION OF THE REACTOR VESSEL (RV) HEAD DEGRADATION
AT DAVIS-BESSE**

**FRAMATOME ANP, INC.
DOCUMENT 31-5029337-02**

**PREPARED FOR
FRAMATOME ANP, INC.**

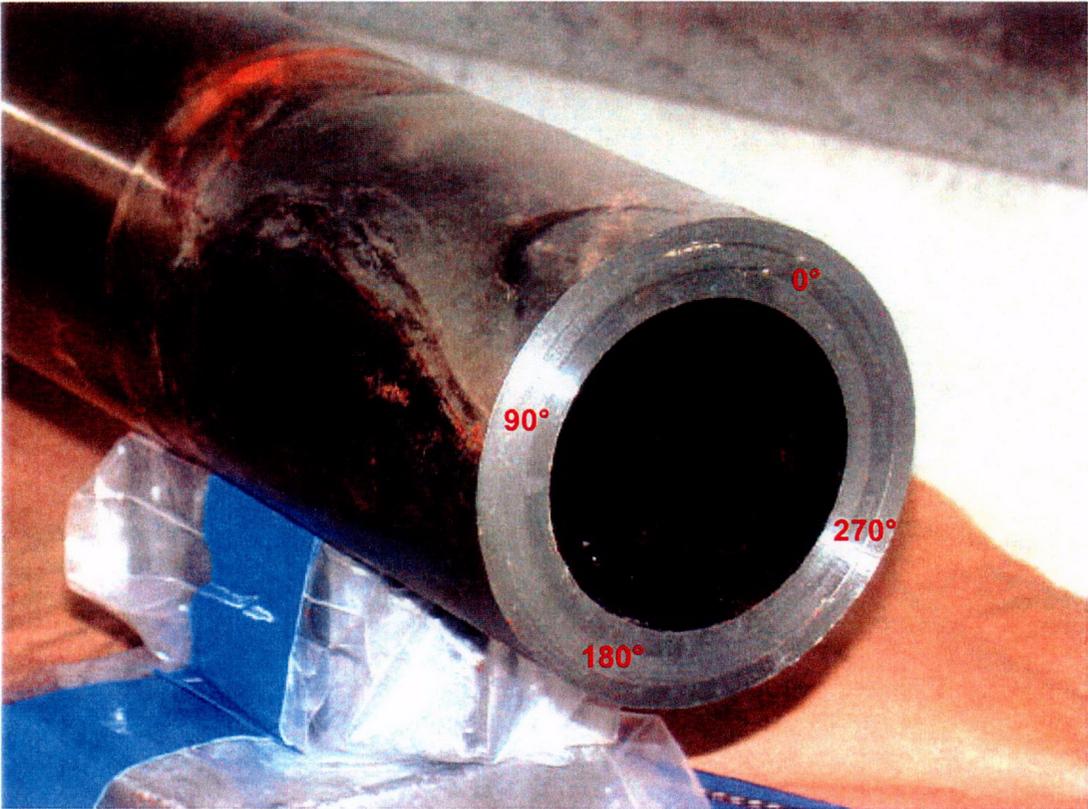
Figure 2.2.3: Photograph showing end view of nozzle #3.

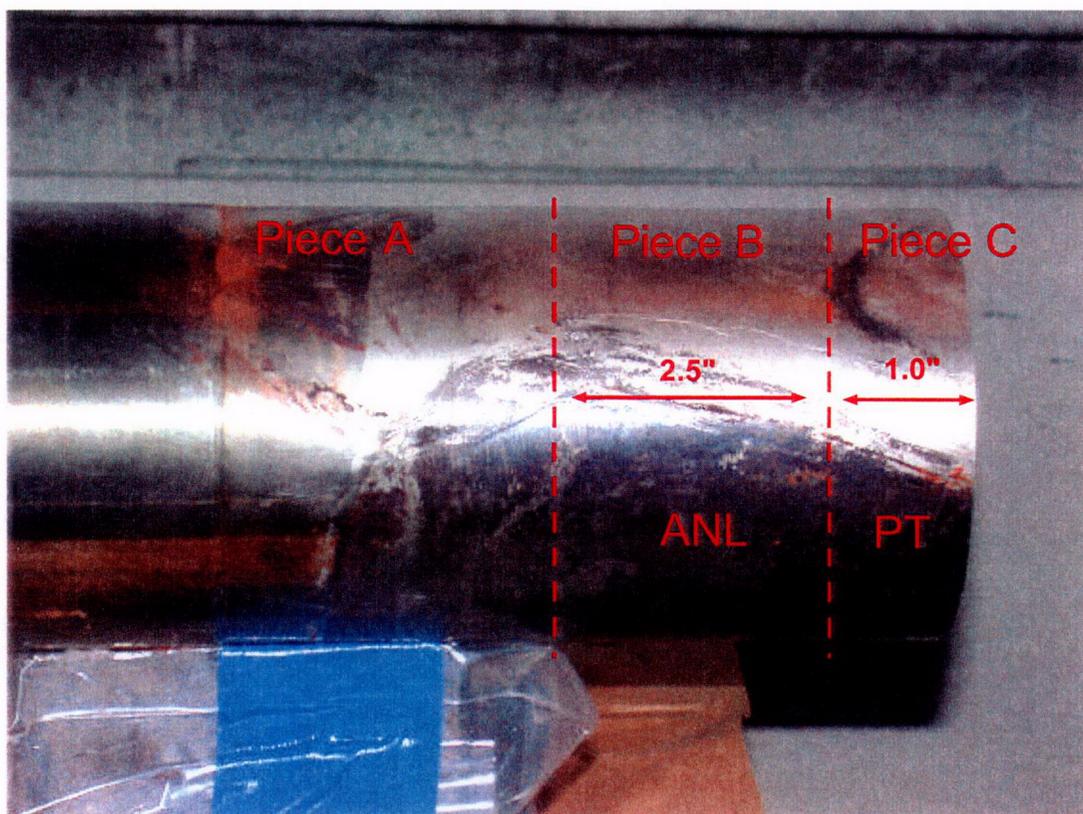
Figure 2.3.1: Sectioning photo for nozzle #3. Piece B was shipped to Argonne National Laboratory and piece C was further tested at BWXT.

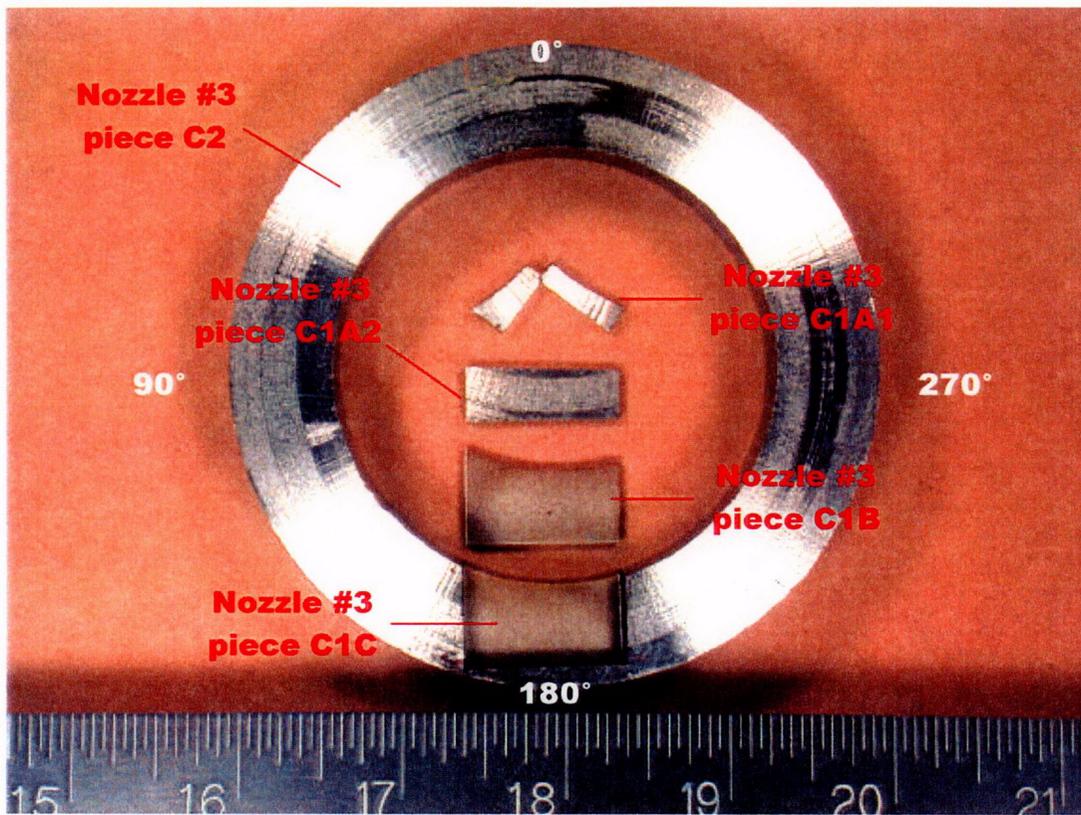
Additional sectioning was required on the piece C ring to produce samples suitable for metallography and SEM/EDS. These sections were made using either electrical discharge machining (EDM) or a precision diamond cut-off saw. The details of sectioning along with the identifications of the newly created samples are provided in Figures 2.5.1 and 2.5.2. The primary objective of this sectioning was to separate the largest crack into three sections axially. This was accomplished by removing a ~1" wide by ~0.5" deep section containing the nozzle cracks. The piece containing the cracks was designated piece C1 and the remaining piece of the nozzle was designated piece C2 (spare). Piece C1 was then split twice in the transverse direction, creating pieces C1A (lowermost portion of

Sectioning for nozzle #3 piece C - looking at lower surface

Figure 2.5.1: Section locations and new sample identifications for nozzle #3 piece C.

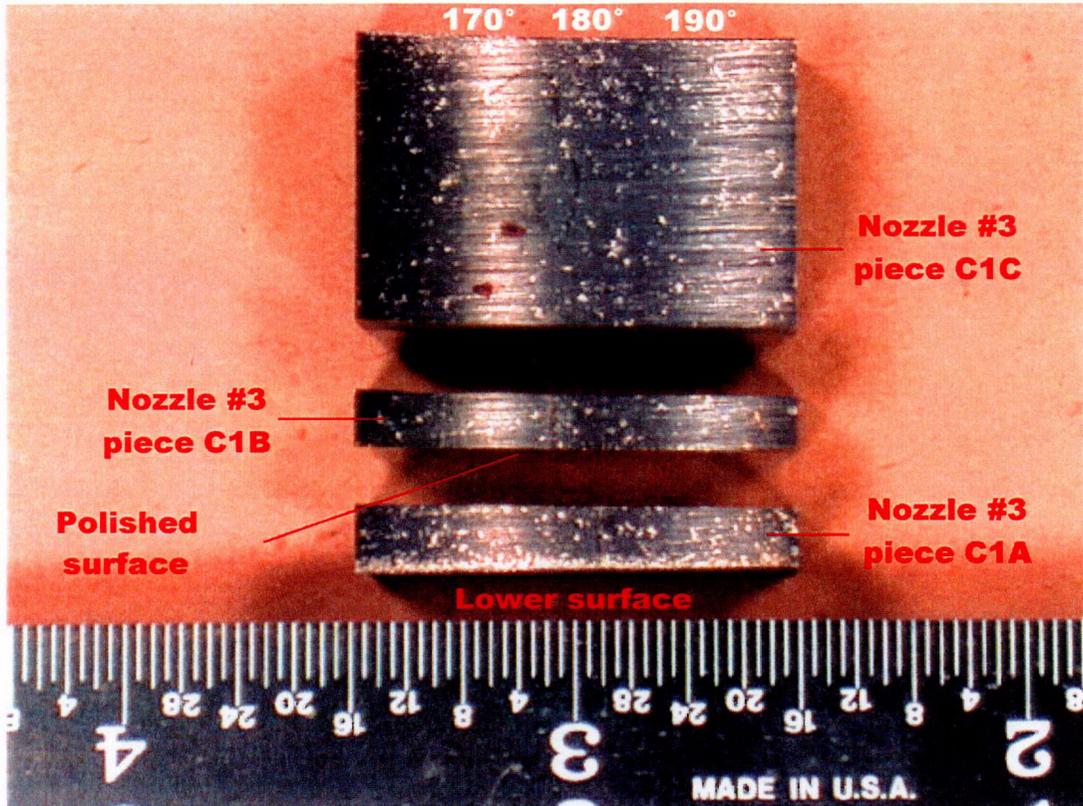
Sectioning for nozzle #3 piece C1 prior to opening lower portion of crack. Looking at nozzle ID surface; the largest crack is located near 180°.

Figure 2.5.2: Photograph of nozzle #3 samples C1A, C1B, and C1C.

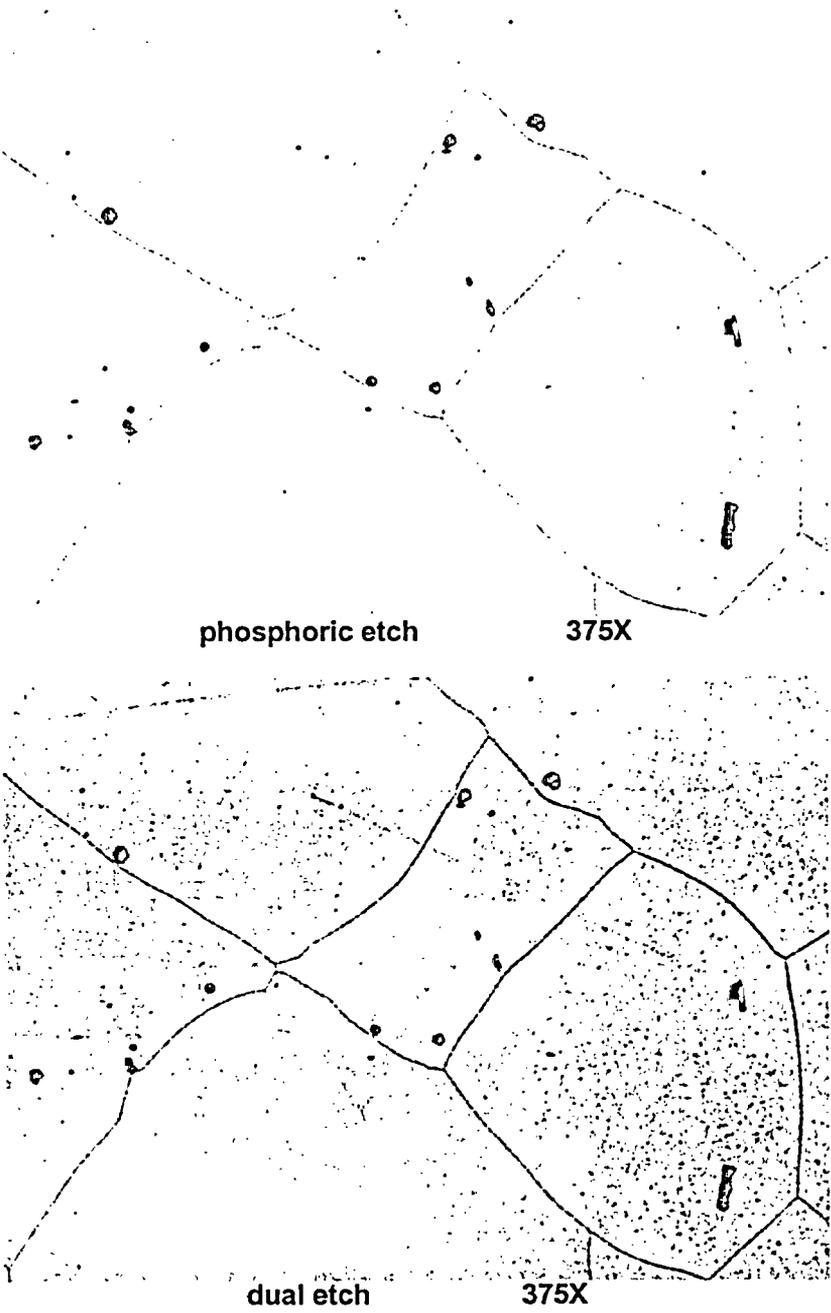
Figure 2.6.5: Typical micrographs taken of the nozzle base material.

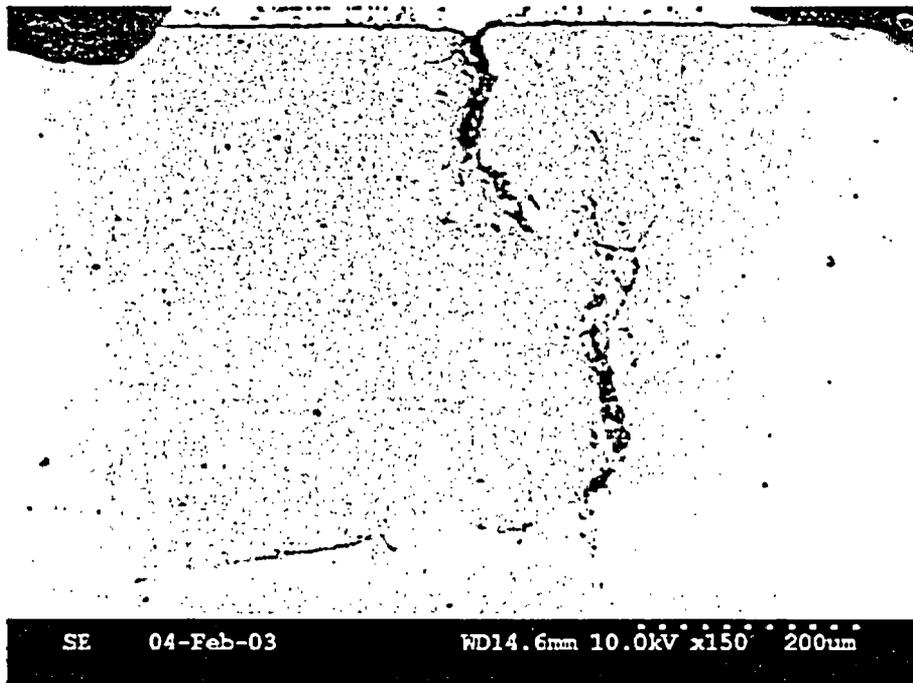
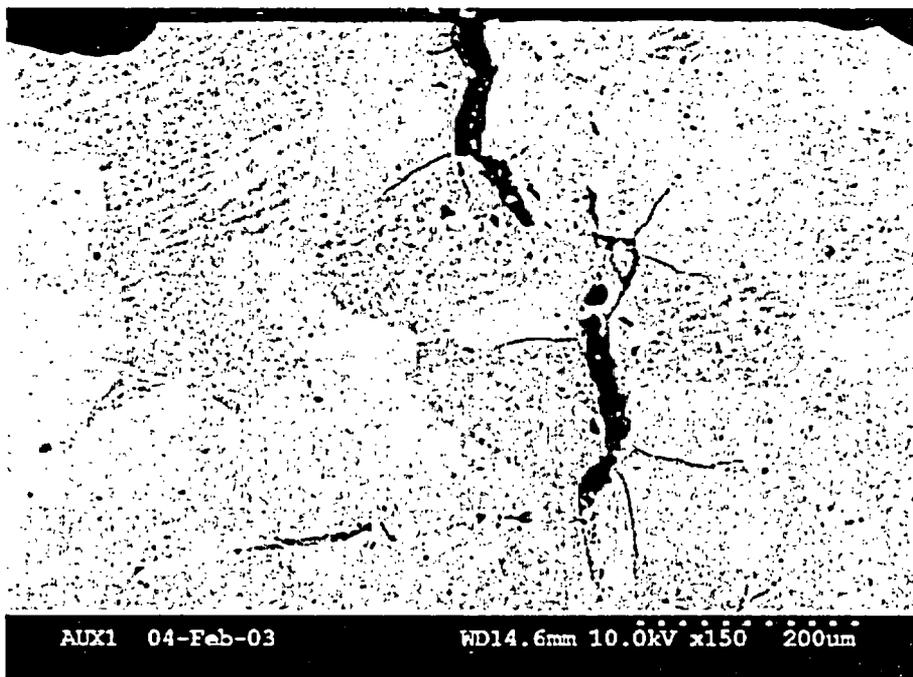
The mounted sample discussed in Section 2.6 above was also examined by SEM/EDS. The sample was examined in the as-polished condition (i.e., no chemical etching). Low magnification micrographs of the largest crack are presented in both the SE and BSE imaging modes in Figure 2.7.1. The full crack length is shown in Figure 2.7.2. In this area, the crack extended approximately 0.08" below the nozzle ID surface. Cracking was also intergranular in nature. A higher magnification micrograph showing the typical grain boundary appearance is provided along with the EDS results in Figure 2.7.3. These results indicated the primary grain boundary constituents were carbon, oxygen, aluminum, nickel, chromium and iron. A very high magnification micrograph and corresponding EDS results are provided in Figure 2.7.4. For this area, the grain boundary composition (solid fill spectrum) is compared to the bulk grain composition (line spectrum). These results clearly show increased oxygen, chromium, and iron as well as diminished nickel at the grain boundary compared to the bulk grain chemical composition. Semi-quantitative EDS analysis was used to determine the nozzle base material chemical composition. These results, which are presented in Figure 2.7.5, were consistent with those expected for Alloy 600.

Figure 2.7.1: Low magnification SE (top) and BSE (bottom) taken near the nozzle ID surface (upper edge of micrographs). 150X

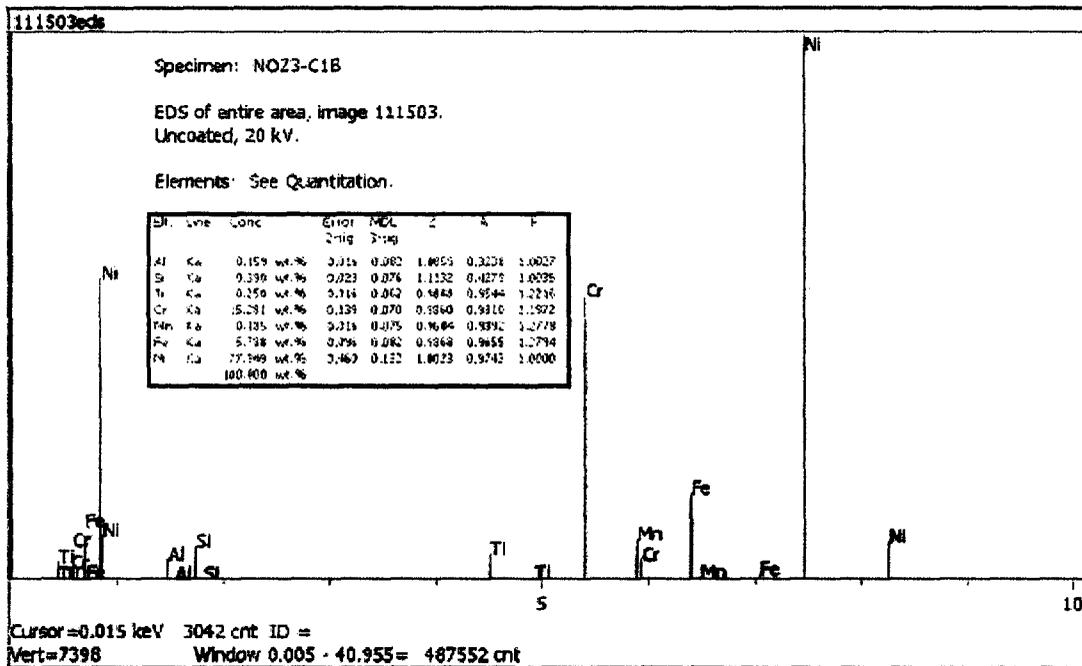
Reference micrograph for EDS semi-quantitative analysis

Figure 2.7.5: Reference micrograph and semi-quantitative EDS results for nozzle material. The results appeared consistent with those expected for Alloy 600.
