BWR steam dryer integrity

SIL No. 644 Revision 1

November 9, 2004

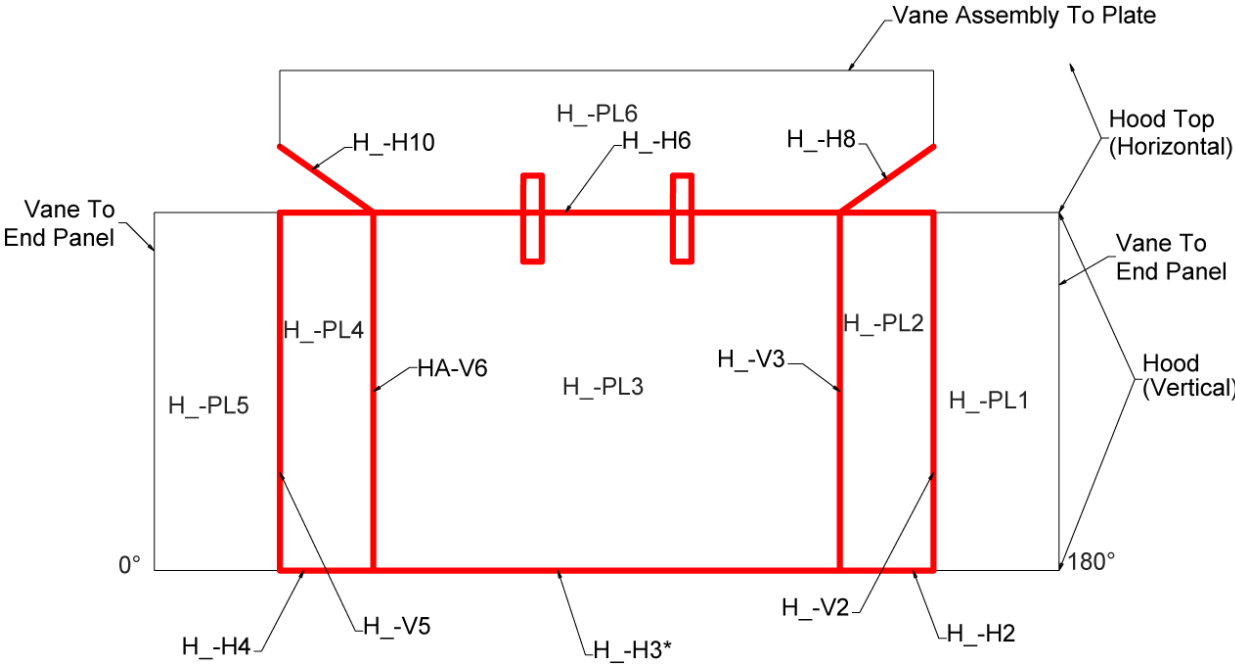
Figure C-3: Weld layout for interior of outer banks (Square Hood Dryer)

The brackets shown only exist in those plants where they were part of the original design and were not removed as part of dryer modifications.

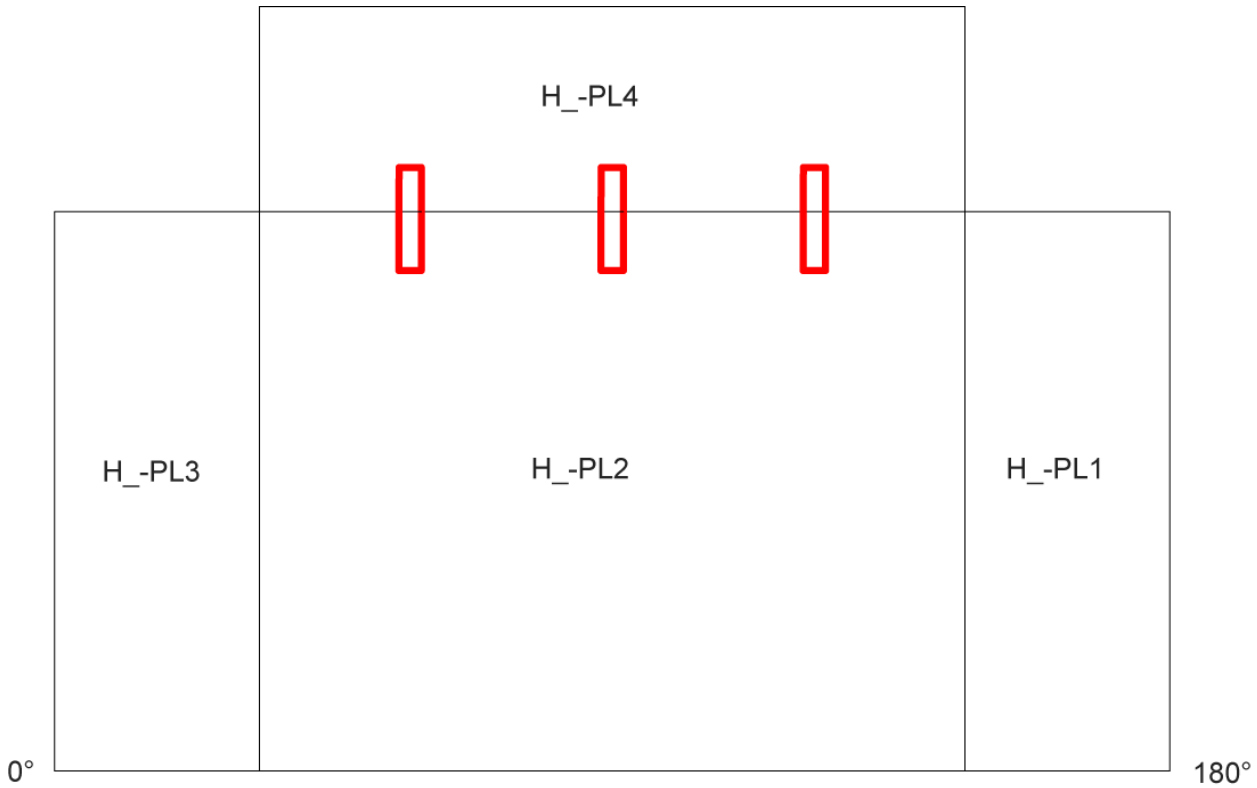
Figure C-4: Weld Rollout – Inner banks with internal brackets (Square Hood Dryer)

H_-PL# = Plate (Bank B, C, D or E) (Ex. HB-PL1)
Internal View - View Is Looking Away From Vane Assembly

The brackets shown only exist in those plants where they were part of the original design and were not removed as part of dryer modifications.

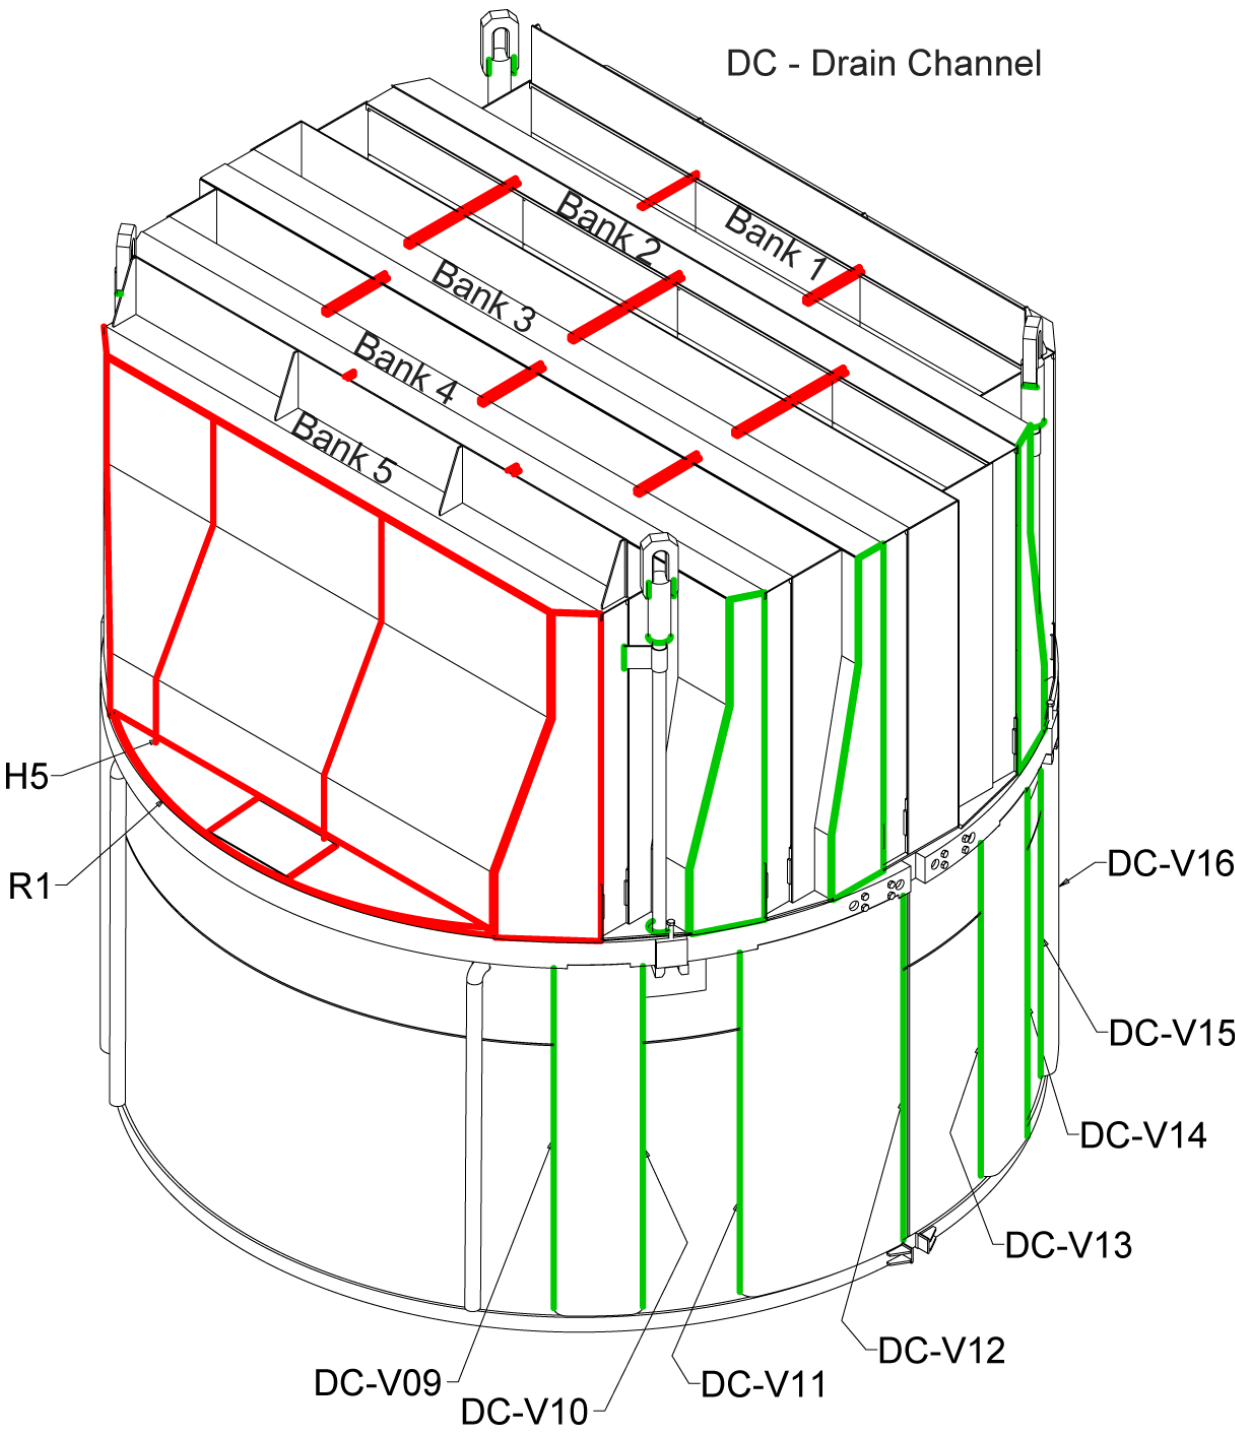
Figure C-9: Inspection Locations (Slanted Hood Dryer)

Cracking has been detected in these end panels in later design dryers. Therefore, these additional weld seams associated with the outer side of the inner banks should also be inspected in that this represents a steam path through the dryer. These areas are shown in green in Figure C-9. Cracking has been observed in these locations in dryers of this design. The other locations of interest are primarily associated with IGSCC in drain channels (refer to SIL No. 474 “Steam Dryer Drain Channel Cracking” issued October 26, 1988), support ring, and lifting rod attachments.

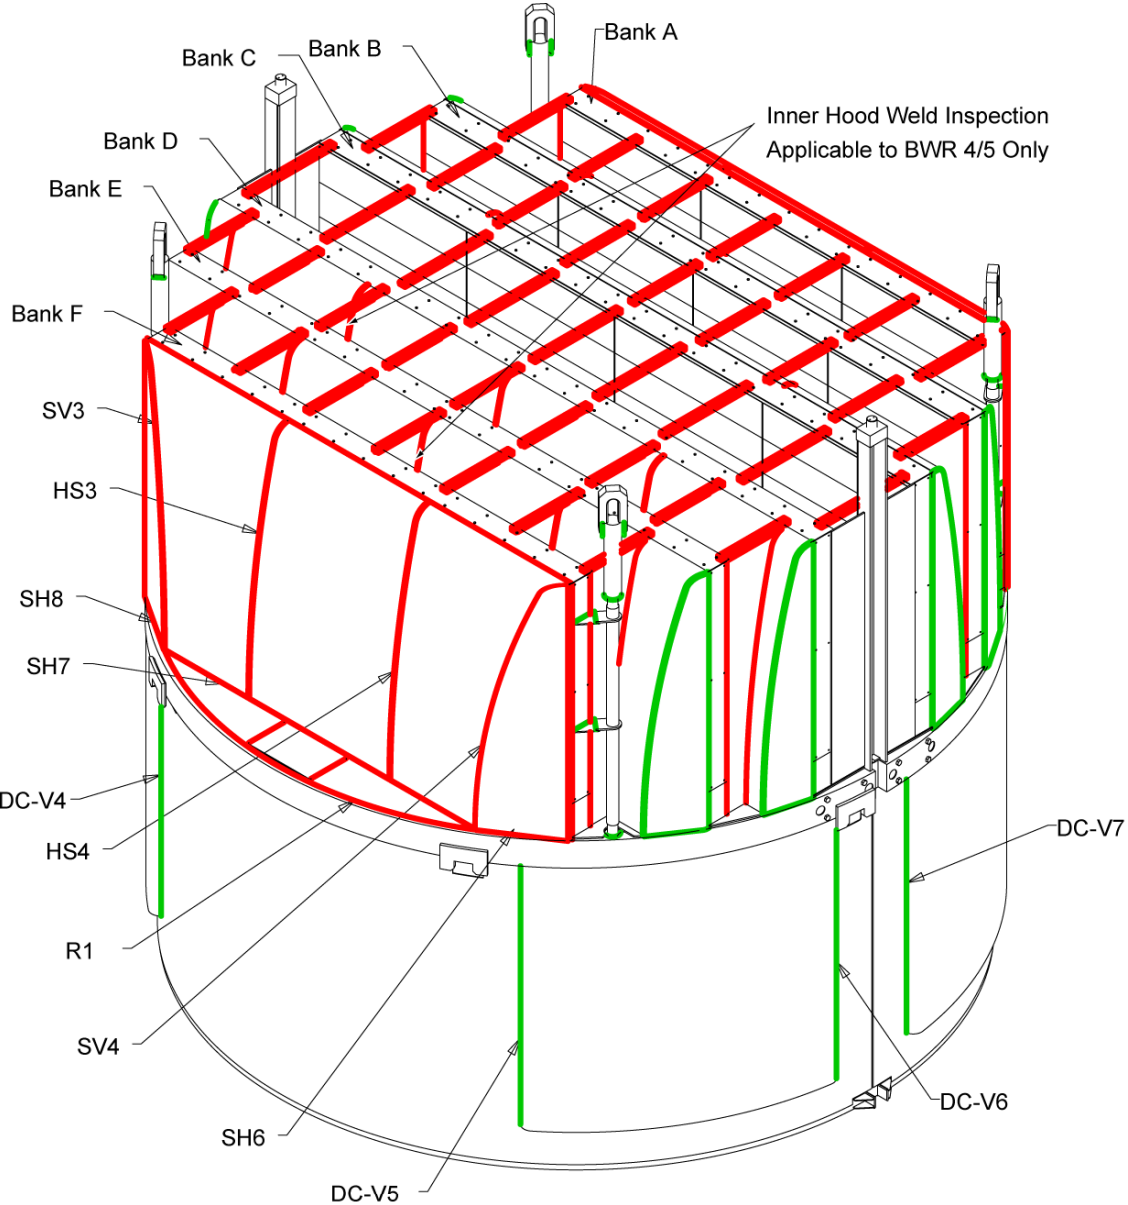
Figure C-11: Inspection Locations (Curved Hood Dryer)

Cracking has been detected in the end panels in later design dryers. Therefore, these additional weld seams associated with the outer side of the inner banks should also be inspected in that this represents a steam path through the dryer. These areas are shown in green in Figure C-11. Cracking has been observed in these locations in dryers of this design. The other locations of interest are primarily associated with IGSCC in drain channels (refer to SIL No. 474 “Steam Dryer Drain Channel Cracking” issued October 26, 1988) and lifting rod attachments.
