**U.S. DEPARTMENT OF ENERGY  
NEVADA OPERATIONS OFFICE**

**REPORT OF THE INVESTIGATION  
OF THE ACCIDENT AT THE  
MIDAS MYTH/MILAGRO TRAILER PARK  
ON RAINIER MESA AT NEVADA TEST SITE  
ON FEB. 15, 1984**

**DATE OF INVESTIGATION REPORT  
APRIL 9, 1984**

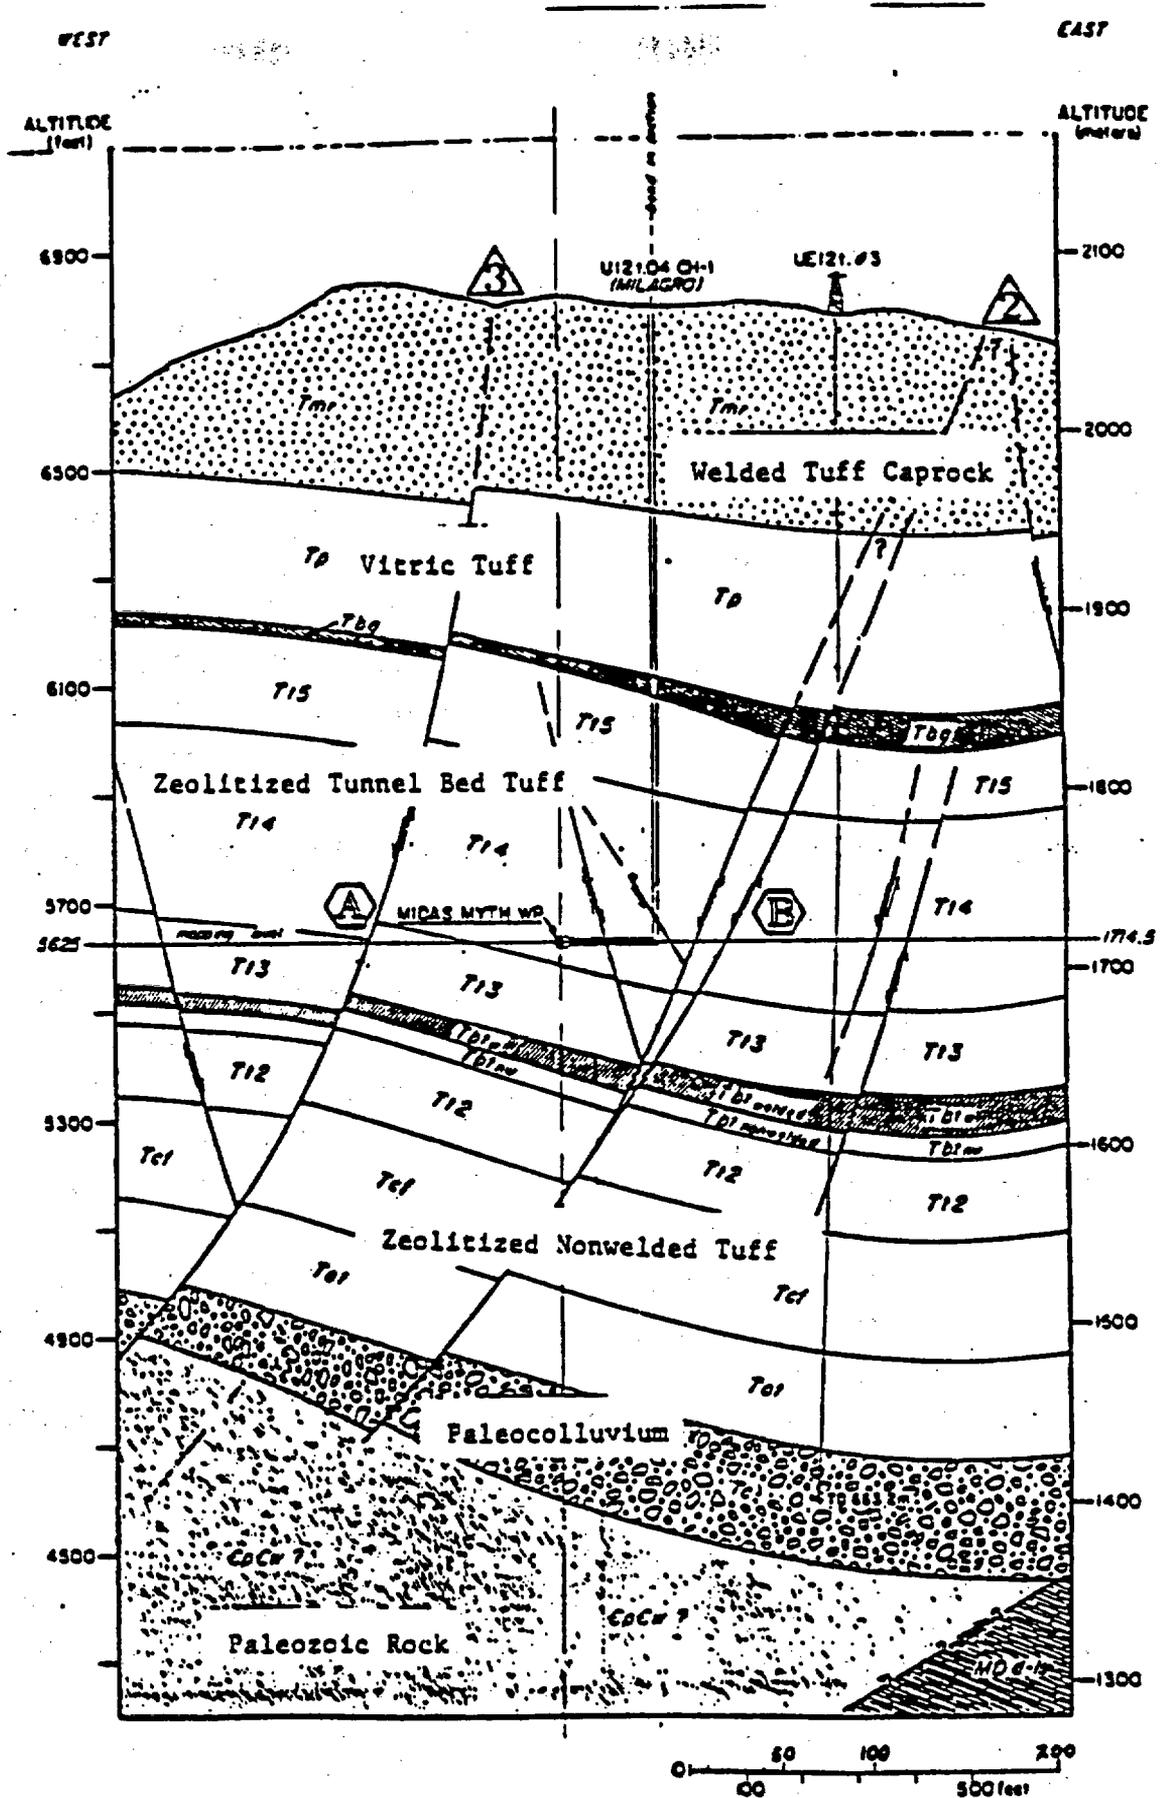
Nearly all Rainier Mesa effects tests have been detonated in the tunnel bed units. One difference in the MIDAS MYTH stratigraphy from most other Rainier Mesa test locations is the densely welded nature of the tuff member (Tub Springs) 56 m beneath the WP. While the structure (faulting, folding, and jointing) was noted in the Containment Review as being more complex than in other portions of Rainier Mesa, there were no preshot observations regarding relative frequency of jointing in the welded caprock. The WP was located 361 m vertically below the surface, and 356 m from the nearest free surface on slope at the edge of Rainier Mesa (Exhibit 5).

Figure 4: Cross-section through the MIDAS MYTH Working Point

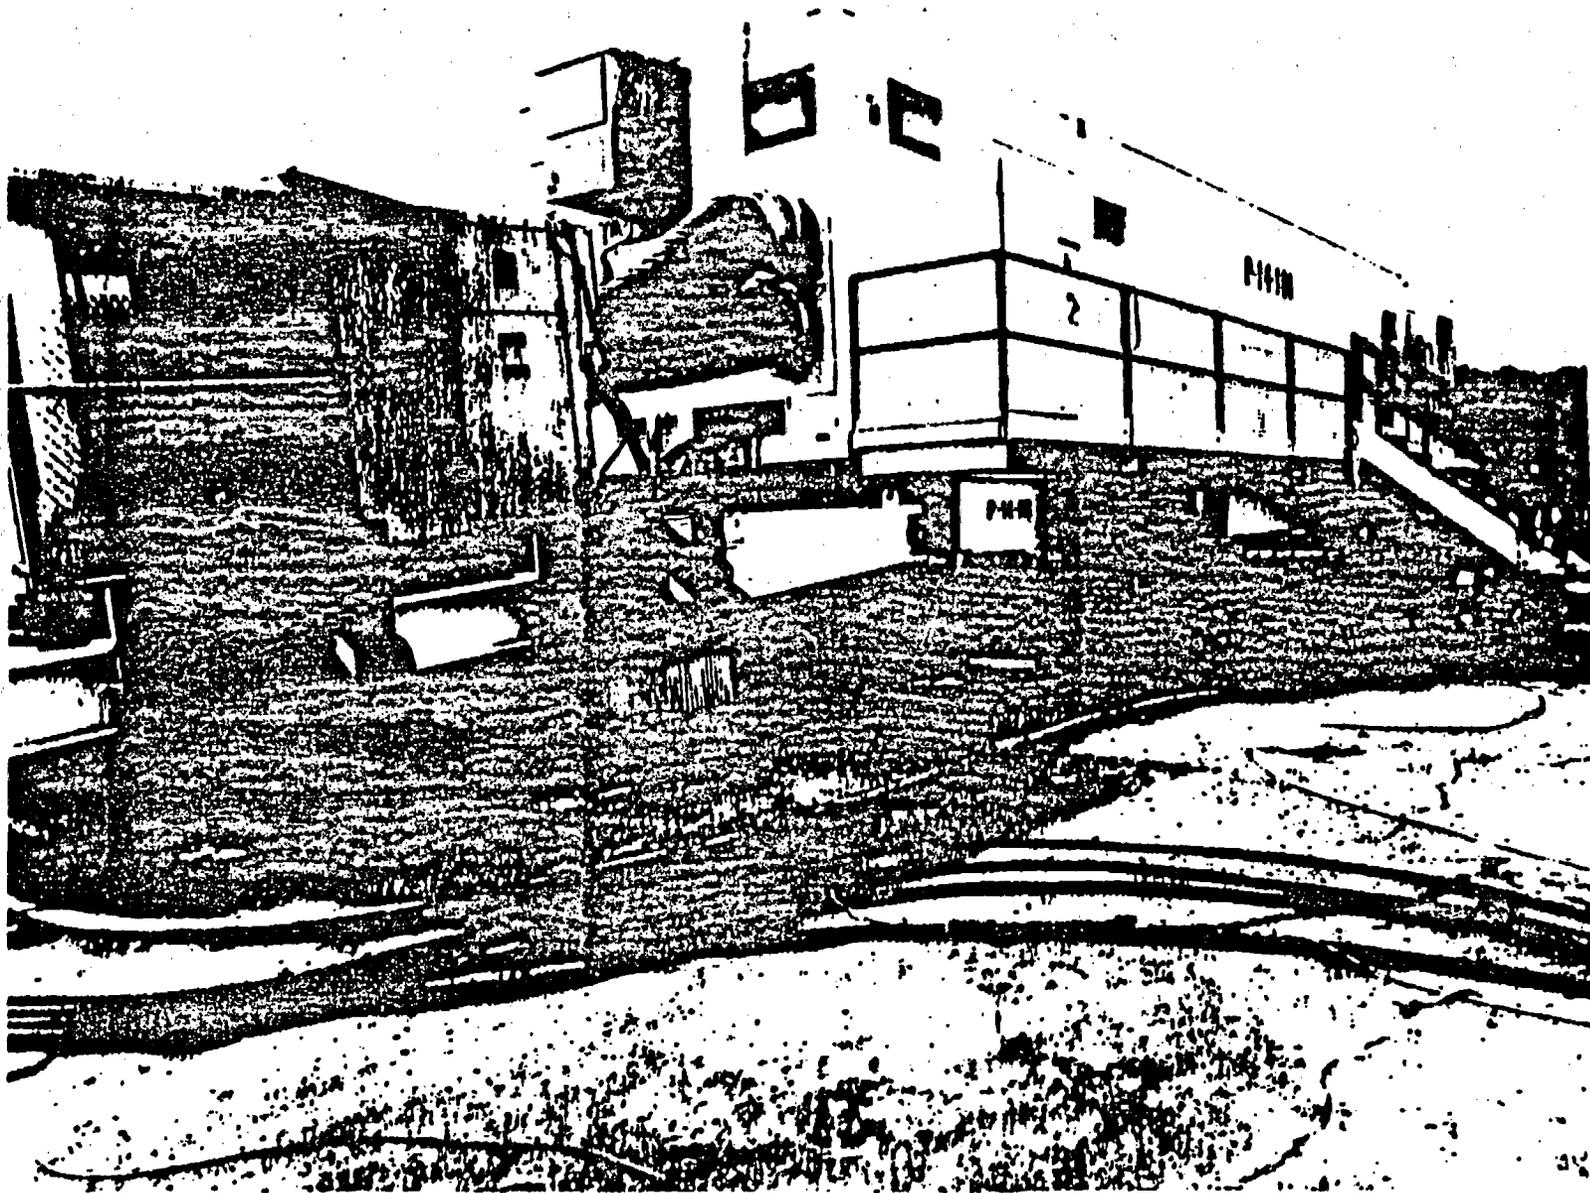
Figure 11 — MILAGRO Trailer Park, Trailer P-14-101 NW Corner,  
Postshot, Prior to Collapse

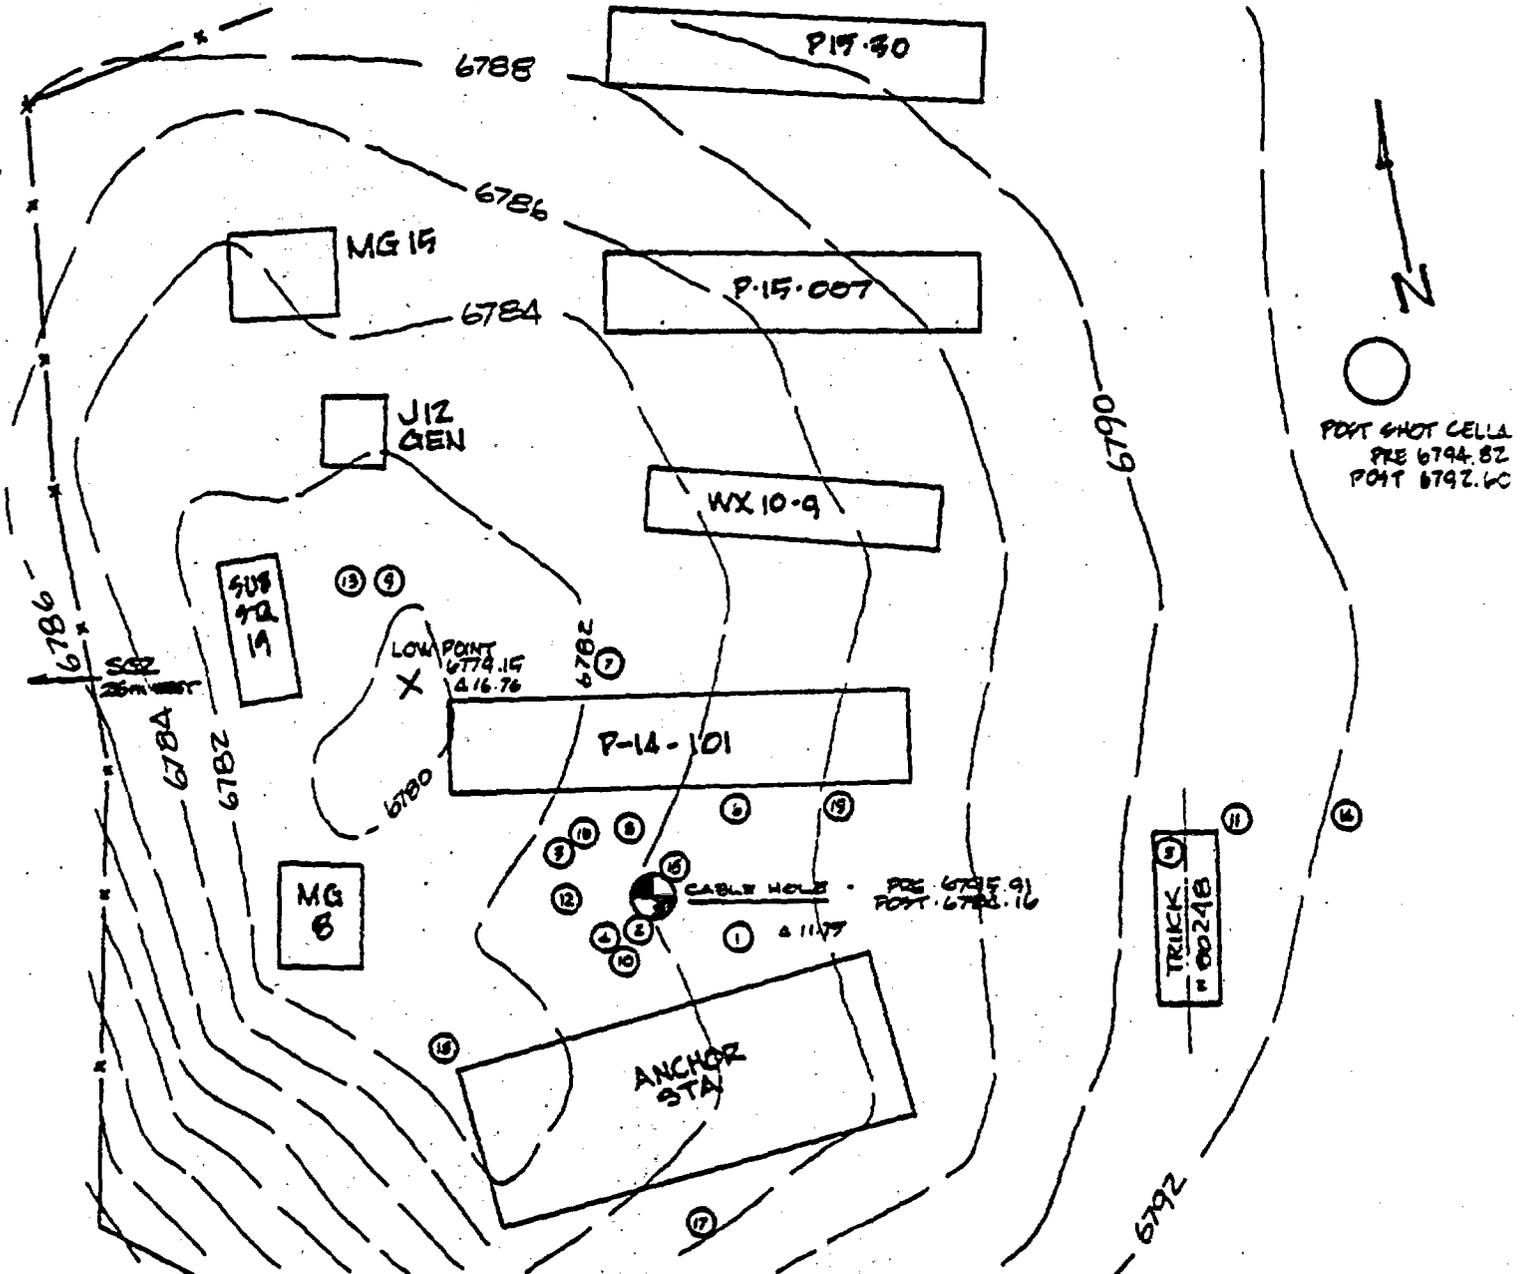
the trailer park. Fourteen were injured, one fatally. Most of the people injured were in the cable hole area and fell approximately 3.6 meters (Figures 16 through 25).

Figure 16 — MILAGRO Trailer Park,  
 Collapse Contours and Personnel Location

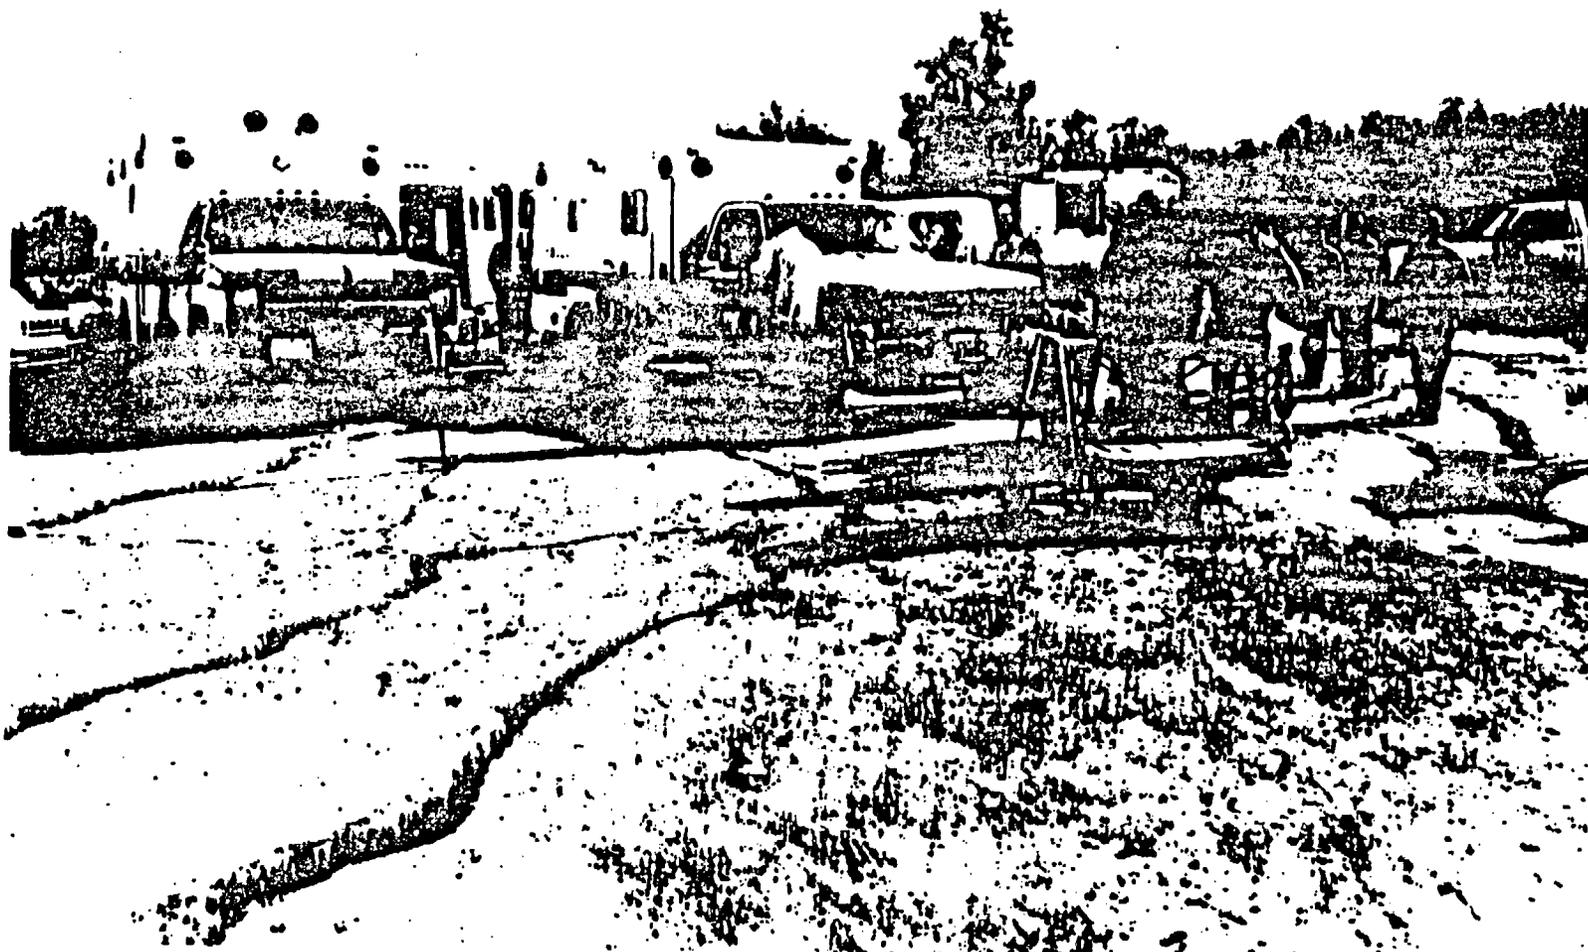
A total of fourteen injured were examined at the site of the accident and a field determination of the order of seriousness of the injured was made. Initial treatment was primarily to treat shock and immobilize fractures. The patients were then evacuated (Figures 26 and 27).

Figure 26 — MILAGRO Trailer Park Emergency Response

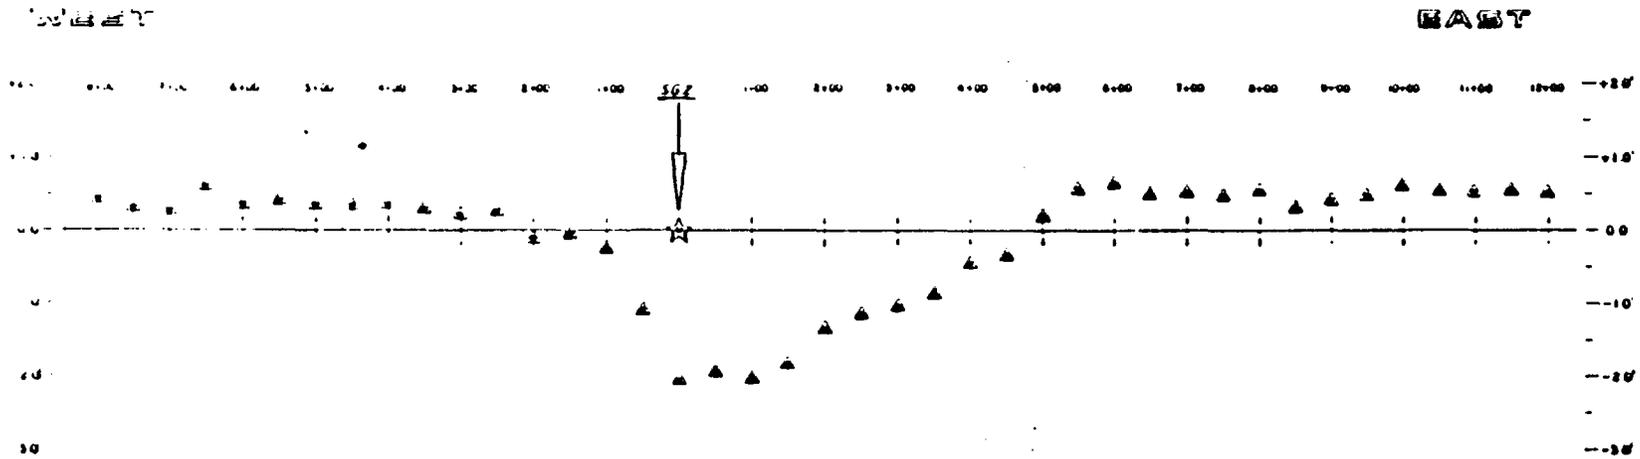
FIGURE 7-- Cross section showing differences in elevation (pre- vs. post-event) measured along a N75°E line through HURON LANDING SGZ.

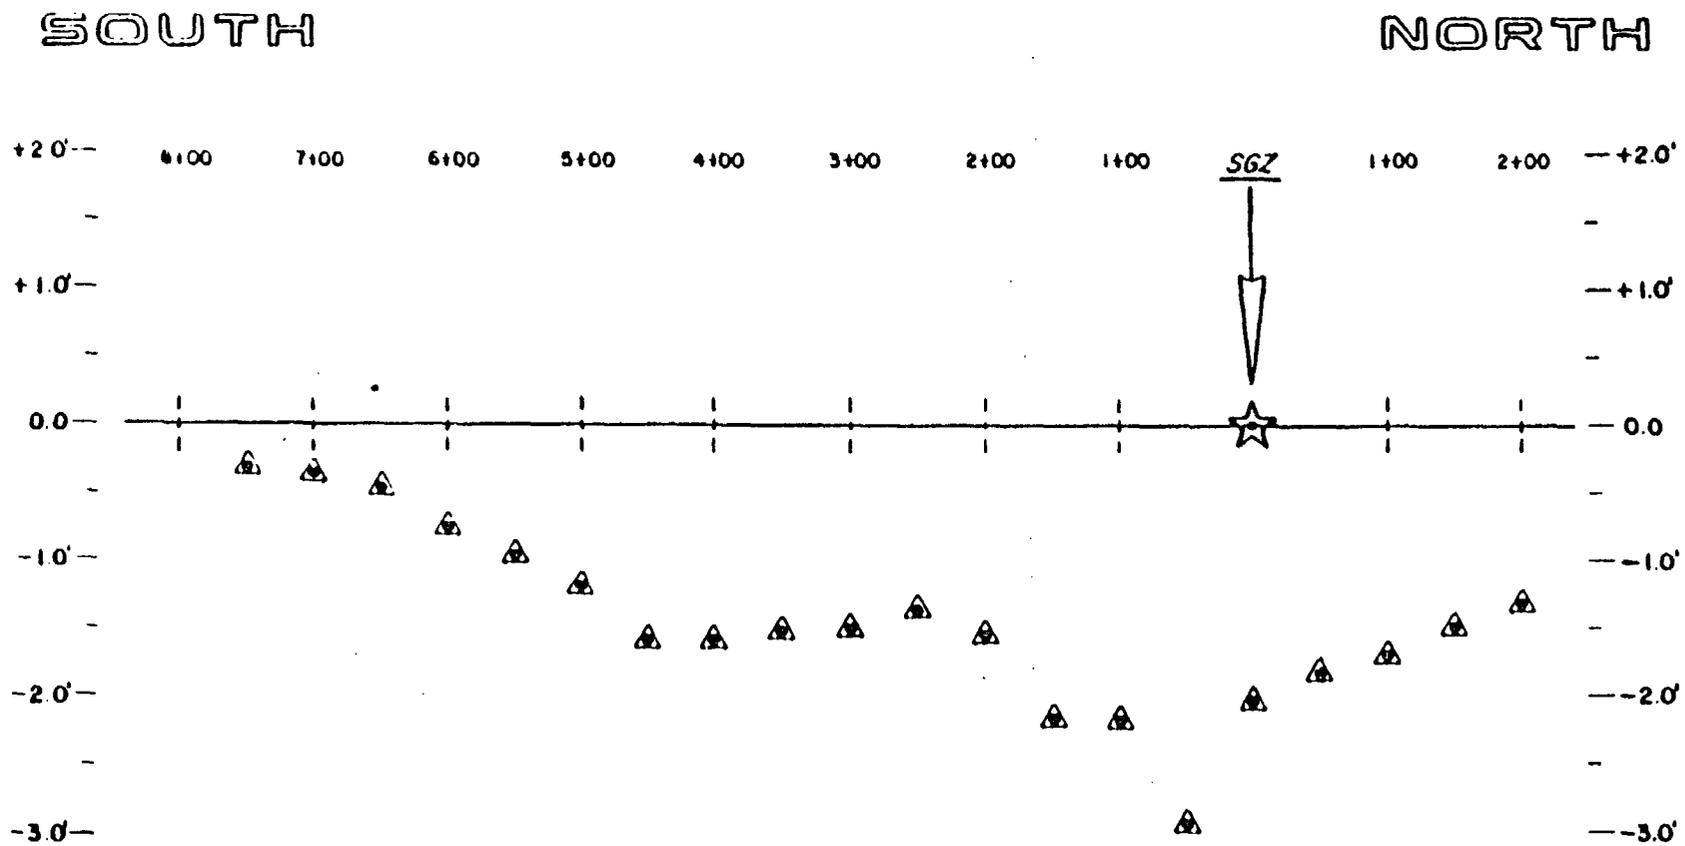
FIGURE 8.--Cross section showing differences in elevation (pre-vs. post-event) measured along a N15°W line through HURON LANDING SGZ.

note the apparent reversal of the true surface displacement versus the measured relative displacement along Fault #1.

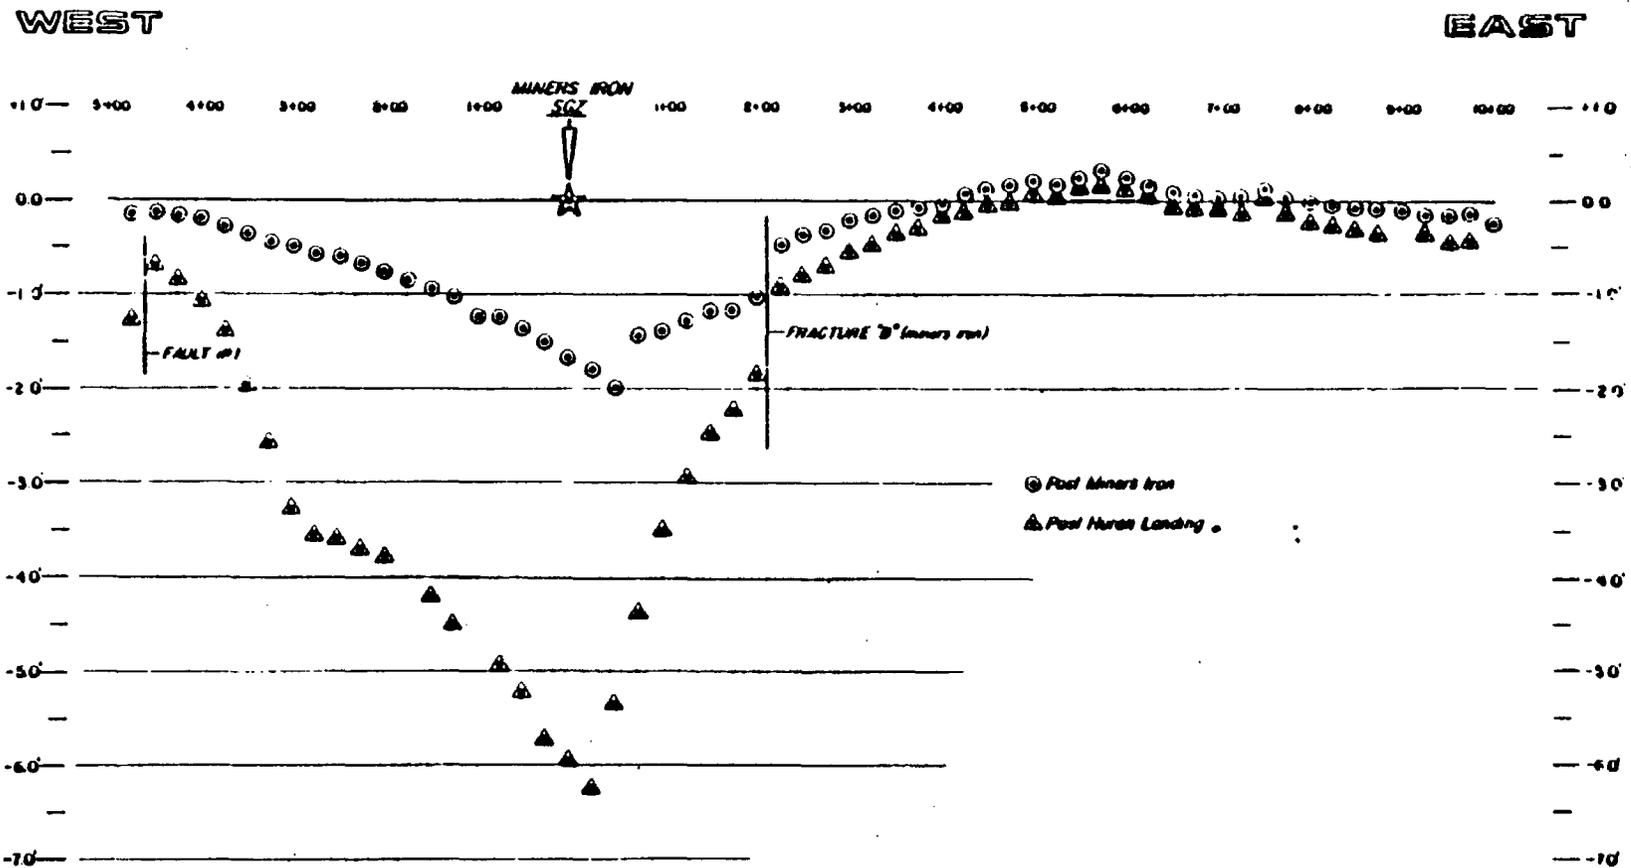
FIGURE 9.--Cross section showing differences in elevation (post MINERS IRON vs. post HURON LANDING) measured along a N75°E line through MINERS IRON SGZ.

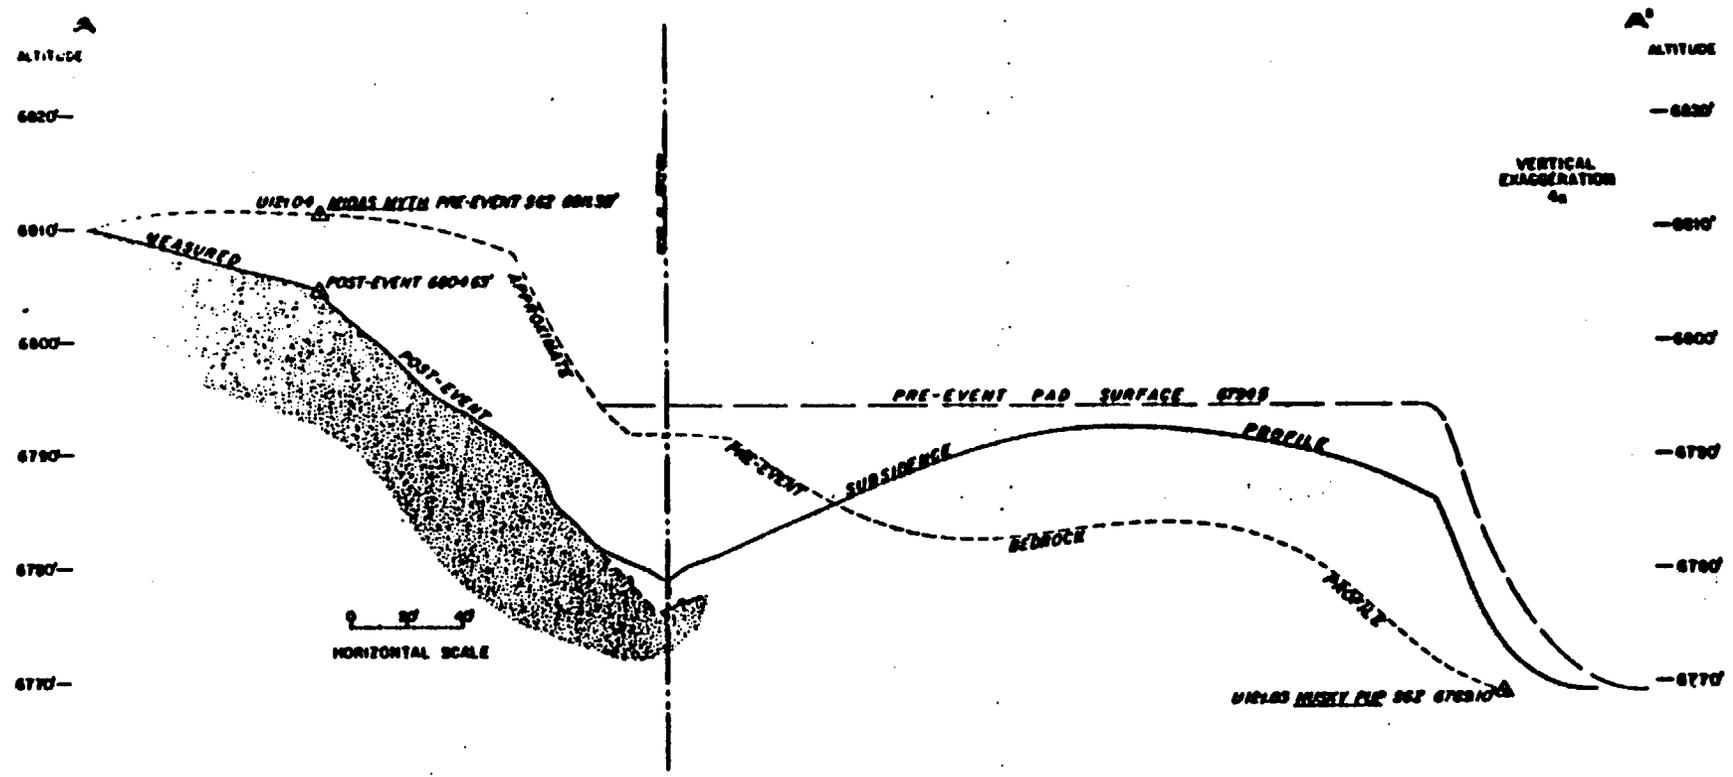
FIGURE 8.--Cross section through MIDAS MYTH SGZ--subsidence crater--HUSKY PUP SGZ, showing pre-vs post-event topography.

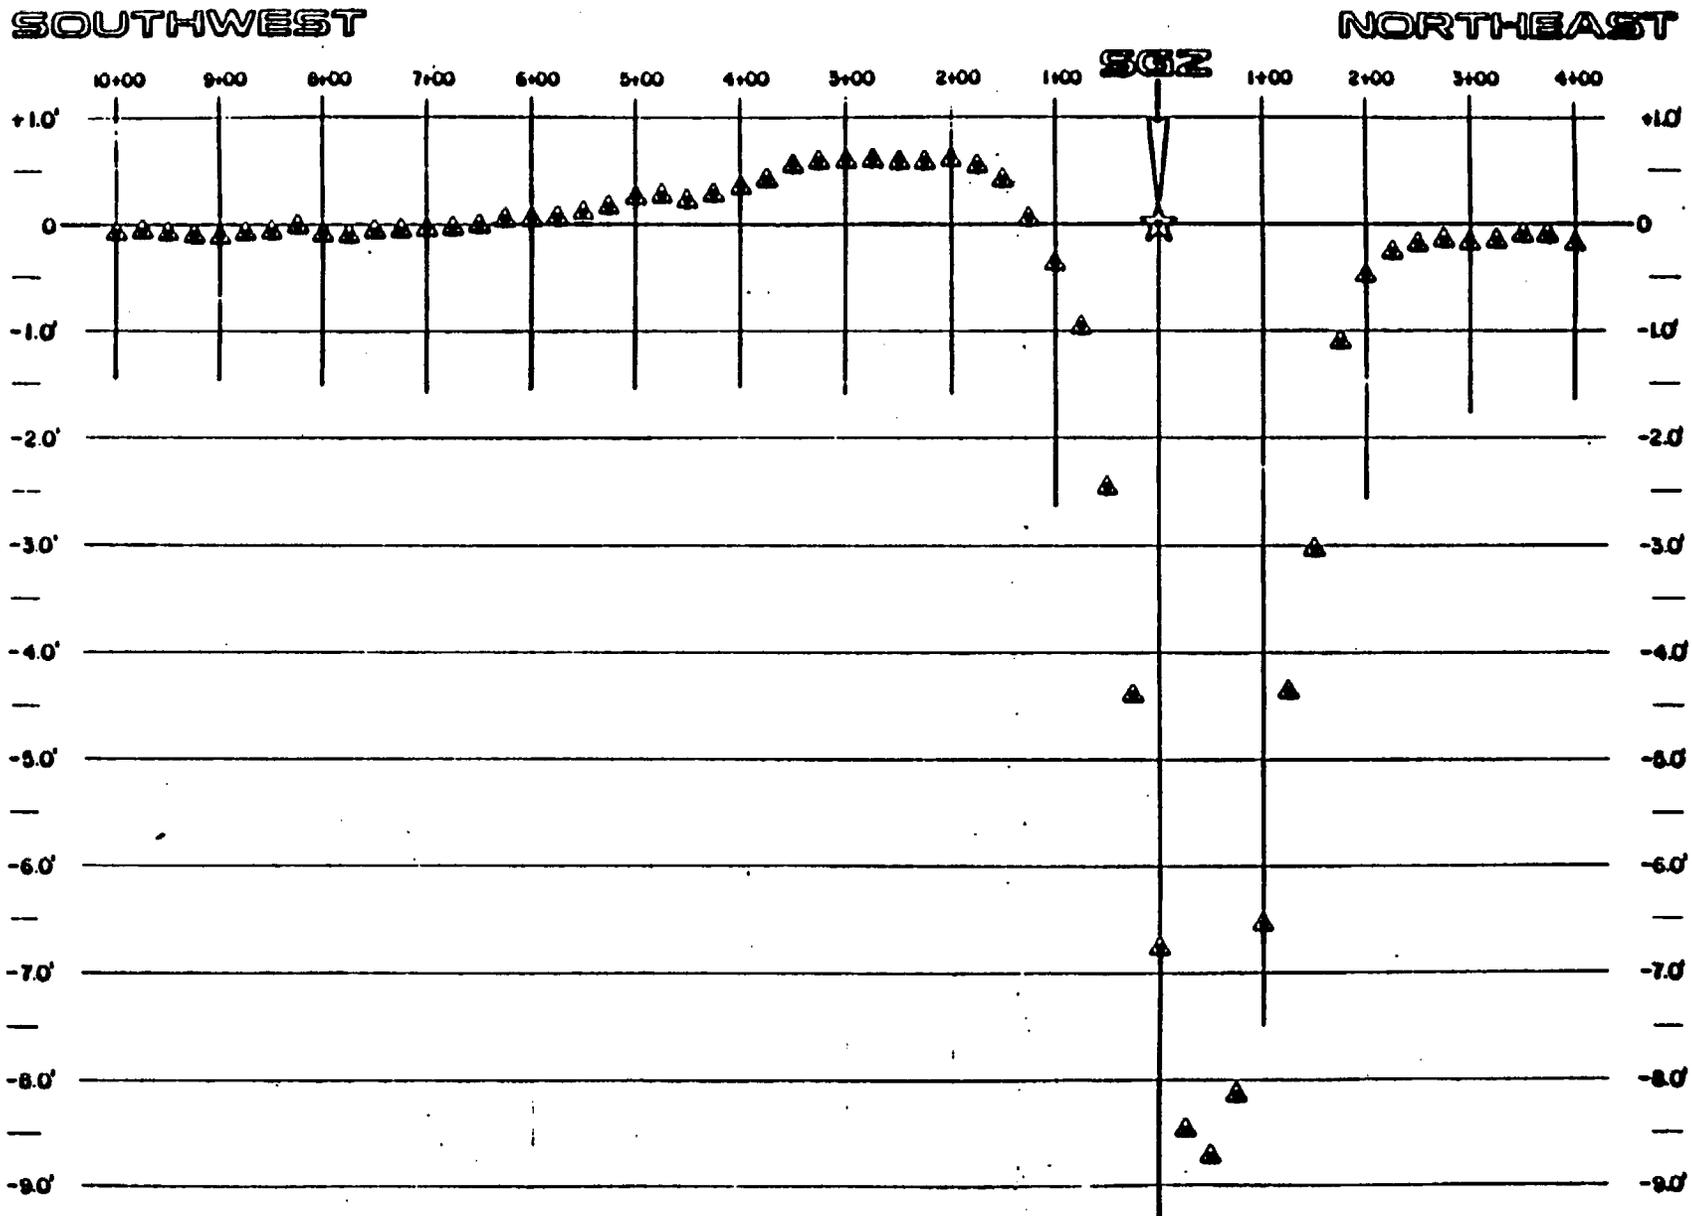
FIGURE 13.--Cross section showing differences in elevation (pre-vs. post-event) measured along a N40°E line through MIDAS MYTH SGZ.

The southwest-northeast line (fig. 13) shows a slight increase in elevation south of SGZ, and the subsidence crater starts approximately 200 ft southwest of SGZ. Toward the northeast, the subsidence extends to slightly more than 200 ft, and the remainder of the line is slightly lower than it was pre-event. The maximum decrease in elevation on this line is 8.72 ft, 50 ft northeast of SGZ.

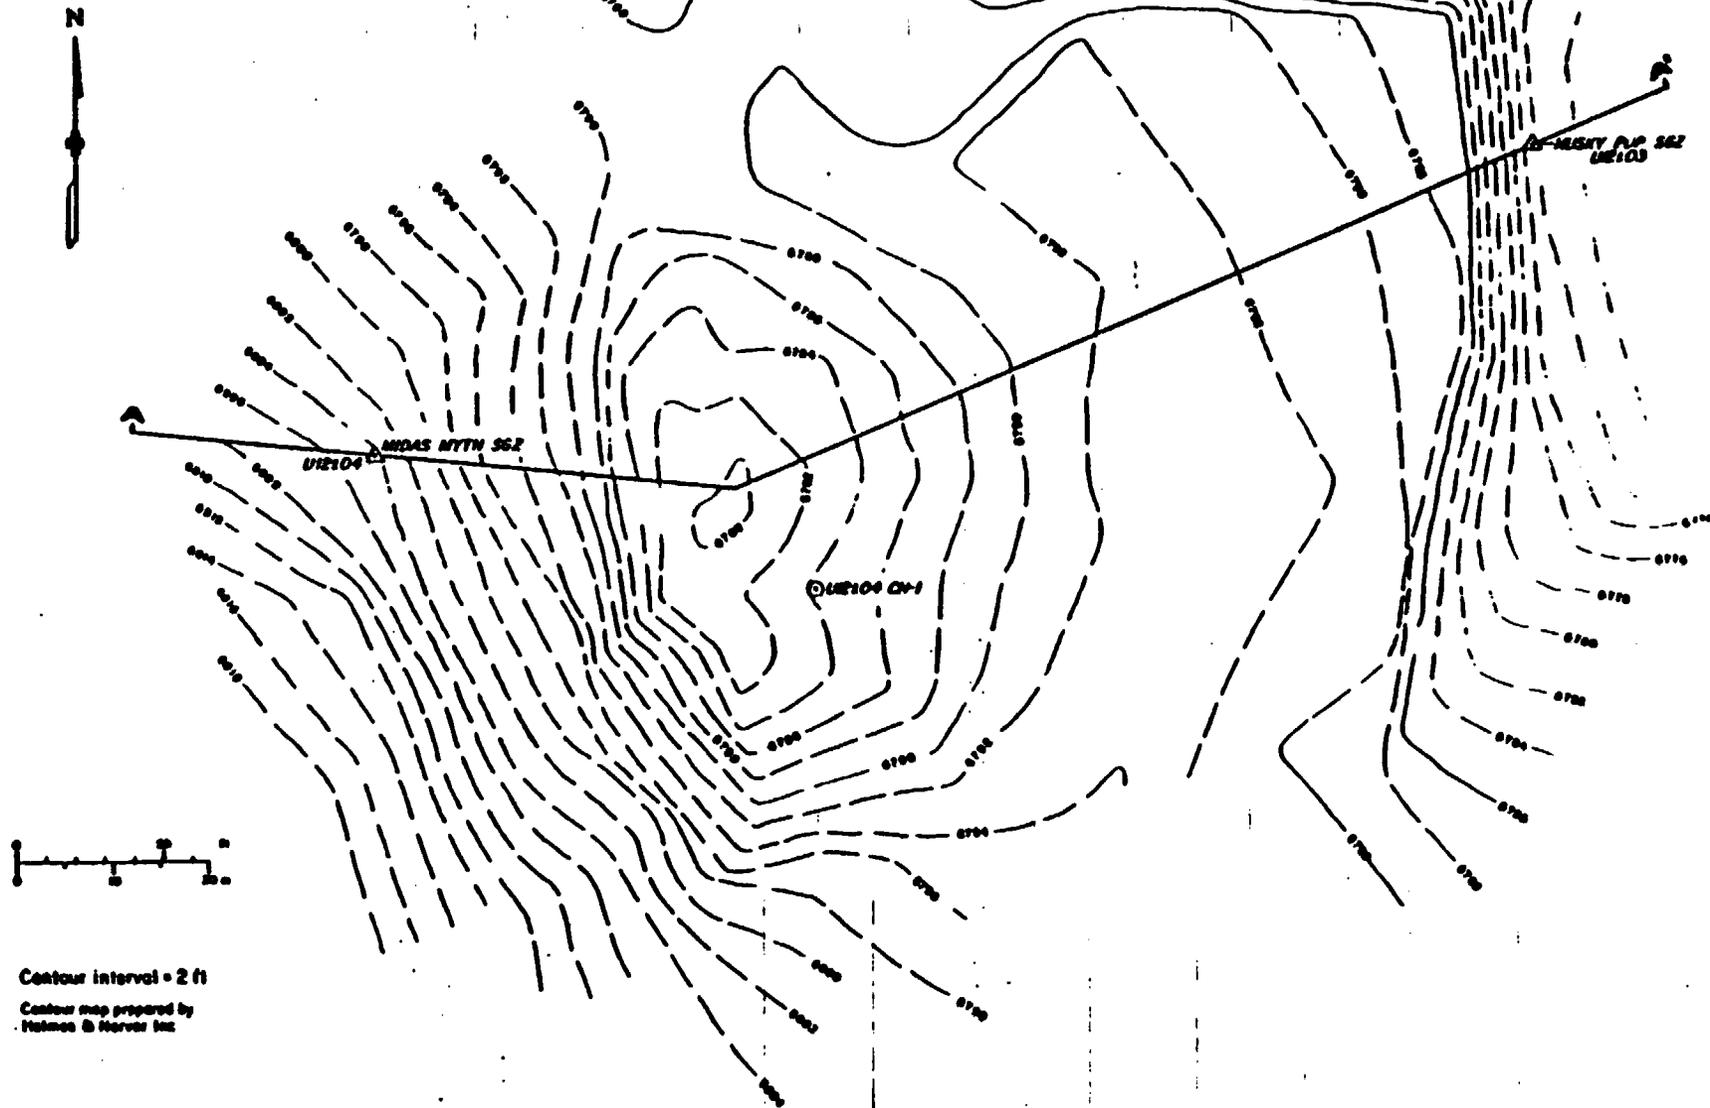
**FIGURE 15.--Post-event topographic map of the MIDAS MYTH area, showing location of cross section A-A' (fig-8).**

Unfortunately, the majority of the surface subsidence occurred between the survey lines. Holmes & Narver Inc. has prepared a preliminary topographic map of the subsidence area (fig. 15). Cross section A-A', shown on Figure 8, gives the topographic relationships through the apparent deepest part of the subsidence.
