**TENNESSEE VALLEY AUTHORITY  
BROWNS FERRY NUCLEAR PLANT (BFN)  
UNIT 2**

**EVALUATION OF DISSIMILAR METAL WELD INDICATION AT WELD RCRD-2-52**

WCAP-16845-NP  
Revision 0

# **Metallurgical Investigation of Recorded Indications at the Check Valve to Pipe Dissimilar Metal Weld at Browns Ferry Unit 2 Nuclear Generating Station**

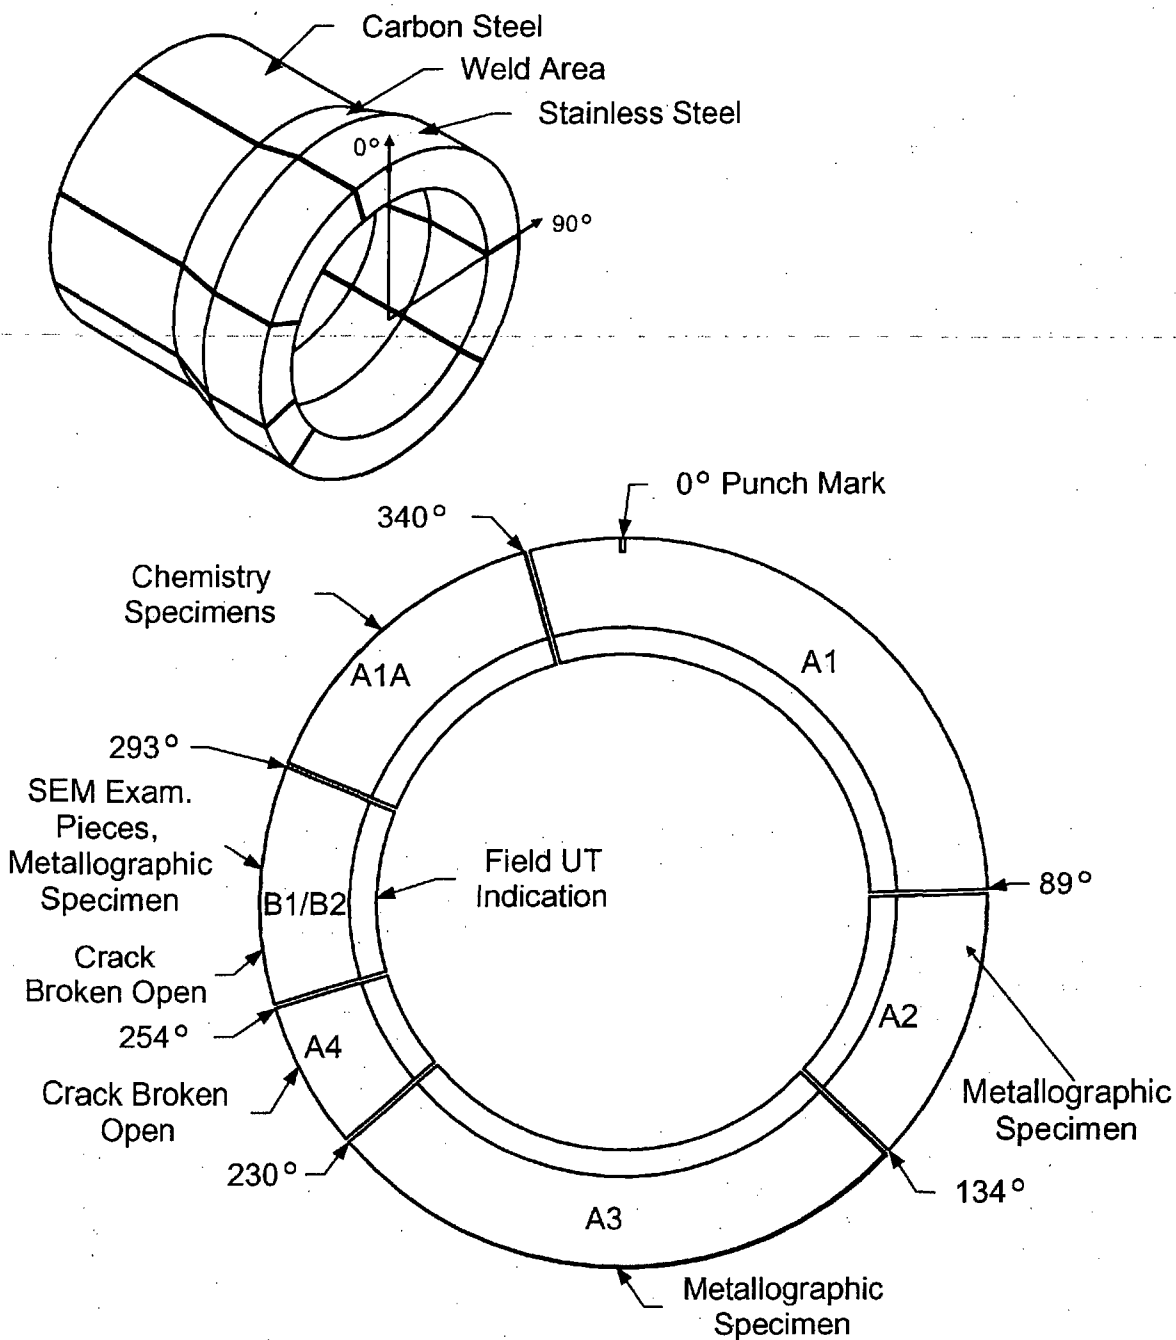
**Figure 11** Schematic Representation of Pipe to Valve Weld Sample Illustrating the Orientation of Initial Axial Cuts and Sample Identifications (Looking from the Valve Body into the Pipe)

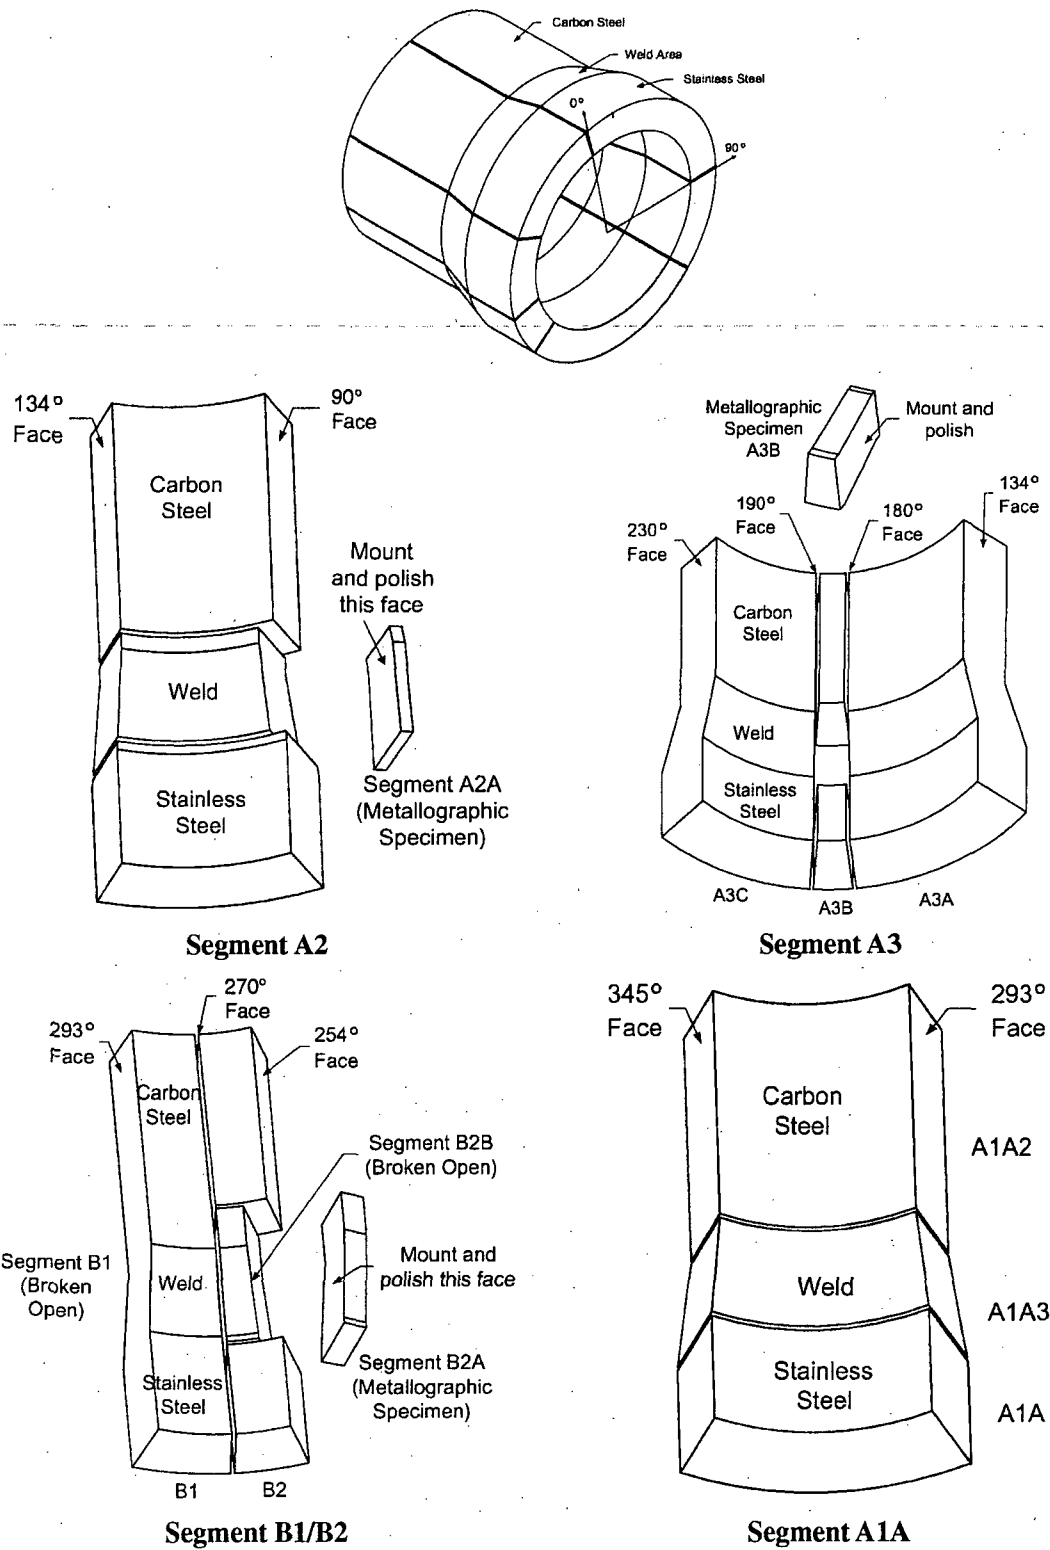
Based on the results of the NDE evaluations, a detailed sectioning plan was developed to facilitate test samples employed in the various examinations and tests. The sectioning plan is summarized in Figures 11 and 12.

**Figure 12 Schematic Representation of Sectioning Procedure Employed in Securing Test Samples for Various Examinations and Tests**

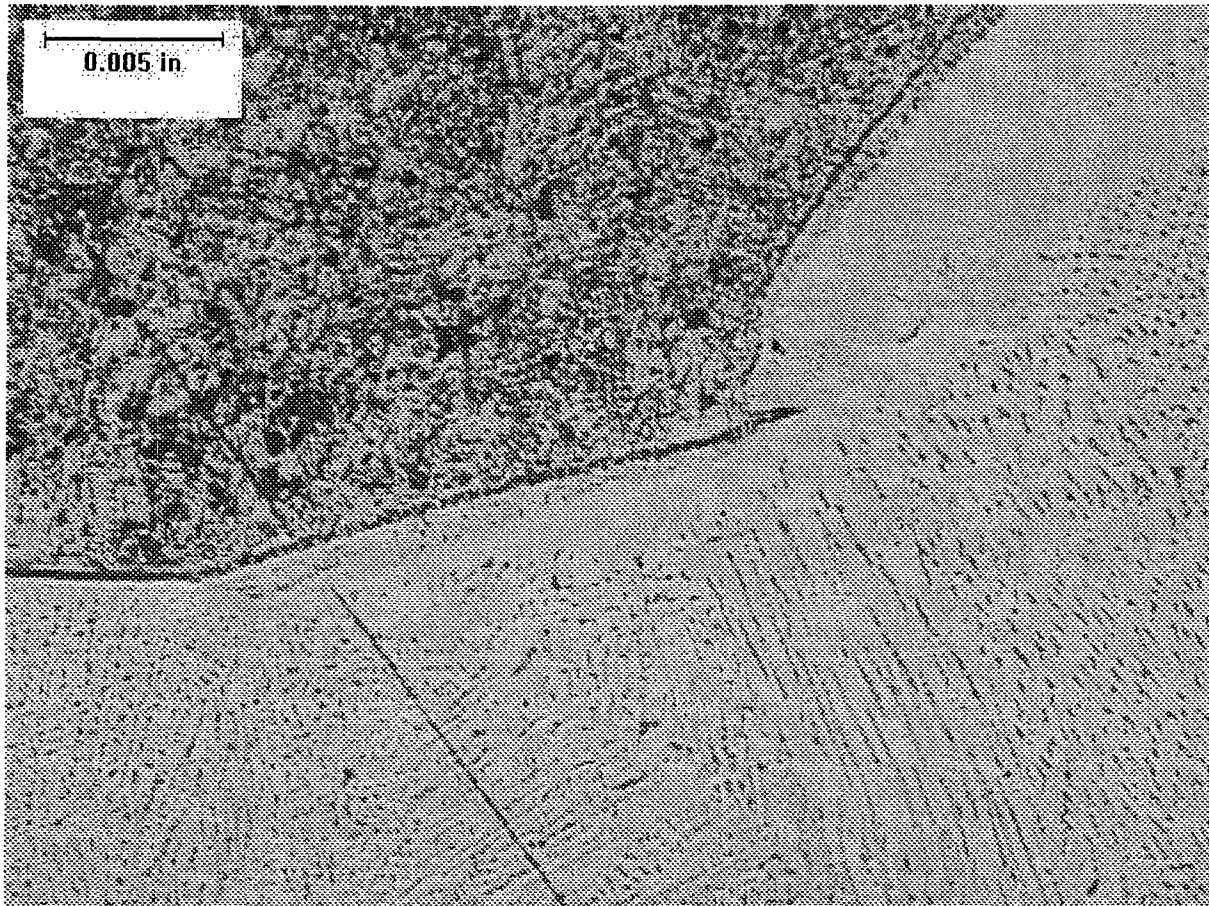
**Figure 24** Morphology of Crack in the Carbon Steel Side, on 90° Section (Specimen A2A Polished and Etched Condition)
