INSPECTION REPORT

**Spent Fuel Project Office
Office of Nuclear Material Safety and Safeguards**

Docket No.: 72-1007

Inspection Report: 72-1007/97-212

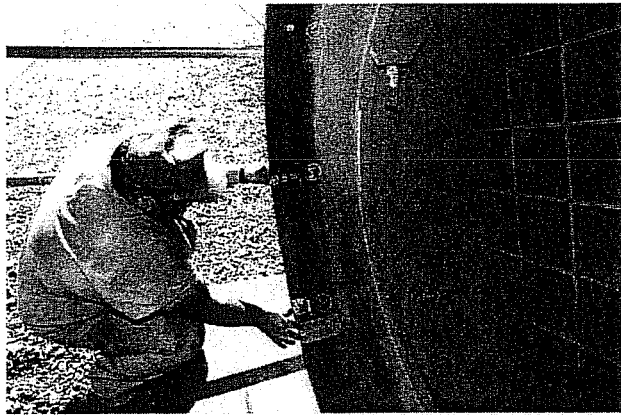
Photo #4

Photograph #4 illustrates the positions of the samples taken from AMSB-009 which were subsequently sent for analysis.

Note that none of these imperfections were found to be deep enough to intrude upon the minimum wall thickness
