SUBJECT: NRC INSPECTION REPORT 050-00312/08-001

Docket No.: 050-00312  
License No.: DPR-54  
Report No.: 050-00312/08-001  
Licensee: Sacramento Municipal Utility District  
Facility: Rancho Seco Nuclear Generating Station  
Location: 14440 Twin Cities Road  
Herald, California  
Dates: April 14 through May 16, 2008  
Inspectors: Emilio M. Garcia, Health Physicist  
James L. Montgomery, Health Physicist  
Accompanied by: Thomas H. Youngblood, Jr., Health Physicist Reactor  
Decommissioning Branch, Office of Federal and State  
Materials and Environmental Management Programs  
Approved By: Jack E. Whitten, Chief  
Nuclear Materials Safety Branch B  
Attachments: Supplemental Information  
Partial List of Documents Reviewed

### Rancho Seco Nuclear Generating Station NRC Inspection Report 050-00312/08-001

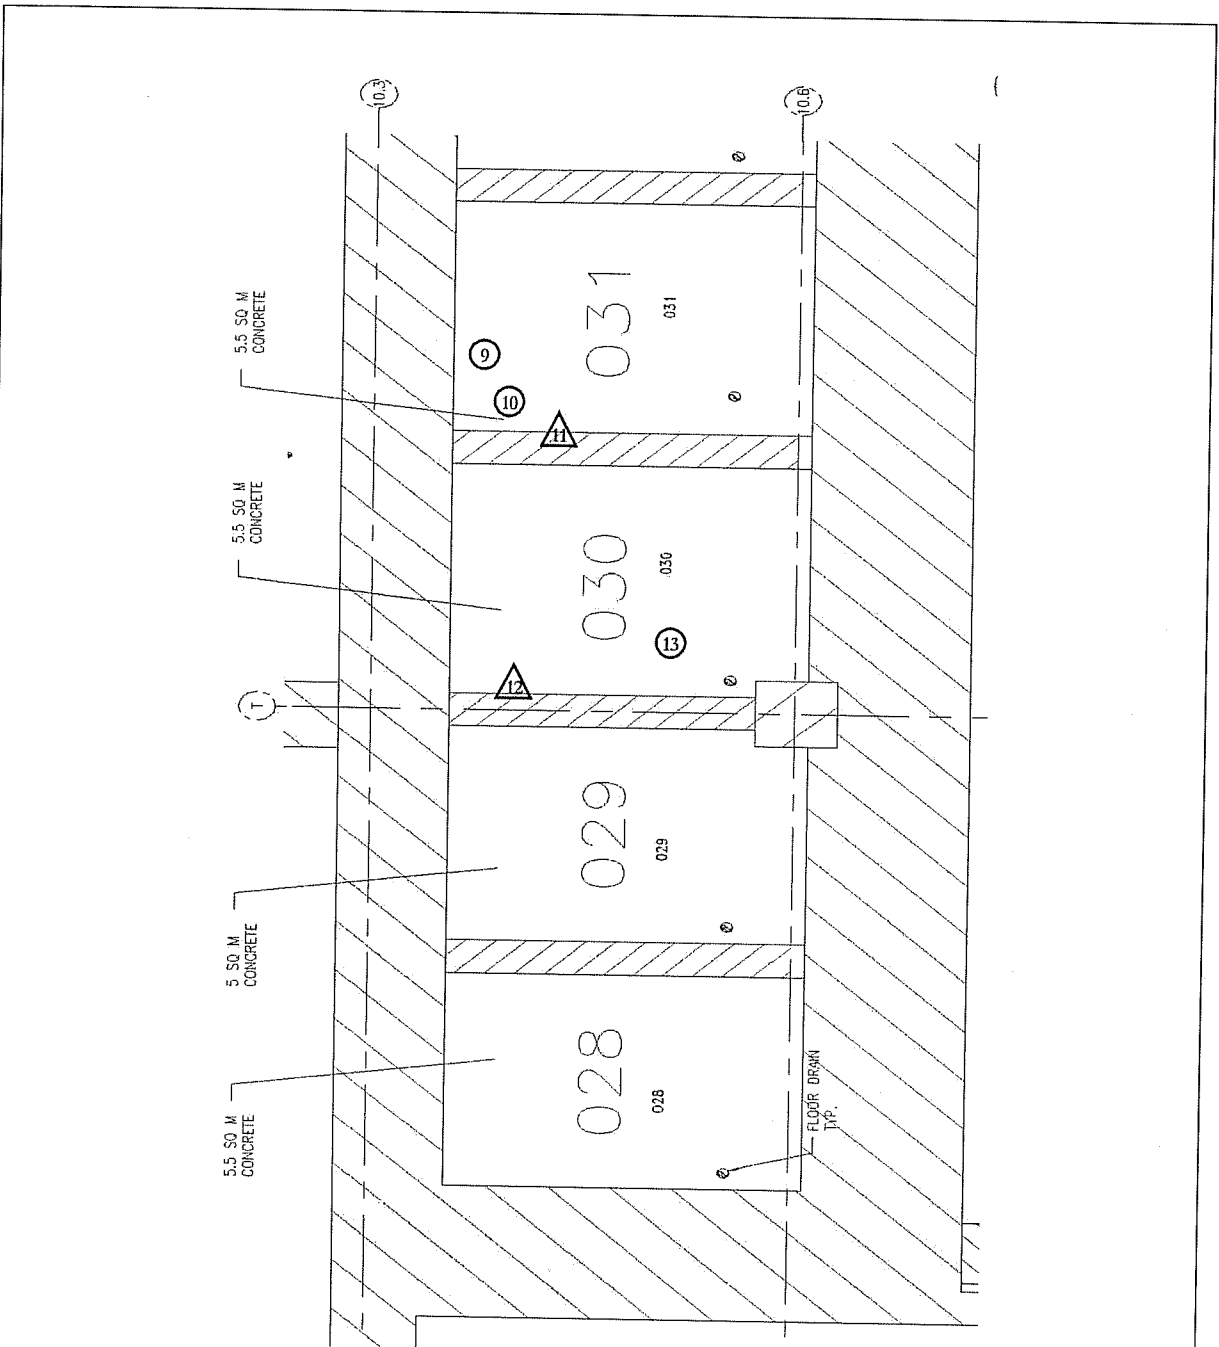
Figure 4: Survey Unit F8130401, Vaults 30 and 31 – Direct Measurement and Sample Locations

Based on beta and gamma surface scan results, direct measurements for beta activity were performed at 26 judgmentally-selected locations on the evaluated structural surfaces within the Auxiliary Building which were available for confirmatory survey activities. Direct measurements were performed using hand-held gas proportional detectors coupled to ratemeters-scalers. A smear sample for determining removable gross alpha and gross beta activity levels was collected from each direct measurement location. Direct measurement and smear locations are indicated on Figures 4 through 8.

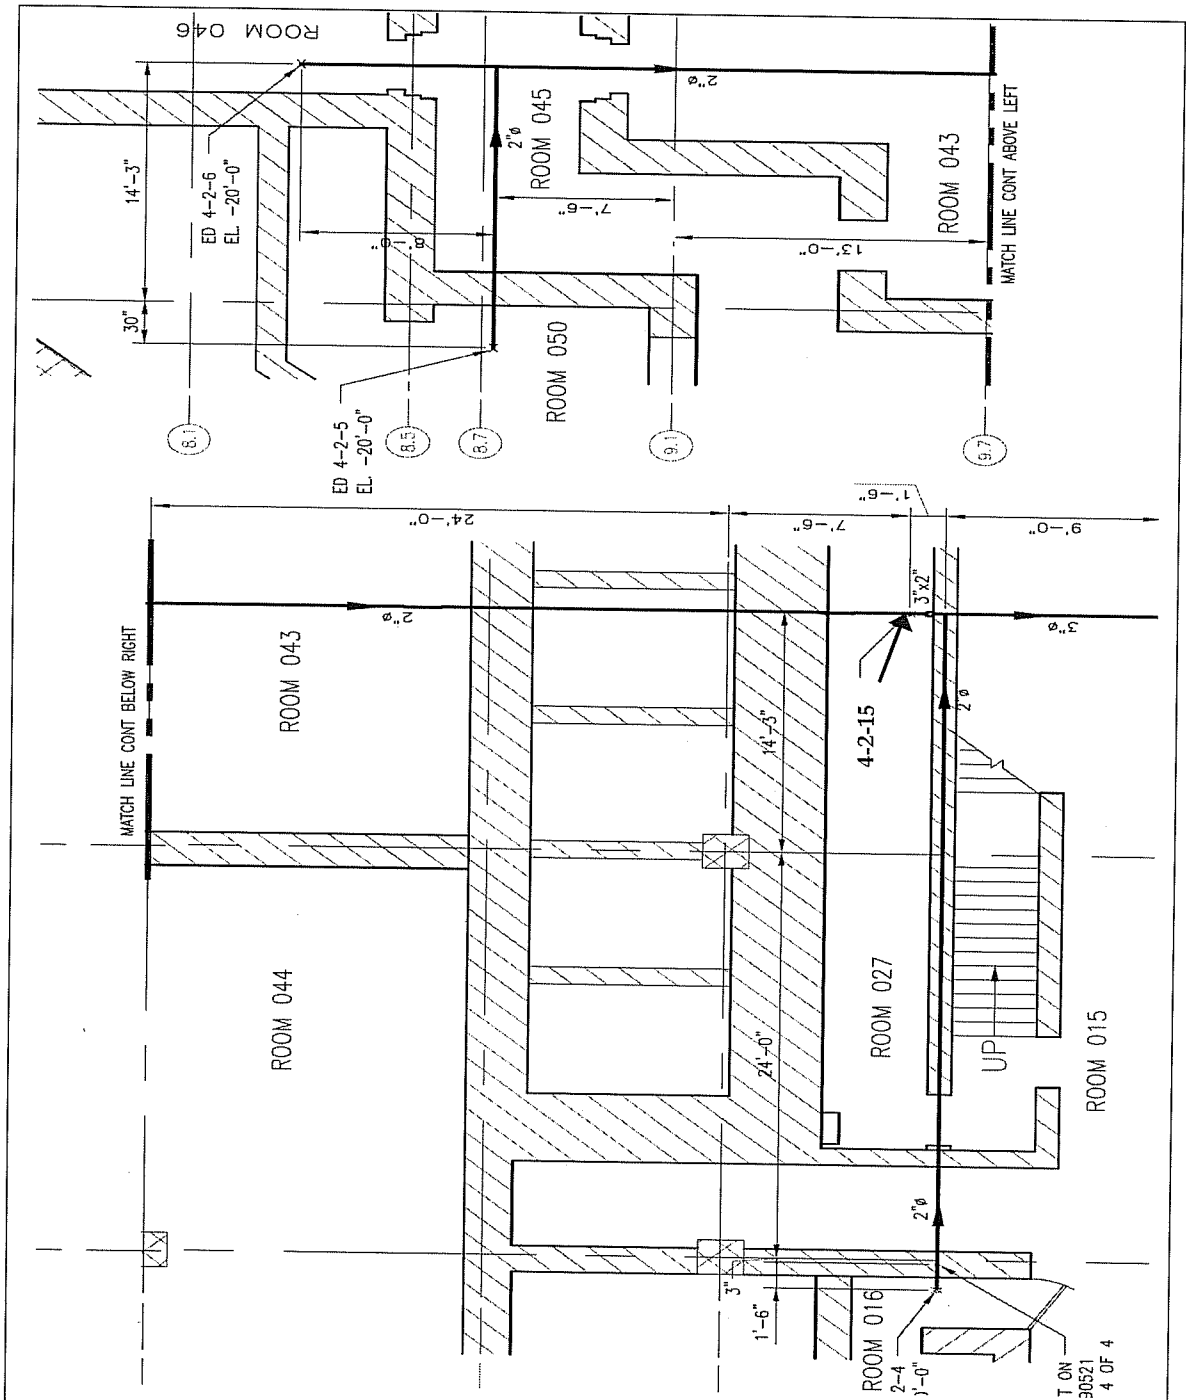
Figure 10: Survey Unit F8990521, Acid Waste Drains – Surveyed Drain 4-2-15

Gamma surface scans of the evaluated Auxiliary Building pipe penetrations did not indicate any areas of elevated gamma radiation levels; the scan results within Acid Waste System Drain Line 4-2-15 were consistent with the results presented in the preliminary FSS data packages for that drain. However, the gamma scan results for Acid Waste System Drain Line 4-1-12, Segment 1 were not in agreement with the preliminary FSS results. Further investigations by SMUD indicated that Drain Line 4-1-13 had been removed and the preliminary FSS results for Drain Line 4-1-12, Segment 1 were erroneously reported as the results for 4-1-13 (Refer to Figure 9). Due to this discrepancy, SMUD re-surveyed Segments 1 and 2 of Drain Line 4-1-12 and provided preliminary results to ORISE on February 12, 2008.<sup>3</sup> SMUD's gamma scan range for the 0 to 8 foot length of Segment 1 is thirteen times higher and not in agreement with ORISE's gamma scan results (Table 3). Based on the discrepancy between the ORISE confirmatory and SMUD FSS gamma scan ranges and the confusion with the incorrect numbering of the drain line, ORISE recommends that a side-by-side instrument comparison be performed in this drain line during a subsequent confirmatory survey trip.
