Replacement Steam Generator

Divider Plate Weld Joint Separation

Root Cause Evaluation

San Onofre Nuclear Generating Station, Units 2 & 3 REPLACEMENT STEAM GENERATORS

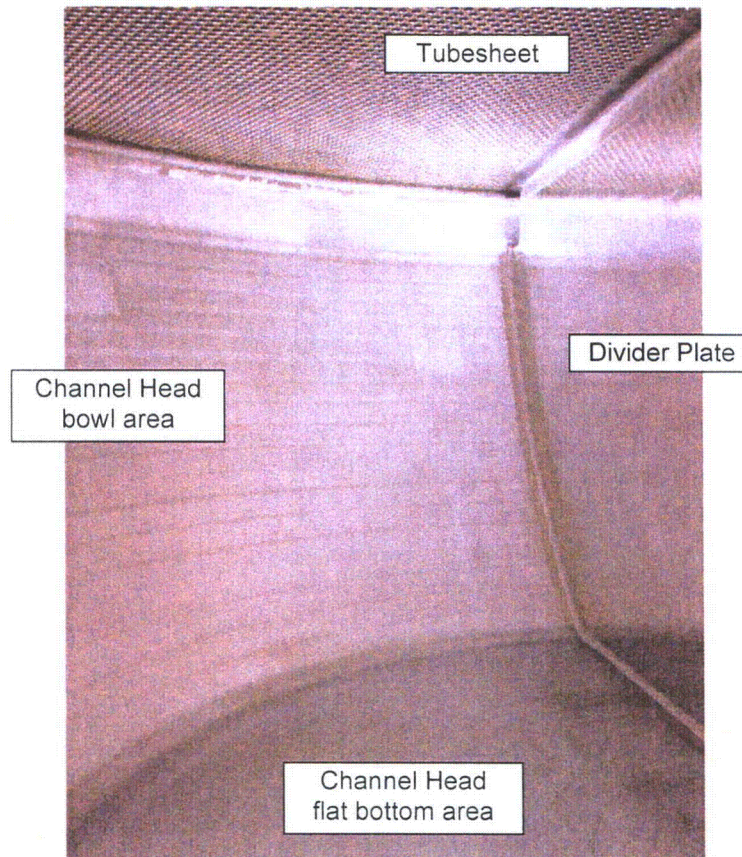
Figure 1-2 RSG 2A Channel Head after Hydrotest & Electropolishing

The divider plate separates the hot leg side from the cold leg side of the channel head and is welded to the channel head and the tubesheet. Figure 1-2 is a photograph taken in the 2A RSG that shows the tubesheet, channel head and divider plate after the hydrostatic test and electropolishing.

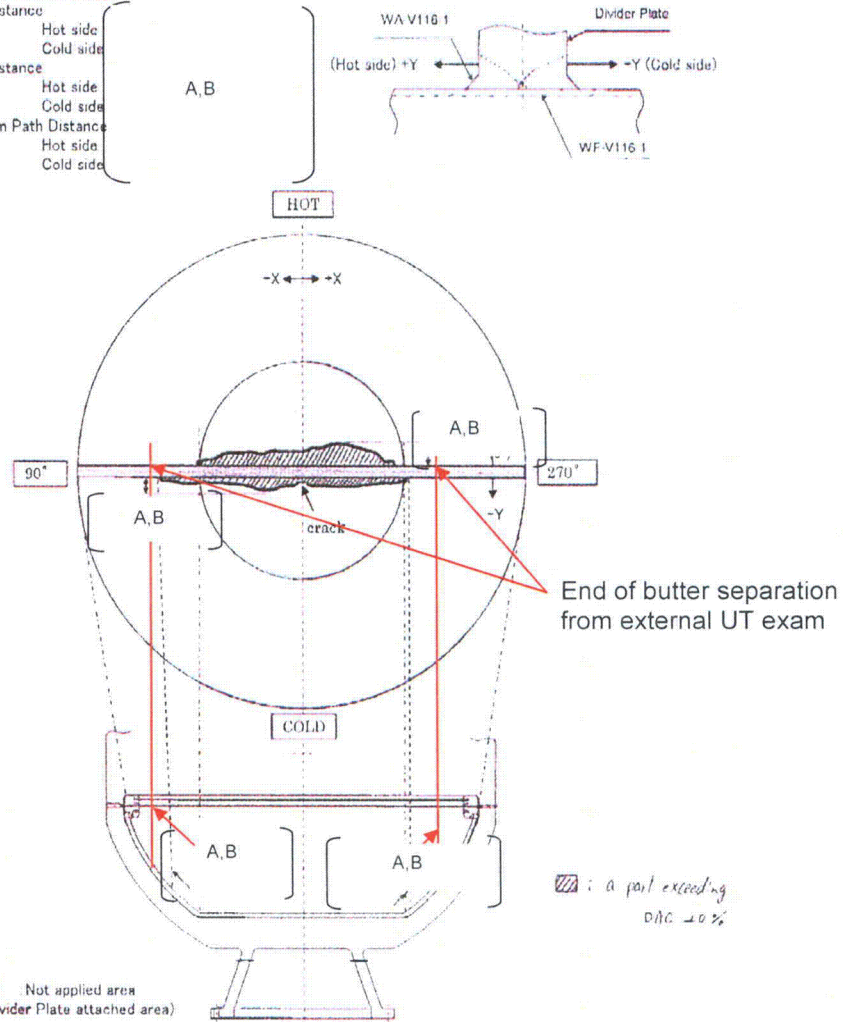
Figure 2.1-2 RSG 3B Butter/Clad Separation Map

On both Unit-3 RSGs, straight beam UT examinations were performed from the outside of the channel head underneath the divider plate weld joint and from the inside of the channel head in the areas adjacent to the divider plate. Clad and butter separation was detected under and adjacent to the divider plate on both RSGs. Figures 2.1-2 and 2.1-3 show the areas where butter/clad separation was detected.

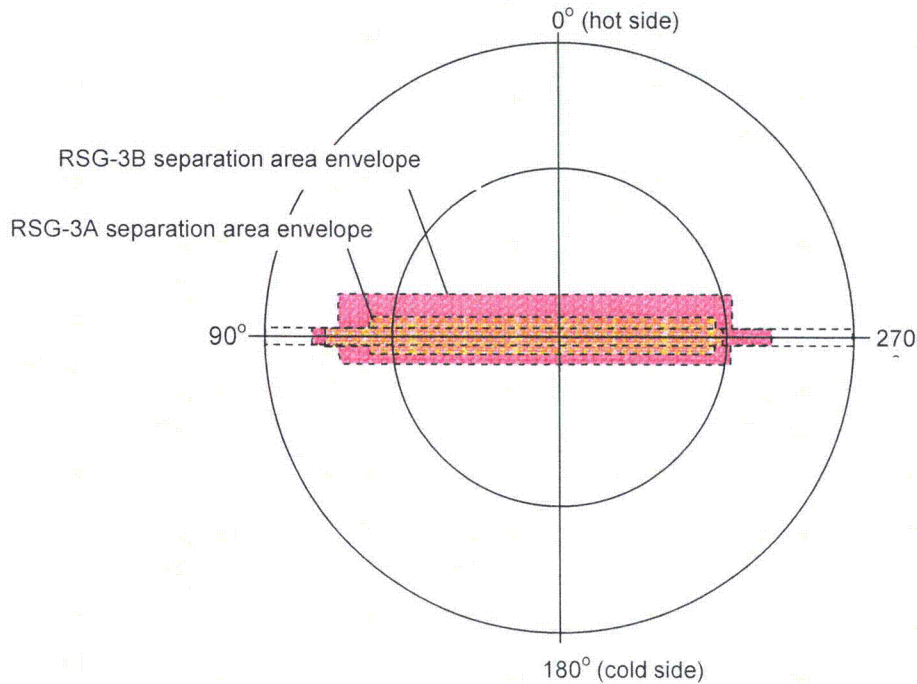
Figure 2.1-4 Unit-3 Butter/Clad Separation Area Envelopes

The dimensions of the butter/clad separation area envelopes are summarized in Table 2.1-1.

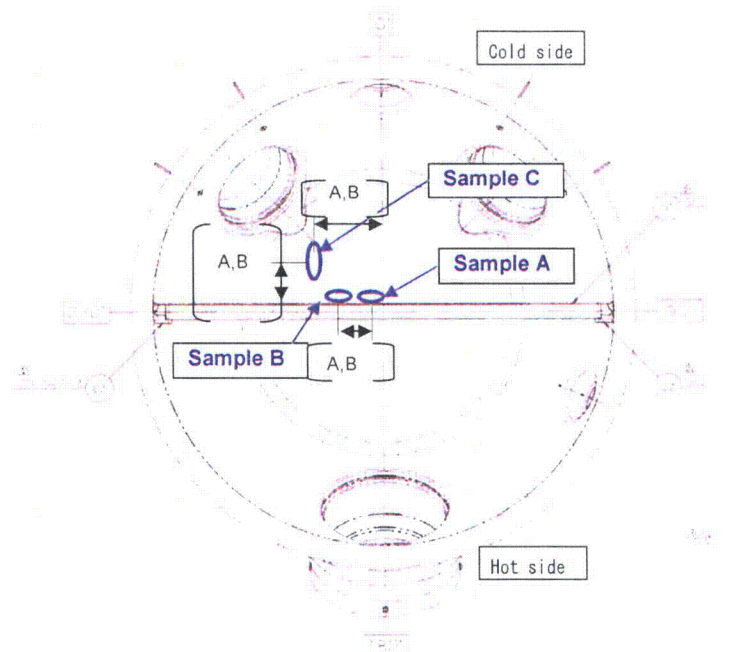
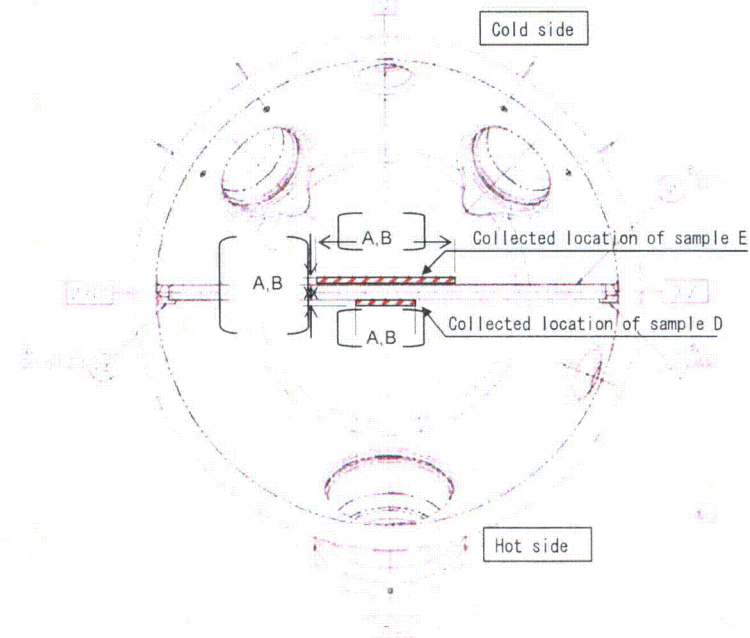
Figure 3.1-1 Sample Collection Locations (1/2)

Table 3.1-1 provides description of the samples, Figure 3.1-1 shows the locations where the samples were collected, and Table 3.1-2 describes the analyses performed on the samples.

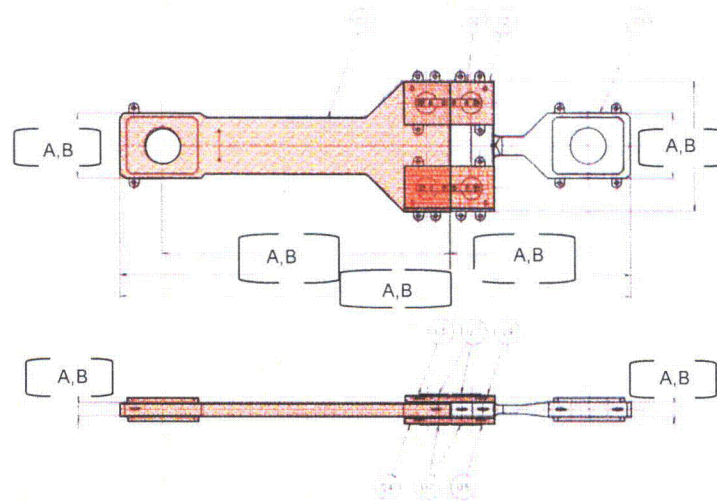
Figure3.3-1 T-Type Full-Scale Test Configuration

Two test samples were fabricated as shown in Figure 3.3-1 using the low alloy steel plates to simulate both the divider plate and channel head pieces. The piece simulating the divider plate had an Alloy 152 butter applied to one end and was welded to the butter applied to the piece simulating the channel head, which had stainless steel clad applied

and then removed prior to butter application. On Sample A, the clad was removed by gouging and on Sample B the clad was removed by machining.

Sample A (gouged) fractured within the divider plate simulated by the Alloy 152 butter under a load of [A,B]. Sample B (machined) also fractured within the divider plate simulated by the Alloy 152 butter under a load of [A,B]. Metallurgical structure near the fusion boundary of Sample A (gouged) was similar to that found on the samples collected from the Unit 3 RSGs, including the presence of the "white zone."

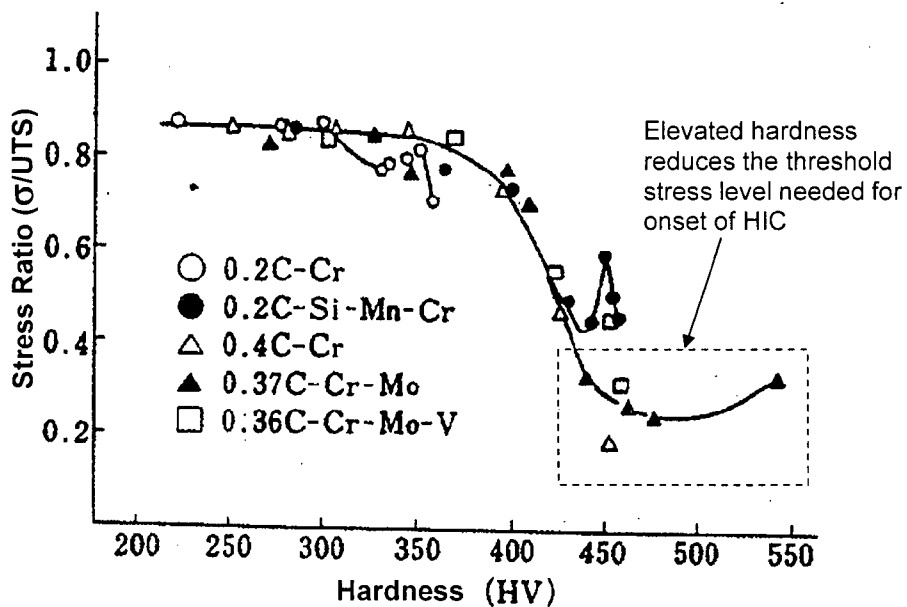
Figure 3.10-1 HIC Sensitivity to Hardness

Figure 3.10-1 contains a textbook figure describing the effect of material hardness on the stress level needed for onset of the HIC. This data is for materials different than the channel head low alloy steel base metal. However, the trend is believed to apply to the materials used on the RSGs. The stress ratio shown in Figure 3.10-1 is the ratio of the stress needed to produce a tensile failure, divided by the material ultimate tensile strength (UTS). For elevated hardness the stress level needed for failure is reduced from ~85% UTS to ~25% UTS, i.e. by a factor of ~3. If carbon deposits were left behind by the air carbon-arc gouging process on the base metal surface, then especially high hardness areas could be present at the butter-to-base metal fusion boundary.

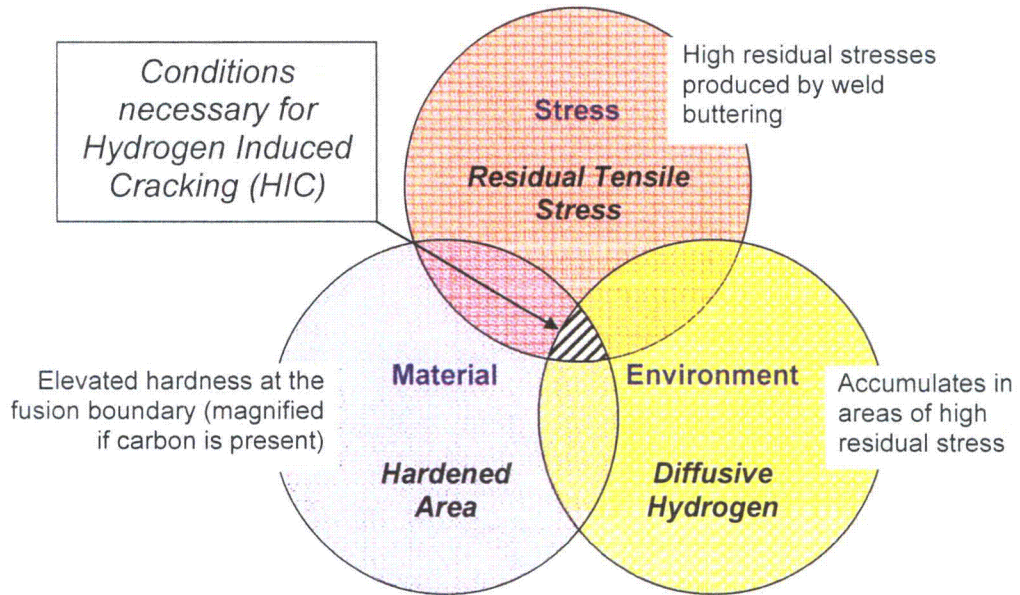
Figure 4-1 Hydrogen Induced Cracking (HIC) Diagram

Figure 4-1 summarizes the conditions necessary to produce HIC.

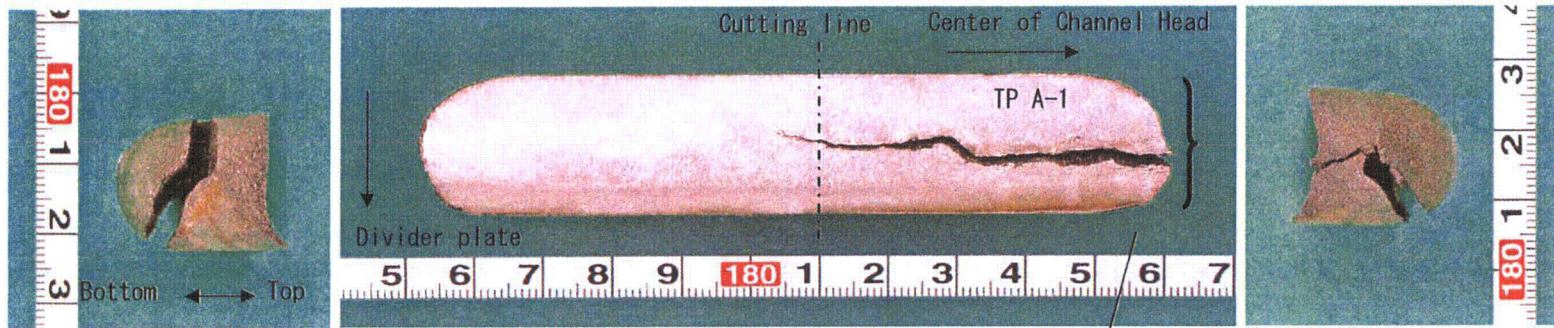
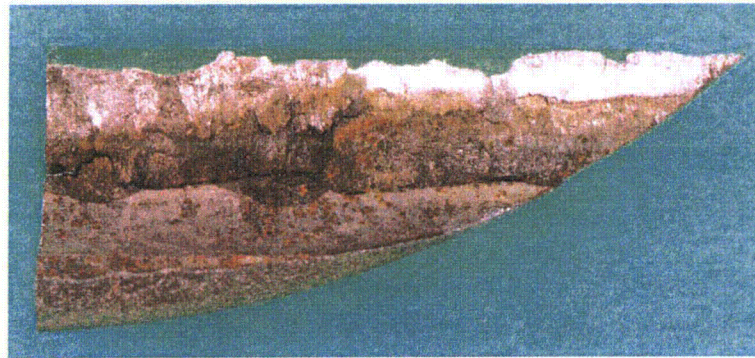
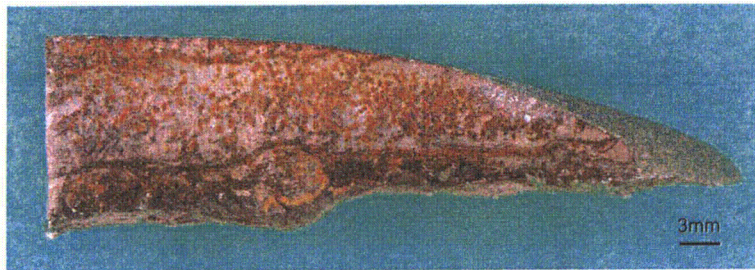
Fig.A.7 Appearance of fracture surface of TP A-1 (sample A)

Separated two pieces

Fracture surface (from Direction C)

Fracture surface (from Direction B)

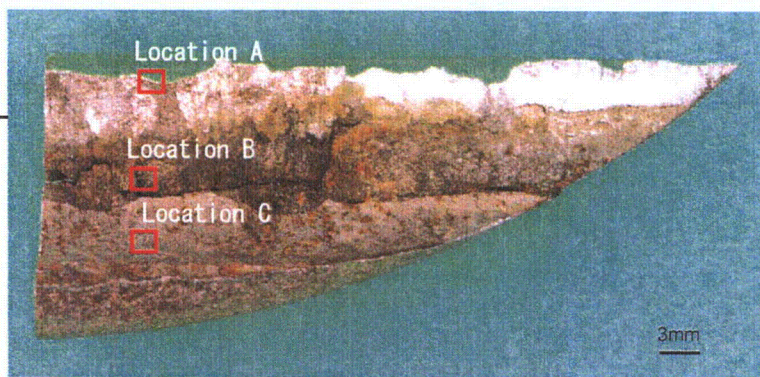
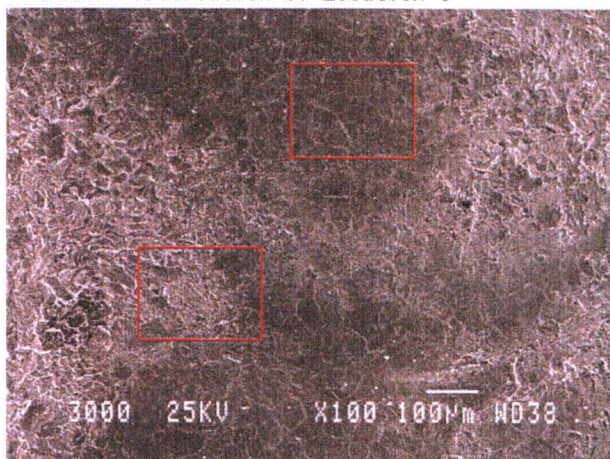
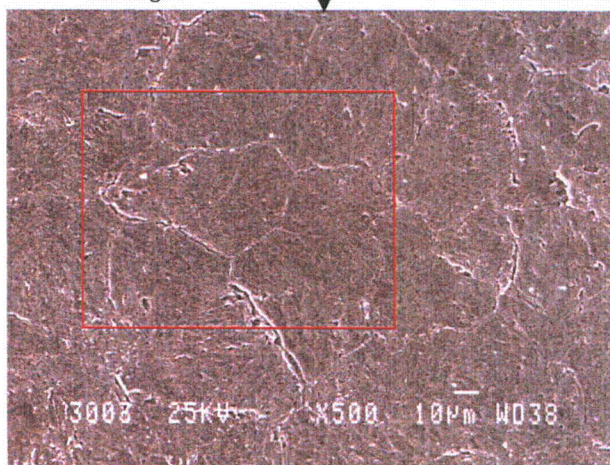
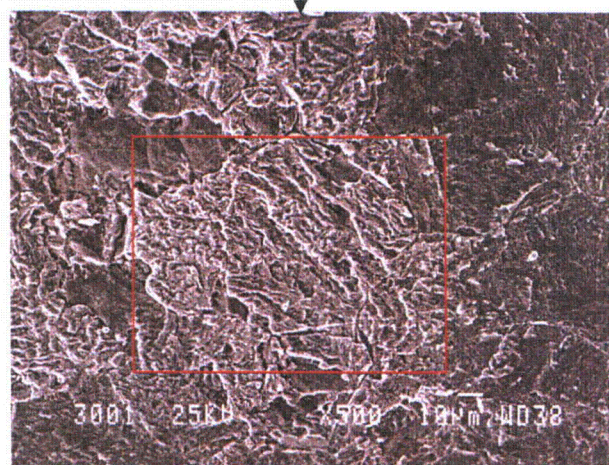
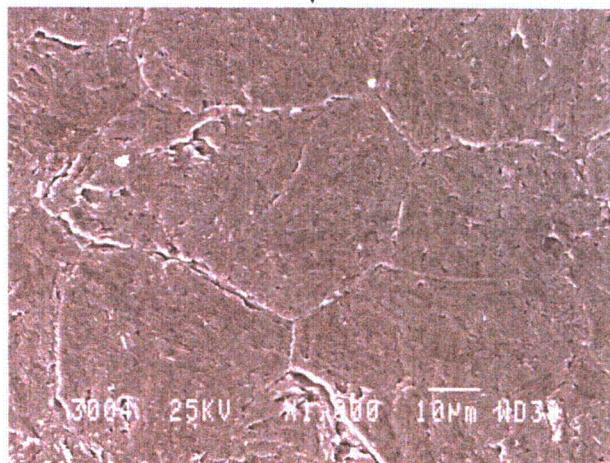
Fig. A.8(2) SEM observation of fracture surface of TP A-1 (sample A) (Continued)

Grain-boundary-like pattern

Quasi-cleavage fracture surface

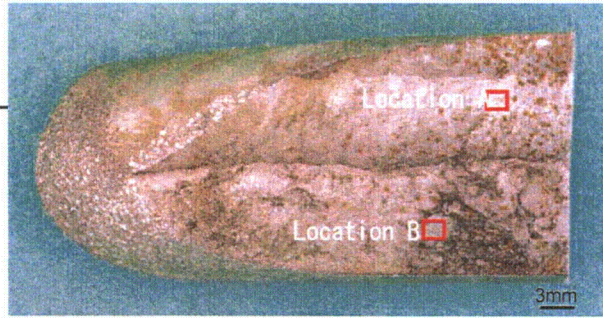
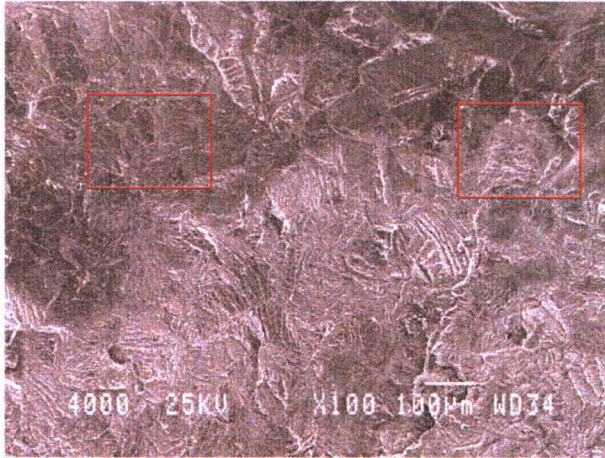
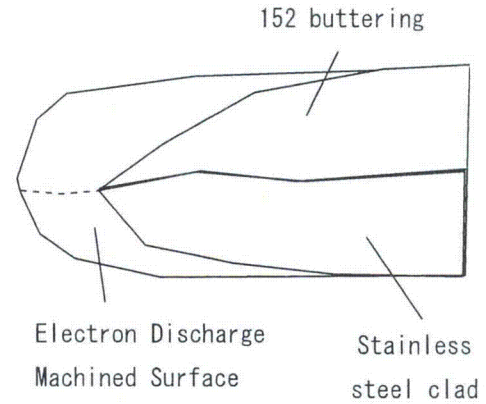
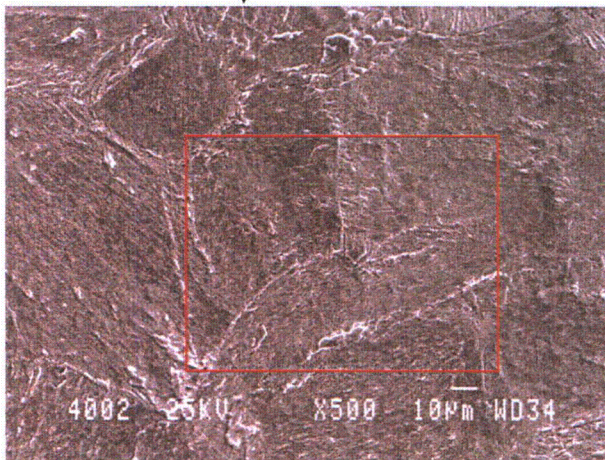
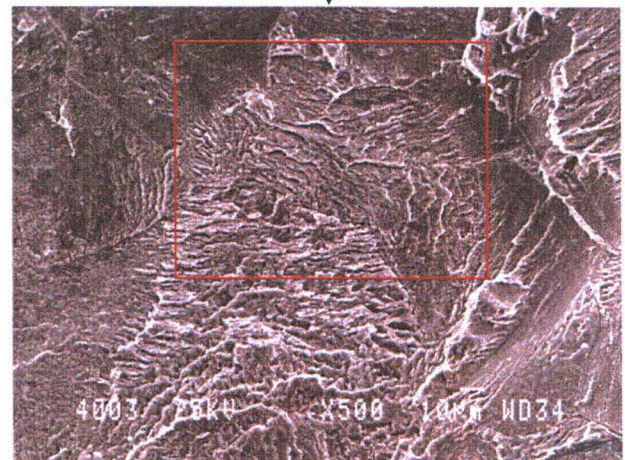
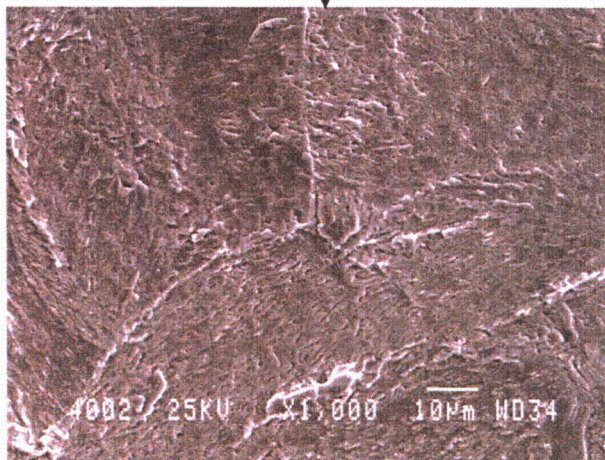
Fig. A.10(1) SEM observation of fracture surface of TP A-2(sample A)

Dendrite-boundary-like pattern

Quasi-cleavage fracture surface

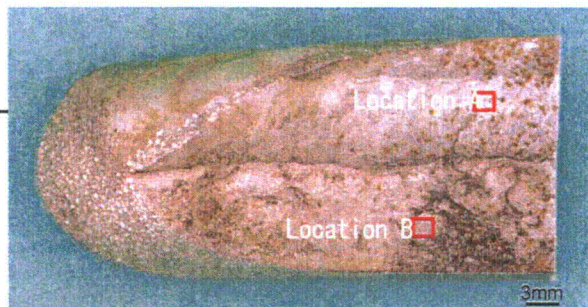
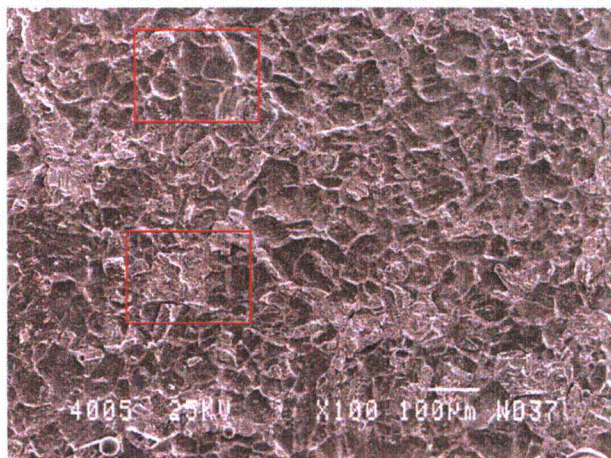
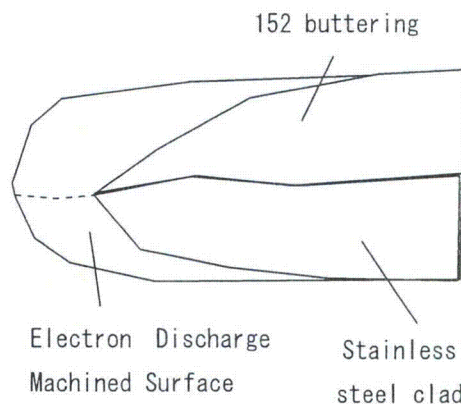
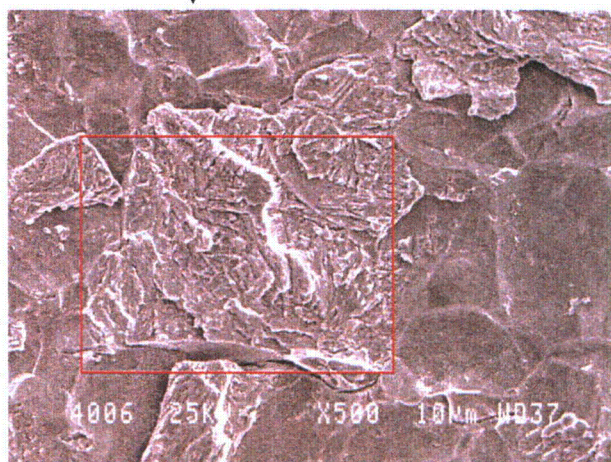
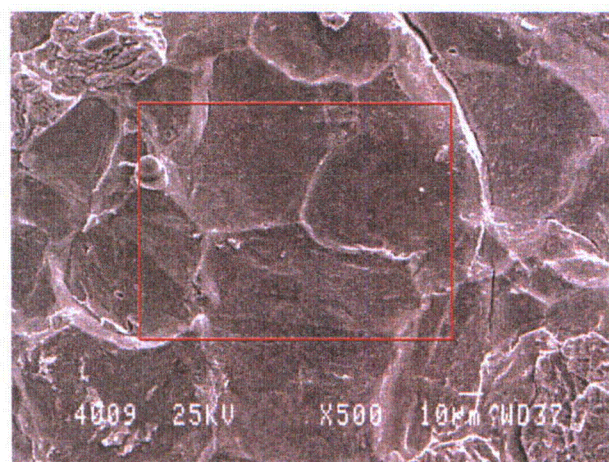
Fig. A.10(2) SEM observation of fracture surface of TP A-2(sample A) (Continued)

Quasi-cleavage fracture surface

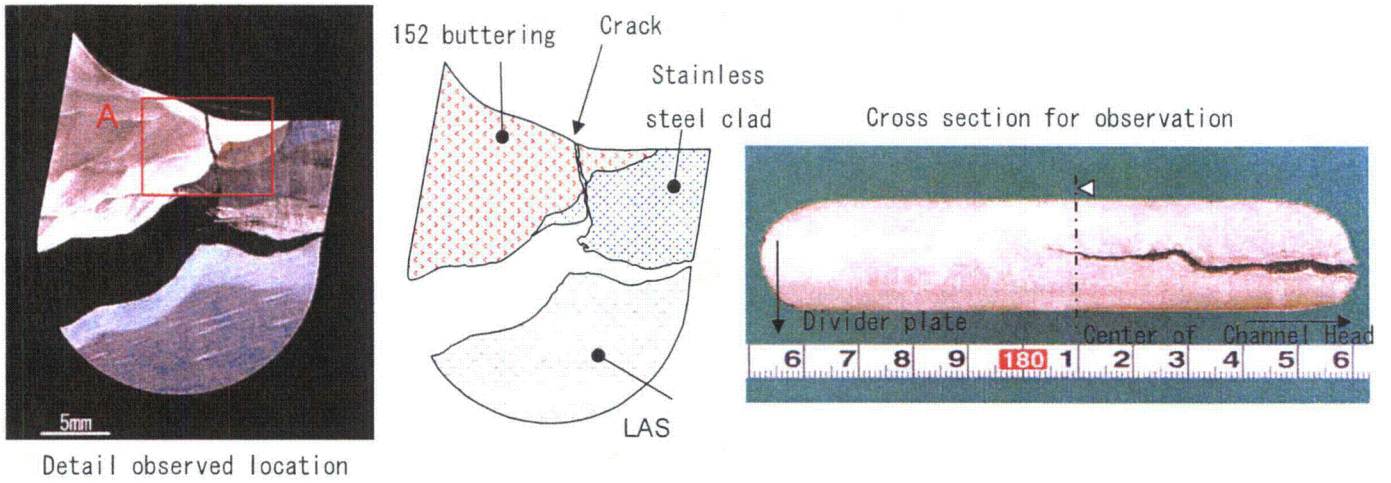
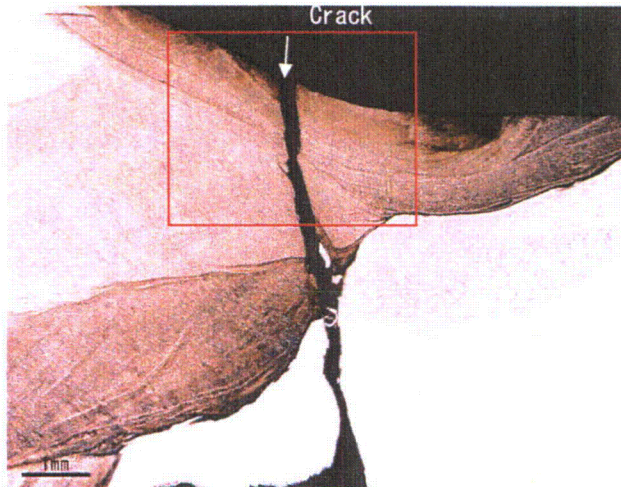
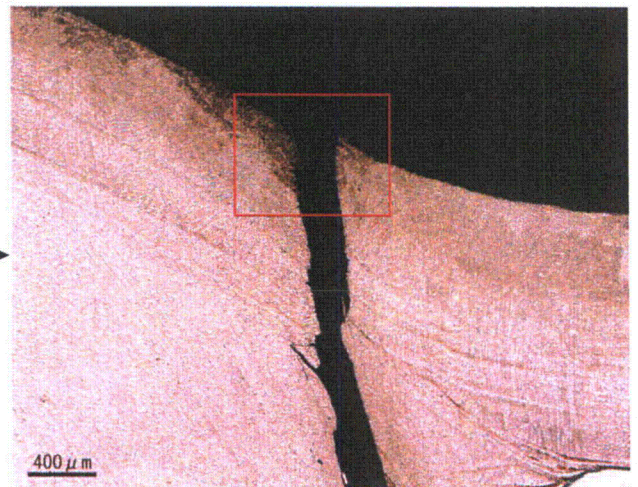
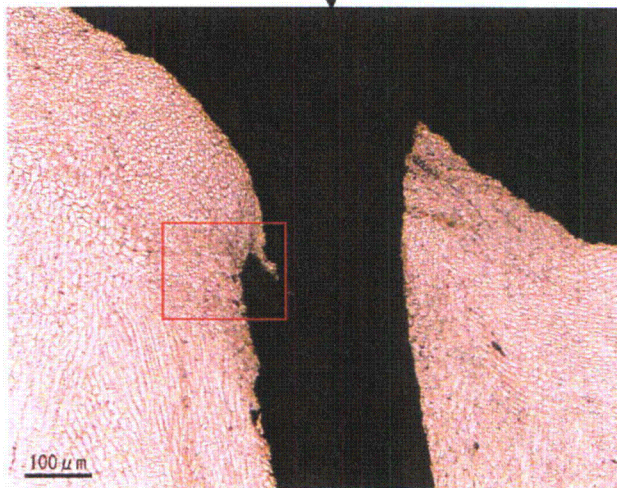
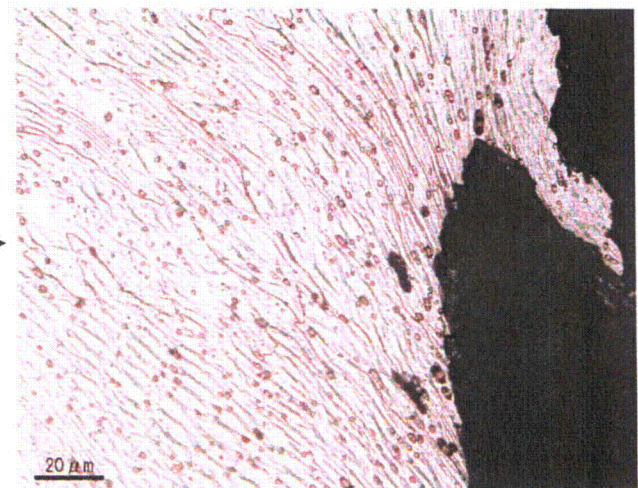
Fig. A. 11(1) Micro-structure observation of cross section of sample A

152 buttering ↔ Stainless steel clad

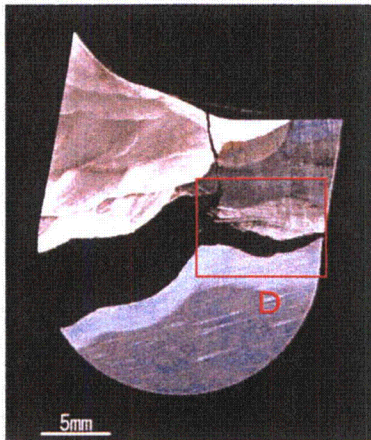
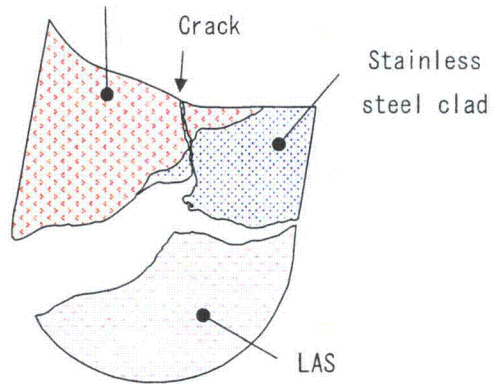
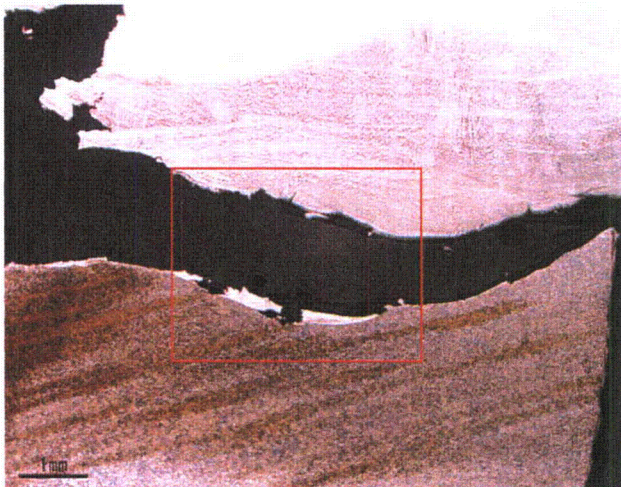
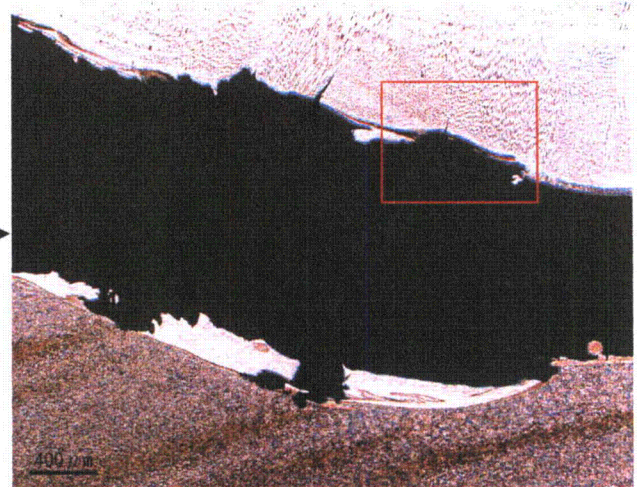
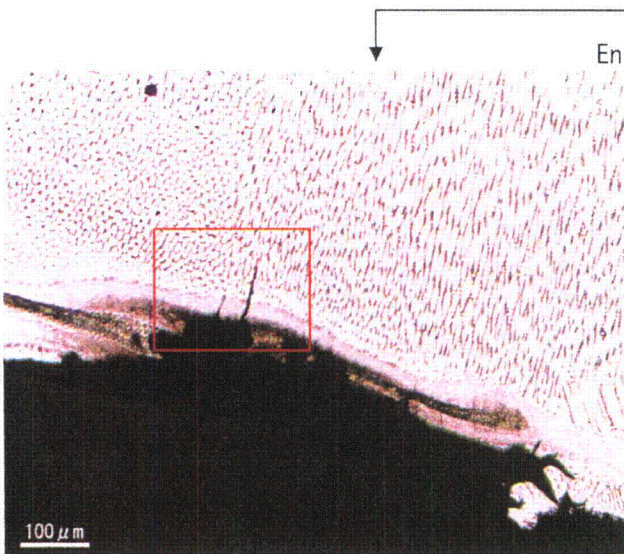
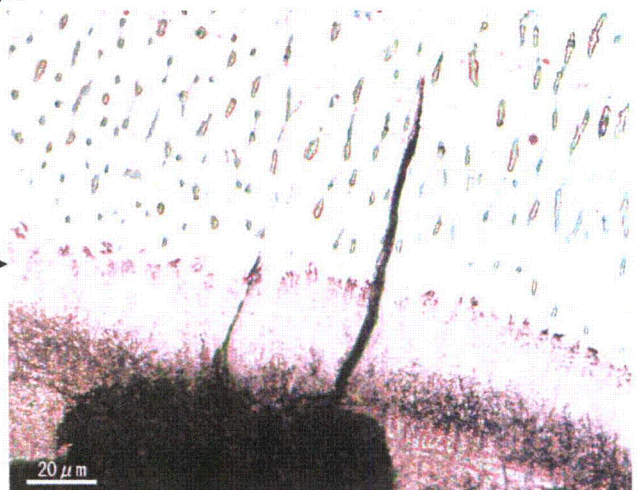
Fig. A.11(5) Micro-structure observation of cross section of sample A (Continued)

Detail observation of location D

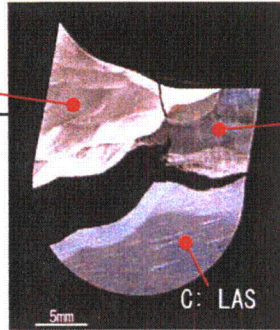
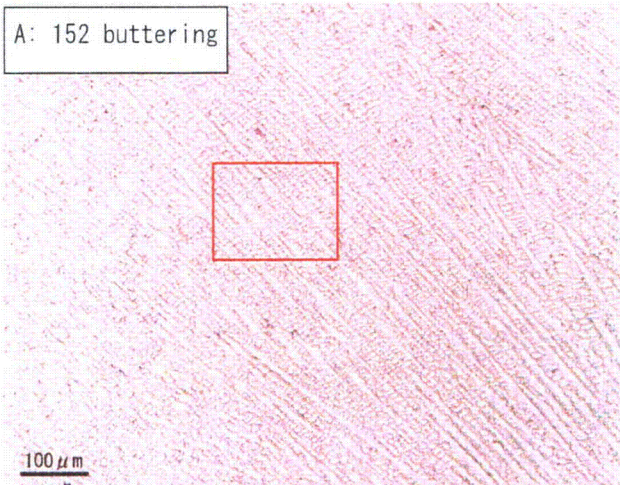
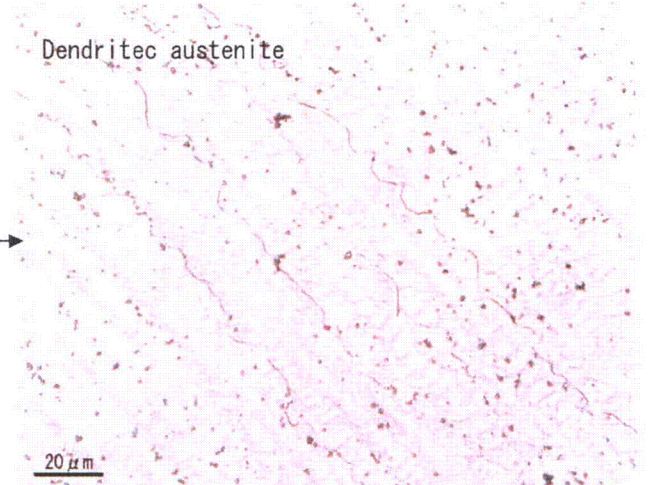
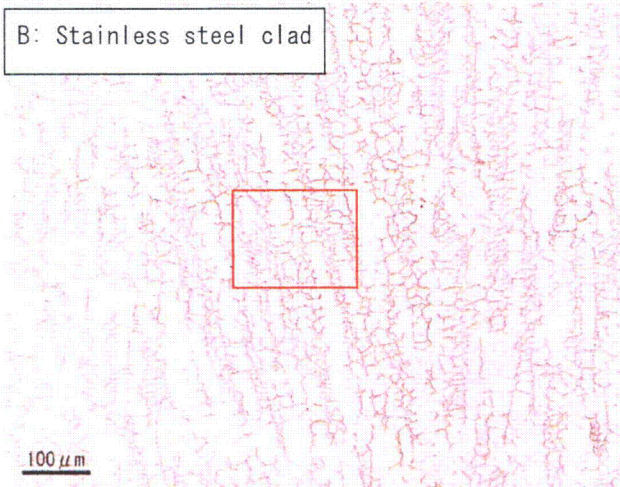
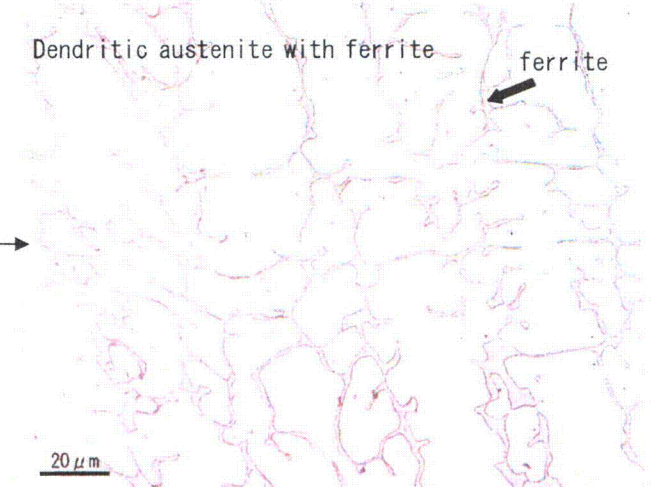
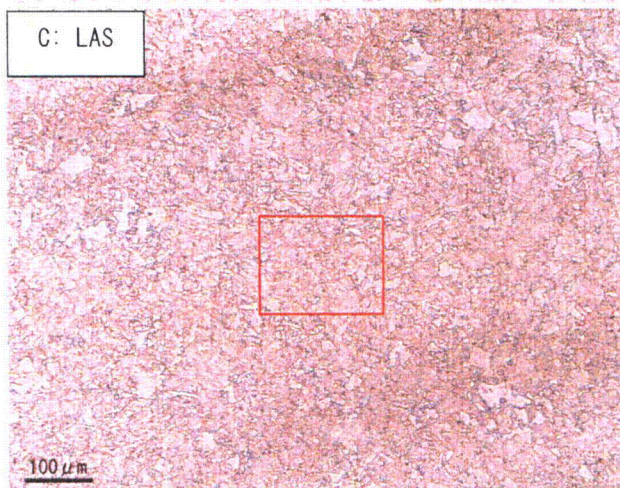
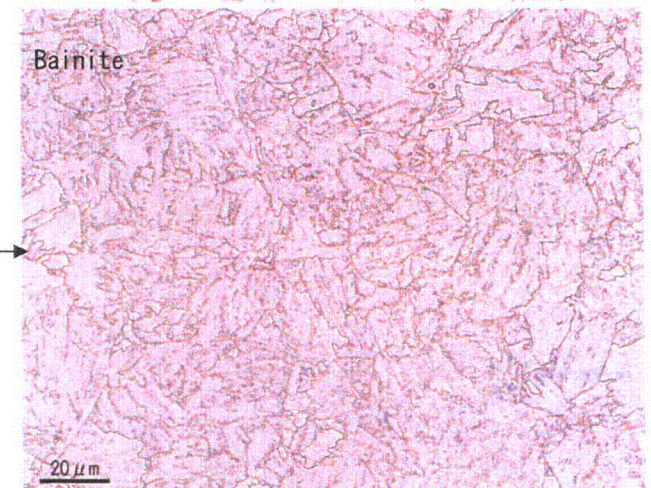
Fig. A.11(6) Micro-structure observation of cross section of sample A (Continued)

Typical micro-structure of weld metal and base metal

Dendritic austenite

Dendritic austenite with ferrite

Bainite

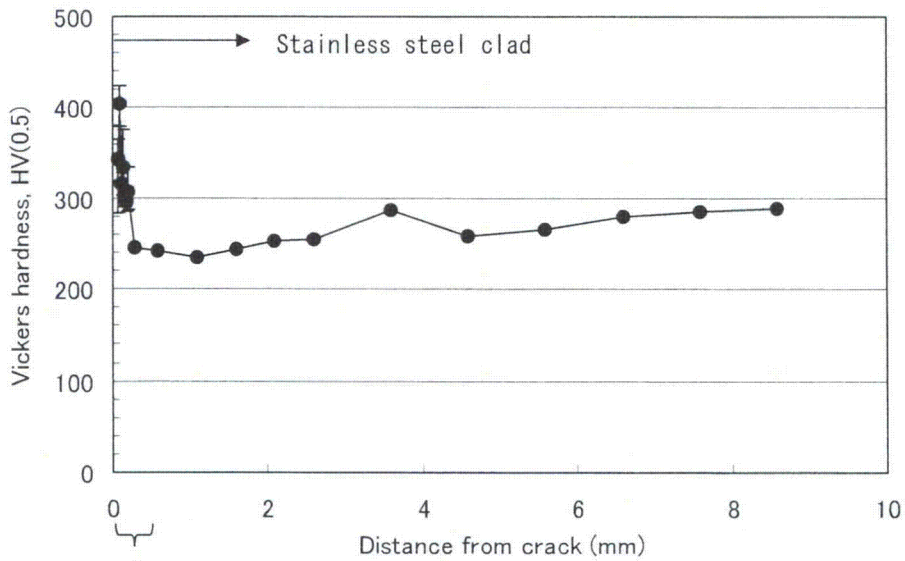
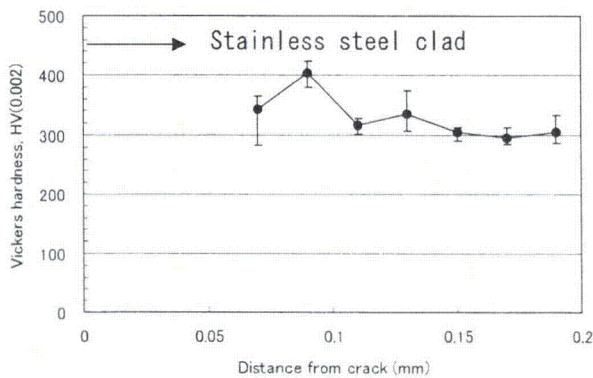
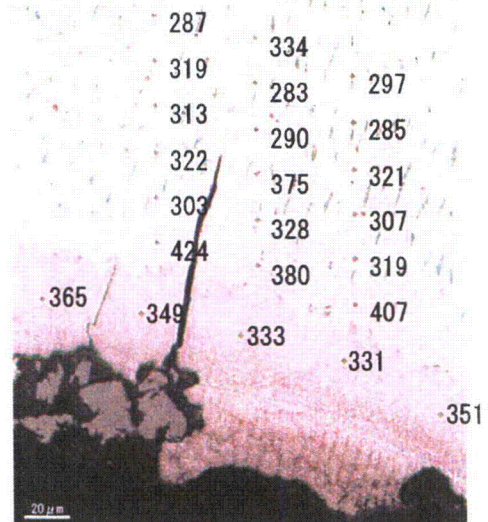
Fig. A.13(1) Vickers hardness of cross section of sample A (Stainless steel clad/LAS boundary)

The result of hardness test

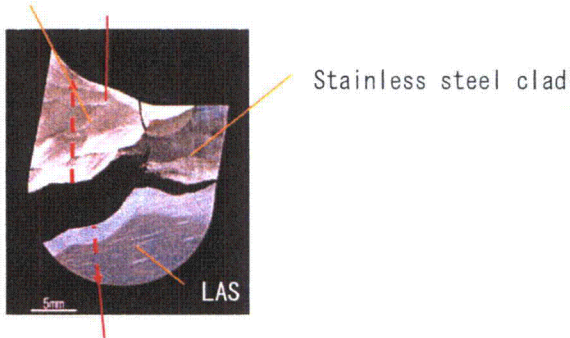
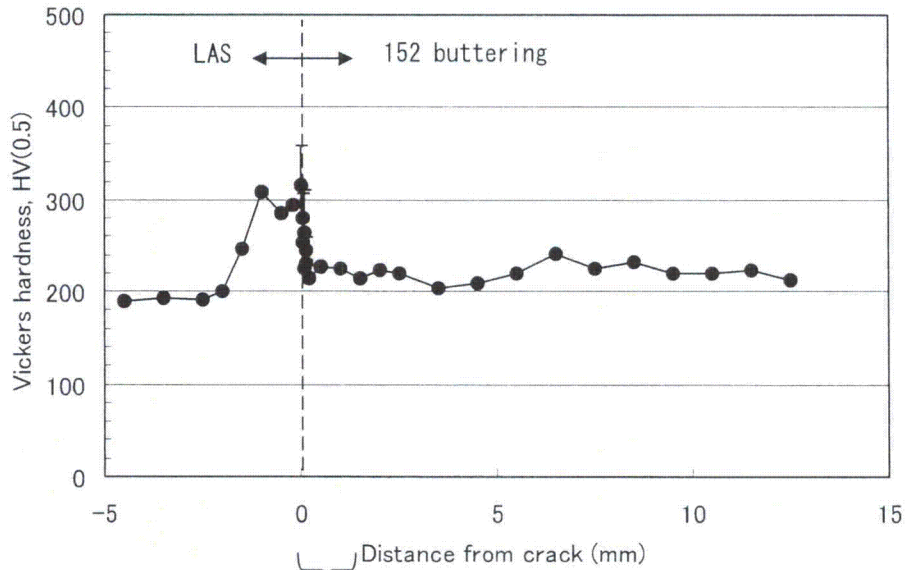
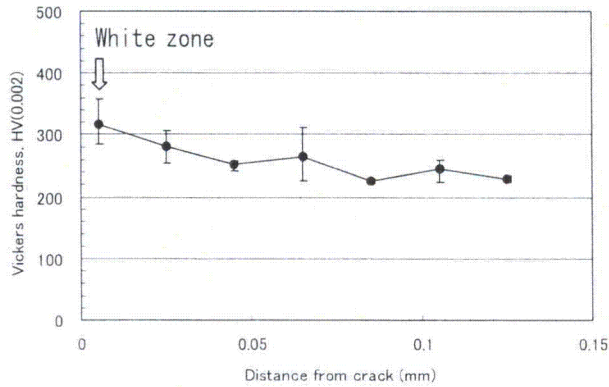
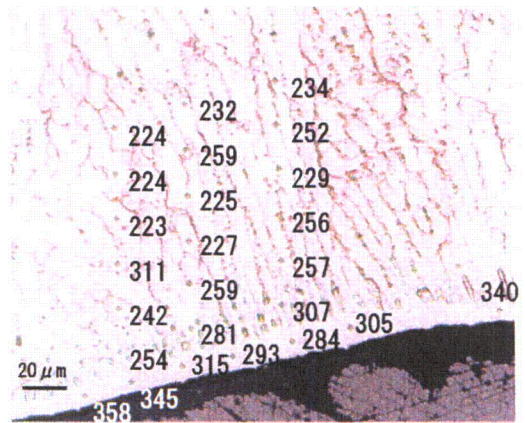
Fig. A.14 Vickers hardness of cross section of sample A (152 buttering/LAS boundary)

As shown in the results of investigation, crack propagated near fusion boundary and hardening was observed along fusion boundary (white zone/colored zone). It seems that hardening along fusion boundary can affect crack propagation. Mechanisms of the hardening are described as follows;

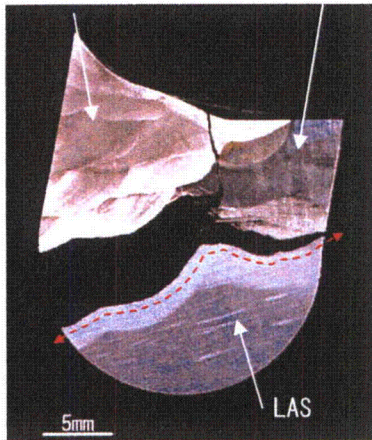
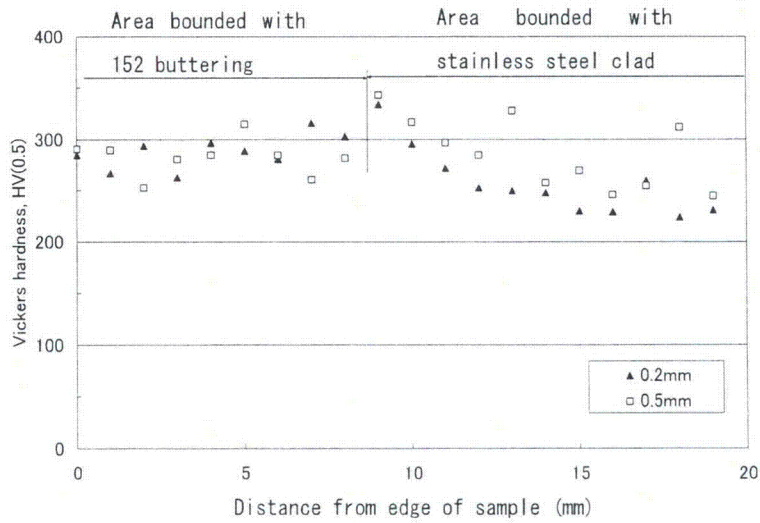
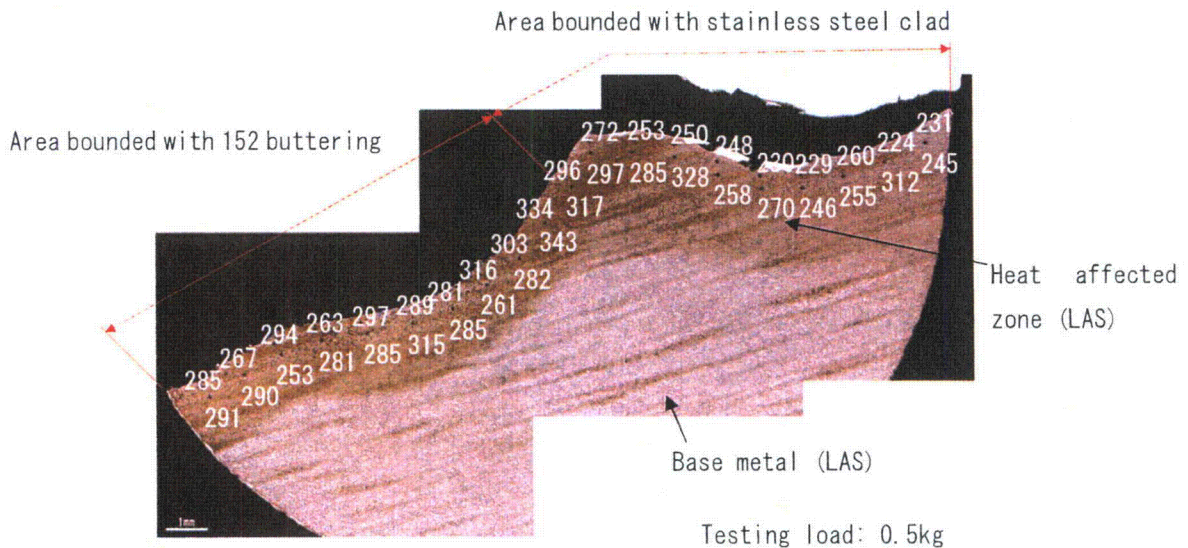
Fig. A.15 Distribution of Vickers hardness of heat affected zone in cross section of sample A

Three boat samples were collected from Unit 3B RSG and two samples were collected from Unit 3A for investigation. On each sample, hardened area was observed adjacent to the fusion boundary between 152 buttering and LAS base metal. Similar hardened area was also observed near the fusion boundary between stainless steel cladding and LAS base metal. These areas with higher hardness value might have been generated by carburization during heat treatment and would cause the propagation of separation of the buttering/clad from the LAS at or near the fusion boundary.

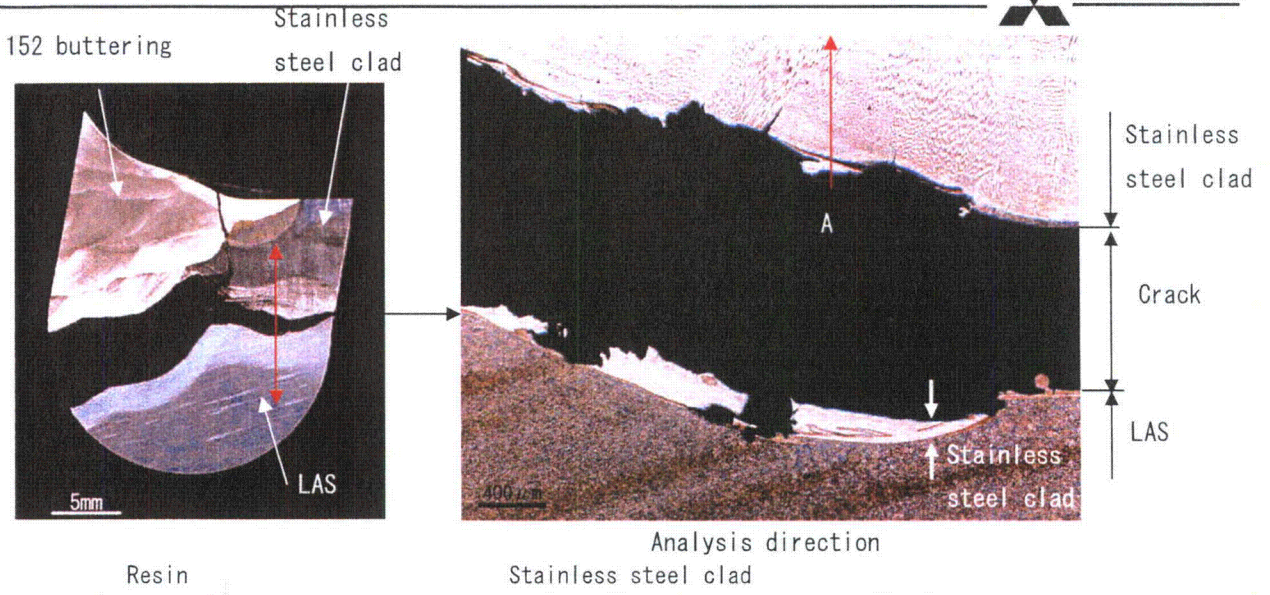
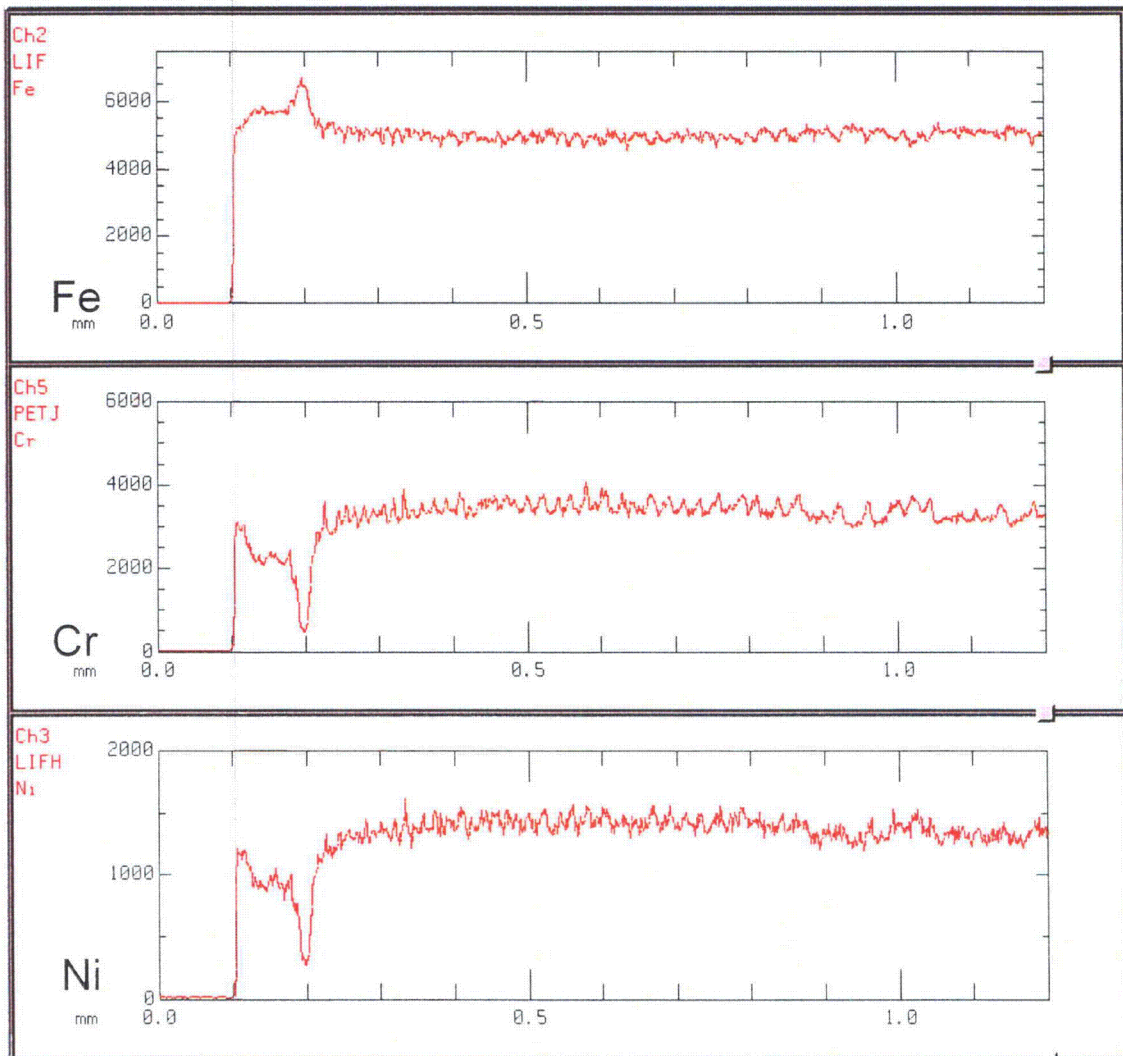
Fig. A.16(1) EPMA line analysis of cross section of sample A
 (Stainless steel clad/LAS boundary)

The result of line analysis to depth direction in cross section of sample A (Line A)
