Replacement Steam Generator

Divider Plate Weld Joint Separation

Root Cause Evaluation

San Onofre Nuclear Generating Station, Units 2 & 3 REPLACEMENT STEAM GENERATORS

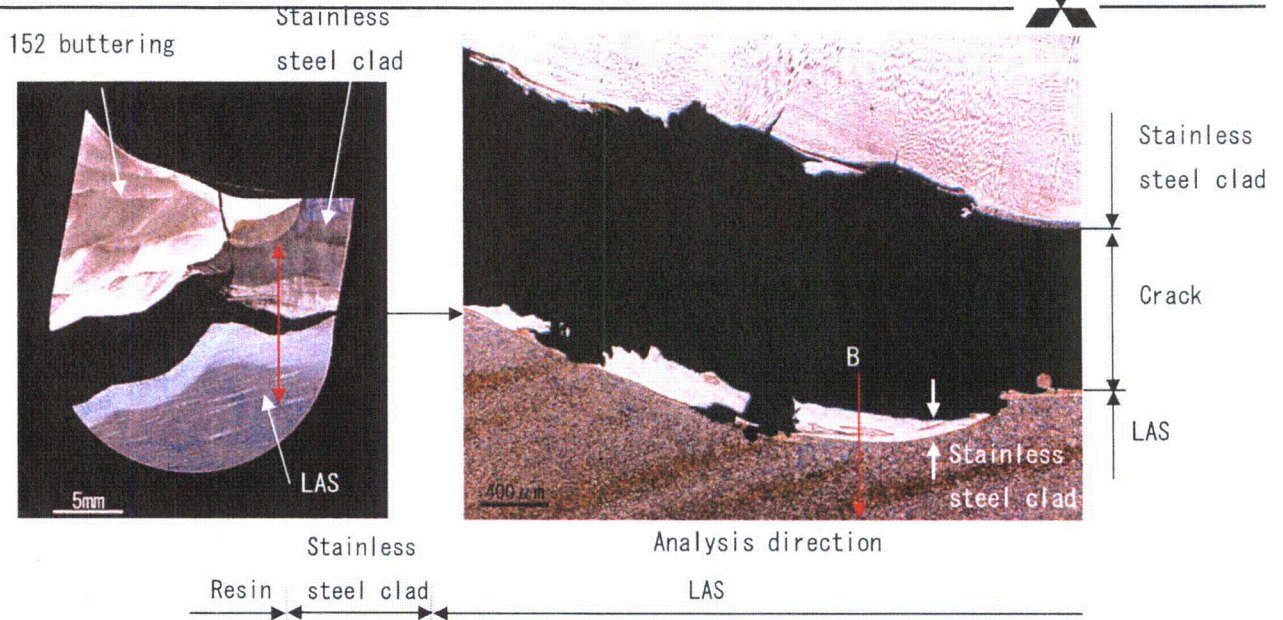
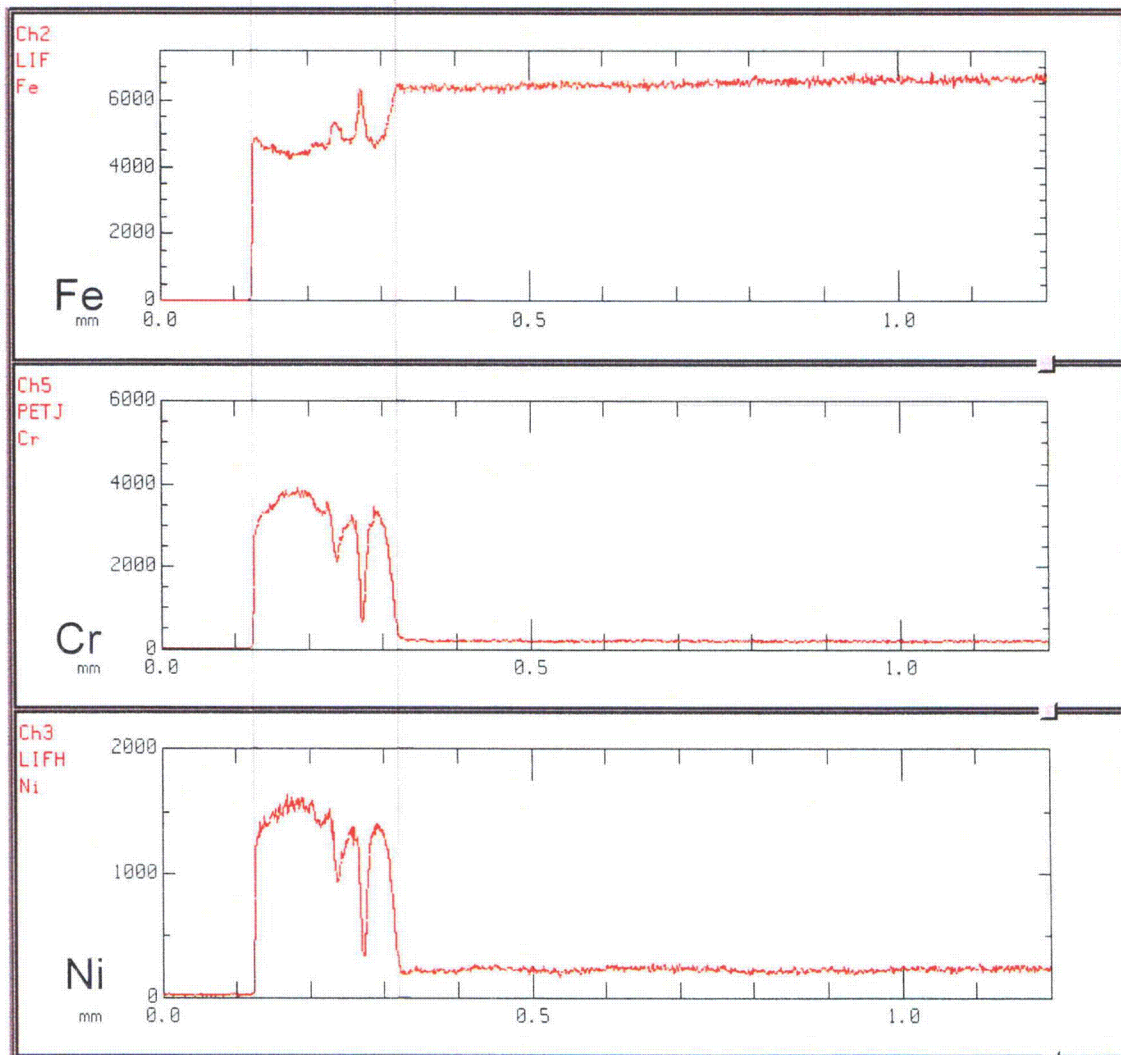
Fig. A.16(2) EPMA line analysis of cross section of sample A

The result of line analysis to depth direction in cross section of sample A (Line B)

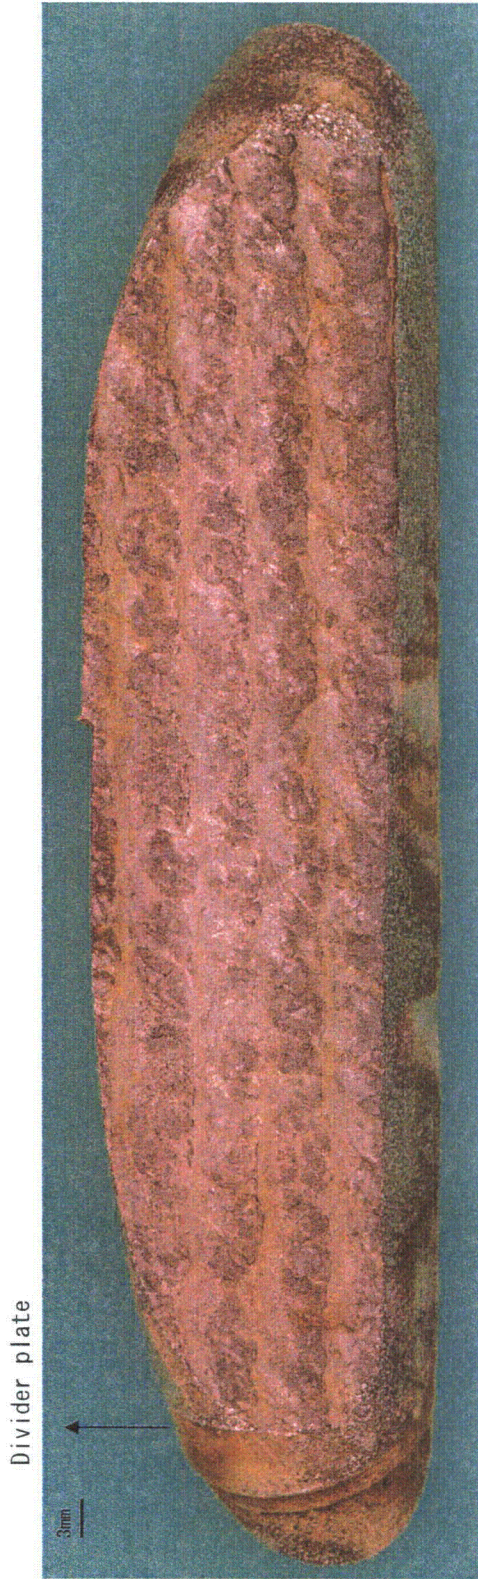
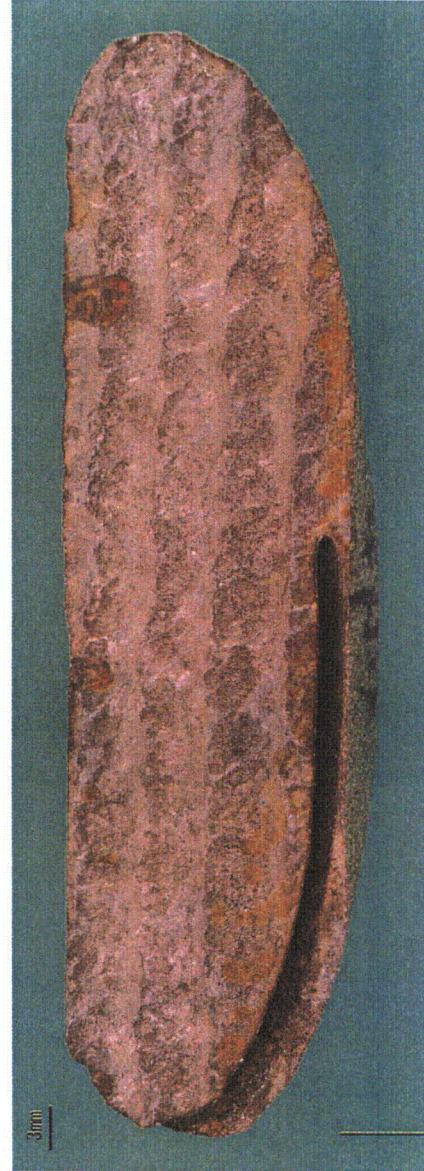
Fig. A.19 Appearance of fracture surface

Fracture surface of sample B (152 buttering)

Fracture surface of sample B (Low Alloy Steel channel head)

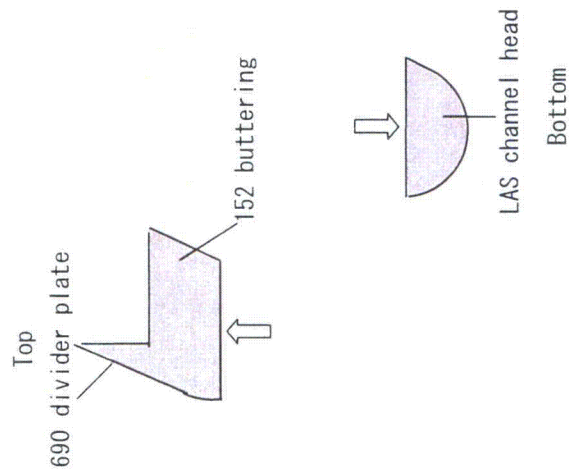
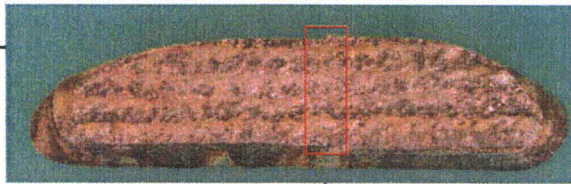
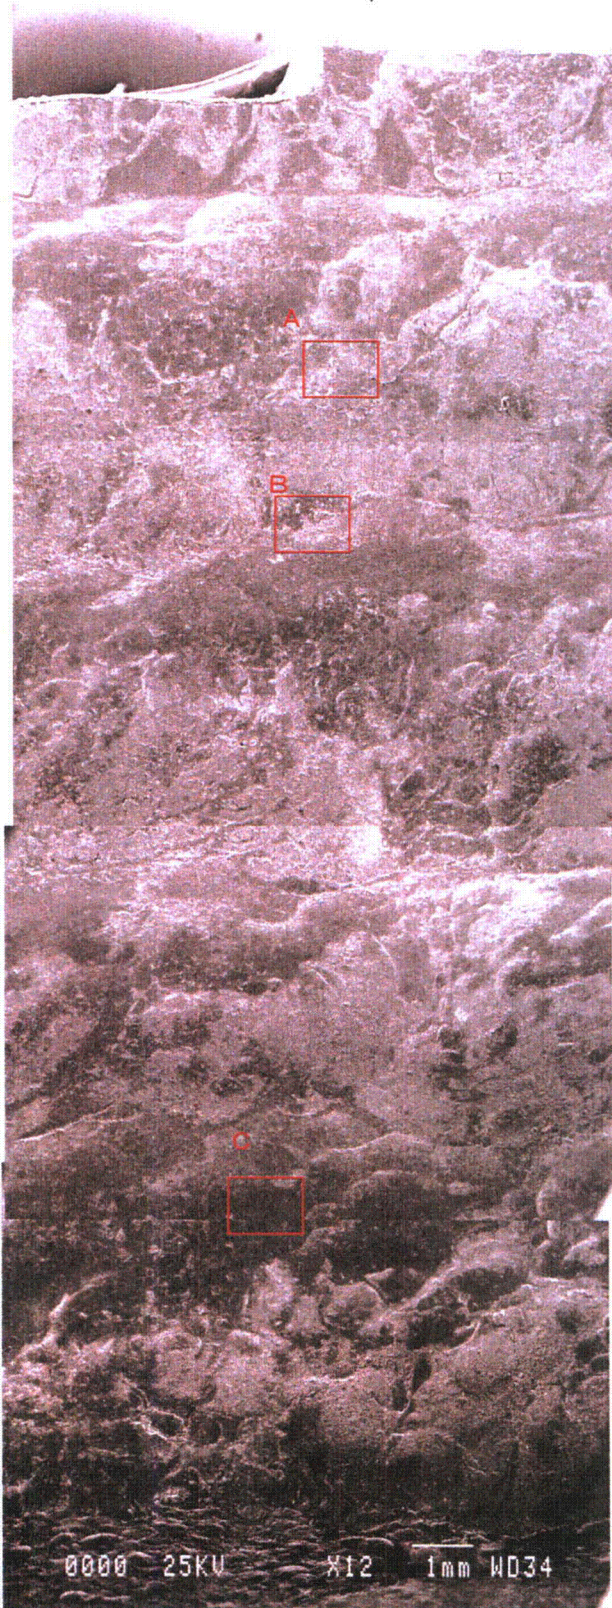
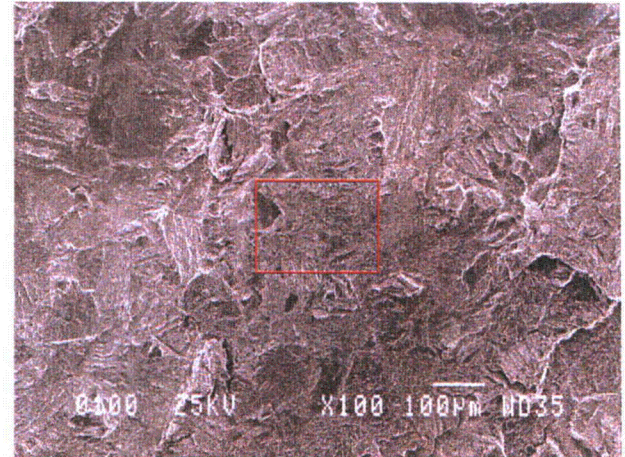
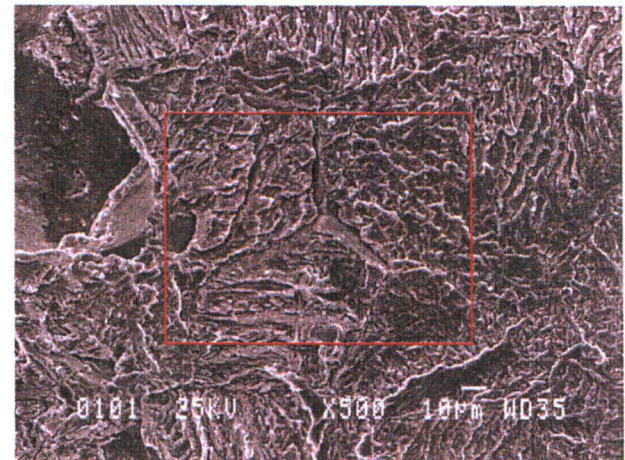
Fig. A. 20(1) SEM observation of fracture surface of sample B (152 buttering)

Quasi-cleavage fracture surface

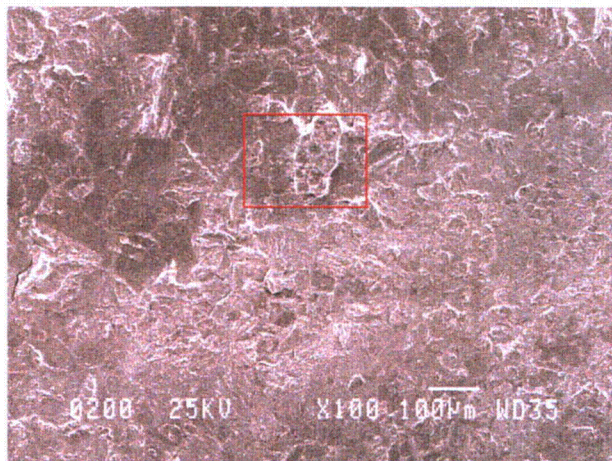
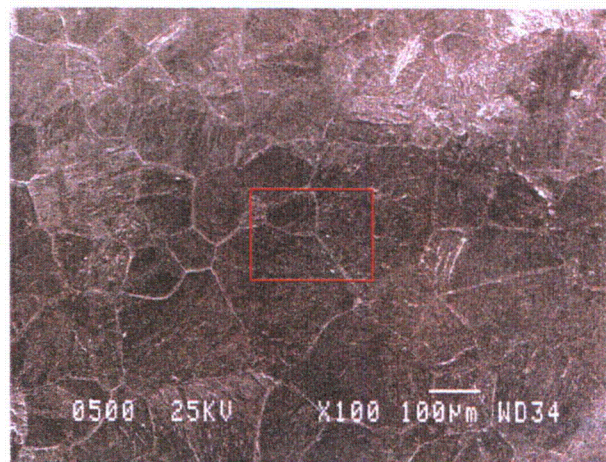
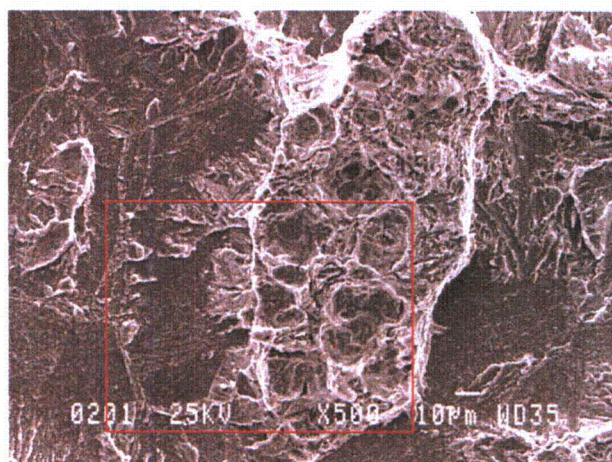
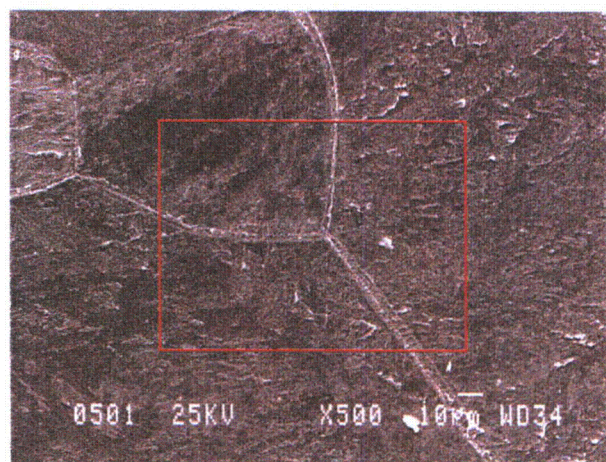
Fig. A. 20(2) SEM observation of fracture surface of sample B (152 buttering) (continued)

Ductile fractured surface

Dendrite-boundary-like pattern

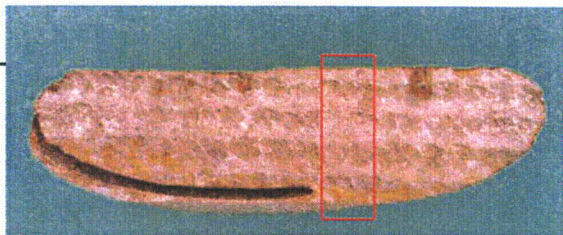
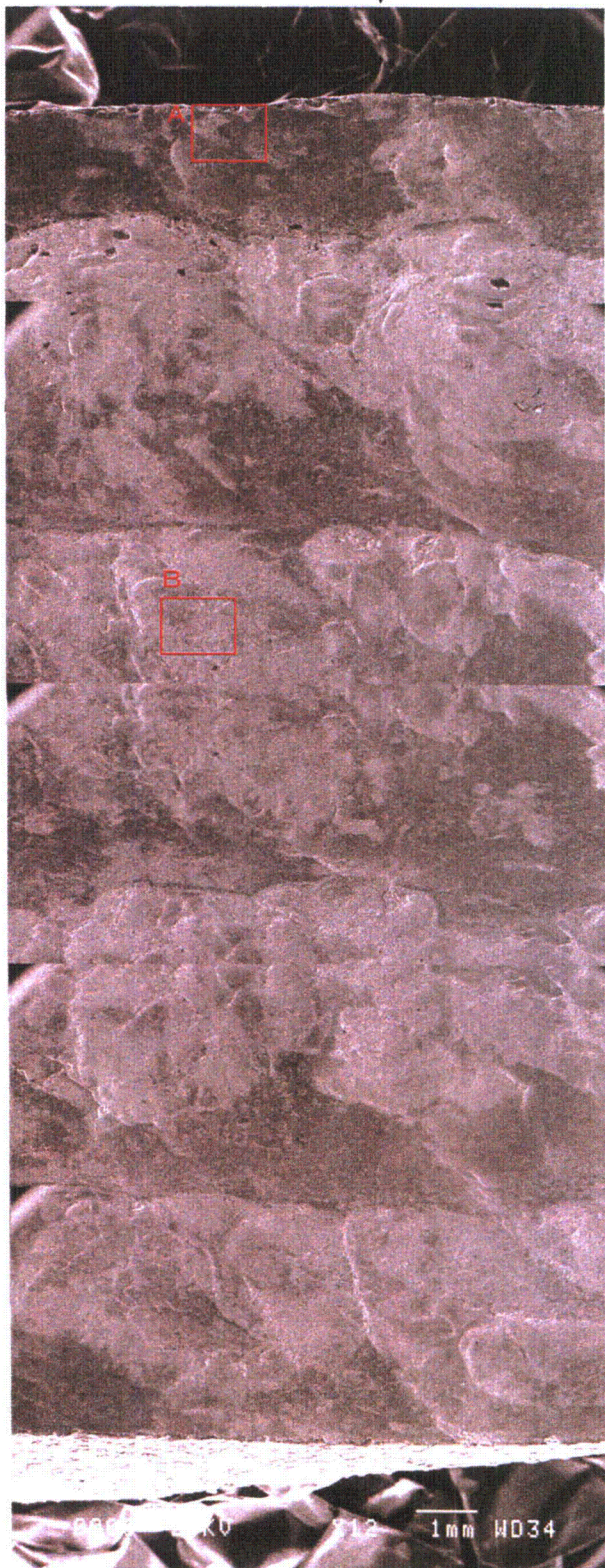
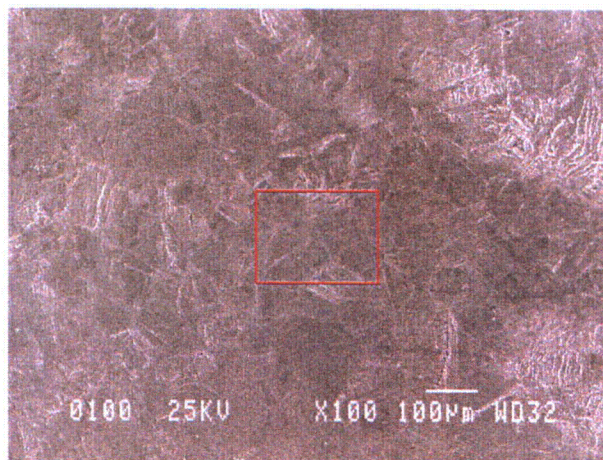
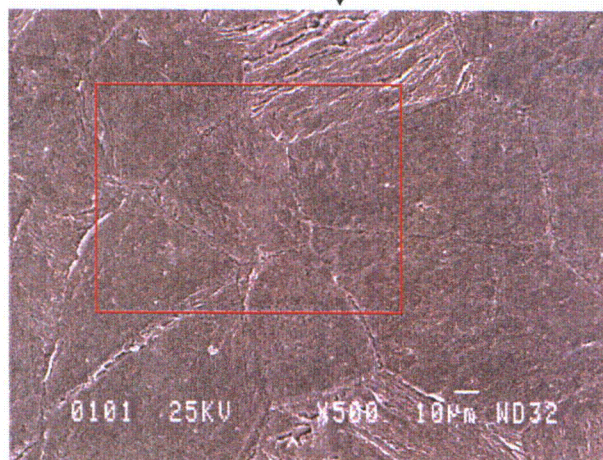
Fig. A. 21(1) SEM observation of fracture surface of sample B (Low alloy steel channel head)

Fracture surface of sample B (Low alloy steel channel head)

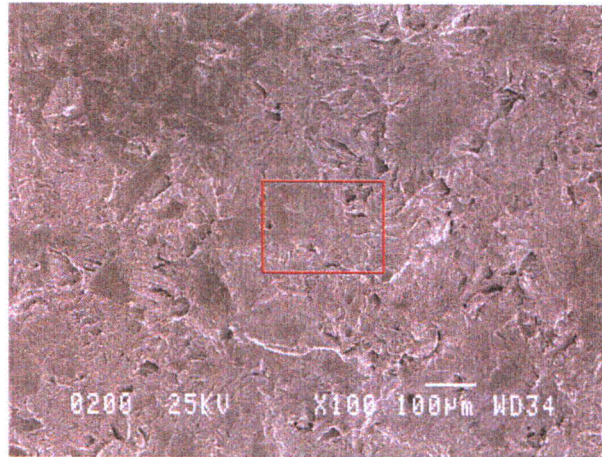
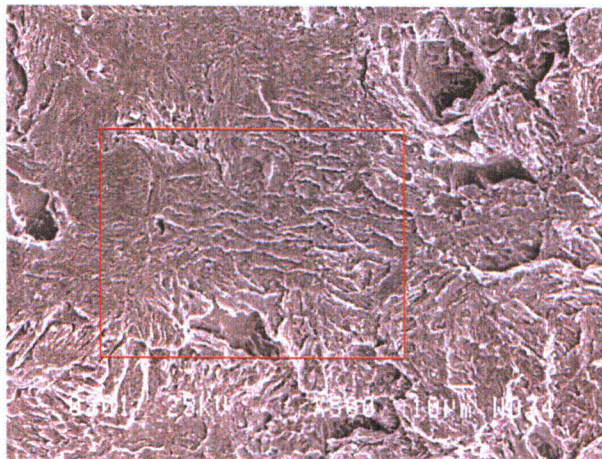
Fig. A. 21 (2) SEM observation of fracture surface of sample B (Low alloy steel channel head) (continued)

Quasi-cleavage fracture surface
