Fig. A.24(1) Vickers hardness of cross section of sample B (152 buttering)

Fig. A.25 Vickers hardness of cross section of sample B (Low alloy steel channel head)

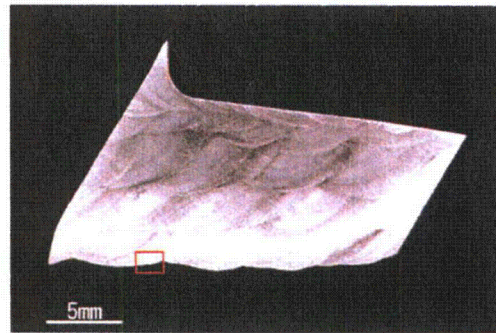
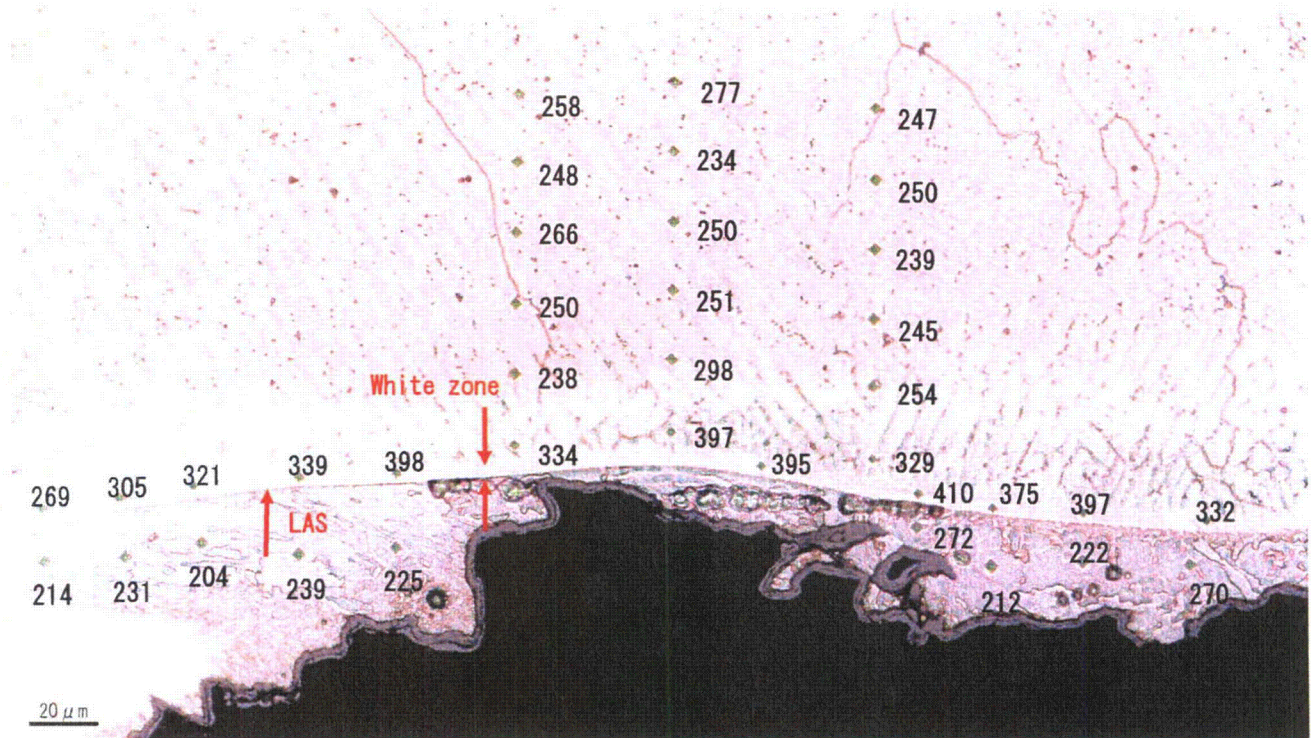
Load: 2g

Fig. A. 24(2) Vickers hardness of cross section of sample B (152 buttering) (Continued)

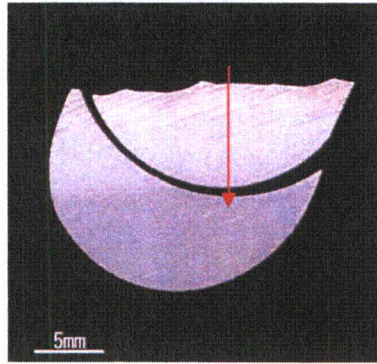
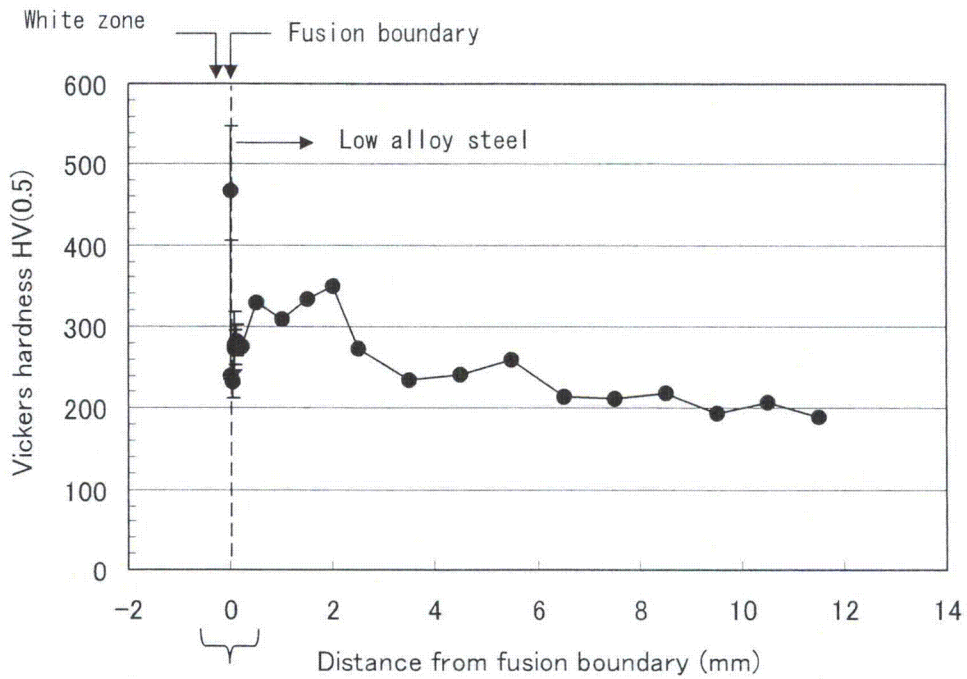
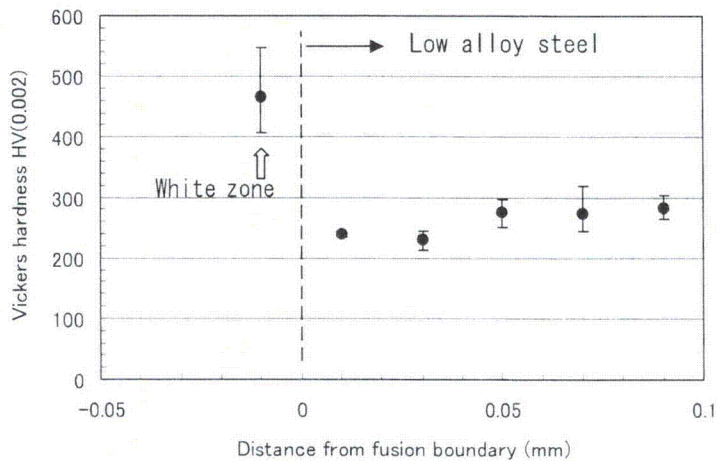
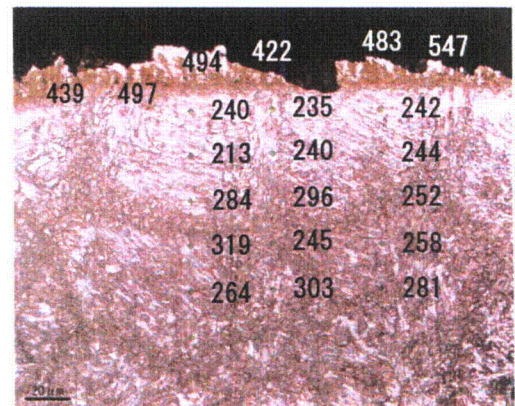
* Testing load is 2g at the distance between -0.05 to 0.15mm

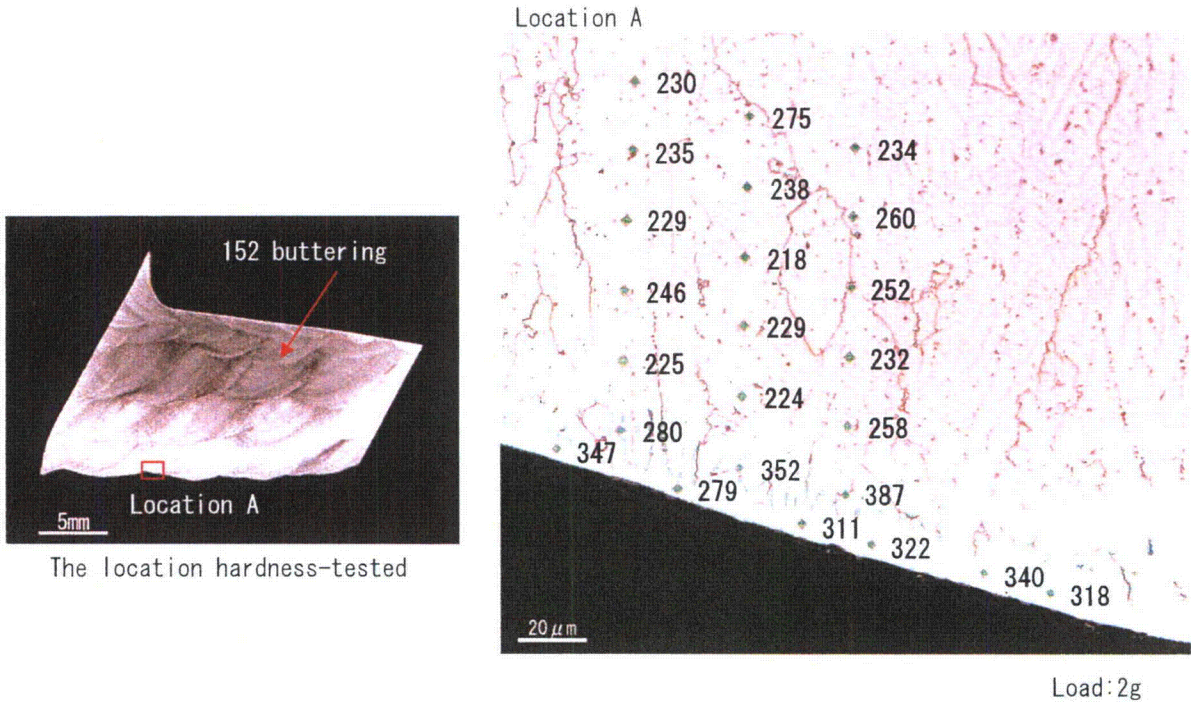
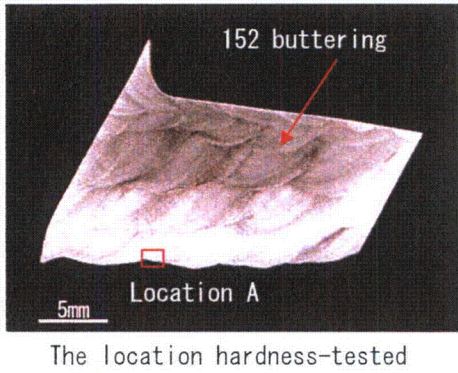
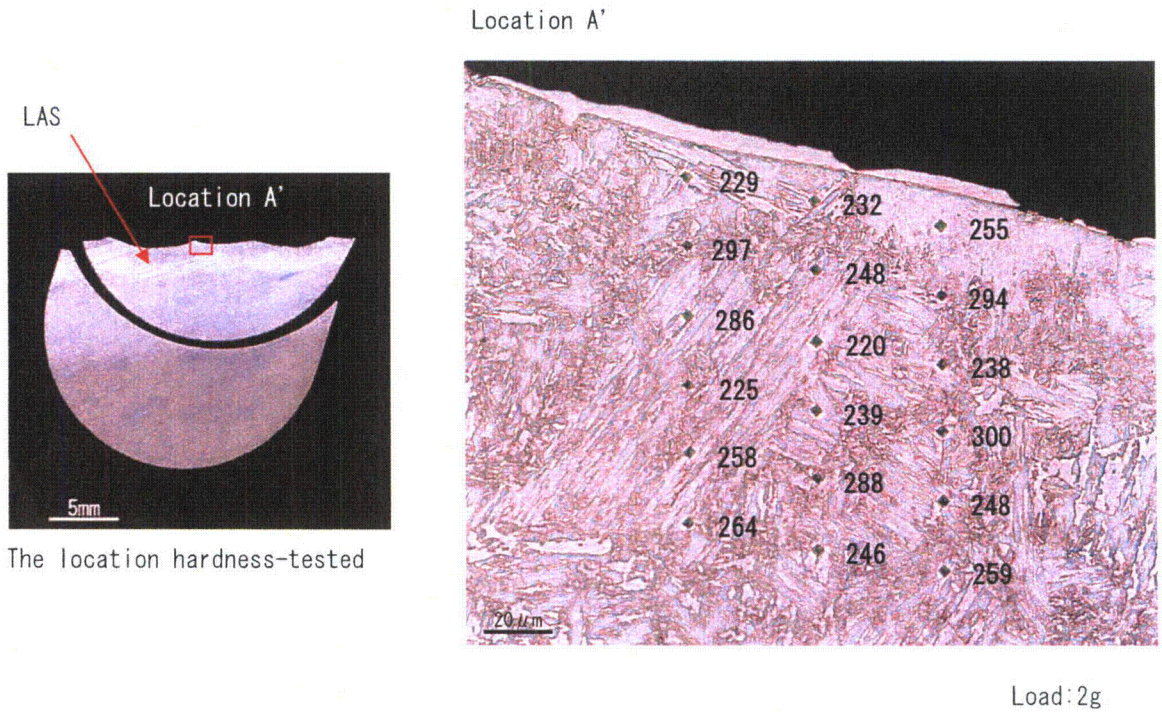
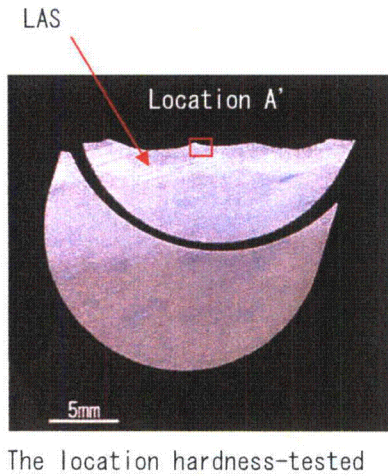
Fig. A. 26(1) Vickers hardness of cross section of sample B

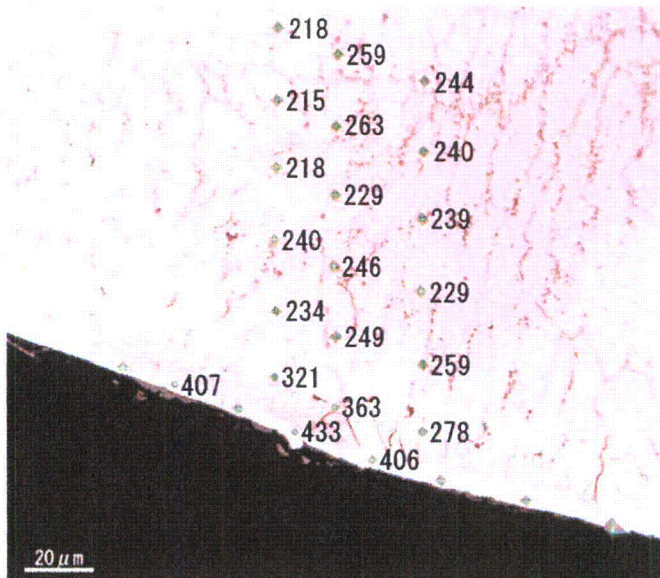
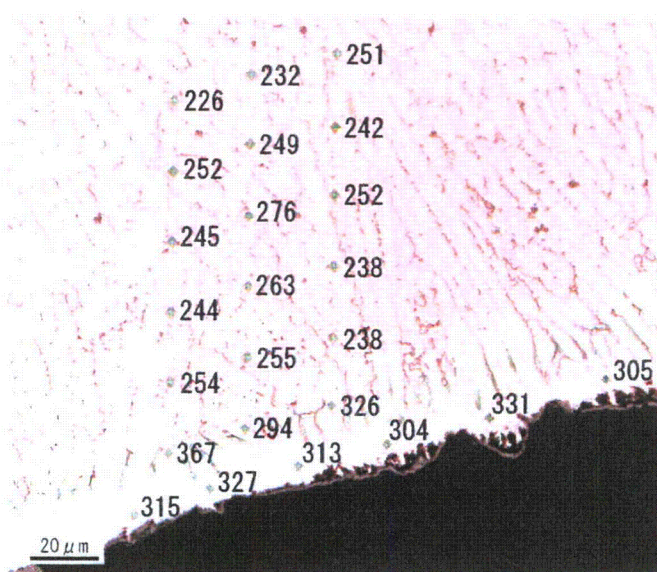
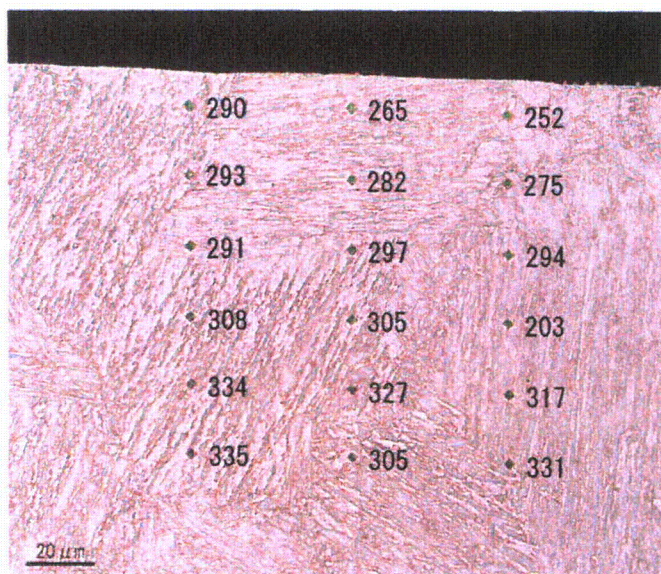
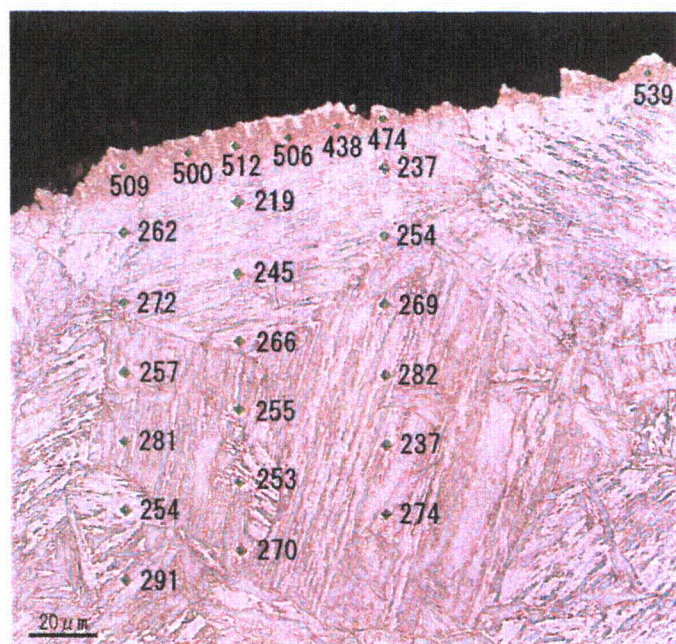
The results of hardness test (152 buttering side)

The results of hardness test (LAS Channel head side)

Fig. A.26(2) Vickers hardness of cross section of sample B (Continued)

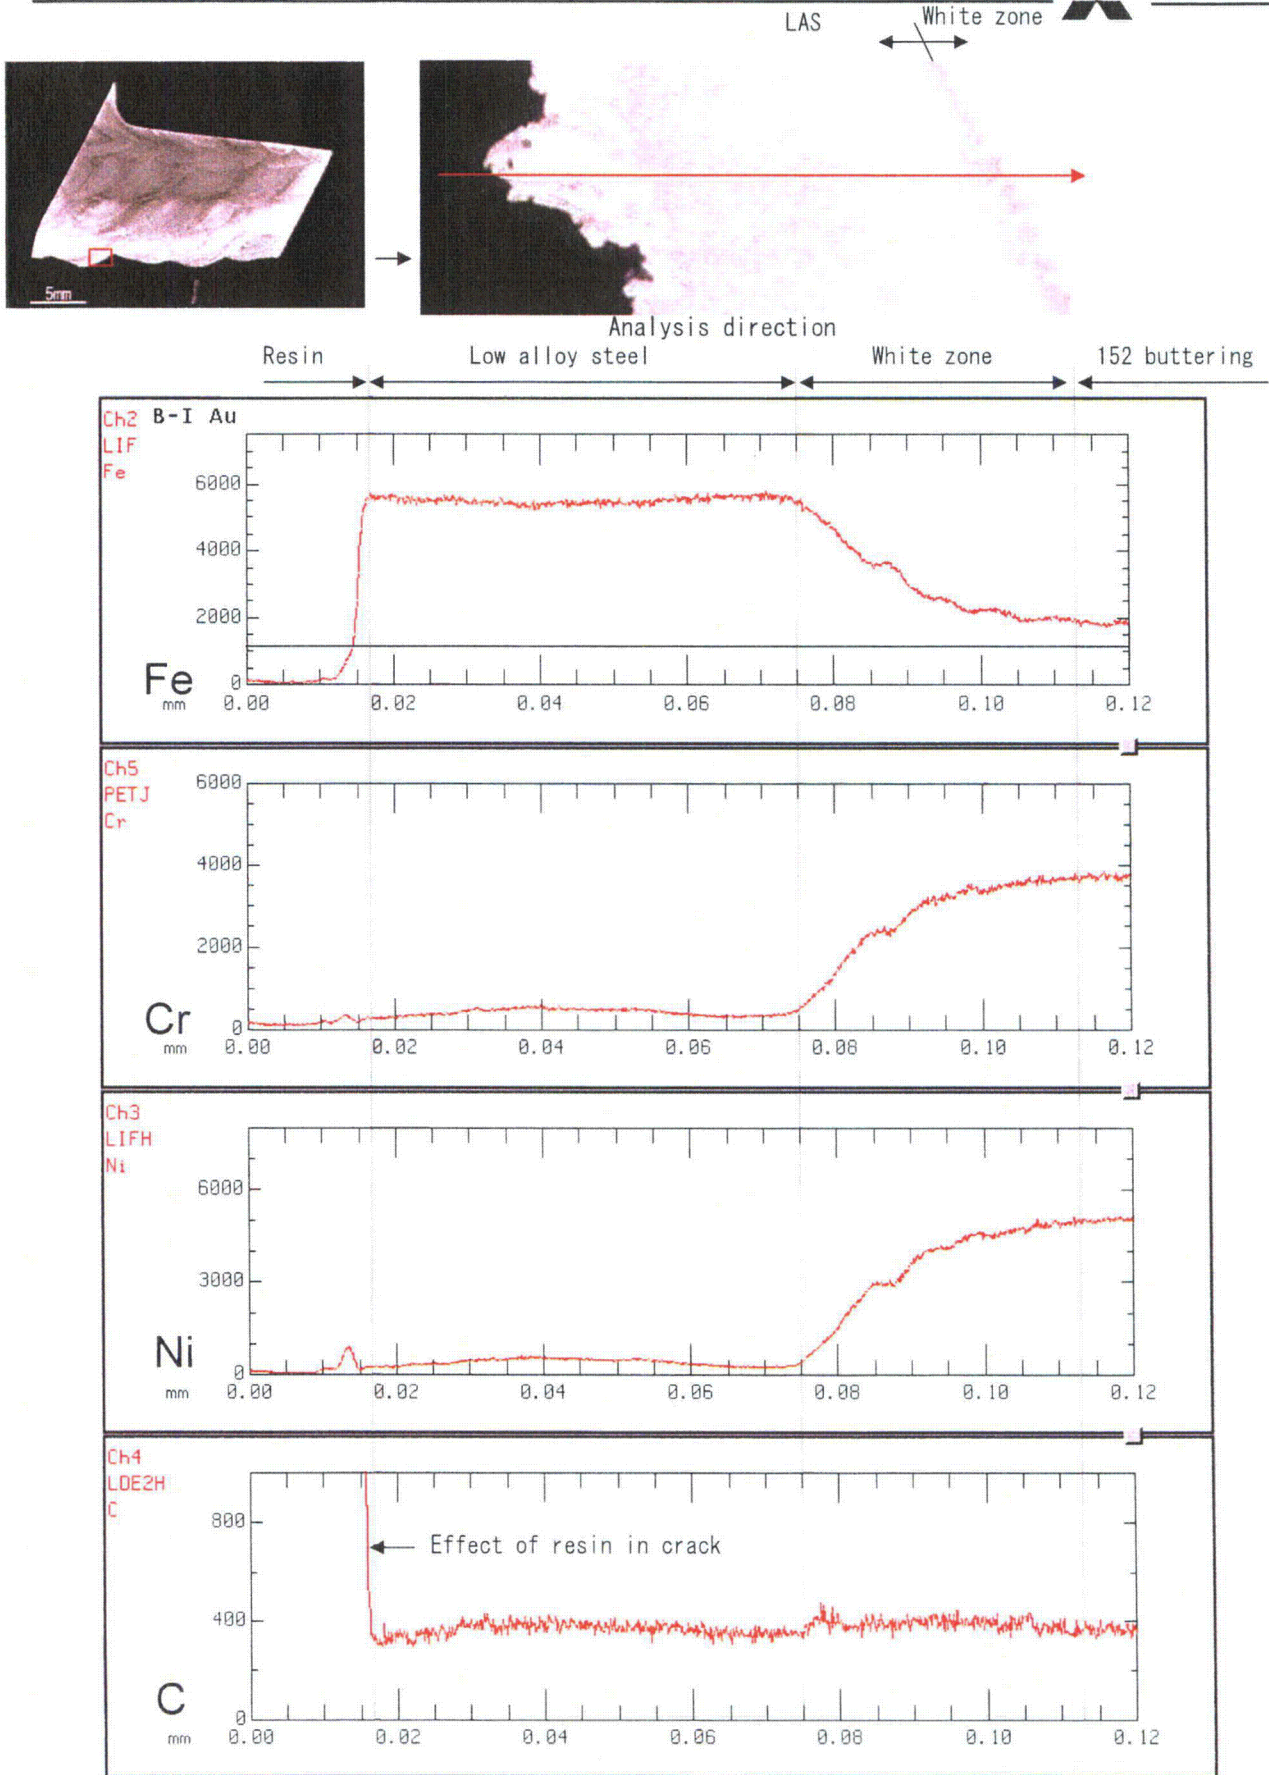
The result of C is for reference. The sample was evaporation coated with Au.

Fig. A.27 EPMA line analysis of cross section of sample B (152 buttering)

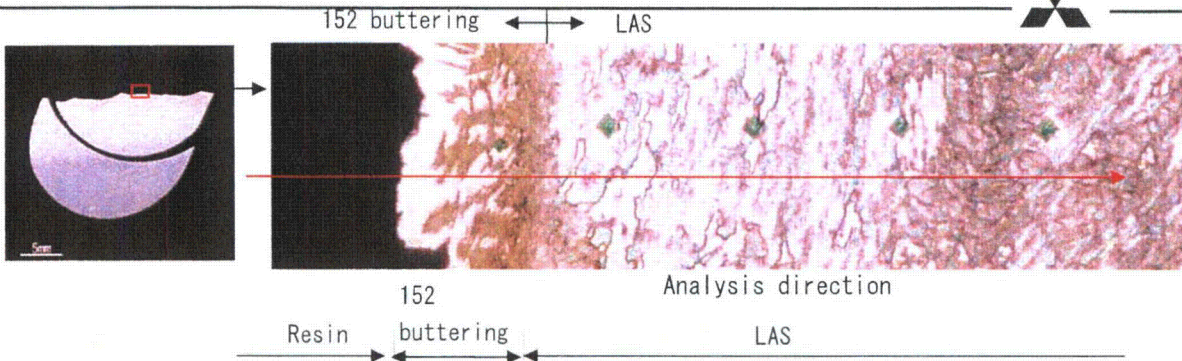
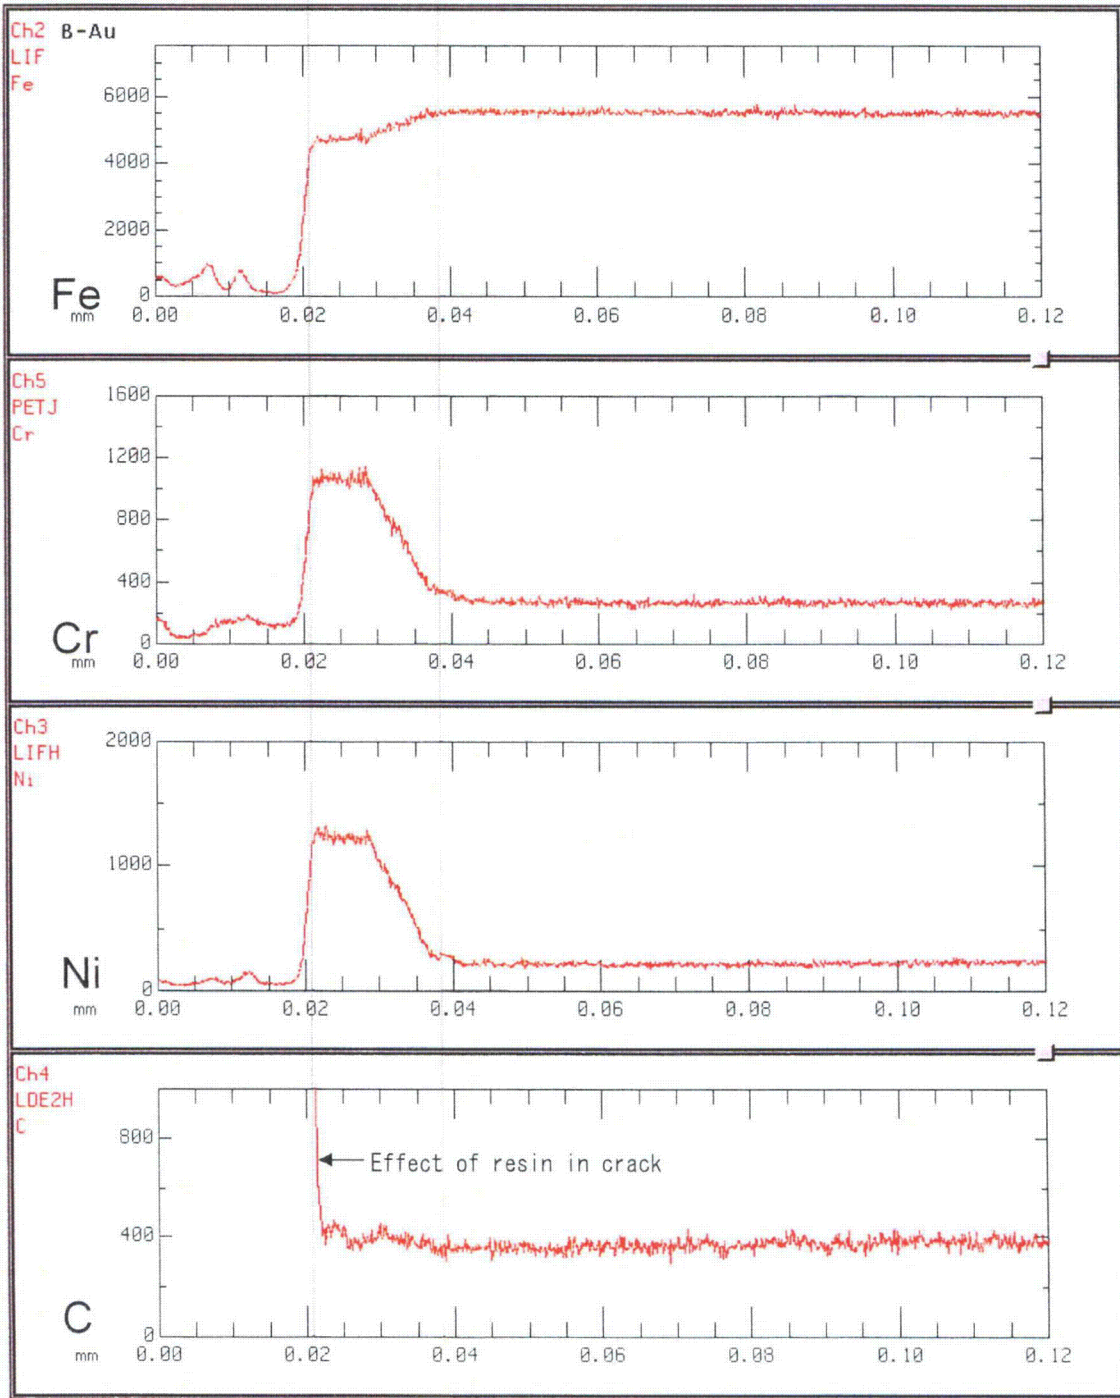
The result of C is for reference. The sample was evaporation coated with Au.

Fig. A.28 EPMA line analysis of cross section of sample B (Low alloy steel channel head)

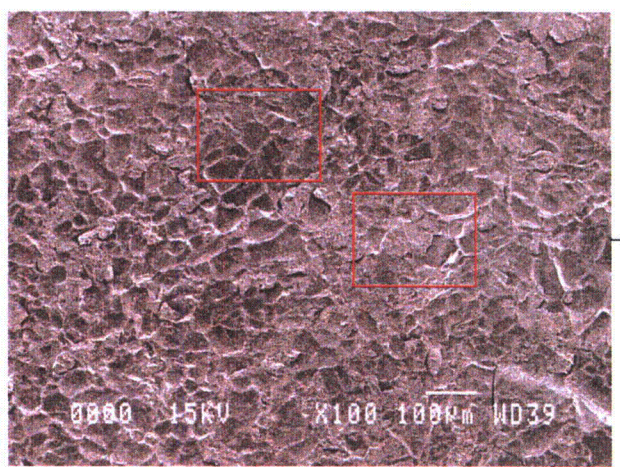
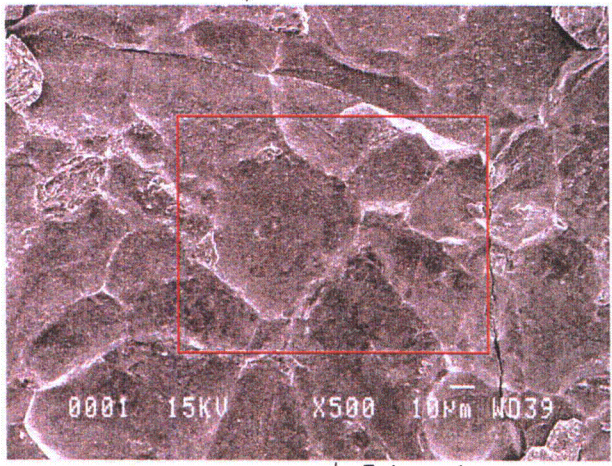
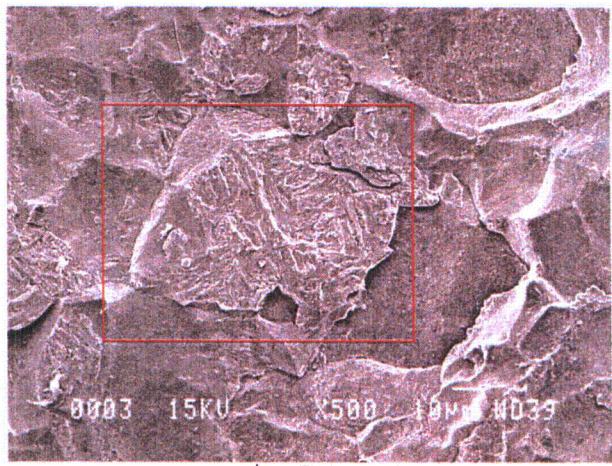
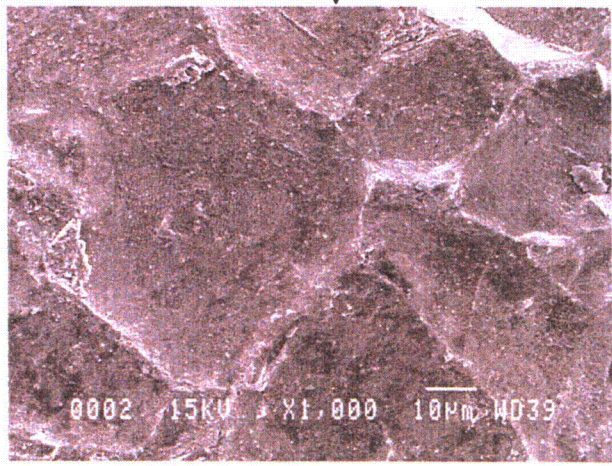
Detail observation of Location A

Dendrite-boundary-like pattern

Quasi-cleavage fracture surface

Fig. A. 31(1) SEM observation of fracture surface of TP C-1 (sample C)

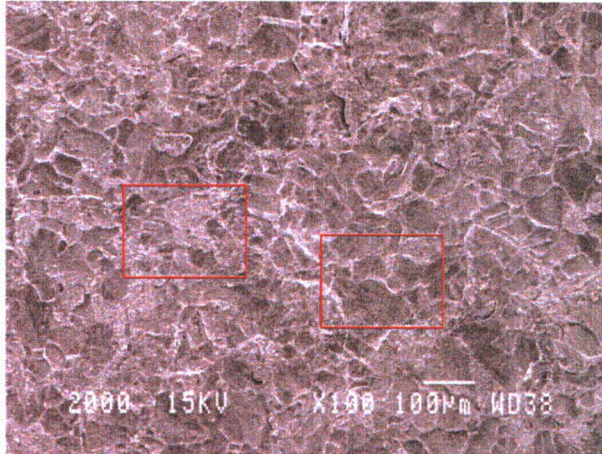
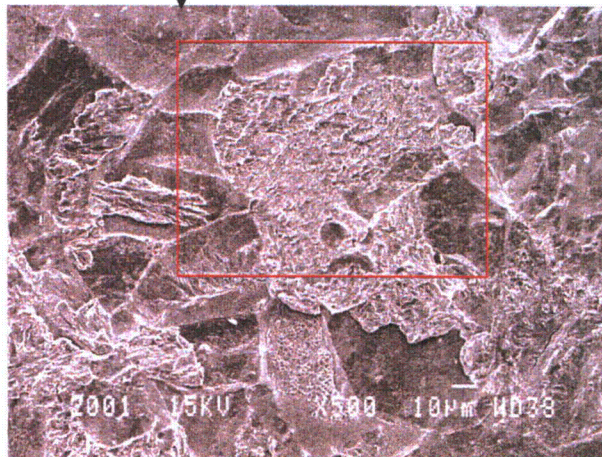
Detail observation of Location B

Quasi-cleavage fracture surface

Dendrite-boundary-like pattern

Fig. A.31(2) SEM observation of fracture surface of TP C-1(sample C) (Continued)

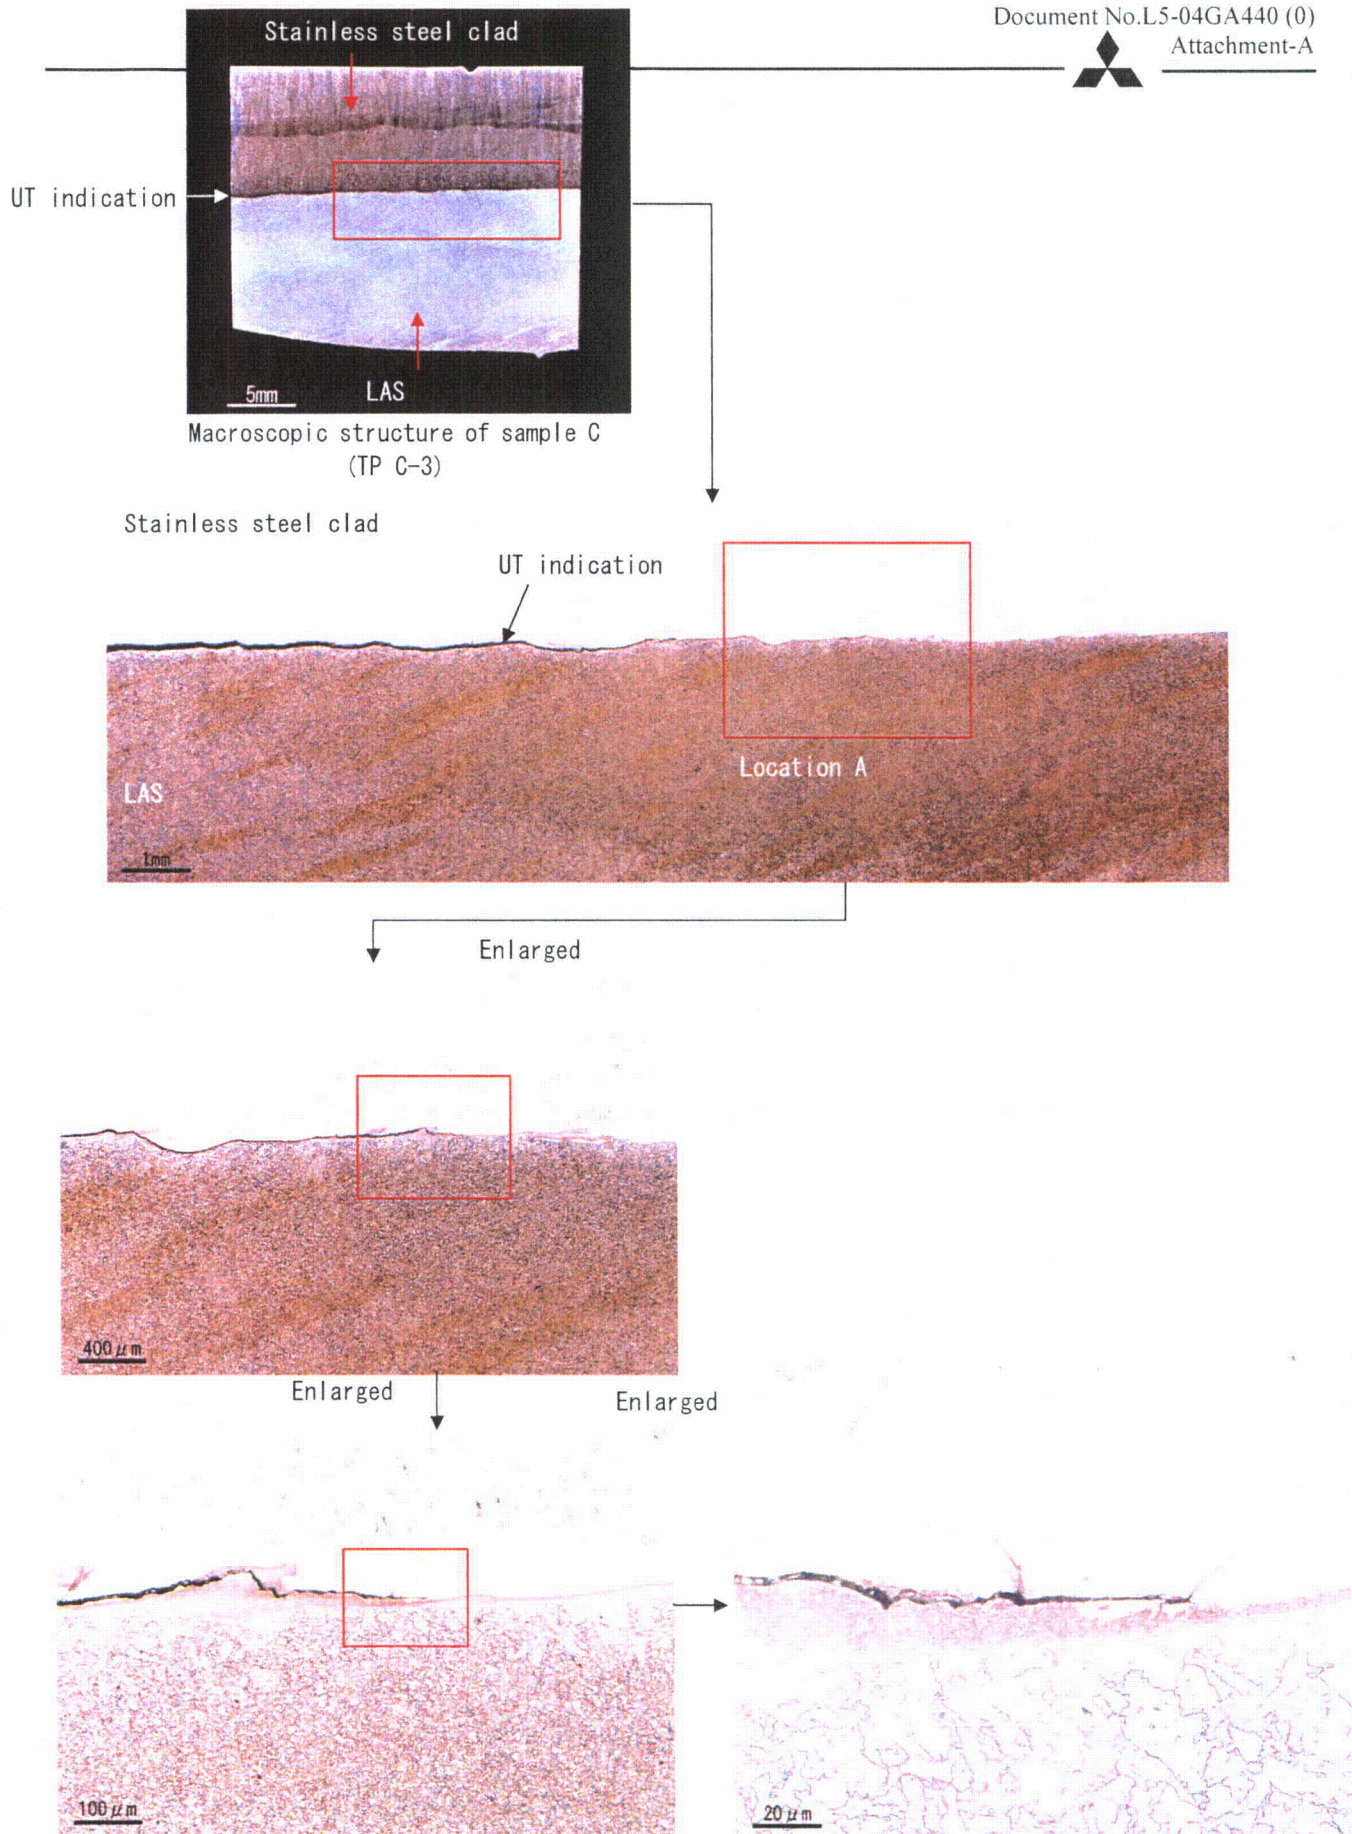
Fig. A.32(1) Micro-structure observation of cross section of sample C

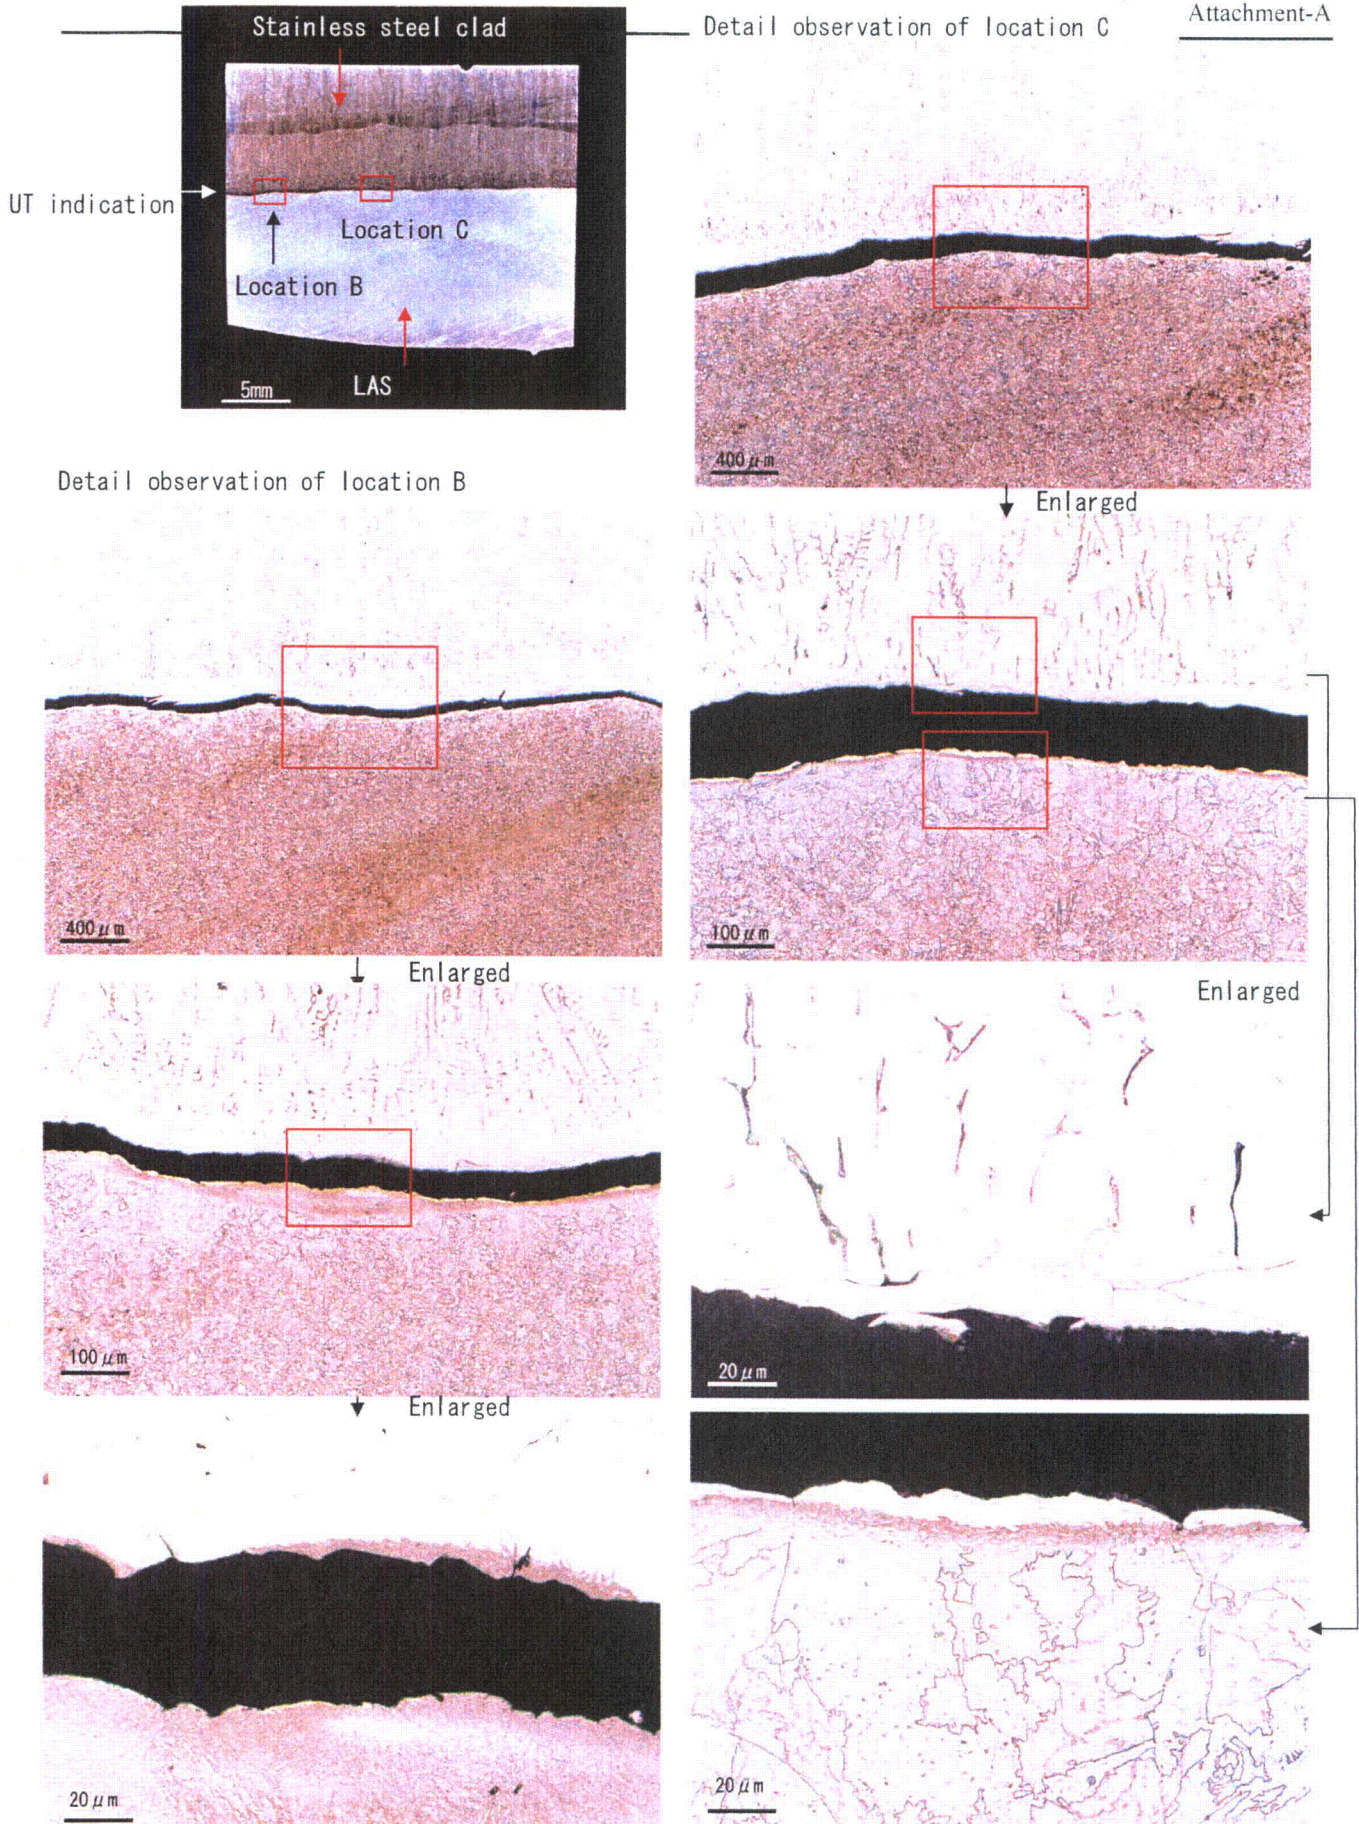
Fig. A. 32 (2) Micro-structure observation of cross section of sample C (Continued)

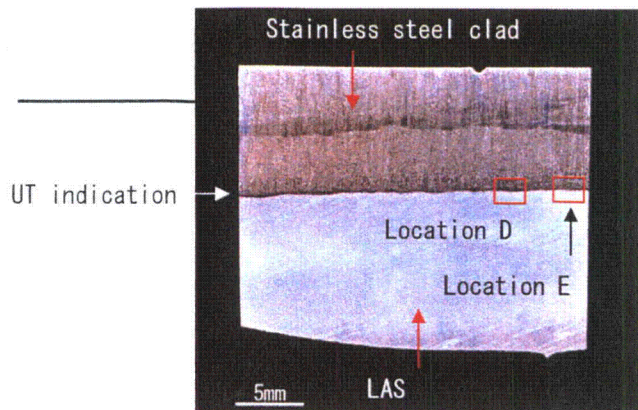
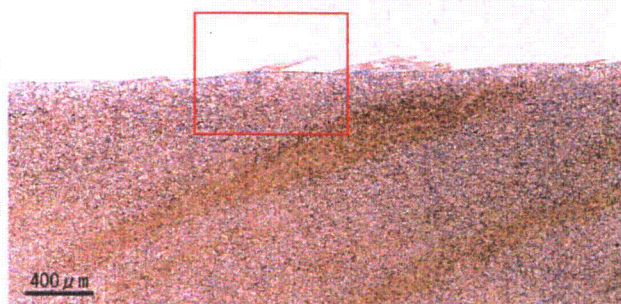
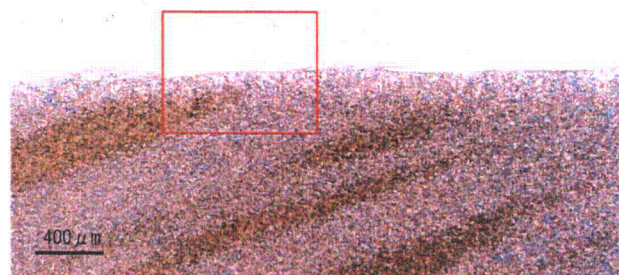
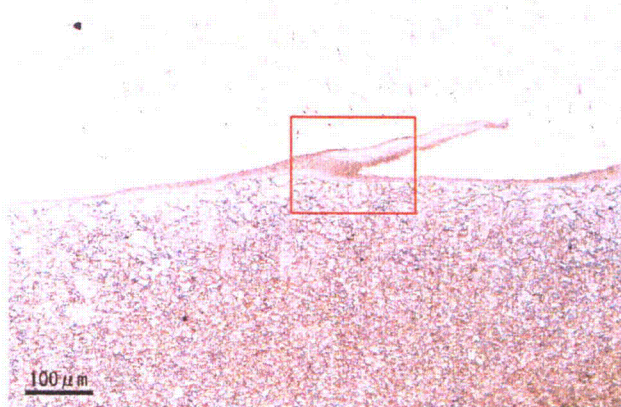
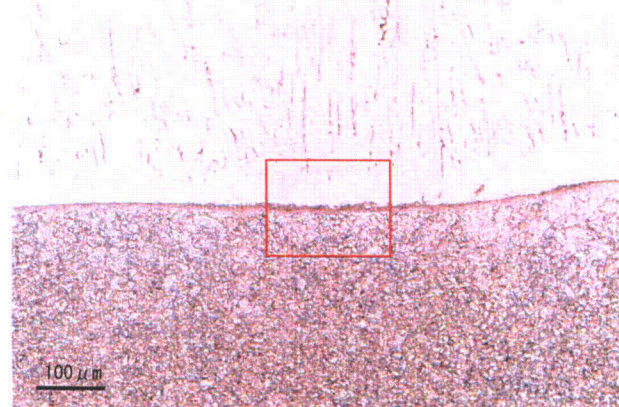
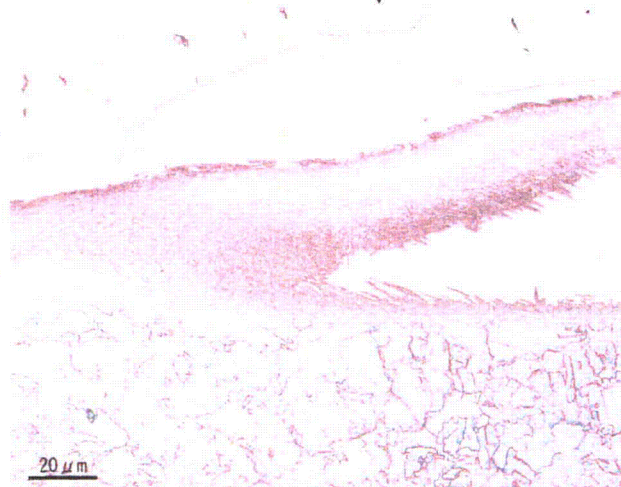
Detail observation of location D

Detail observation of location E

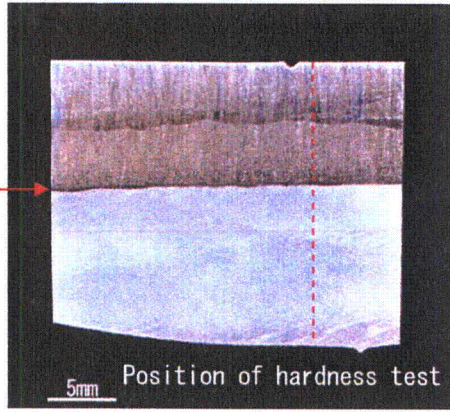
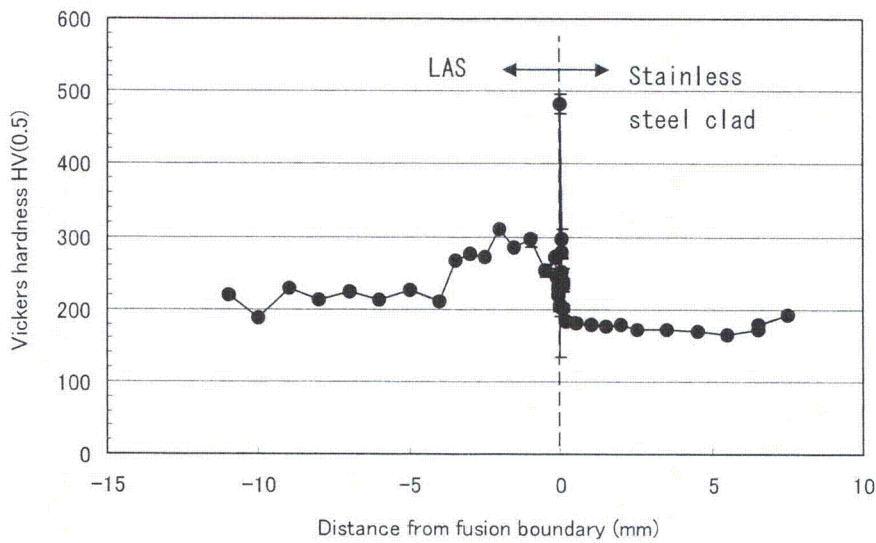
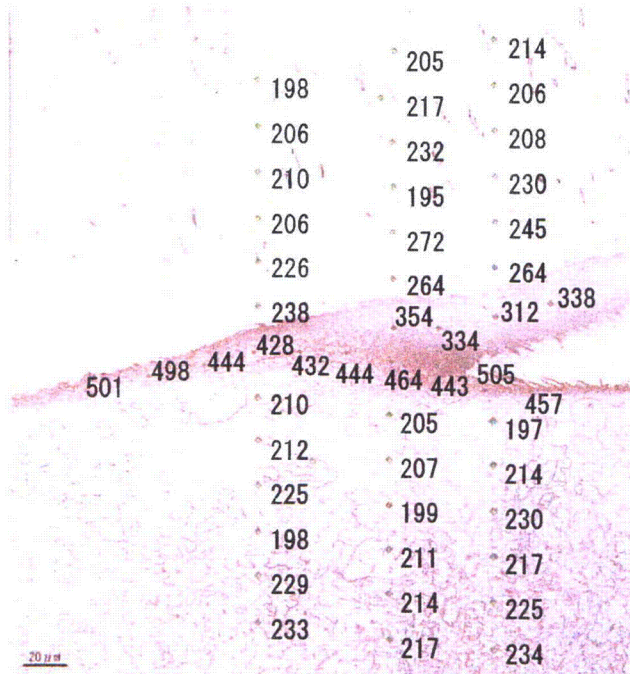
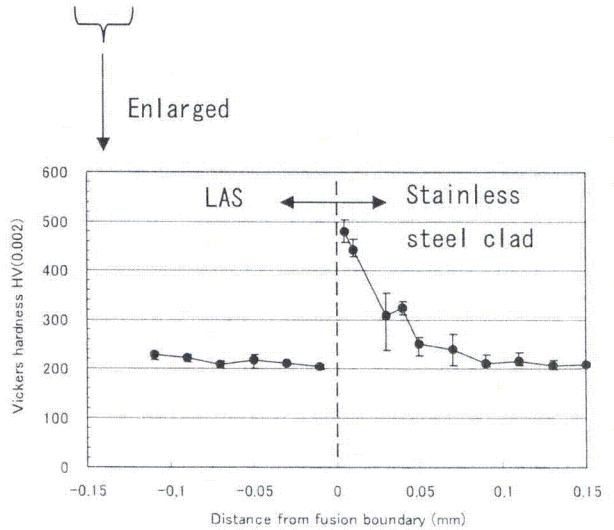
Fig. A.33(2) Vickers hardness of cross section of sample C (Continued)

Stainless steel clad
 UT indication
 LAS

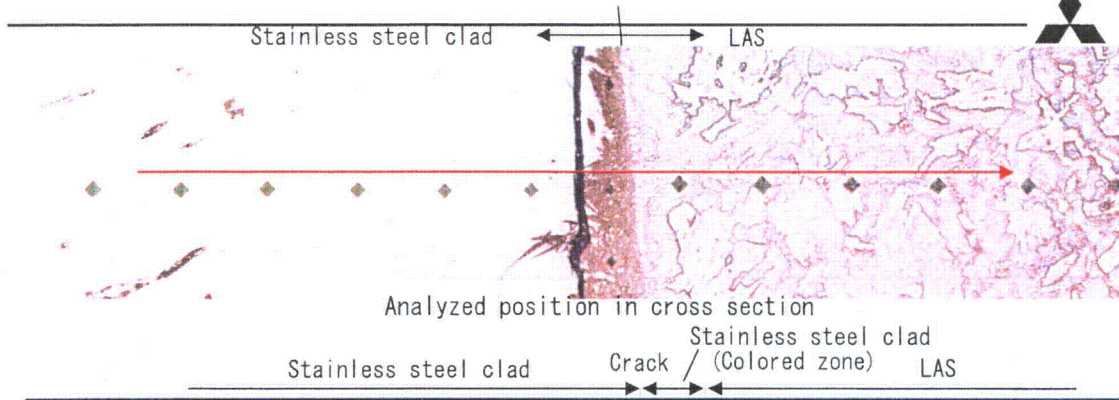
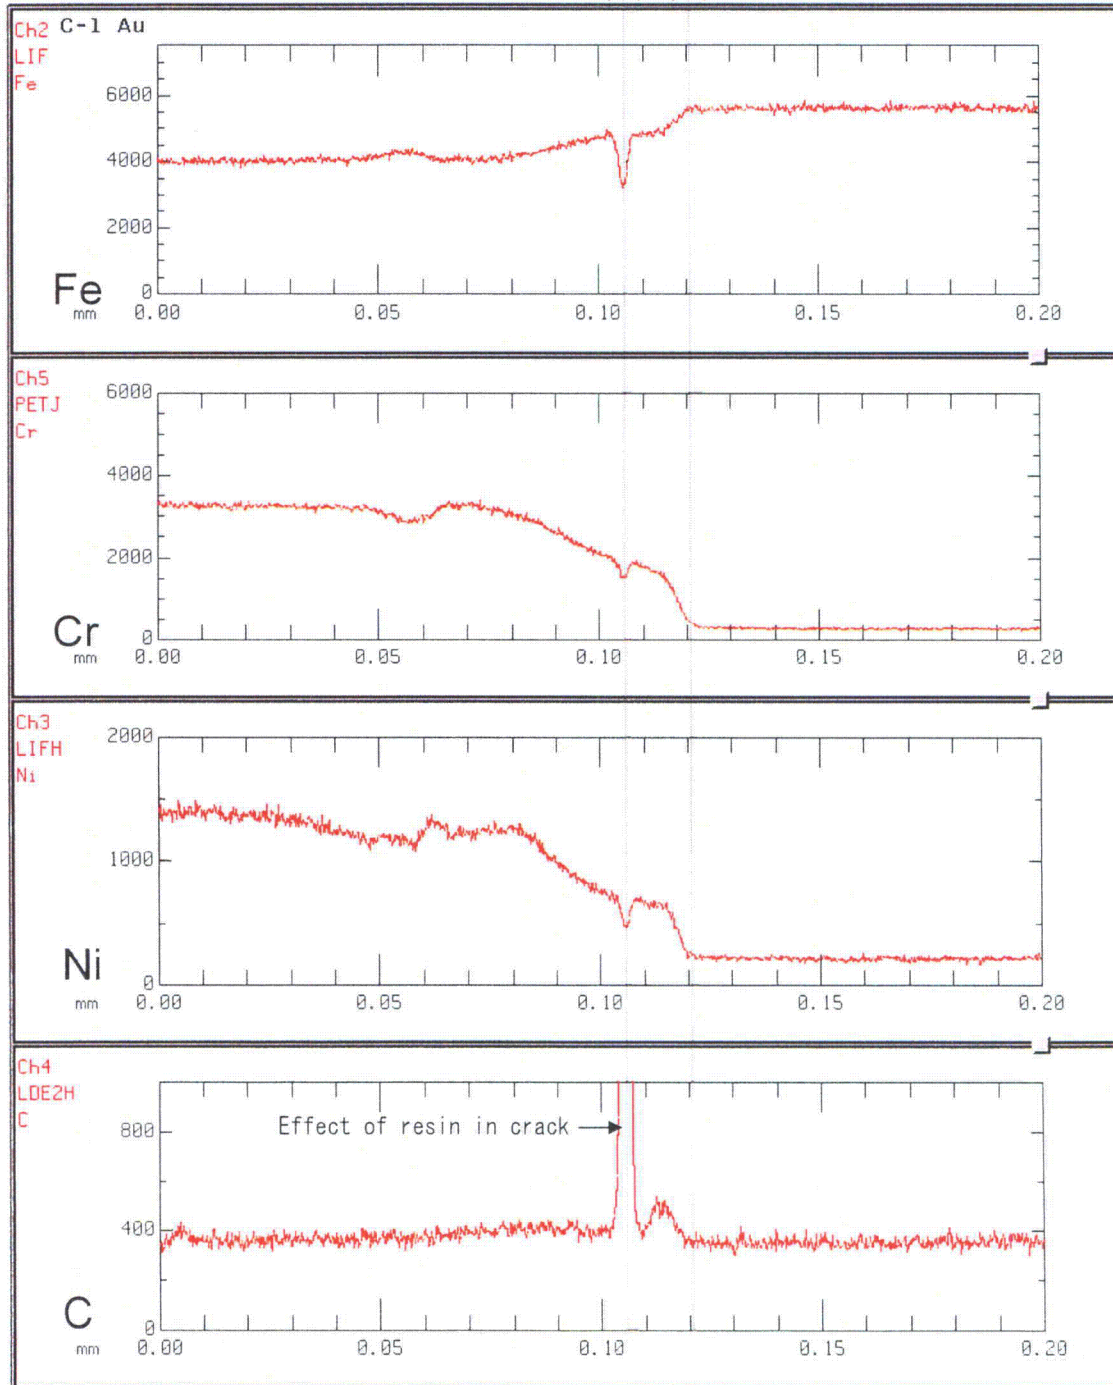
Fig.A.34(1) EPMA line analysis of Cross Section of sample C

The result of C is for reference. The sample was evaporation coated with Au.
