Fig. A.24(1) Vickers hardness of cross section of sample B (152 buttering)

Fig. A.25 Vickers hardness of cross section of sample B (Low alloy steel channel head)

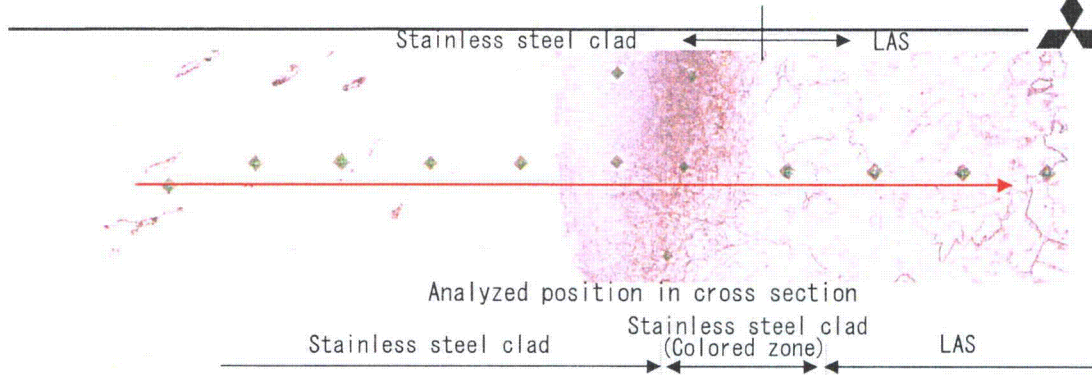
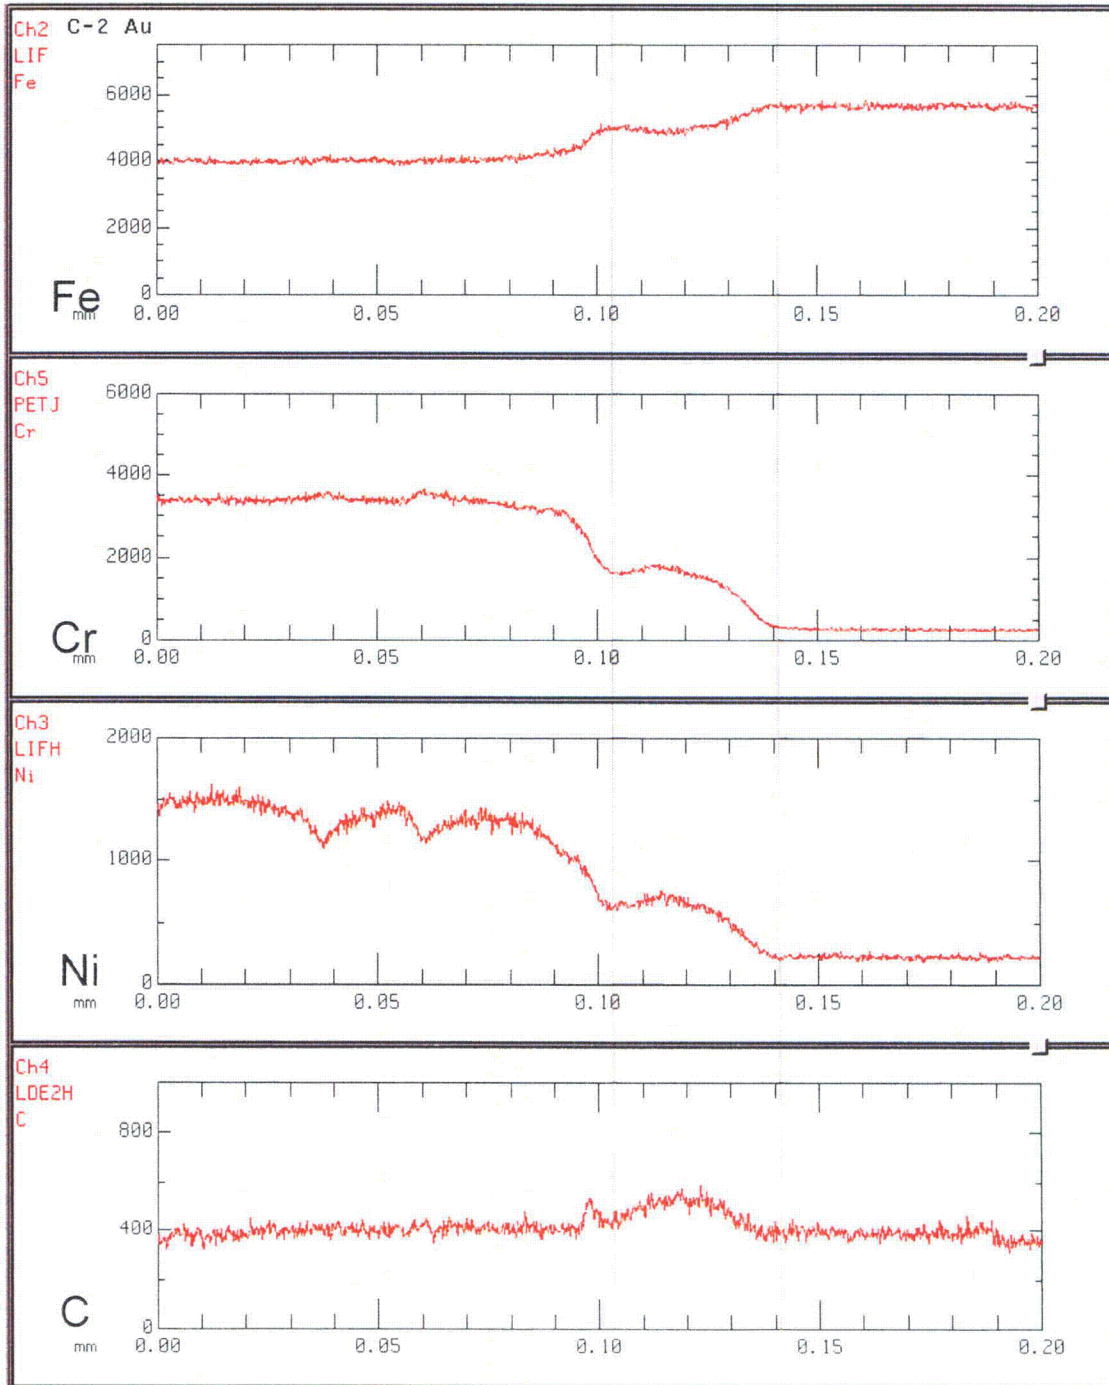
Fig.A.34(2) EPMA line analysis of Cross Section of sample C (Continued)

The result of C is for reference. The sample was evaporation coated with Au.

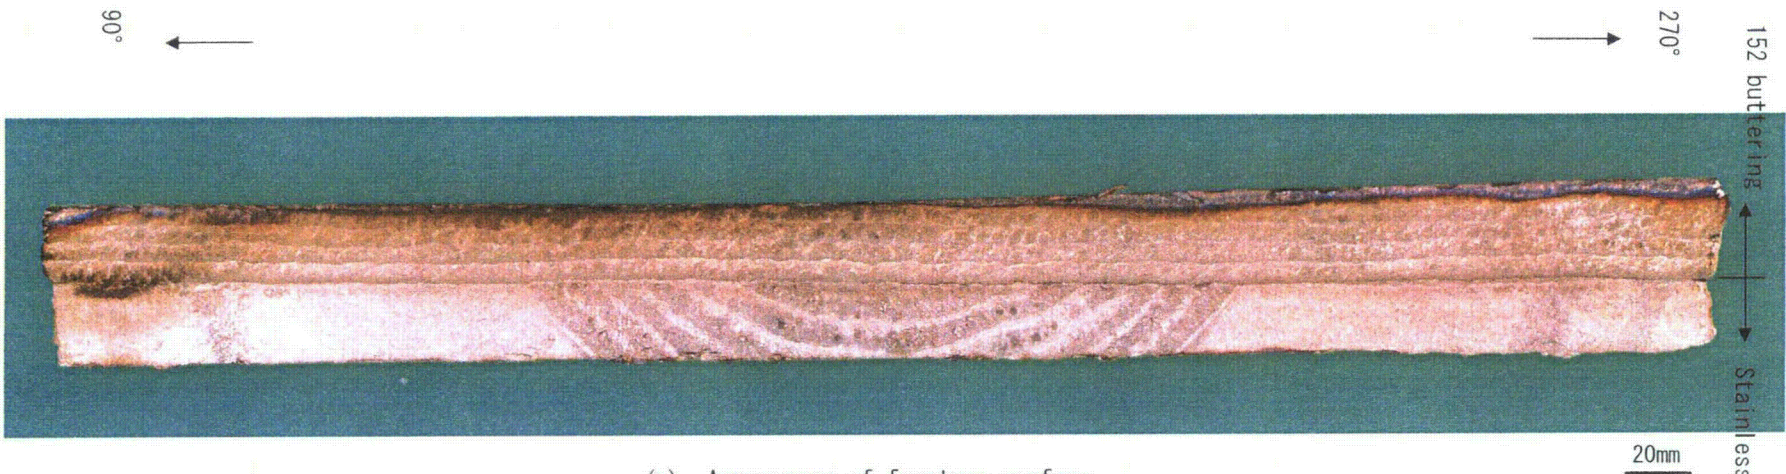
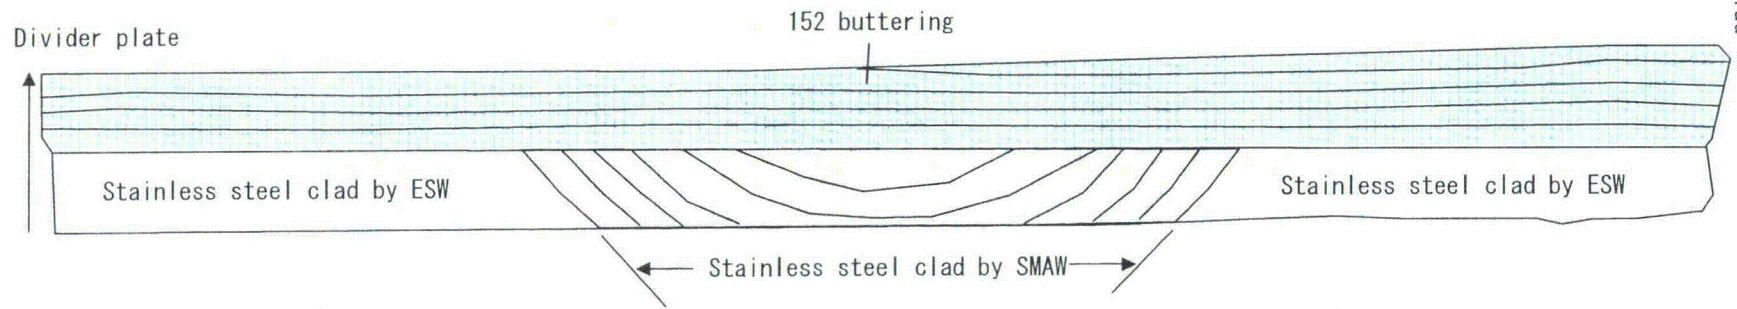
Fig.A.36(1) Appearance of fracture surface (Schematic illustration)

(a) Appearance of fracture surface

(b) Schematic illustration of fracture surface

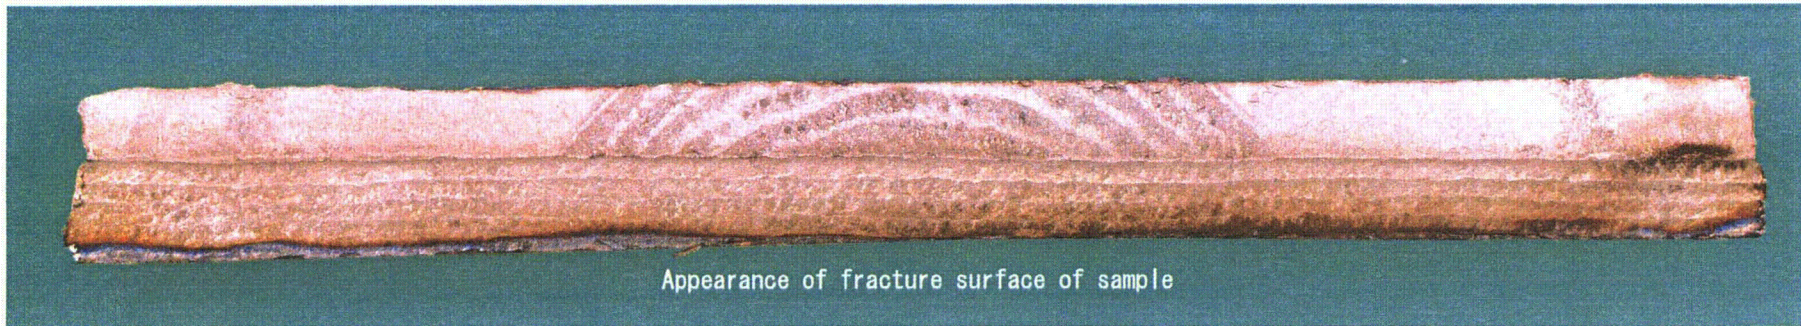
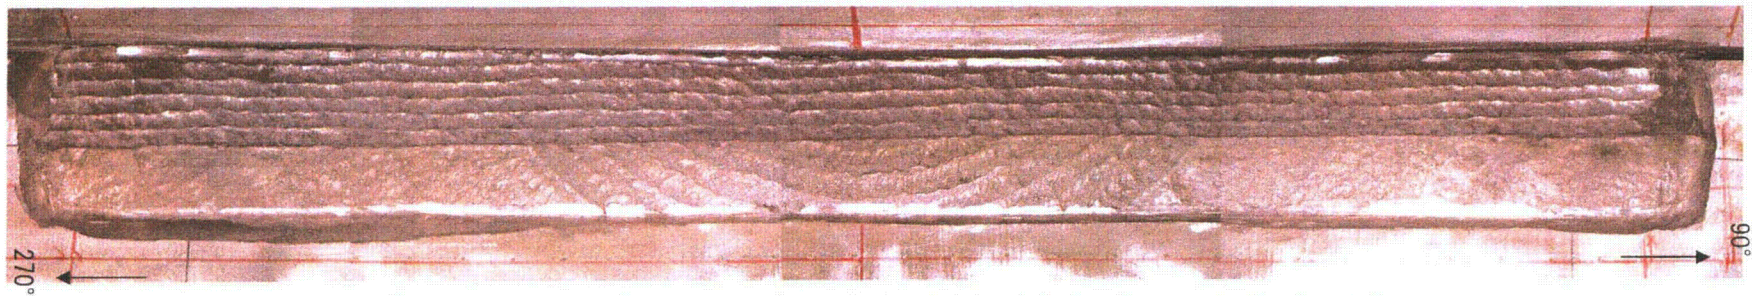
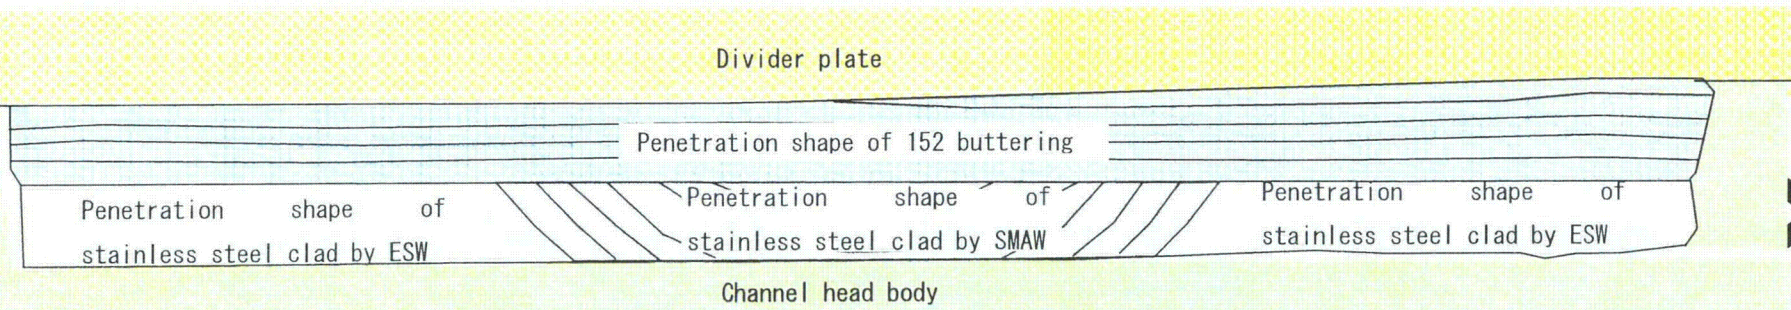
Fig.A.37(1) Appearance of fracture surface of channel head body after removal of sample

(c) Schematic illustration channel head body after removal of sample

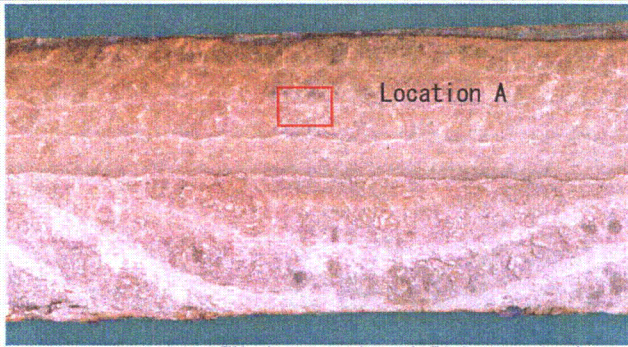
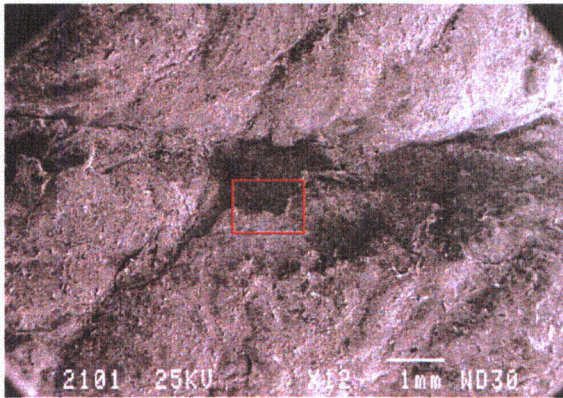
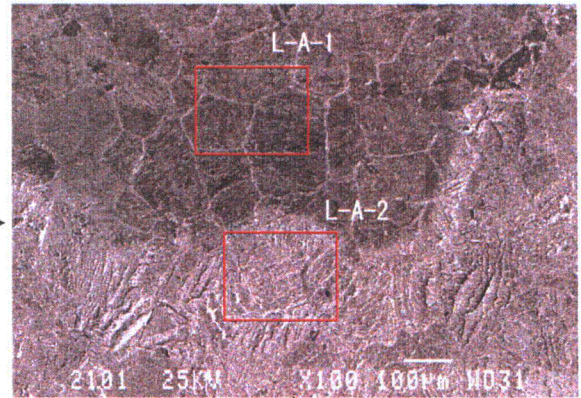
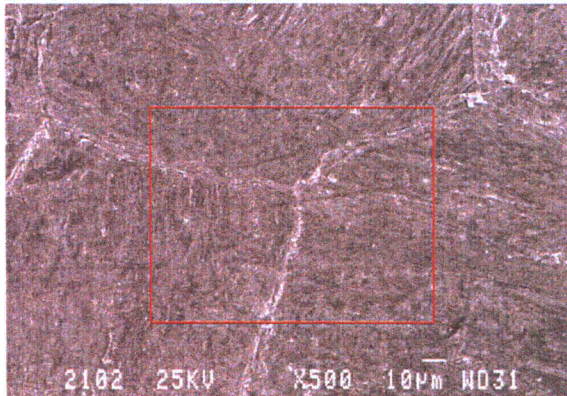
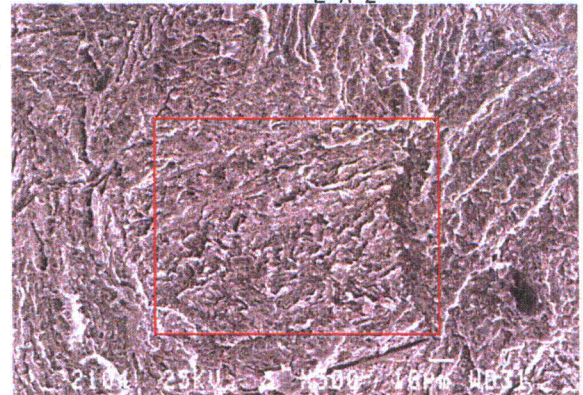
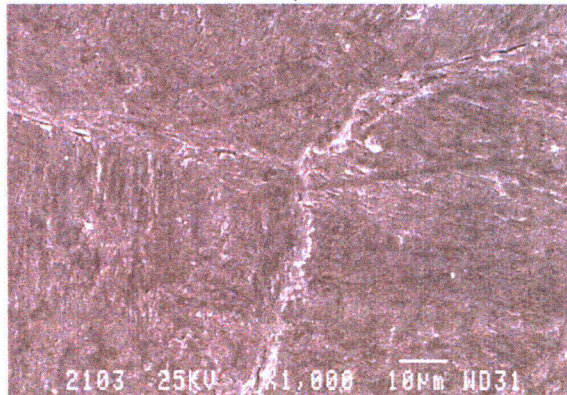
Fig.A.38(1) SEM observation of fracture surface of sample D (152 buttering)

Location for SEM observation (152 buttering)

Dendrite boundary like or grain boundary like pattern

Quasi-cleavage fracture surface

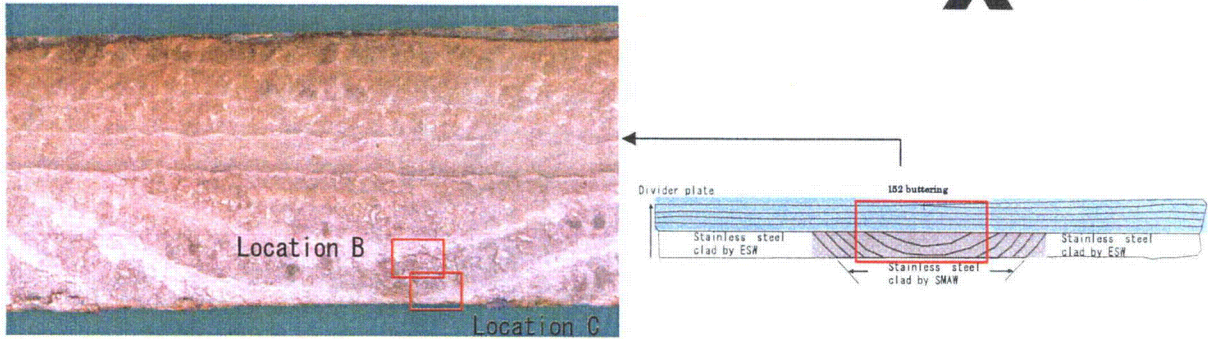
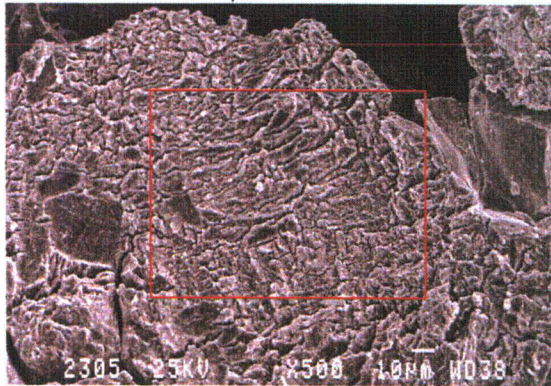
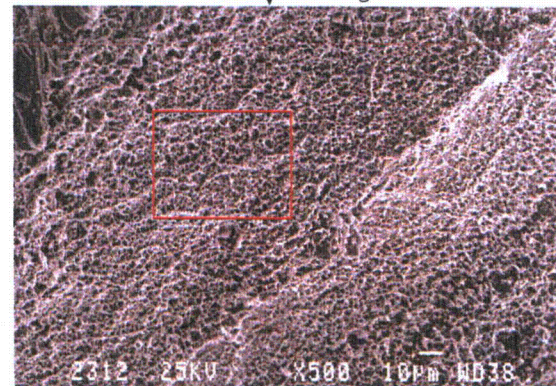
Fig.A.38(2) SEM observation of fracture surface of sample D (Stainless steel clad by SMAW)

Location for SEM observation (stainless steel clad by SMAW)

Quasi-cleavage fracture surface

Ductile fracture surface

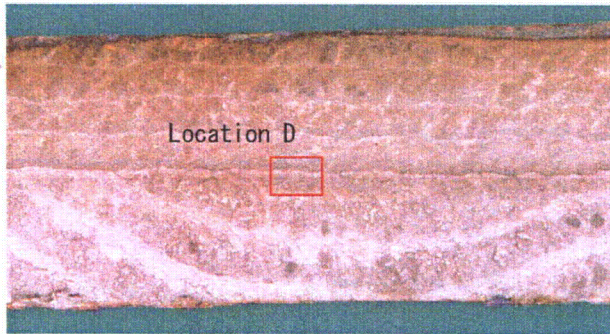
Fig.A.38(3) SEM observation of fracture surface of sample D (boundary between 152 buttering and stainless steel clad by SMAW)

Location for SEM observation (boundary between 152 buttering and stainless steel clad)

Ductile fracture surface

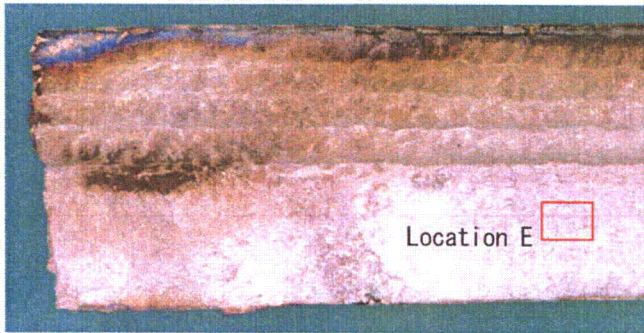
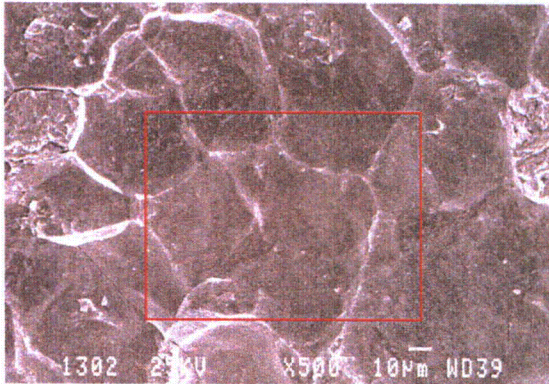
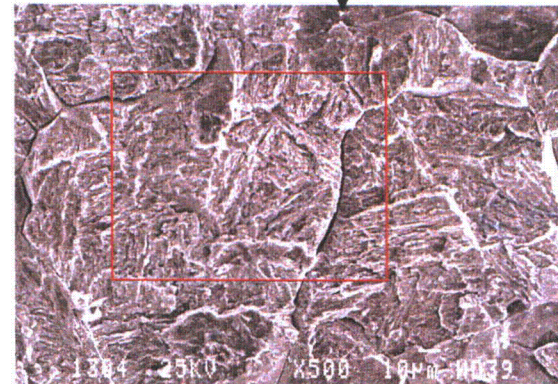
Fig.A.38(4) SEM observation of fracture surface of sample D (Stainless steel clad by ESW)

Location for SEM observation (stainless steel clad by ESW)

Dendrite boundary like or grain boundary like

Quasi-cleavage fracture surface

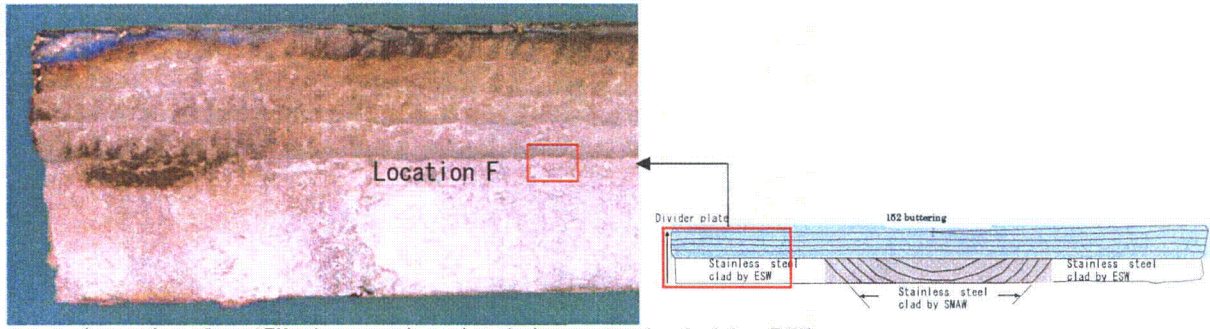
Fig.A.38(5) SEM observation of fracture surface of sample D (boundary between 152 buttering and stainless steel clad by ESW)

Location for SEM observation (stainless steel clad by ESW)

Ductile fracture surface

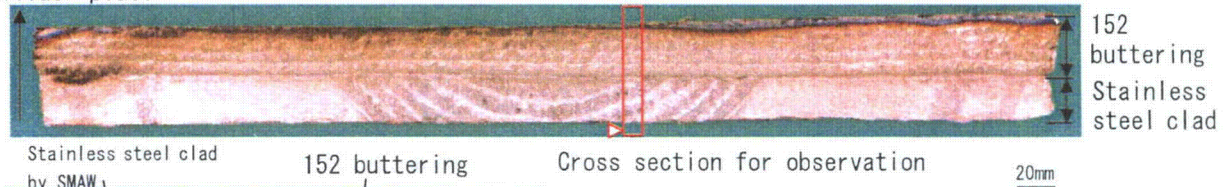
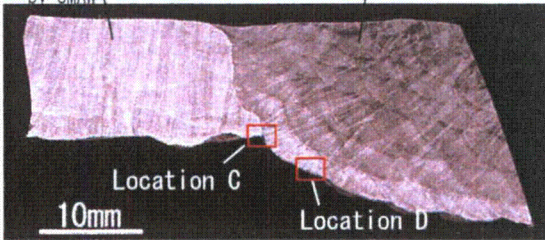
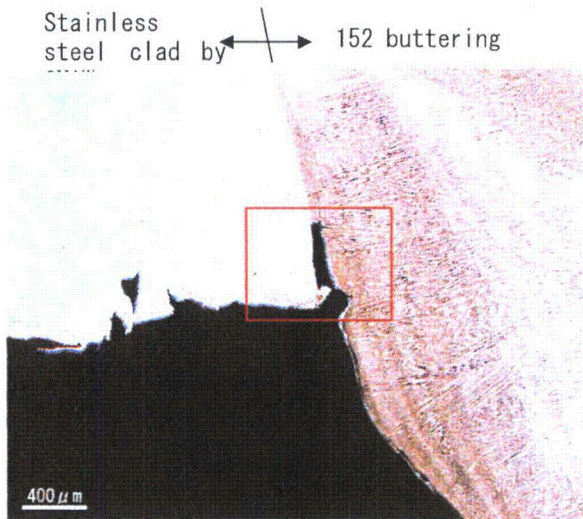
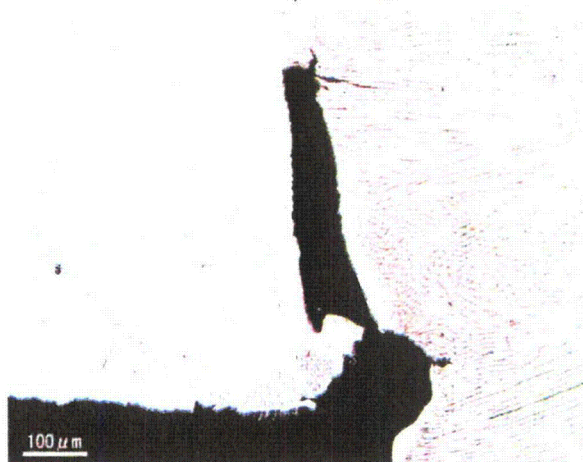
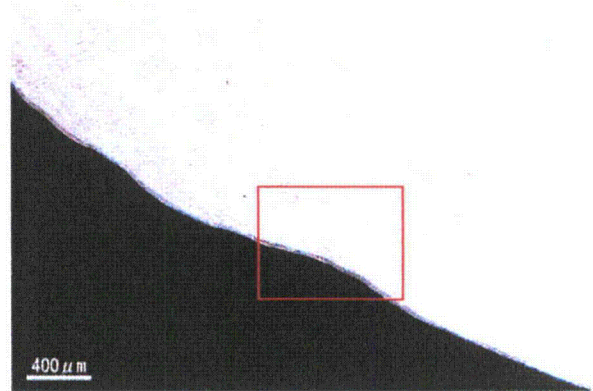
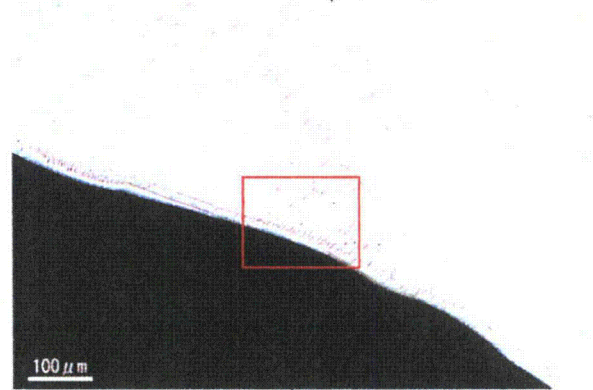
Fig.A.39(2) Microstructure observation of cross section of sample D
 (152 buttering and boundary between 152 buttering and stainless steel clad)

Detail observation of location C

Detail observation of location D

- Crack propagated near boundary between 152 buttering and stainless steel clad.
- Crack opened widely.

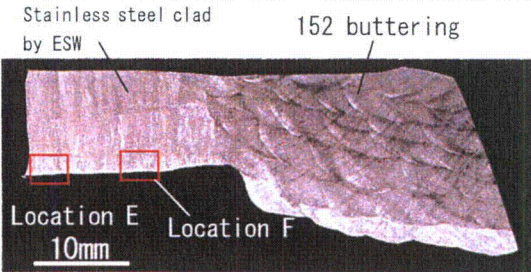
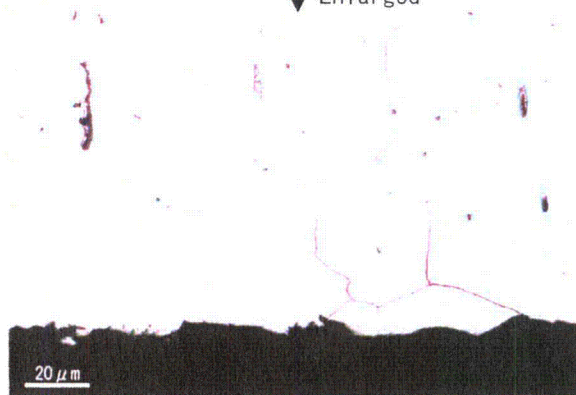
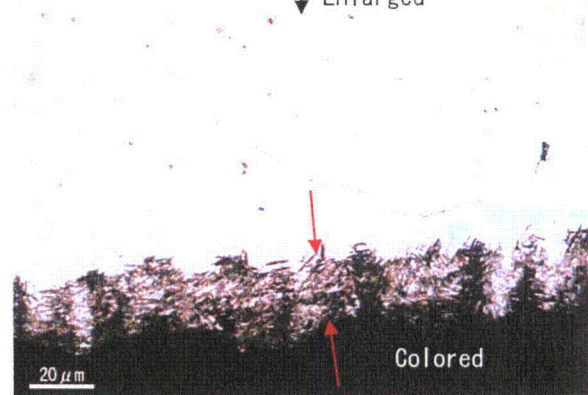
Fig.A.39(3) Microstructure observation of cross section of sample D
 (Stainless steel clad by ESW)

Detail observation of location E

Detail observation of location F

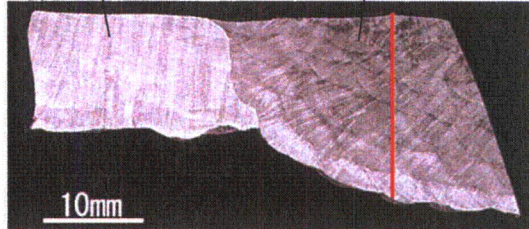
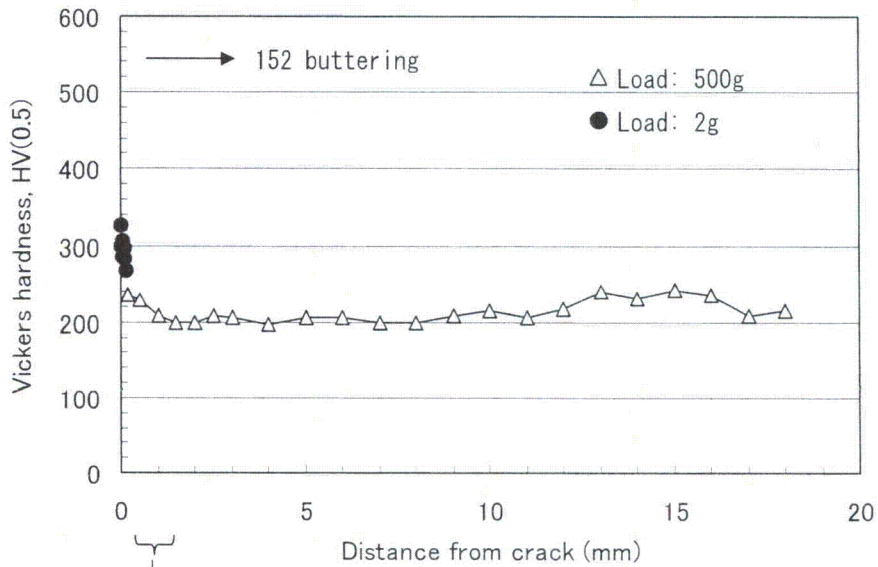
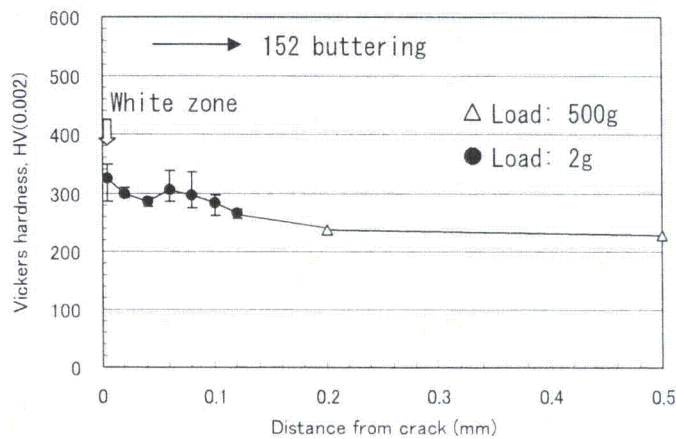
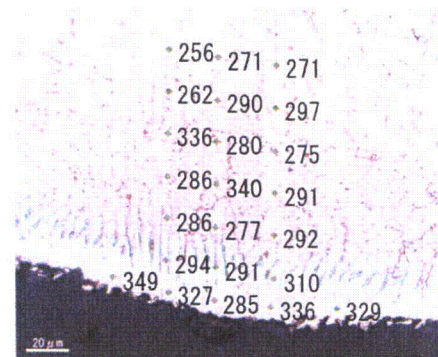
Fig.A.40(2) Vickers hardness of cross section of sample D (152 buttering)

Line of hardness measurement
 (152 buttering)

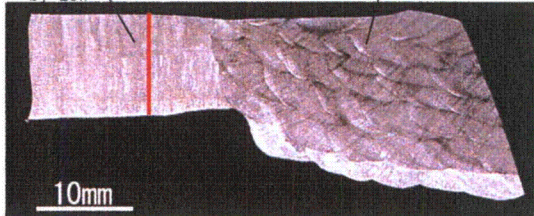
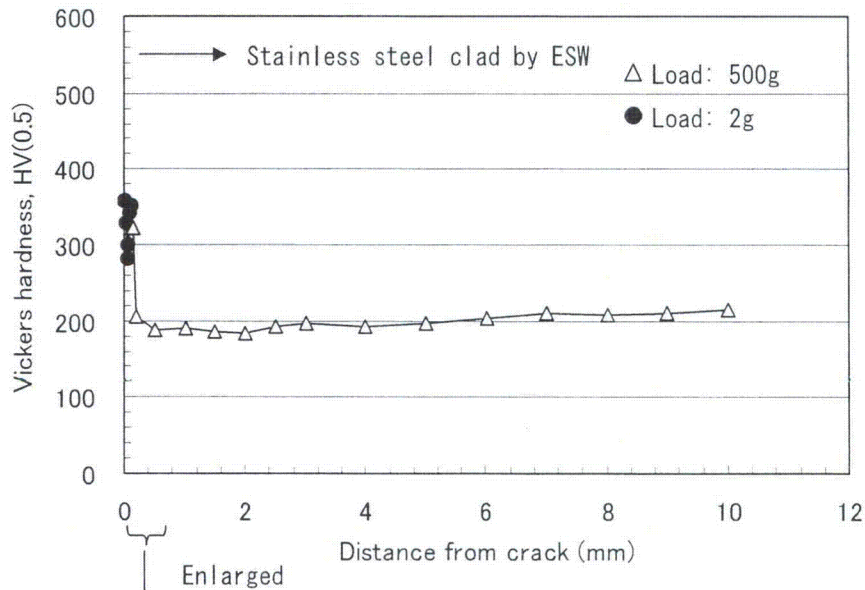
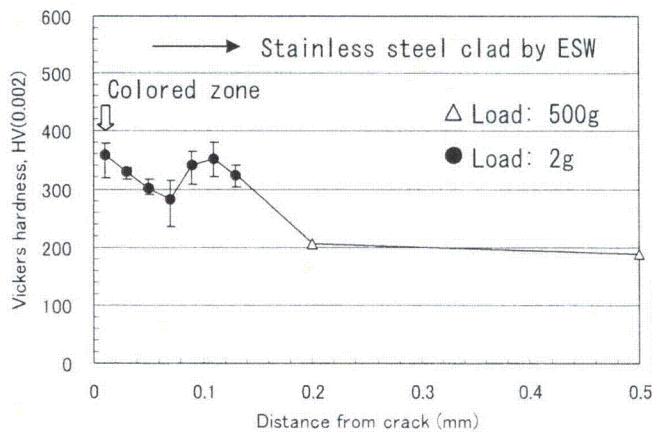
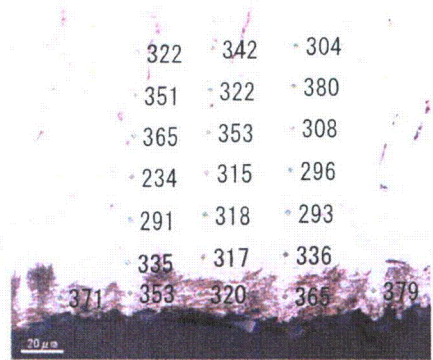
Fig.A.40(3) Vickers hardness of cross section of sample D (Stainless steel clad by ESW)

Line of hardness measurement
 (Stainless steel clad by ESW)

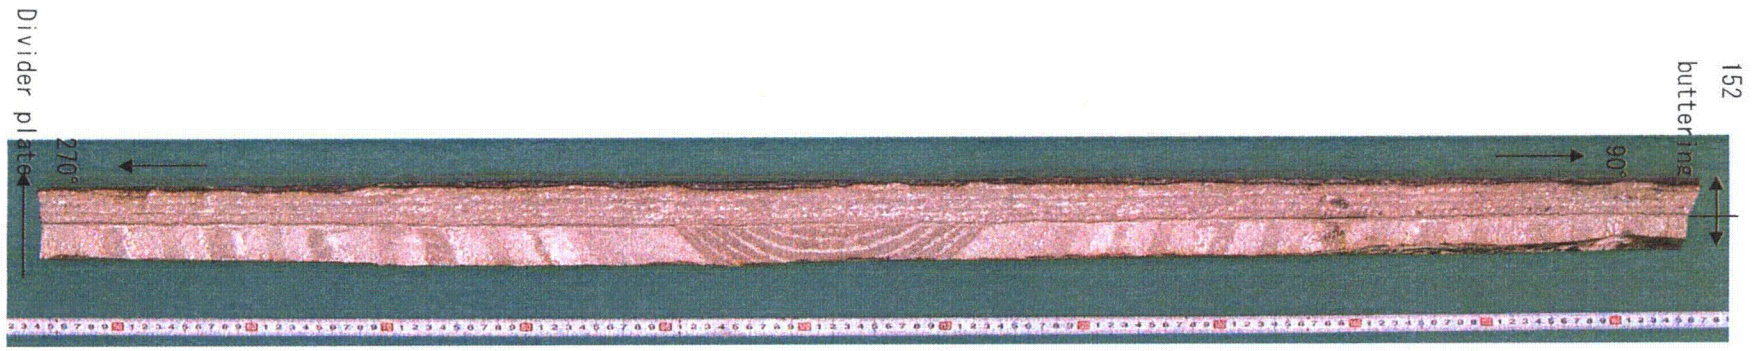
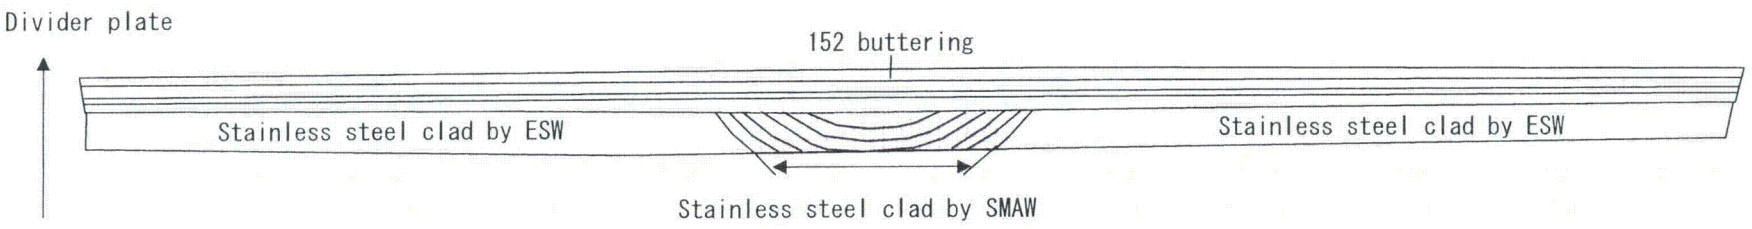
Fig.A.42(1) Appearance of fracture surface (Schematic illustration)

(a) Appearance of fracture surface

(b) Schematic illustration of fracture surface

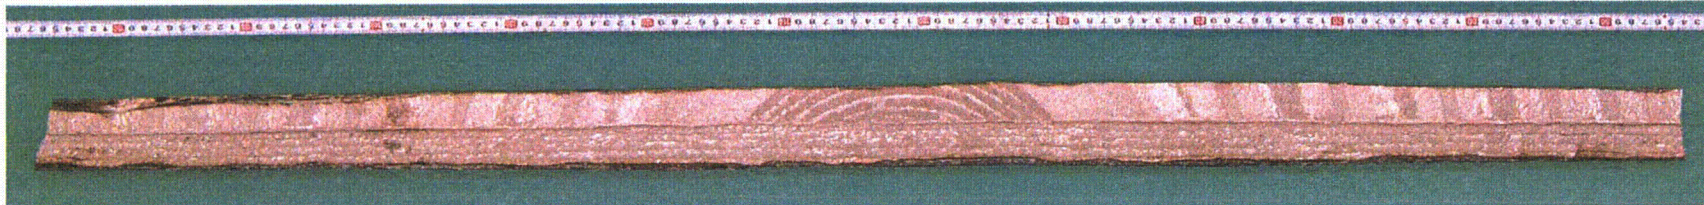
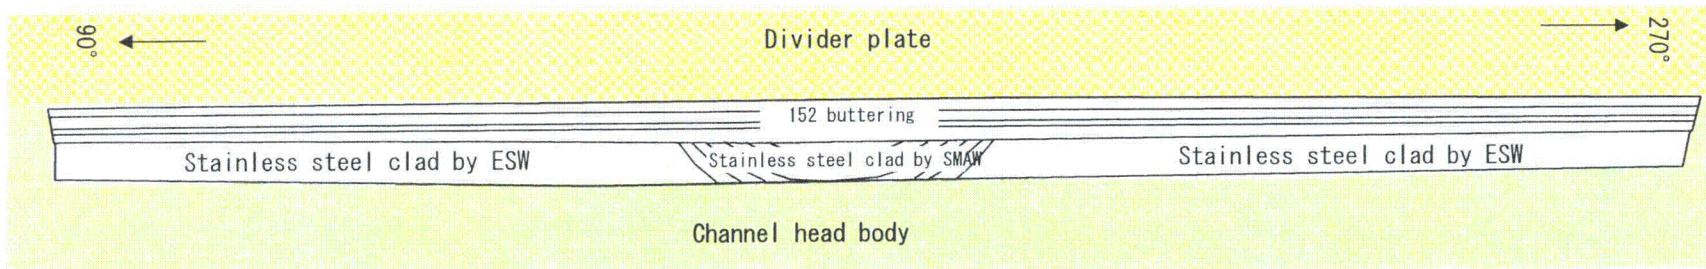
Fig.A.43(1) Appearance of fracture surface of channel head body after removal of sample

(a) Appearance of fracture surface of sample

(b) Appearance of fracture surface of channel head body after removal of sample

(c) Schematic illustration channel head body after removal of sample
