II. Second Investigation

The purpose of this report is to provide results of additional investigation of I type mockups and boat samples collected from the U3B and U3A RSGs.

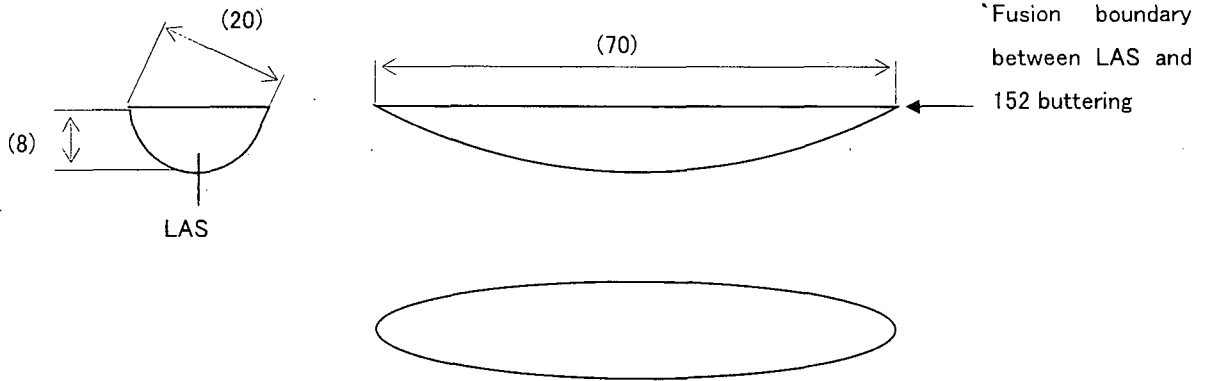
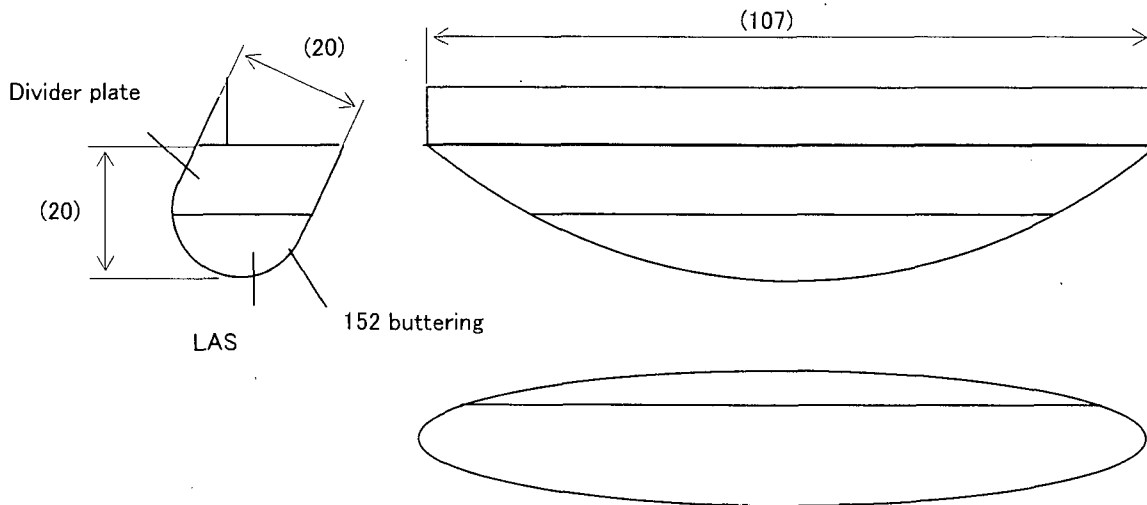
2 boat samples were additionally collected from Unit 3A RSG at the location as shown in Figure A.44. The detail of the each sample was shown in Table A.5.

Figure A.44(1) The collecting location and schematic illustration of boat samples.
(collecting location of boat samples)

Figure A.44(2) The collecting location and schematic illustration of boat samples.
 (schematic illustration of boat samples)

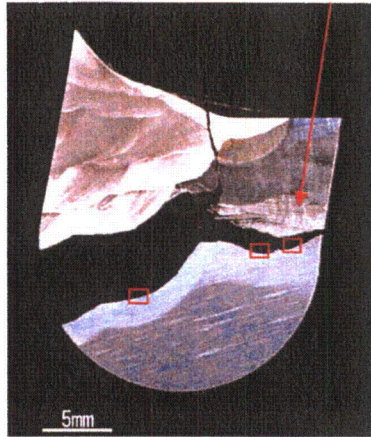
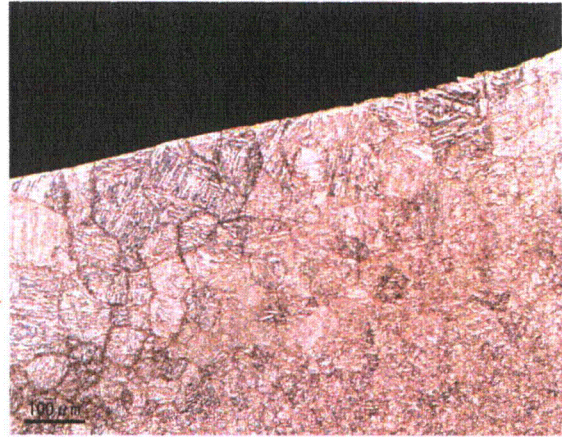
The HAZ of 152 buttering tends to reveal larger grains (mean grain size was about 0.1mm) compared with HAZ of stainless steel clad (mean grain size was 0.02mm to 0.01mm). It was considered that the HAZ of stainless steel clad was refined by heat input of 2nd layer welding.

Sample A, HAZ by 152 buttering (SMAW)
Grain size number: 4, Grain size: 0.088mm

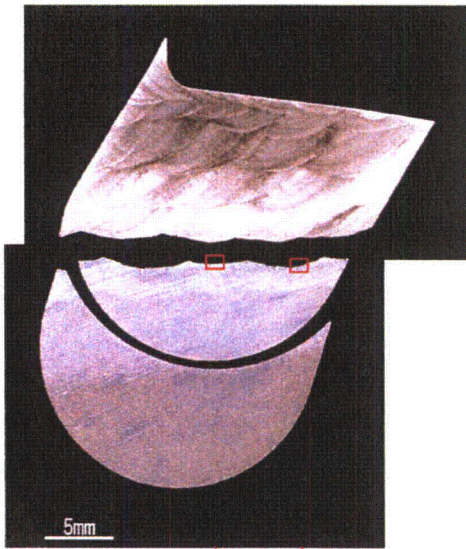
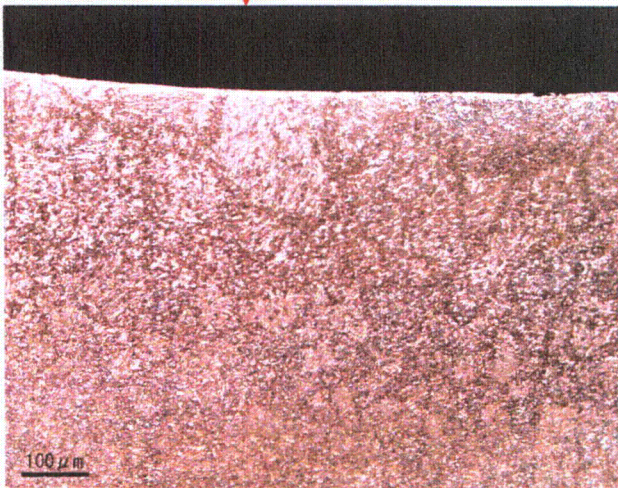
Sample B, HAZ by 152 buttering (SMAW)
Grain size number: 3, Grain size: 0.125mm

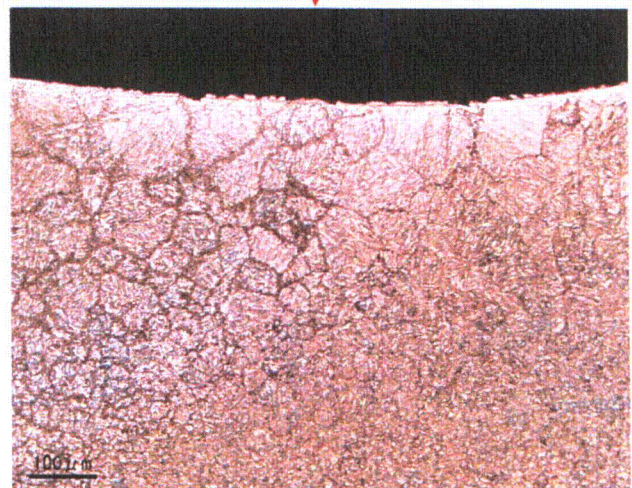
Sample B, HAZ by 152 buttering (SMAW)
Grain size number: 5, Grain size: 0.063mm

Figure A.45(1) Microstructure of the cross section of LAS channel head in boat samples A and B(152 buttering)

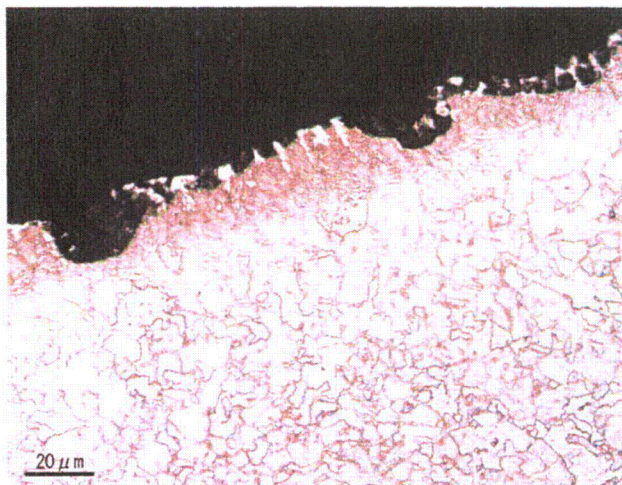
Sample A, HAZ by Stainless steel (SMAW)
Grain size number: 10.5, Grain size: 0.009mm

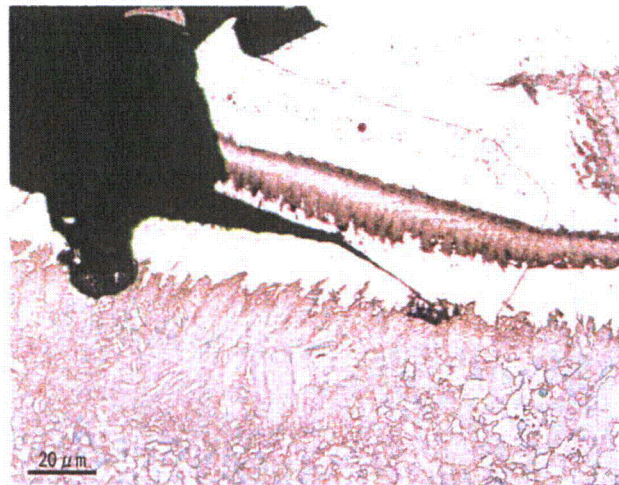
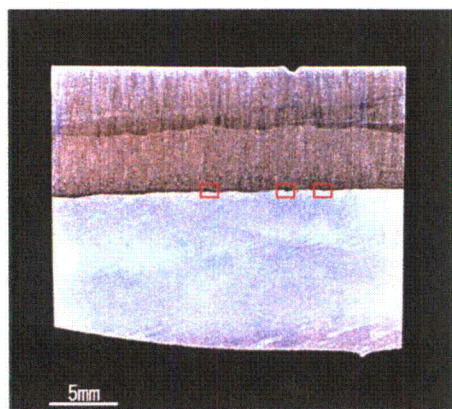
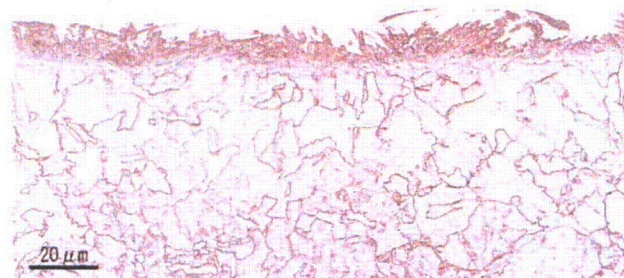
Sample C, HAZ by Stainless steel (ESW)
Grain size number: 9.5, Grain size: 0.013mm

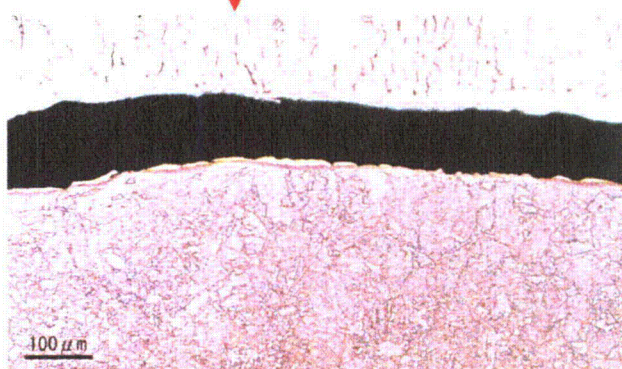
Sample C, HAZ by Stainless steel (ESW)
Grain size number: 6, Grain size: 0.044mm

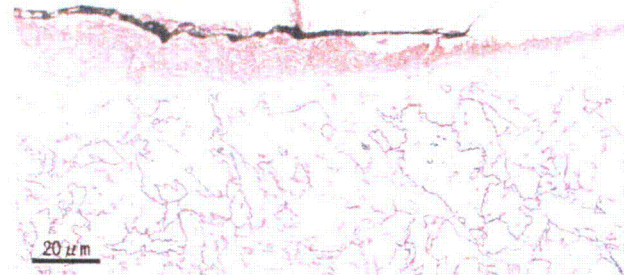
Sample C, HAZ by Stainless steel (ESW)
Grain size number: 9, Grain size: 0.0193mm

Figure A.45(2) Microstructure of the cross section of LAS channel head in boat samples A and C

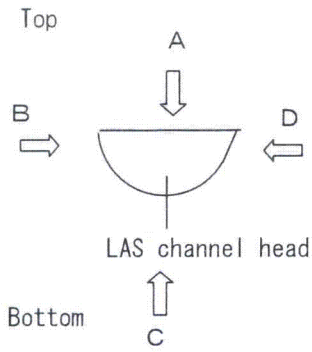
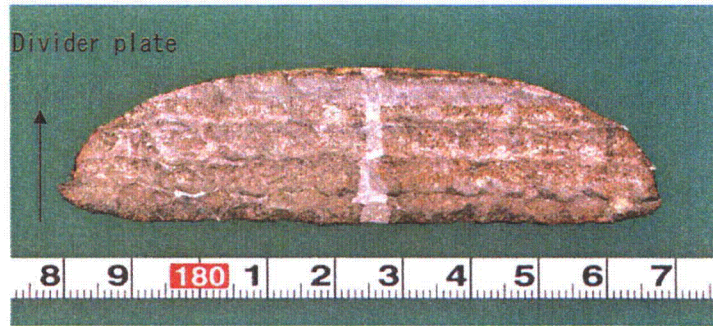
Fracture surface (direction A)

Figure A.46 Appearance of sample F collected from U3A

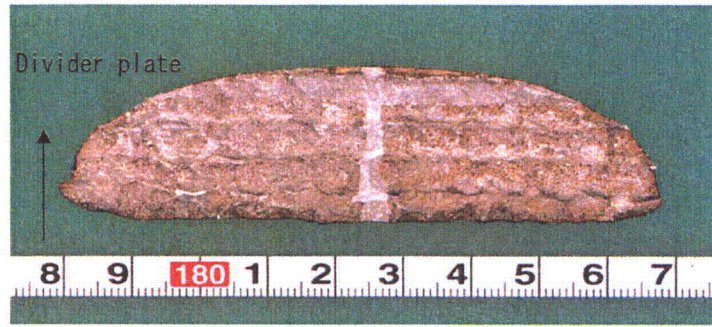
Fracture surface of sample F

Figure A.47 shows appearance of fracture surface of the sample. A rough surface was observed on the fracture surface as observed in sample F. It is supposed that the rough surface corresponds to welding bead shape of 152 buttering.

- 1) Sample F revealed similar rough fracture surface as observed in U3B.
- 2) The separation occurs in LAS or in weld metal adjacent to fusion boundary.
- 3) Micro-cracking in HAZ was not observed in the cross section.
- 4) The grain size distribution of HAZ of 152 buttering was almost similar to those of boat samples collected from U3B. There were both coarse grained region and small grained region in HAZ of 152 buttering.

Figure A.47 Appearance of fracture surface of sample F

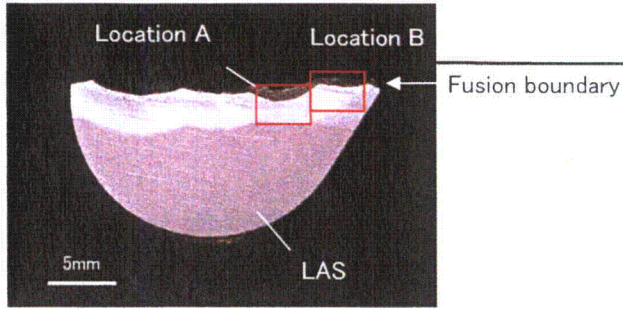
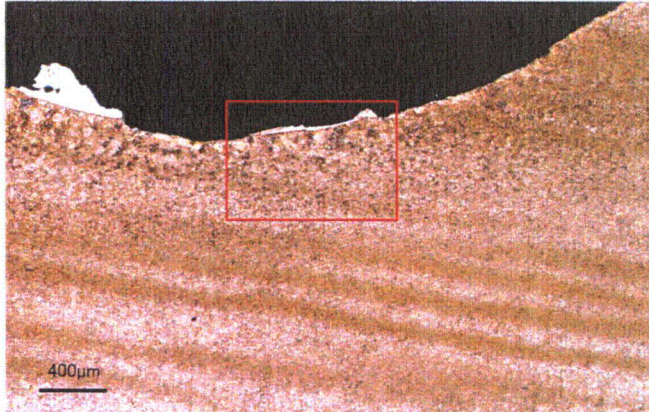
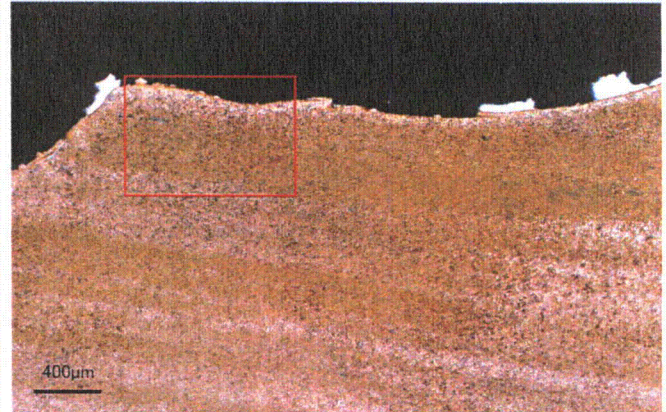
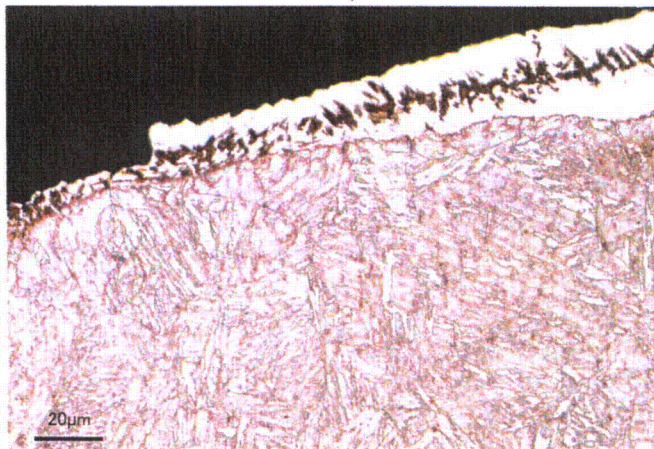
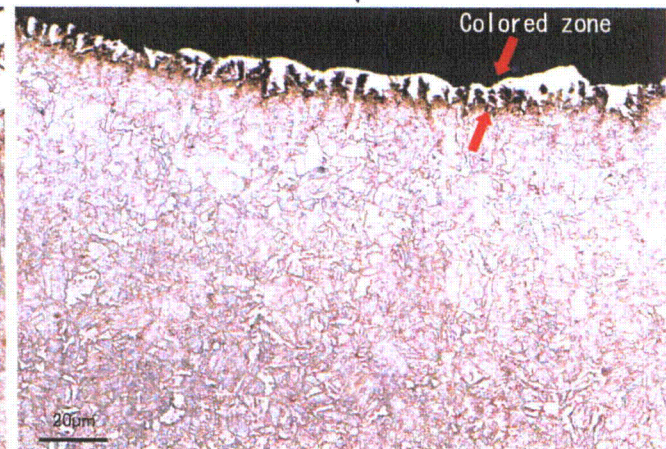
Figures A.48 show macro-structures and micro-structures of cross section of sample F. The separation occurs along the fusion boundary between 152 weld metal and LAS base metal. In higher magnification pictures, the crack paths seem to be similar to the boat samples collected from U3B; crack path in LAS or crack path in the weld metal locate adjacent to the fusion boundary. Any micro-cracking in HAZ was not observed in the cross section.

Figure A.48(1) Macro structure and micro structure of cross section of sample F

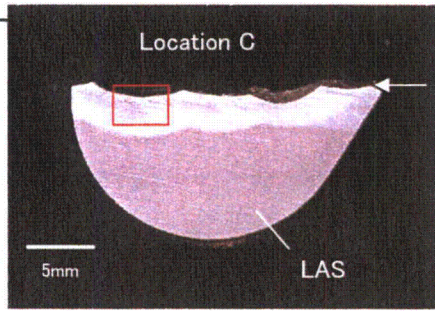
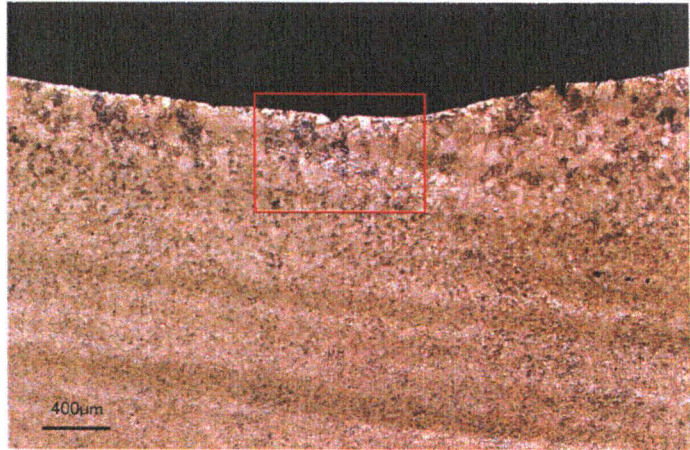
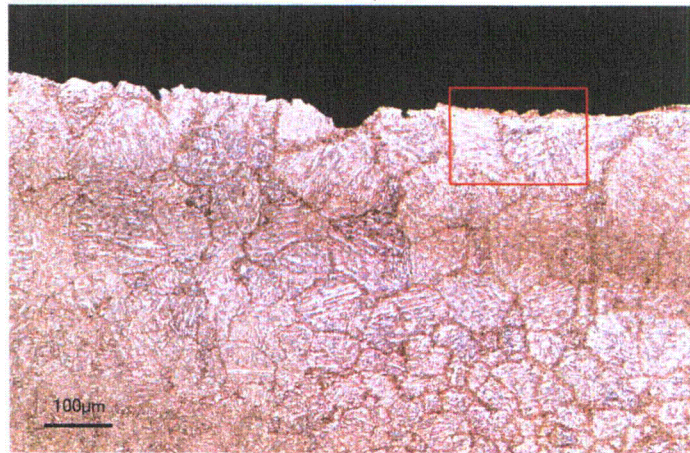
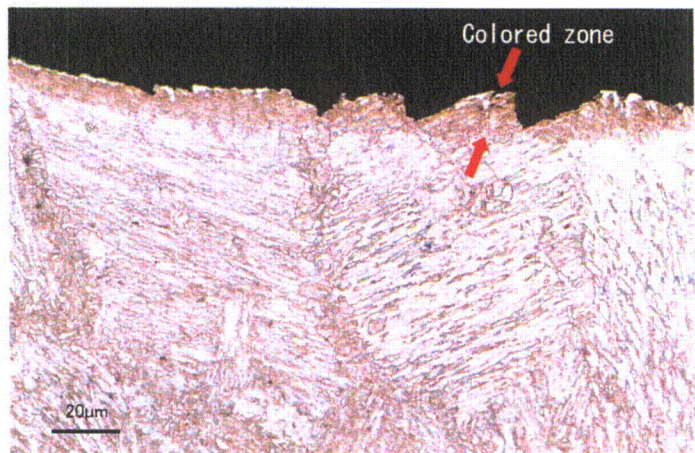
Detail observation of location C

Colored zone

Weld metal	Welding process	Grain size number/ Grain size measured			Mean grain size
		10.5/ 0.009mm (Location A)	5/ 0.063mm (Location B)	3.5/ 0.105mm (Location C)	
152	SMAW				0.059mm

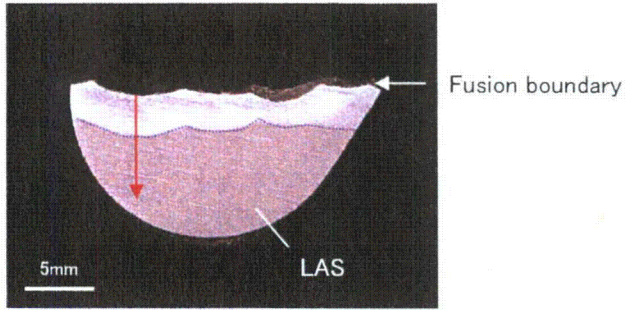
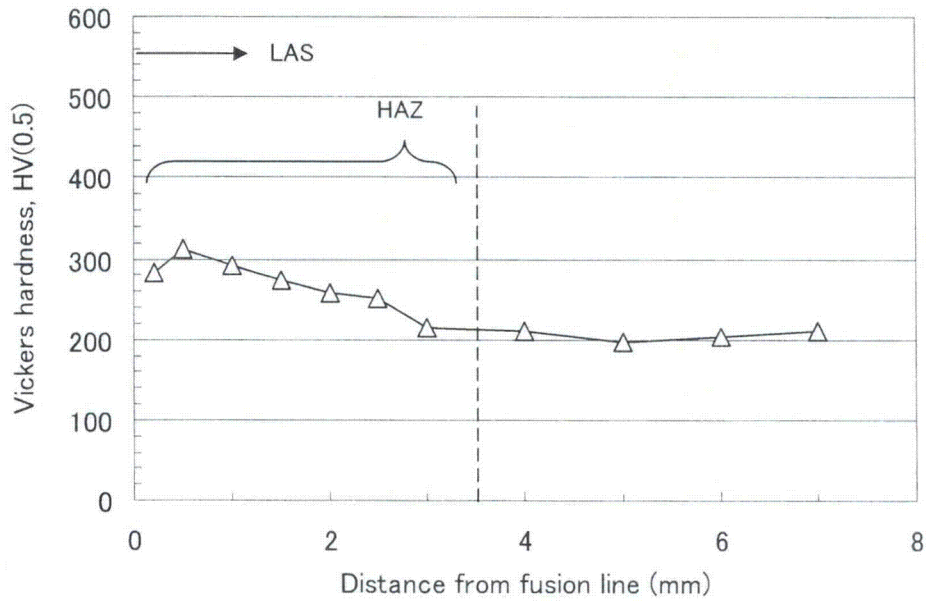
Hardness measurement location

Figure A.49 Vickers hardness of cross section of sample F

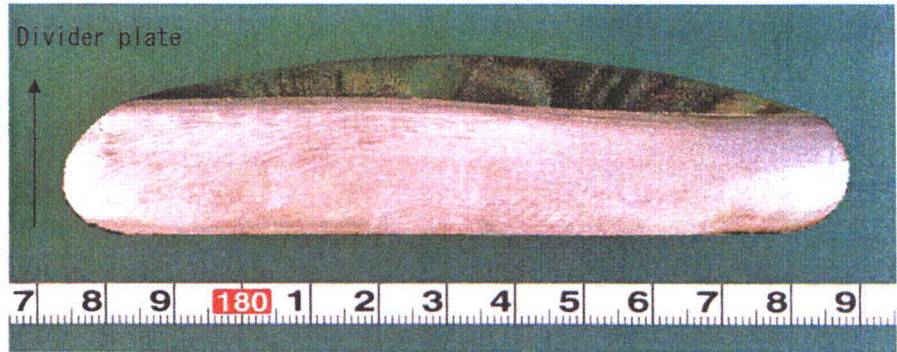
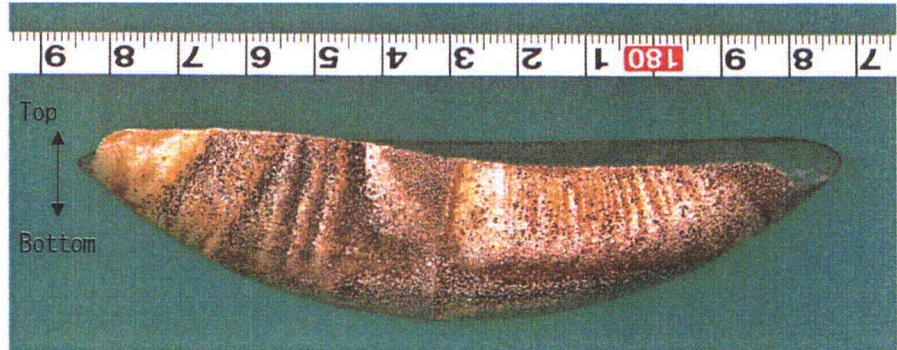
Figure A.50 shows appearance of boat sample G collected from 152 buttering area without separation in U3A. The sample contains low alloy steel and 152 buttering. Any surface cracks were not observed.

- 1) Any surface cracks were not observed.
- 2) Any micro-cracking or defect were not observed in HAZ in cross section.
- 3) There were both coarse grained region and small grained region in HAZ of 152 buttering. Mean grain size of the HAZ of 152 buttering was approximately 0.1mm.
- 4) The 152 buttering revealed high hardness (HV440 to 480) in colored zone adjacent to the fusion boundary as observed in boat samples collected from U3B.

Figure A.50 Appearance of boat sample G

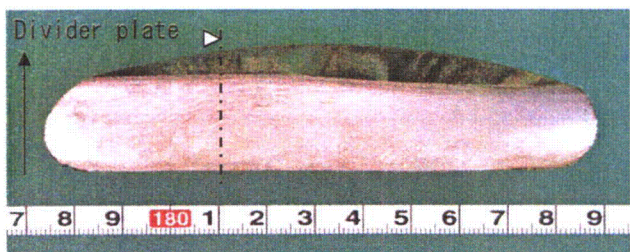
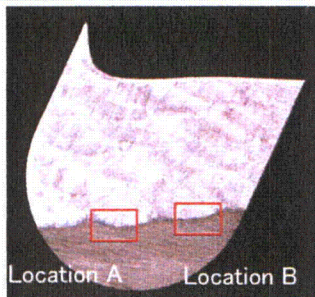
Cross section 1

Figures A.51 show macro-structures and micro-structures of cross section of sample G. Any separations were not observed. The micro structure of sample G was similar to that of sample F and those of boat samples collected from U3B. Any micro-cracking or defect were not observed in HAZ.

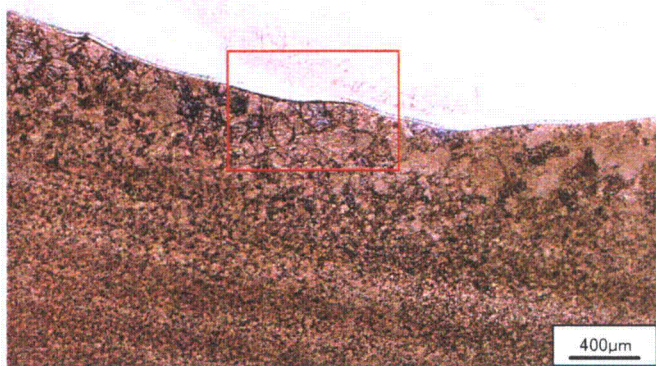
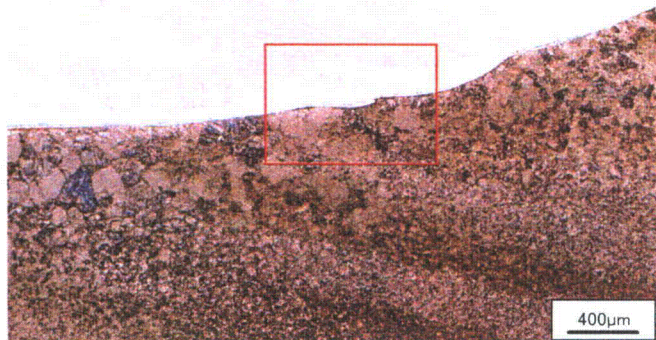
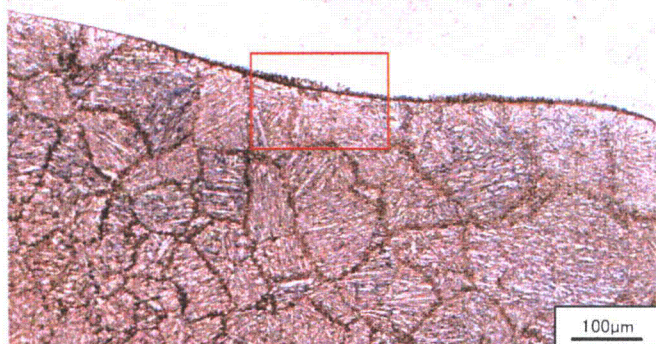
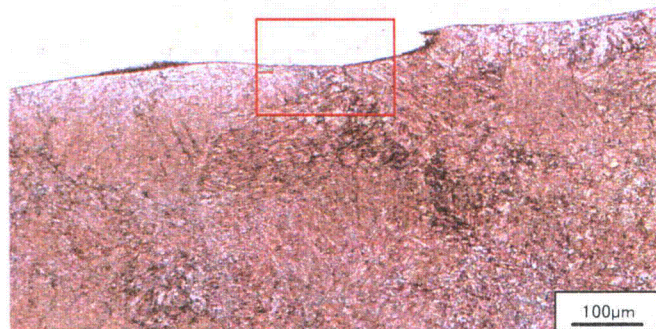
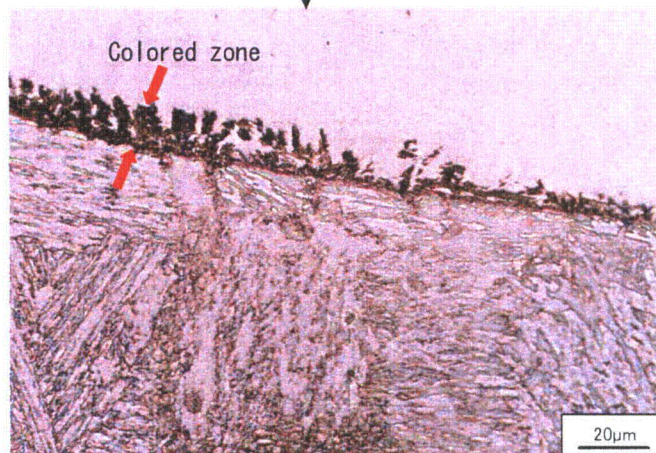
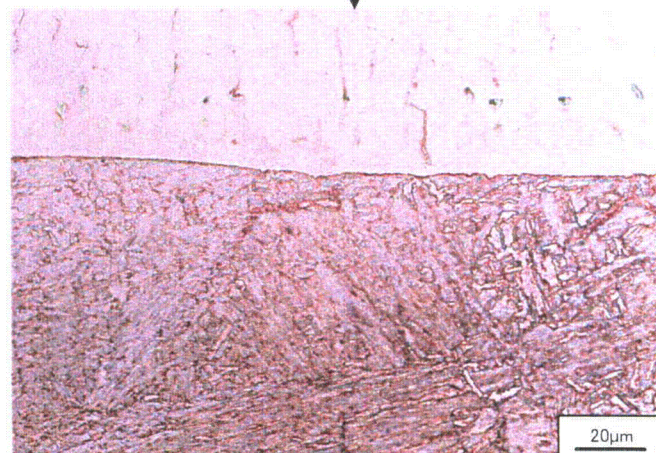
Figure A. 51(1) Macro structure and micro structure of cross section 1 of sample G

Detail observation of location A

Detail observation of location B

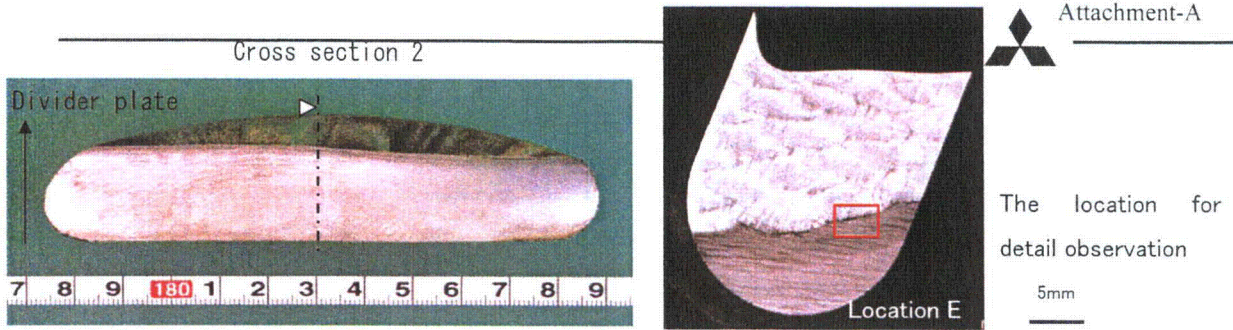
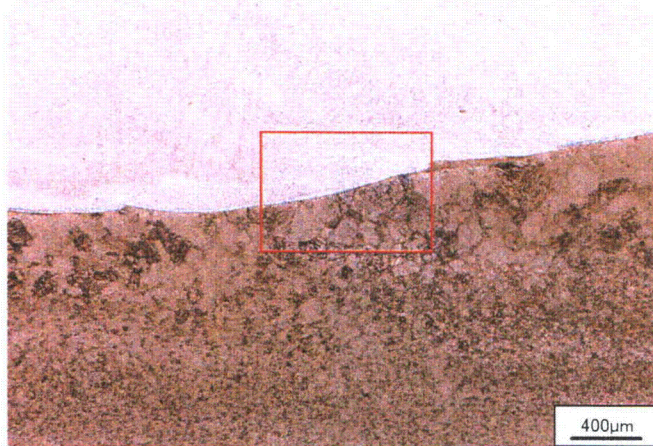
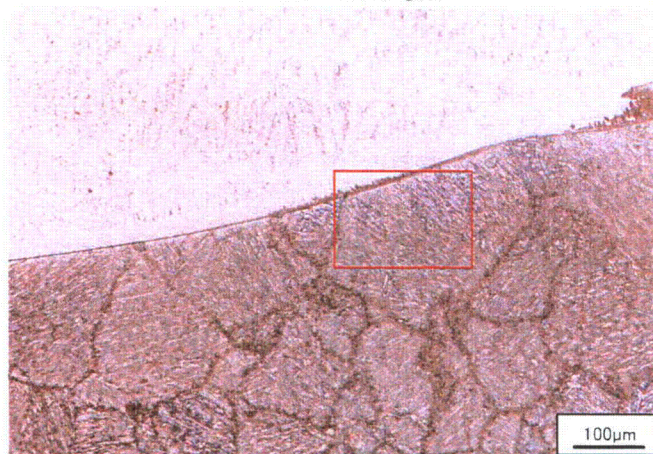
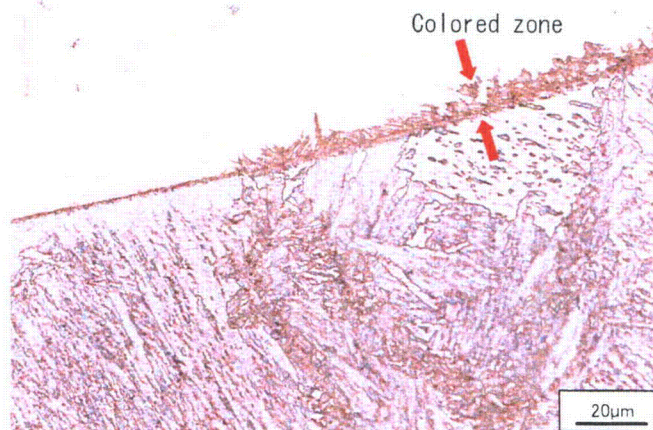
Figure A. 51(3) Macro structure and micro structure of cross section 2 of sample G

Detail observation of location E

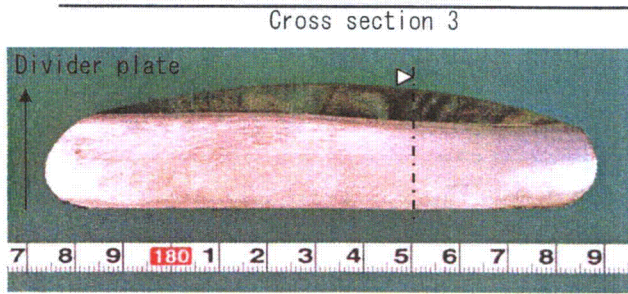
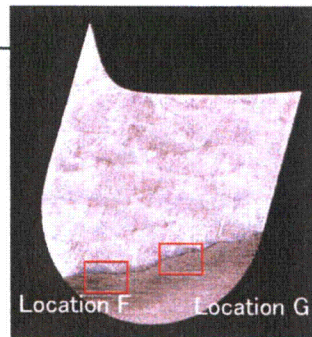
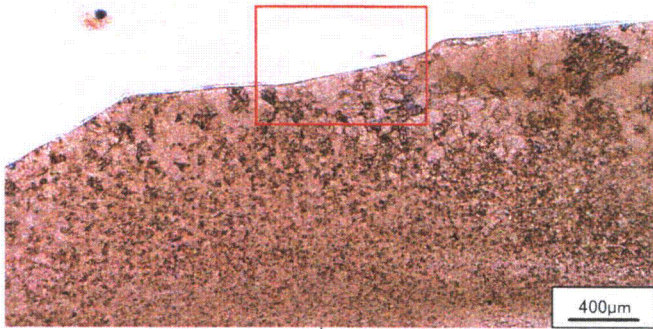
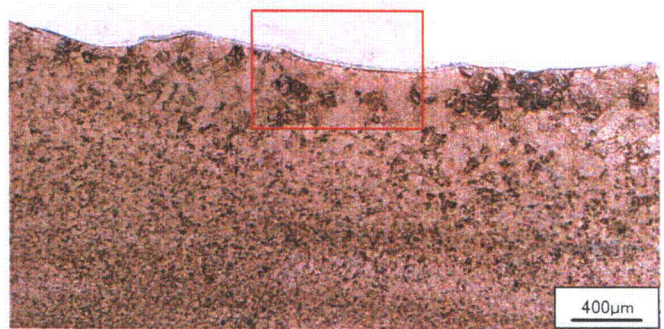
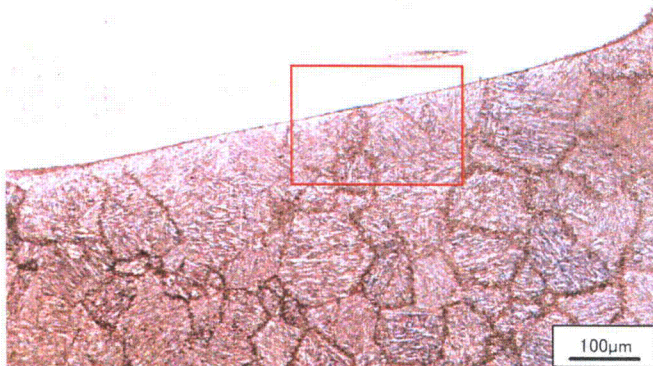
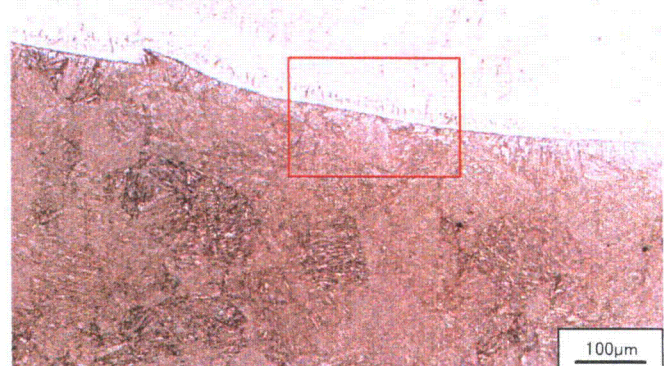
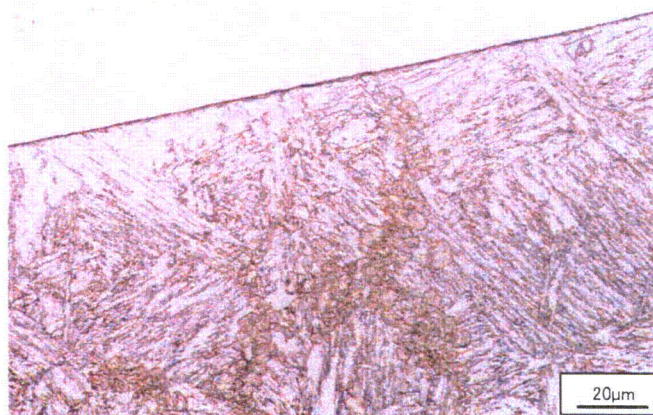
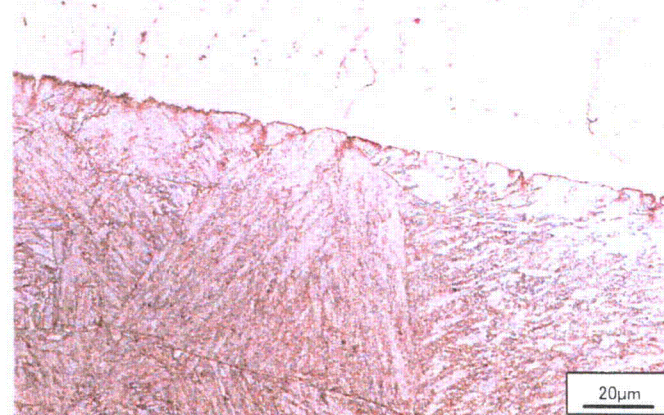
Figure A. 51(4) Macro structure and micro structure of cross section 3 of sample G

Detail observation of location F

Detail observation of location G

Weld metal	Welding process	Grain size number/ Grain size measured			Mean grain size
		3.5/ 0.105mm (Location A)	3/ 0.125mm (Location B)	-	
152	SMAW	10.5/ 0.009mm (Location C)	4.5/ 0.074mm (Location D)	2.5/ 0.148mm (Location E)	0.096mm
		2.5/ 0.148mm (Location F)	5/ 0.063mm (Location G)	-

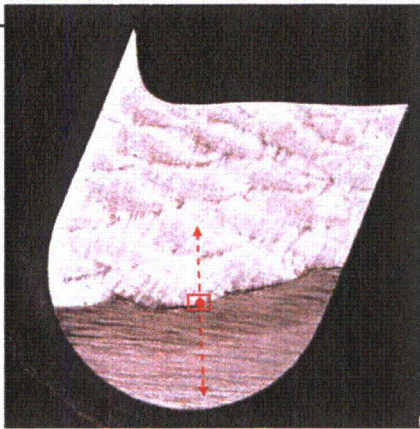
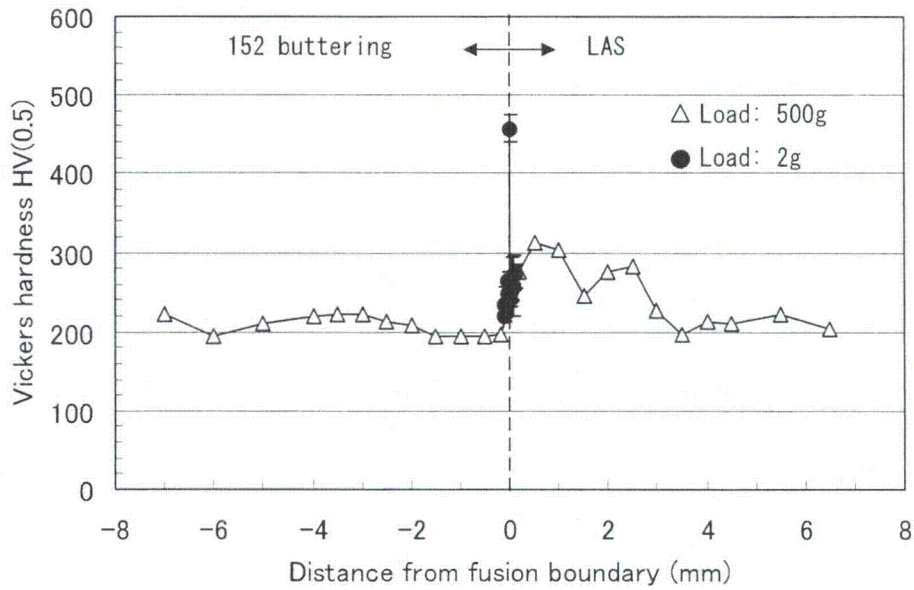
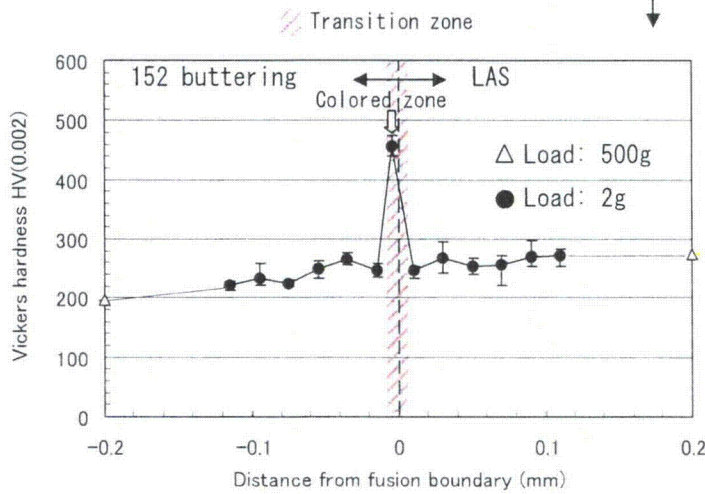
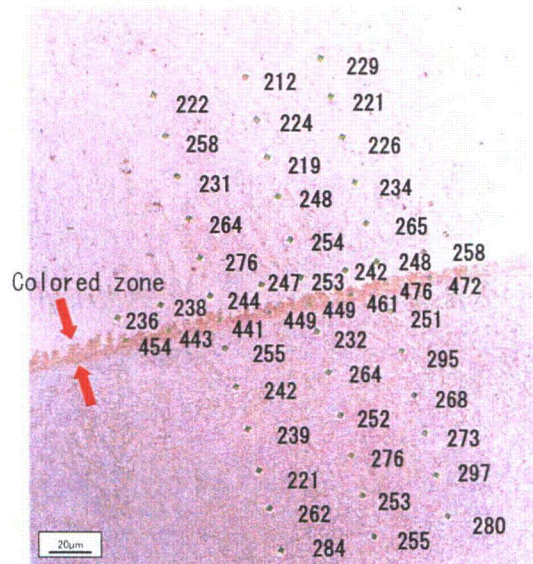
Figure A.52 Vickers hardness of cross section of sample G

The location for hardness test (cross section 2)

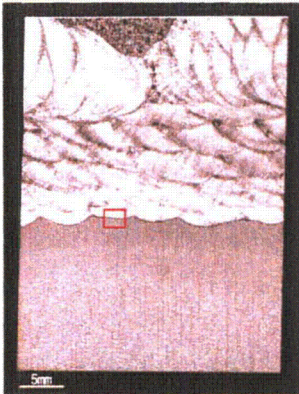
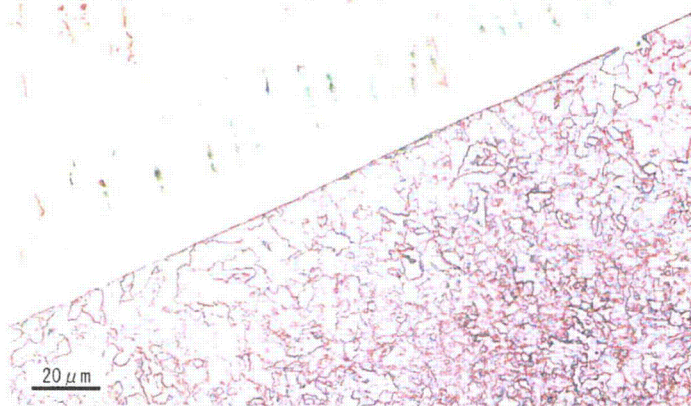
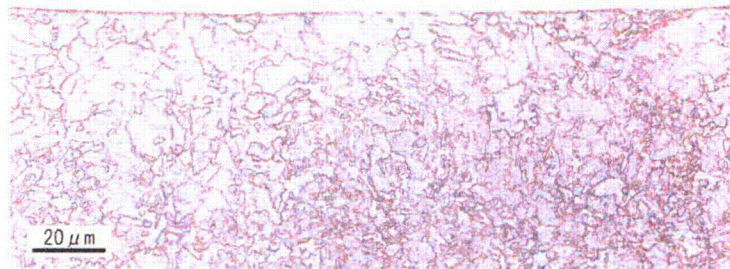
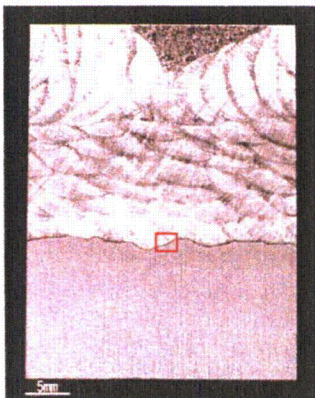
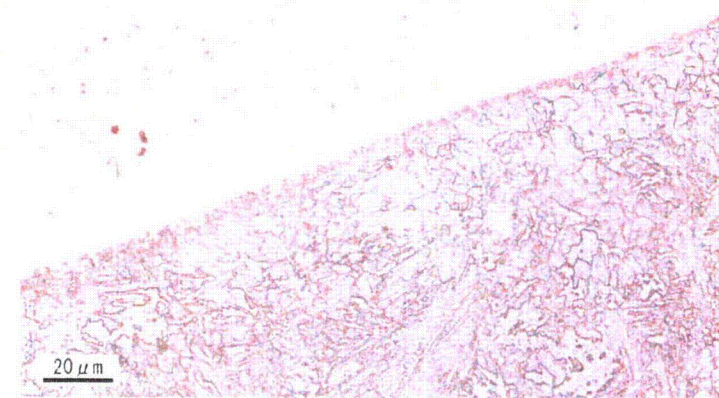
Figure A. 53(1) Microstructure of the cross section of LAS in I type model (after 152 buttering)

TP.2-2, ESW + Gouging + grinding + 152 buttering (SMAW)
Grain size number: 10.5, Grain size: 0.009mm

TP.3-1, ESW + Machining + 152 buttering (SMAW)
Grain size number: 10.5, Grain size: 0.009mm

- (1) Metallurgical structure observed near the fusion boundary of the mockup to which gouging was applied was similar to that observed near the fusion boundary of Unit 3, but were found to have a smaller grain size than the as-built (boat/strip) samples. It is considered that this was because grain refining occurred in the I-Type samples under the heat input during application of the second layer of the butter, because the distance between the butter/base metal fusion boundary and the second layer of the butter was smaller on the I-Type samples than on the actual RSGs.

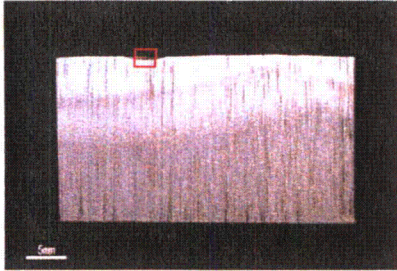
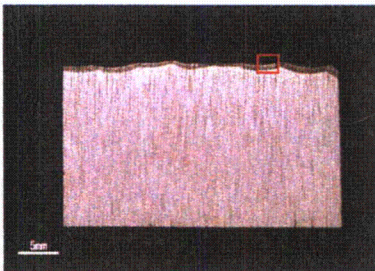
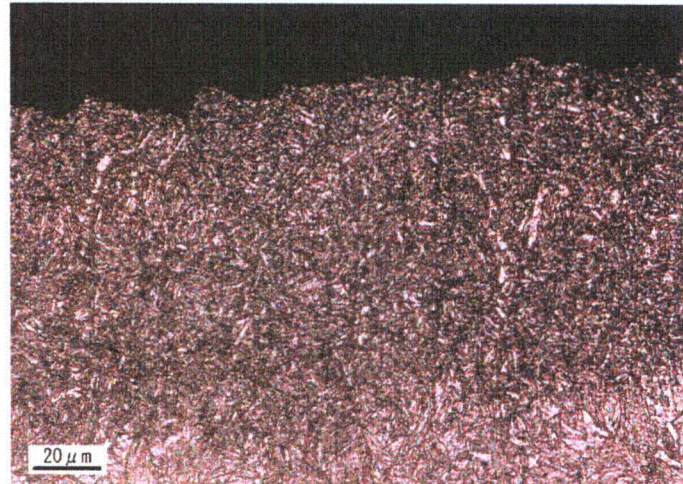
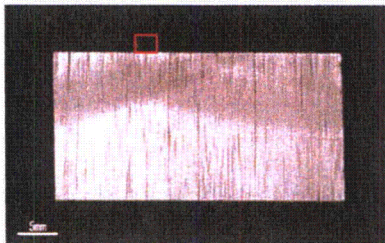
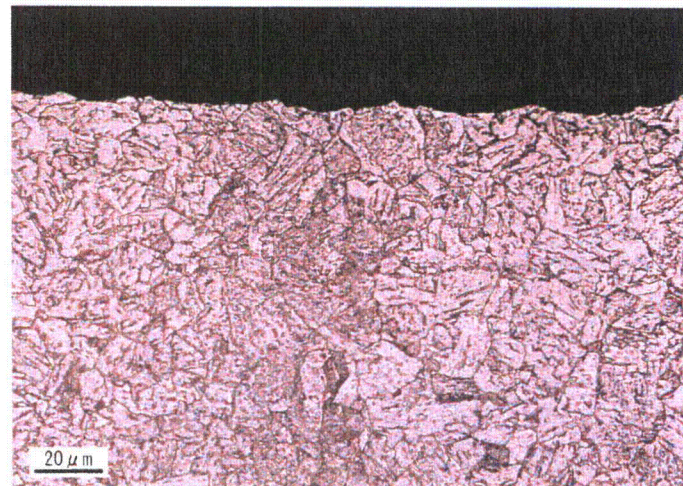
Figure A. 53(2) Microstructure of the cross section of LAS in I type model (before 152 buttering)

TP.2-1, ESW + Gouging + grinding
Grain size number: 13, Grain size: 0.004mm

TP.4-2, As gouging
Grain size number: 14, Grain size: 0.003mm

TP.3-1, As machining
Grain size number: 10, Grain size: 0.011mm

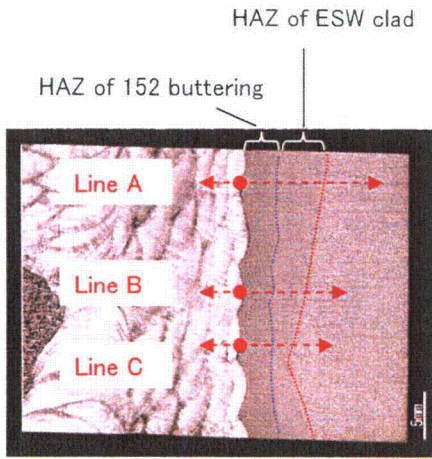
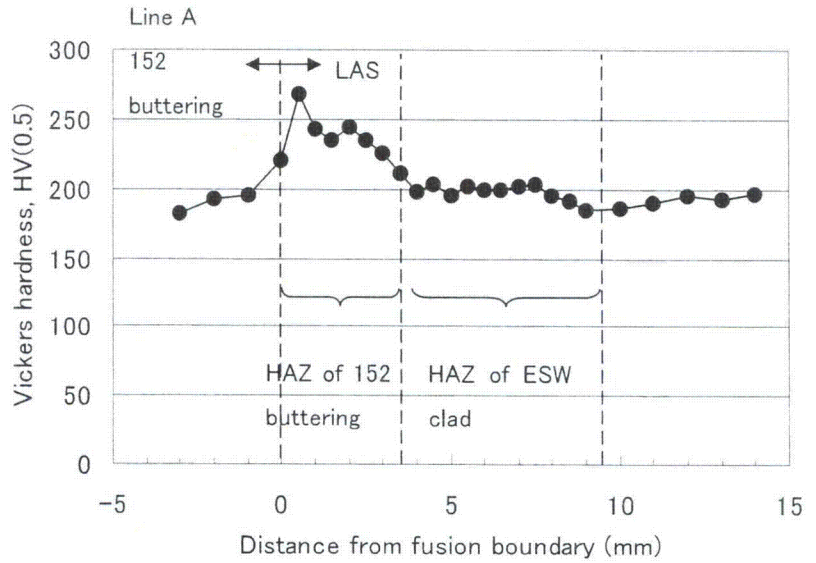
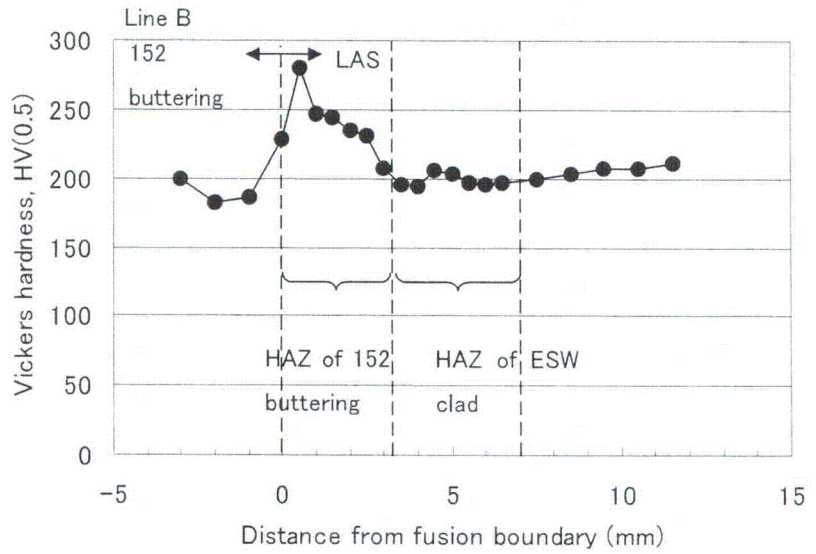
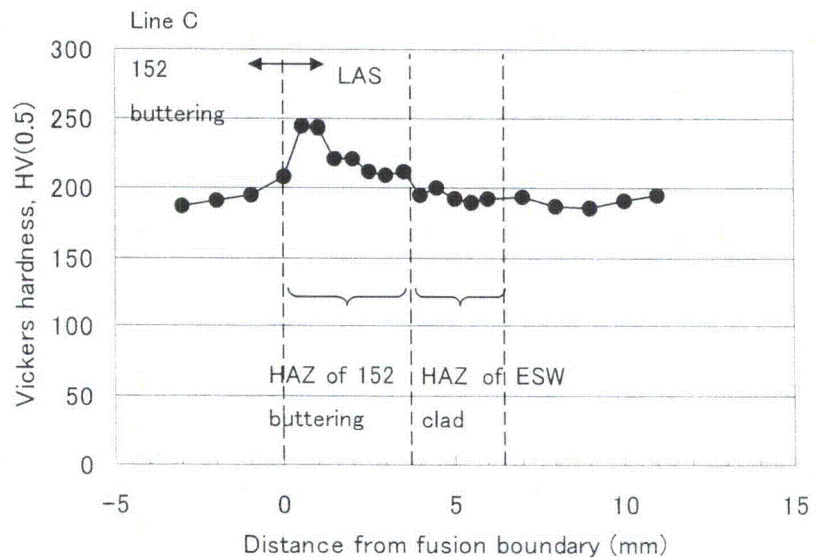
Figure A. 54(1) Vickers hardness of cross section of I type mockup 2-2

Hardness measurement location

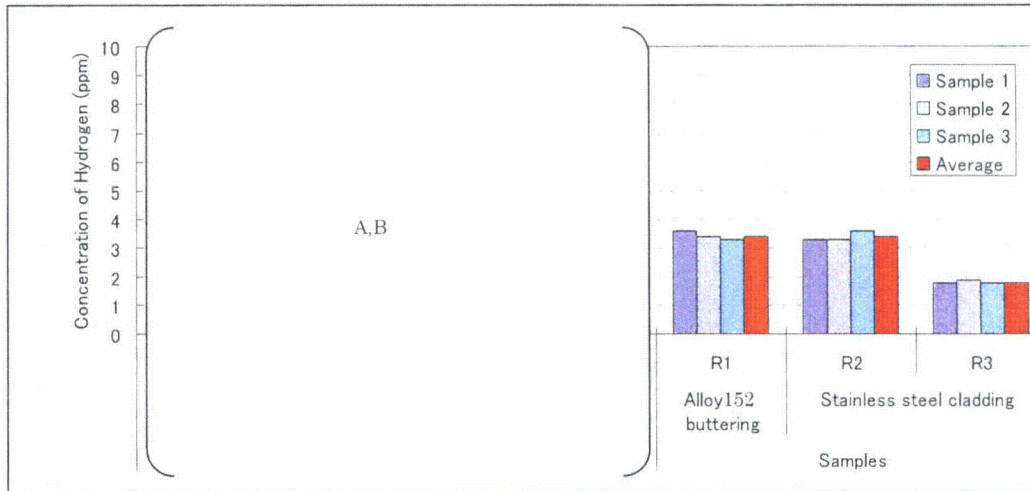
Figure I.4 Results of Measurement

The hydrogen concentration was approximately 3 ppm in alloy 152 buttering and stainless steel cladding (SMAW), and approximately 2 ppm in stainless steel cladding (ESW).

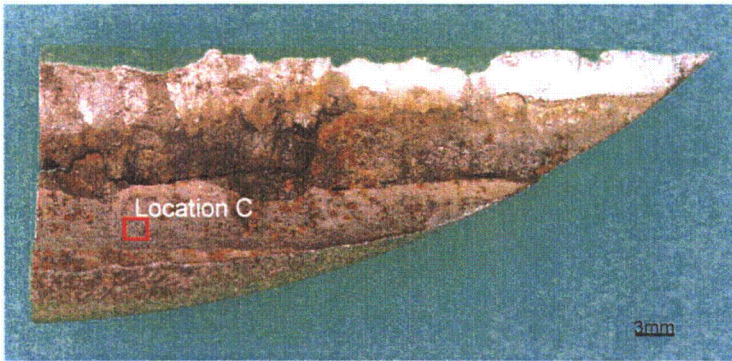
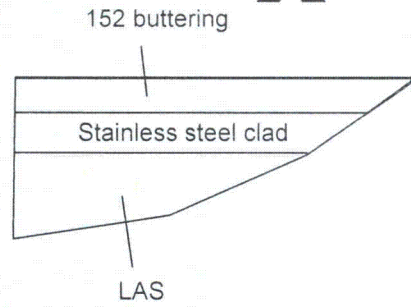
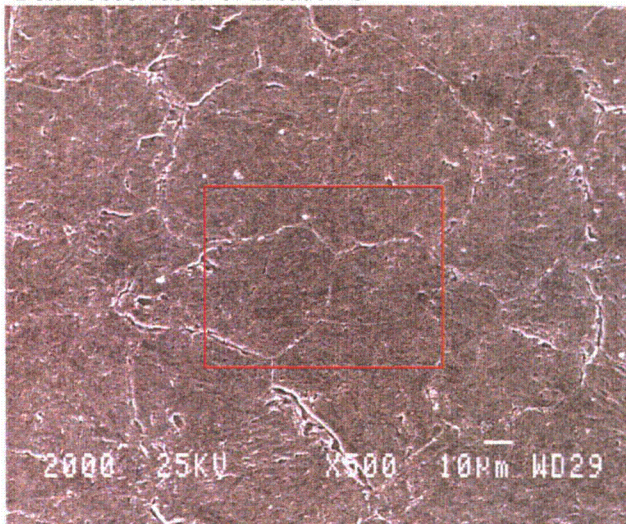
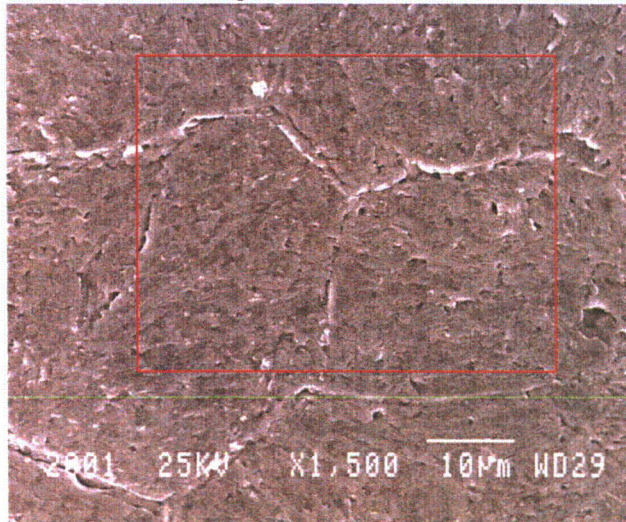
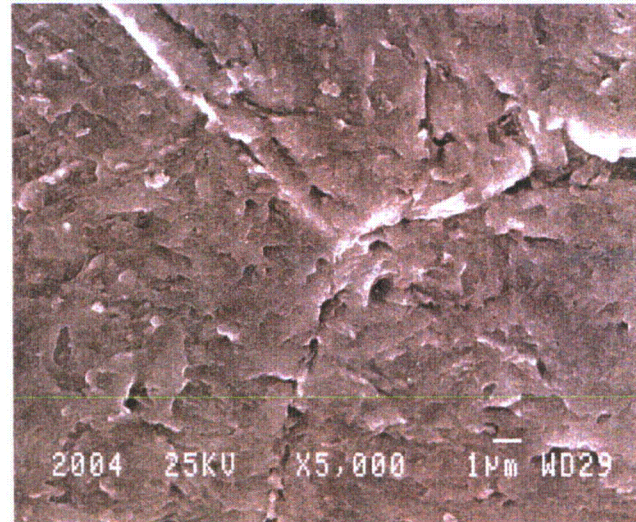
Figure S.2(1) SEM pictures of the fracture surface of the boat sample
(Sample A, TP A-1, location C)

It was observed that the separation between low alloy steel and 152 buttering reveals indented surface which was like martensitic lath structure at high magnification, though relatively flat fracture surface was observed at low magnification (Figure S.2(1), S.2(2) and S.2(3)). At high magnification, the separation between low alloy steel and 152 buttering appeared with similar fracture surface morphology to hydrogen-induced transgranular cracking in its feature as shown in Figure S.2(5)(a) for reference.

Fracture surface of the separation between low alloy steel and stainless steel clad reveals relatively smooth surface at high magnification (Figure S.2(4)). It is assumed that the separation between low alloy steel and stainless steel clad appeared with similar fracture surface morphology to hydrogen-induced intergranular cracking in its feature at high magnification as shown in Figure S.2(5)(b) for reference.
