II. Second Investigation

The purpose of this report is to provide results of additional investigation of I type mockups and boat samples collected from the U3B and U3A RSGs.

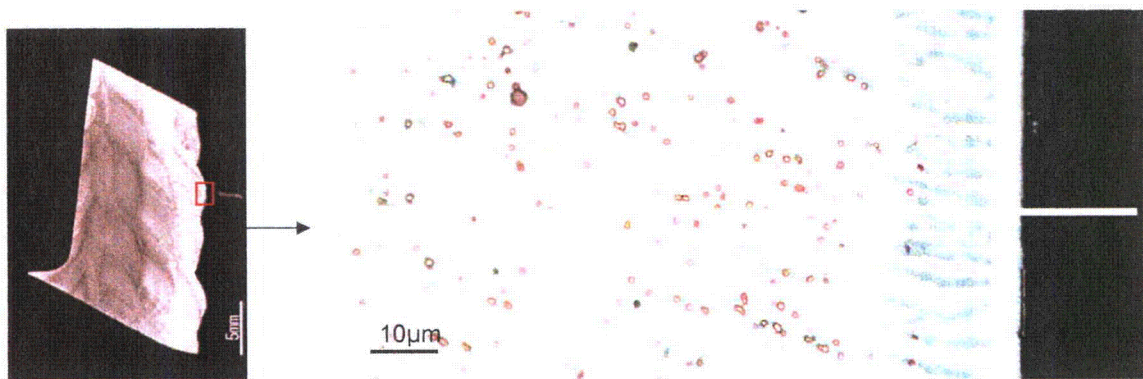
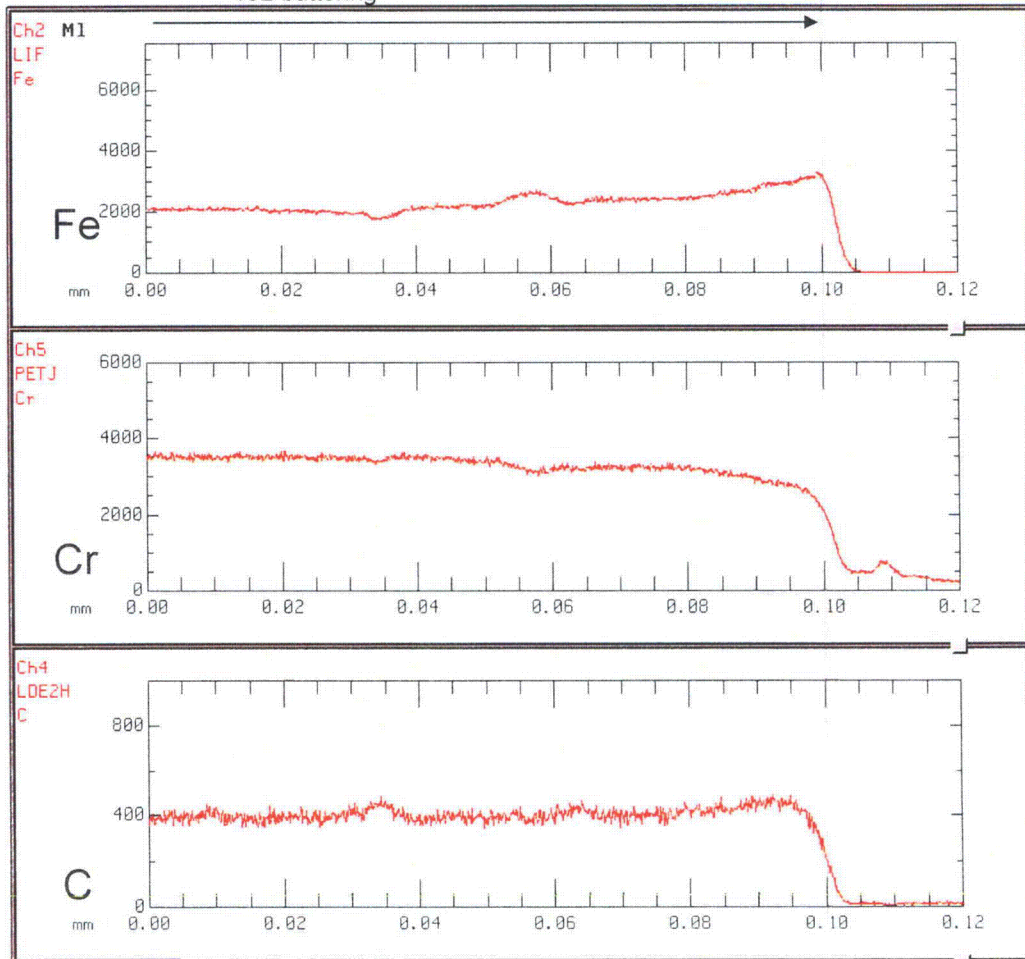
Figure S.3(1) EPMA line analysis across fusion boundary (sample B, 152 buttering side)

Figures S.3 shows the results of EPMA line analysis across fusion boundary in the cross section of sample B. Component variations was observed in 152 buttering adjacent to the separation.

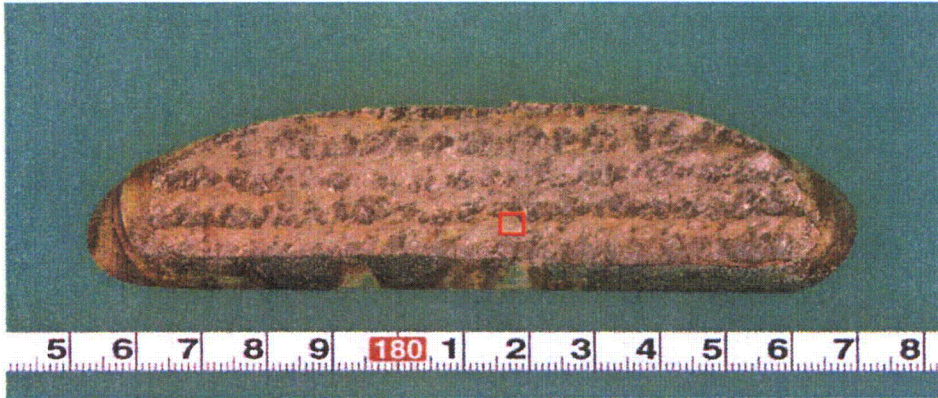
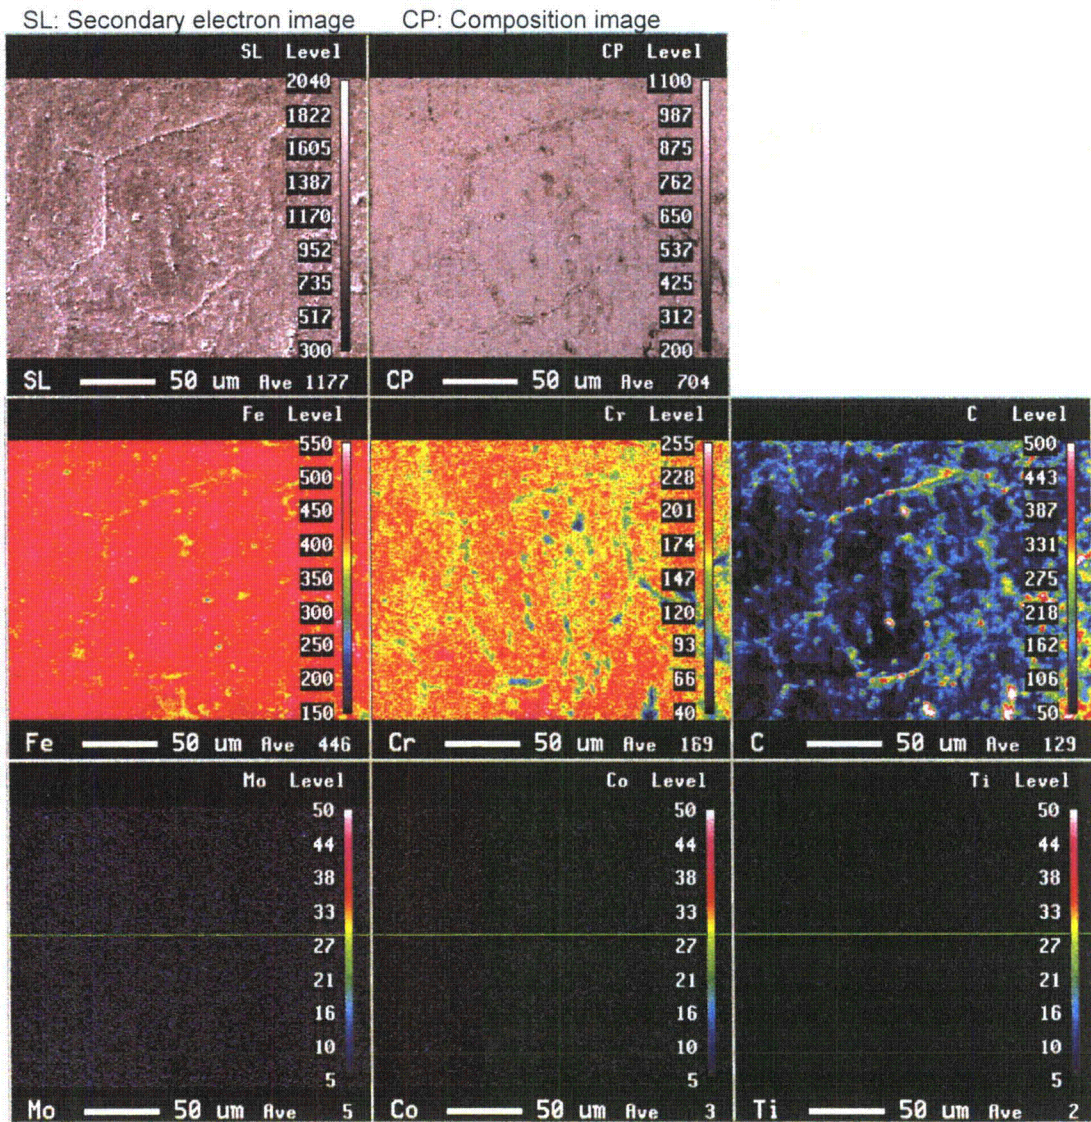
Figure S.4(1) Compositional mapping by EPMA on the fracture surface

Figures S.4 shows the results of compositional mapping by EPMA in the fracture surface of sample B and C. It was observed that there was a certain level of compositional distribution of Fe, Cr and C at the fracture surface.
