Unit 1 Cook Nuclear Plant Turbine Event Status Report

***Nuclear Regulatory Commission
Presentation
November 2, 2009***

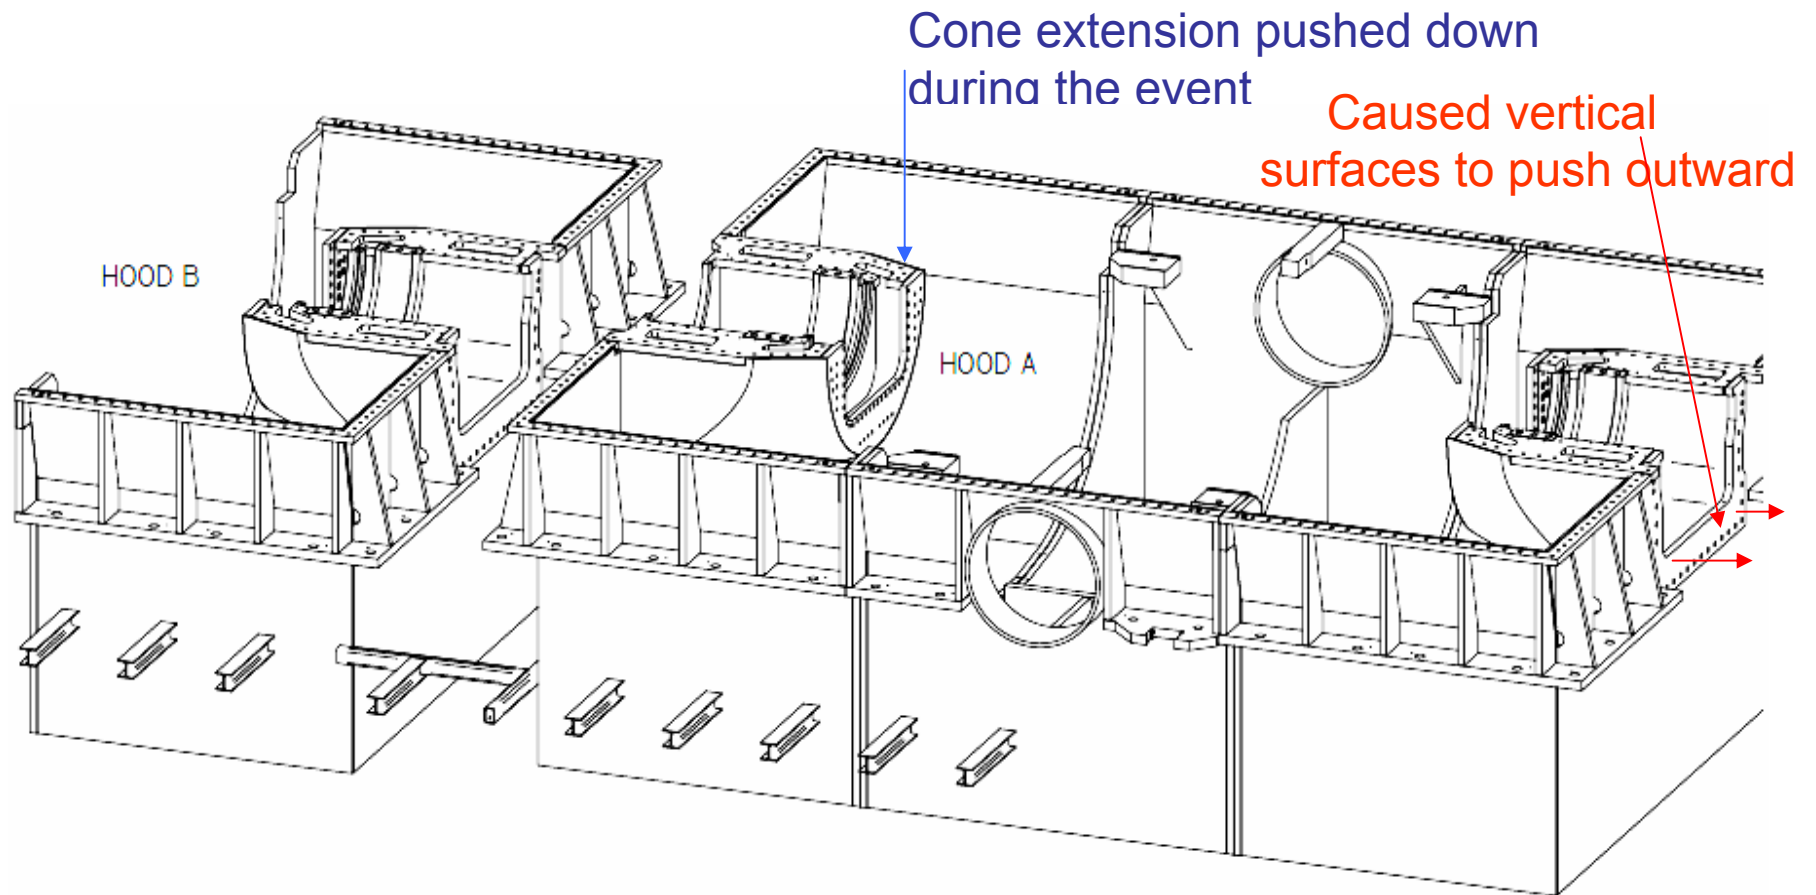
Lower Exhaust Hood (LEH)

- Structural supports and struts damaged
 - Grout cracking and foundation bolts damaged
 - Cone extension have moved
-
- LEHs required extensive repairs and are now complete
