SUBJECT: PUBLIC MEETING SUMMARY– REGULATORY CONFERENCE FOR
BROWNS FERRY NUCLEAR PLANT, DOCKET NO. 50-259

REGULATORY CONFERENCE
 TENNESSEE VALLEY AUTHORITY
 APRIL 04, 2011
 NRC REGION II, ATLANTA, GEORGIA

**TENNESSEE VALLEY AUTHORITY
BROWNS FERRY NUCLEAR PLANT, UNIT 1**

**Low Pressure Coolant Injection Valve
1-FCV-74-66**

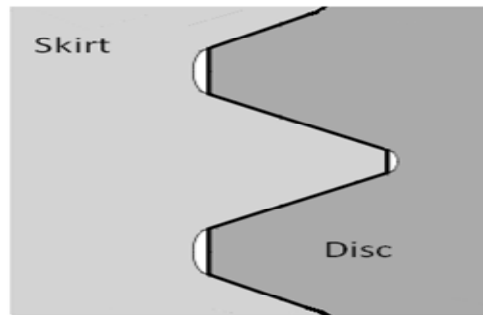
As-Designed Thread

Root Cause – Disc Separation Forensics (Disc/Skirt Threads)

- The valve was purchased as an assembly that would not be taken apart to perform receipt inspections
 - Undersized skirt thread diameter caused the threaded connection between disc and skirt to be 38 percent of design strength

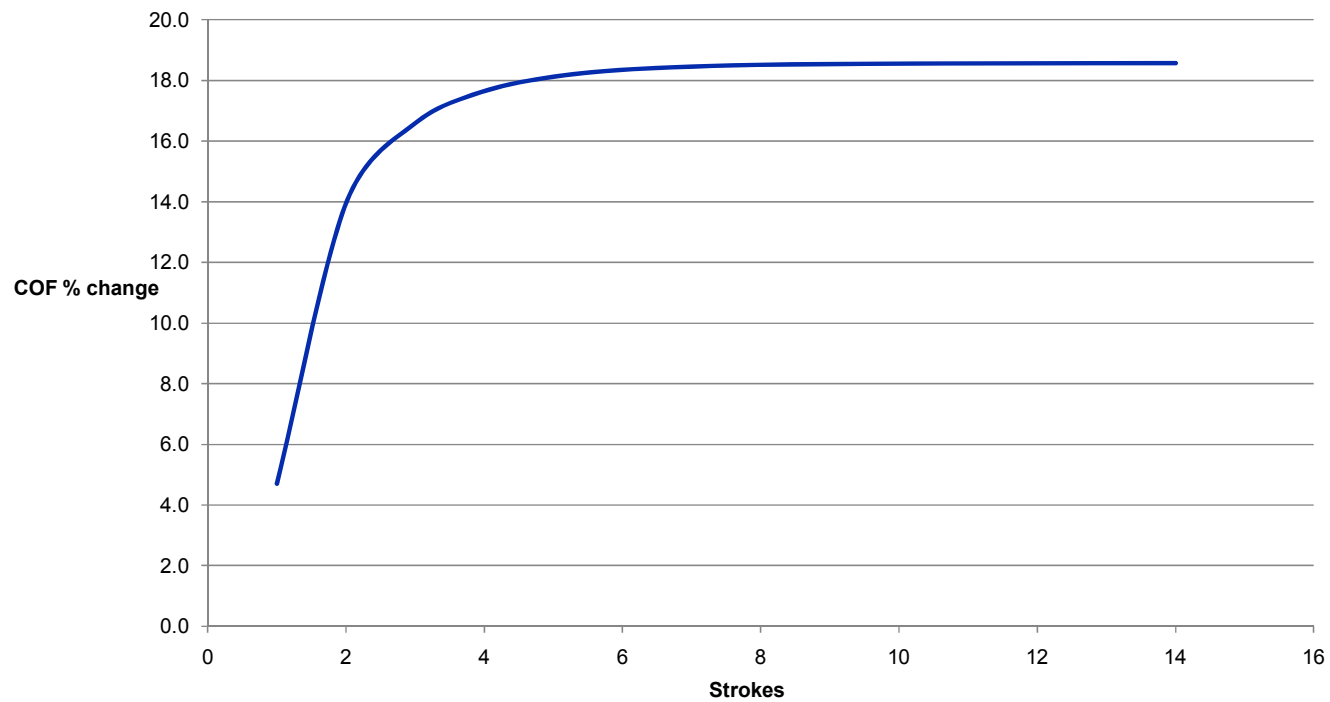
Appendix R (limiting scenario) Percent Friction Change Needed

Analysis of Force Balance and Coefficient of Friction Significance *(continued)*
