Report of Japanese Government
to the IAEA Ministerial Conference on Nuclear Safety
- The Accident at TEPCO's Fukushima Nuclear Power Stations -

June 2011

Nuclear Emergency Response Headquarters
Government of Japan

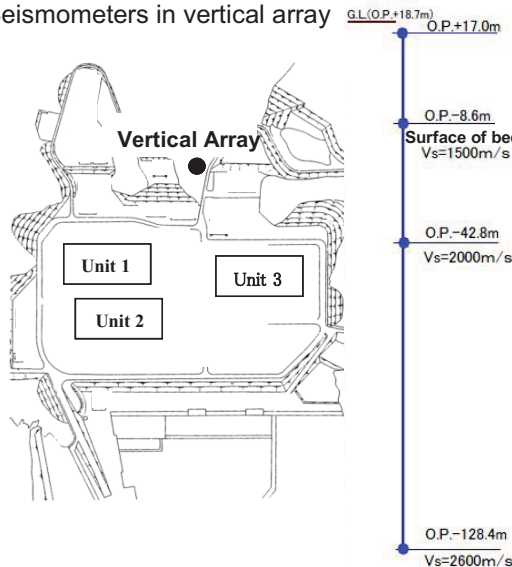
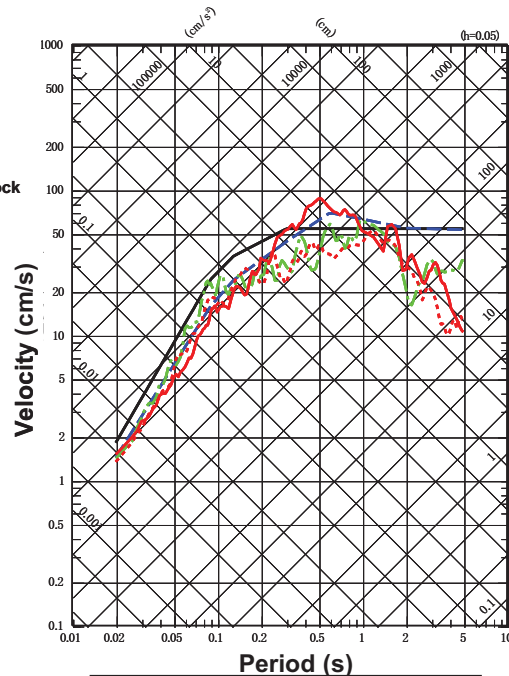
Fig. III-3-1 Deployment of seismometers and comparison of observed response spectra with the DBGM Ss on a free surface (equivalent to the base stratum) at Onagawa NPS.

Figure III-3-1 shows a comparison between response spectra of the observed seismic ground motions at the upper part of the bedrock on the site and response spectra for the standard seismic ground motion Ss. Response spectra of the observed seismic ground motions exceed response spectra for the standard seismic ground motion Ss in the periodic band between 0.2 and 1.0 sec.

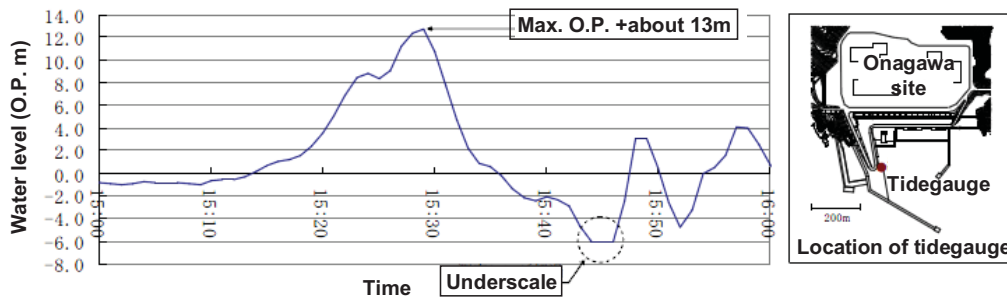
Fig. III-3-3 Time history of water level changes observed at Onagawa NPS.

Figure III-3-3 shows the tsunami time history recorded by the tide gauge. From the record, it can be seen that the first big wave arrived at about 15:29 (43 min after the main shock). The observed tsunami height was about 13 m relative to O.P. (O. P.: the reference surface for construction of Onagawa NPS), which did not exceed the height of the site, i.e. 13.8 m relative to O.P. (the real height of the site is 14.8 m, adjusted to sinking by about 1 m due to crustal deformation, according to the Geographical Survey Institute QE, see Figure III-3-4). Although seawater was found to have entered the sea-facing side of the site, it did not reach the major buildings.

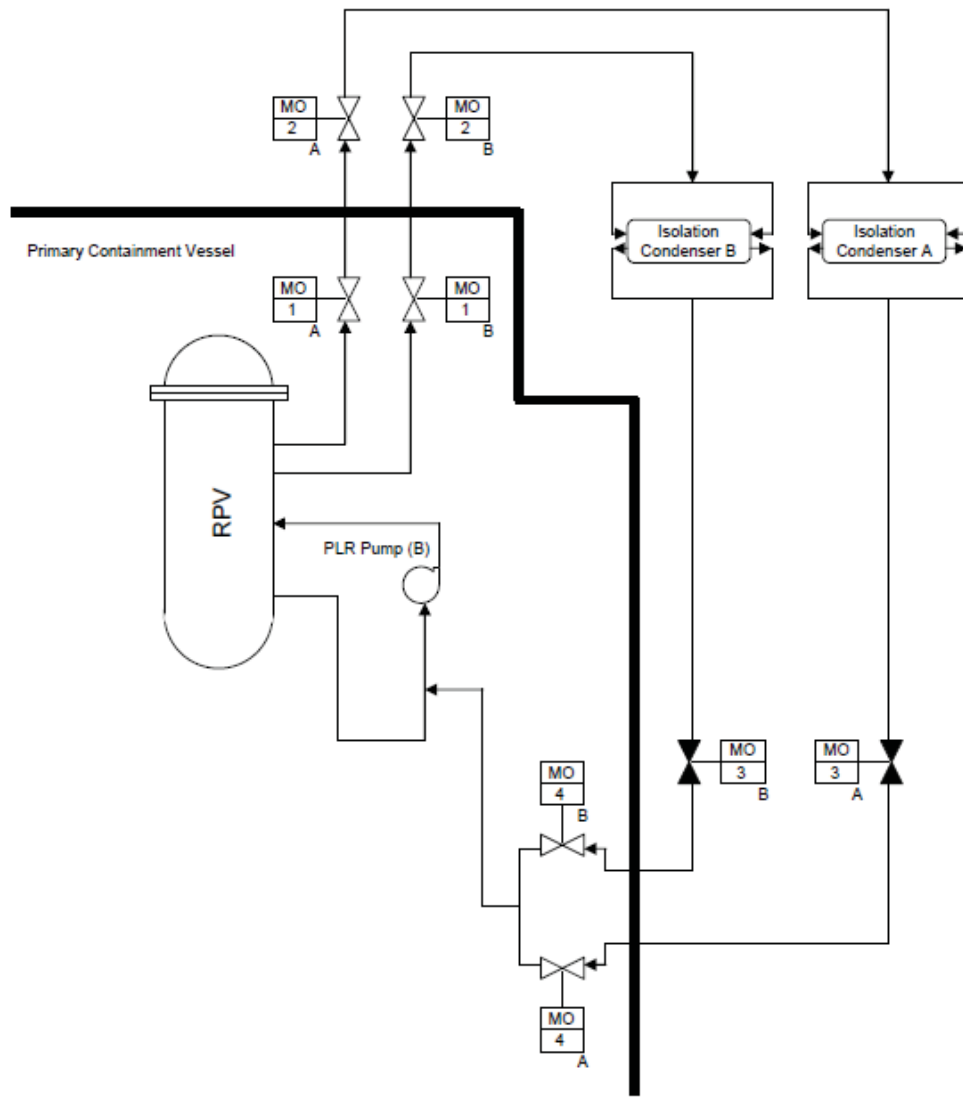
Fig. IV-2-4 System Structure Diagram of Isolation Condenser (Unit 1)

- *1: During normal operation (in a standby condition), MO-1, 2 and 4 valves are "open" and MO-3 valve is "close". At startup, MO-3 valve is "open".
- *2: MO-1 and 4 valves are inoperative due to AC power loss. (as-is)
- *3: MO-2 and 3 valves are inoperative due to DC power loss (the same power source as isolation logic circuits). (as-is)
- *4: During DC power loss, isolation (close) logic circuits are operative.
At that time, if the drive power of each valve (written in *2 and *3) is activated, each valve is closed. If the drive power of each valve is lost, the valves are inoperative. (as-is)

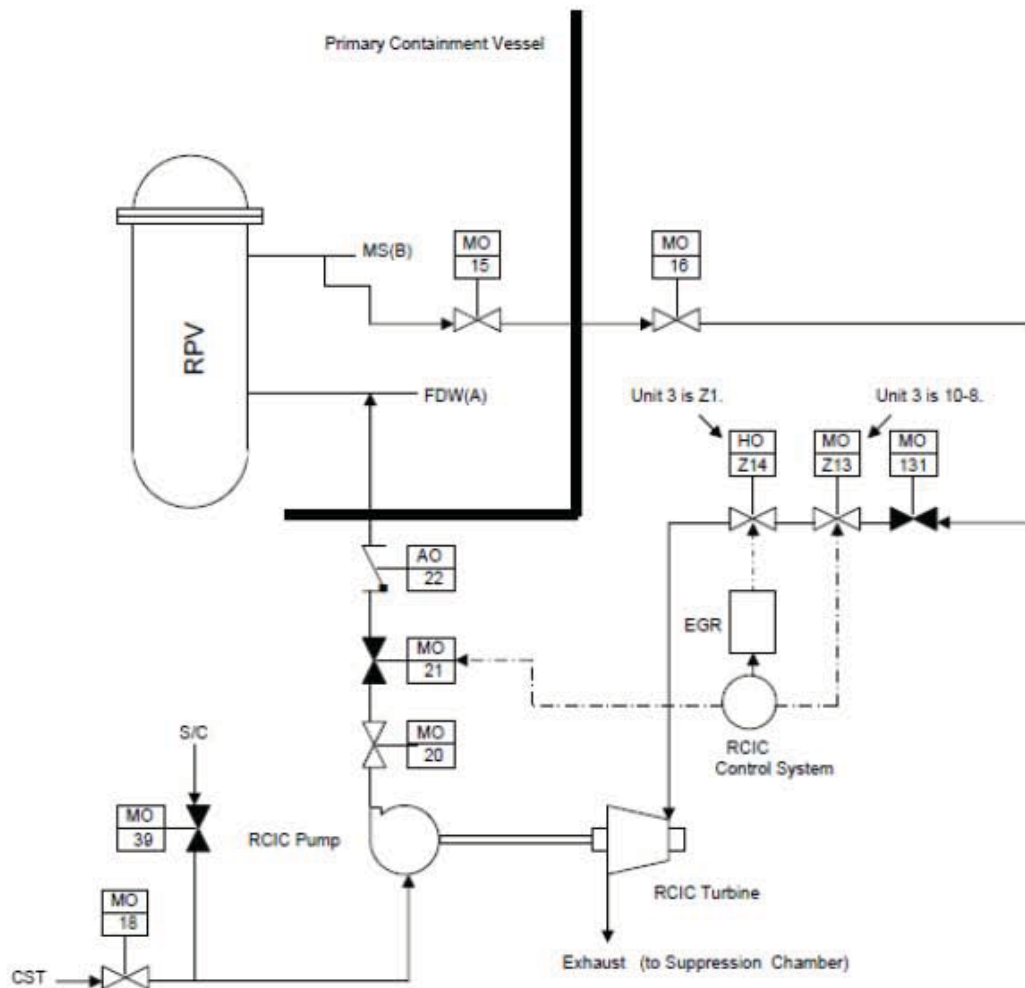
Fig. IV-2-5 System Structure Diagram of Reactor Core Isolation Cooling System (Units 2 and 3)

- *1: During normal operation (in a standby condition), MO-15, 16, 18, 20 and Z13 valves and HO-Z14 are "open" and MO-131 and 21 valves are "close".
At startup, 131 and 21 valves are "open".
- *2: MO-15 valve is inoperative due to AC power loss. (as-is)
- *3: MO-16, 18, 20, 21 and 131 valves are inoperative due to DC power loss (the separate power source from isolation logic circuits). (as-is)
- *4: During DC power loss, isolation (close) logic circuits are operative.
At that time, the drive power of each valve (written in *2 and *3) is activated, each valve is closed. If the drive power of each valve is already lost, the valves are inoperative. (as-is)

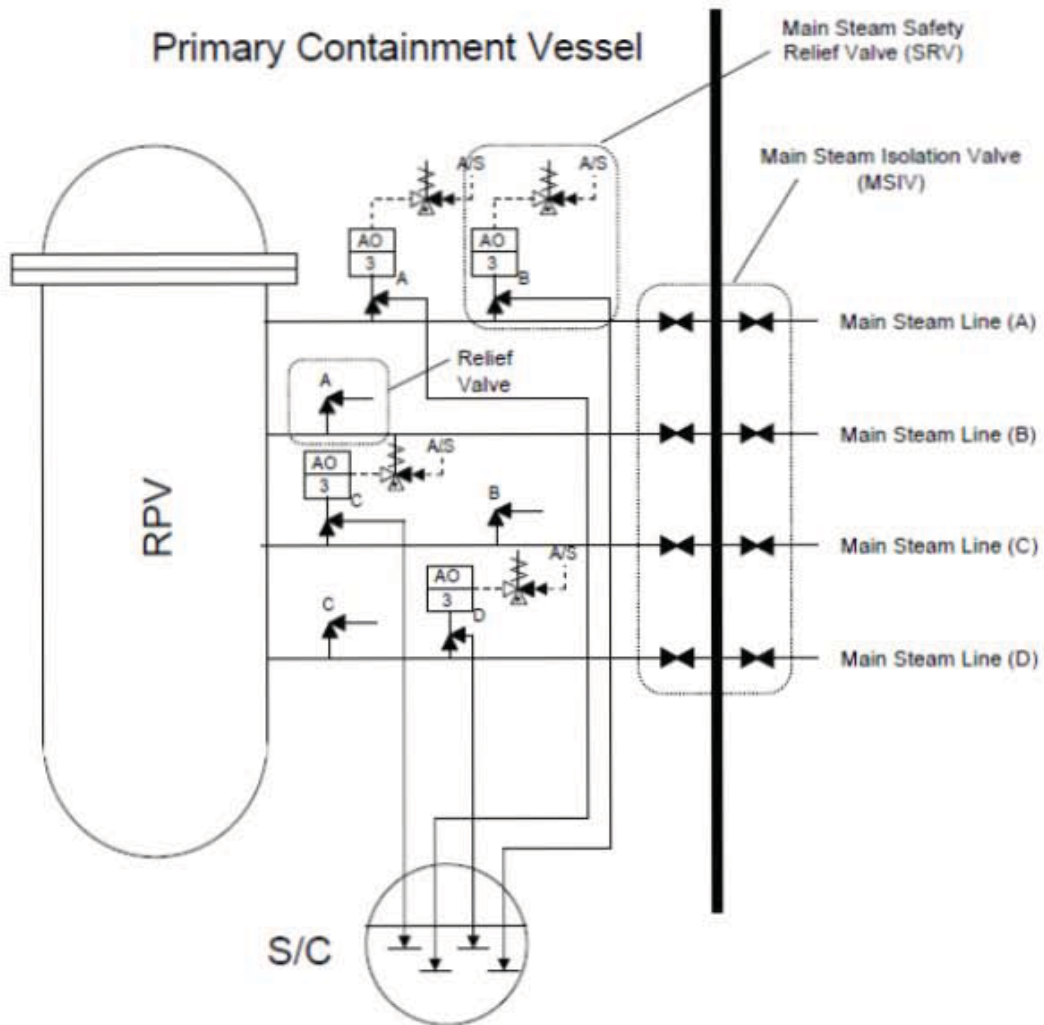
Fig. IV-2-6 System Structure Diagram of Main Steam Safety Relief Valve
(Unit 1)

*1: The main steam safety relief valves (4 valves) are AO valves, and open drive air is supplied by the energized solenoid valves of air supply lines. During power loss, solenoid valves become deenergized and main steam relief valves are in a closed condition.

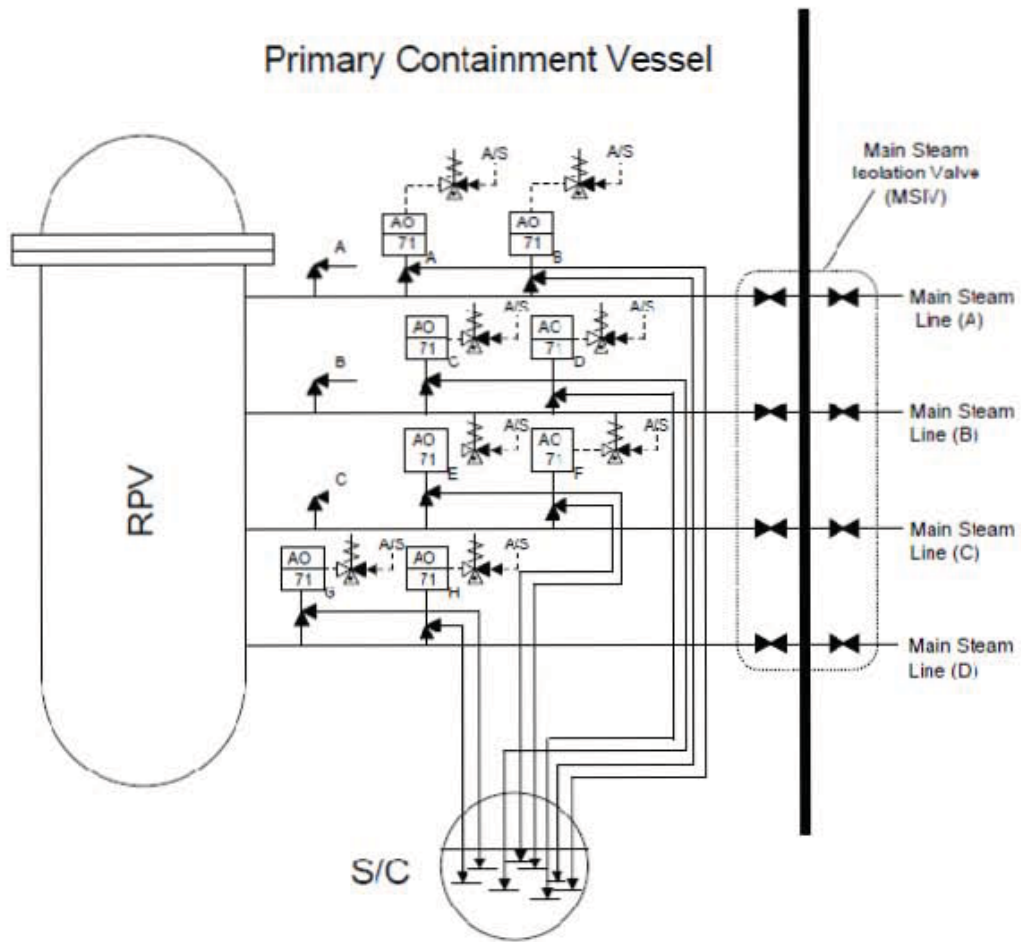
Fig. IV-2-7 System Structure Diagram of Main Steam Safety Relief Valve (Units 2 and 3)

*1: Main steam safety relief valves (8 valves) are AO valves, and open drive air is supplied by the energized solenoid valves of air supply lines. During power loss, solenoid valves become deenergized and main steam relief valves are in a closed condition.

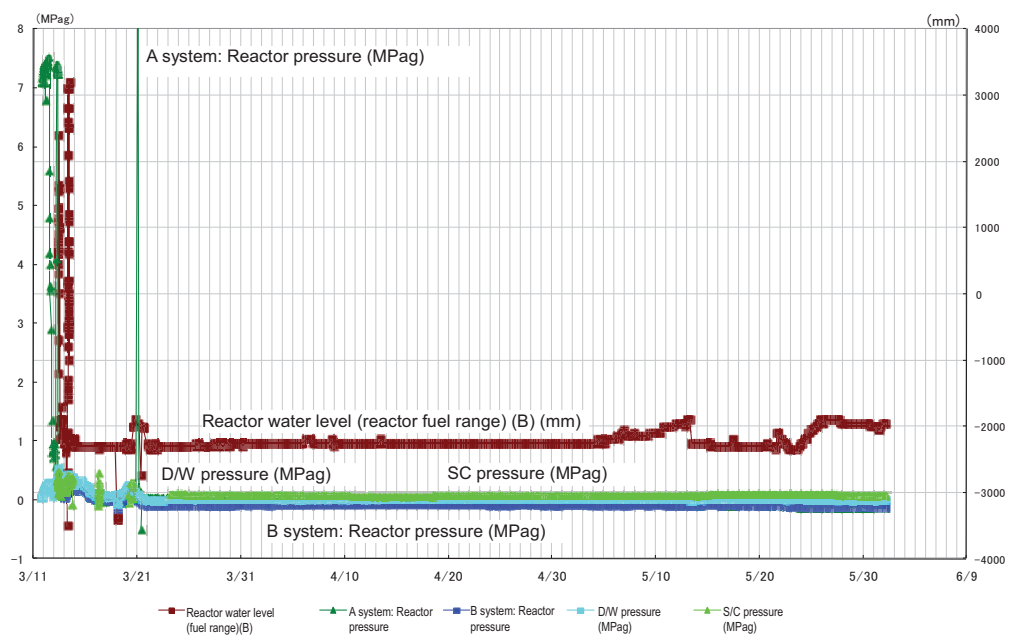
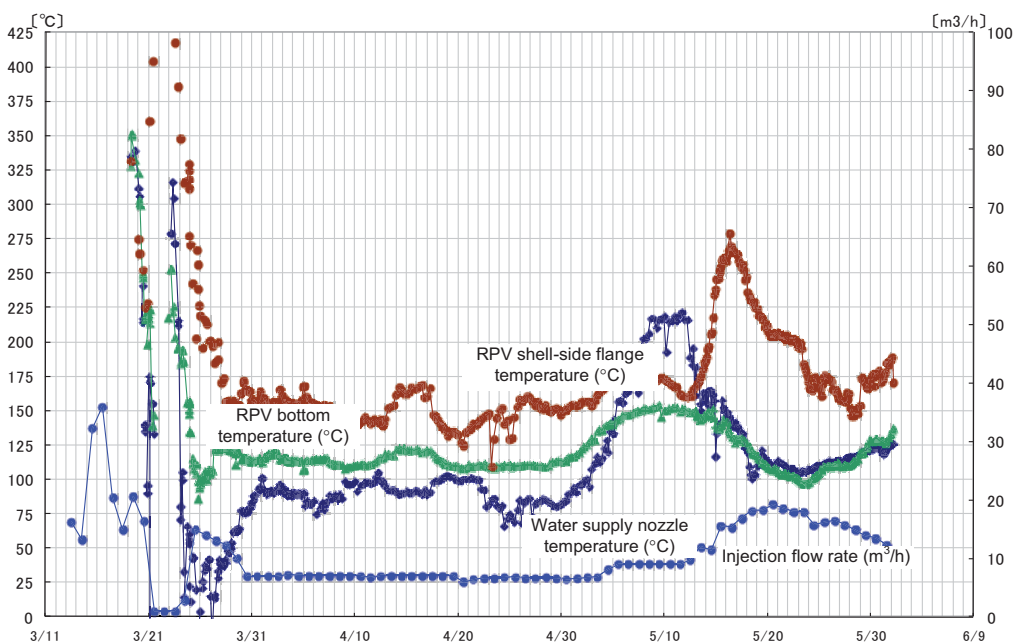
Figure IV-5-7 Changes of Main Parameters (1F-3) (March 11 to May 31)

Some RPV temperatures exceeded the measurable range (higher than 400°C) due to the lower injection flow rate caused by the increase of RPV pressure on March 20, but the temperature dropped through the securing of injection flow rate on March 24 and stayed around 100°C. Accordingly a considerable amount of reactor fuel may remain within the RPV. It cannot be denied at this moment that the bottom of the RPV might get

As the pressure of D/W and S/C exceeded the maximum operating pressure (0.427 MPag) of the PCV to reach about 0.5 MPag on March 13, it is assumed at this moment that the performance of the gaskets of flanges and the seals of penetrations deteriorated. The D/W pressure is maintained around the atmospheric pressure (0 MPag). Therefore, it is assumed at this moment that the vapor generated by decay heat may be released to the outside through D/W.

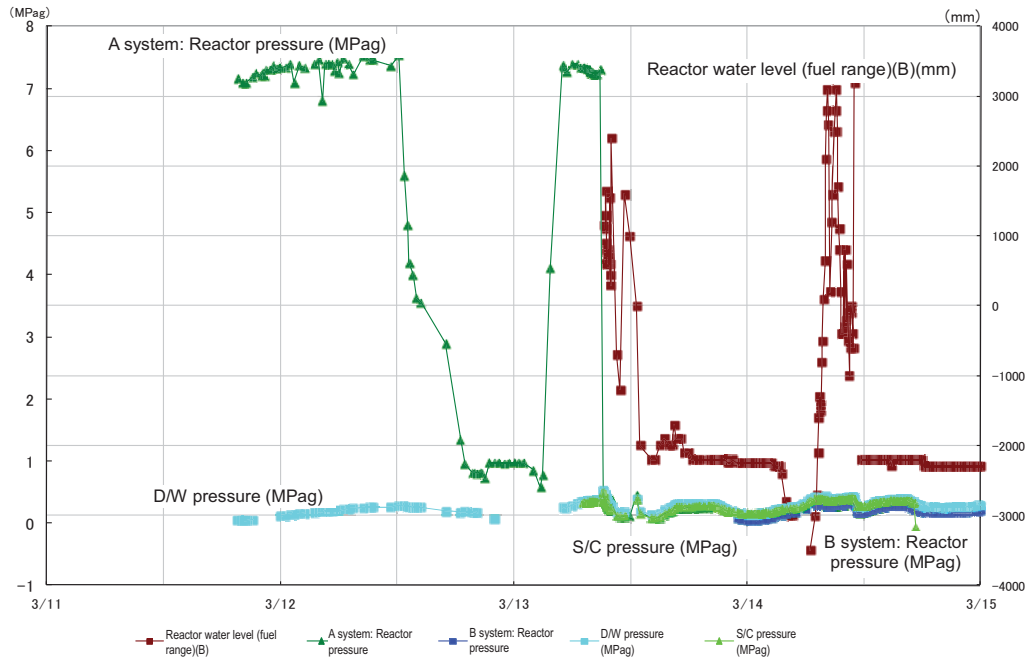
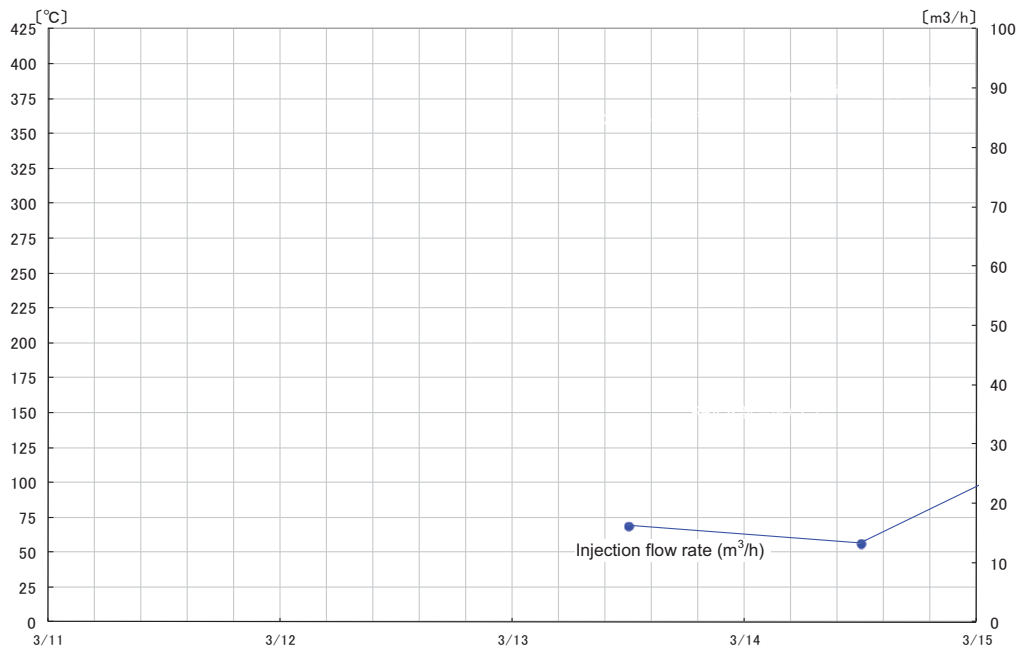
Figure IV-5-8 Changes of Main Parameters (1F-3) (March 11 to March 15)

Considering that the reactor pressure dropped for more than six hours from 12:30 on March 12, it is considered unlikely that a large-scale pressure leak occurred. Steam may have leaked from the HPCI, since the pressure began to drop at around the same time as the HPCI started and the reactor pressure began rising after the HPCI stopped.

around the 7 MPa level, during which time it is estimated that the reactor water dropped and the reactor fuel was damaged.

It is estimated that the main steam SRV opened to lower the reactor pressure, and at 9:25 on March 13 alternative injection was carried out and wet vent operation done in response to the increase in PCV pressure. It was reported that the alternative injection from fire engines was executed, but this measure could not demonstrate the required performance due to the relation with the reactor pressure, etc. as the water level has not been restored yet. More detailed investigations and analyses of the conditions/situations of equipment would be necessary in order to find out to what extent such measures worked.

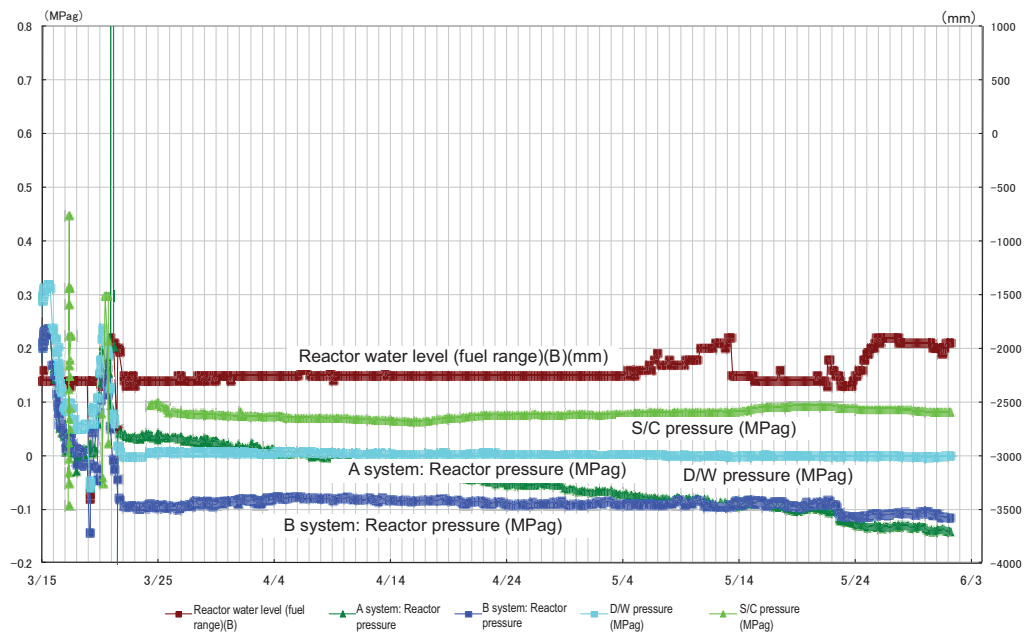
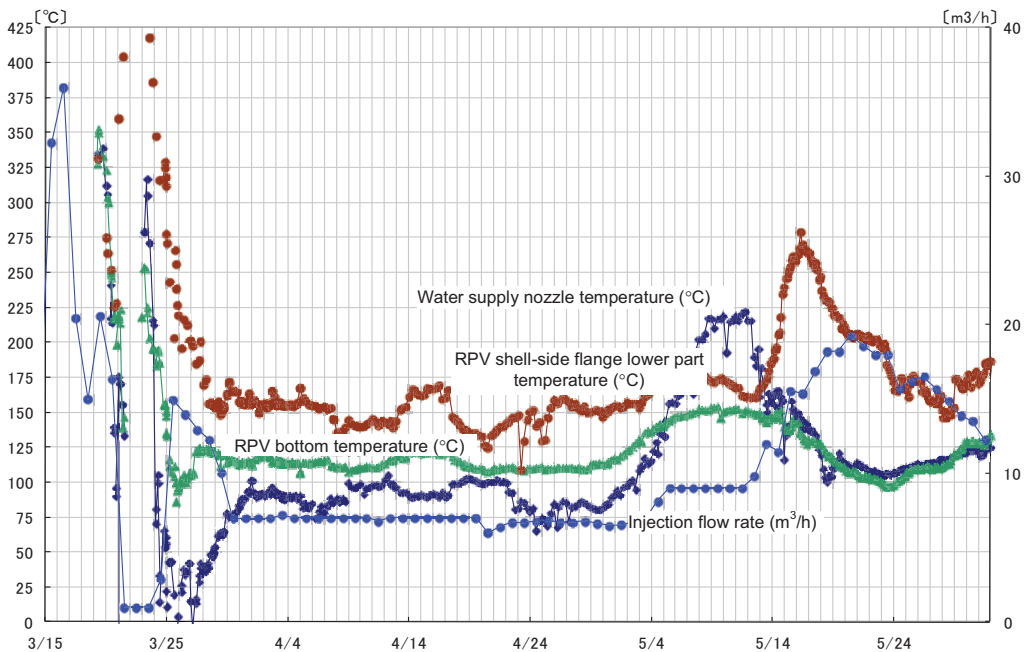
Figure IV-5-9 Changes of Main Parameters (1F-3) (March 15 to May 31)

The study was done on plant data obtained during the period from March 15 to May 31, when the plant was in a comparatively stable condition, and the plant data from this period was handled as shown below.

According to the information of the Tokyo Electric Power Co., Inc. (TEPCO), the total injection amount to RPV up to May 31 is considered to be about 20,700 tons. The total amount of vapor generated from the start of injection is about 8,300 tons when the decay heat is estimated on the outside in the decay heat evaluation formulation. If the pressure boundary is secured, a difference of about 12,400 tons at least may be kept there. As the capacity of RPV is 500 m³ at most, the injected water may not only evaporate within RPV and leak as vapor, but also may leak as water. The injection to RPV was executed through the nozzles of recirculating water inlet and water supply equipment. The water injected through the nozzle of water supply equipment would gather once in the outside of shroud (from about 17:00 May 21 to about 23:00 May 28) and then would move to the bottom of RPV via the jet pump diffuser to cool the reactor fuel. The water is very likely to leak to outside at this portion.

From the balance between the injected water volume and volume of steam produced, it is estimated that the water injected into the RPV is leaking.

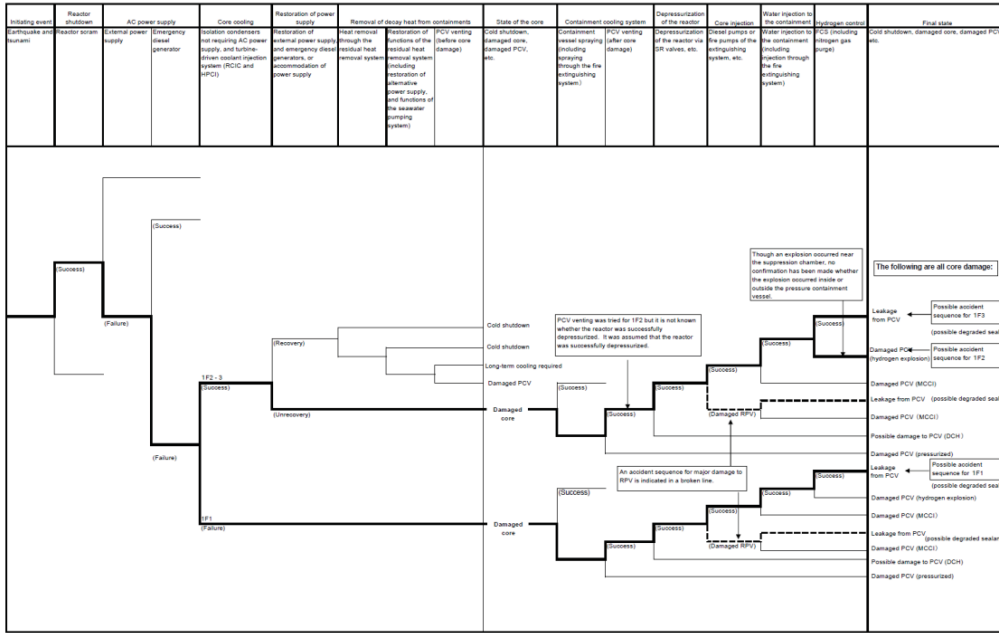
Figure IV-7-1 Function Event Tree of Unit 1 to Unit 3 at Fukushima-Dai-ichi NPS

The PCV pressure increased in Unit 3 during this time. For depressurization, spray to the S/C was used, and it was confirmed that the accident management system functioned properly. In units 1 and 2, the PCV vent was superseded, and thus the PCV spray (D/W and S/C) was not performed.
