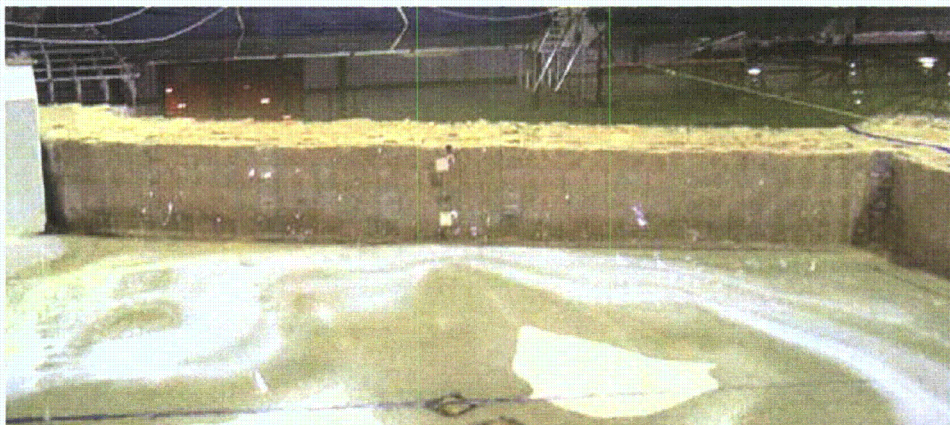
Hydrostatic head test, 2-ft reservoir (66 percent height). The water level in the reservoir on the pool side of the levee was raised to a height of 2 ft (66 percent of levee height). Seepage flow rate was measured in the range from 0.063 to 0.089 gpm/ft (Figure 2-129), and no horizontal displacement was observed. However, vertical settlement or subsidence can be seen in Figures 2-130 through 2-132. A white liquid can be seen in the seepage through the levee as shown in Figure 2-130.

Figure 2-130. View of seepage under left wall

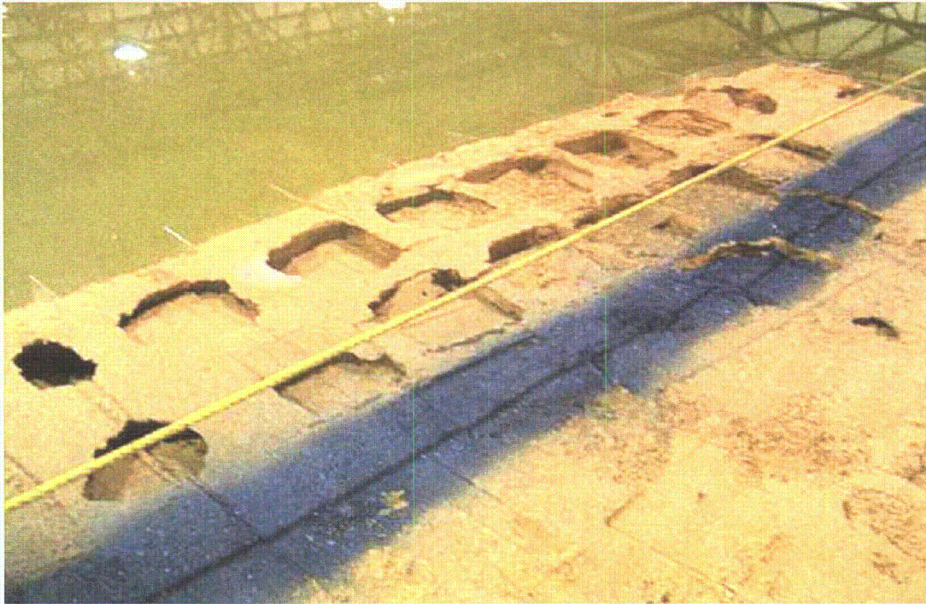
Figure 2-131. Sand subsidence in outer grid cells along center wall

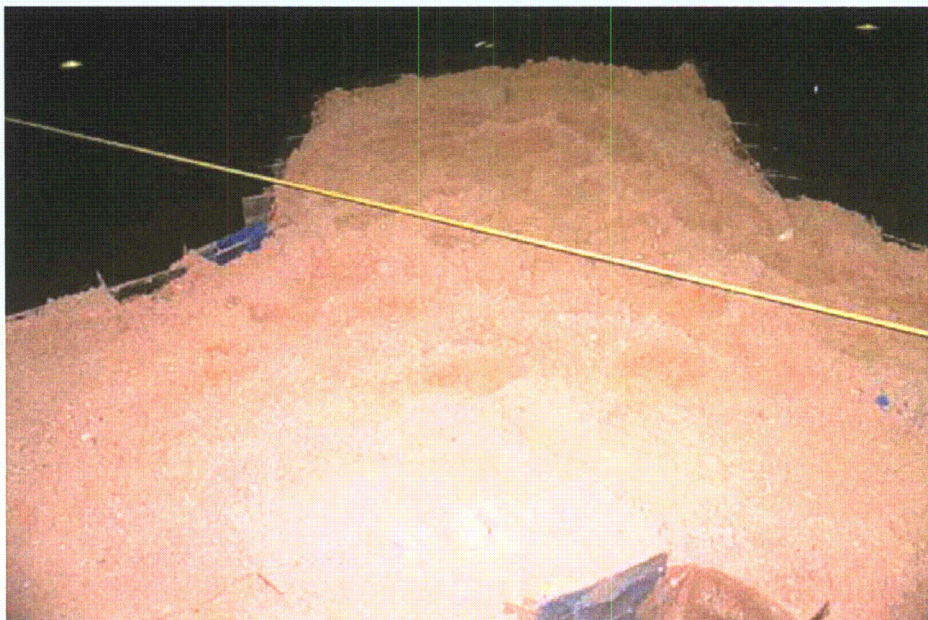
Minimum subsidence of the sand in the grid units was noted at test conclusion. Figure 2-138 shows the left wall buttress and Figure 2-139 shows the right wall buttress, viewed from the lee side.

Figure 2-138. Left wall buttress

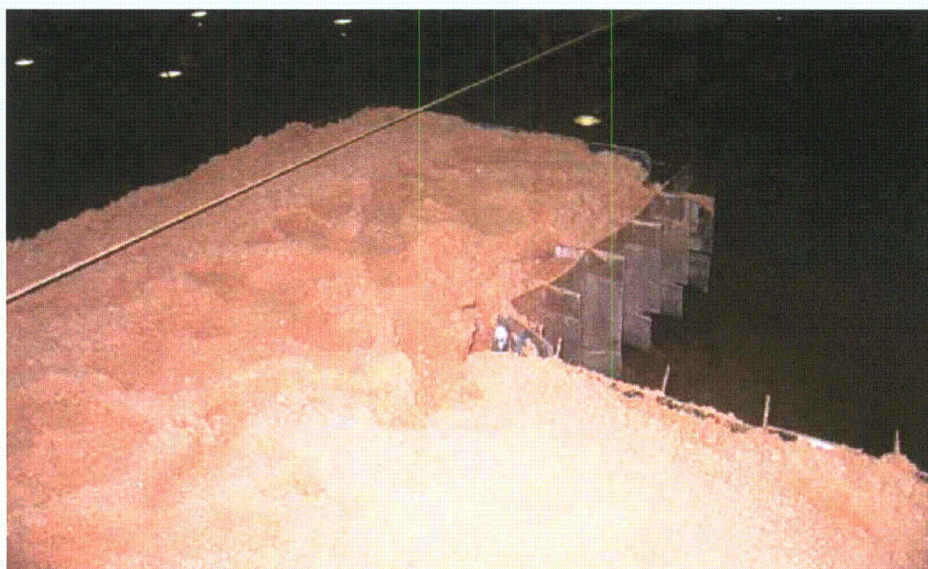
Figure 2-139. Right wall buttress

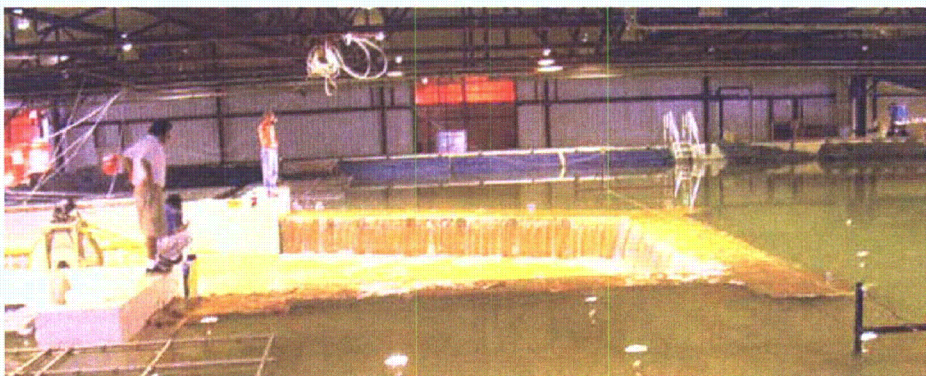
Figure 2-157 shows an overall view of the overtopped levee. Figure 2-158 shows a close-up of the left wall with the overtopping test in progress, and Figure 2-159 shows the eroded sand on the concrete floor after the test was concluded.

Figure 2-157. Overtopped levee

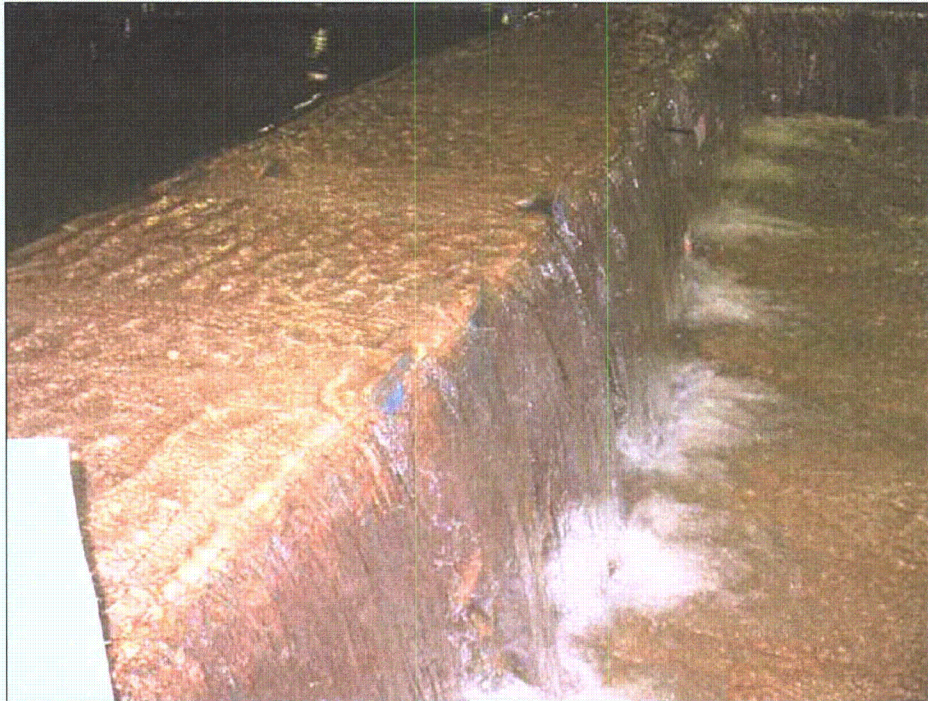
Figure 2-158. View along left wall

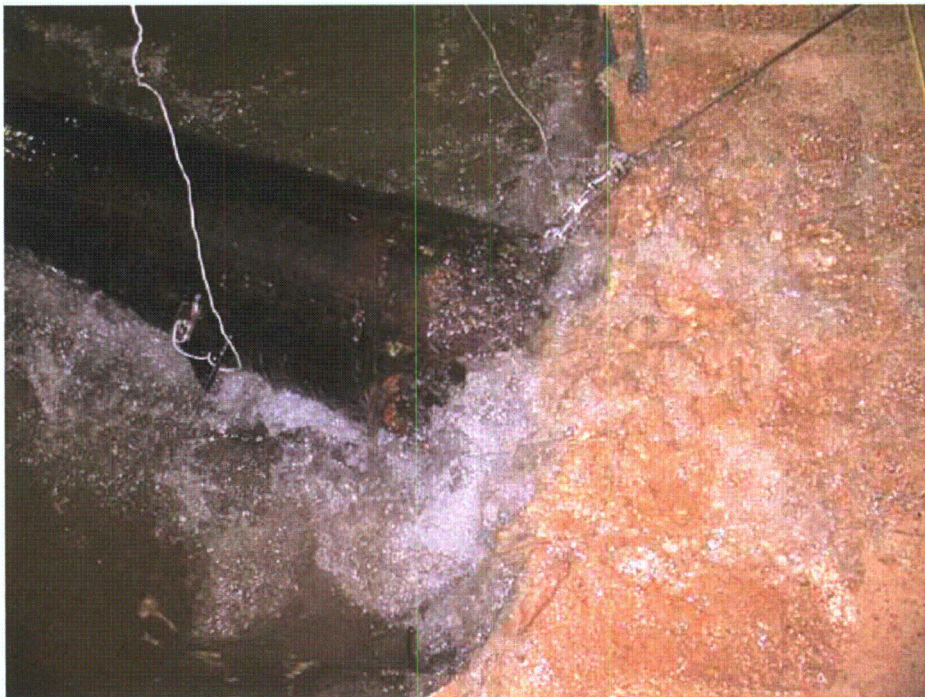
The 12-in. log impacted the structure and bounced back without any noticeable damage to the structure. The structure responded to the impact but did not permanently displace. The 16-in. log (Figure 2-160) impacted the structure and also bounced back (Figure 2-161) without causing any noticeable damage or permanent displacement.

Figure 2-161a. Log impact

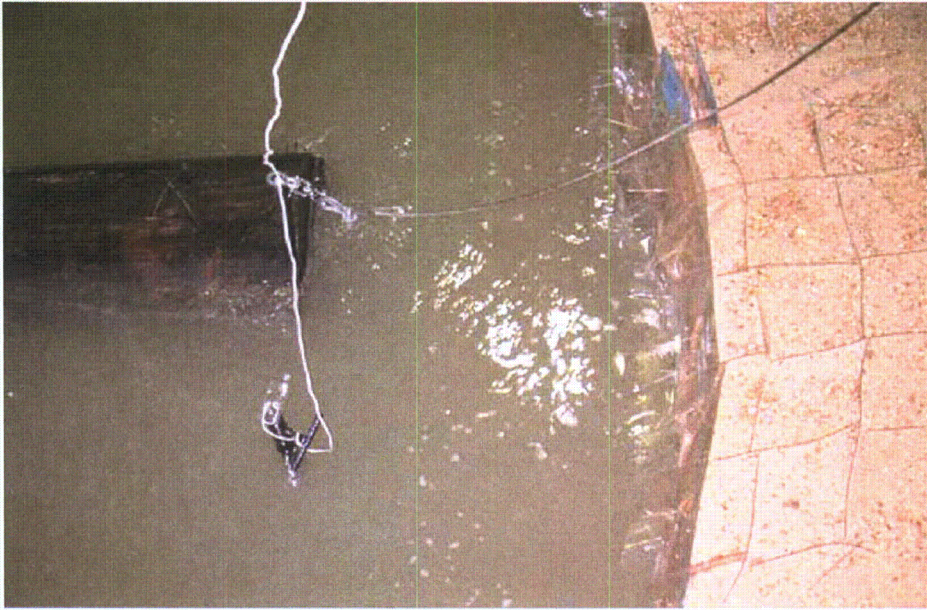
Figure 2-161b. Bounce-back

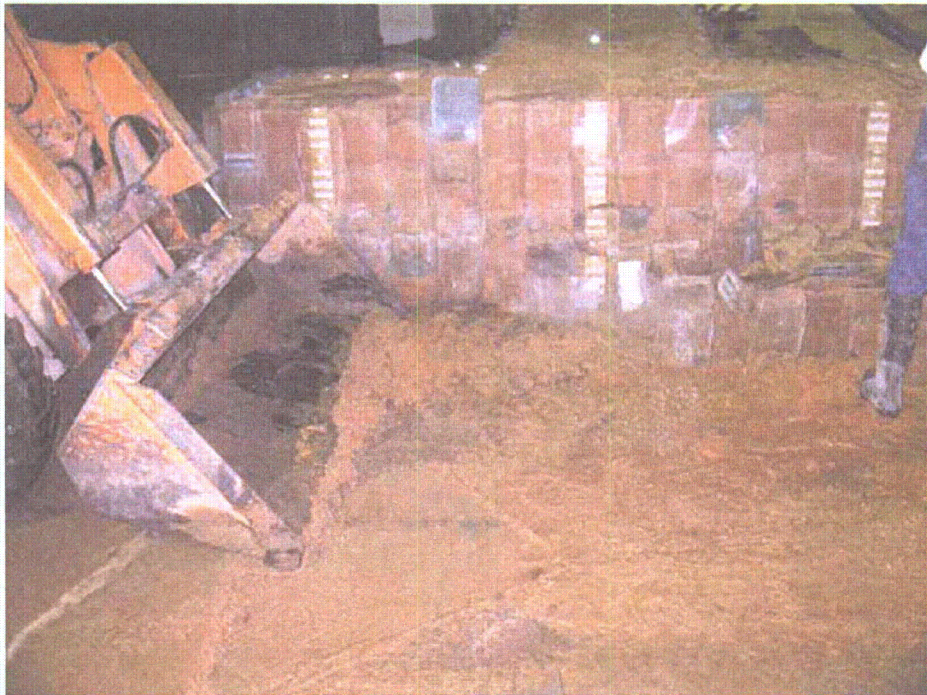
Figure 2-162. Scooping up eroded sand along toe grid units

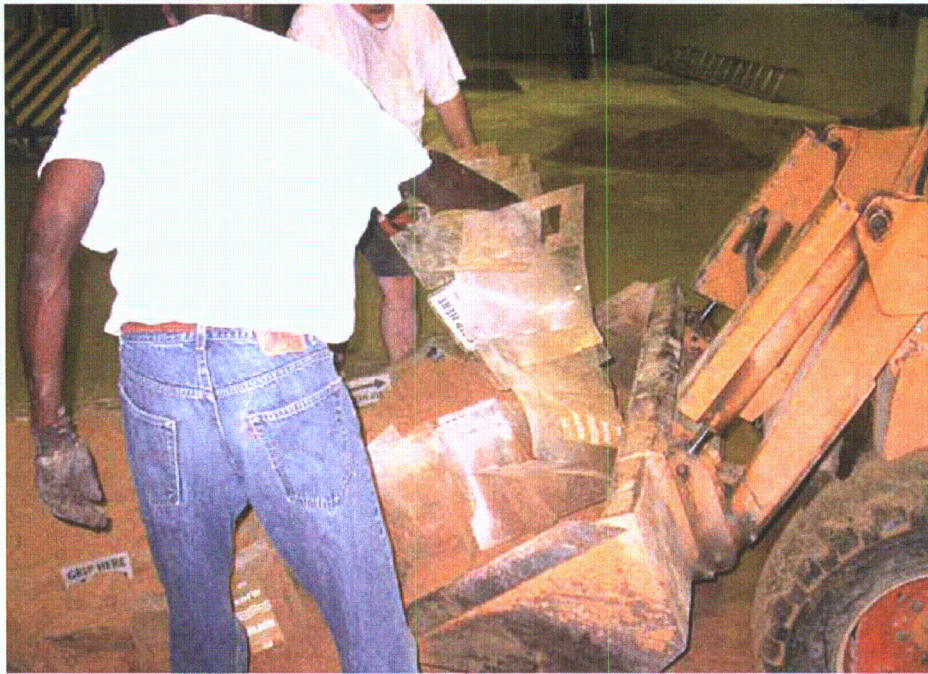
Figure 2-182. Removing grid unit/sand combination

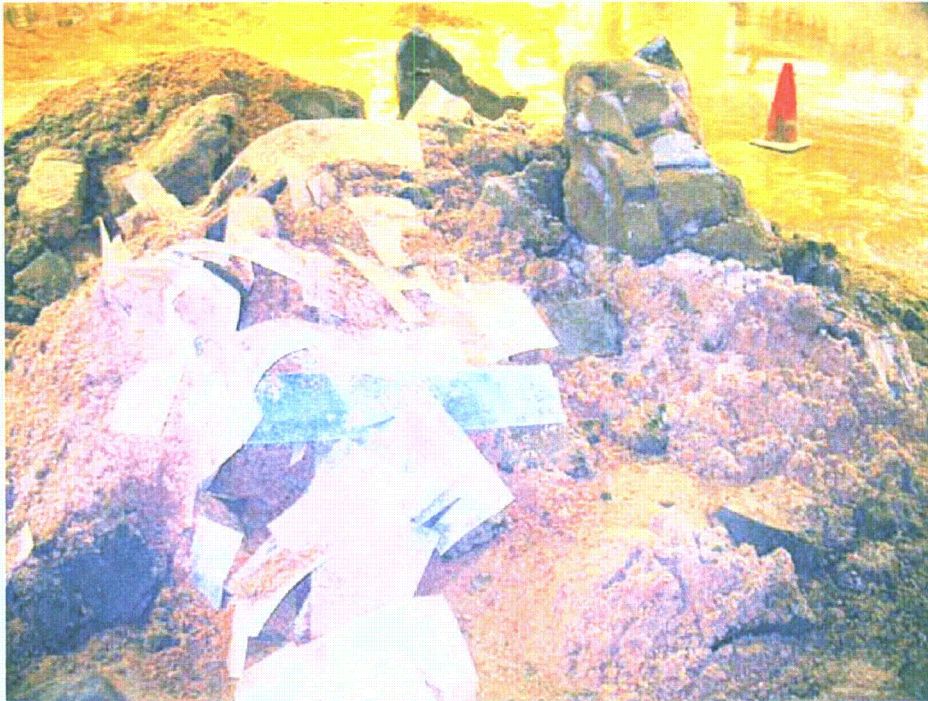
The preceding sequence was repeated for each grid unit layer until the entire levee structure was disassembled. Figures 2-178 through 2-182 are views of the remainder of levee removal. Assistance from the small front-end loader achieved greater removal speed, but decreased the reusability of the grid units due to damage. Figure 2-184 shows a debris pile of nonreusable grid units mixed with sand and sand/cement materials.

Due primarily to the effects of disassembly, approximately 10 percent of the plastic material was nonreusable and nonrepairable. According to the manufacturer's literature, normally-anticipated breakage is repaired by replacing the broken grid unit piece or by reinforcing the broken piece. Manufacturer stipulations apply regarding reusability and placement of repaired grid units back into service.

Figure 2-184. Nonreusable grid units, sand, and sand/cement mixture ready for disposal

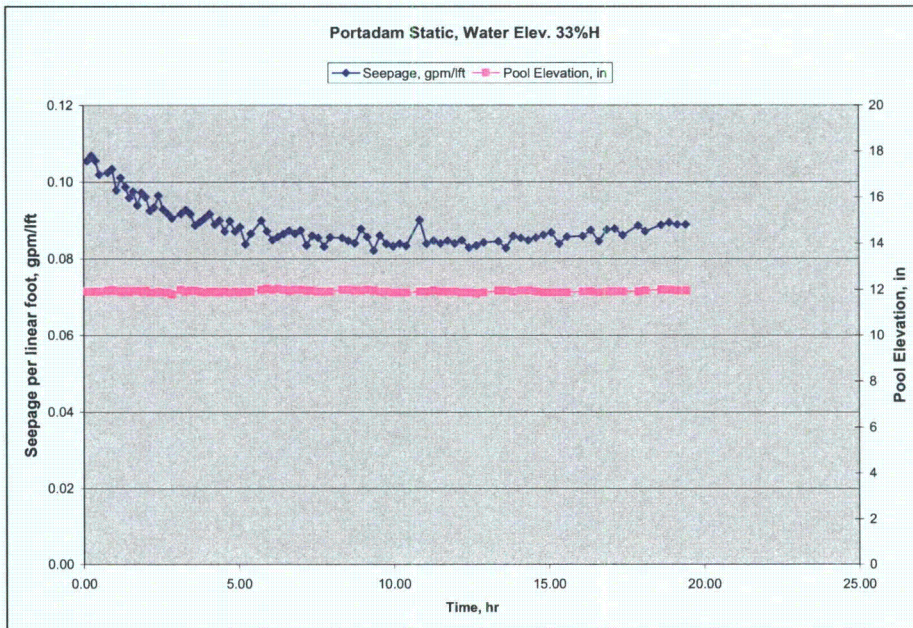
0.08 to 0.11 gpm/ft (Figures 2-216 and 2-217). Zero displacement was observed. Prior to the next test, Repair 1 was performed (discussed in the following paragraphs).

Figure 2-217. Seepage flow rate per linear foot at 1-ft pool elevation (33% H)

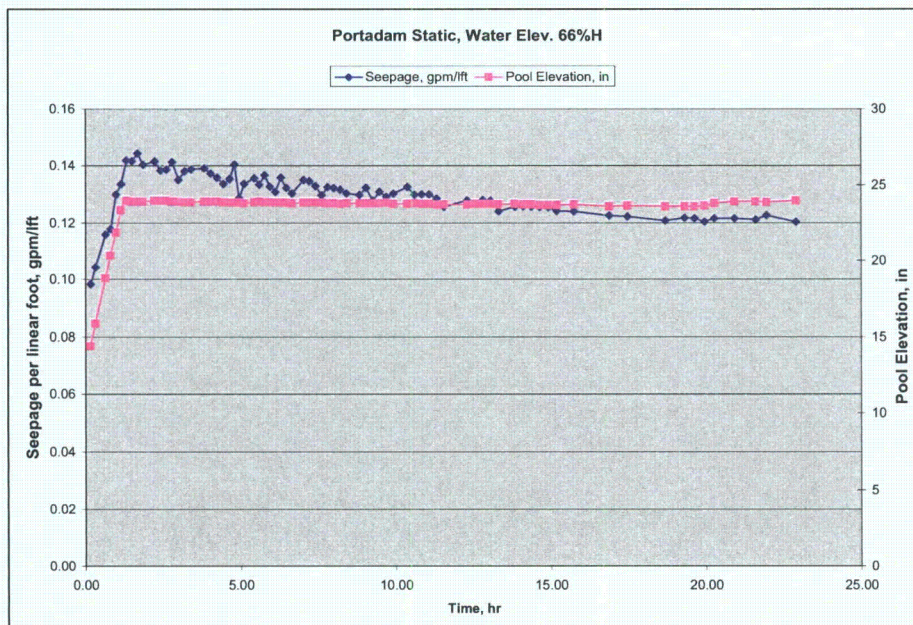
Hydrostatic head test, 2-ft reservoir (66 percent height). The water level in the reservoir on the pool side of the levee was raised to a height of 2 ft (66 percent of levee height). Seepage rate was similar to the 1-ft head test, ranging from 0.12 to 0.15 gpm/ft (Figure 2-218), and no displacement was observed. Figure 2-219 shows a typical view.

Figure 2-218. Seepage flow rate per linear foot at 2-ft pool elevation (66% H)

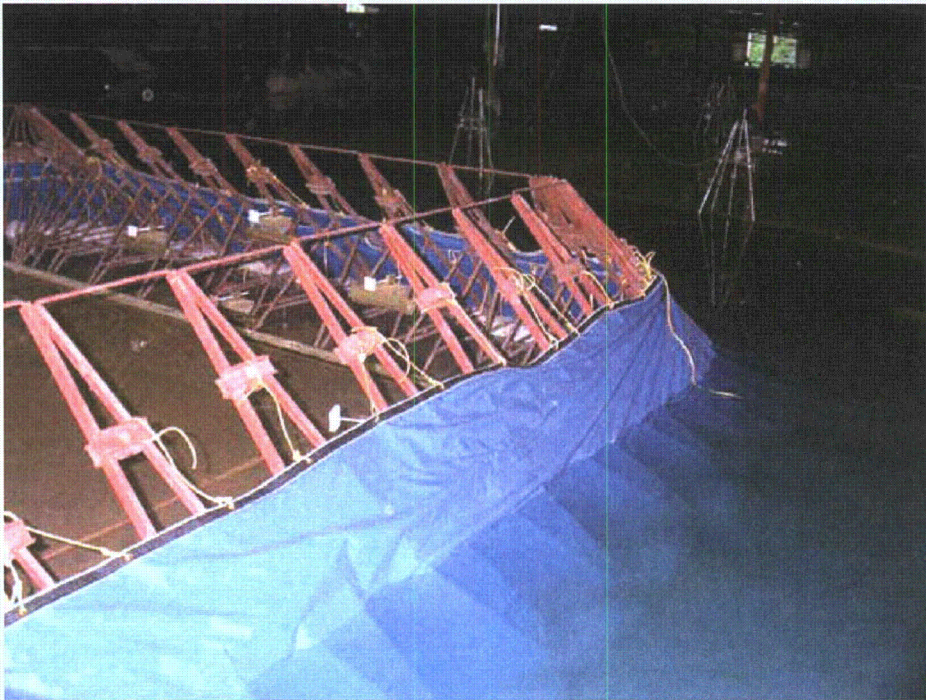
Figure 2-219. View of right wing from pool side, 2-ft hydrostatic head

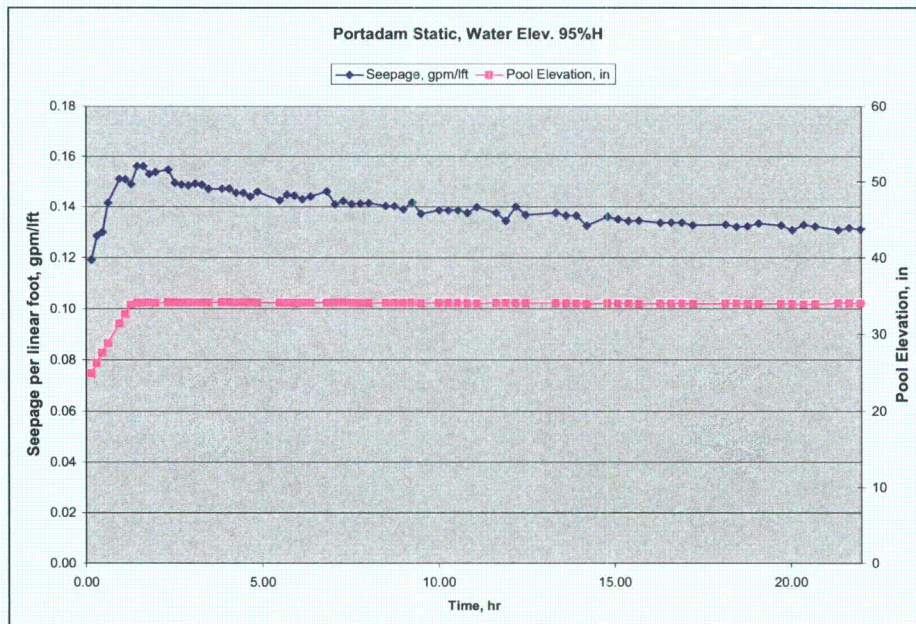
Hydrostatic head test, 3-ft reservoir (95 percent height). The water level in the reservoir on the pool side of the levee was raised to a height of 34 in. (95 percent of levee height). Seepage ranged from 0.13 to 0.15 gpm/ft (Figure 2-220), and zero displacement was observed. Figure 2-221 shows a typical view.

Figure 2-220. Seepage flow rate per linear foot at 95 percent pool elevation
