## Hydrostatic head tests

## **RDFW® Levee Tests**

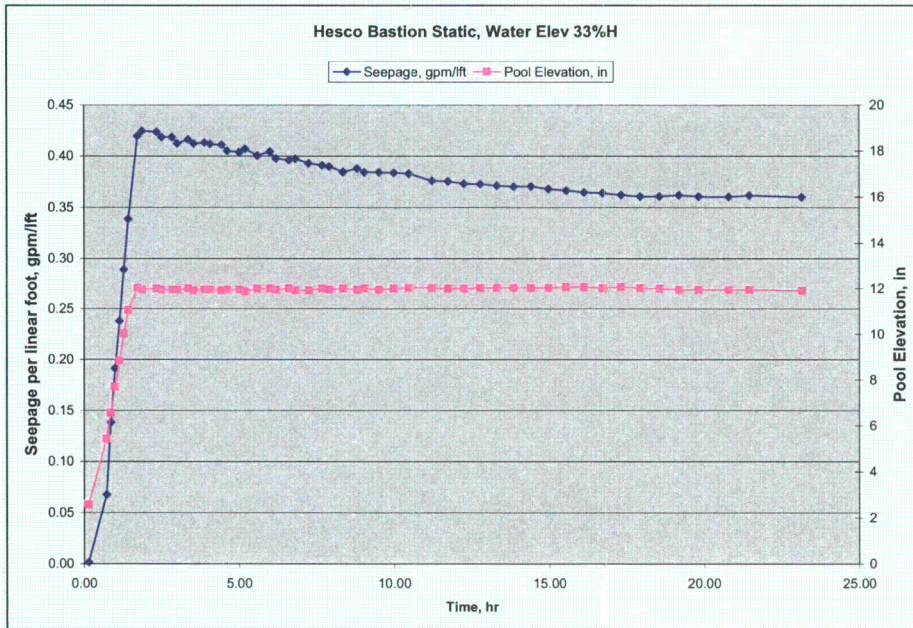
Figure 2-62. Seepage-flow rate per linear foot at 1-ft pool elevation (33% H)

**Hydrostatic head test, 1-ft reservoir (33 percent height).** The water level in the reservoir on the pool side of the levee was raised to a height of 1 ft (33 percent of the levee height). Seepage flow rate ranged from 0.36 to 0.42 gpm/ft (Figure 2-62), and no displacement was observed. Most of the flow rate was observed coming from the wall corners, and the vertical joint between unit ends.

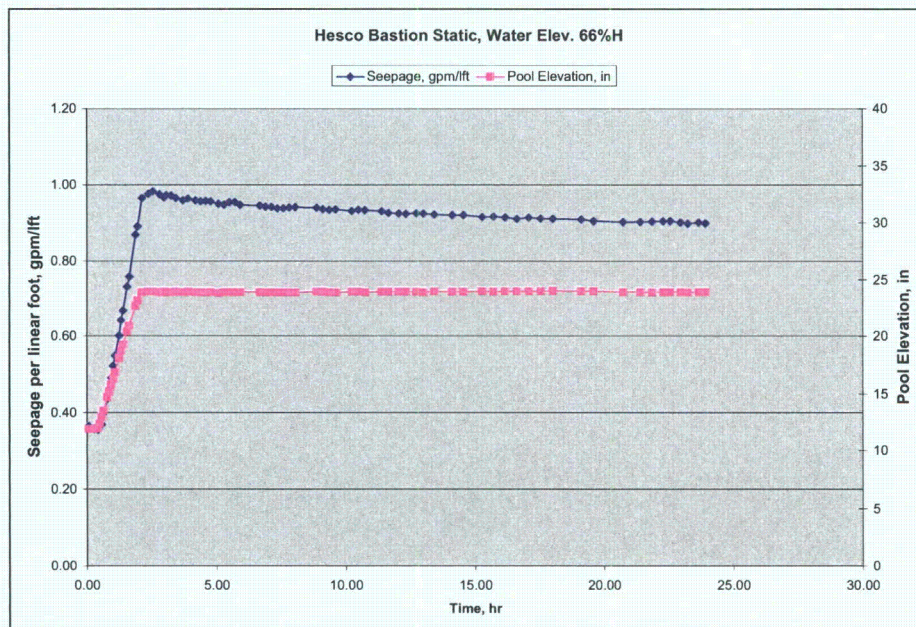
Figure 2-65. Seepage flow rate per linear foot at 2-ft pool elevation (66% H)

**Hydrostatic head test, 2-ft reservoir (66 percent height).** The water level in the reservoir on the pool side of the levee was raised to a height of 2 ft (66 percent of levee height). Seepage flow rate ranged from 0.90 to 0.97 gpm/ft (Figure 2-65), and no displacement was observed. Most of the flow was observed coming from the wall corners and the vertical joint between unit ends. Figure 2-66 shows the structure from the front.

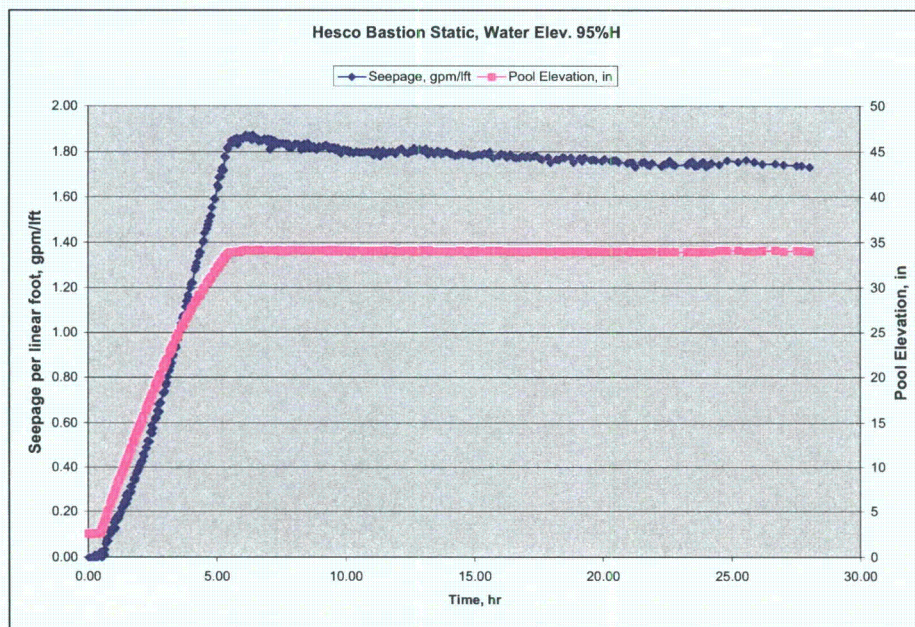
Figure 2-67. Seepage flow rate per linear foot at 95 percent pool elevation

**Hydrostatic head test, 3-ft reservoir (95 percent height).** The water level in the reservoir on the pool side of the levee was raised to an approximate height of 34 in. (95 percent of levee height). Seepage flow rate ranged from 1.76 to 1.86 gpm/ft (Figure 2-67). Lateral displacement ranged from 3 to 9 mm. Vertical deformation was observed to range from 0.24 to 2.28 in., and was assumed to be a result of units “barreling” as the sand became completely saturated. Most of the flow was observed coming from the wall corners and the vertical joint between unit ends.

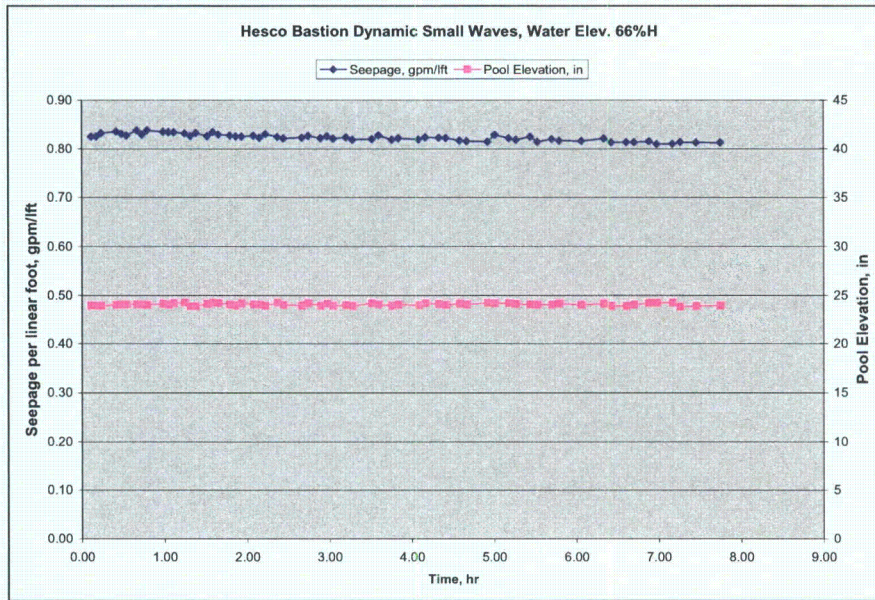
Figure 2-68. Seepage flow rate per linear foot, small wave at 66 percent pool elevation

**3-in. wave test, reservoir level at 66 percent levee height.** The water level in the reservoir of the levee was lowered from the 95 percent level to a height of 24 in. within an interval of about 2 hr. The wave generator was activated and the waves began to impact the levee. Flow rate was observed to range from 0.81 to 0.83 gpm/ft (Figure 2-68), with no displacement. No wave overtopping was observed. Figure 2-69 is a view of the left wall and center wall intersection showing seepage at the wall base.

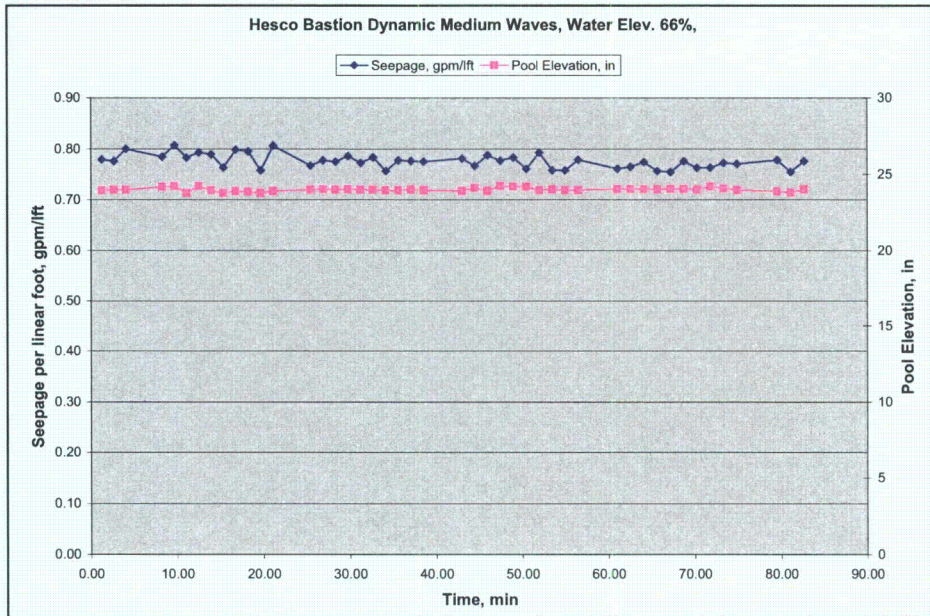
Figure 2-70. Seepage flow rate per linear foot, medium wave at 66 percent pool elevation

**7- to 9-in. wave test, reservoir level at 66 percent levee height.** The water level in the reservoir on the pool side of the levee was held at a height of 24 in., the wave generator was activated, and the waves began to impact the levee. Flow rate was observed to subside within a range of 0.77 to 0.78 gpm/ft (Figure 2-70), with no levee displacement. No wave overtopping was observed.

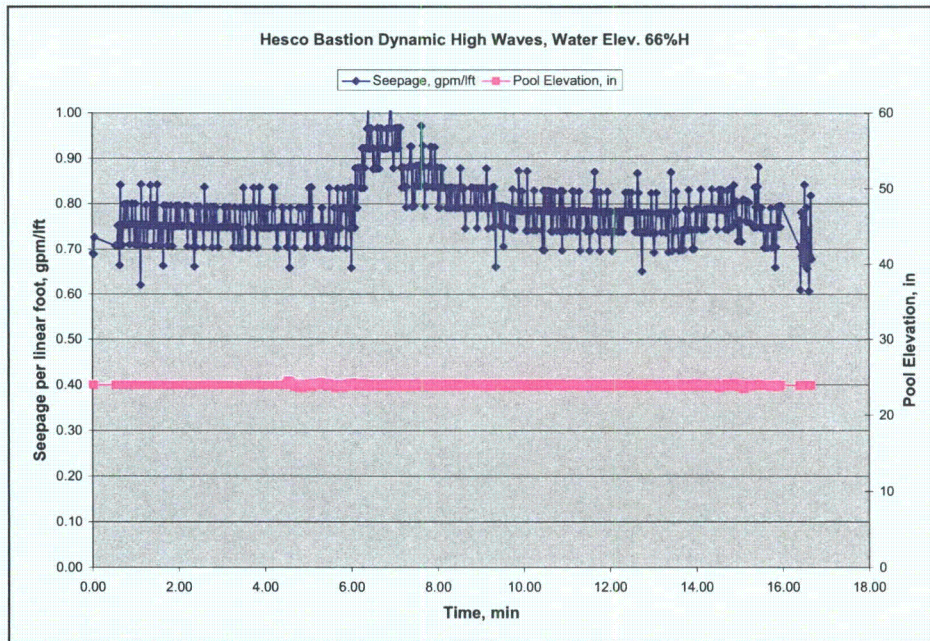
Figure 2-71. Seepage flow rate per linear foot, high wave at 66 percent pool elevation

**10- to 13-in. wave test, reservoir level at 66 percent levee height.** The water level in the reservoir on the pool side of the levee was held at a height of 24 in., the wave generator was activated, and the waves began to impact the levee. Flow rate was observed to range from 0.78 to 0.98 gpm/ft (Figure 2-71), with no displacement. Minor sporadic wave overtopping was observed, primarily along the center wall (Figure 2-72).

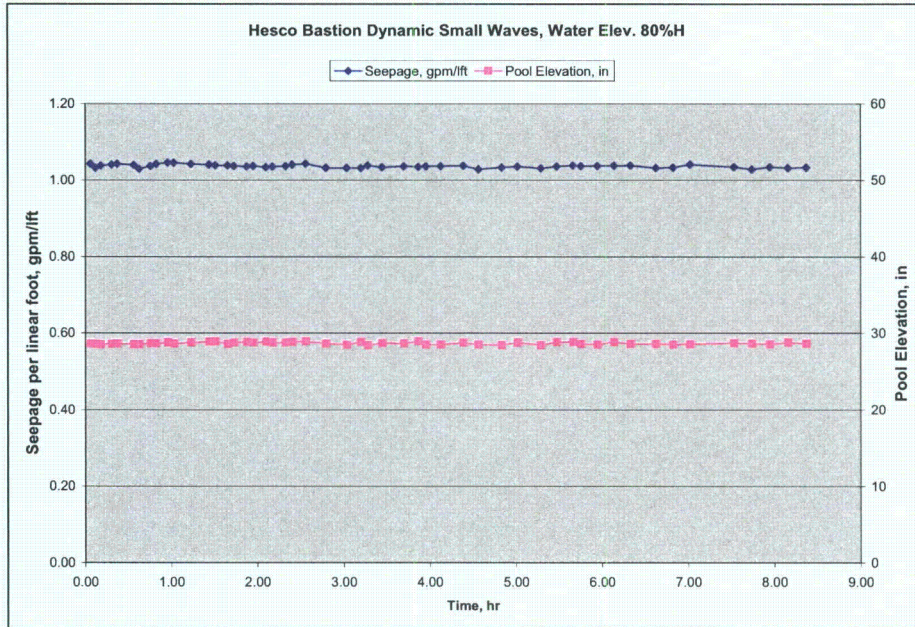
Figure 2-76. Seepage rate per linear foot, small wave at 80 percent pool elevation

was activated, and the waves began to impact the levee. Flow rate was observed to range from 1.03 to 1.04 gpm/ft (Figure 2-76), with no displacement. No wave overtopping was observed. Figure 2-77 shows seepage under the center wall base.

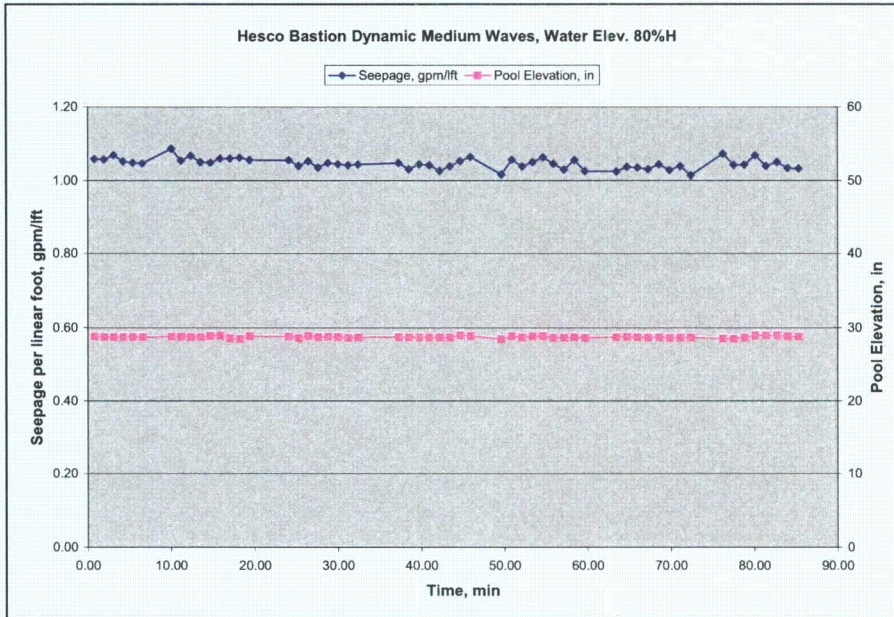
Figure 2-78. Seepage flow rate per linear foot, medium wave at 80 percent pool elevation

observed to range from 1.03 to 1.07 gpm/lft (Figure 2-78), with no displacement. No wave overtopping was observed. Figure 2-79 shows a view of the structure.

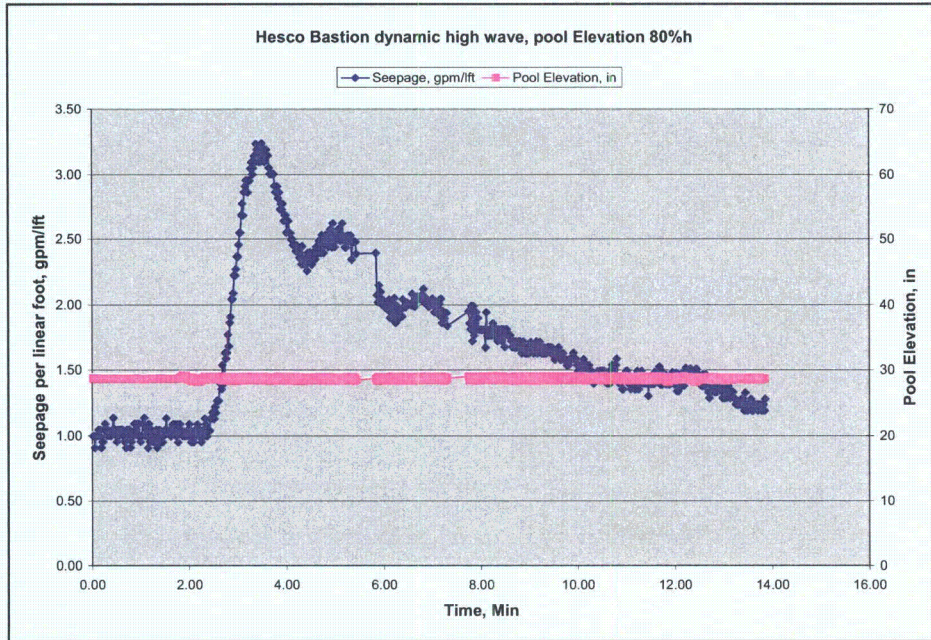
Figure 2-80. Seepage flow rate per linear foot, high wave at 80 percent pool elevation

**10- to 13-in. wave test, reservoir level at 80 percent levee height.** The water level in the reservoir on the pool side of the levee was held at a height of 29 in., the wave generator was activated, and the waves began to impact the levee. Flow rate was observed to range from 1.05 to 3.14 gpm/ft (Figure 2-80), with no displacement. Wave overtopping was observed at each wave front, which contributed to the significant flow rate increase. Figure 2-81 shows wave overtopping.

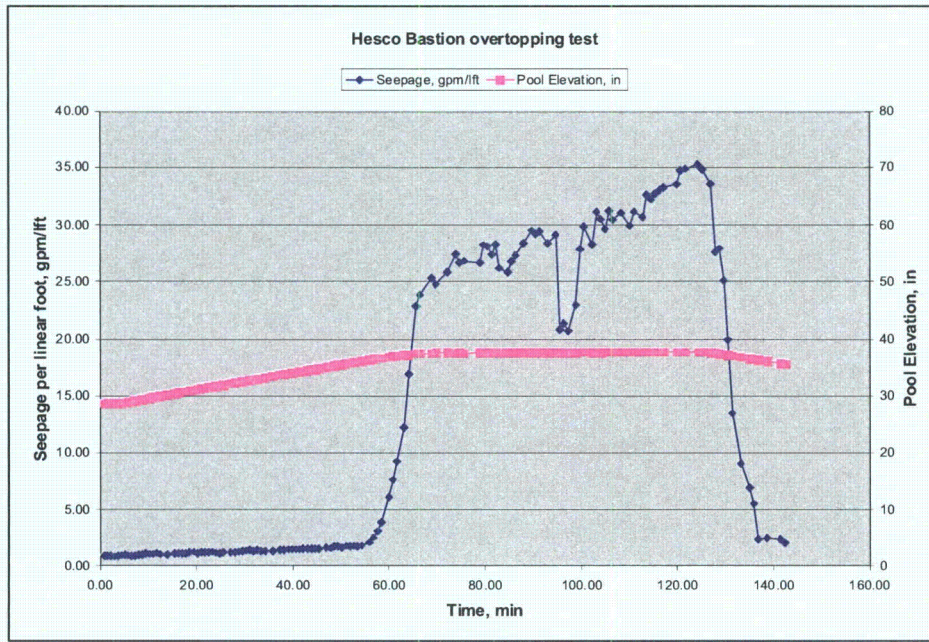
Figure 2-82. Seepage flow rate per linear foot during overtopping

withstood overtopping without failure. Overtopping water combined with seepage water to increase the measured flow rate within a range of 25.2 to 35.0 gpm/ft (1,800 to 2,500 gpm) in the span of 1 hr as shown in Figure 2-82. The overflow was uniform due to the uniform levee height. Figures 2-83 and 2-84, show the overtopped levee.

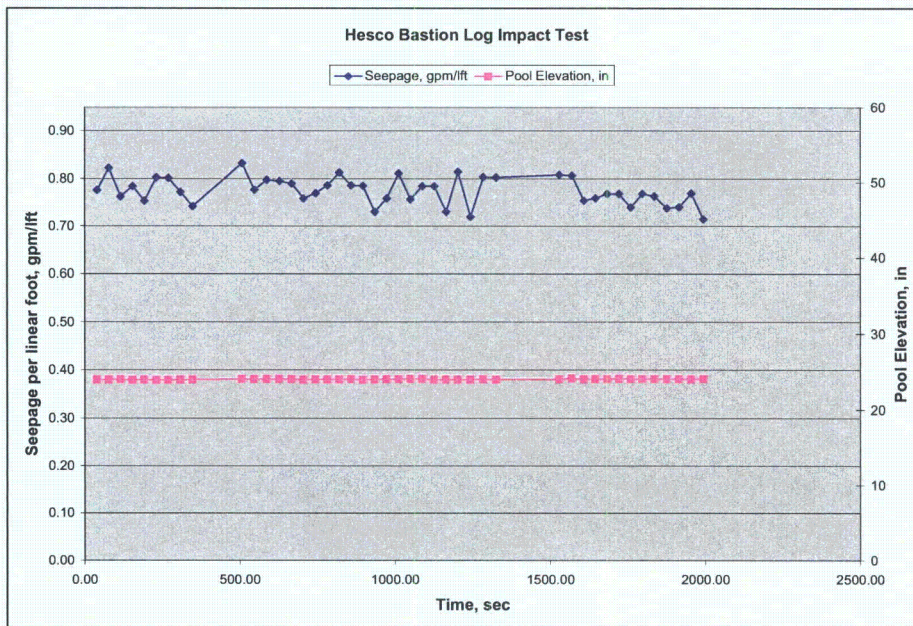
Figure 2-85. Seepage flow rate per linear foot during impact tests

With reservoir level at 24 in., the log impact tests were begun. The 12-in. log impacted the structure and bounced back without causing noticeable damage. The structure displaced slightly and recovered to its original position. The 16-in. log impacted the structure and bounced back also without causing any noticeable damage. The structure displaced slightly and recovered to its original position, but vertical deformations of the sand fill ranging from 4.02 to 0.72 in. were noted. Figure 2-85 shows the minor change in seepage flow rate during impact testing and Figure 2-86 shows the area where the logs hit, viewed from the pool side.

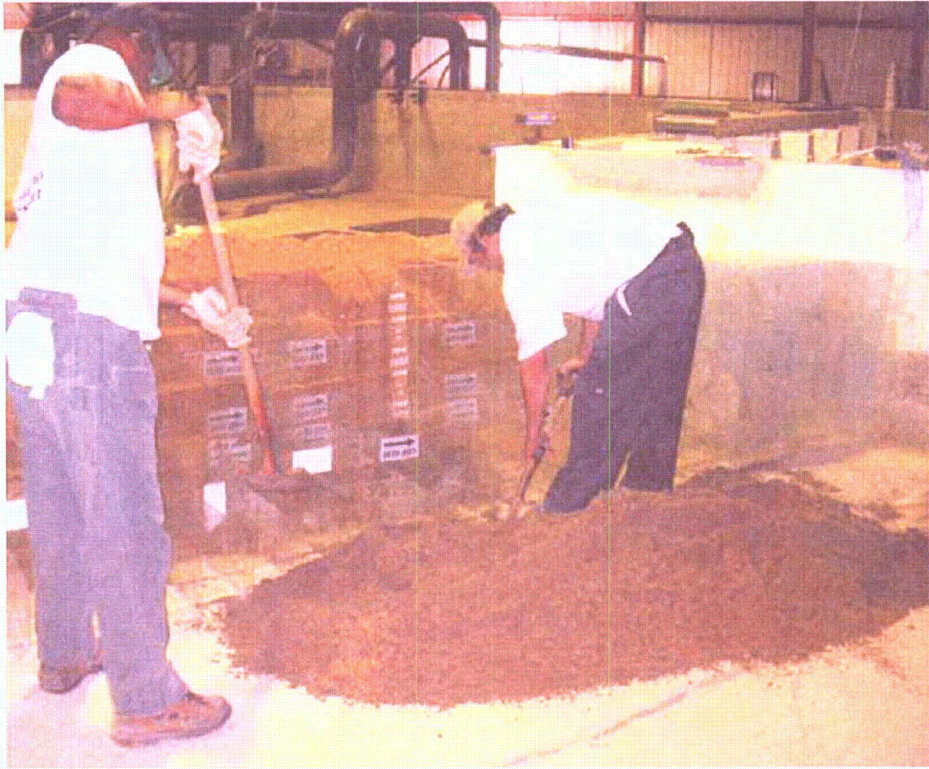
Figure 2-116. Shoveling mixture into left wall toe grid cells

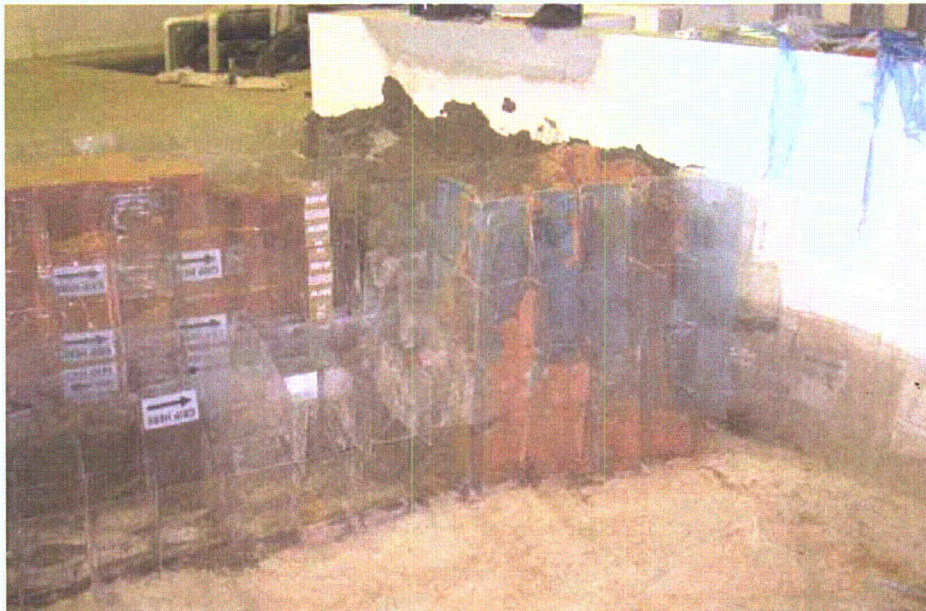
Figure 2-117. View of left concrete wall abutment from pool side

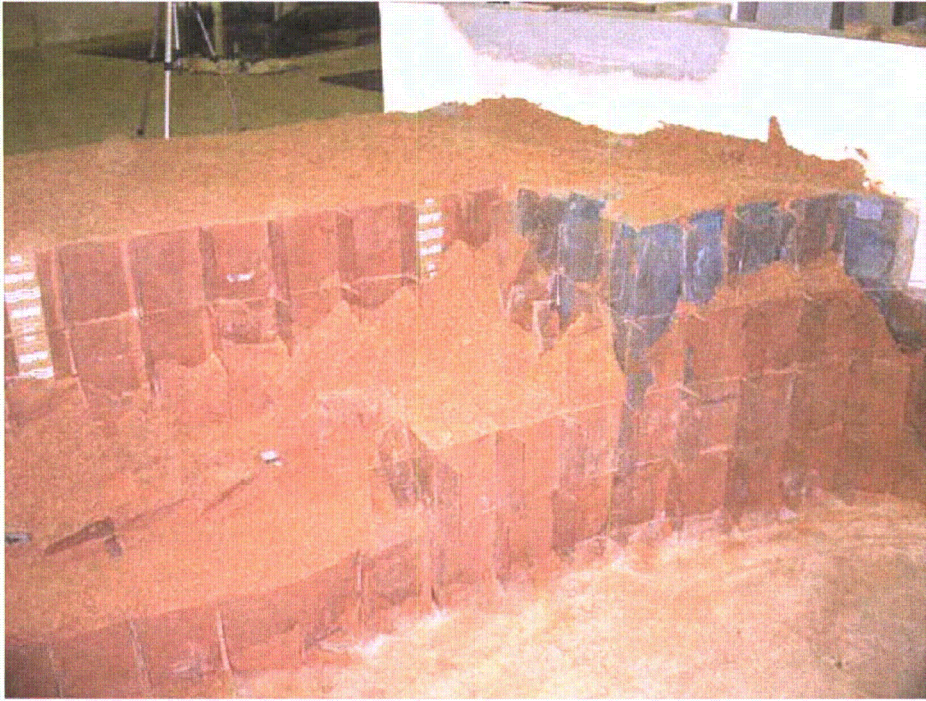
Figure 2-118. Completed sand and mixture fill, left concrete wall abutment

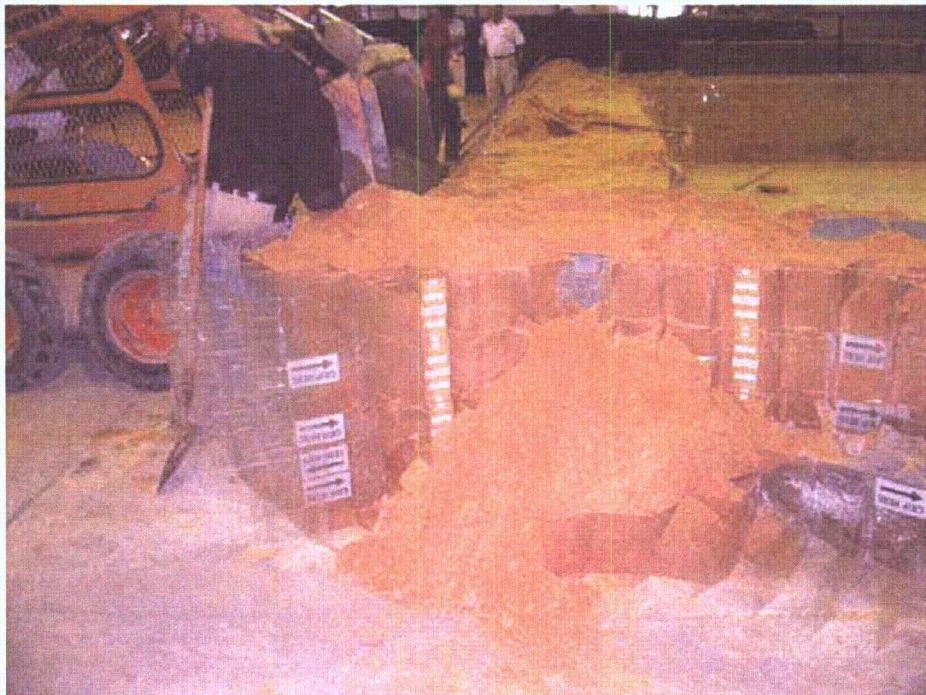
Figure 2-119. View of left wall/center wall buttress from pool side

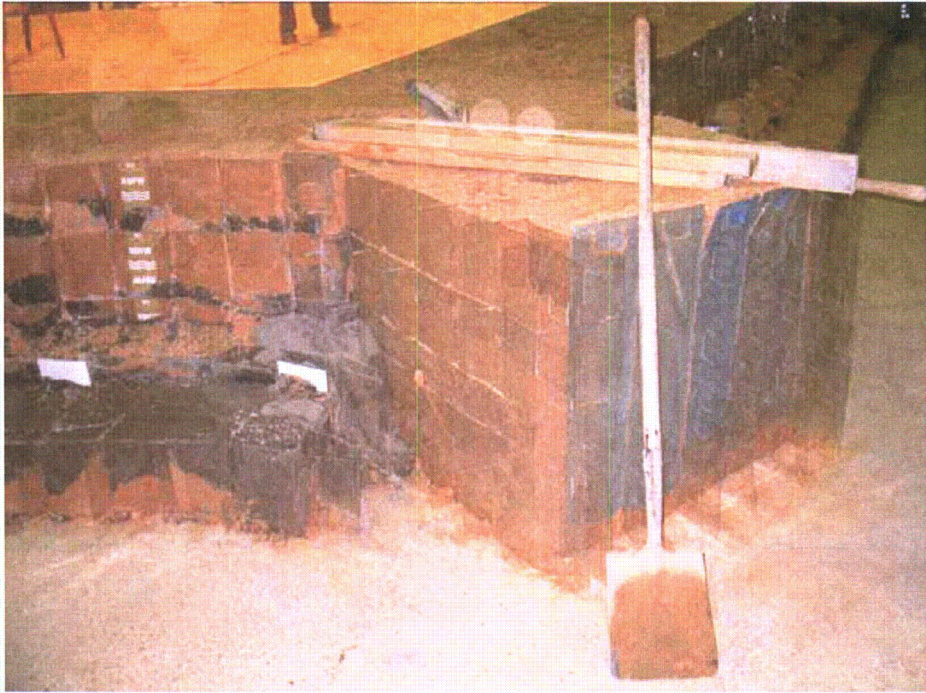
Figure 2-120. Completed sand and mixture fill viewed from pool side

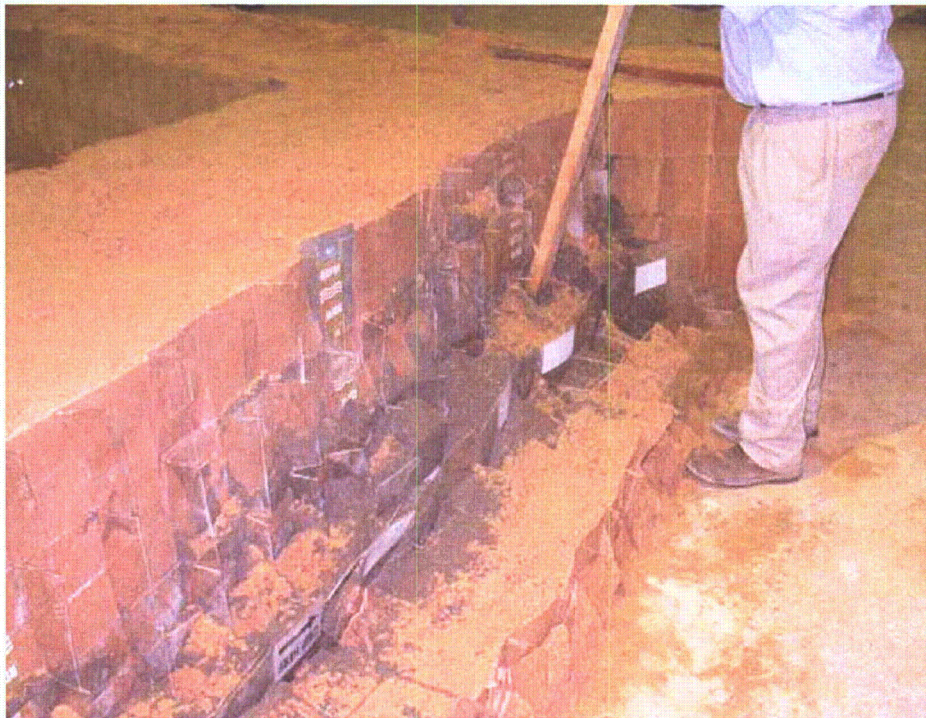
Figure 2-121. Mixture fill and tamping in center wall toe grid

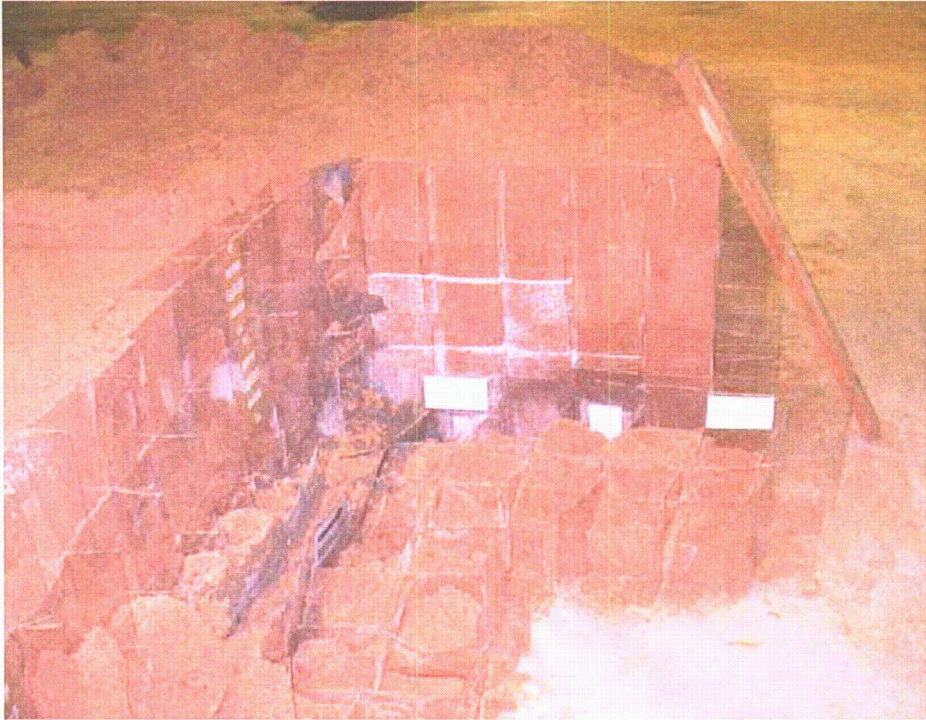
Figure 2-122. Right wall buttress viewed from pool side

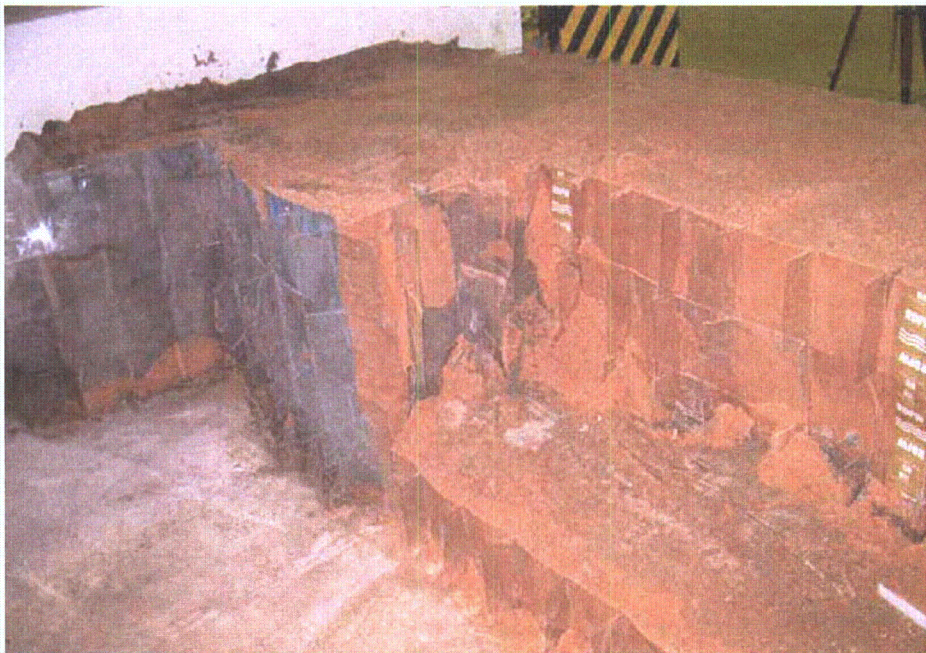
Figure 2-123. Right concrete wall abutment completed sand and mixture fill, viewed from pool side

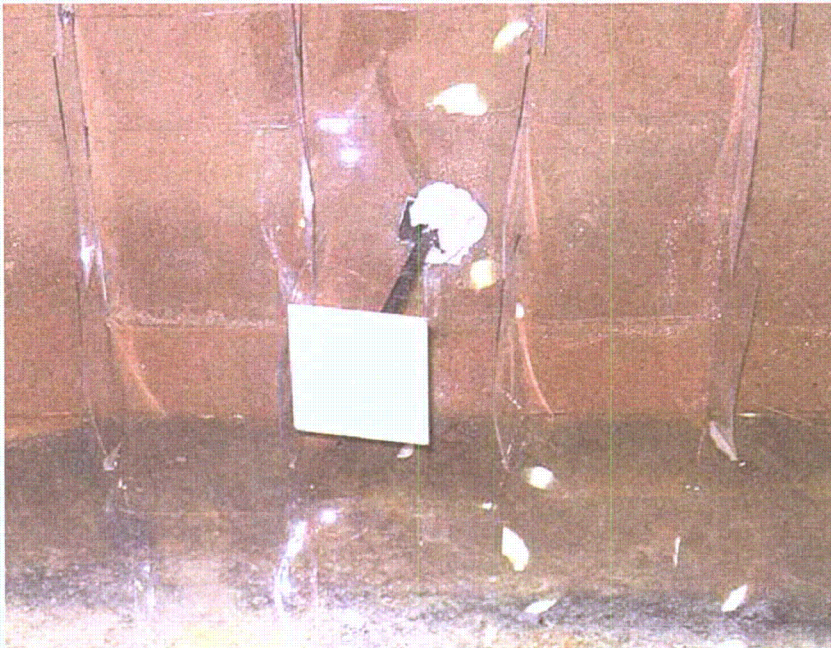
Figure 2-124. Typical laser target installation

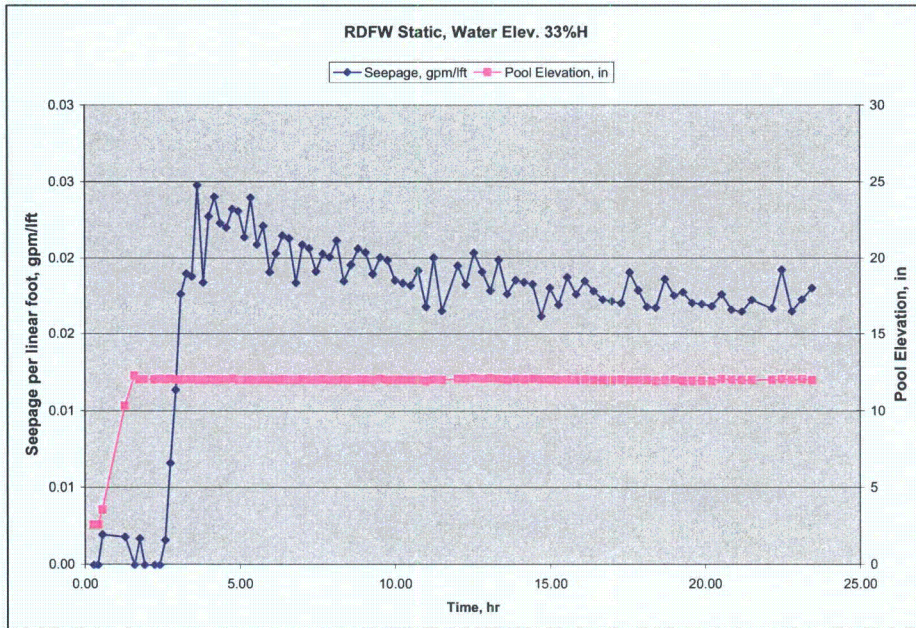
**Hydrostatic head test, 1-ft reservoir (33 percent height).** The water level in the reservoir on the pool side of the levee was raised to a height of 1 ft (33 percent of levee height). Seepage flow rate was measured in the range from 0.017 to 0.025 gpm/lft (Figure 2-125), and no displacement was observed. Figure 2-126 shows the view from the pool side, including the lateral-displacement-monitoring system over the center wall. Figure 2-127 shows the view from the protected side, and Figure 2-128 is a view along the left wall.

Figure 2-125. Seepage flow rate per linear foot at 1-ft pool elevation

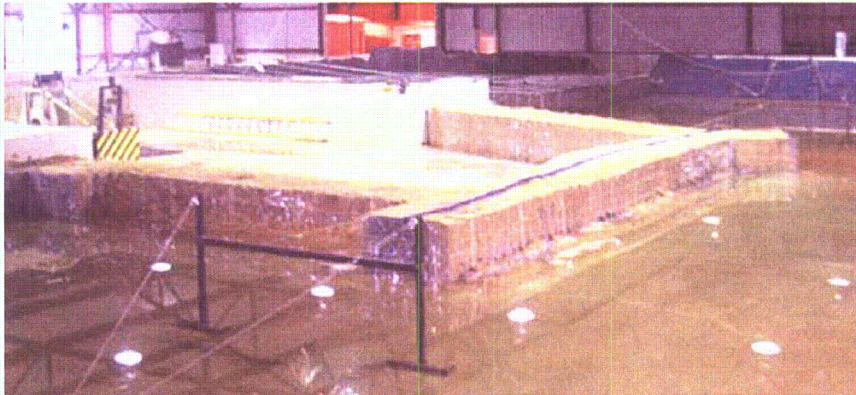
Figure 2-126. View from pool side

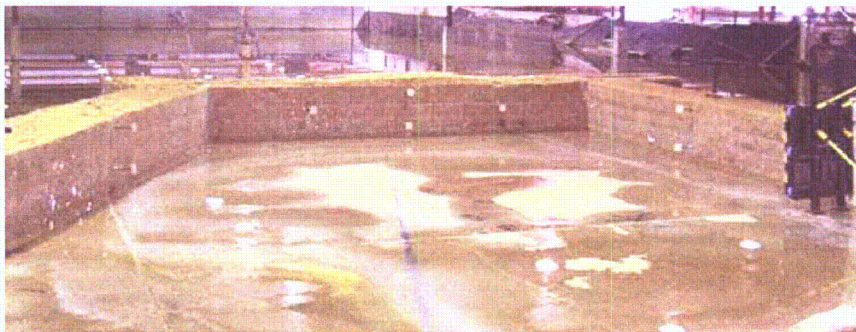
Figure 2-127. View from protected side

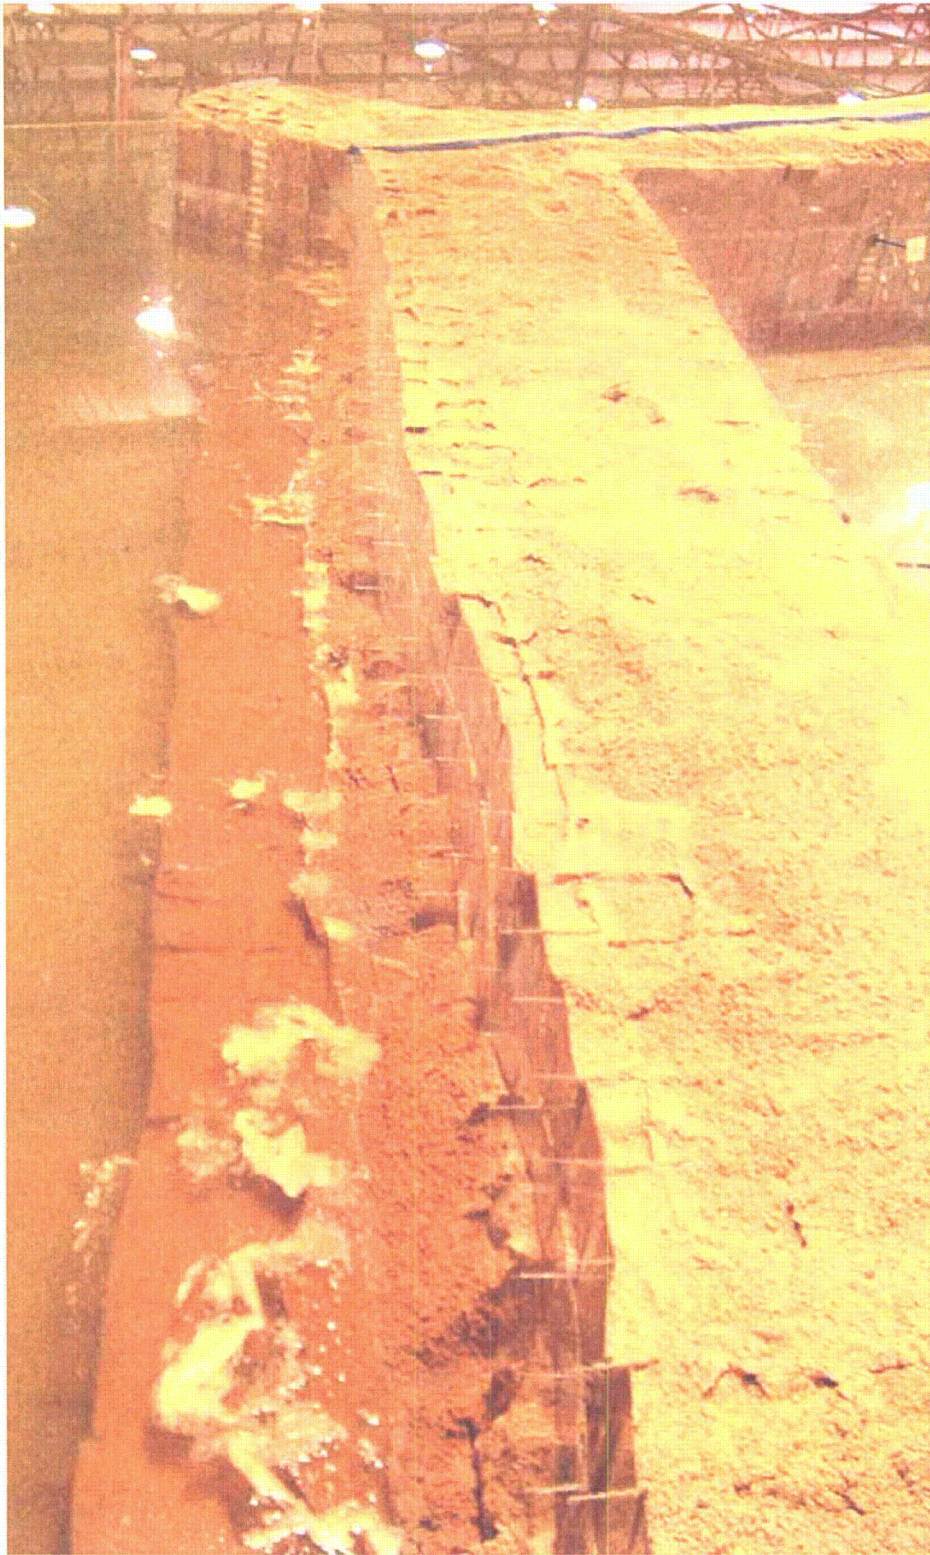
Figure 2-128. View looking down at left wall
