2011 Annual Site Inspection and Monitoring Report for Uranium Mill Tailings Radiation Control Act Title I Disposal Sites

January 2012

**U.S. Department of Energy
Office of Legacy Management**

**2011 Annual Site Inspection and Monitoring Report
for
Uranium Mill Tailings Radiation Control Act
Title I Disposal Sites**

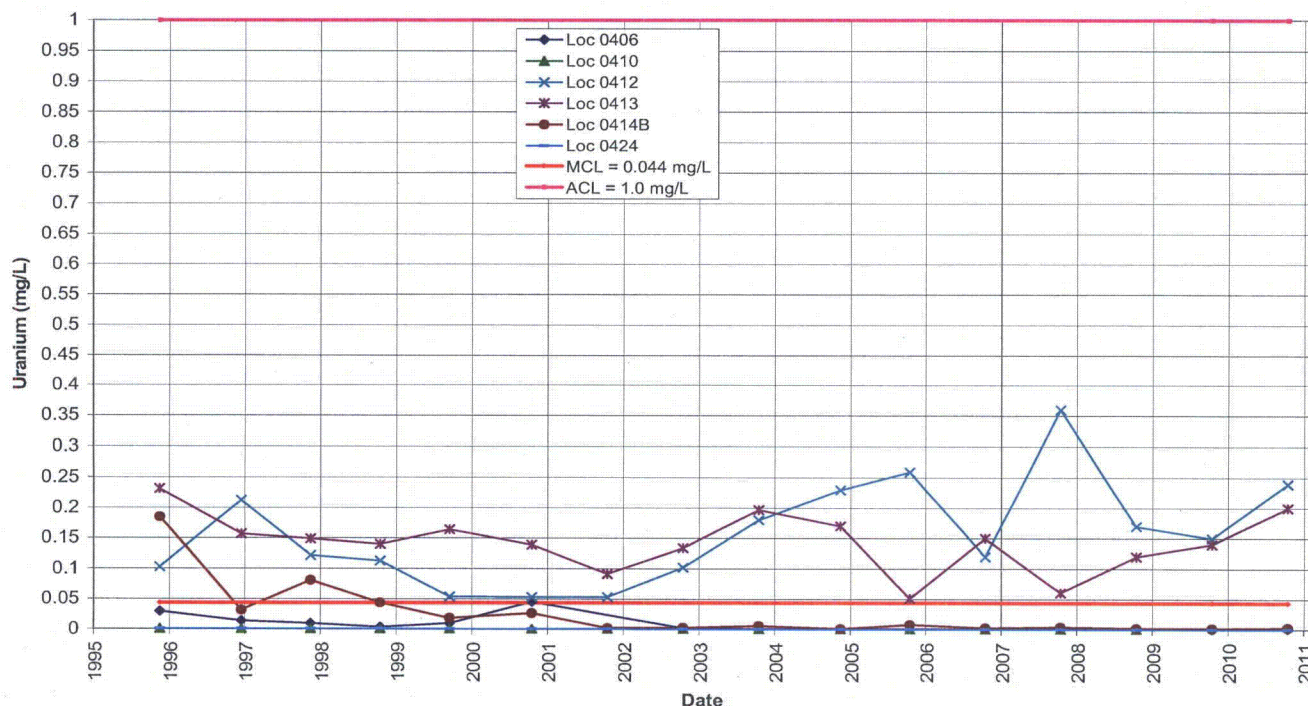
Figure 3-2. Time-Concentration Plot of Uranium in Groundwater at the Canonsburg Disposal Site

Groundwater—Uranium concentrations in 2010 were considerably below the established ACL (Figure 3-2). With the exception of monitoring wells 0412 and 0413, uranium concentrations in 2010 also were below the MCL.

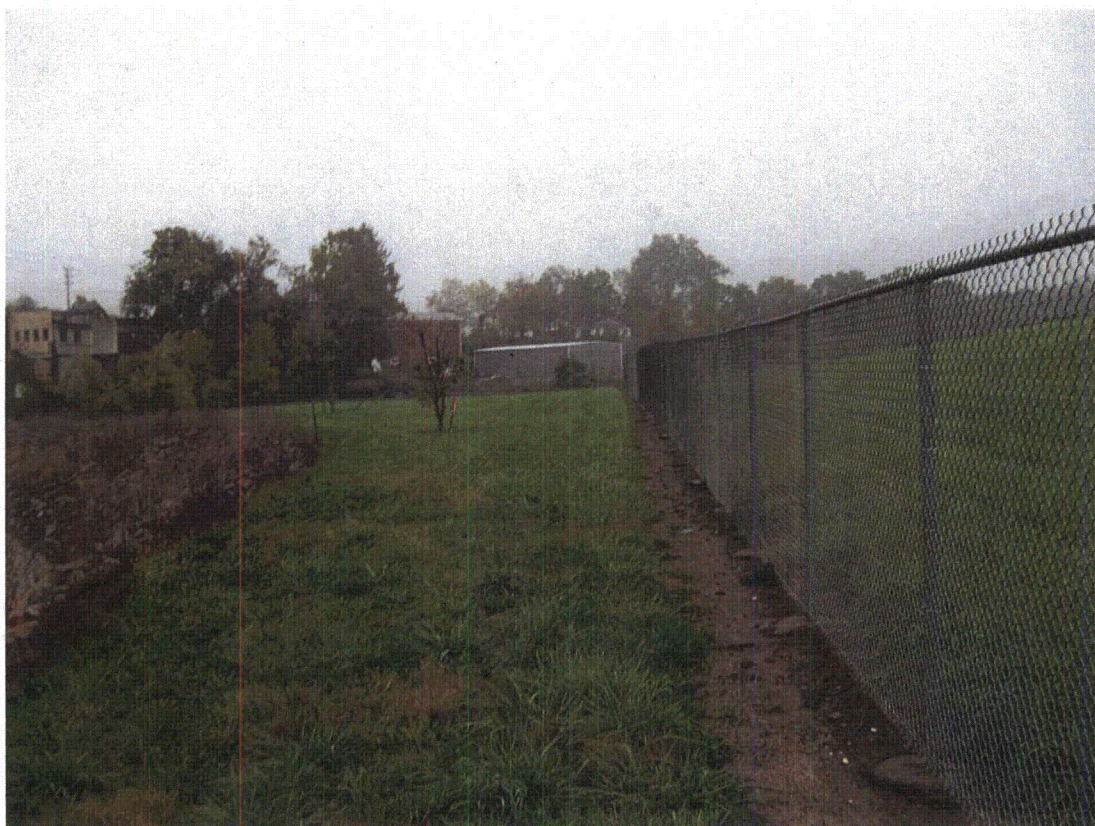
Access, Gates, Fence, and Signs—Access to the site is directly from Strabane Avenue, a public right-of-way within the Borough of Canonsburg in Washington County, Pennsylvania. The security fence and all four site gates were in excellent condition. A vegetation-free buffer zone is being maintained around the entire site security fence (PL–2). The entrance sign and 11 perimeter signs were in good condition.

CAN 10/2011. PL-2. Vegetation-free corridor along base of perimeter fence.

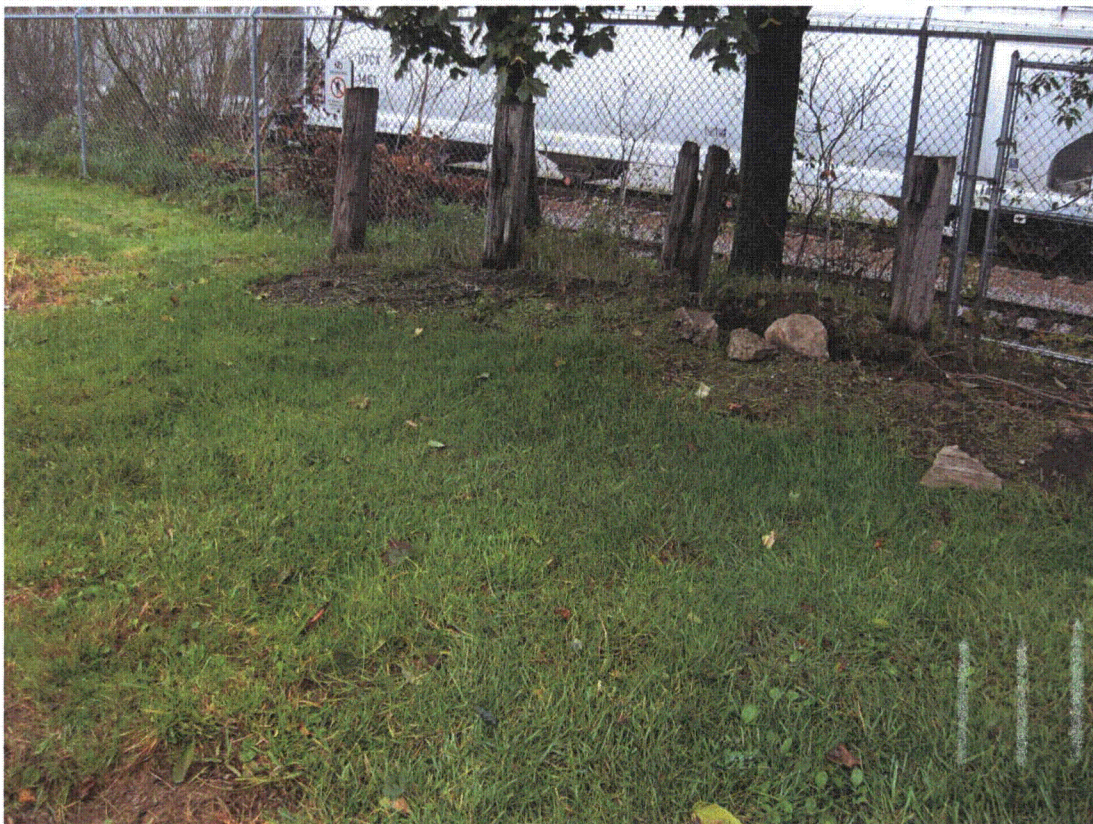
CAN 10/2011. PL-3. Prior location of monitoring well 0410.

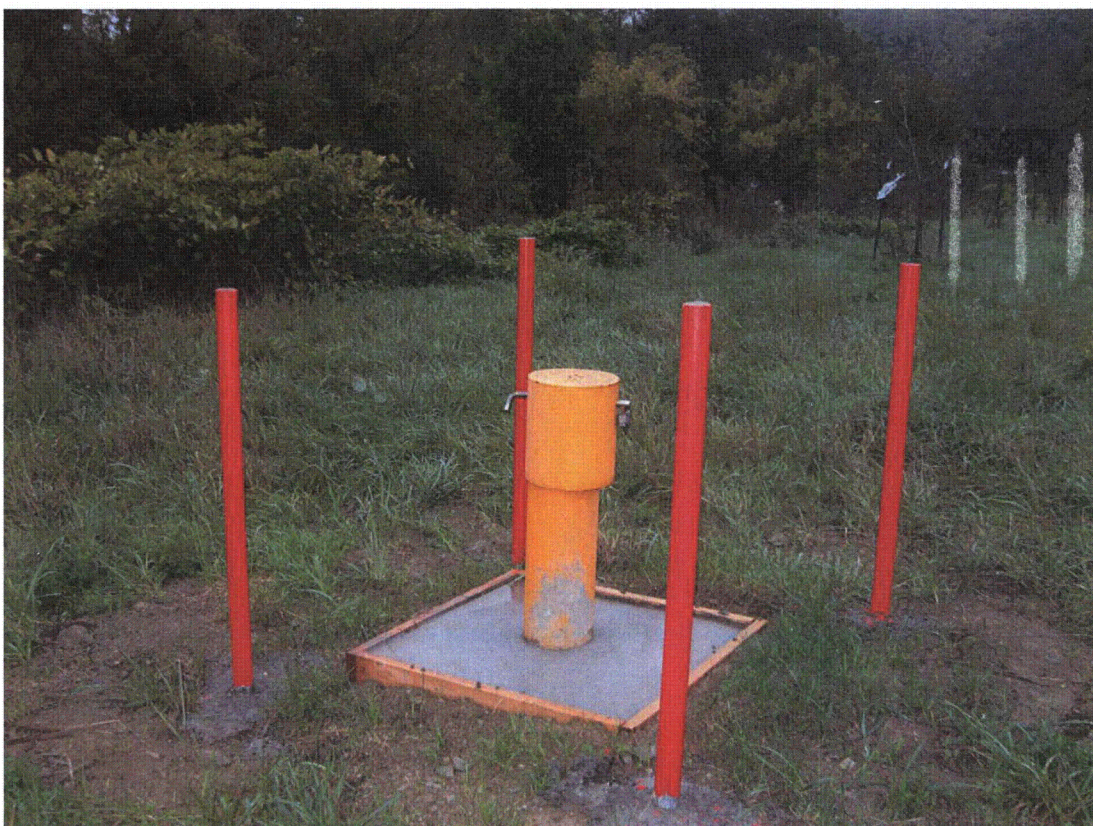
CAN 10/2011. PL-4. Monitoring well 0413.

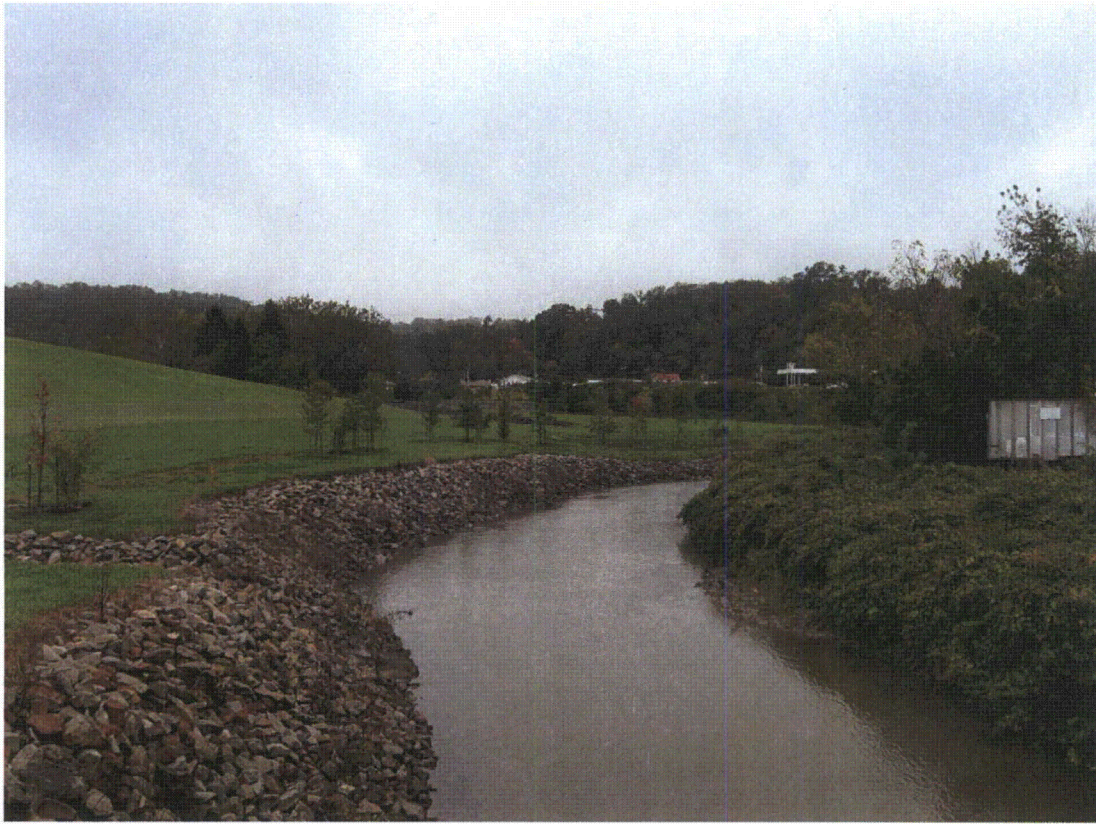
CAN 10/2011. PL-5. Contrast between riprap stream bank, where vegetation is managed, and non-riprap stream bank, where vegetation is not managed.

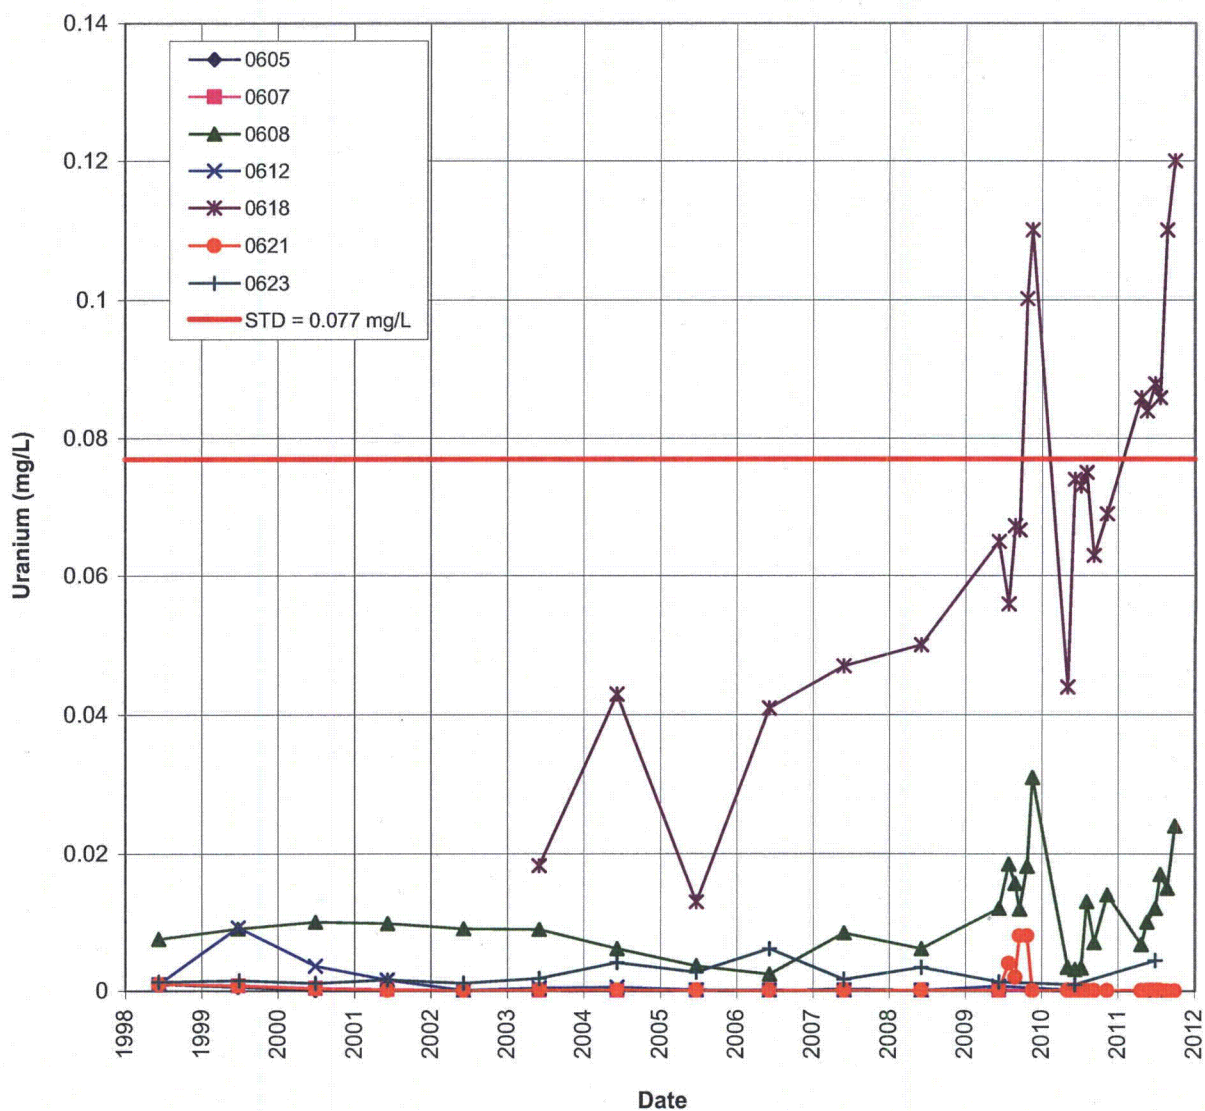
Figure 4-2. Time-Concentration Plot of Uranium in Groundwater at the Durango Disposal Site

Uranium concentrations in monitoring well 0618 had decreased since 2009 and were below the standard until an increase observed during the June 2011 sampling event. Concentrations in well 0608 have decreased slightly. Selenium concentrations decreased slightly in both of these wells, and molybdenum remained steady. Analytical results from all other locations are on trend with previous results.

In 2009, the most significant groundwater monitoring result reported was the uranium concentration in well 0618. The uranium concentration of 0.11 milligram per liter (mg/L) reported in this well in November 2009 is consistent with the increasing trend that began in 2005, and exceeded the site-specific standard of 0.077 mg/L. In fall 2009, well 0618 was redeveloped, and the purging method and pump materials were evaluated. The uranium levels had decreased below the standard in 2010. The 2011 results show an increase in uranium back above the standard as well as above levels observed in 2009 (0.12 mg/L). All other concentrations of uranium, along with all concentrations of both selenium and molybdenum, remain on trend and well below their respective standards.

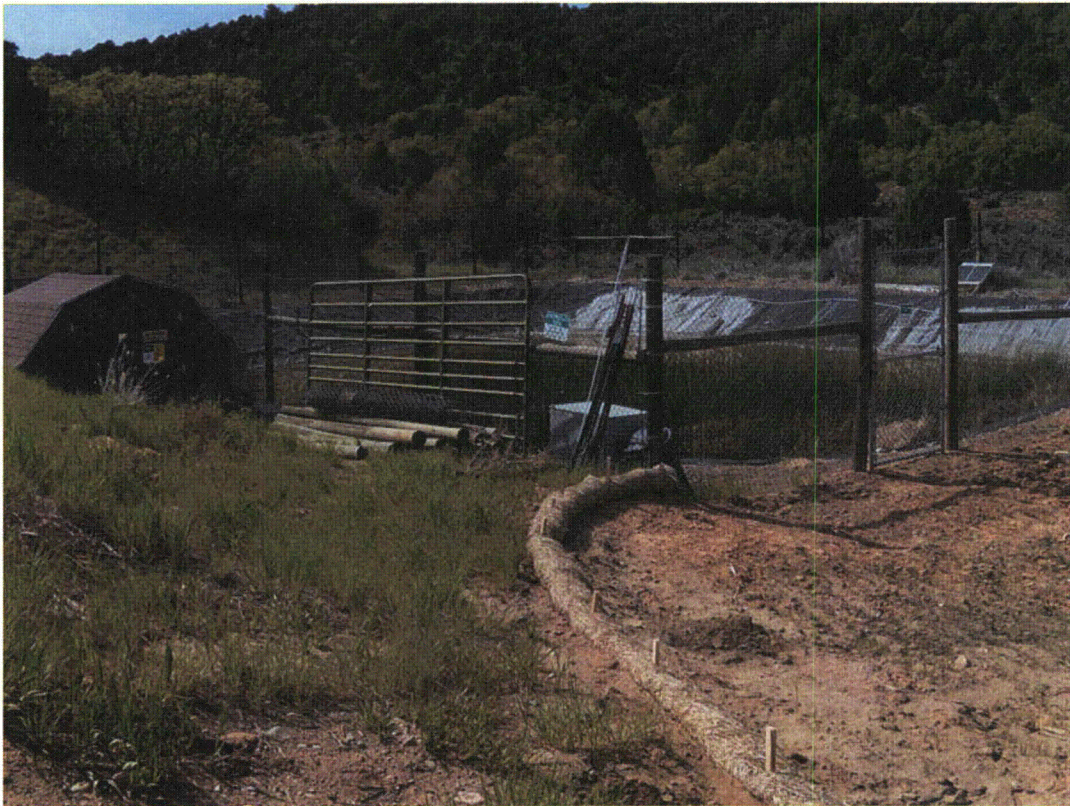
DUR 5/2011. PL-3. New fence around east side of retention pond area.

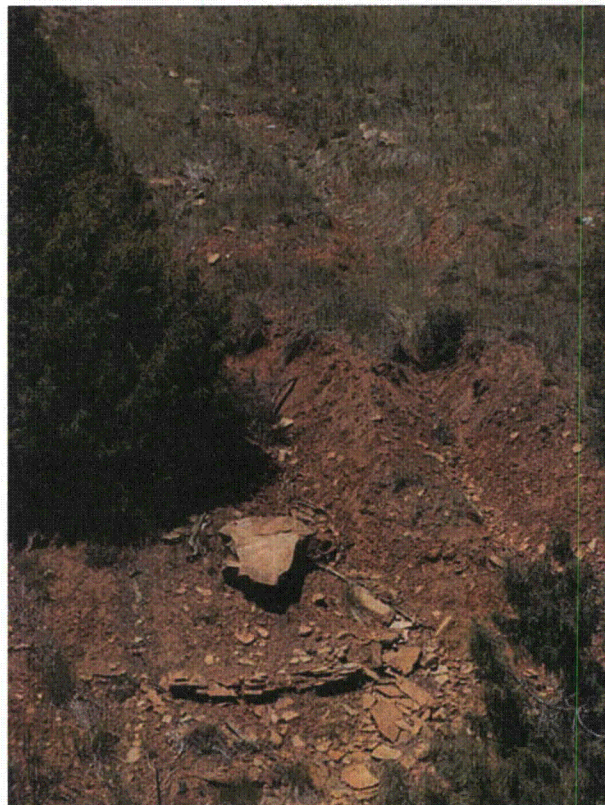
DUR 5/2011. PL-4. Headcuts of gullies below southwest corner of disposal cell; no change from 2009.

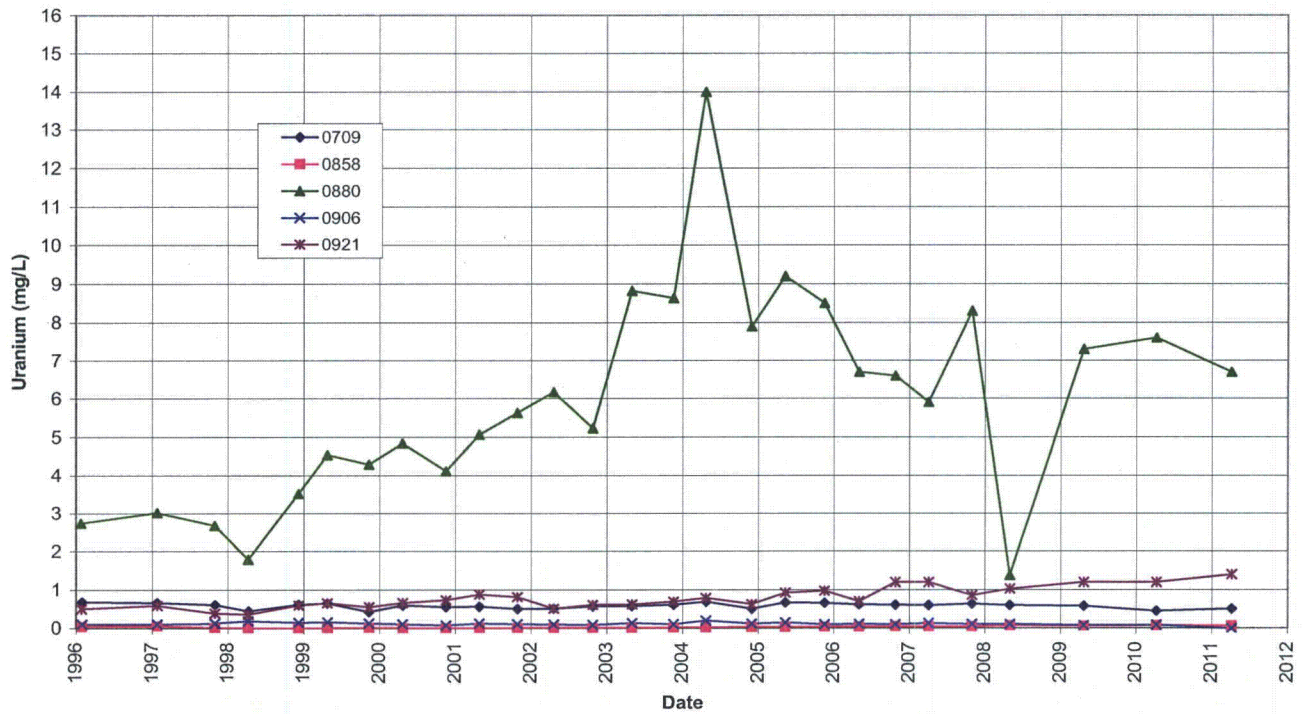
Figure 5-5. Uranium in Groundwater at Cell Performance Monitoring Locations at the Falls City Disposal Site

In 2011, the uranium concentrations in the cell performance network remained relatively stable, approximately 1.4 mg/L or less, with one exception. At well 0880, uranium has varied from a low concentration of 1.38 mg/L in 2008 to a high concentration of 14 mg/L in 2004 (Figure 5-5). Over time, the concentration of uranium in this well has been variable and, until 2008, substantially greater than the uranium concentrations at the other cell performance wells. The pH at this location is lower than and has varied more than at other locations in the cell performance monitoring network (Figure 5-3). Water levels are also generally falling at well 0880 (see the following section, "Groundwater-Level Monitoring Results"). These results suggest that the interaction among the disposal cell, the legacy groundwater mound, and processing plumes is still equilibrating. However, monitoring results do not indicate that the disposal cell is contributing to the degradation of the uppermost aquifer. Because the groundwater in the uppermost aquifer is not used as a potable water source near the site, the site remains protective.

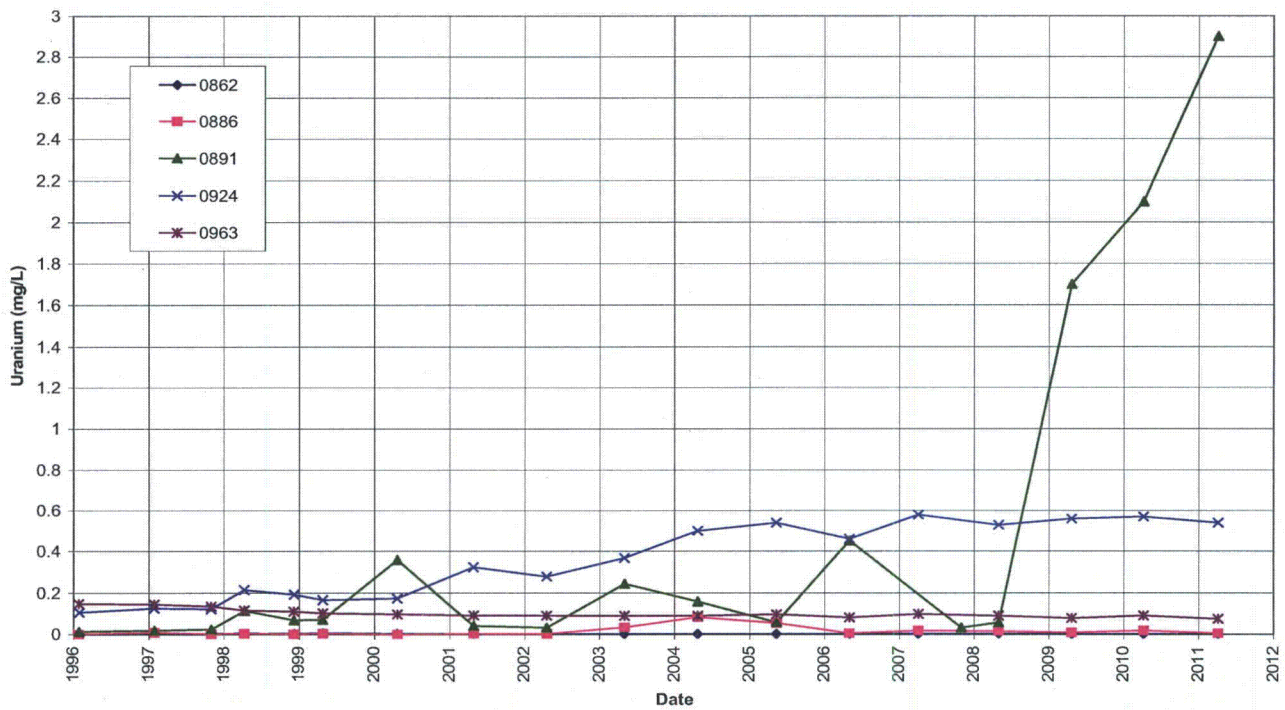
Figure 5-6. Uranium in Groundwater at Compliance Monitoring Locations at the Falls City Disposal Site

The concentration of uranium in groundwater within the compliance monitoring network shows that the uranium concentration trends at monitoring wells 0862, 0886, and 0963 remain stable at low levels (<0.2 mg/L) (Figure 5–6). The increasing uranium concentration trend at well 0924 appears to be leveling off between 0.5 mg/L and 0.6 mg/L. The uranium concentrations measured at well 0891 in 2009 (1.7 mg/L), 2010 (2.1 mg/L), and 2011 (2.9 mg/L) are anomalously high compared to historical measurements at the well, but not for the aquifer.

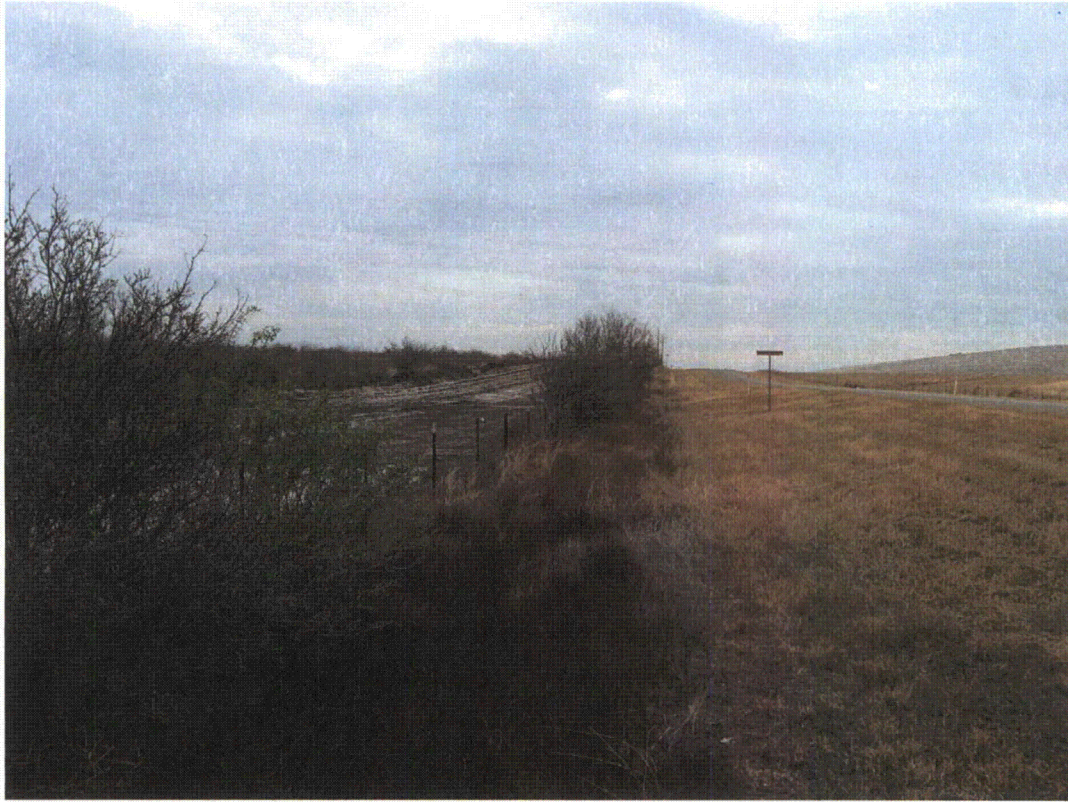
FCT 1/2011. PL-7. Route of new pipeline installed east of FM 1344.

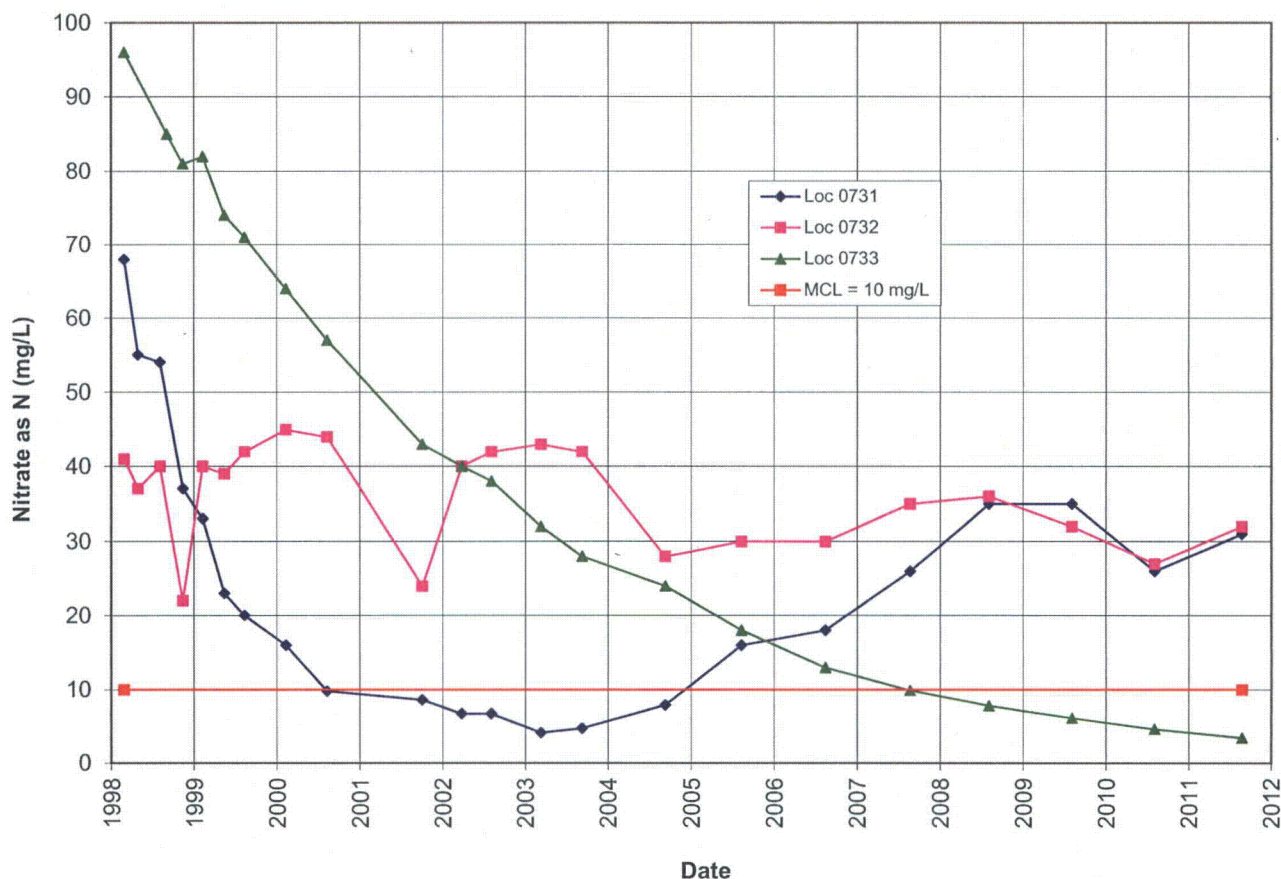
Figure 6-3. Time-Concentration Plots of Nitrate (as Nitrogen) in Groundwater at the Grand Junction Disposal Site

Nitrate (as nitrogen) concentrations in groundwater continued to exceed the MCL of 10 mg/L in the paleochannel monitoring wells (0731 and 0732) through 2011 (Figure 6–3). Concentrations

in well 0731, following an initial steep downward trend, remained below the MCL from 2000 through 2004. In 2005 and continuing through 2011, concentrations steadily increased and remain above the MCL. Concentrations in well 0732, though varied, have consistently remained above the MCL since 1998. Concentrations in well 0733 continued a significant downward trend, dropping below the MCL in 2006, and reaching a low of 3.4 mg/L in 2011. Historically, the highest concentration of nitrate (96 mg/L) occurred in 1998 from disposal cell well 0733. In 2011, the concentration of nitrate has increased slightly, and the nitrate levels in both paleochannel monitoring wells are very similar: 31 mg/L in well 0731 and 32 mg/L in well 0732.

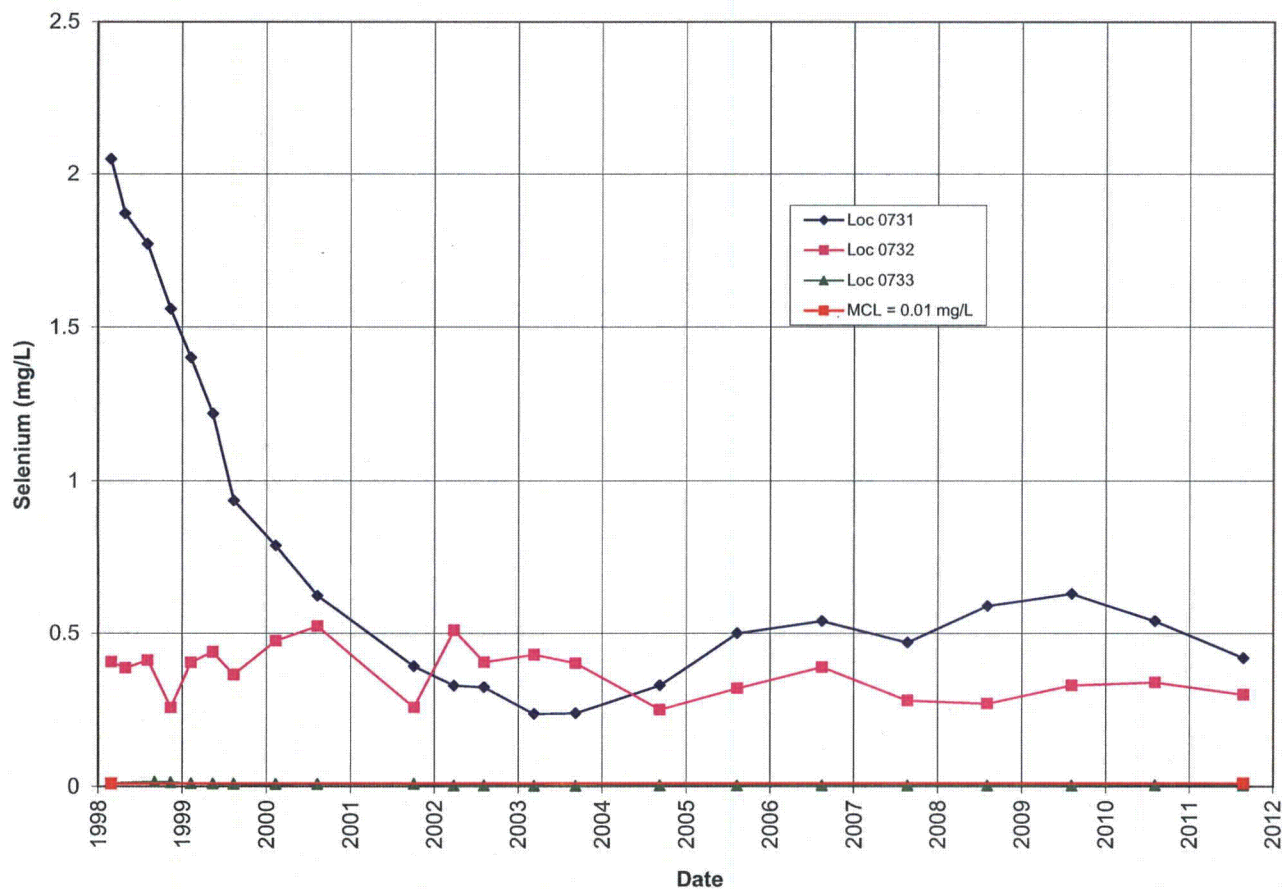
Figure 6-4. Time-Concentration Plots of Selenium in Groundwater at the Grand Junction Disposal Site

Selenium occurs naturally in the Mancos Shale deposits that underlie the disposal cell, and may be the cause of the elevated concentrations reported in both paleochannel monitoring wells (0731 and 0732). Selenium concentrations continued to exceed the MCL of 0.01 mg/L in the paleochannel wells (Figure 6-4). Concentrations in well 0731 displayed a sharp decreasing trend, and the decreasing trend continued until 2003, when a slight upward trend began. Selenium concentrations in well 0731 have decreased since 2009. Concentrations in well 0732 continue to display no trend. In well 0733, the selenium concentration of 0.0038 mg/L remained well below the standard, with no trend evident.

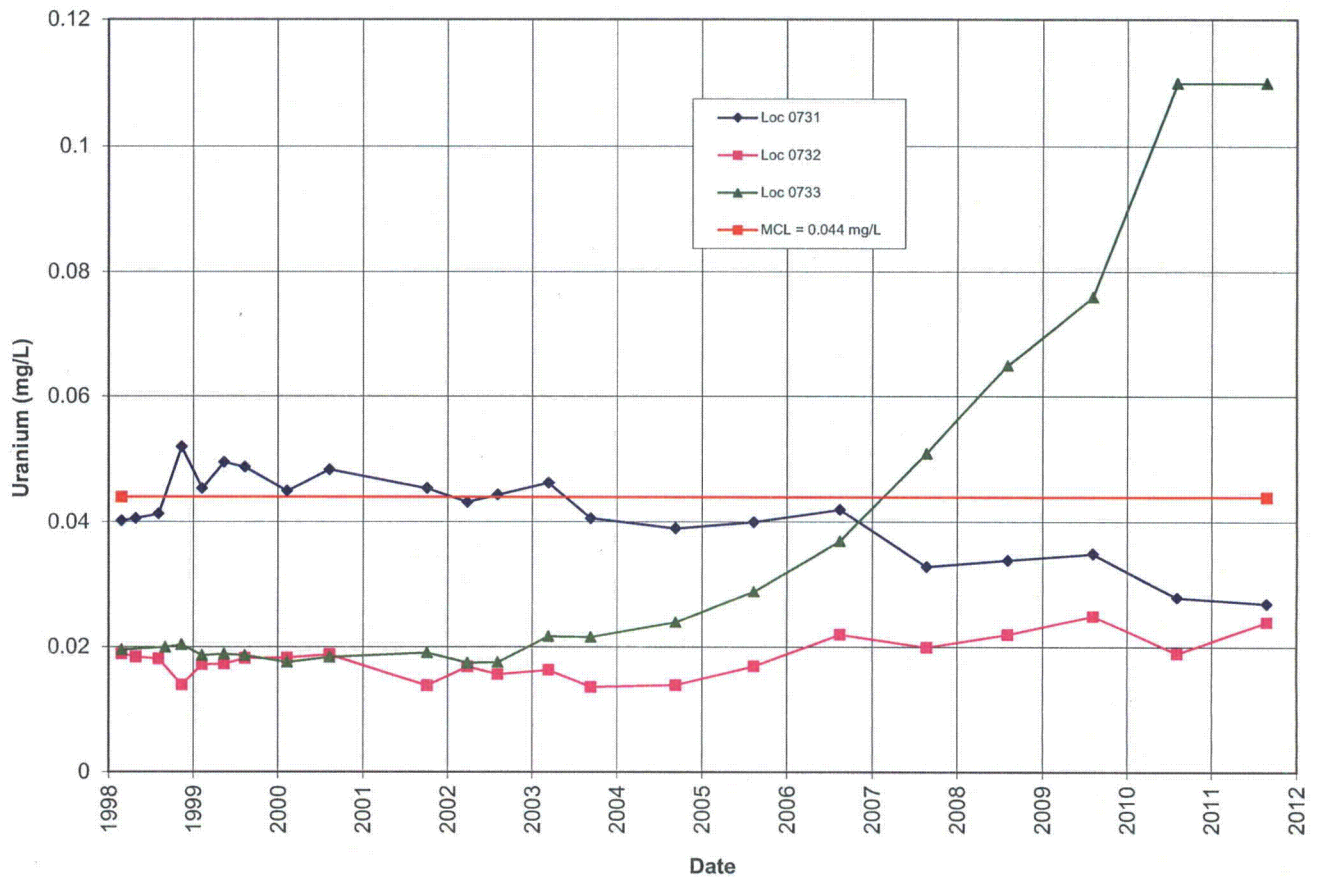
Figure 6-5. Time-Concentration Plots of Uranium in Groundwater at the Grand Junction Disposal Site

Uranium concentrations in groundwater were below the MCL of 0.044 mg/L in paleochannel wells 0731 and 0732, and were above the MCL in well 0733 (Figure 6-5). Concentrations in well 0731, after an initial increase above the MCL, have displayed a decreasing trend that continued in 2011. Concentrations in well 0732 have remained relatively consistent. Concentrations in well 0733 remained relatively consistent through 2003, at which time an upward trend began, which has leveled off at 0.11 mg/L for the 2010 and 2011 sampling events.

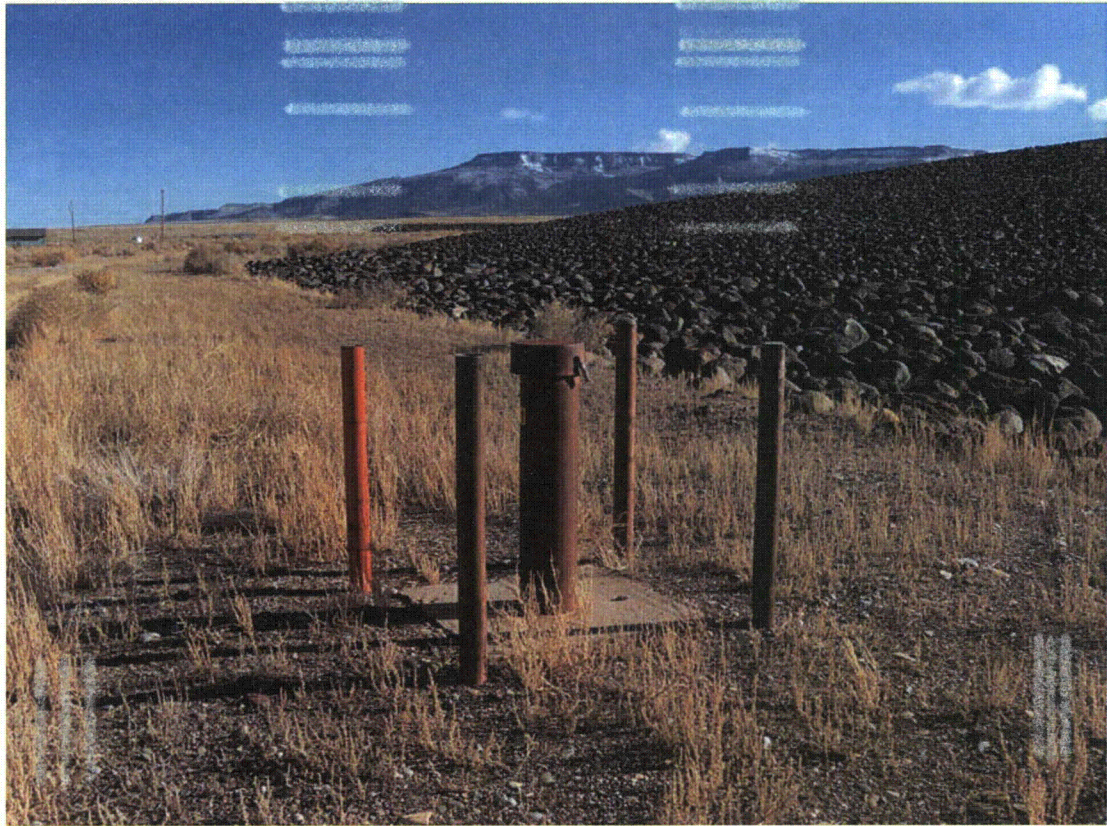
GRJ 3/2011. PL-1. Monitoring well 0731 near the northwest corner of the disposal cell.

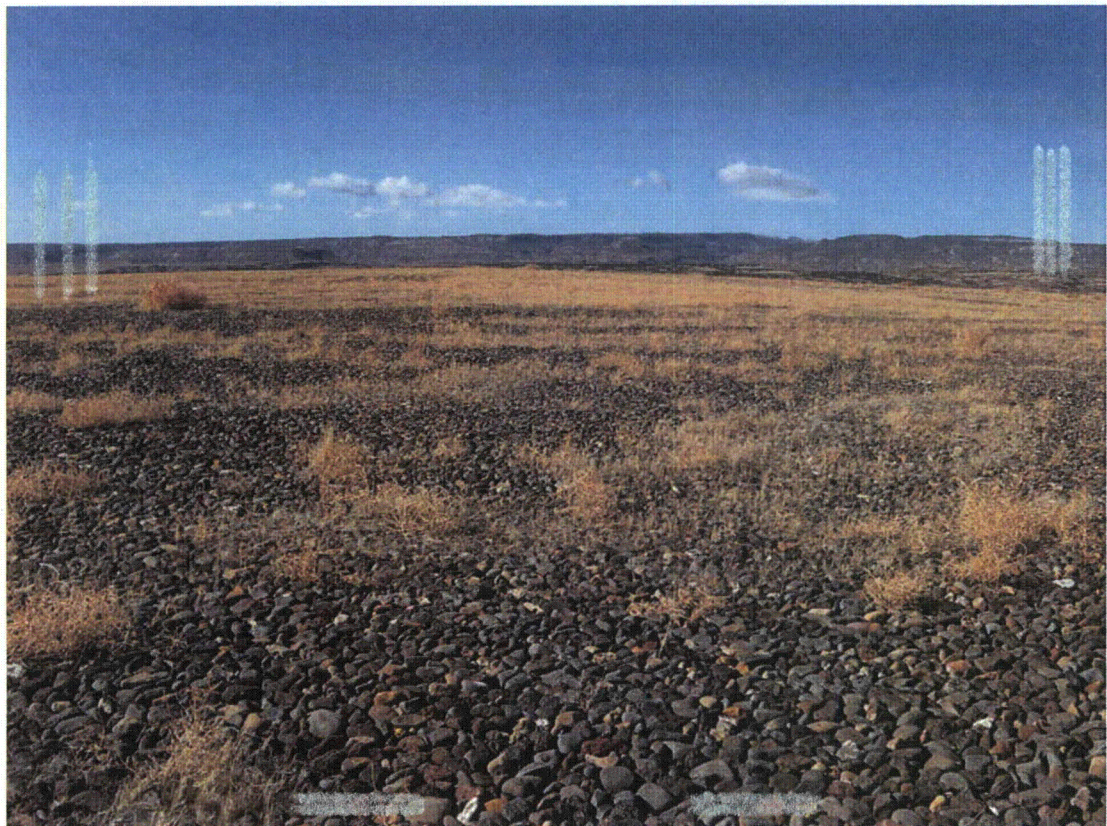
GRJ 3/2011. PL-2. Northeast corner of the disposal cell cover.

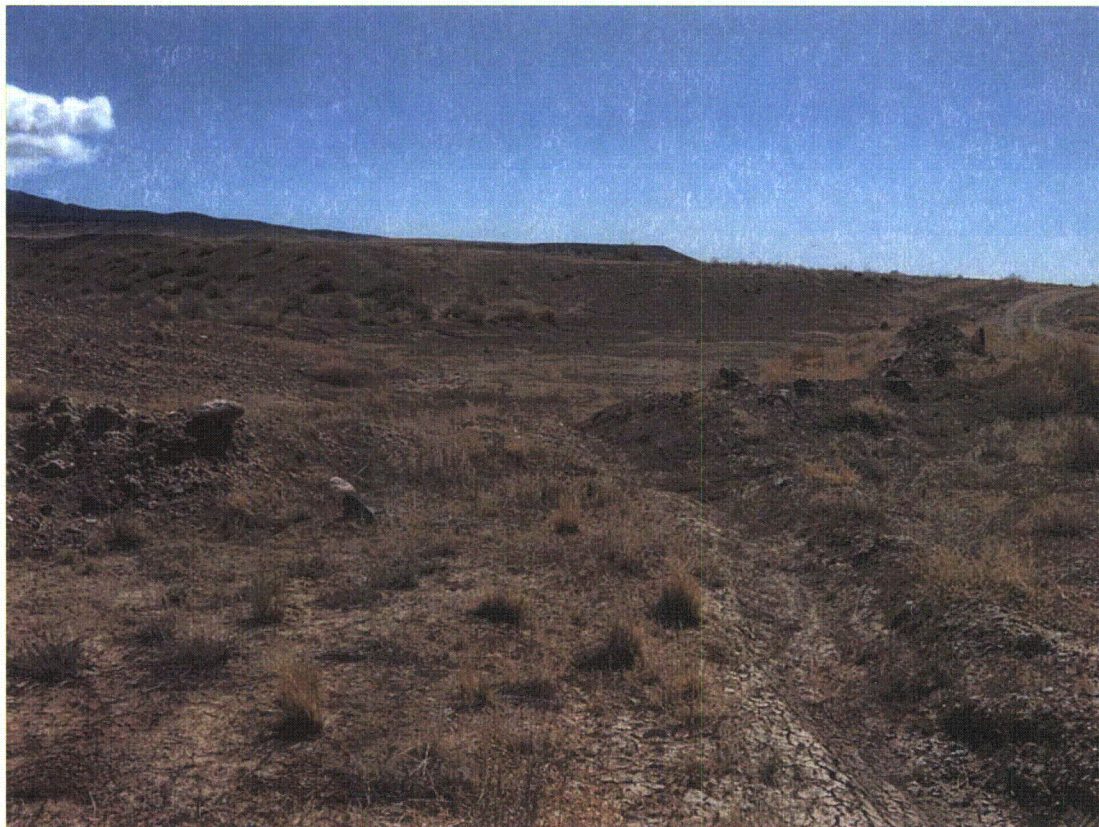
GRJ 3/2011. PL-3. East storm water and sediment collection pond.

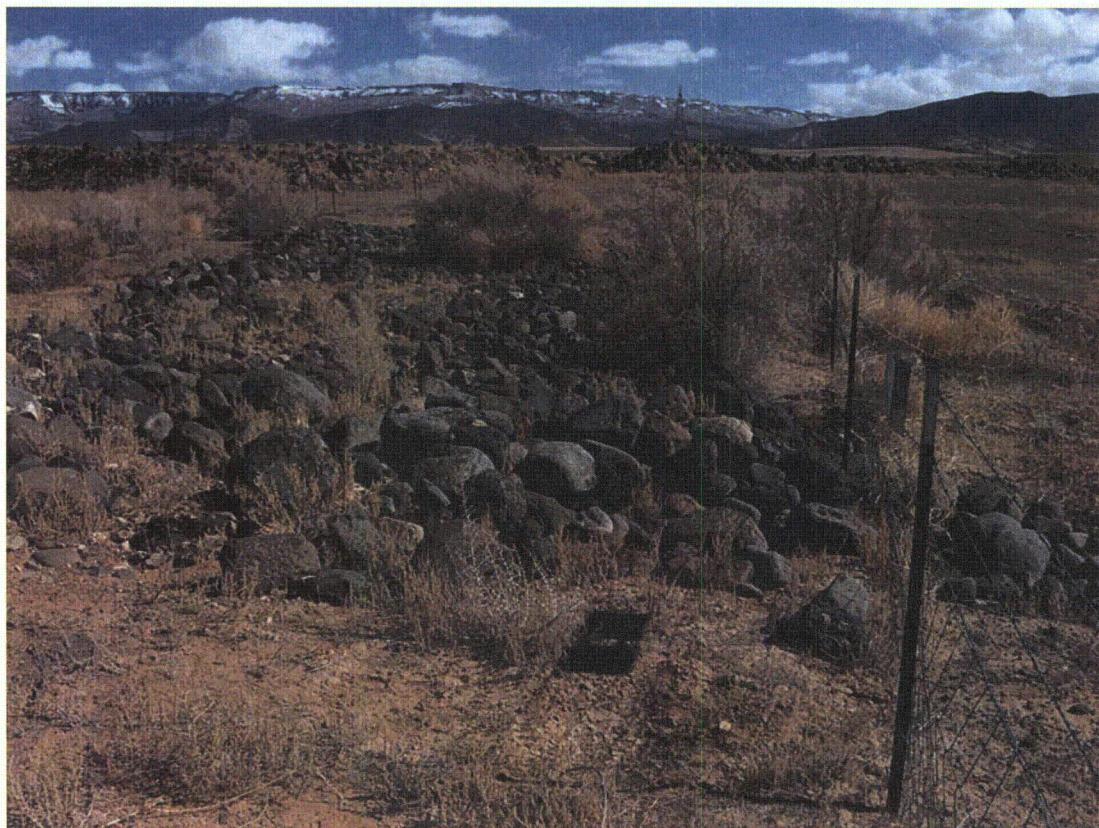
GRJ 3/2011. PL-4. Riprap erosion protection near the southeast corner of the perimeter fence.

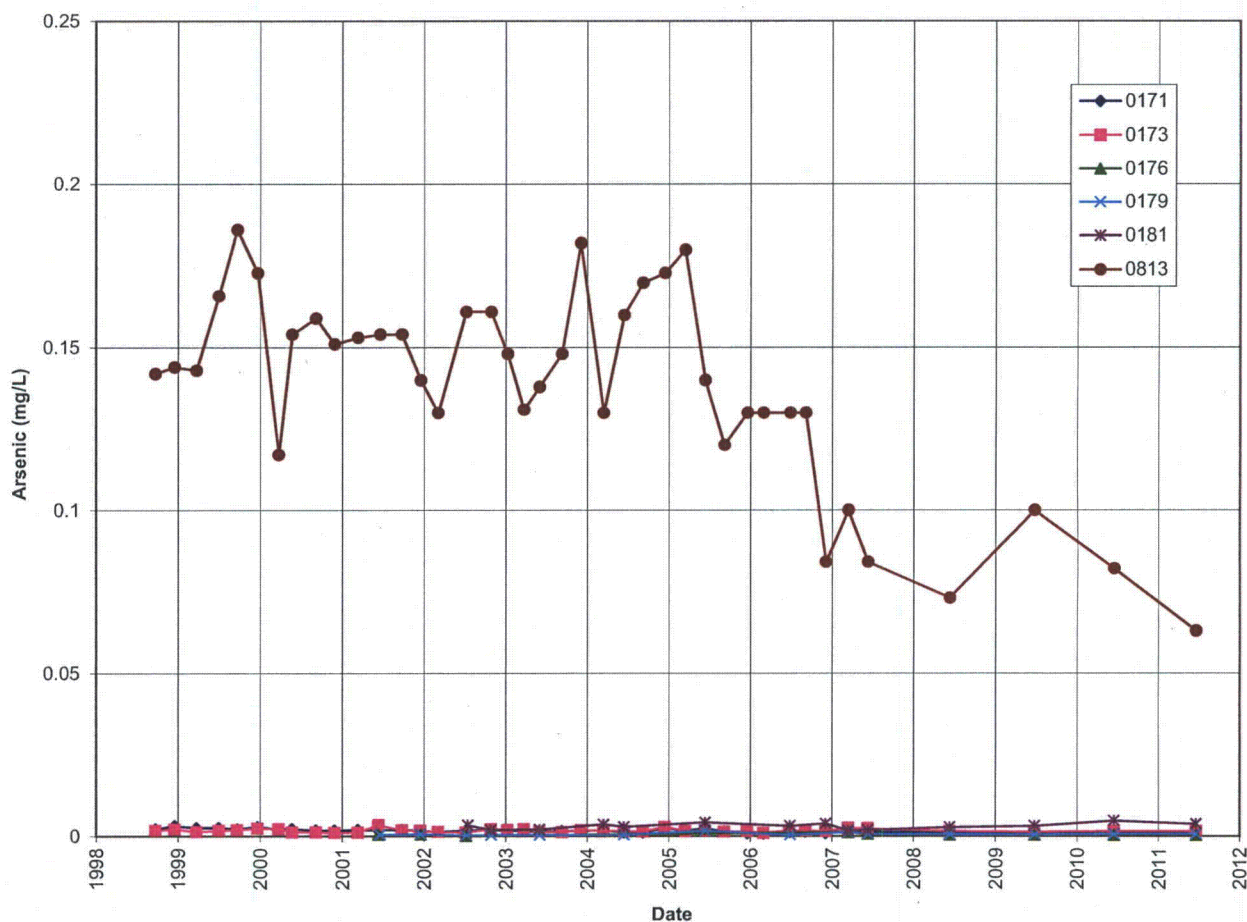
Figure 7-2. Time-Concentration Plots of Arsenic in Groundwater at the Green River Disposal Site

Arsenic concentrations in groundwater remain below the U.S. Environmental Protection Agency (EPA) maximum concentration limit (MCL) of 0.05 milligram per liter (mg/L) in all POC wells except well 0813, and remain considerably below the proposed ACL of 1.9 mg/L in all POC wells. In well 0813, levels continue to exceed the MCL, as shown on Figure 7-2, but are substantially below the proposed ACL. The results for this well indicate that arsenic concentrations have trended downward since 2005.

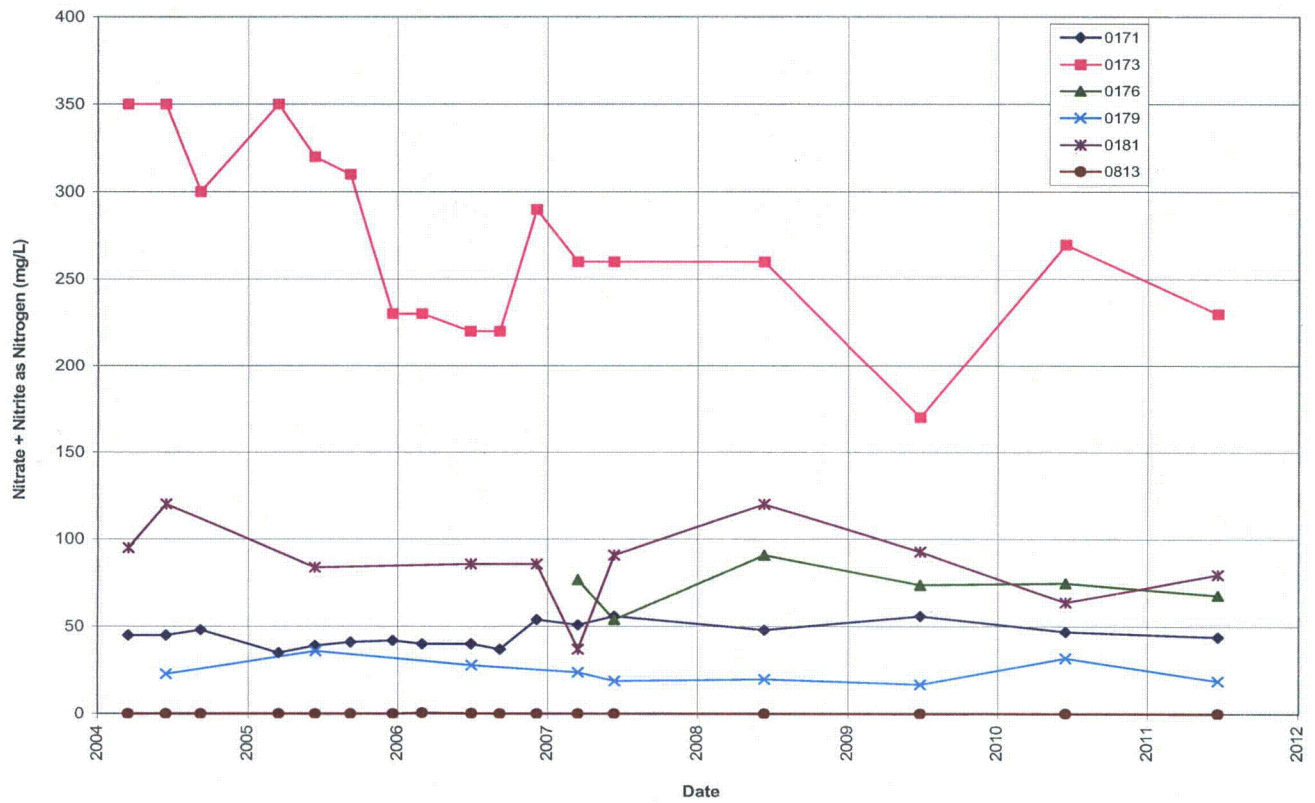
Figure 7-3. Time-Concentration Plots of Nitrate in Groundwater at the Green River Disposal Site

Nitrate concentrations have been measured as nitrate plus nitrite as nitrogen since early 2004 (before then, nitrate was measured as NO_3). Concentrations have continued to exceed the EPA MCL of 10 mg/L in all POC wells except well 0813, but they are considerably below the proposed ACL of 4,270 mg/L in all wells (Figure 7-3). Nitrate concentrations in well 0813 continue to be below the laboratory detection limit. Nitrate concentrations in the other wells are similar to previous measurements, and no trends are apparent.

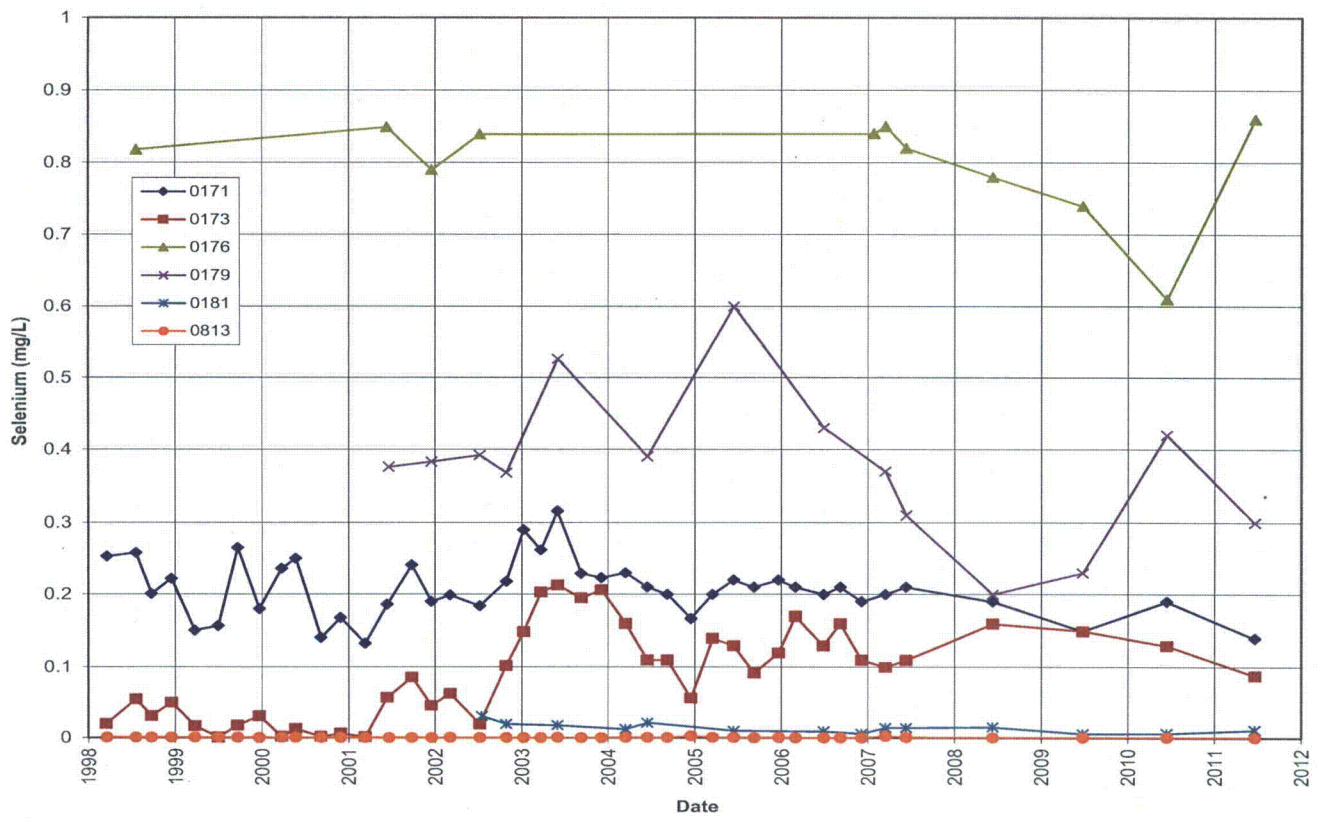
Figure 7-4. Time-Concentration Plot of Selenium in Groundwater at the Green River Disposal Site

Selenium concentrations in wells 0181 and 0813 remain below the EPA MCL of 0.01 mg/L. Concentrations in the other wells continue to be above the standard but are substantially below the proposed ACL of 8.5 mg/L (Figure 7-4). Well 0176 was showing a decreasing trend; however, the June 2011 result has rebounded to 2007 levels.
