2011 Annual Site Inspection and Monitoring Report for Uranium Mill Tailings Radiation Control Act Title I Disposal Sites

January 2012

**U.S. Department of Energy
Office of Legacy Management**

**2011 Annual Site Inspection and Monitoring Report
for
Uranium Mill Tailings Radiation Control Act
Title I Disposal Sites**

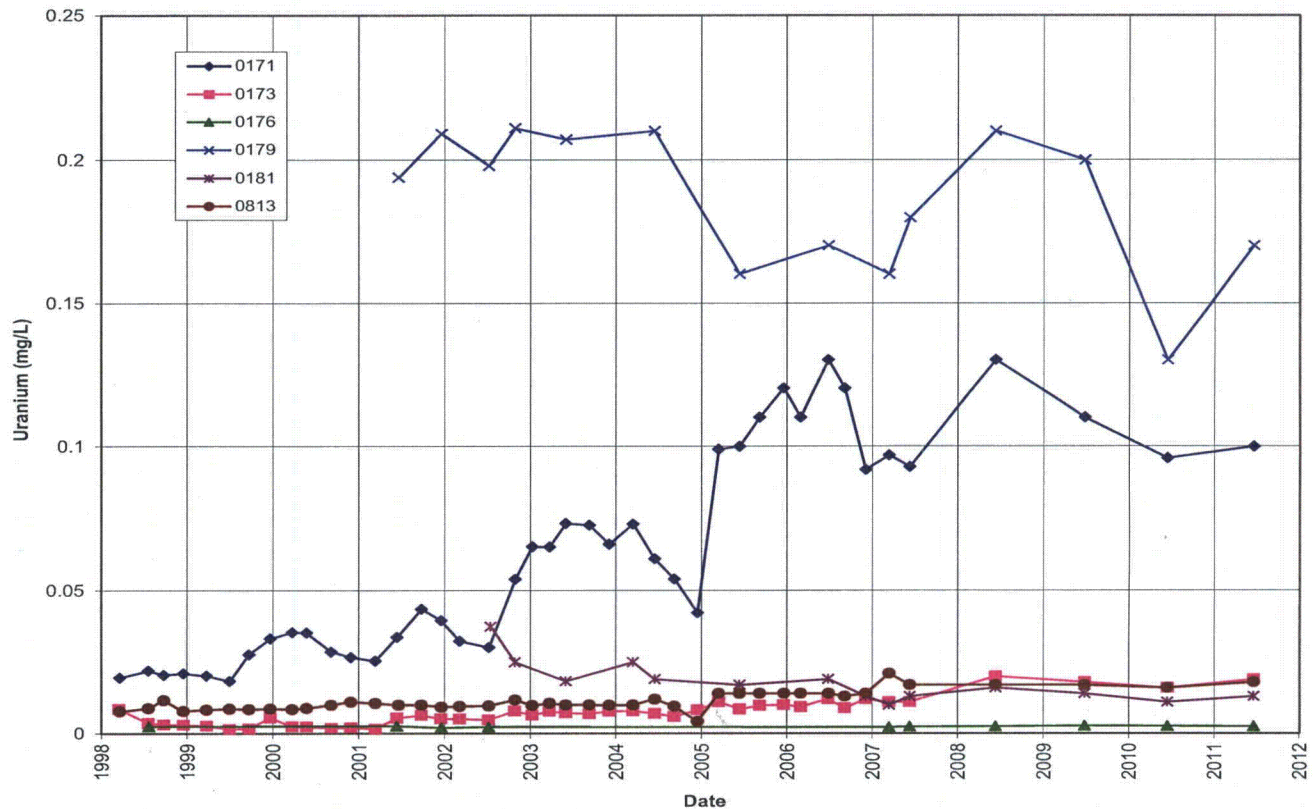
Figure 7-5. Time-Concentration Plot of Uranium in Groundwater at the Green River Disposal Site

Uranium concentrations in groundwater remain below the EPA MCL of 0.044 mg/L in all POC wells except wells 0171 and 0179, and remain considerably below the proposed ACL of 2.3 mg/L in all POC wells. The highest uranium concentrations continue to occur in well 0179 (0.17 mg/L), which is upgradient of the disposal cell. The reason for the elevated concentration of uranium in well 0179 has not been determined, but it may be due to natural causes. At well 0171, concentrations exceed the MCL and indicate an upward trend since 1998 (Figure 7-5). Because uranium is the only constituent of concern that has indicated an upward trend in well 0171, no conclusions regarding the cause of the trend have been reached.

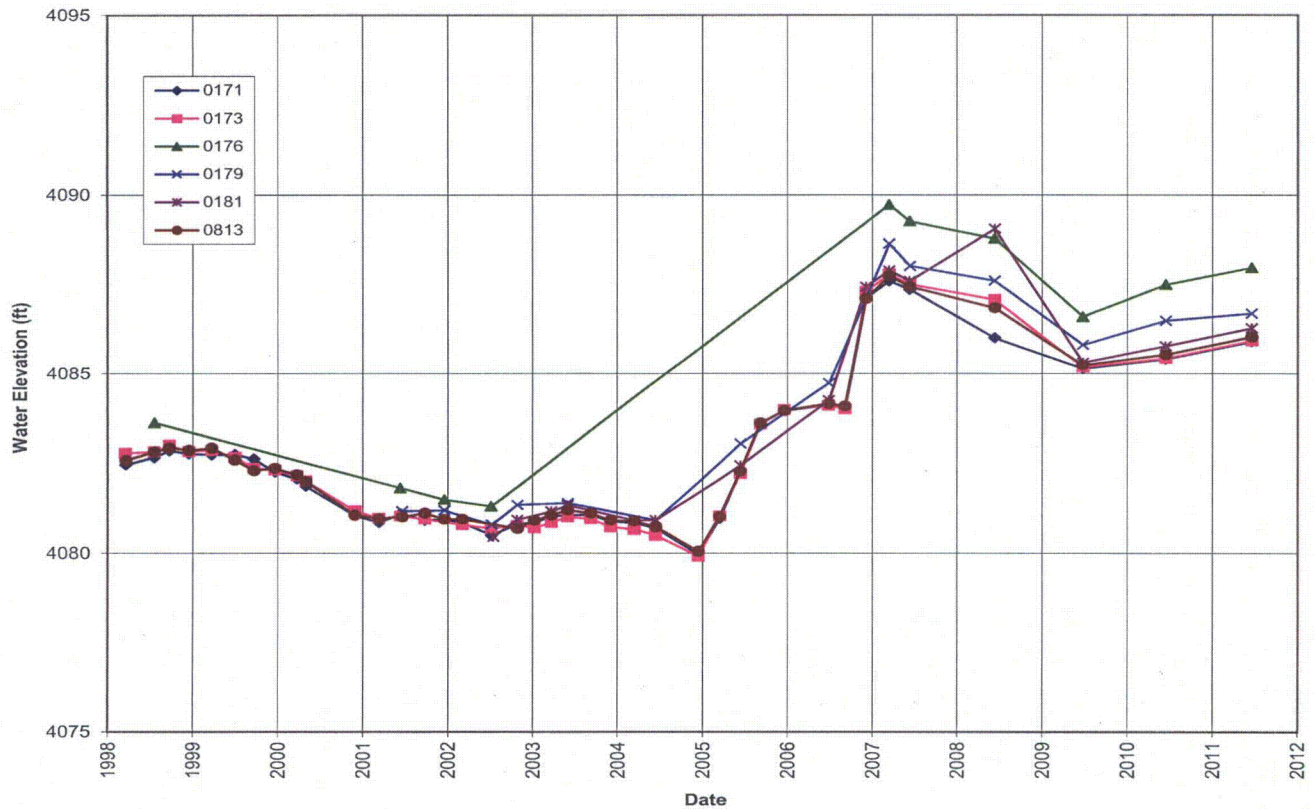
Figure 7-6. Groundwater Elevations at the Green River Disposal Site

Water-level hydrographs of the POC wells, completed in the middle sandstone aquifer, indicate that the groundwater elevation decreased approximately 3 feet overall from 1998 through 2004, and then increased approximately 8 feet between 2004 and 2007. Water levels have decreased approximately 2 to 3 feet since 2007, although slight increases occurred in 2010 and 2011 (Figure 7-6).

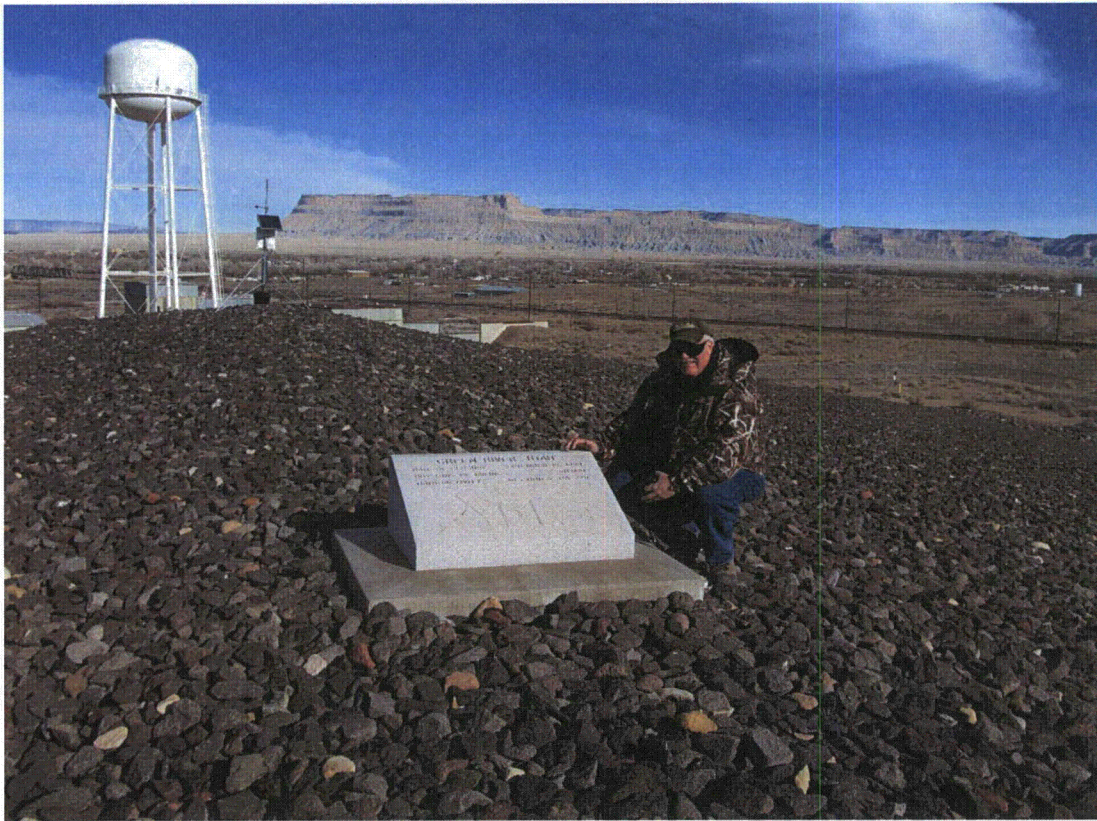
Site Markers and Monuments—Two granite site markers are on site, and both were in good condition (PL-1). The concrete base of site marker SMK-1 has several cracks, but there is no need for repairs at this time. Eleven boundary monuments and three survey monuments are along the site perimeter. All of the monuments were in excellent condition.

GRN 3/2011. PL-1. Site marker SMK-2 on the disposal cell top.

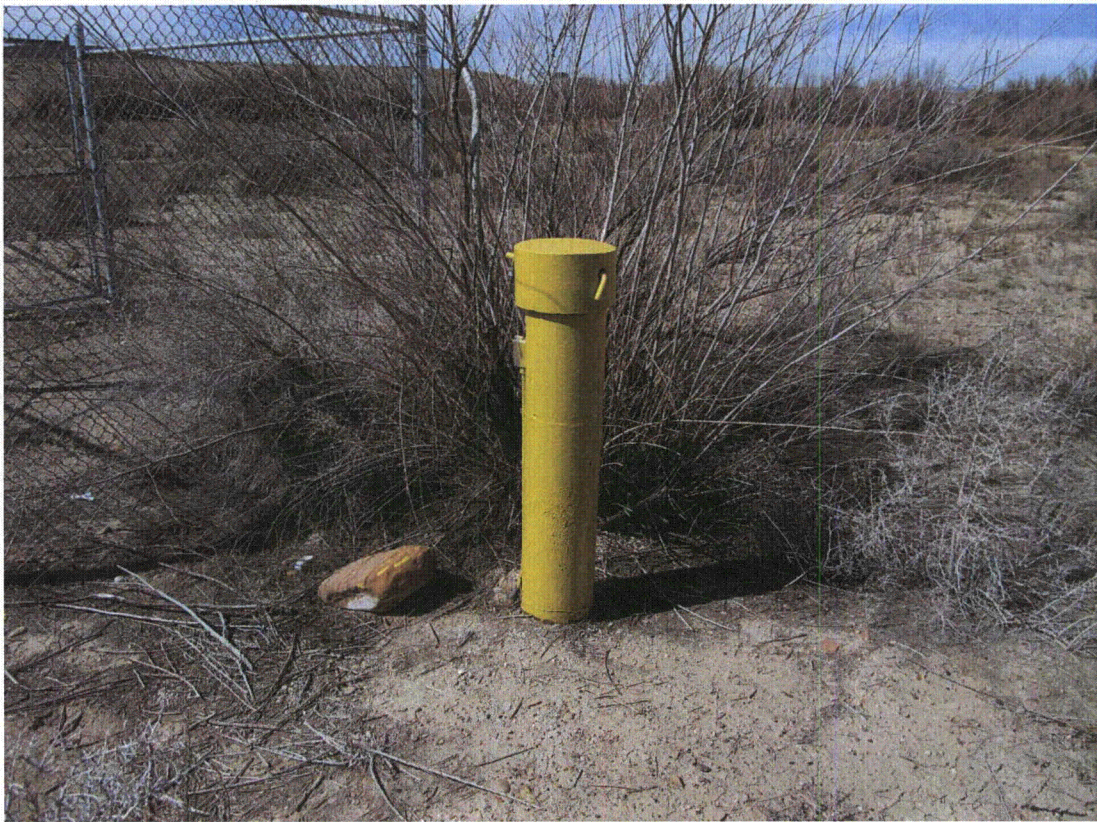
Monitoring Wells—The twenty-two groundwater monitoring wells were secure and in excellent condition at the time of the inspection (PL-2). Section 7.3.4 describes the groundwater monitoring and its results.

GRN 3/2011. PL-2. Monitoring well 0817.

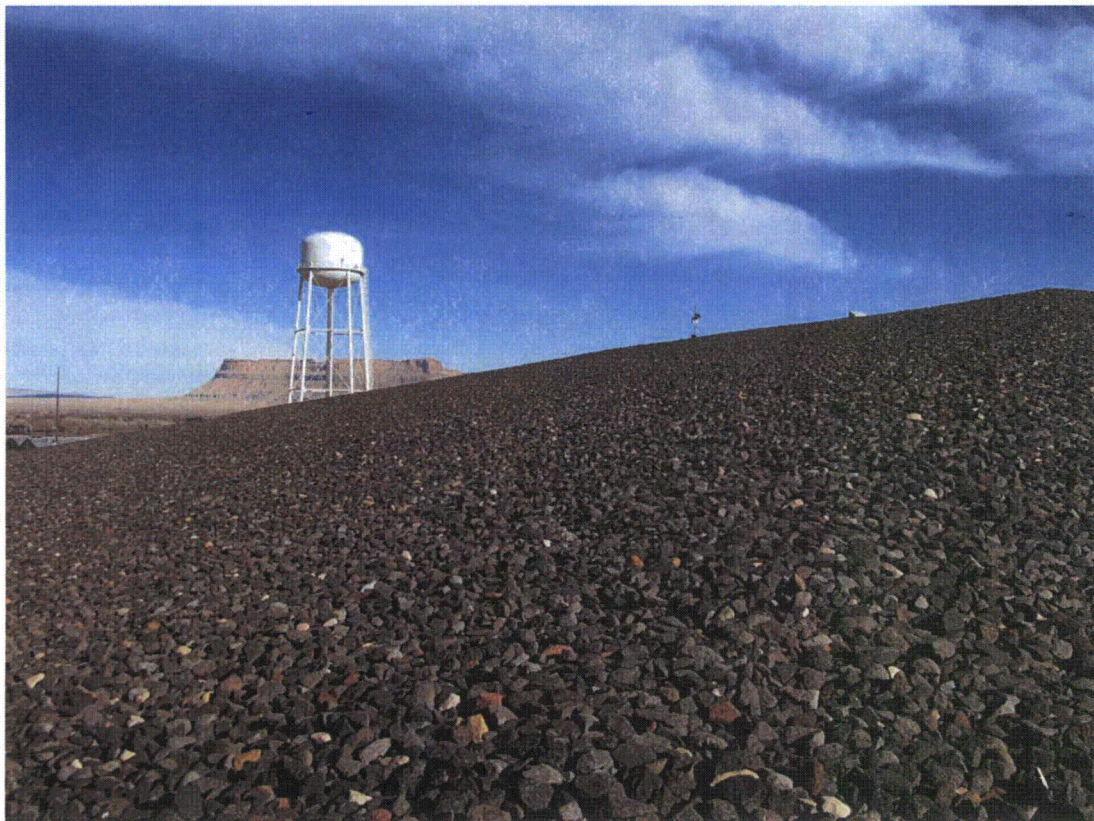
Disposal Cell and Adjacent Area Inside the Security Fence—The 6-acre disposal cell was completed in 1989. The slopes of the disposal cell cover are armored with basalt rock. No evidence of any disturbance of the cell surfaces was observed. No vegetation was present on the cell. The quality of the rock is excellent, and the disposal cell cover was in excellent condition (PL-3).

GRN 3/2011. PL-3. Southwest side slope of the disposal cell.

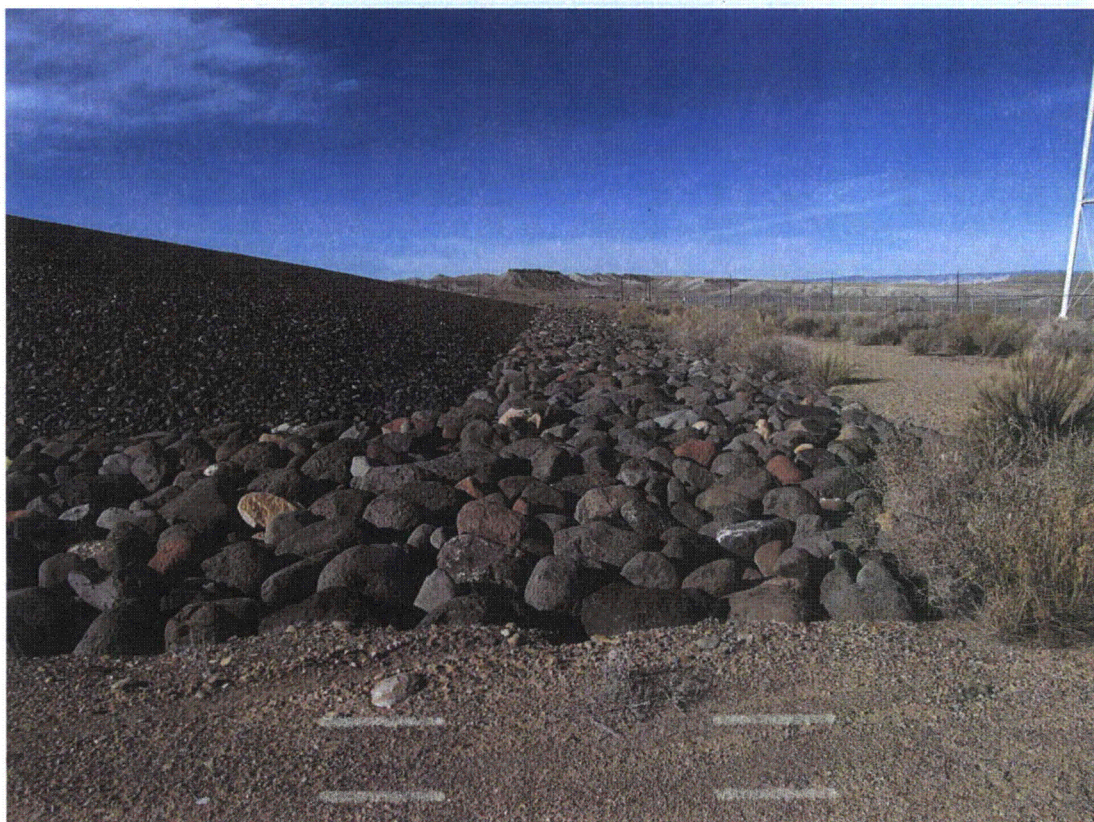
A basalt boulder-filled trench, referred to as an apron, surrounds the disposal cell. The apron collects all runoff water from the cell, and the water is reduced by evaporation, evapotranspiration through deep-rooted shrubs that grow along the apron, and infiltration into the underlying bedrock and aquifer through the sides and bottom of the apron. The apron was in excellent condition (PL-4).

GRN 3/2011. PL-4. Northwest side slope and apron of the disposal cell.

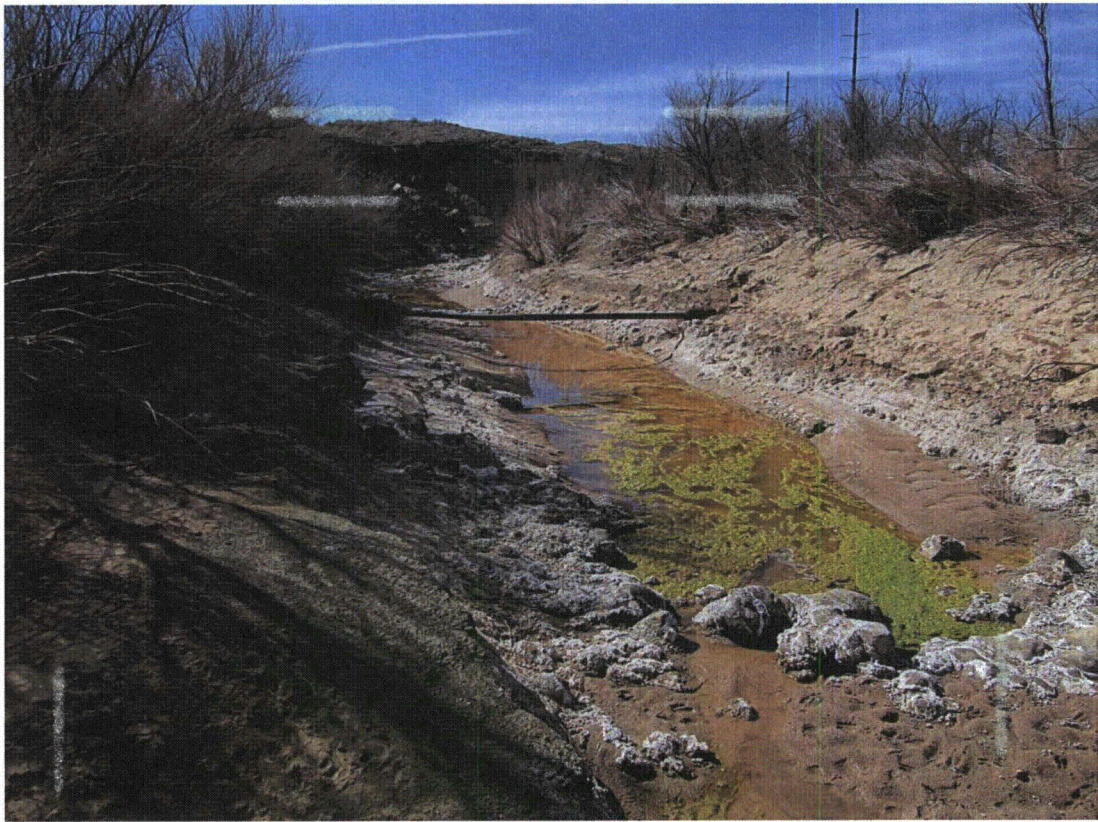
The conditions of Browns Wash were observed during the inspection. Flow was occurring in the channel between the road bridge and the backwater area near the confluence with the Green River (PL-5). The streambed upstream of the bridge was dry; therefore, the flow downstream of the bridge was from seeps. Because the middle sandstone unit is not present under the principal seep area (seep location 0718), the source of the seep water is most likely from the Browns Wash alluvium.

GRN 3/2011. PL-5. Seep 0710 in Browns Wash.

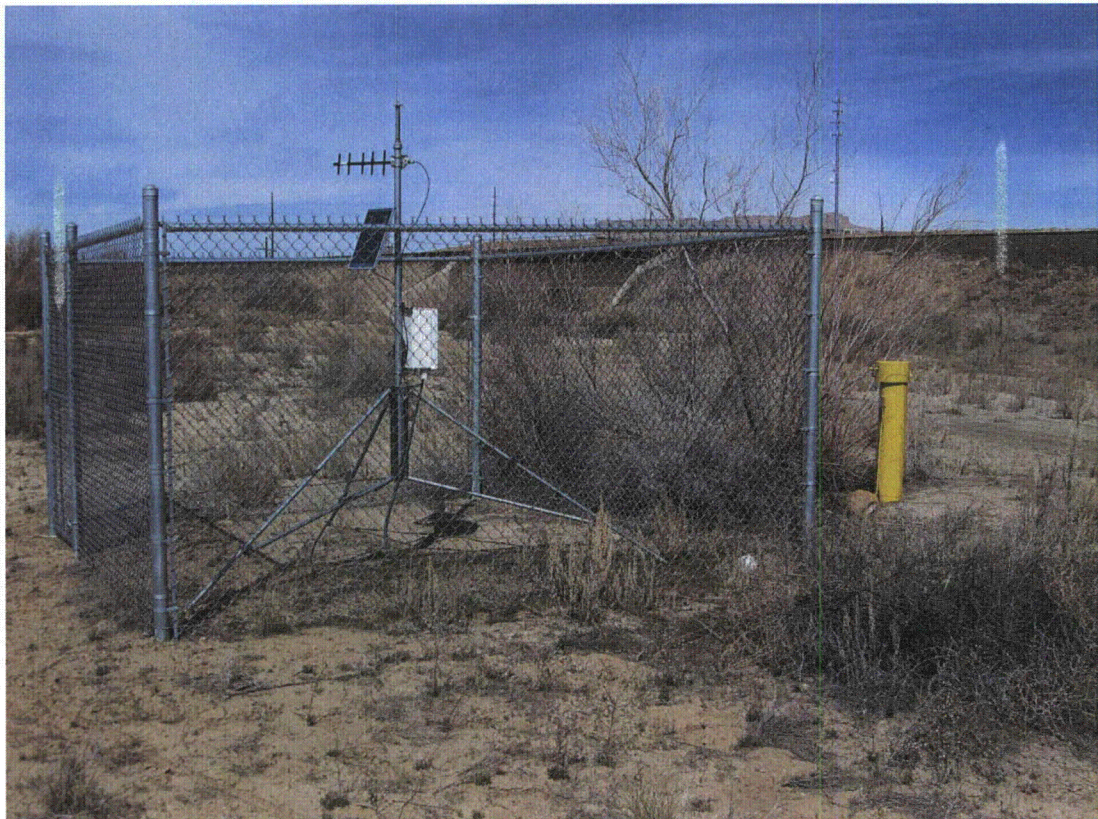
GRN 3/2011. PL-6. Monitoring well 0817 and enclosed telemetry tower.

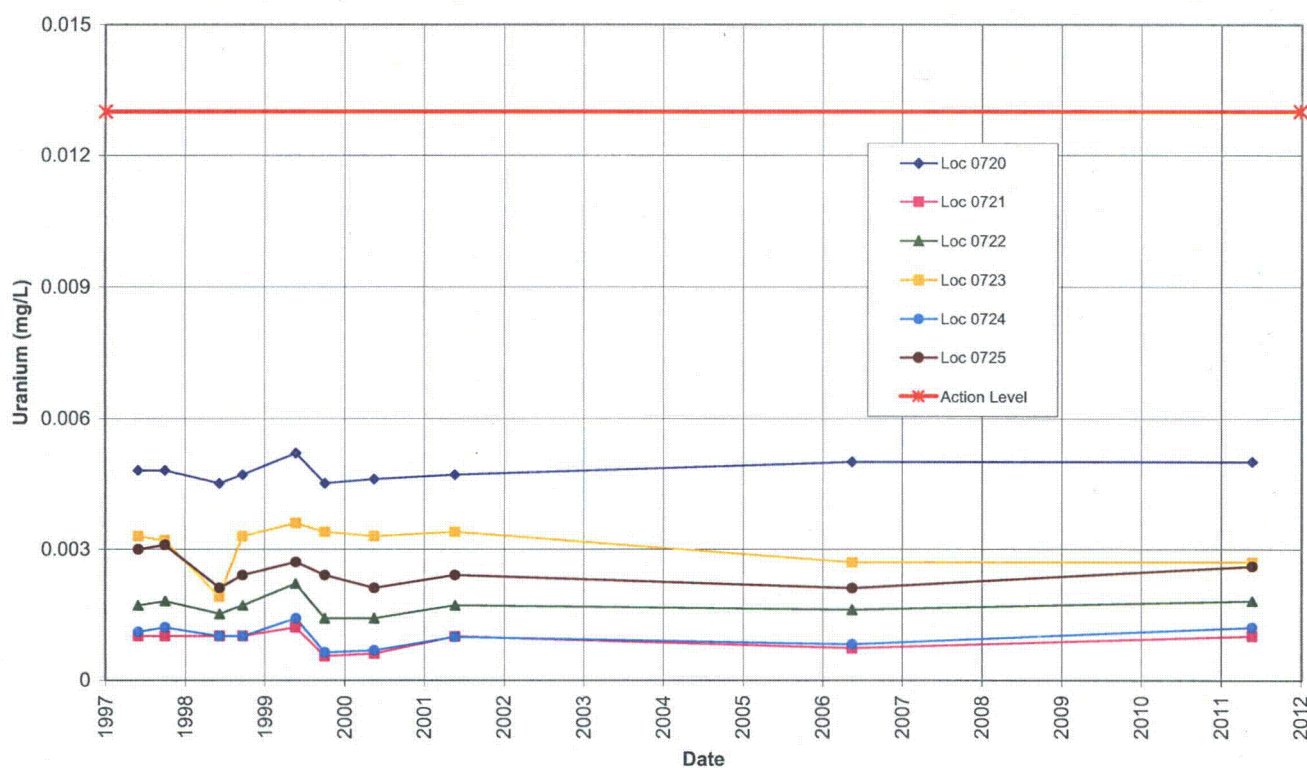
Figure 8-2. Time-Concentration Plots of Uranium in Groundwater at the Gunnison, Colorado, Disposal Site

0.0038 mg/L and 0.0022 mg/L, respectively. The concentrations of uranium in samples collected from POC wells ranged between 0.001 mg/L and 0.005 mg/L, which is consistent with historical results, as shown in the time-versus-concentration graph (Figure 8-2). Uranium results from the POC wells were an order of magnitude below the action level of 0.013 mg/L.

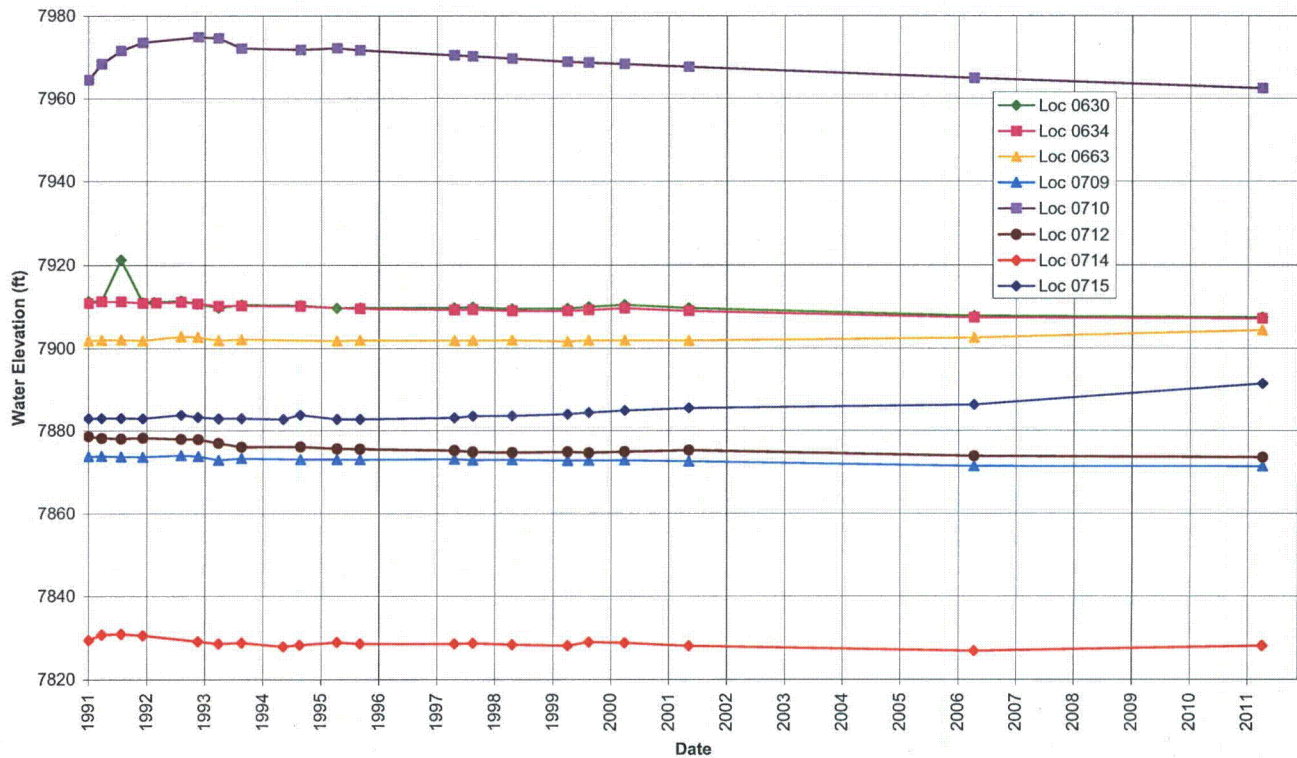
Figure 8-3. Water-Level Measurements at Active Monitoring Wells at the Gunnison, Colorado, Disposal Site

Groundwater-Level Monitoring—Water levels from the entire monitoring network were measured in May 2011. Data from water-level measurements show only minor fluctuations in groundwater elevations since completion of the disposal cell in 1995; hydrographs from selected wells across the site illustrate this consistency in water levels (Figure 8-3). Water-level measurements indicate essentially steady-state groundwater conditions at the site.

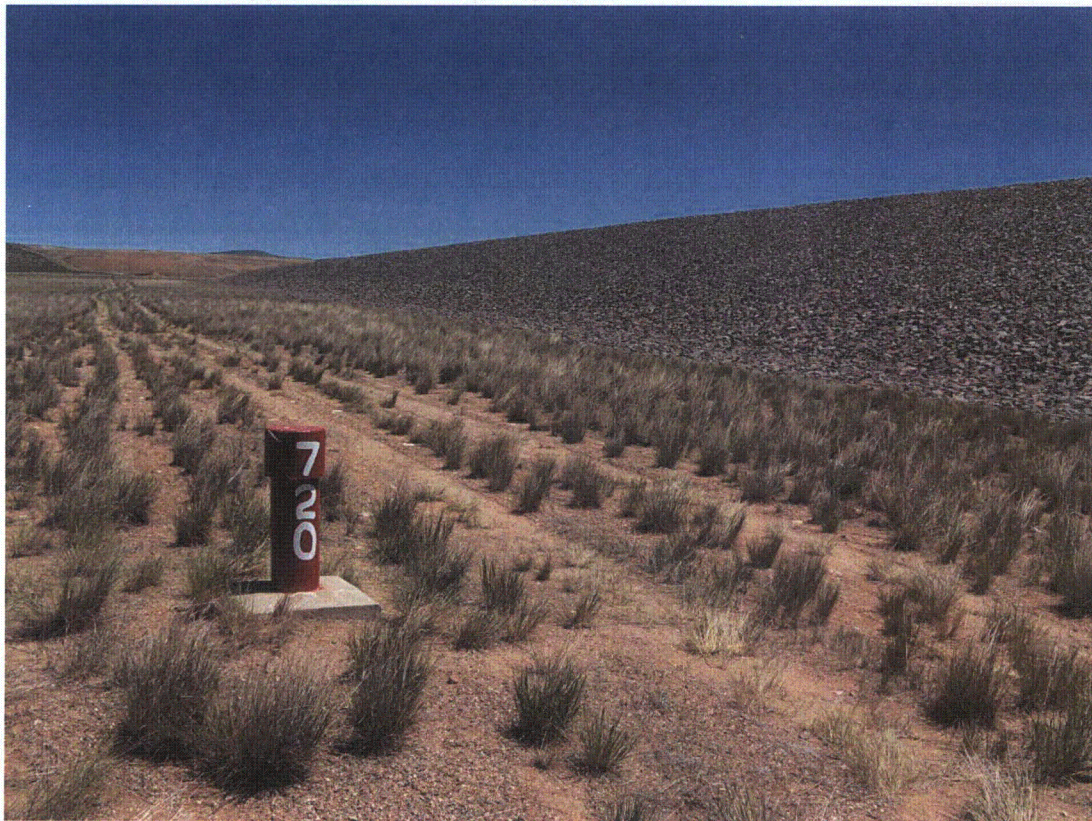
GUN 6/2011. PL-1. Monitoring well 0720.

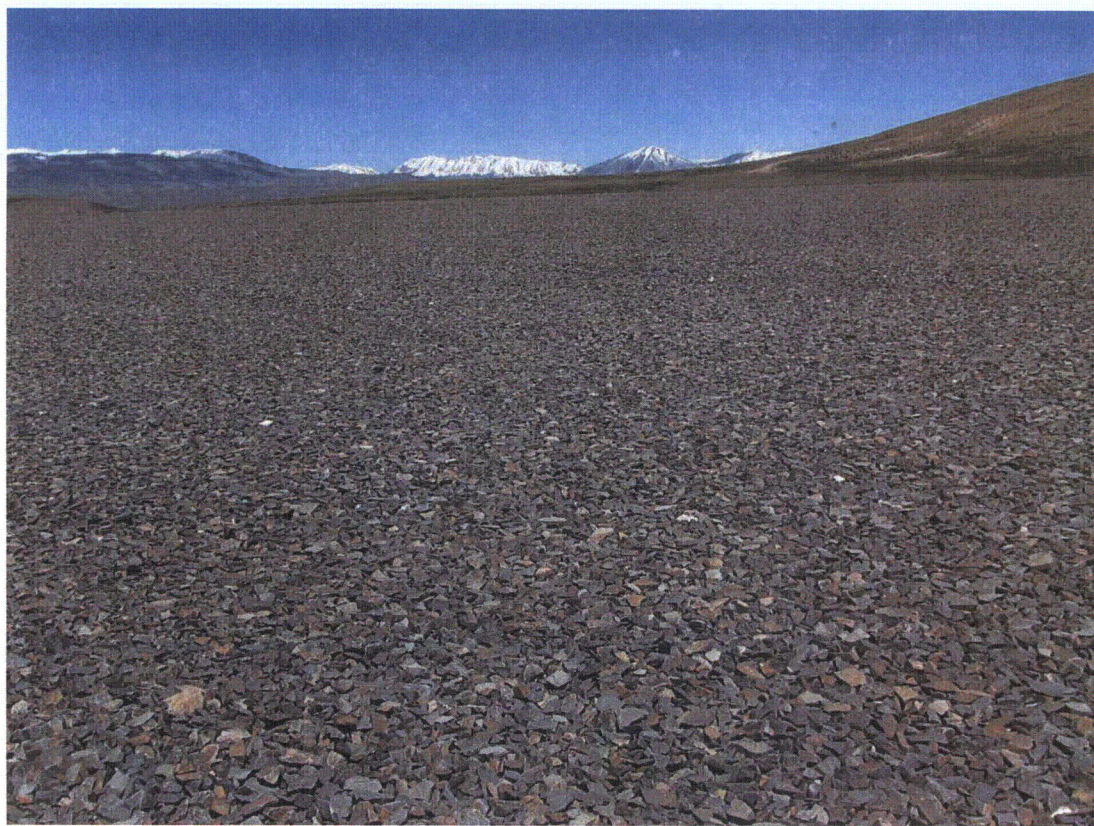
GUN 6/2011. PL-2. West portion of the disposal cell top.

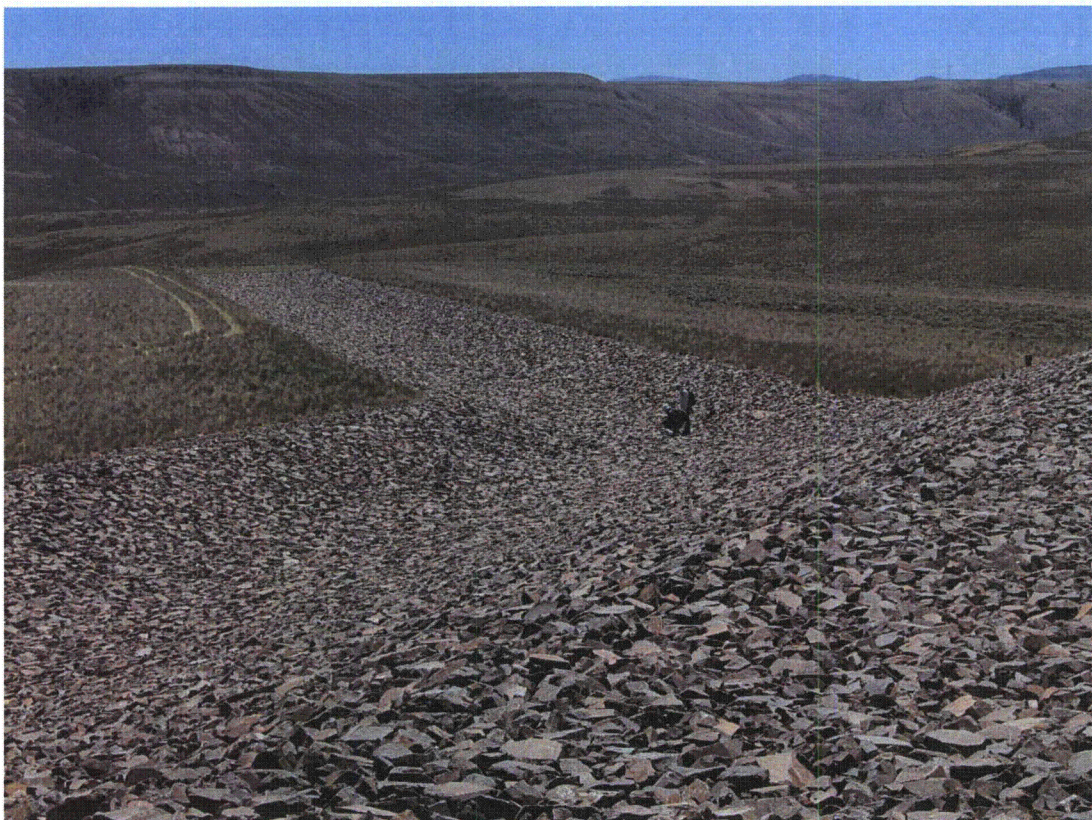
GUN 6/2011. PL-3. East diversion channel.

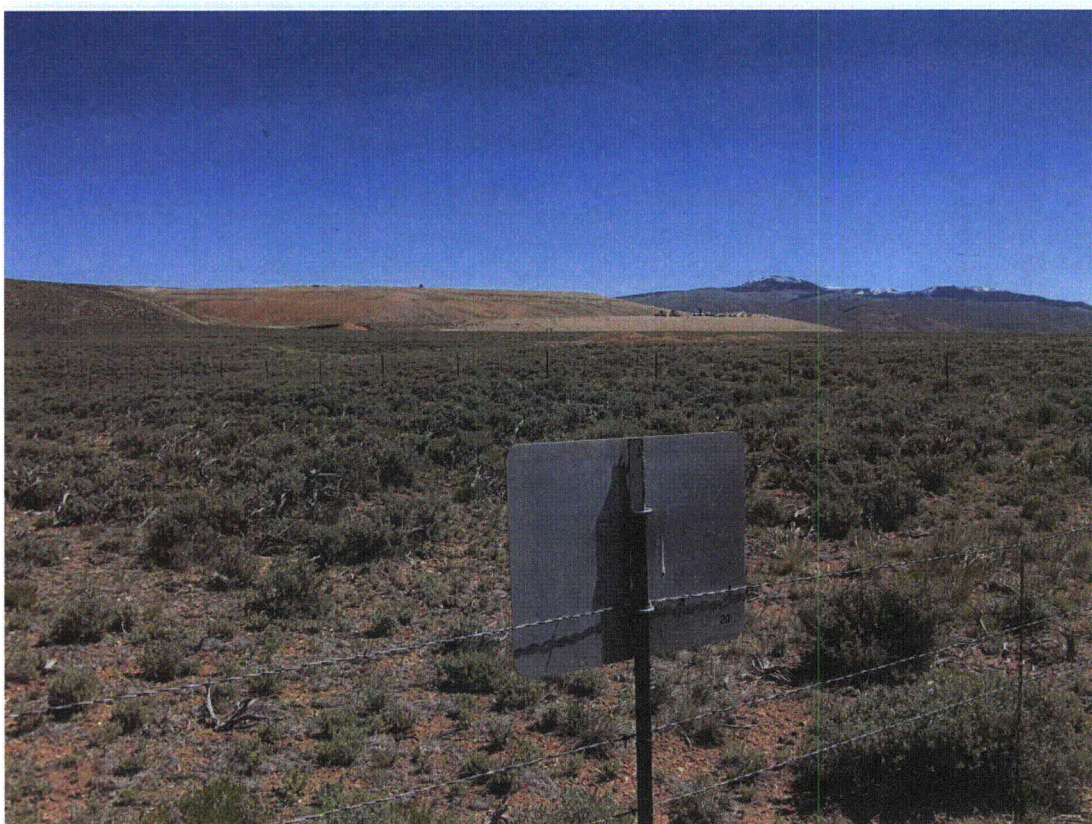
GUN 6/2011. PL-4. County landfill activities northeast of the site.

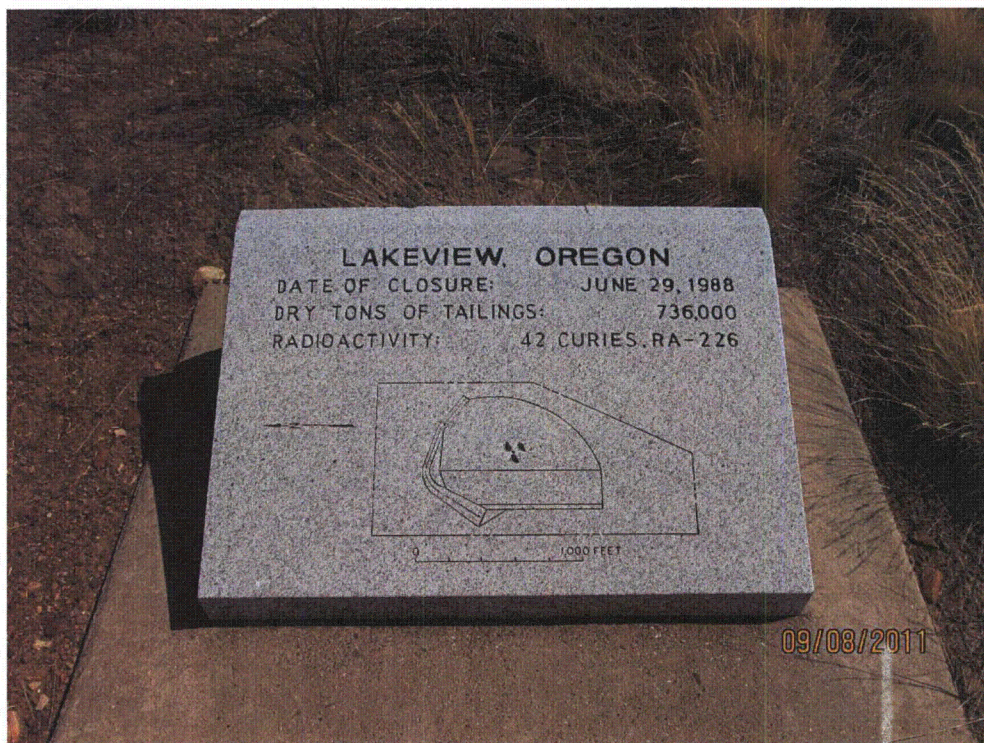
LKV 9/2011. PL-1. Site marker SMK-2 on top slope

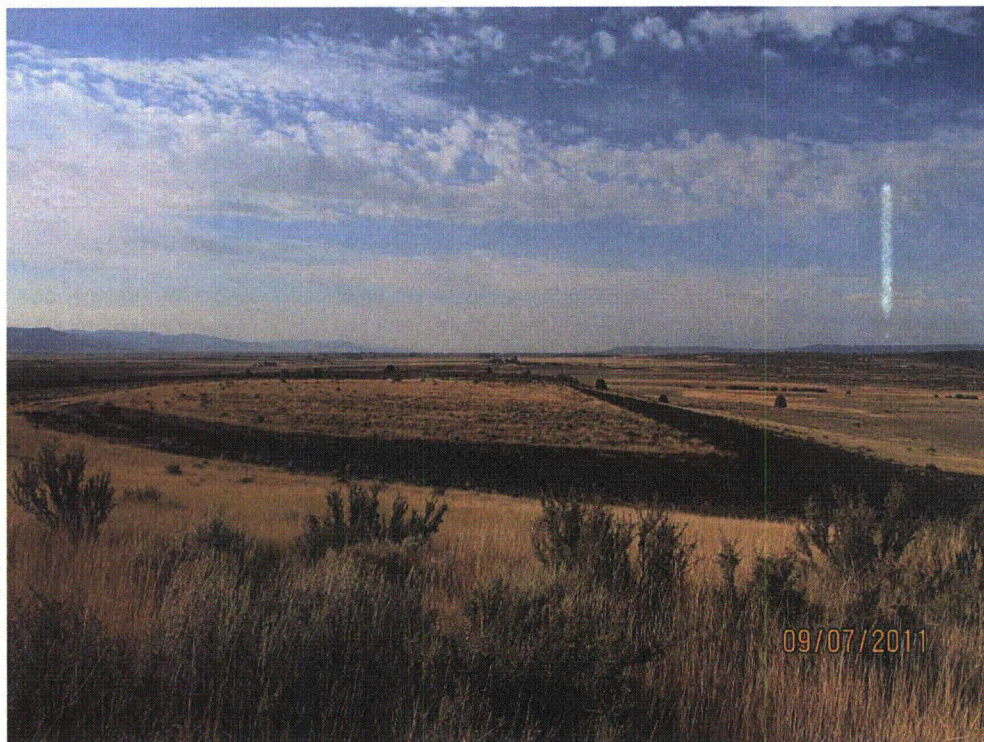
LKV 9/2011. PL-2. View from north site fence to south, showing cell top and side slopes.

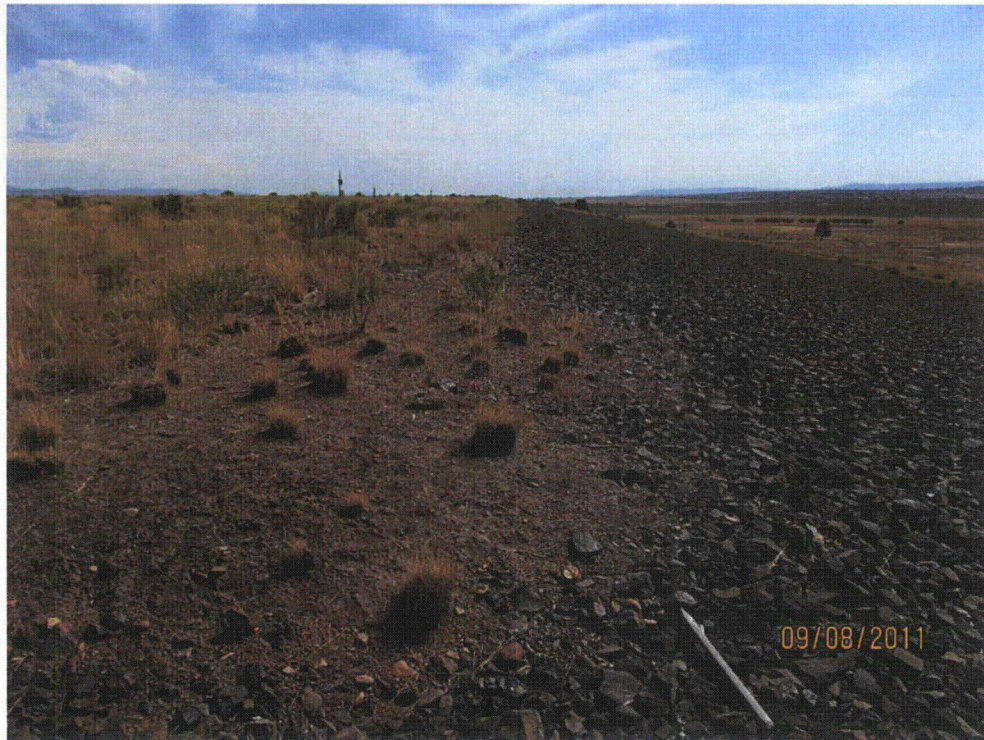
LKV 9/2011. PL-4. Photo taken (looking south) at intersection of west and north side slopes and top slope. Soil from top slope is being deposited onto side slope riprap.

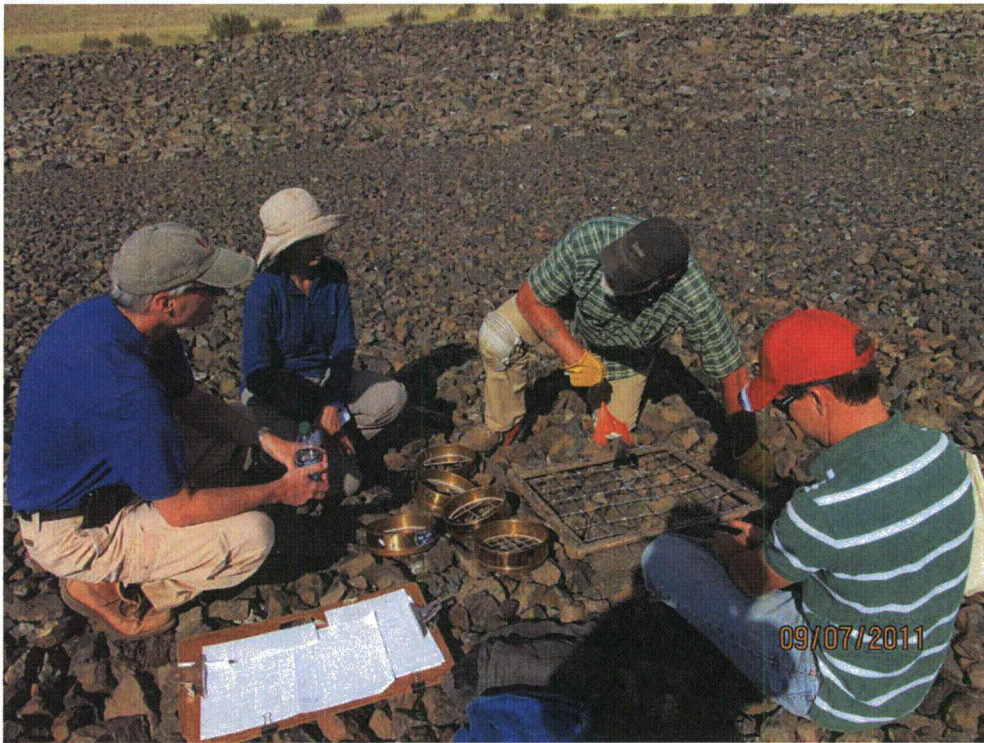
LKV 9/2011. PL-5. DOE representatives watching rock monitoring on west side slope. A grid is used to mark rocks for gradation and durability monitoring. Marked rocks are first sized using a series of sieves and then identified by rock type and durability class.

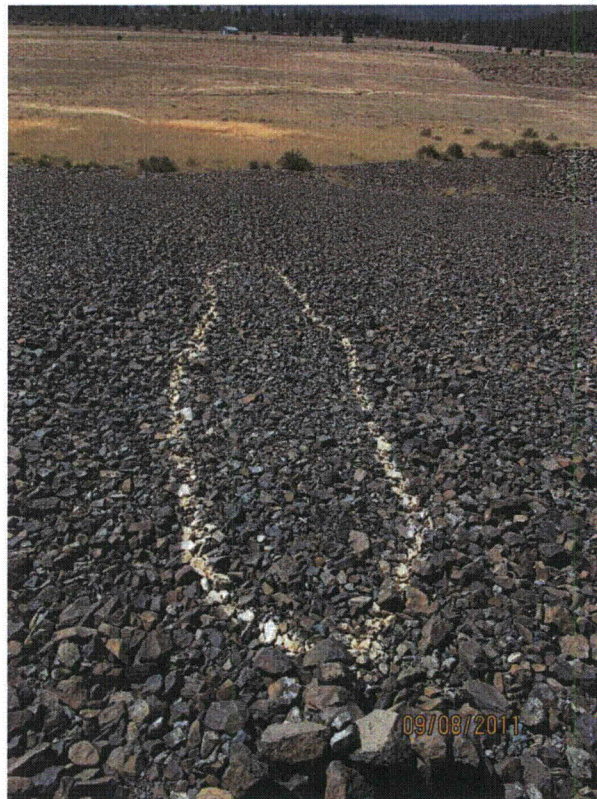
LKV 9/2011. PL-6. Marked streak (area of finer rock) on west side slope near water fluxmeter 2. Photo taken looking down slope to west.
