4.0 DISCUSSION OF RESULTS/EVALUATION

In August 2011, a Type 416 stainless steel (SS) coupling fractured in Service Water System (SWS) pump P-7C at Palisades Nuclear Plant (PLP). A previous coupling fracture occurred in the same pump in 2009. As a result of the recent failure, some couplings extracted from all three pumps at the PLP site were examined by magnetic particle testing that revealed four additional cracked couplings from pumps P-7C and P-7B, but not P-7A.

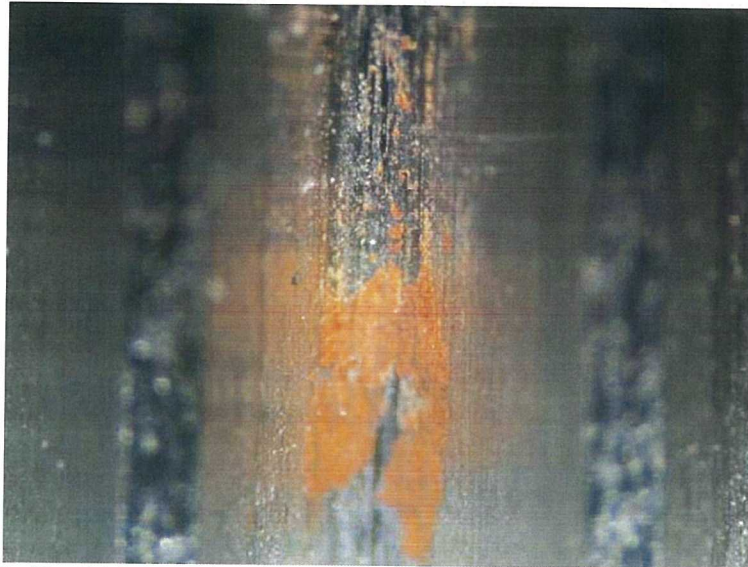
Figure 3-22: Representative Image of P-7A Coupling Showing No Pitting

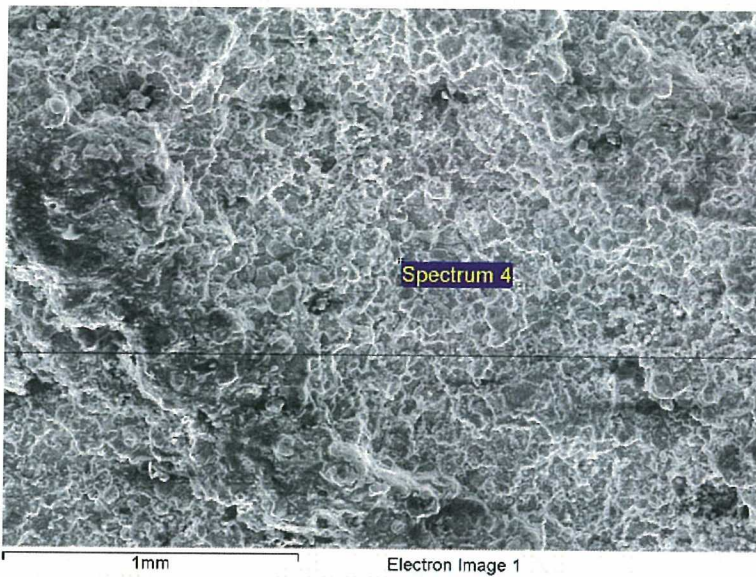
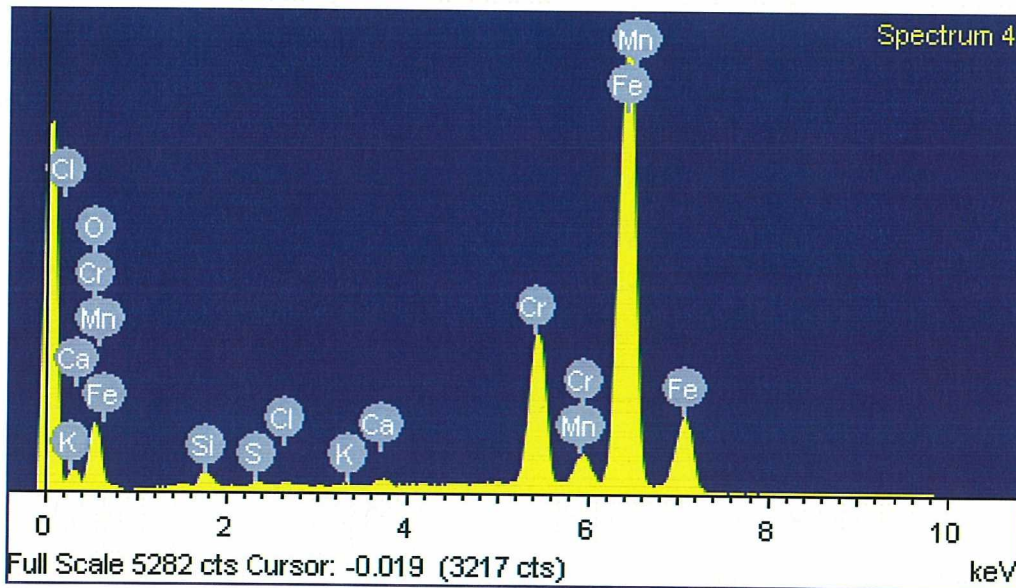
Figure 3-24: EDS of Coupling 11-P7C-6F Surface Deposit – Spectrum 4

EDS analysis of fracture surface revealed the presence of corrosive agents (chlorides, oxides and sulfides), consistent with stress corrosion cracking. The high chromium level in the spectrum is likely attributed to local chromium carbides in the EDS sampling volume.

Element	Weight %
O	7.5
Si	0.9
S	0.3
Cl	0.3
K	0.2
Ca	0.4
Cr	14.6
Mn	1.6
Fe	Bal.

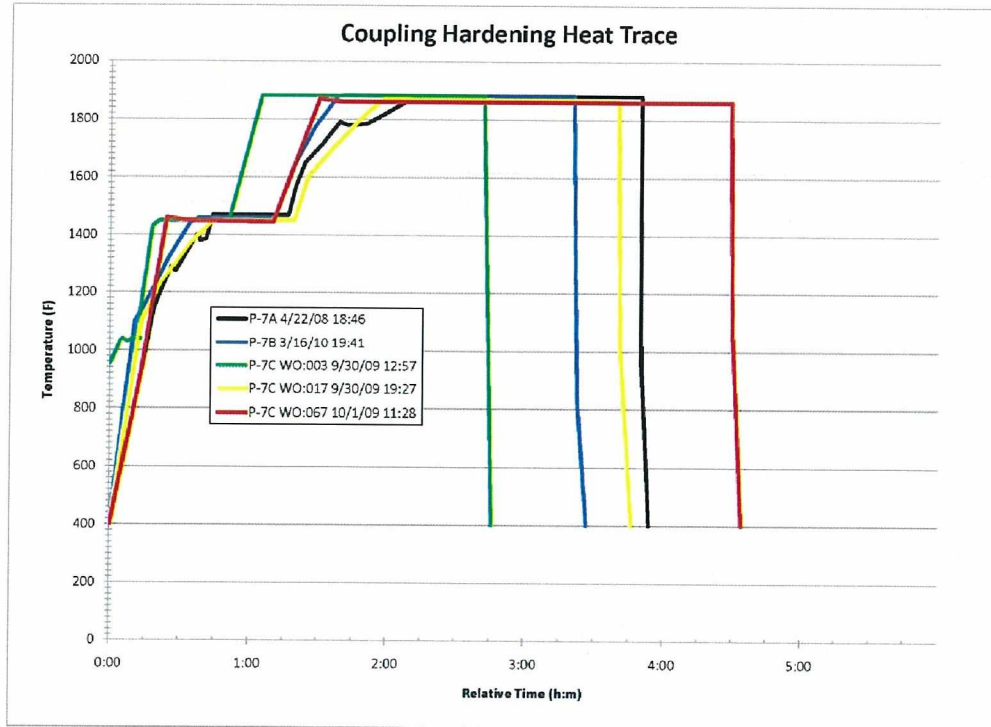
Figure 4-1: Hardening Heat Traces

According to the heat treatment process described in Attachment VI of the root cause evaluation report for CR-PLP-2009-04519 [1] and the heat trace in Figure 4-1, the couplings were hardened by quenching (rapid cooling) using nitrogen in a vacuum furnace from approximately 1870°F that quickly cooled the parts to ambient. The microstructure transforms from austenite to martensite when the couplings are quenched. The ASM metals handbook [26] and heat treater's guide [25] recommends an austenitizing temperature in the range of 1695°F to 1850°F for 416 SS. The austenitizing temperature of 1870°F, exceeds the recommended maximum of 1850°F. The effect of austenitizing temperature on the as-quenched hardness of three martensitic grades is shown in the figure to the right (extracted from [26]). It shows that "the hardness increases with increasing austenitizing temperature to about 1800°F, then decreases because of austenite retention and (occasionally) the formation of delta ferrite. Certain subtle anomalies in these steels that should be considered before specifying a heat treating procedure are exemplified in the opposing injurious effects of the high and low extremes of austenitizing temperature, depending on the subsequent tempering temperature [26]." The ASM heat treater's guide [25], recommends using the low side of the austenitizing range when tempering is to exceed 565°C (1050°F), which would be applicable to the subject couplings given their tempering treatment.

Based on the material properties from metallurgical testing and heat treatment provided in Figure 4-1 and Figure 4-2 , it is concluded that the material is susceptible to SCC.

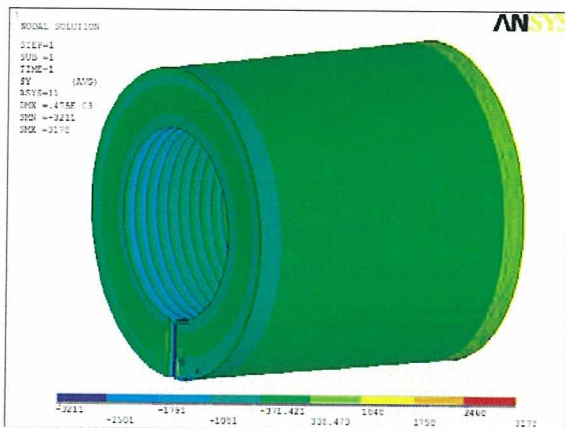
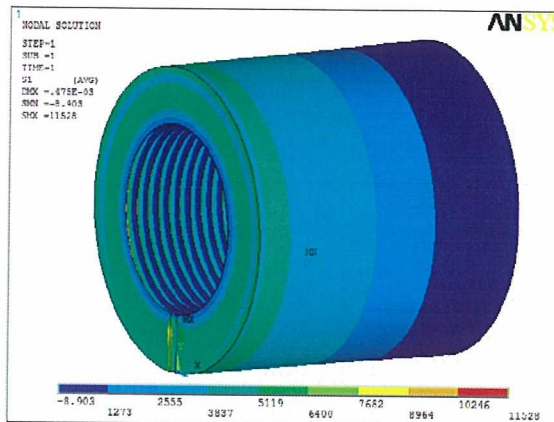
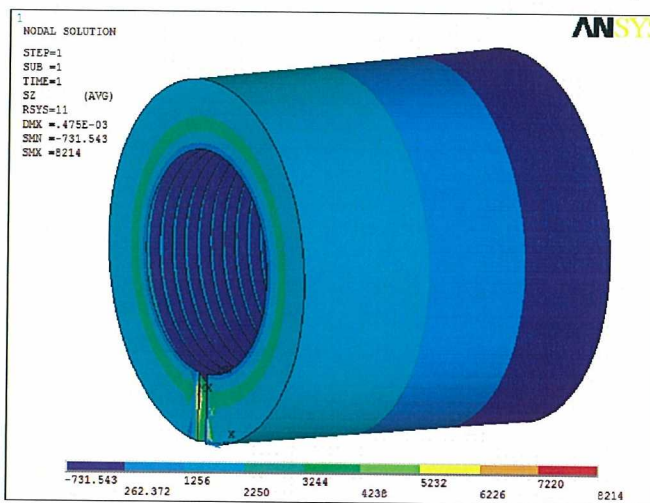
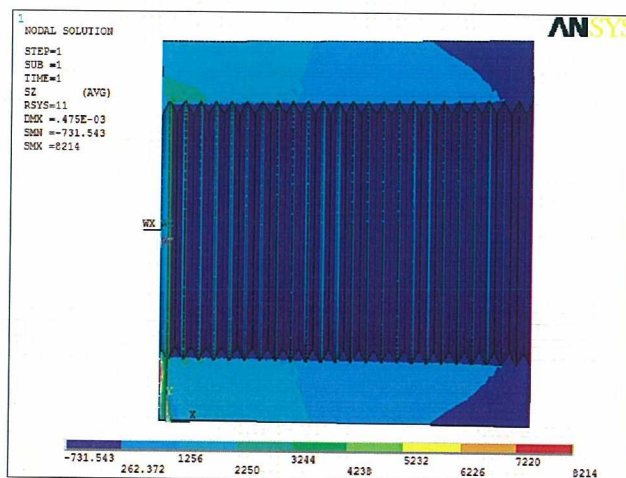
Figure 4-10: Resultant stresses for LC1

- 1) LC1: In this case, the circumferential stress, axial stress and first principal stress are relatively low due to the even distribution of loads on the coupling (see Figure 4-10). Axial tensile stresses at the thread root are on the order of 3.5 to 5 ksi. This result indicates that if the motor torque is transmitted across the coupling purely by thread frictional resistance, then the coupling tensile stresses are relatively low.

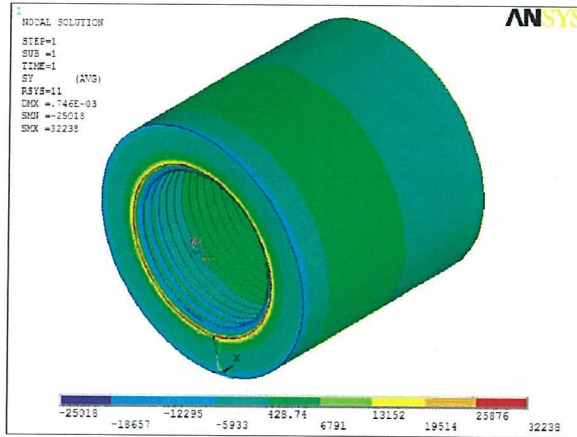
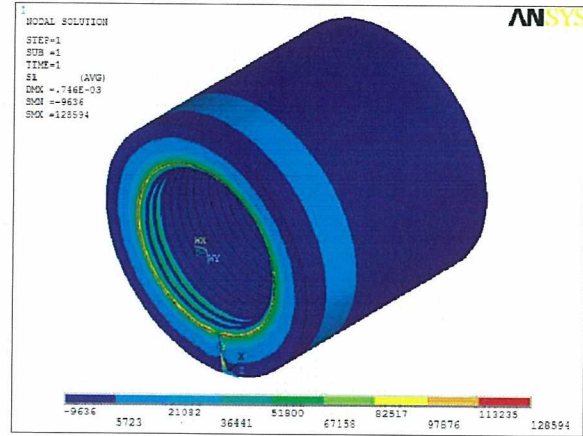
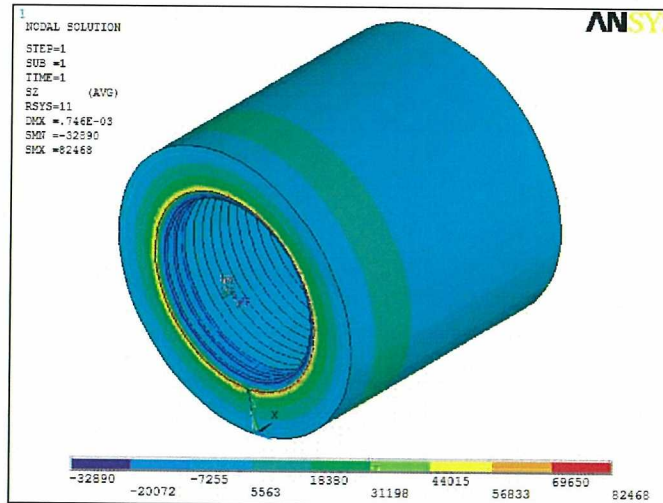
Figure 4-11: Resultant stresses for LC2

- 2) LC2: This load combination results in high stress concentrations at the thread root of the coupling at the contact plane of the two shafts. Axial tensile stresses at the thread root are over 10 times greater than LC1 with stresses on the order of 60 to 70 ksi. The stress distribution at the middle thread root across the coupling wall for this load combination root is presented in Figure 4-12.

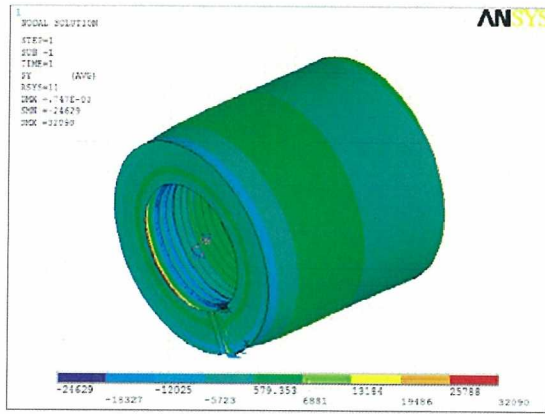
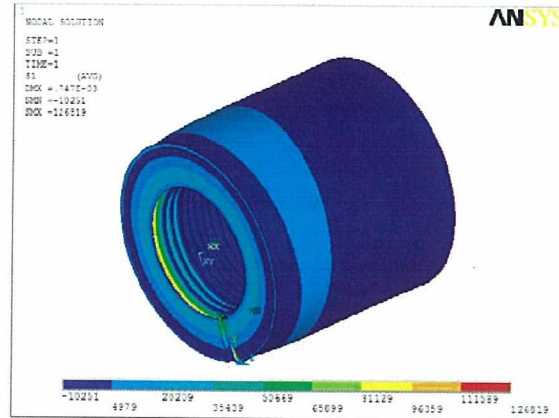
Figure 4-13: Resultant stresses for LC3

For this load combination, loads are applied in the same manner as LC2 with the addition of a moment on the coupling to account for misalignment or other postulated scenarios that can induce bending across the coupling. A bending moment equivalent to 20% of the stress induced by MTS2 of approximately 4,962 in-lb (see below) was also applied to the coupling. This moment was converted into axial force, F_z , and applied on the nodes on the end cross-section based on the nodes' y direction distance from center (see Figure 4-9).
