## IP3 ASME Section XI, IWL Concrete Containment Inspection for 2005

IP-RPT-06-00013

## Attachment 7.2 of ENN-EP-S-003, Rev. 0 CONTAINMENT INSERVICE INSPECTION RECORD OF VT-3 / GENERAL VISUAL EXAMINATION

STATION/UNIT	: IPEC / Indian Point No. 3	COMPONENT NO. :	VCC - 47
ZONE No:	005

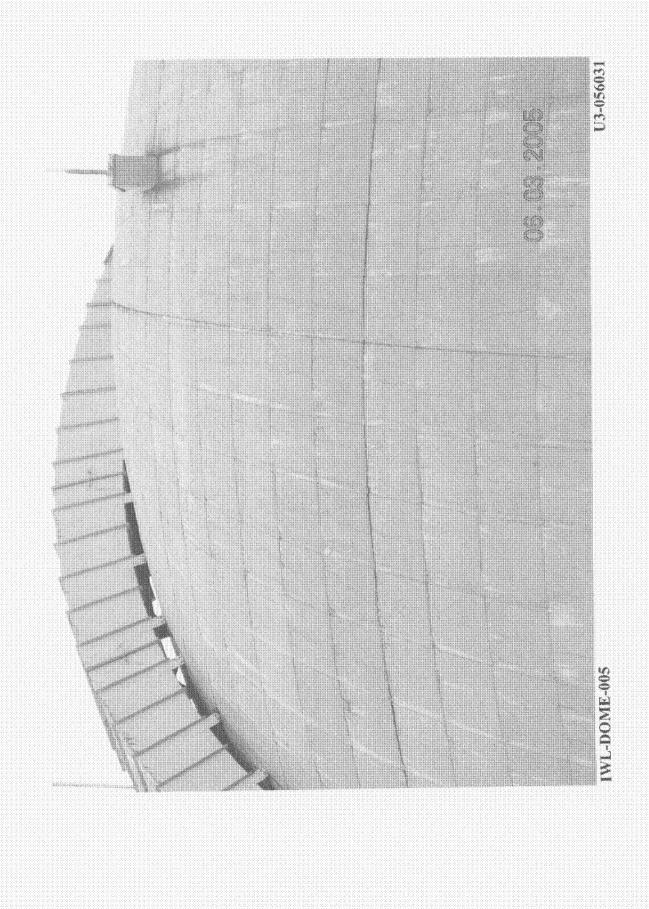
No.	Comment	Initials
1	First two rows of dome: Minor cracking due to shrinkage; popouts; leaching; scaling and spalling; all non-active, minor.	Pas
2	Vertical cracks 5' long and 5' o/c along the first row of the dome. See photo U3-056095	PB PB
3	Third and fourth rows of dome: Joint cracking; spalling; staining from duct support steel; vertical cracks 5' long and 5' o/c; small popouts with rust and staining.	PMS
4	Fifth and sixth rows of dome: Joint cracking; vertical cracks; minor spalling; bugholes; staining from lightning arrester support. See photo U3-056031	PMB
5	Seventh and eighth rows of dome: Joint crack and spall approximately 5' long adjacent to duct support; spall areas less than 5" in size; pitting/abrasion; bugholes; two small popouts with rust and staining.	PMB
6	Ninth and tenth rows of dome: Leaching; pattern cracking; joint spalls and cracking; staining.	PB.
7	Eleventh thru thirteenth rows of dome: Small spall areas; popouts adjacent to duct; rust and staining.	P.M.B

8	Steel cable rusting along a vertical joint. See photos U3-056094 and U3-056095	PAB
