UNITED STATES
NUCLEAR REGULATORY COMMISSION
REGION IV
1600 EAST LAMAR BLVD
ARLINGTON, TEXAS 76011-4511

March 12, 2012

Subject: FORT CALHOUN STATION – NRC SPECIAL INSPECTION REPORT
05000285/2011014; FINDING OF PRELIMINARY HIGH SAFETY
SIGNIFICANCE

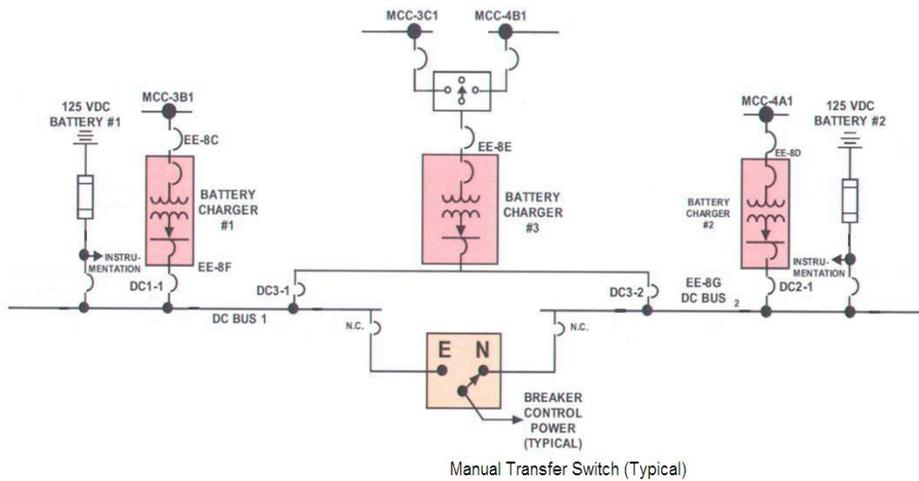
Figure 2: Simplified 125 Vdc Distribution Diagram

The ungrounded 125 Vdc distribution system, illustrated in Figure 2 of Attachment 4, consisted of three battery chargers, two storage batteries, two main distribution panels, manual transfer switches and other distribution equipment necessary for operation of the plant. The dc control power for each 4160 Vac and 480 Vac load center was fed via manual transfer switches, which allowed manual selection of either dc train as the source of control power to the buses. The manual transfer switches were designed with both trains of dc power in a common enclosure, with the normal and emergency supplies to the manual transfer switches fed from their respective dc buses via independent circuit breakers that were designed to provide selective fault protection and train separation.
