December 28, 2011
Revision 2

Omaha Public Power District

**Fort Calhoun Station
Flood Recovery Action Plan 4.1
Plant and Facility Geotechnical and
Structural Assessment**

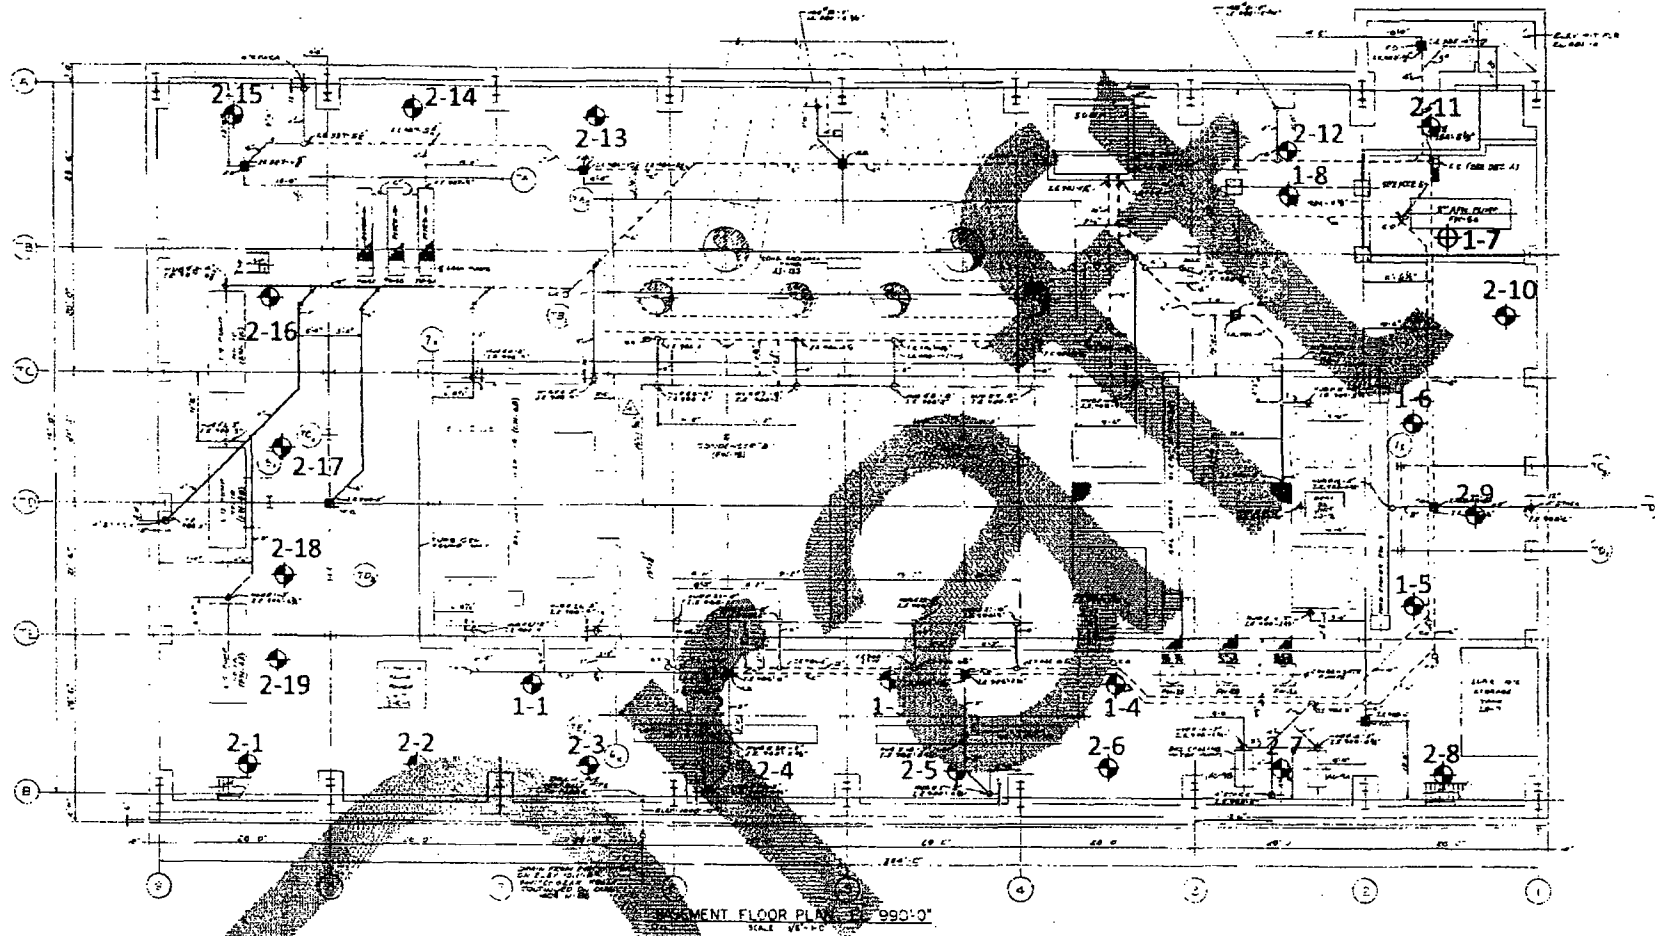
- Direct visual observation through the open holes with the aid of a flashlight
- Direct visual observations using a lighted, water-proof bore scope lowered through the open drill-holes
- Estimation of depth to water in each borehole using a T-rod probe
- Measurement of the floor slab thickness
- Depth to subgrade using a tape measure (to determine thickness of existing voids)

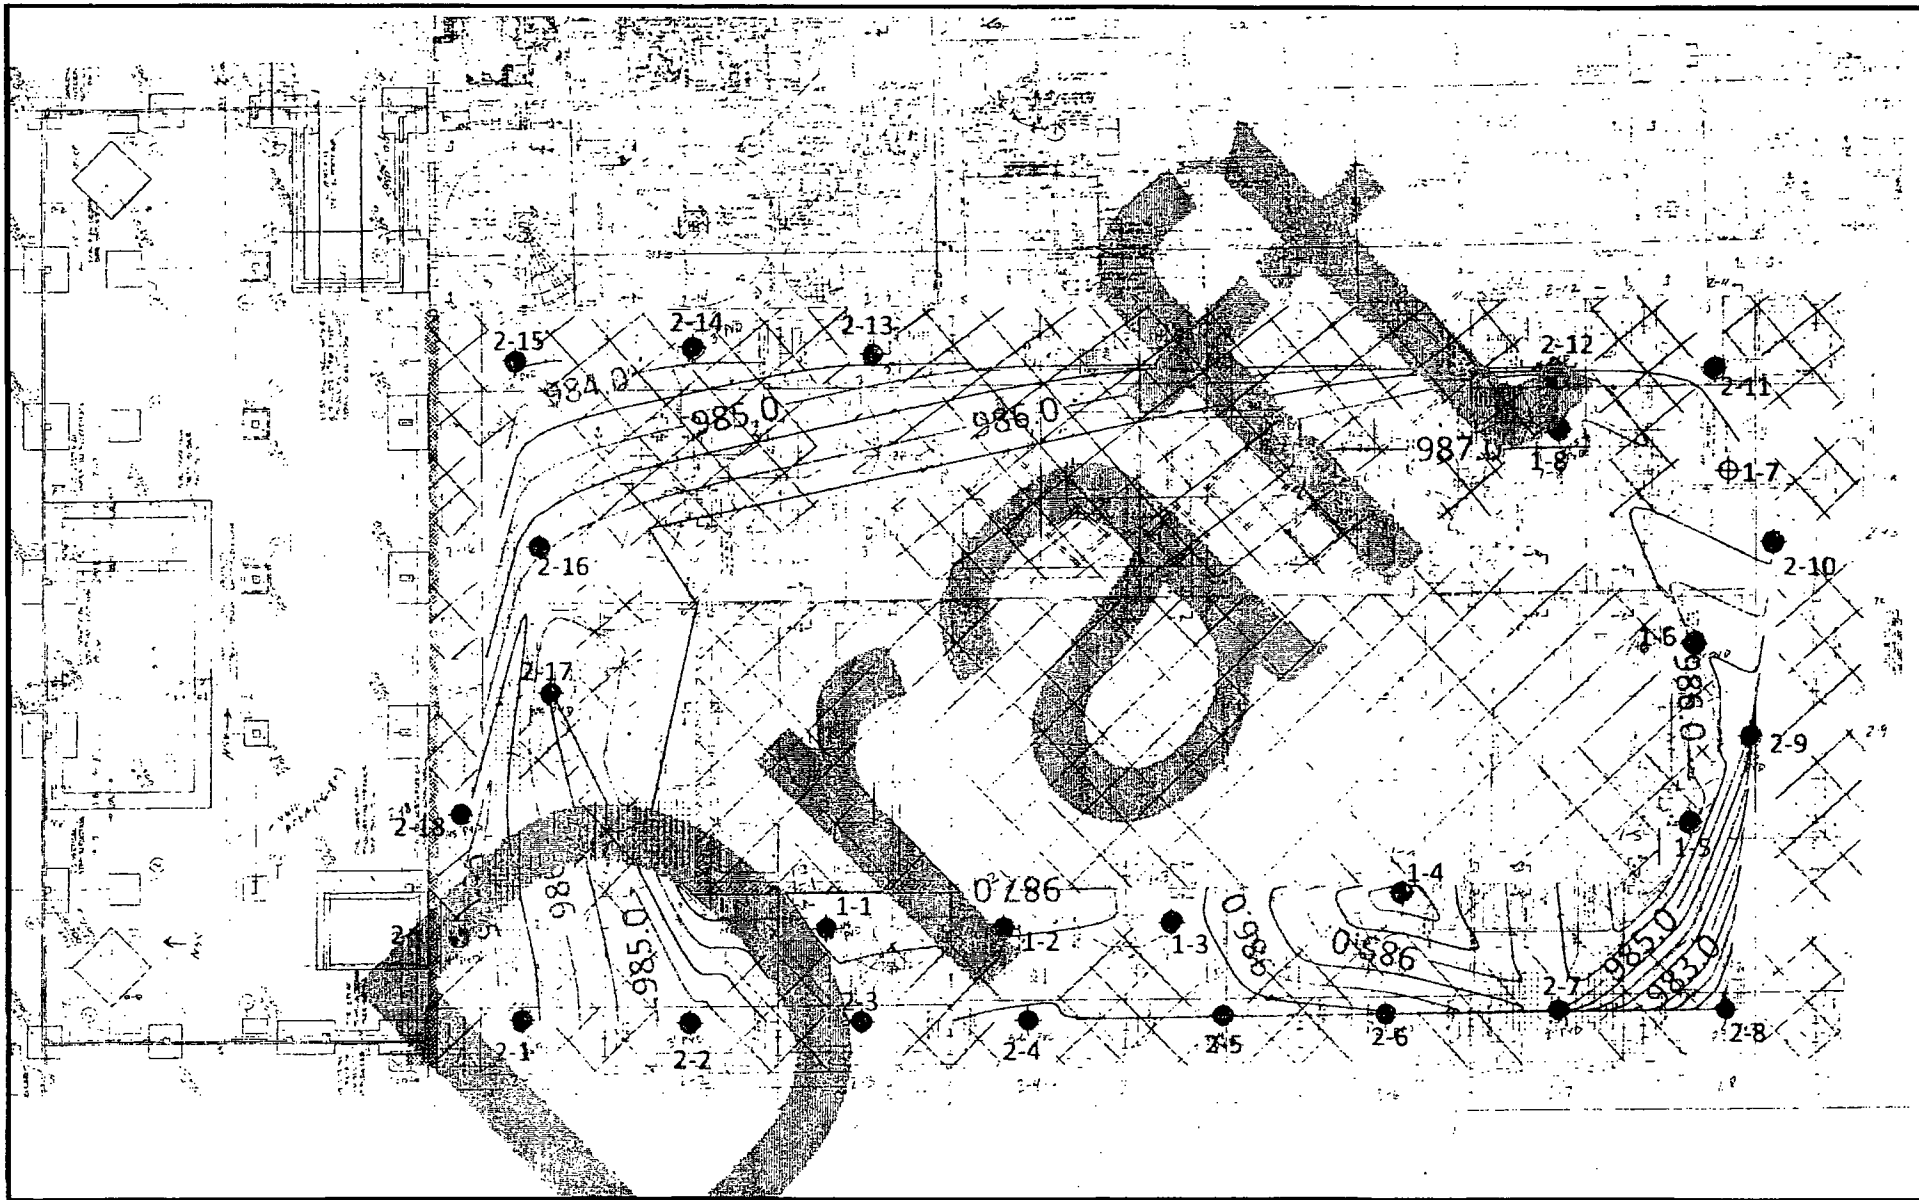
FIGURE
4-6

Figure 4-6 shows the estimated top of subgrade beneath the floor slab based on Probe Measurements taken on 12/09/11 by HDR personnel. Figure 4-7 also presents the estimated top of subgrade beneath the floor slab based on the acquired depth to subgrade data at the time of DCP testing.

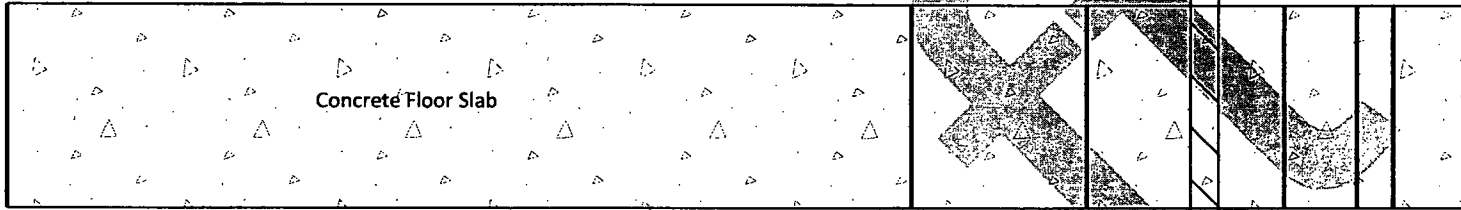
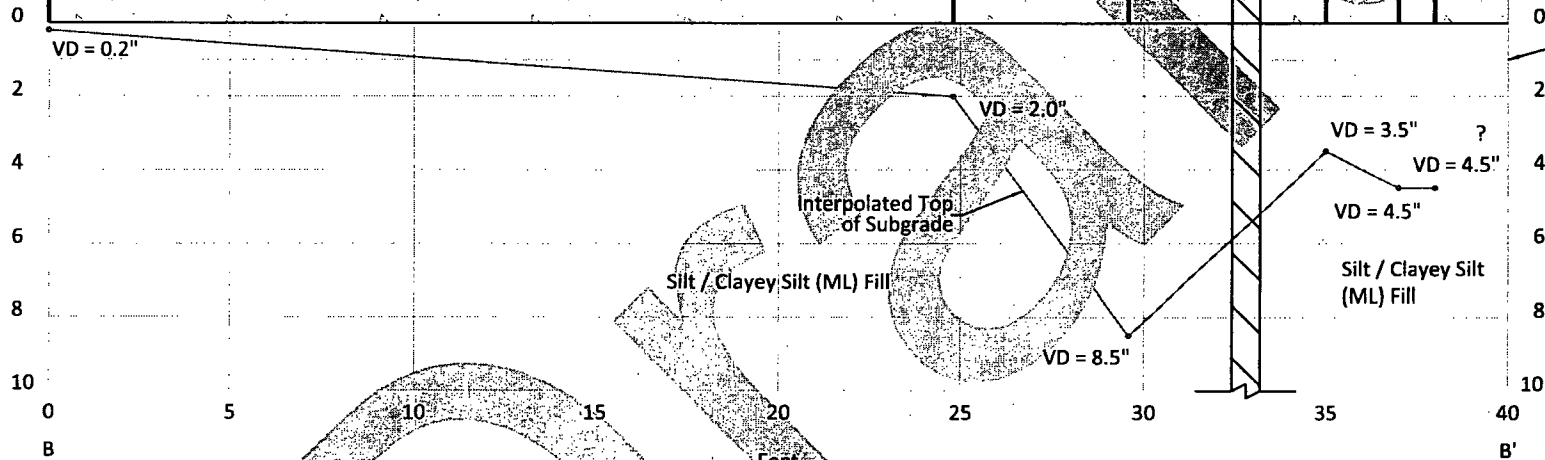
FIGURE
 4-12

- Within about 3.5 feet of the settled column, void space averaged 6.2 inches
- Within about 4.5 feet of the settled column, void space averaged 5.8 inches
- Within about 5.5 feet of the settled column, void space averaged 5.5 inches
- Within about 7.5 feet of the settled column, void space averaged 5.3 inches
- Beyond about 7.5 feet from the settled column, void space averaged 1.4 inches
- Beyond about 18 feet from the settled column, void space averaged 0.5 inches

The above statements related to void space are illustrated in cross sections A-A', B-B', and C-C' presented as Figures 4-12, 4-13, and 4-14. The Section locations are shown in Figure 4-11.

- Physical modifications to remediate the distress in the Maintenance Shop should be implemented as planned.
- Further investigations could be undertaken by OPPD as part of the design for the remedial work to repair the Maintenance Shop and Technical Support Center distress.
- Physical modifications outlined in the KDI #1 forensic investigations should be completed before the physical modifications to remediate the distress in the Maintenance Shop and Technical Support Center are implemented.
