2.0 SITE HISTORY, DESCRIPTION, AND BASELINE CONDITION

Plant and Facility Geotechnical
and Structural Assessment

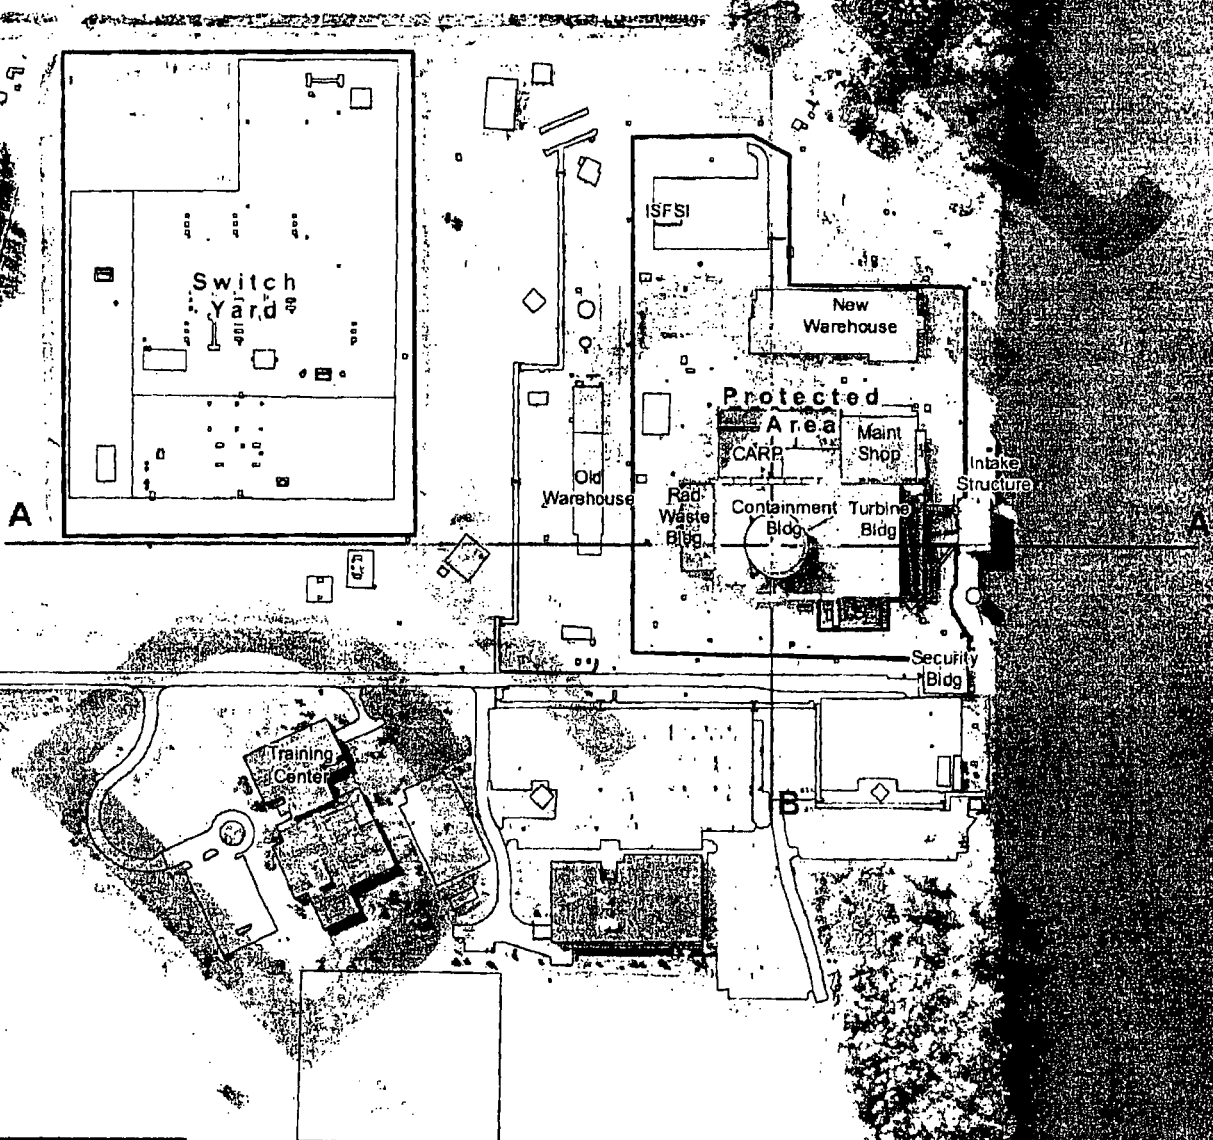
Approximate Extent and Orientation of Linear Karst

Dames & Moore (1968) identified at least two significant karst features in the Winterset Member of the Dennis Formation Limestone that apparently have developed along existing fractures. The features were estimated to be as much as 5 ft wide, 16 ft deep, and 45 ft long and consist of an upper 1.5- to 3-ft void and a lower zone of decomposed limestone and detritus. The approximate location of these features is shown in Figure 2-1, Geotechnical Areas and Cross-Section Locations. Cross-sectional views of the geologic setting are presented in Figures 2-2 and 2-3. Figure 2-2, Section A-A, shows where these karst features approximately intersect the subsurface section.

Pile installation at FCS for the Containment, Auxiliary Building, Turbine Building, and Intake Structure was designed to penetrate any overlying layer of limestone that covers the karst feature and to found the pile on sound rock at the bottom of these features. The potential influence of these karst features on foundation stability is considered minimal. It is likely that additional karst features exist across the site, but the overlying alluvial cover of a minimum of 61 ft offers a buffer to the influence of these features on any structure. Further dissolution of limestone is an assumed process given that the limestone is in contact with groundwater. The most aggressive dissolution of limestone by groundwater occurs in the vadose zone (Myroie, 1984). The fact that the karst features at the FCS site are covered by approximately 60 ft of alluvial material and are in contact with groundwater that has experienced some subsurface residence time dictates that the rate of karst feature development (limestone dissolution) is low. In addition, the karst features encountered in the 1967 Dames & Moore drilling program were primarily filled with decomposed limestone and detritus. The volume of space needed to allow significant collapse of overlying soils is not present. Therefore, within the expected service life of FCS, the process of limestone dissolution is not significant.

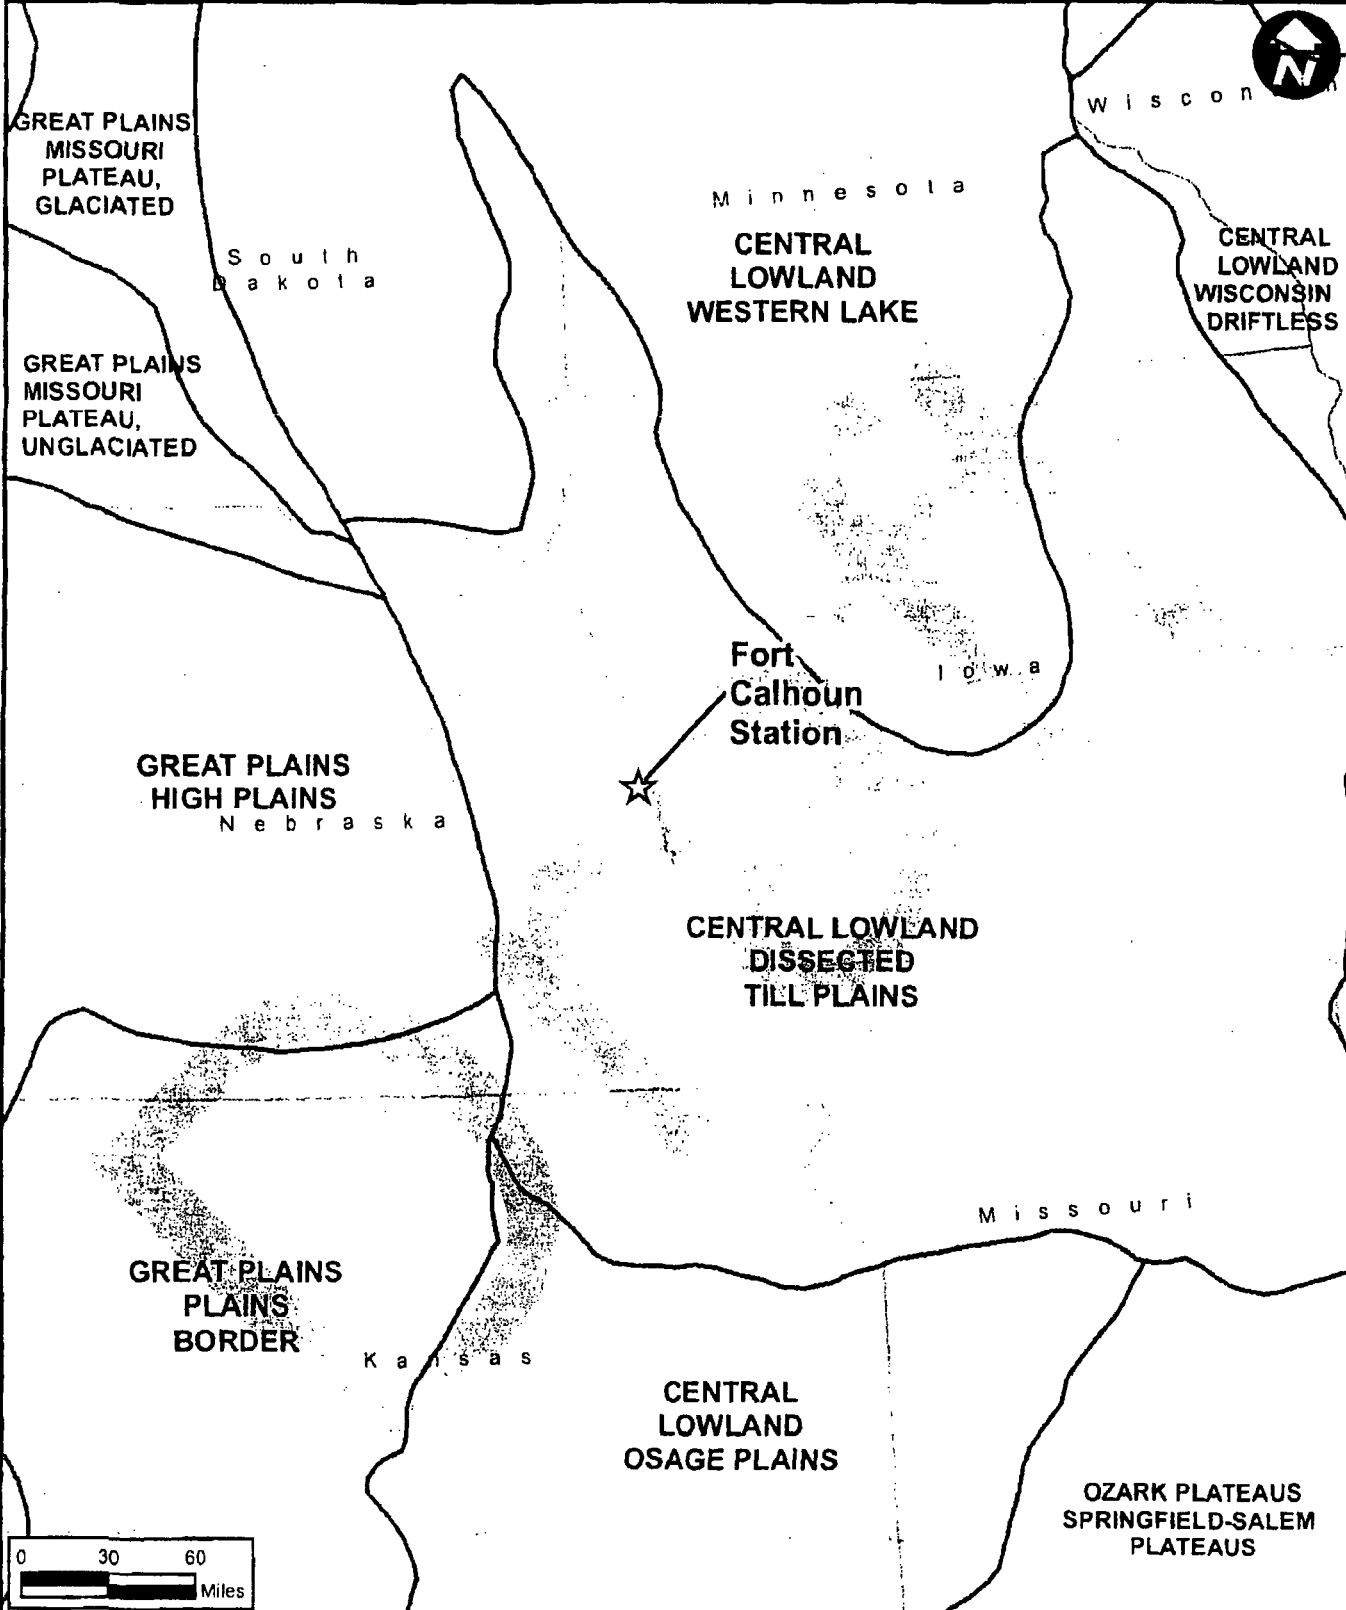
<p>DATE Sep 2011</p> <hr/> <p>FIGURE 2-4</p>
--	---	--

FCS is located in northeastern Washington County, Nebraska, approximately 4 miles southeast of Blair, Nebraska. The site lies within the Central Lowland portion of the Interior Plains Physiographic Province, as shown in Figure 2-4 (USGS, 2003). More specifically, the site is classified as part of the Dissected Till Plains, a subdivision of the aforementioned province, a region covered by Pleistocene glacial events that deposited till during glacial advance as well as during glacial retreat. The till has since been partially covered with eolian (wind-deposited) loess deposits and dissected by erosion caused by the Missouri River and its tributaries.

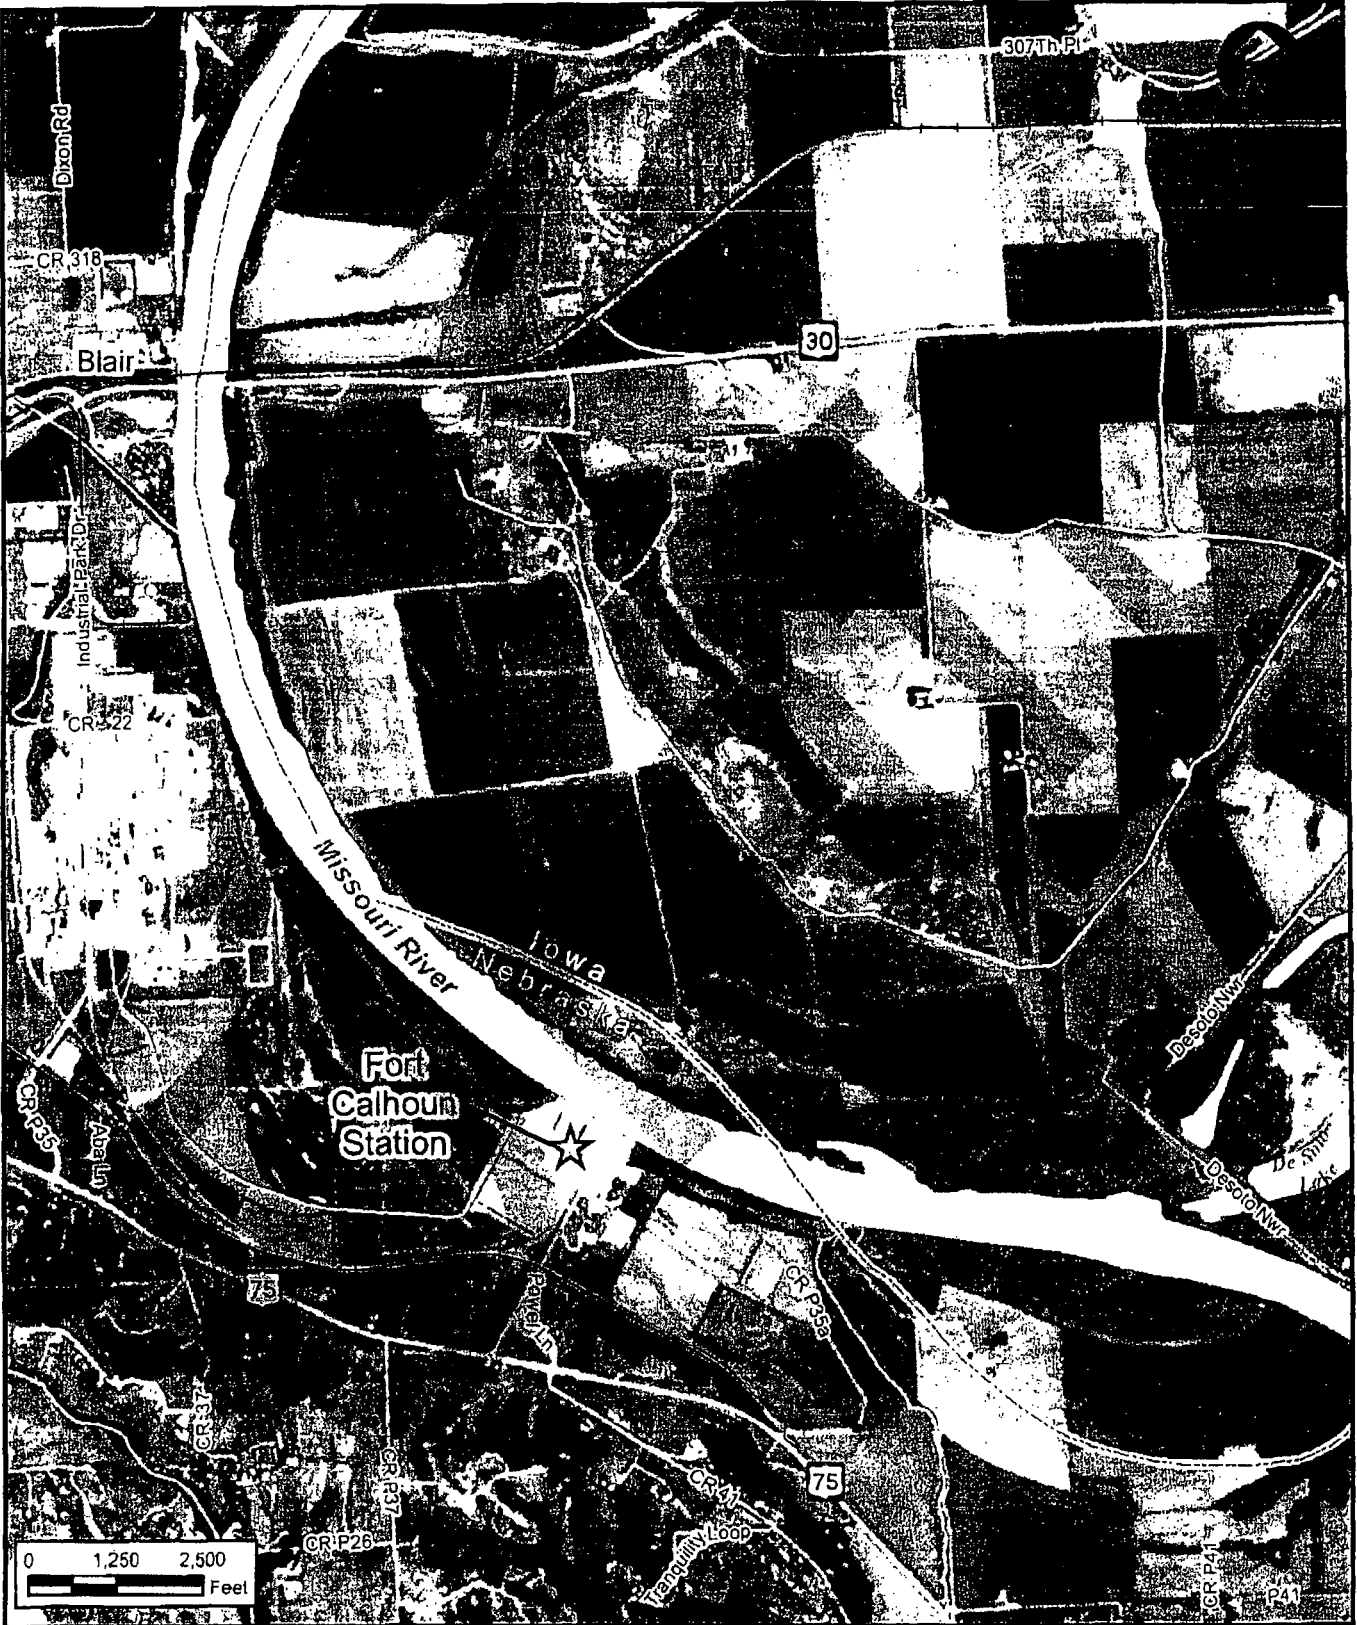
FIGURE
2-5

FCS is situated directly along the Missouri River at River Mile (RM) 646, as shown in Figure 2-5. FCS is not protected by a levee and is therefore subject to flooding during extreme flood events. The average elevation of the FCS site is approximately 1004 ft. Table 2-3 presents data from USACE from its November 2003 report, "Upper Mississippi River System Flow Frequency Study, Hydrology and Hydraulics, Appendix F, Missouri River." According to these data, el. 1004 ft correlates to a flood recurrence interval of slightly over 25 years or an annual probability of flooding of 0.040. This differs from USAR-2.7, Hydrology, where a stage of 1004.2 ft is reported as being a 0.1 percent annual chance event (1000-year recurrence interval) (OPPD, April 29, 2011). USAR 2-7 acknowledges that multiple flow frequency studies have been performed by USACE subsequent to the development of the design peak flood stage.

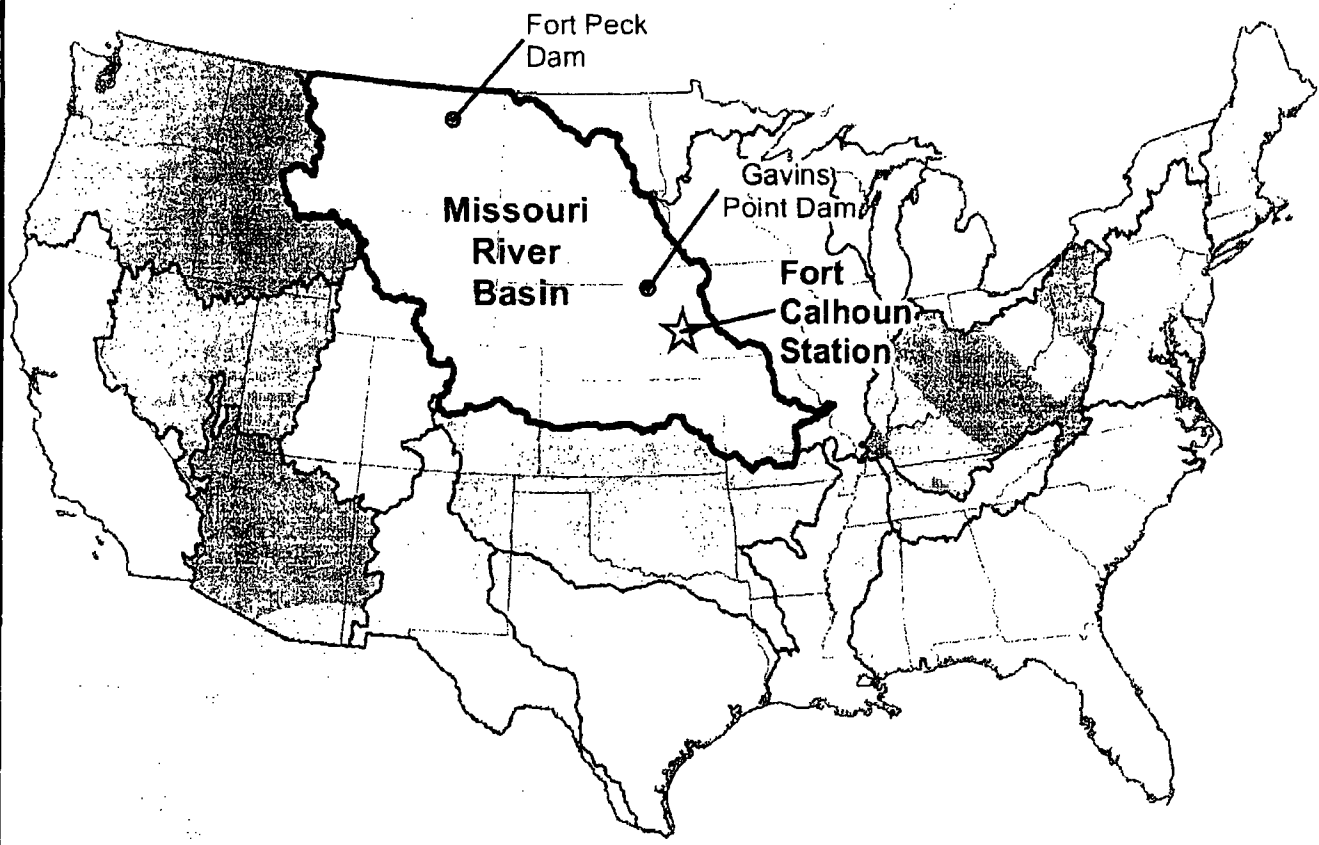
**Missouri River Basin
Fort Calhoun Station**

USACE began releasing record discharges from Gavins Point Dam in late May 2011. The release was increased to 160,000 cfs by June 26, 2011, and remained at this level until mid-August. Beginning on August 19, 2011, USACE began reducing releases daily in 5,000 cfs increments, reaching 90,000 cfs on August 30, 2011. Further reductions began on September 18, 2011, reaching 40,000 cfs on October 2, 2011. USACE has indicated that the 40,000 cfs release will be maintained until at least mid-December, when winter weather conditions set in and the risk of ice jams increases.

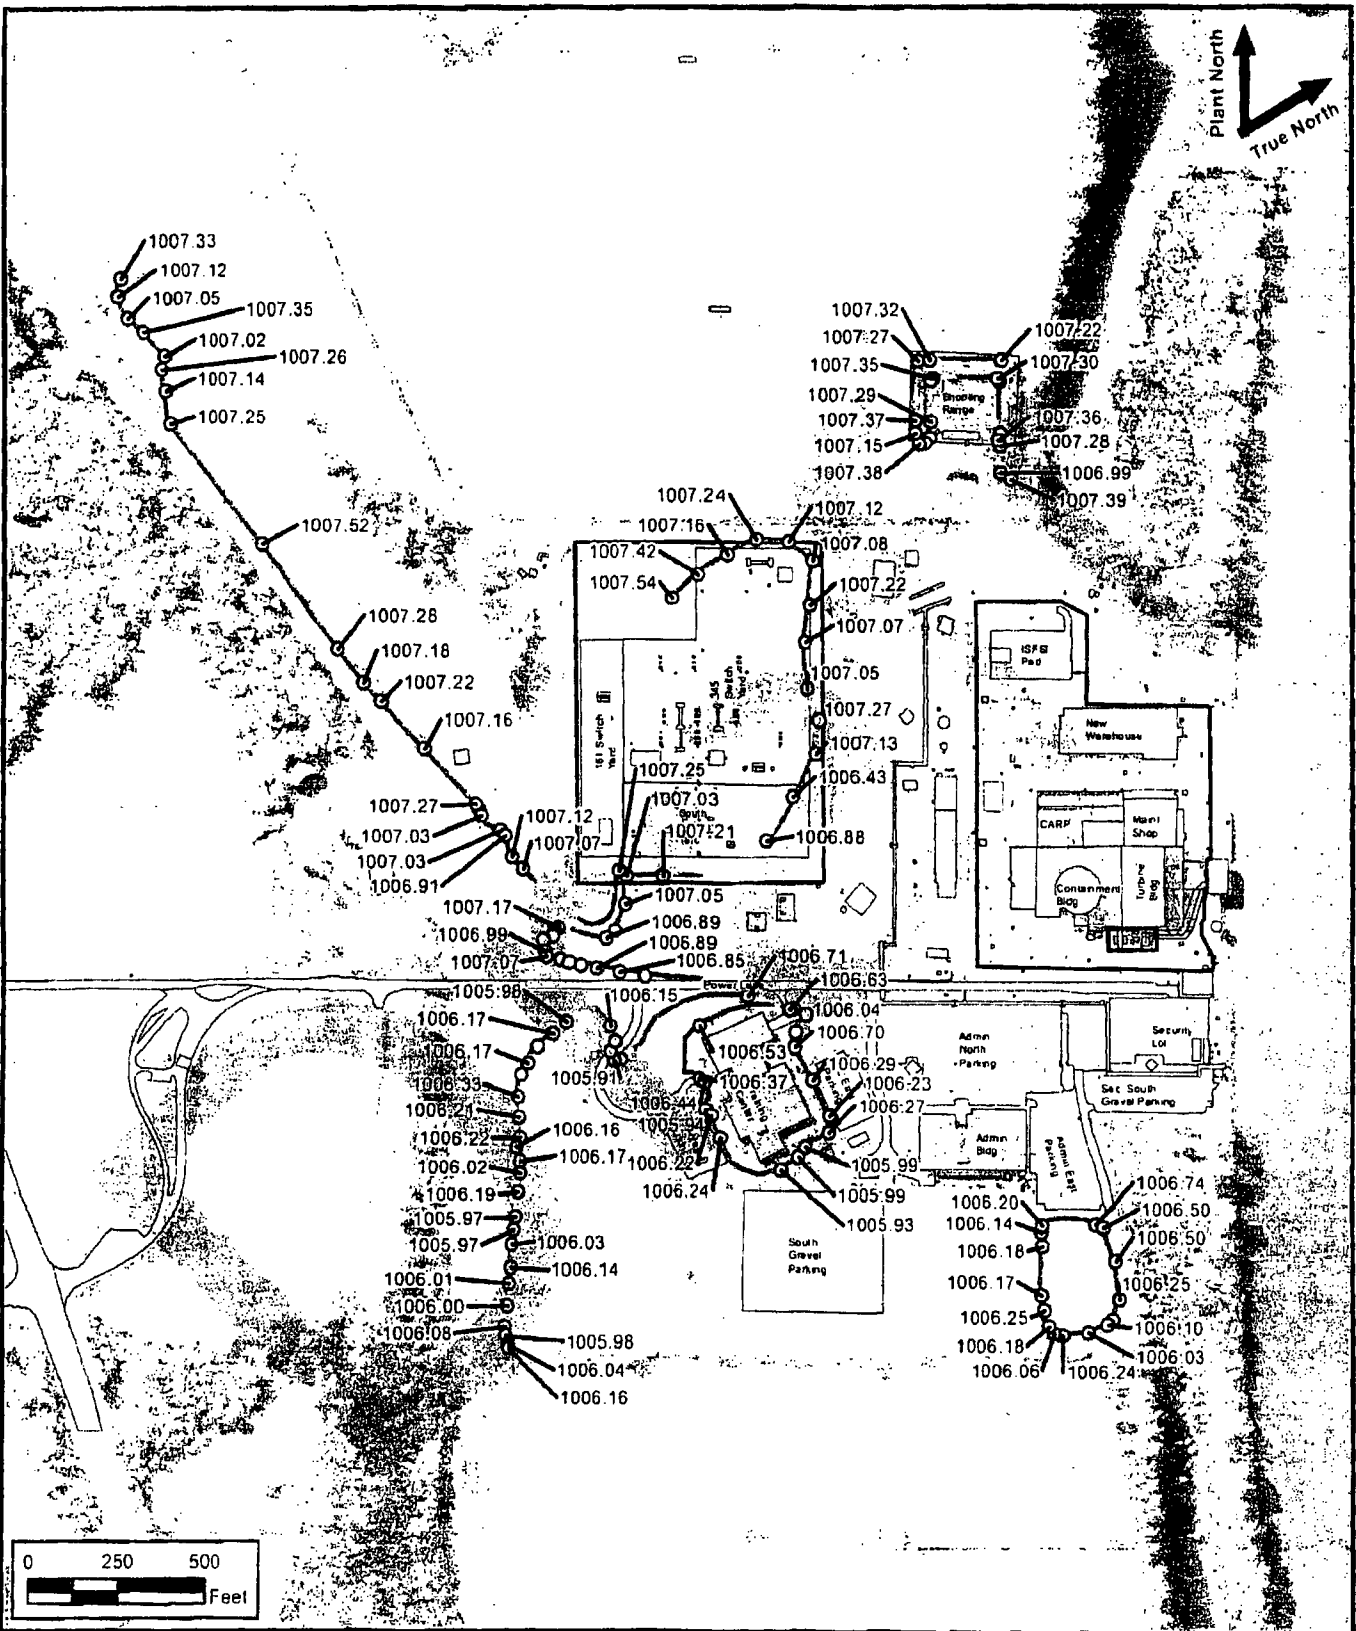
On July 12, 2011, personnel from HDR visited FCS to observe and investigate the impact of floodwater on FCS. Photos 1 and 2 are images of floodwater at FCS. Flow paths and velocities through FCS as observed are shown in Figure 2-14. A figure depicting the high water elevations as surveyed is provided in Figure 2-15.

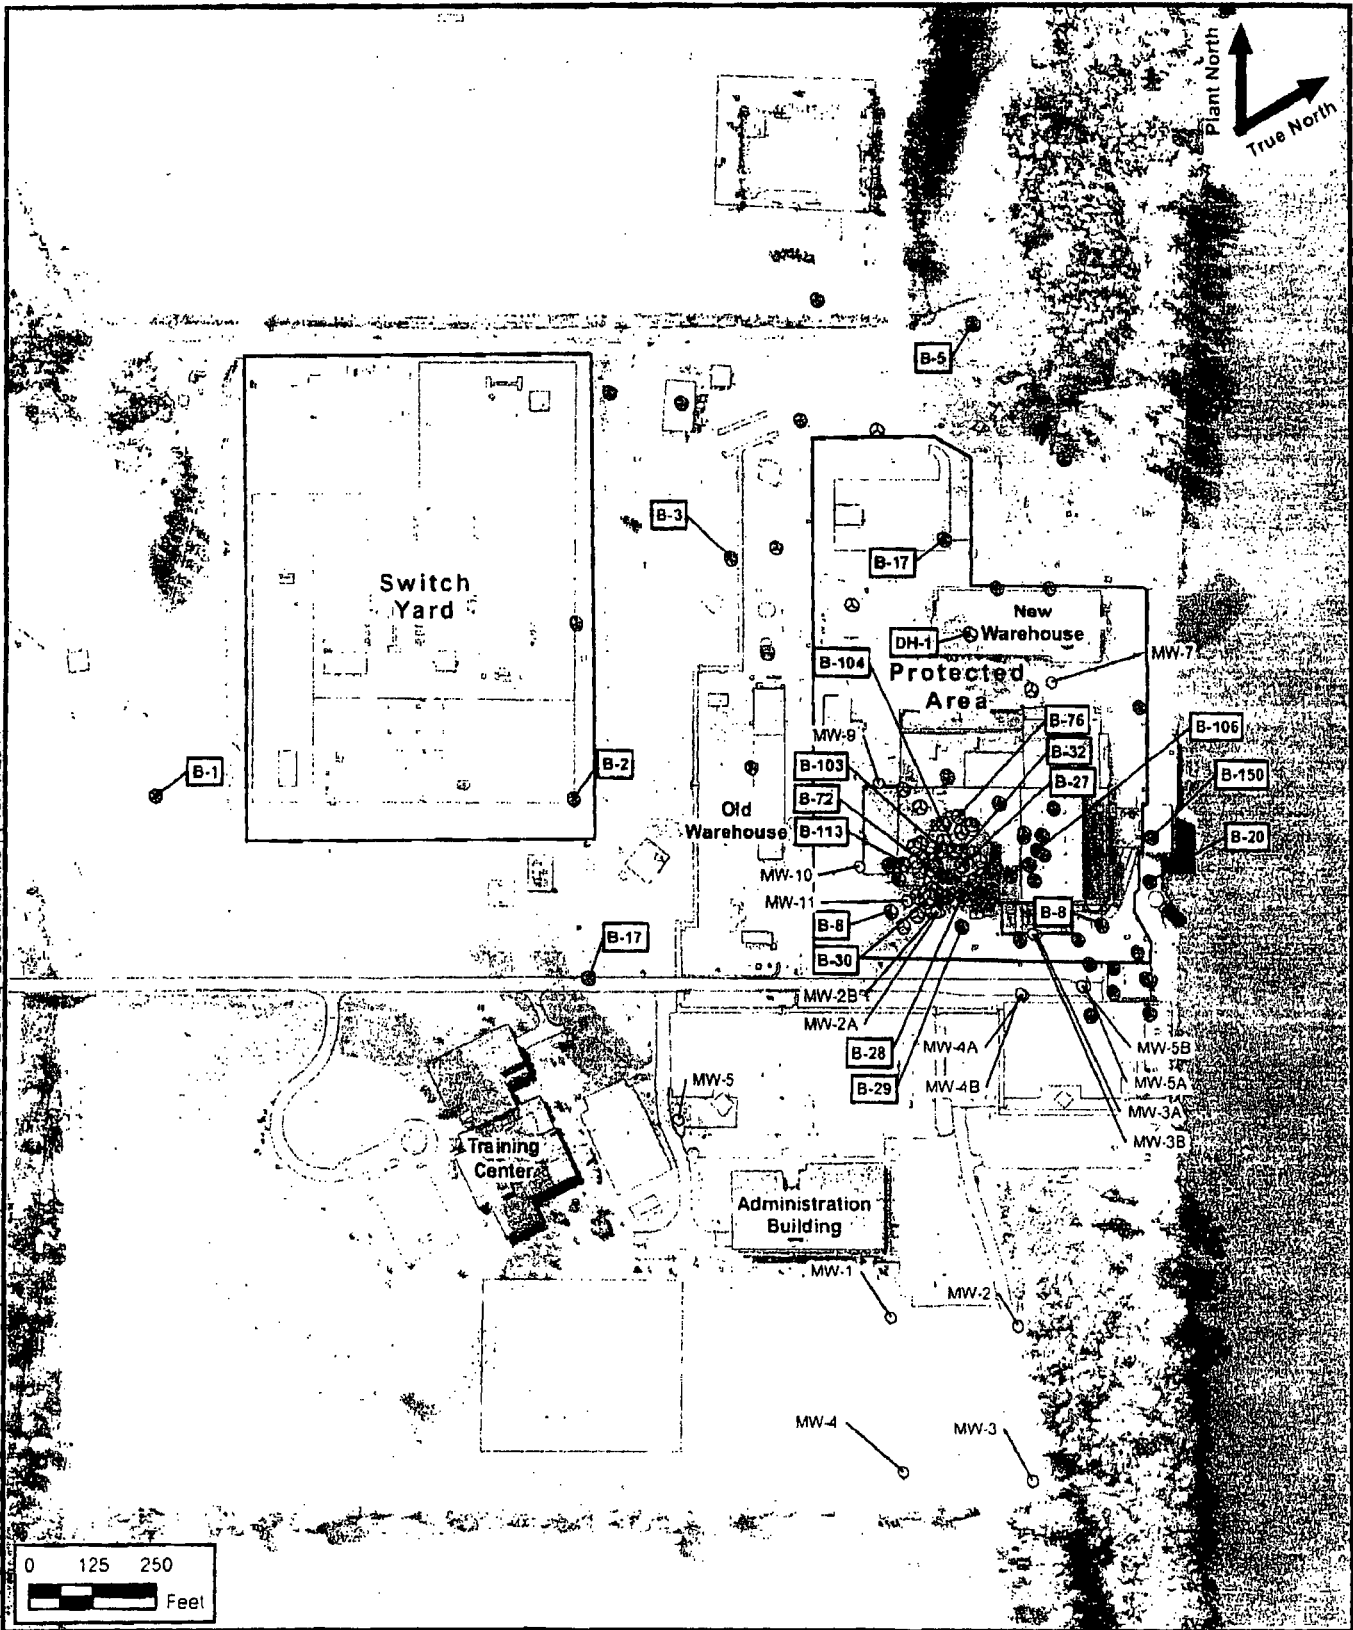
FIGURE
2-16

Dames & Moore conducted a site subsurface investigation in 1967. A total of 89 borings were drilled during this field investigation to assess the properties of the site soils and bedrock, as shown in Figure 2-16. Dames & Moore published the results of their 1967 field work in a 1968 report titled "Foundation Studies, Fort Calhoun Station Number One, Near Fort Calhoun, Nebraska," in which they drew the following general conclusions regarding the subsurface soil characteristics:

Much of the upper 10 to 15 ft of in-situ material was actually logged as low-plasticity silt with varying amounts of sand. N values from this zone were generally lower than 10. The zone below this, described by Dames & Moore (1968) as loose to dense fine sand 30 to 35 ft thick, is shown as poorly graded sand (SP) in Figures 2-2 and 2-3. This zone appears to be consistent across the FCS site; however, the zone of dense fine sand is not as consistent as the Dames & Moore report implies. N values in borings B-27 and B-108 range from 79 to 125 at depths ranging from 35 to 50 ft from existing (at the time of the exploration) ground surface, while borings B-29 and B-28 show N values of 14 to 48 for a comparable depth range less than 100 ft away from borings B-27 and B-108.

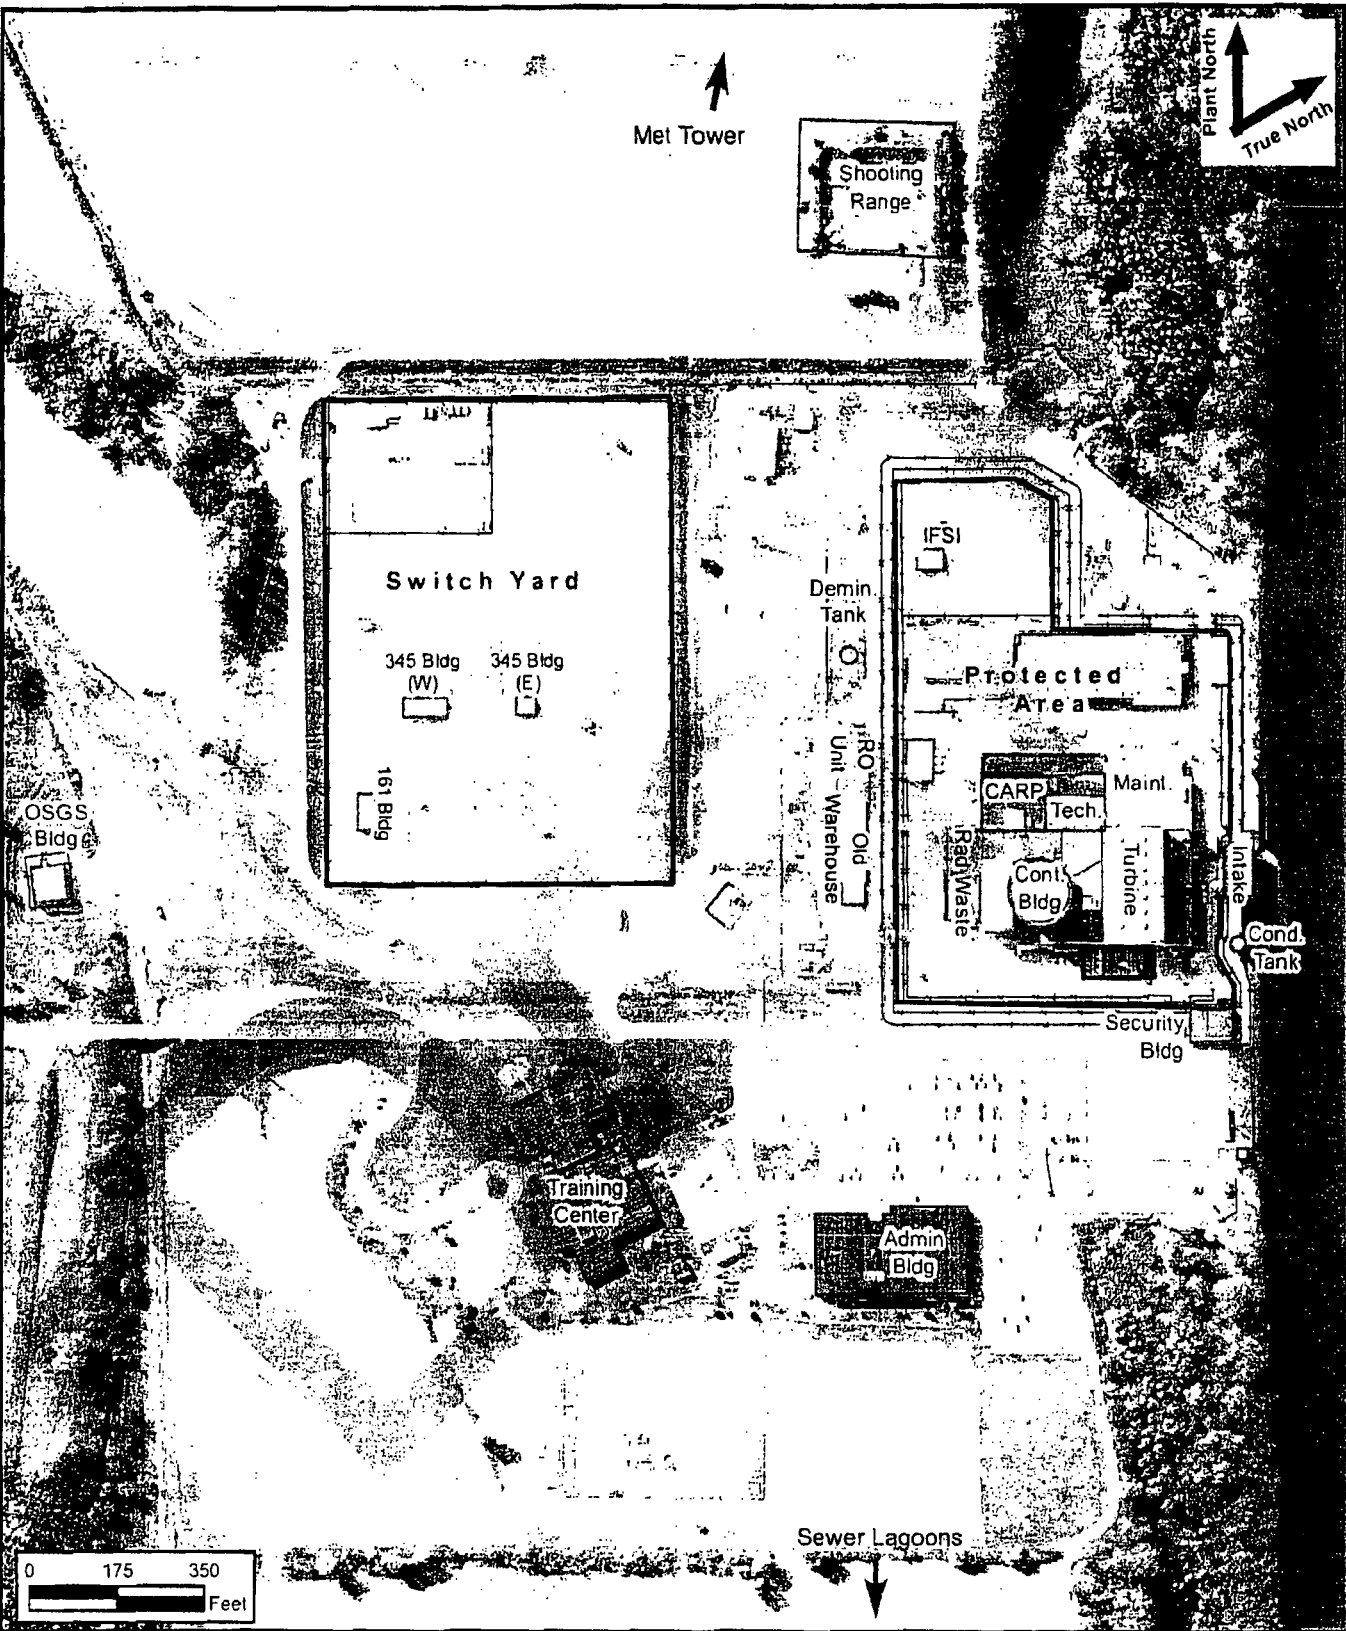
DATE	Sep 2011
FIGURE	2-17

The structural baseline was established for Priority 1 and Priority 2 structures based on the review of existing documentation, including condition reports, design basis documents, the original design drawings, and structural assessments. The condition reports and structural assessments together are referred to as pre-flood structural reports. A list of OPPD documents used in establishing the structural baseline for each structure is provided as Attachment 2. Dimensions presented in the structural baseline discussion are generally expressed in decimal feet. The term "structure" may refer to a specific building, such as the Turbine Building, or may refer to a group of independent non-building structures, such as the Turbine Building South Switchyard. The location of each structure is shown in Figure 2-17, Site Plan Overview.
