APPENDIX C
AREA WALK-BY CHECKLISTS (AWCs)

Area Walk-By Checklist (AWC)

Room 105 Floor El. 545 Bldg. AUXB

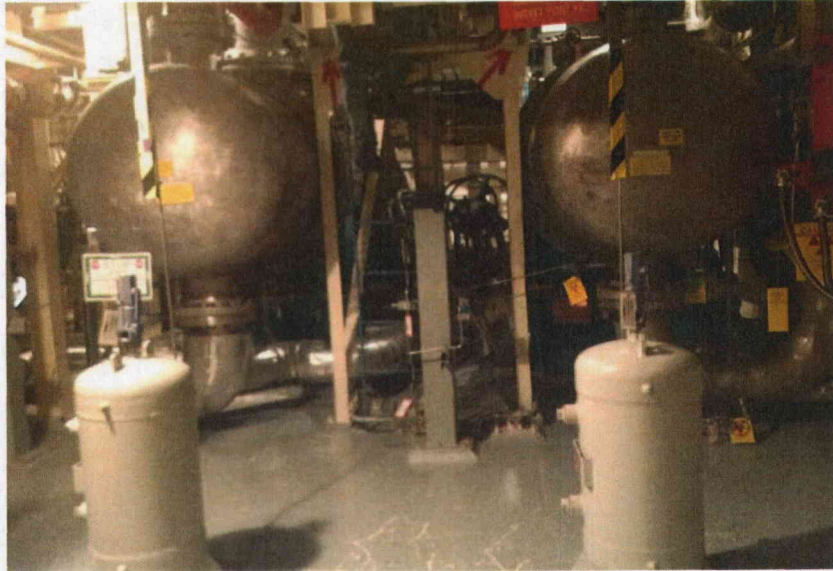
Photo 1
General View of Room 113

Temporary scaffolding installed in area, judged not likely to cause interaction.

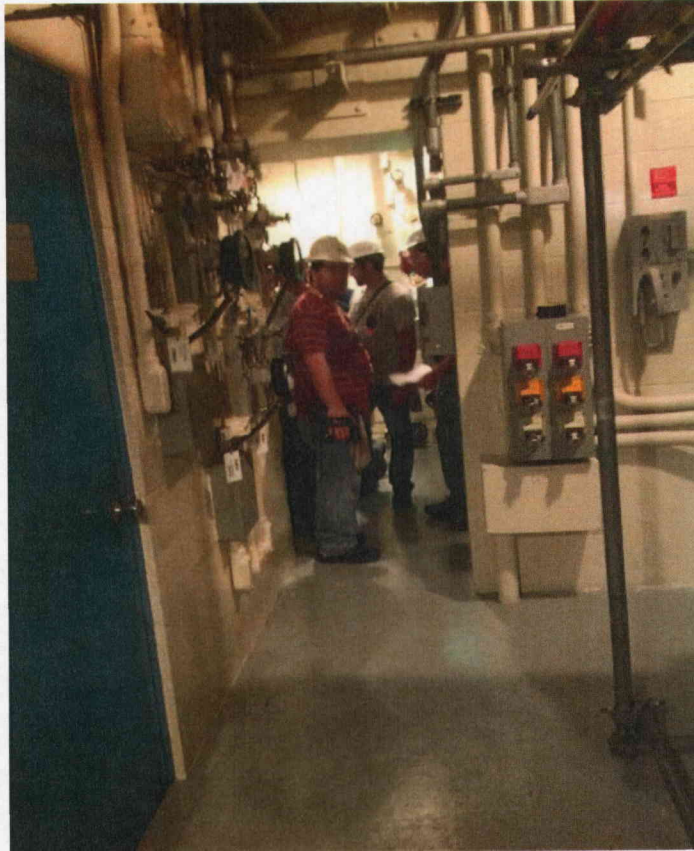
Photo 1
General View of Room 122

Fire extinguisher is mounted on the wall and is not laterally supported. It is judged that since the vertical acceleration at this location is less than 1g, it is unlikely for the extinguisher to fall or cause significant interaction with nearby equipment.

A dolly was found unrestrained in the area. Since the dolly had restraining chains on it, it was judged that it is temporarily located at the position found in the room and will be returned to its storage location and tied when work is done. Also, no sensitive equipment found in the vicinity of this dolly.

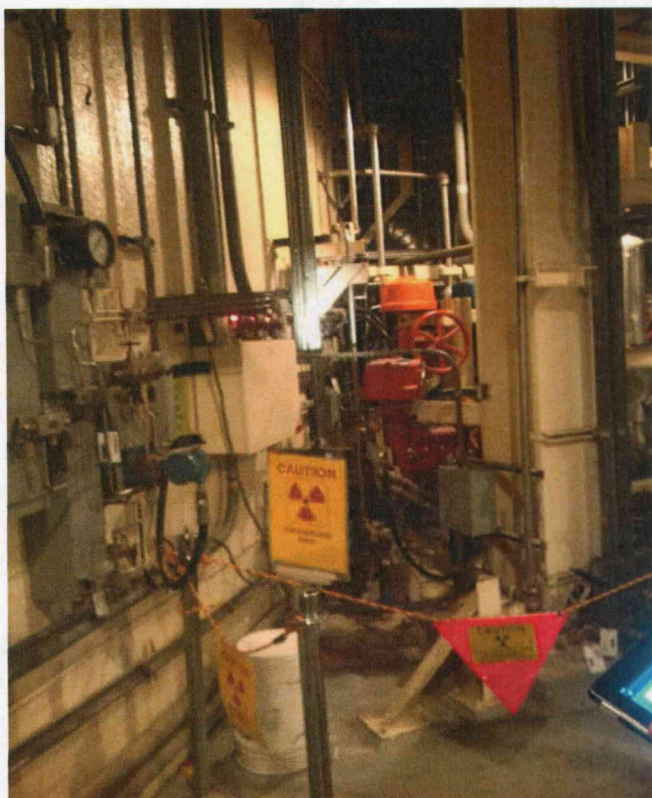
Photo 1
General View of Room 208

Fire extinguisher is mounted on the wall and is not laterally supported. It is judged that since the vertical acceleration at this location is less than 1g, it is unlikely for the extinguisher to fall or cause significant interaction with nearby equipment.

Nuclear filter cask cart unrestrained adjacent to components. There are no sensitive equipment in the zone of influence of this cart and it is judged OK. It is also noted that this cart appear to be temporarily in the area.

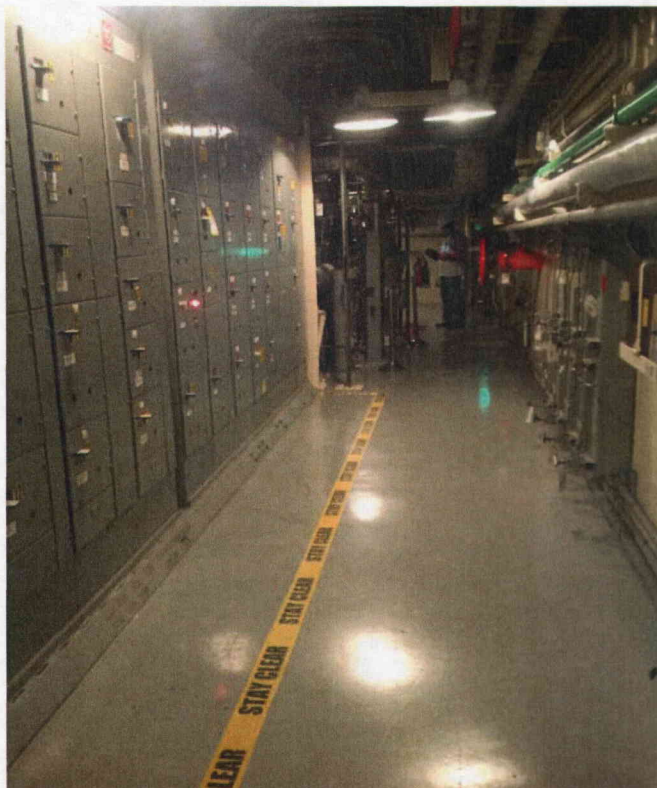
Photo 1
General View of Room 209

*RP cart and dolly not restrained.
In a subsequent visit to his area on the next day, it was observed that this cart was properly restrained.*

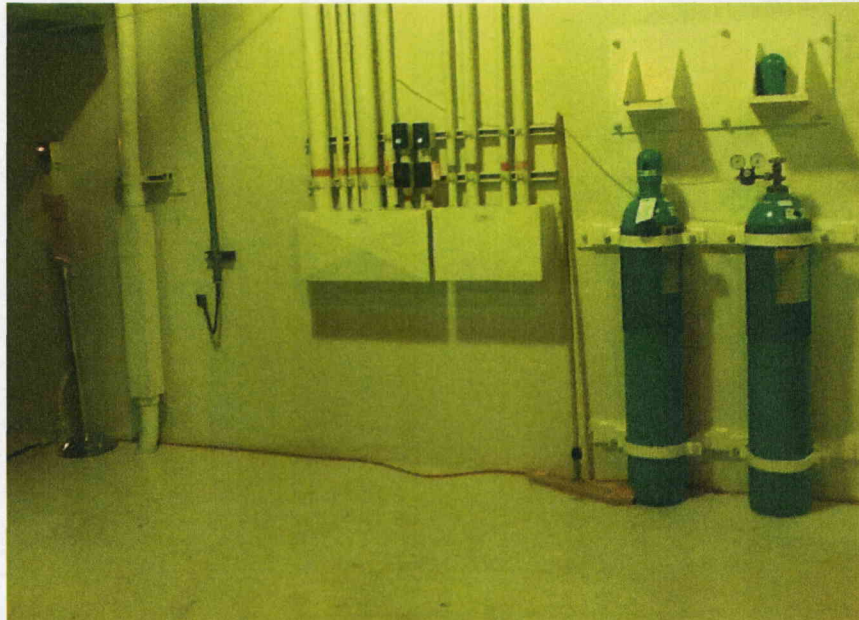
Cylinder tanks properly fixed to wall were found in the area

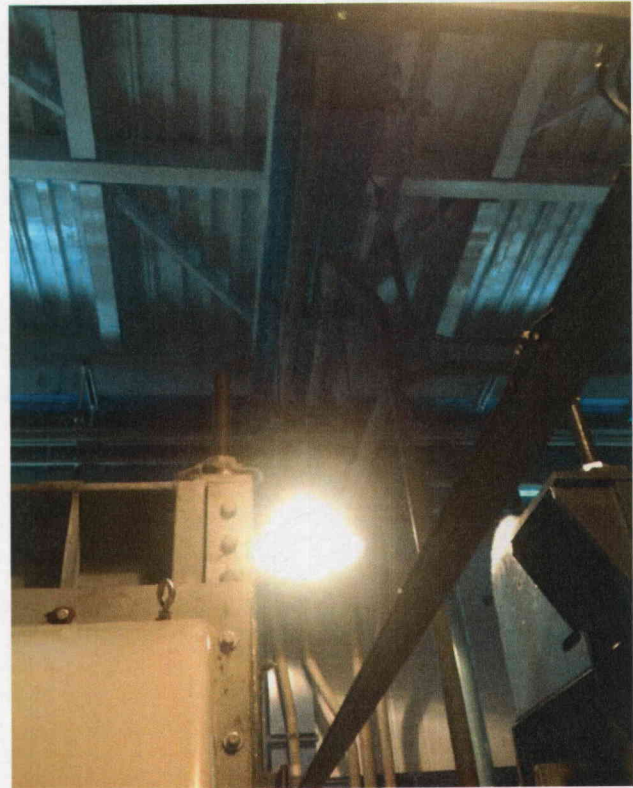
Photo 2
Rod Hung Pipes
