November 1, 2018

SUBJECT: COLEMAN A. YOUNG INTERNATIONAL AIRPORT — RESULTS OF THE U.S. NUCLEAR REGULATORY COMMISSION'S INITIAL SITE VISIT AND REQUEST FOR CONFIRMATION OF VOLUNTARY CONTROLS; EXERCISE OF ENFORCEMENT DISCRETION

**OAK RIDGE ASSOCIATED UNIVERSITIES:  
SITE STATUS REPORT FOR COLEMAN A. YOUNG INTERNATIONAL AIRPORT  
(FORMERLY DETROIT CITY AIRPORT) AT  
11499 CONNER STREET IN DETROIT, MICHIGAN**

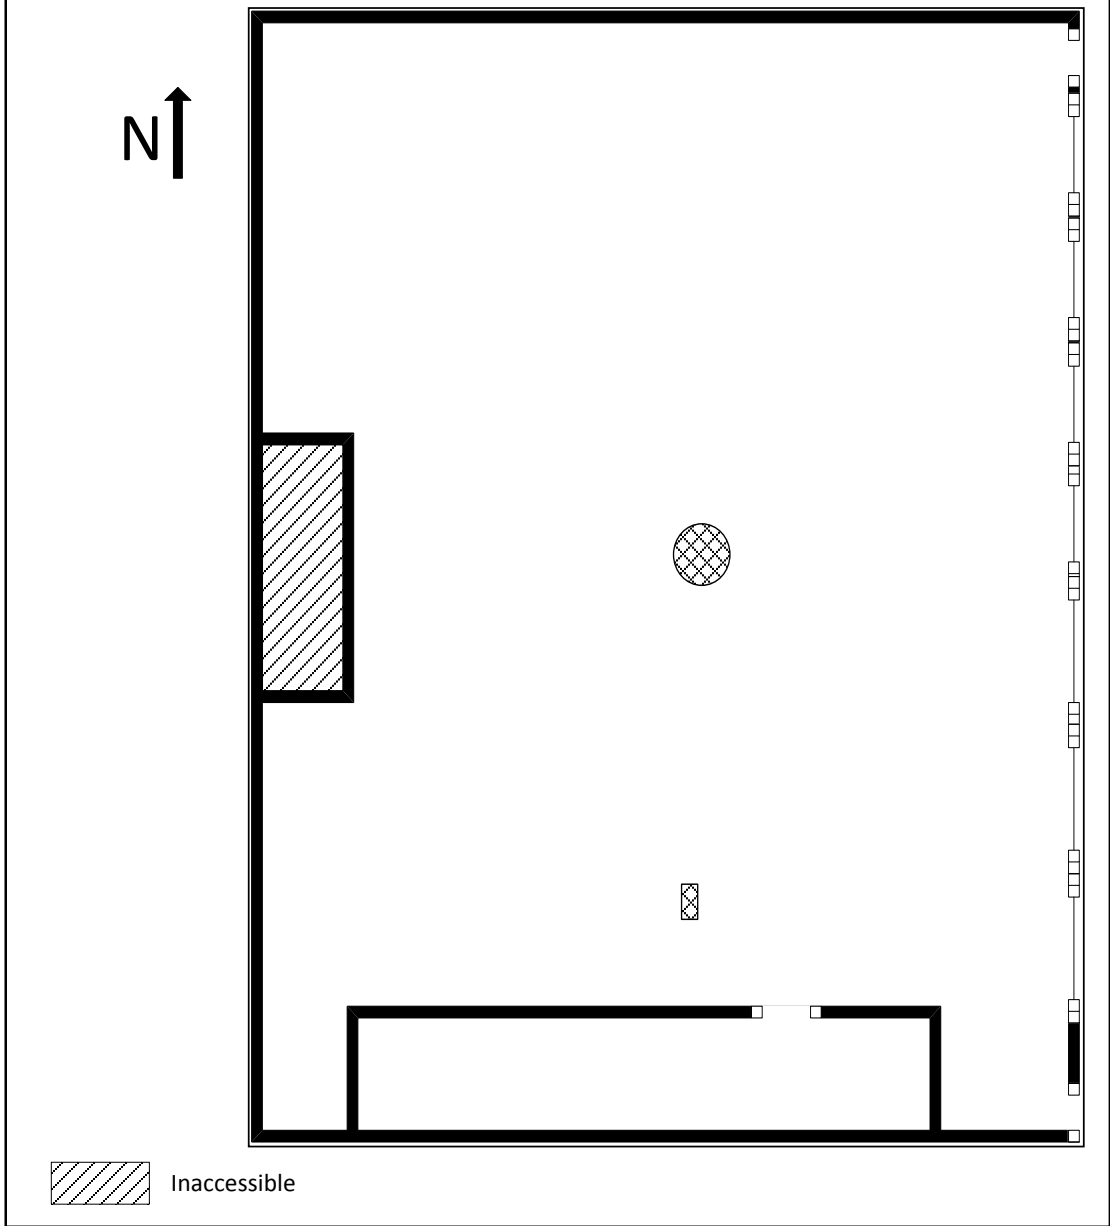
**Figure B-1. Hangar 9 Bay Floor**

**Hangar 9.** As presented in Table B-1, discrete radiation measurements were collected at 211 locations within Hangar 9, including the main bay area and two levels of offices/rooms positioned along the southern hangar. As discussed previously, the roof of the building within Hangar 9 was surveyed and no measurements above background were observed. Measurement data from the Hangar 9 bay are consistent with expected background radiation levels, which are on the order of 10 kcpm with the 2x2 sodium iodide detector and are on the order of 10 µR/h with the exposure ratemeter. Measurement data show that gamma radiation in and around offices/rooms is elevated relative to expected background radiation levels. Specifically, measured 2x2 sodium iodide detector responses in excess of 20 kcpm, and exposure rate measurements are on the order of 20 µR/h were observed. These relatively elevated responses are likely due to naturally occurring radioactive material (NORM) within the cinder block structure. It is also possible that radiation levels are due to uranium or thorium
