Humboldt Bay
Independent Spent Fuel Storage Installation
Site-Specific License Renewal Application

Pacific Gas and Electric Company

Revision 0 July 2018
NRC Docket No. 72-27

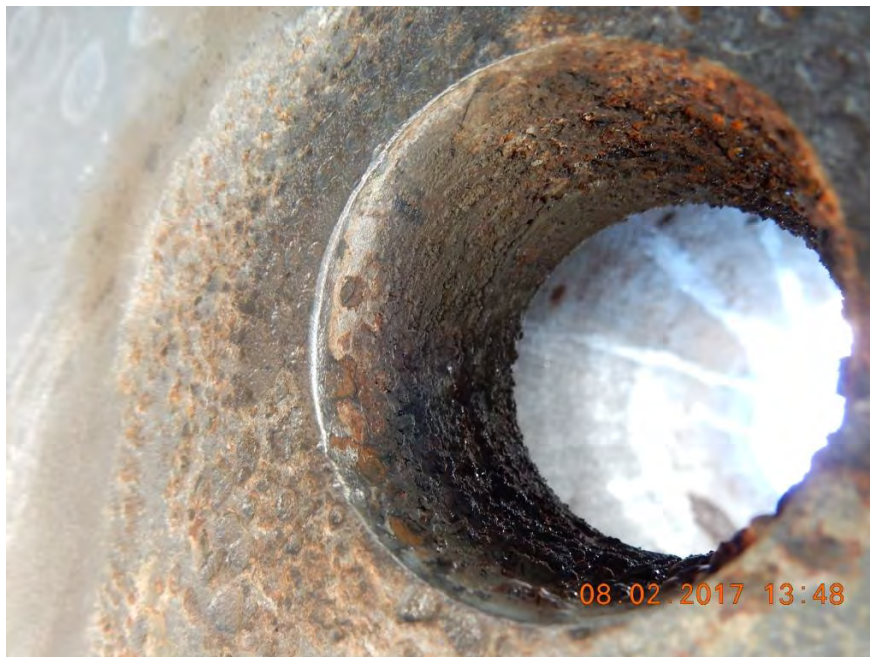
10. Hole #5 after cleaning

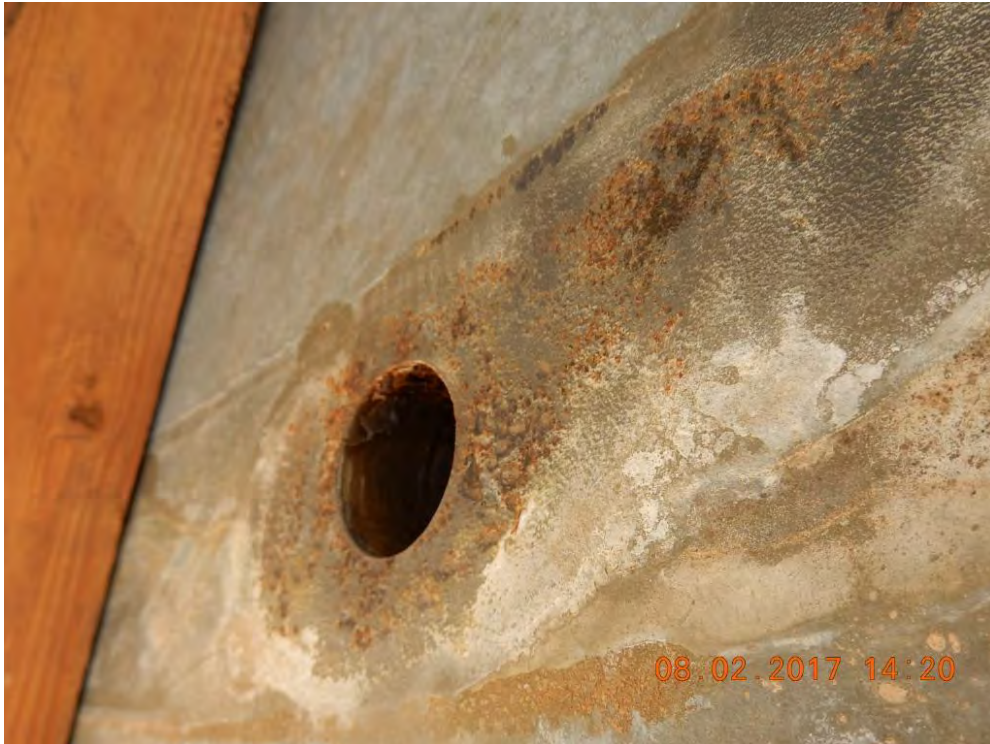
11. Hole #3 after cleaning

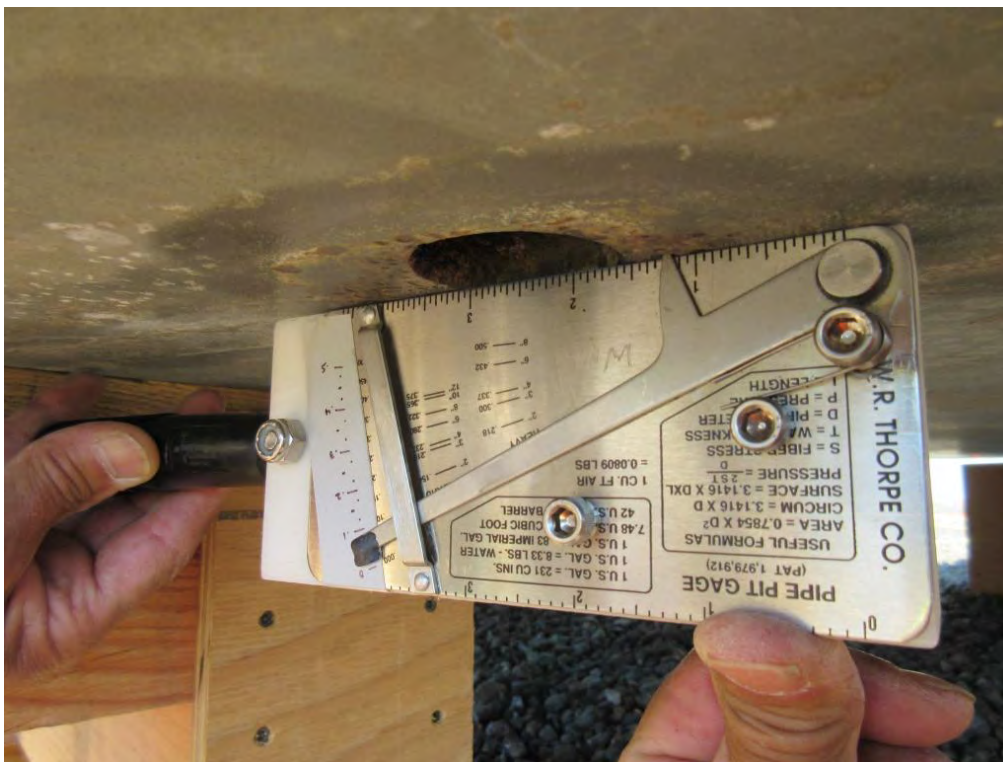
12. Measuring pit depth <math><1/16\text{''}</math>

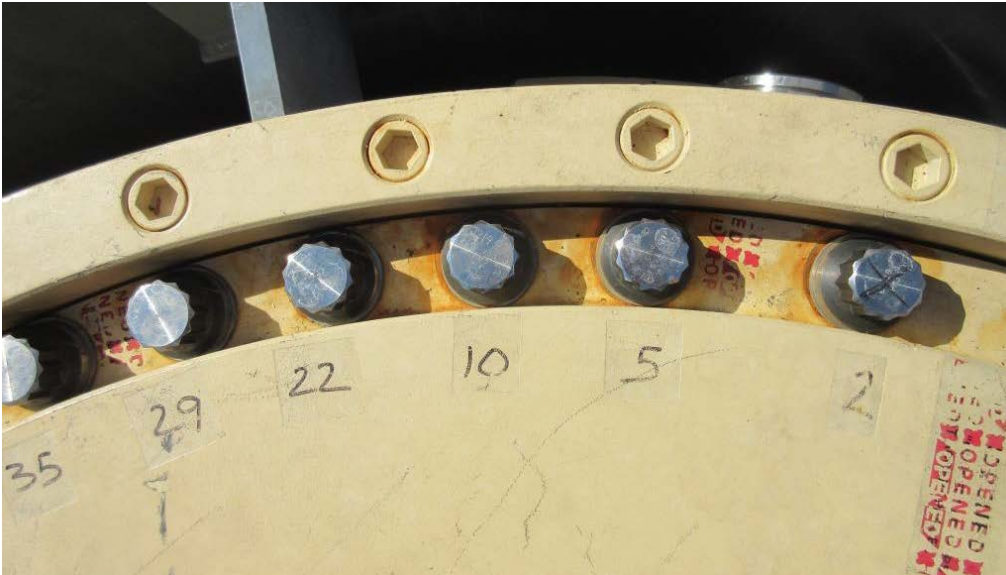
15. Rust staining around overpack lid closure bolting

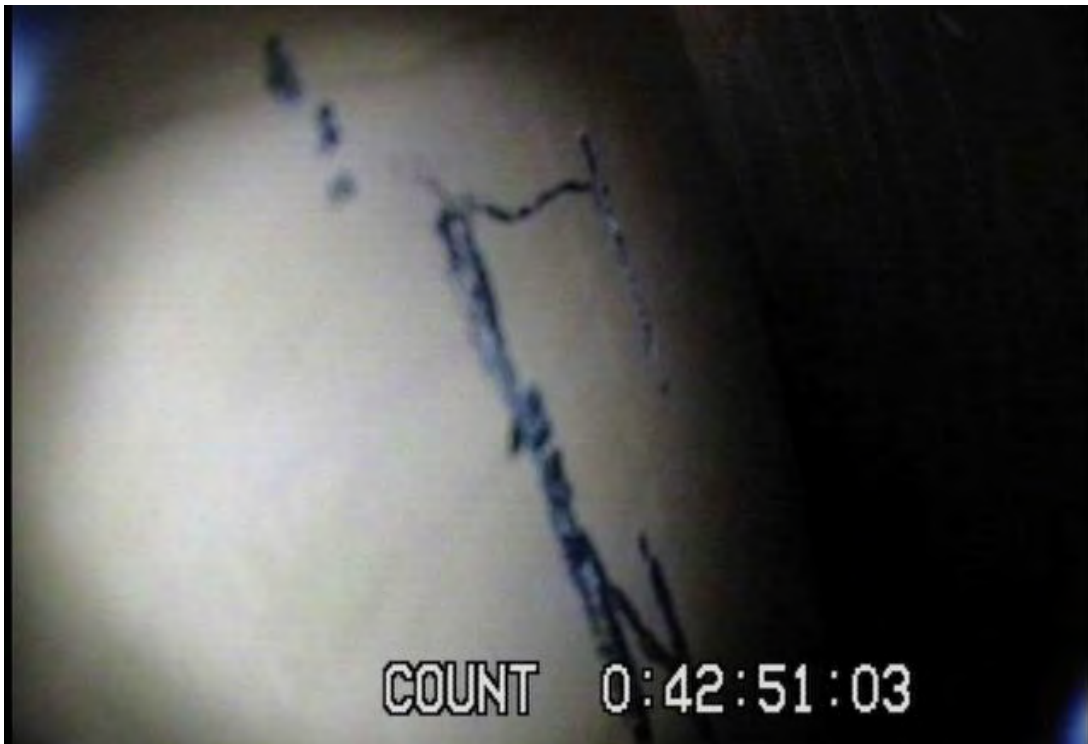
39. Scan 1 / Scan 80 area coating scrape

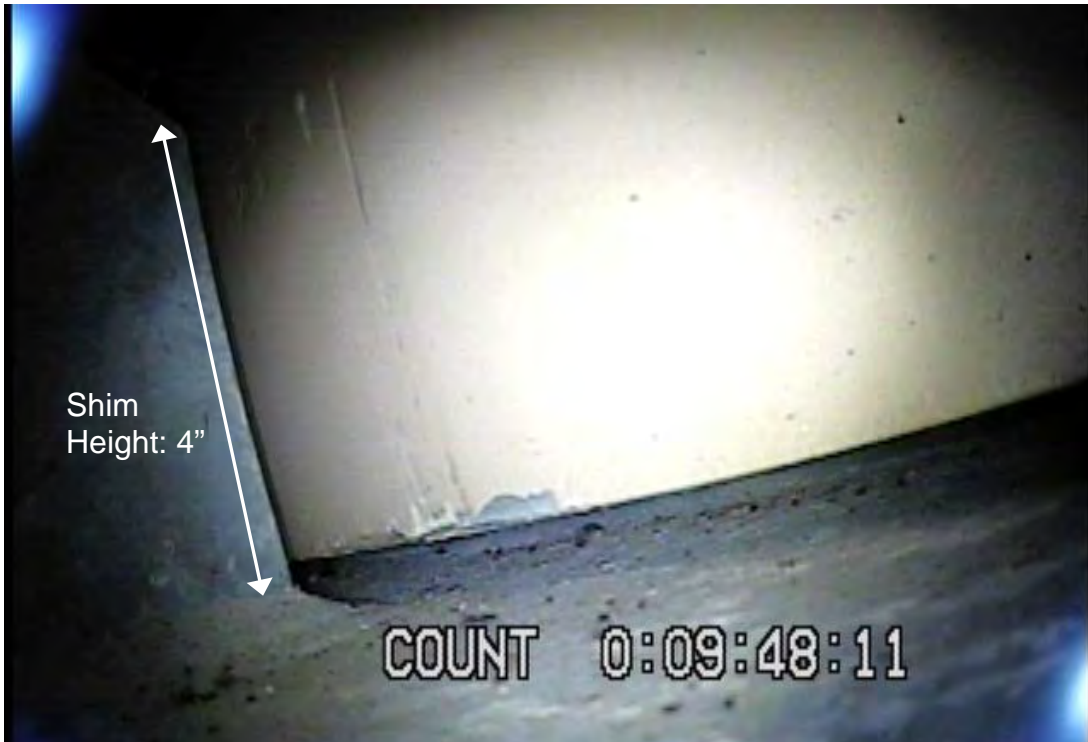
42. Overpack south east section coating scrape adjacent to seismic shim

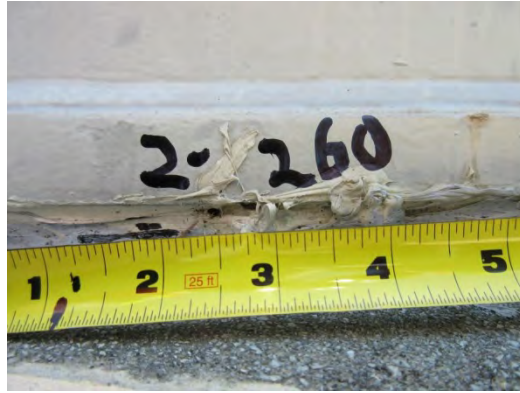
1. Cell 1 Caulking As-Found

In addition: 8/1/2017 Examination of as-found caulking around interface between vault lid and lid ring. No service-related degradation noted, cells 1, 2, 4, & 5 had areas of incomplete adhesion between caulking and metallic components. Cell 4 area had measurable depth less than depth to inner interface. Illumination check 8/1/2017 @ 1300.

8/3/2017 Examination of caulking around interface between vault lid and ring. Exam performed on initial caulking application for cell 2 after lid re-installation. Cells 1, 4, & 5 in areas where incomplete application was previously noted after additional caulking added to those areas. Illumination check 8/3/2017 @ 0945.

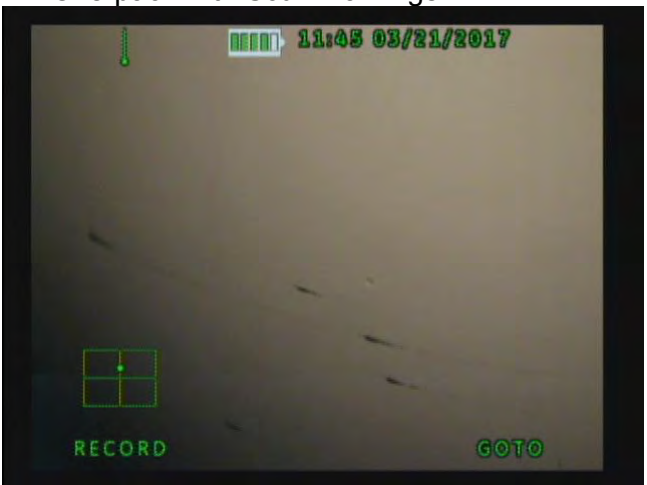
1. As discussed in Sections 3.1 and 3.2, markings were identified on the overpack and vault liner. These markings do not fail acceptance criteria, but will be entered into the CAP as observations (SAPN 1429074, Task 32).

7. Overpack with Scuff Marking

Because of the similar condition of all cells, but the additional mechanical markings noted in cell #2, it is recommended that cell #2 be inspected in the July/August inspection (note that cell #2 also has operating experience with previous water intrusion which may have provided an environment more suitable for degradation).

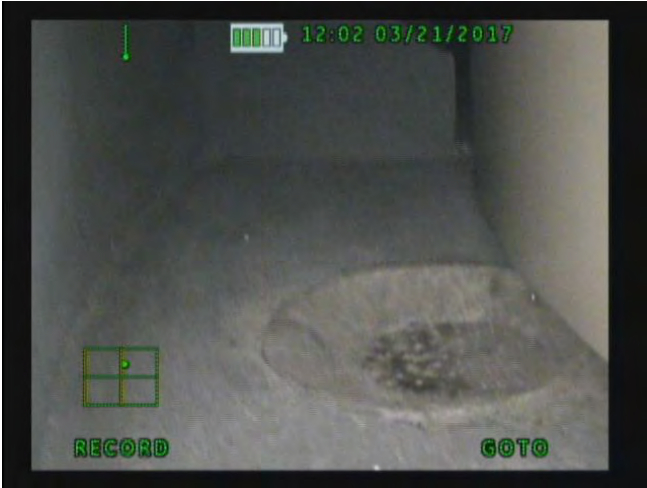
7. Vault Liner Bottom and Vault Drain

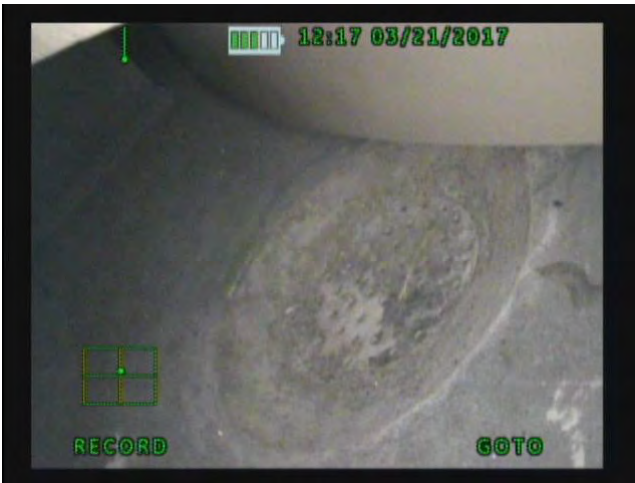
2. As discussed in Sections 3.1, 3.2, 3.3, 3.5, and 3.6, white deposits were noted around the floor drains in cells 1, 2, 3, 5 and 6. The deposit appearance is crystalline with no apparent discoloration, similar to concrete efflorescence or leaching. The boroscope video does not provide enough detail to establish the condition of the drain. It should be noted that the floor drain is not important to safety because of a defense-in-depth design and is not in the scope of license renewal. Although identification of the white deposits are not addressed in the exam acceptance criteria, this finding was entered into CAP as an observation (SAPN 1429074, Task 33) for further evaluation.

5. Vault Liner Bottom and Vault Drain

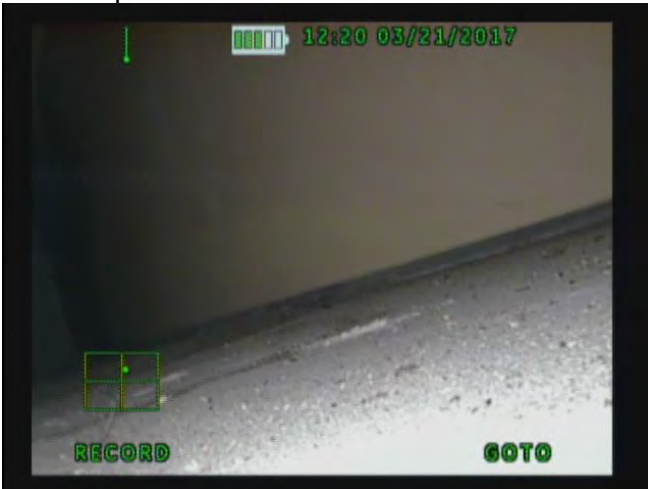
11. Overpack and Vault Liner Bottom with Debris
