Subject: 10CFR21 Reporting of Defects and Non-Compliance -
Engine Systems, Inc. Report No. 10CFR21-0124, Rev. 0

Excitation Transformers for Vickers Voltage Regulator System

Report No. 10CFR21-0124

COMPONENT: Excitation Transformers for Vickers Voltage Regulator System

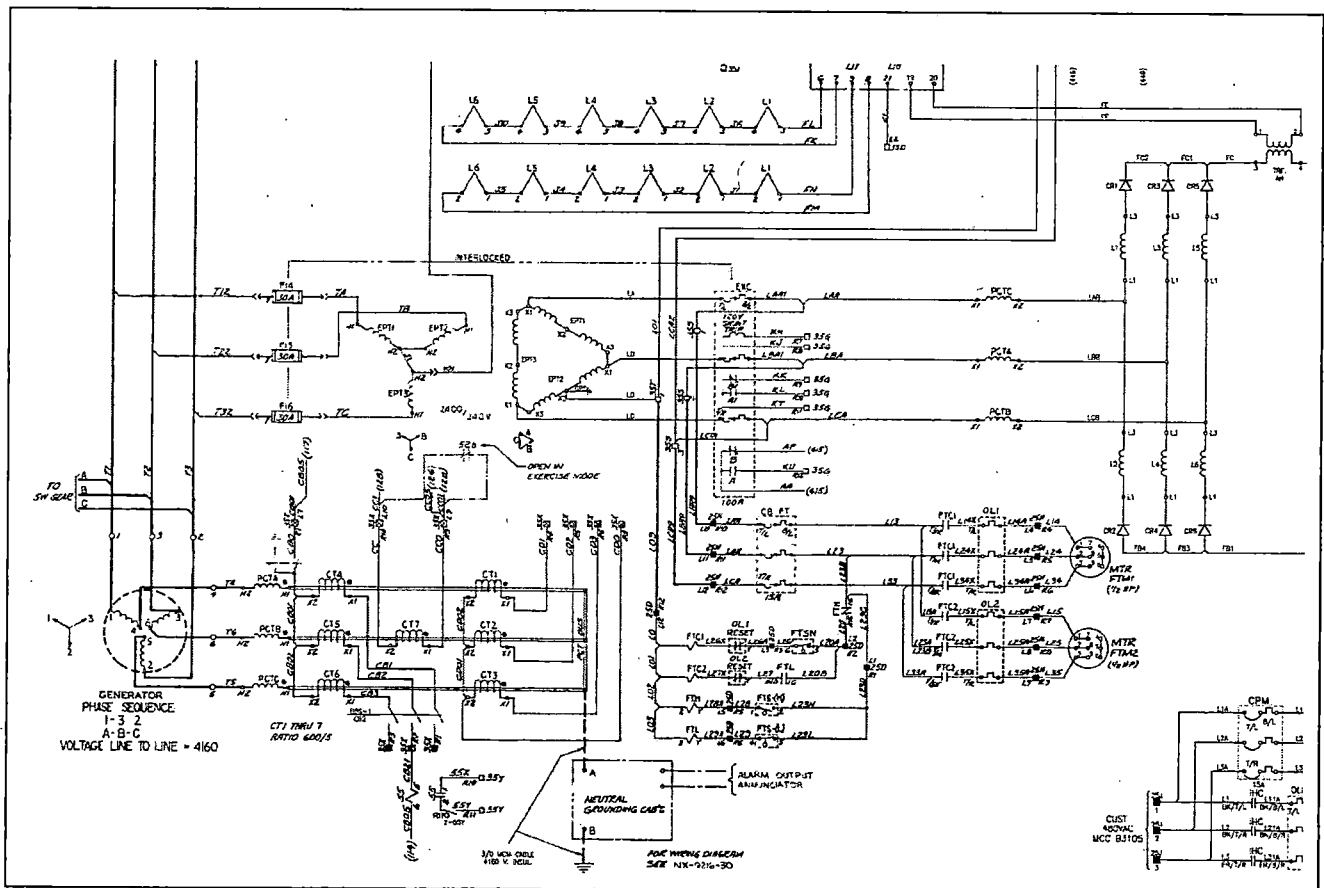
Figure 1: Typical Vickers Voltage Regulator System Schematic

Within the voltage regulator system, the magnetics supply DC excitation current to the generator field based on input from the voltage regulator. A typical schematic is shown in Figure 1 below. The three components in question are the excitation power transformers (identified as EPT1, EPT2, & EPT3), power current transformers (identified as PCTA, PCTB, & PCTC) and saturable reactors (identified as L1 through L6). The issues with each component, as well as outline drawings, are contained on the following pages.
