MEMORANDUM

DATE: December 5, 1996
TO: Vermont State Nuclear Advisory Panel
FROM: Citizens Awareness Network
RE: CAN'S analysis of Vermont Yankee's July 23, 1996 presentation on RHR minimum flow valve
CC: U.S. NRC and general release

Summary of CAN's Analysis of VY's Presentation, "RHR Minimum Flow Valve Enforcement Conference," (July 23, 1996).¹

***RHR Minimum Flow Valve
Enforcement Conference***

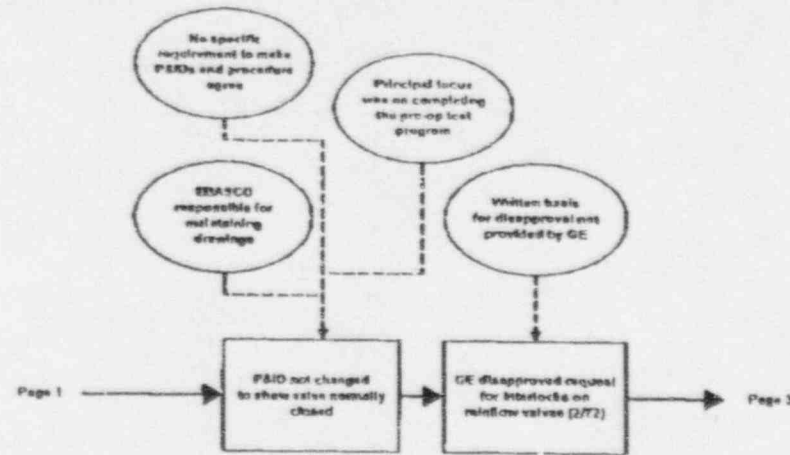
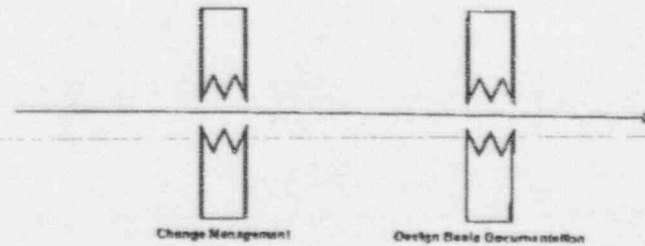
Loss of RHR Minflow Protection

In the original Vermont Yankee configuration, the RHR minimum flow valve (MOV-16A and MOV-16B) were normally closed. The Vermont Yankee staff identified that a single power supply failure would prevent both RHR minimum valves from operating. If this power supply failure occurred during a small break LOCA, all four RHR pumps would automatically start and run without a flow path for a long period of time until the LPCI injection valves opened. The concern was that all four RHR pumps might be damaged.

When Vermont Yankee personnel changed the normal position of the RHR minimum flow valves from closed to open, they resolved the RHR pump protection problem. However, it is not certain that the containment isolation function of these valves was addressed. According to the slides "EXAMPLE CASE STUDY SINGLE FAILURE OF DC BUS 1 WITH LNP," the RHR minimum flow valves are normally open and fail open on loss of this power supply. With these valves now normally open, a single failure could prevent isolation of two containment penetrations.

The normal position of the RHR minimum flow valves was changed to open from closed. Since the valves still have the single failure
