U.S. NUCLEAR REGULATORY COMMISSION
REGION I

Report No. 50-219/85-28

Oyster Creek Nuclear Generating Station

2.0 Followup of Unit Substation Transformers 1A2 and 1B2 Low Oil Level Event

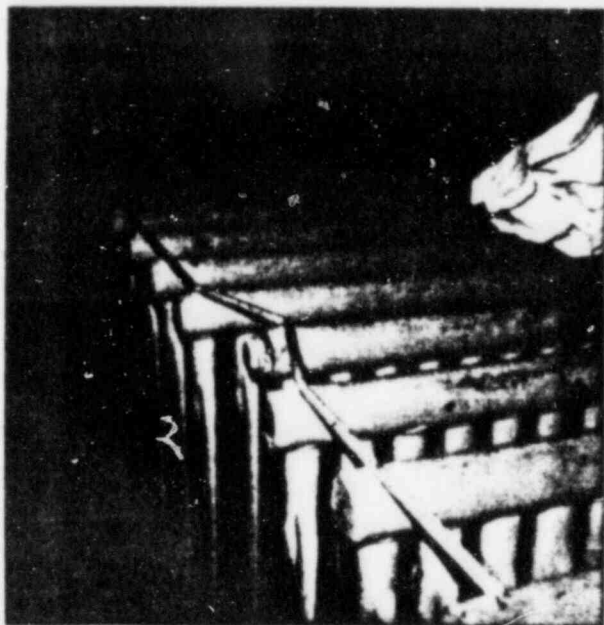
Figure 1. Normal Photograph

Explanatory Note: Figure 1 is a normal photograph of south side cooling fins of 1B2. Figures 2, 3, and 4 are thermograms of the same before, during, and after filling. Dark area in Figure 2 indicates lack of flow in the left side tubes. Figure 3 shows partial establishment of flow in these tubes during filling. Figure 4 shows the flow fully established.
