The Commission has issued the enclosed Amendment No. 20 to Facility Operating License No. DPR-70 for the Salem Nuclear Generating Station, Unit No. 1. This amendment consists of changes to the Technical Specifications in response to your request dated March 2, 1979 with additional information dated April 30, 1979, July 25, 1979, August 3, 1979, August 8, 1979, August 9, 1979, and September 14, 1979.

The amendment revises Radiological Safety Technical Specifications related to the Cycle 2 core. These changes involve the axial flux difference, heat flux hot channel factor, nuclear enthalpy hot channel factor and reactor core. This amendment authorizes initiation of operation for Cycle 2.

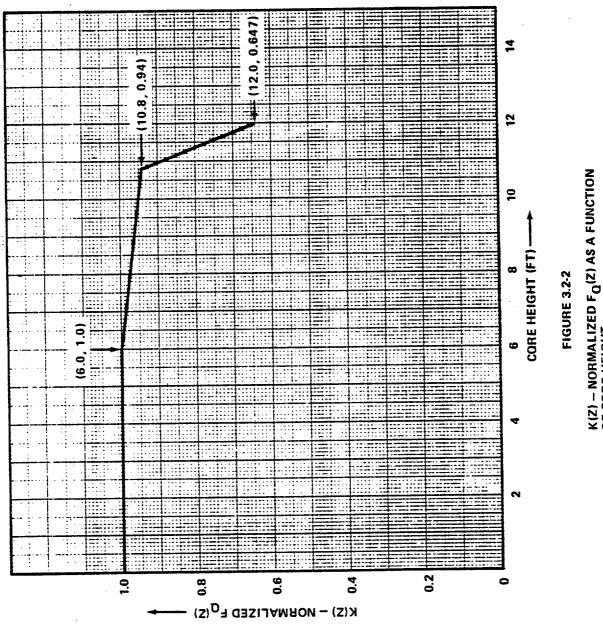
$\mbox{K(Z)}$  – Normalized  $\mbox{F}_{\mbox{\scriptsize Q}}(\mbox{Z})$  as a function of core height

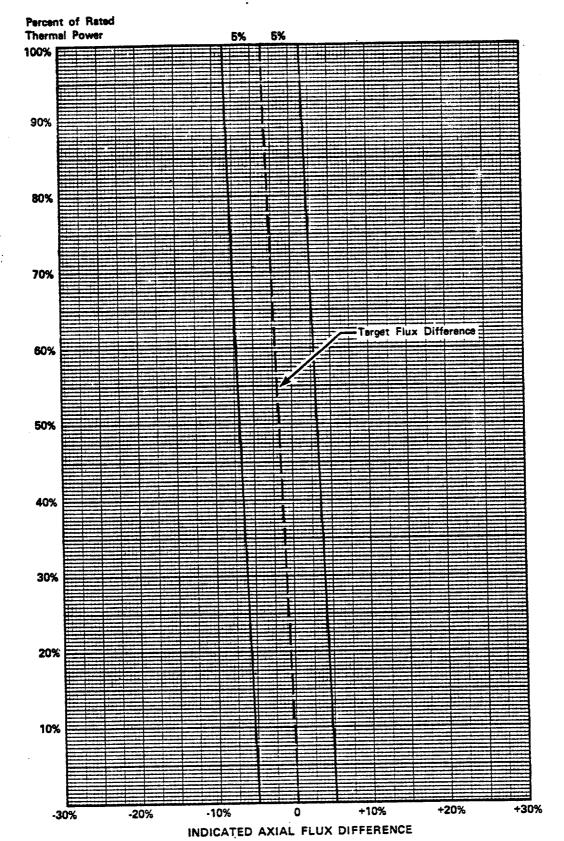
Figure 8 3/4 2-1 TYPICAL INDICATED AXIAL FLUX DIFFERENCE VERSUS THERMAL POWER

Figure B 3/4 2-1 shows a typical monthly target band.

Provisions for monitoring the AFD are derived from the plant nuclear instrumentation system through the AFD Monitor Alarm. A control room recorder continuously displays the auctioneered high flux difference and the target band limits as a function of power level. A first alarm is received any time the auctioneered high flux difference exceeds the target band limits. A second alarm is received if the AFD exceeds its allowable limits for a cumulative time of one hour during any 24 hour time period starting with the occurrence of the first alarm. Time outside the target band is graphically presented on the strip chart.
