Point Beach Nuclear Plant, Units 1 and 2
Dockets 50-266 and 50-301
License Nos. DPR-24 and DPR-27

Clarification to Information Regarding the Point Beach Nuclear Plant
License Renewal Application
(TAC Nos. MC2099 and MC2100)

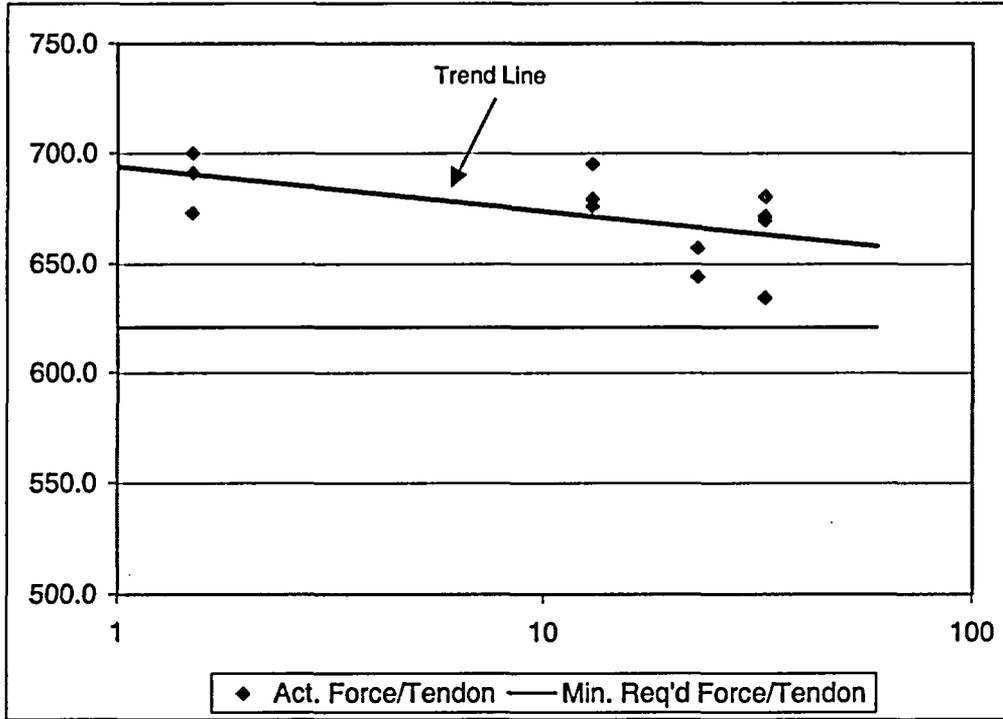
UNIT 1 VERTICAL TENDONS
Projected Pre-stressing Force Trend

Year	Actual (kips)		Year	Actual (kips)
1.5	691.0		23	644.0
1.5	700.0		33	680.3
1.5	673.0		33	669.6
13	679.3		33	671.5
13	695.0		33	634.6
13	676.0			
23	657.1

The specific request from the NRC staff was to re-title the graphs and edit the legend for the projected pre-stressing force trend line graphs (reference RAI 4.5-1(b)). The information should be presented on a per tendon group basis. There are six graphs total, one for each group of tendons for the two units. The graphs follow:

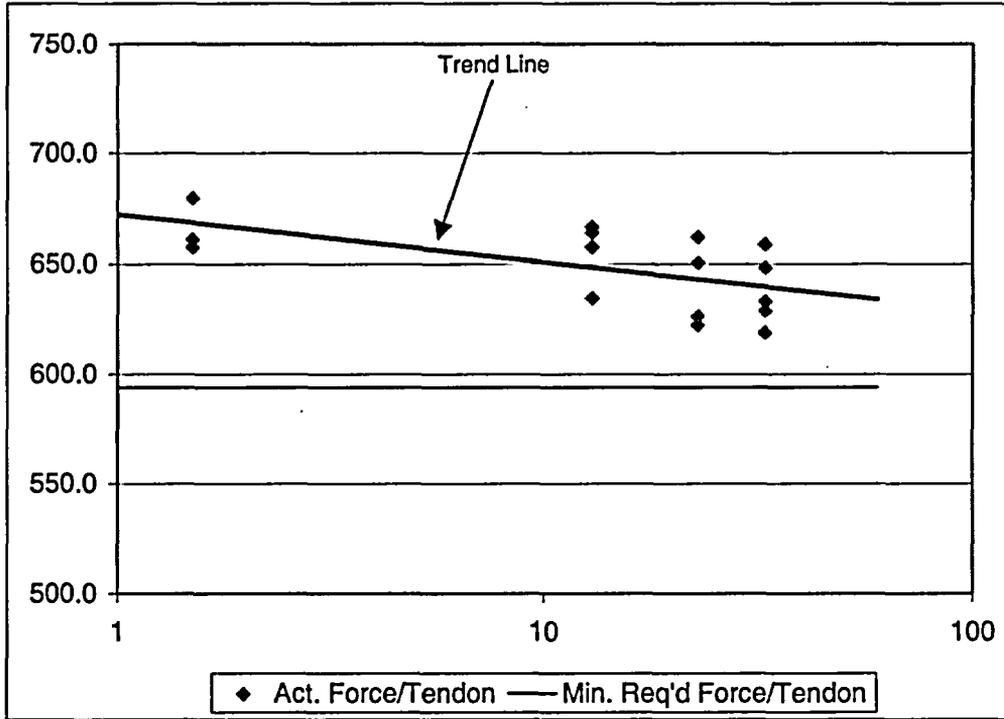
UNIT 1 HOOP TENDONS
Projected Pre-stressing Force Trend

Year	Actual (kips)	Year	Actual (kips)
1.5	657.5	23	662.0
1.5	661.0	23	650.5
1.5	679.5	23	622.45
13	634.5	33	648.2
13	666.5	33	618.9
13	664.0	33	658.7
13	657.5	33	633.0
23	626.35	33	628.8

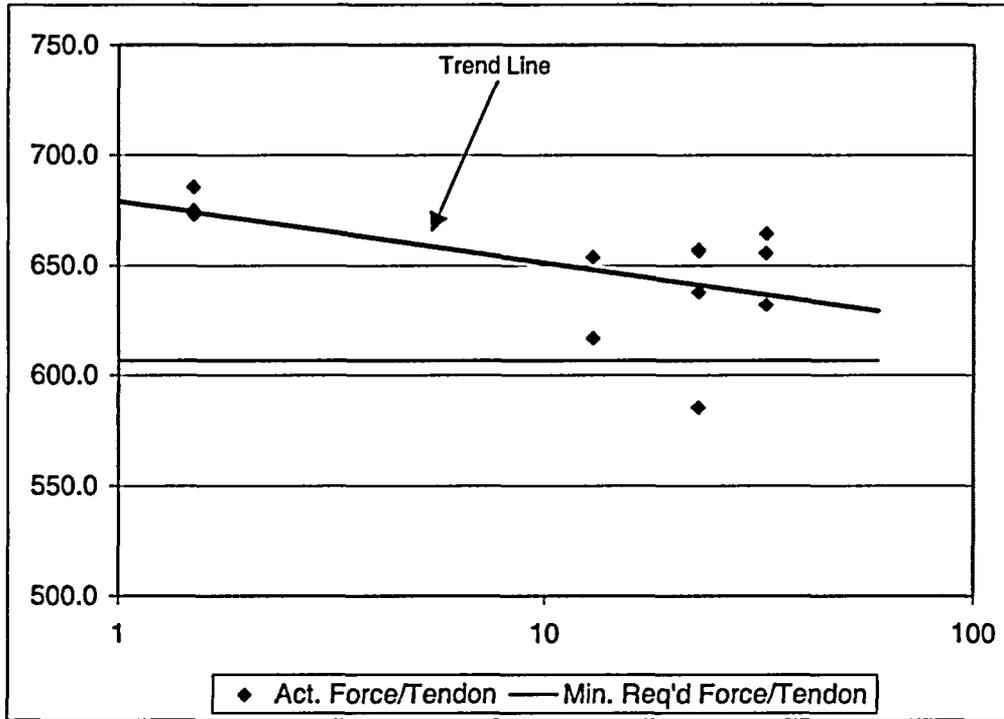
UNIT 1 DOME TENDONS
Projected Pre-stressing Force Trend

Year	Actual (kips)	Year	Actual (kips)
1.5	675.0	23	656.5
1.5	673.0	33	655.5
1.5	685.5	33	632.0
13	653.8	33	664.4
13	616.9		
23	637.85		
23	657.15		
23	585.3

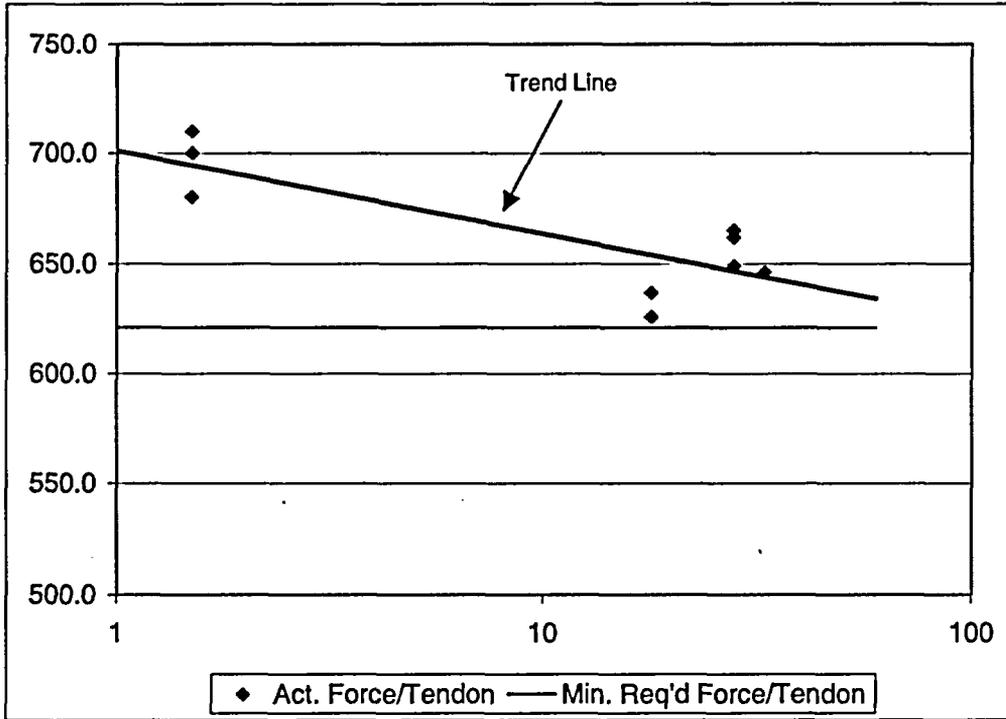
UNIT 2 VERTICAL TENDONS
Projected Pre-stressing Force Trend

Year	Actual (kips)	Year	Actual (kips)
1.5	710.0	28	649.0
1.5	680.0	33	646.0
1.5	700.0		
18	637.0		
18	626.0		
28	662.0		
28	665.0

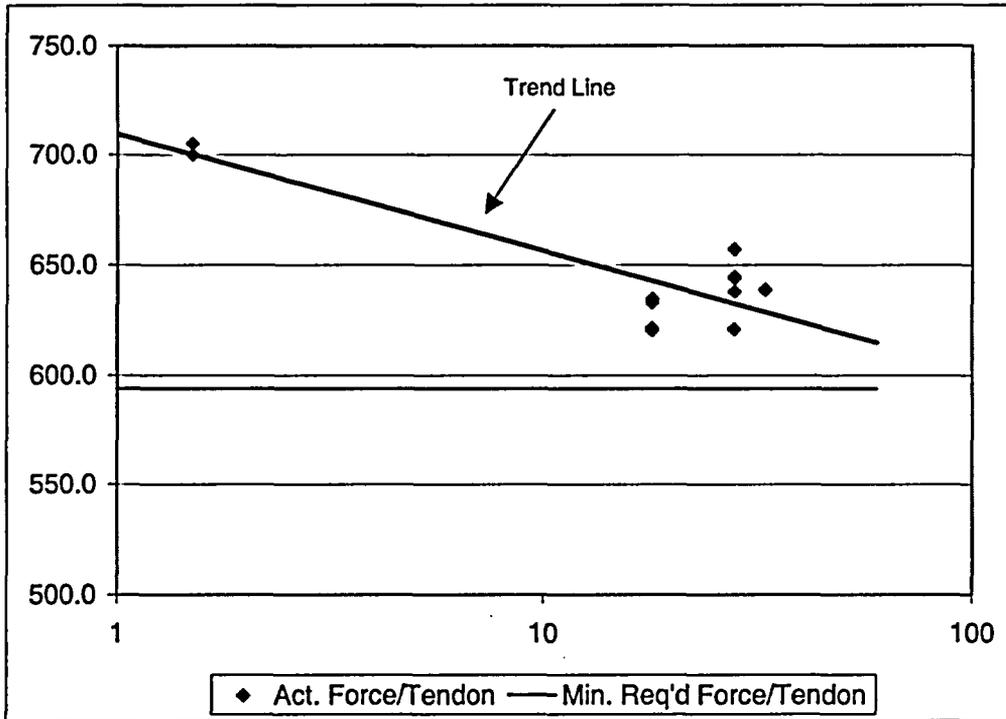
UNIT 2 HOOP TENDONS
Projected Pre-stressing Force Trend

Year	Actual (kips)	Year	Actual (kips)
1.5	700.0	28	621.0
1.5	705.0	28	638.0
1.5	705.0	28	644.0
18	634.5	28	644.5
18	620.5	28	657.0
18	621.5	33	638.7
18	633.0

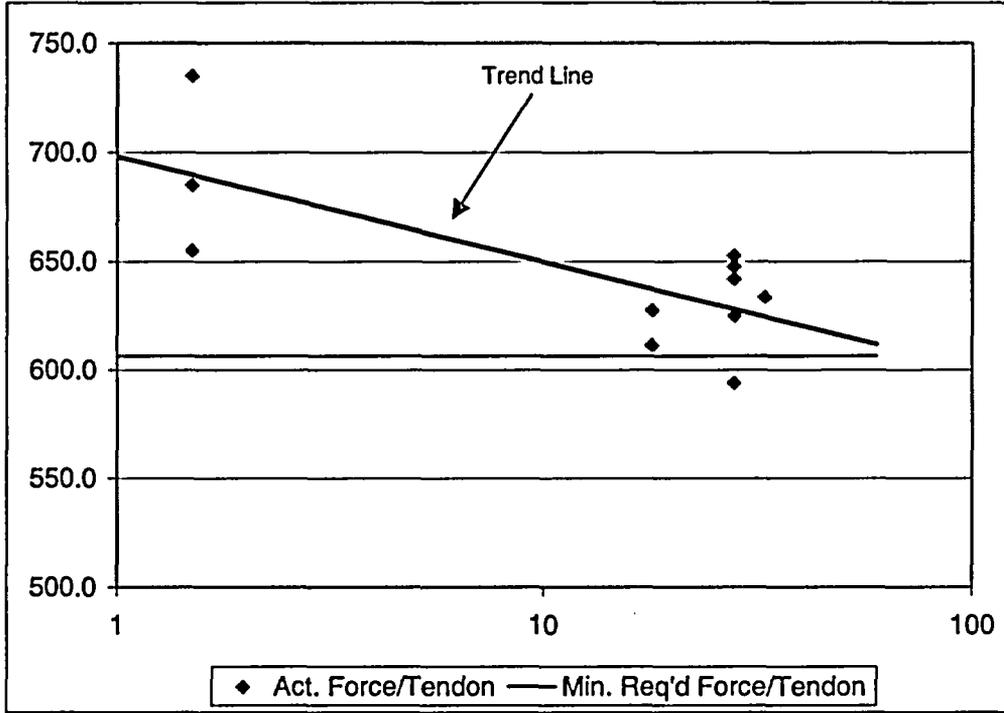
UNIT 2 DOME TENDONS
Projected Pre-stressing Force Trend

Year	Actual (kips)	Year	Actual (kips)
1.5	685.0	28	594.0
1.5	735.0	28	642.0
1.5	655.0	28	652.5
18	627.5	33	633.6
18	611.5		
28	625.0		
28	647.5
