NUREG-1841

# **U.S. Operating Experience With Thermally Treated Alloy 690 Steam Generator Tubes**

**U.S. Nuclear Regulatory Commission  
Office of Nuclear Reactor Regulation  
Washington, DC 20555-0001**

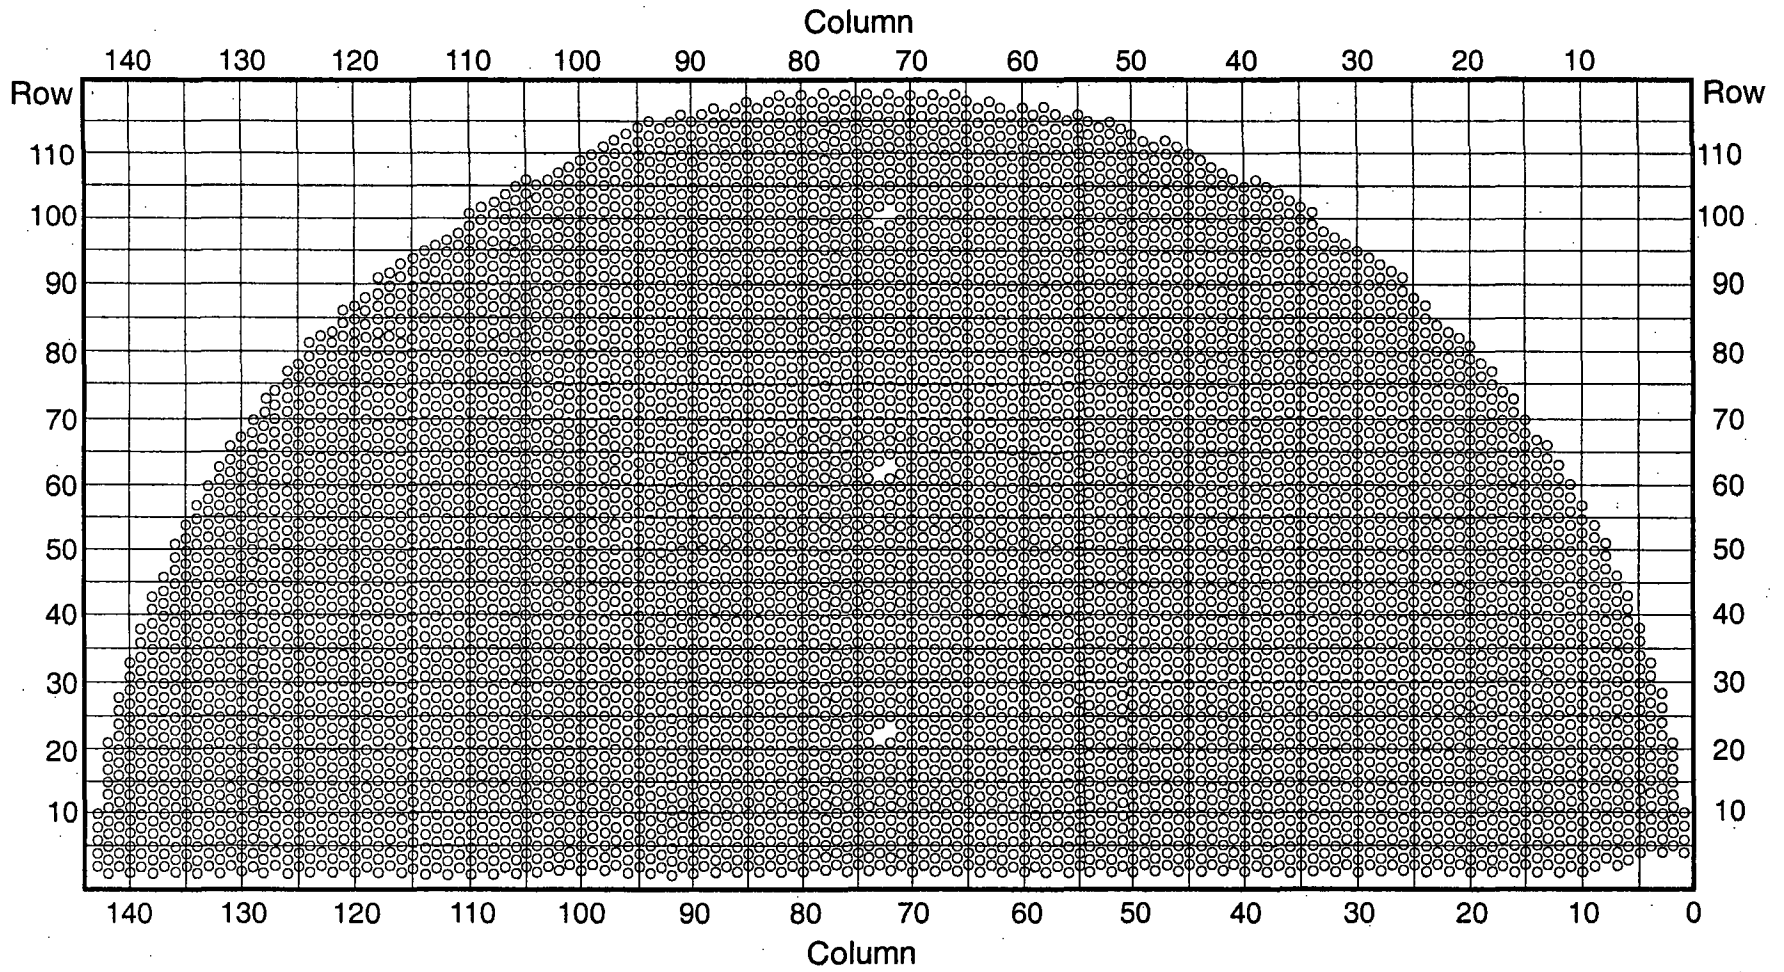
Figure 2-8: Tube Support Naming Convention at ANO Units 2

ANO 2 has two recirculating steam generators which were designed by Westinghouse and fabricated at ENSA. The steam generators went into service in 2000 during refueling outage (RFO) 14. The licensee numbers its tube supports as depicted in Figure 2-8.

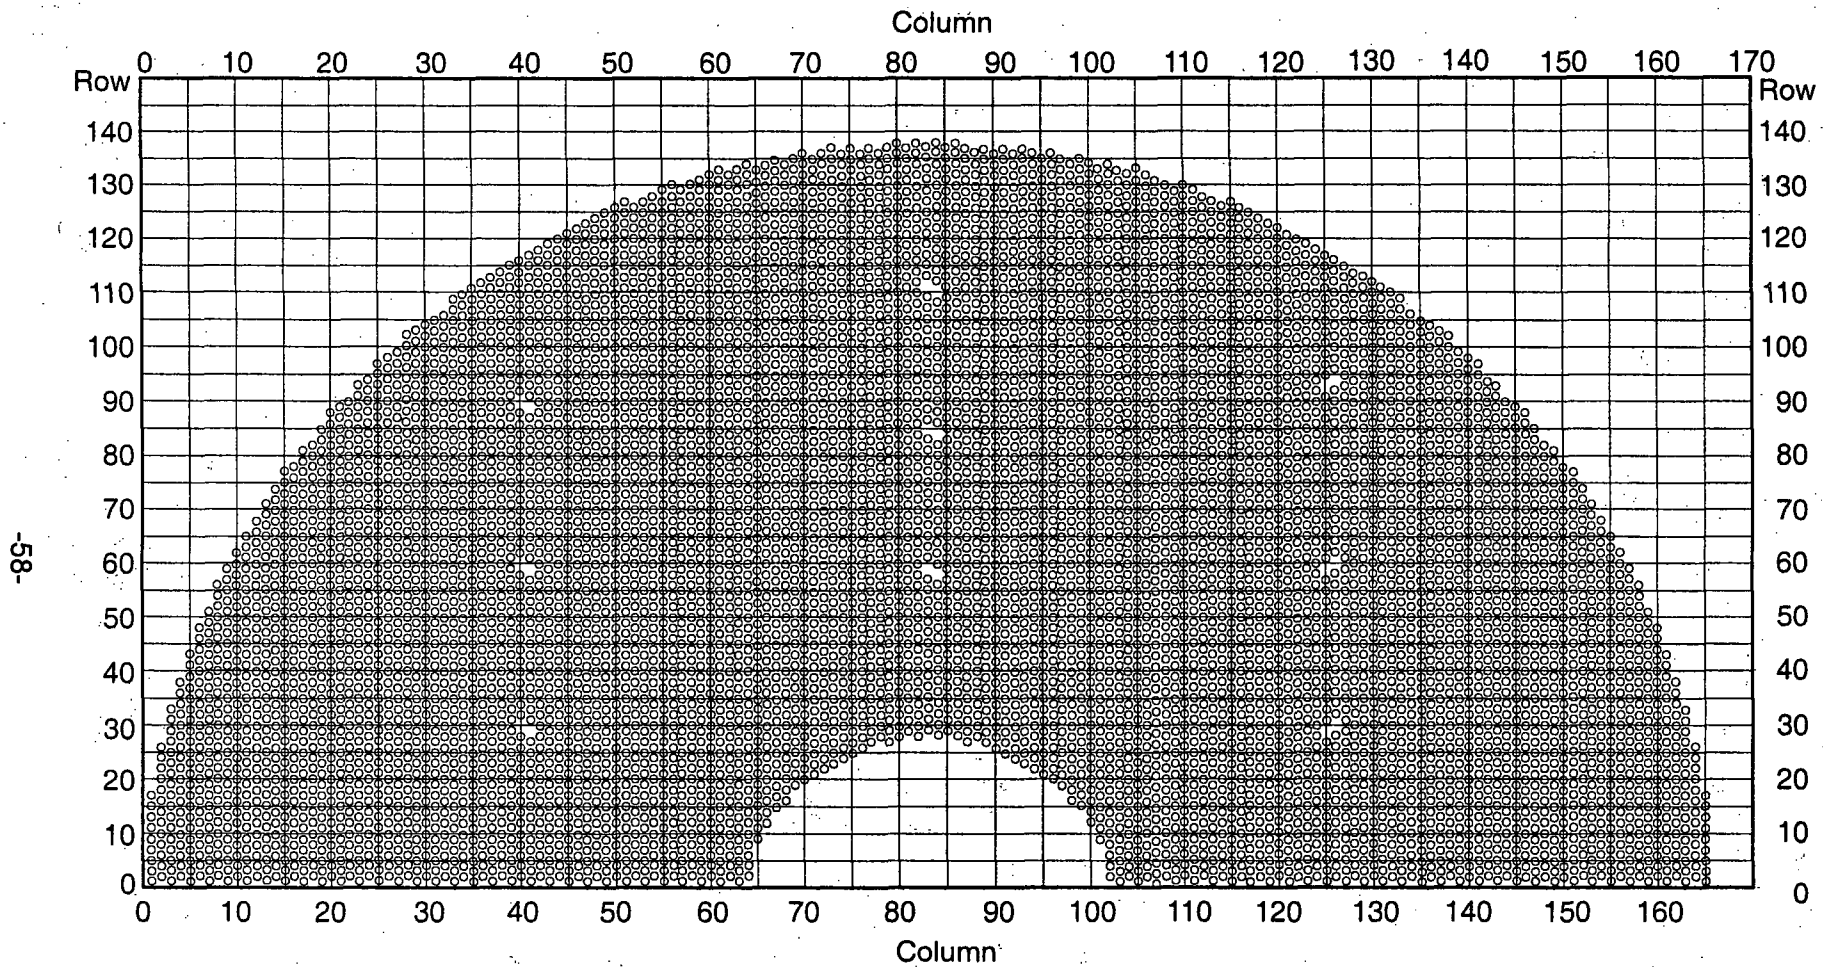
Figure 2-12: Tube Support Naming Convention at Byron Unit 1

Byron 1 has four recirculating steam generators designed and fabricated by BWI. The steam generators were put into service in 1998 during RFO 8. The licensee numbers its tube supports as depicted in Figure 2-12.

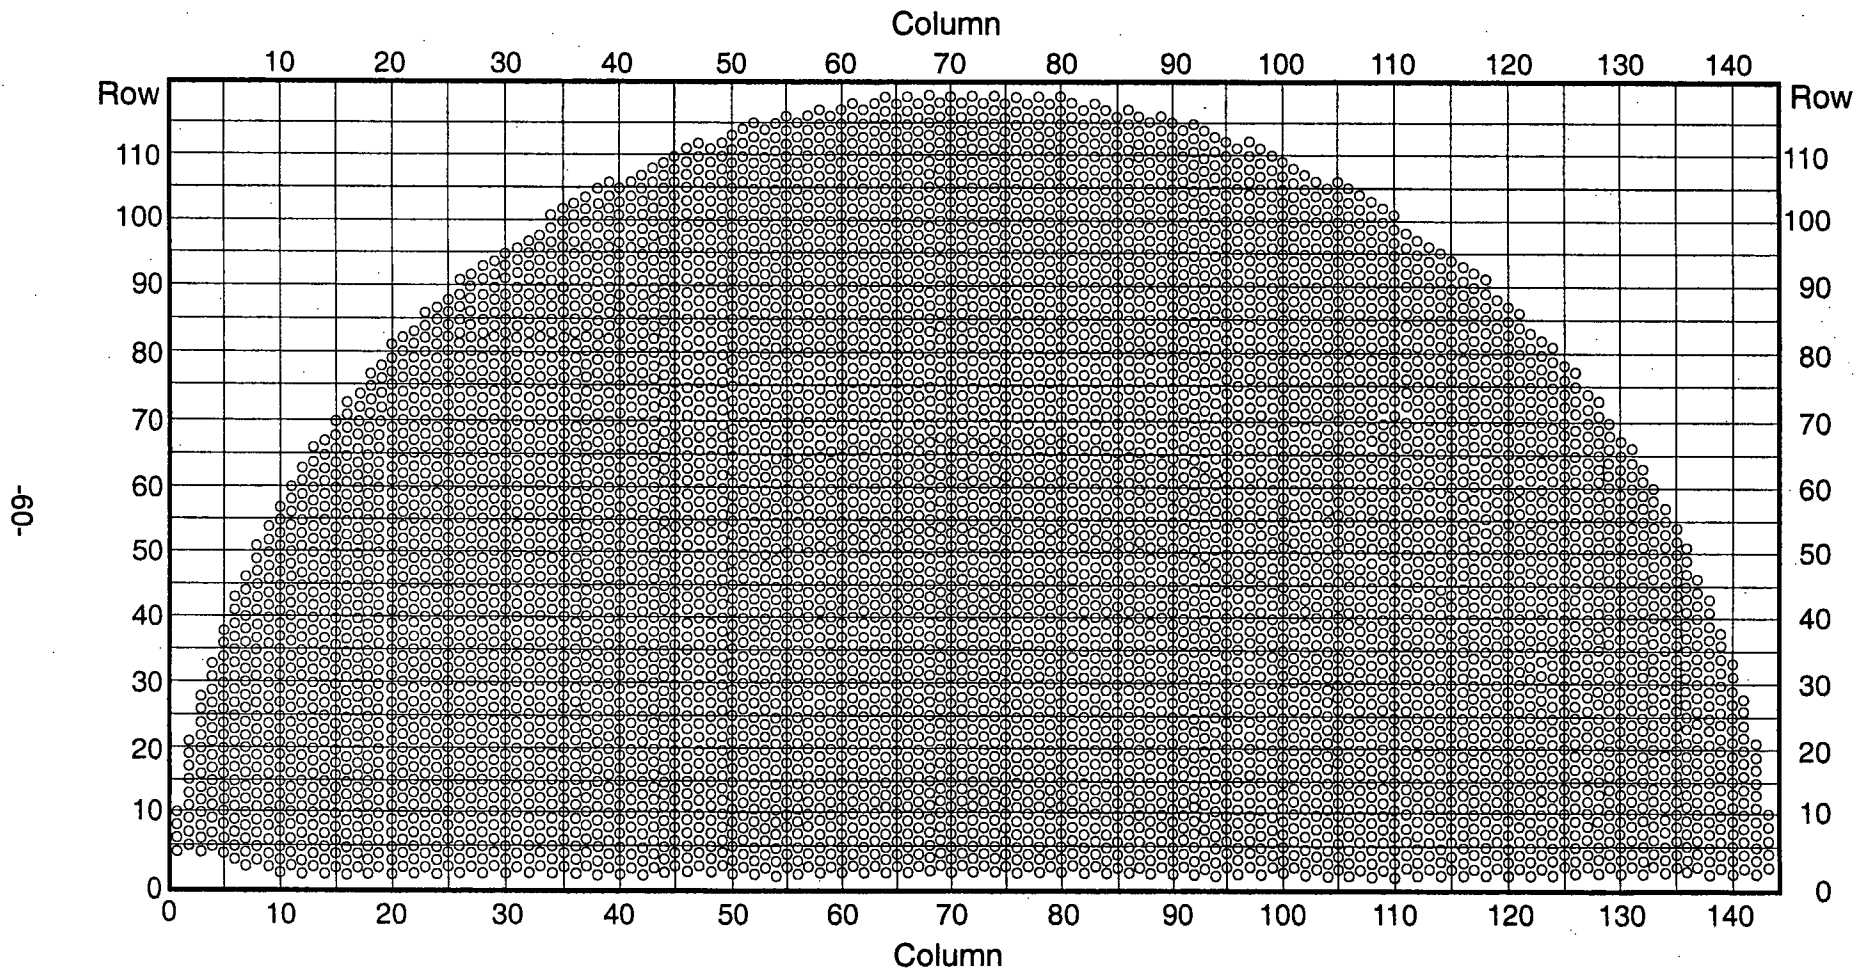
Figure 2-14: Tube Support Naming Convention at Calvert Cliffs 1 and 2

Calvert Cliffs 1 has two recirculating steam generators which were designed and fabricated by BWI. The steam generators were put into service in 2002 during RFO 15. The licensee numbers its tube supports as depicted in Figure 2-14.

Calvert Cliffs 2 has two recirculating steam generators which were designed and fabricated by BWI. The steam generators were put into service in 2003 during RFO 14. The licensee numbers its tube supports as depicted in Figure 2-14.

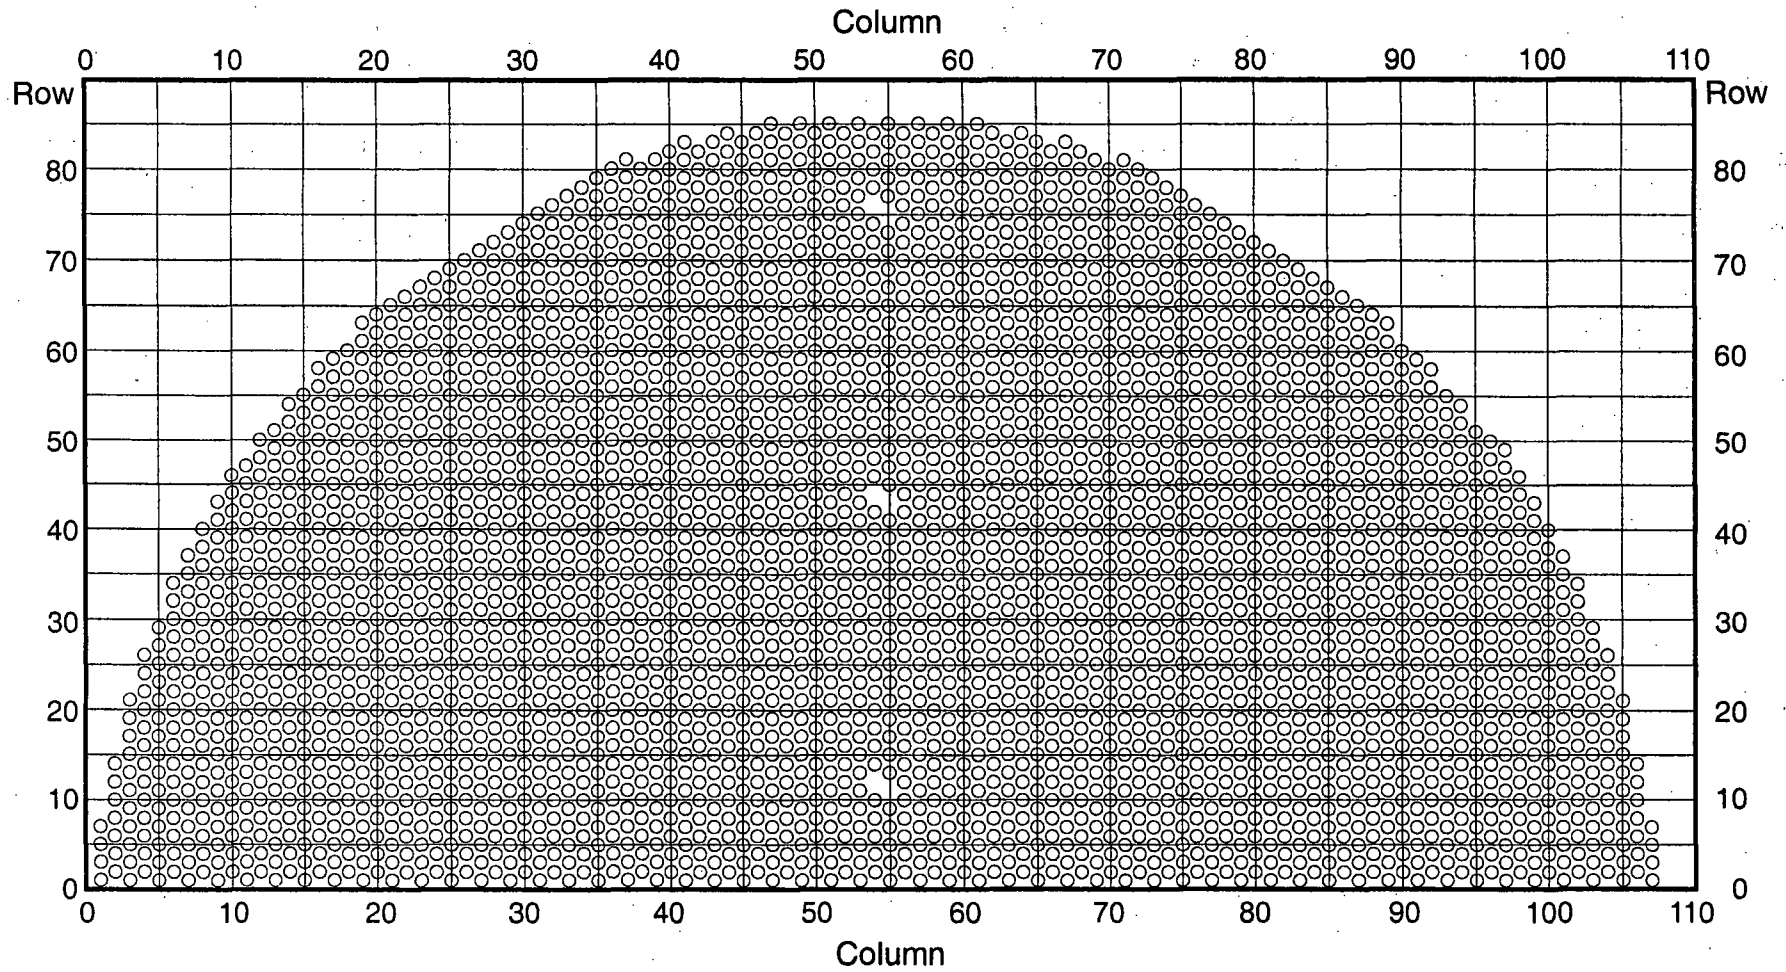
Figure 2-16: Tube Support Naming Convention at Catawba Unit 1

Catawba 1 has four recirculating steam generators which were designed and fabricated by BWI. The steam generators were put into service in 1996 during RFO 9. The licensee numbers its tube supports as depicted in Figure 2-16.
