**APPENDIX B AGING MANAGEMENT PROGRAMS
TABLE OF CONTENTS**

Three Mile Island Nuclear Station

Applicant's Environmental Report
License Renewal Operating Stage

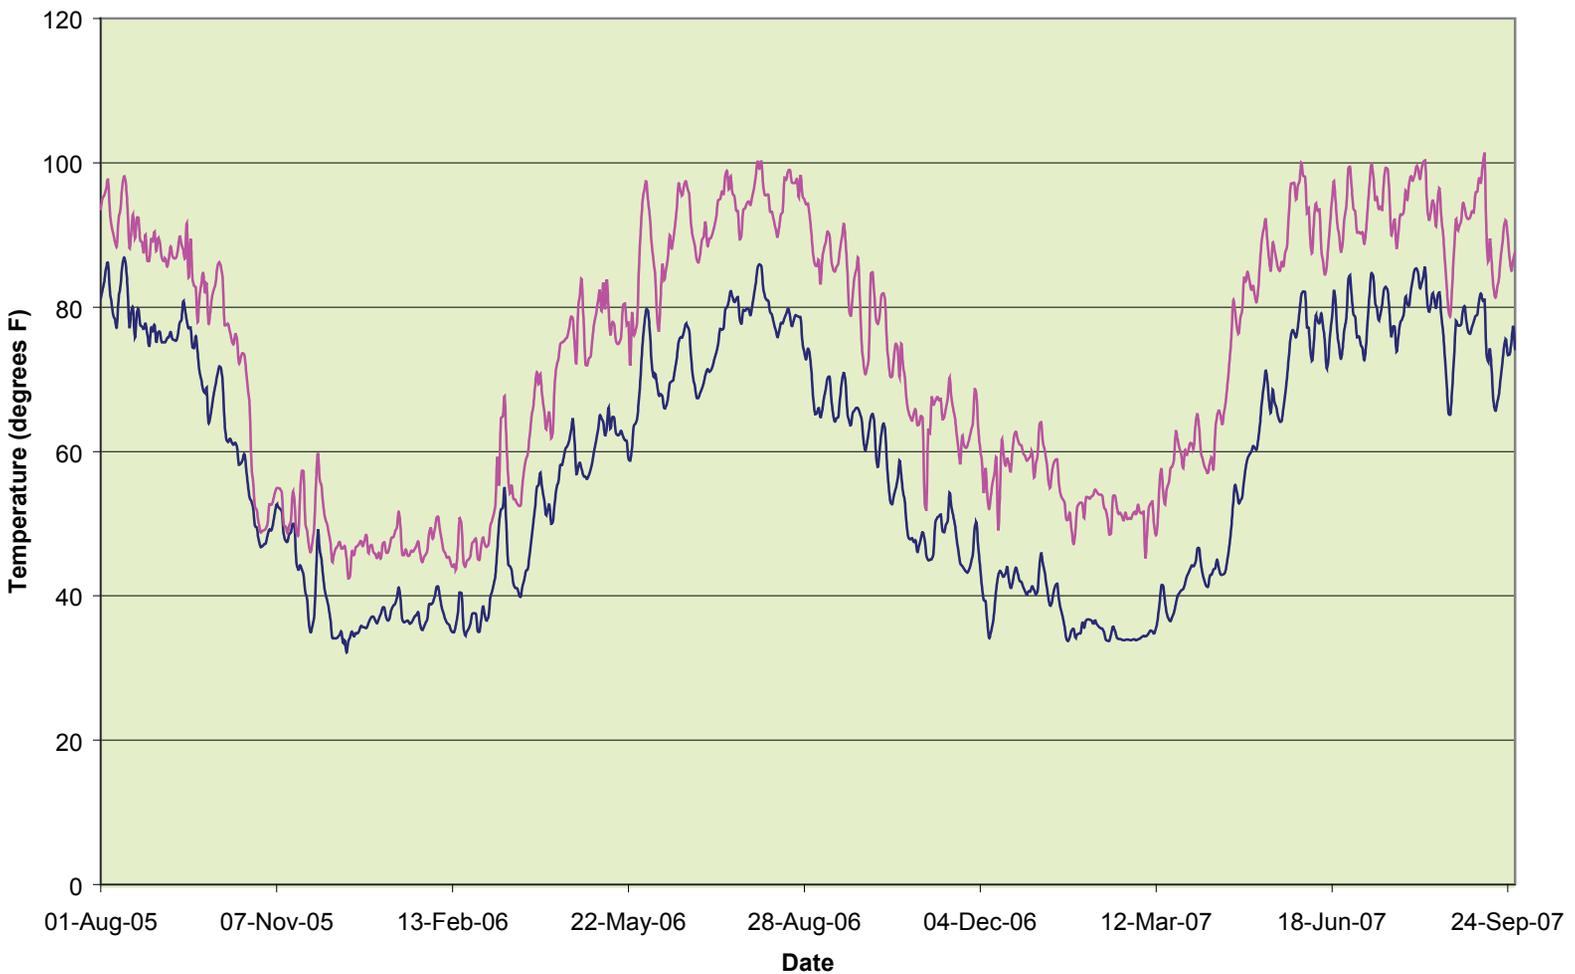
Three Mile Island Nuclear Station Unit 1
License Renewal Environmental Report
Figure 2.2-2 TMI-1 Inlet and Discharge Temperatures

- Daily Average Inlet
- Daily Average Discharge

AmerGen continues to collect water temperature data with an automatic temperature sensor at the intake screen pump house and at the discharge monitoring pit (before the water is mixed with the Susquehanna River water). [Figure 2.2-2](#) presents recent representative data from August 2005 through September 2007. The 24-hour maximum discharge temperature detected in 2006 occurred on August 4 (100.2°F), and in 2007 it occurred on September 11 (101.1°F). The differences between the intake and discharge temperatures (i.e., ΔT) have also been calculated on a monthly basis for the same time period and are presented in [Table 2.2-1](#). During this two year period, the maximum ΔT occurred in April 2006 (30.16°F) (AmerGen 2007b).
