SUBJECT: CERTIFICATION OF THE MINUTES OF THE ACRS SUBCOMMITTEE  
MEETING ON THE OYSTER CREEK GENERATING STATION LICENSE  
RENEWAL APPLICATION, JANUARY 18, 2007 - ROCKVILLE,  
MARYLAND

## Unresolved Problems With Drywell Corrosion

# **Structural Integrity Analysis of the Degraded Drywell Containment at Oyster Creek**

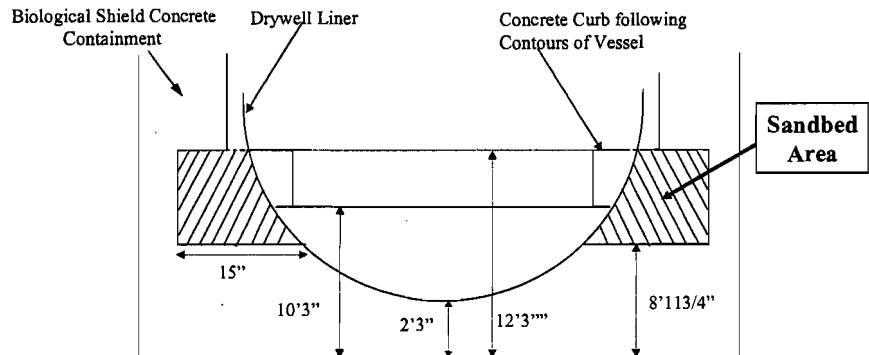
**Schematic Drawing of Lower Spherical Section of Drywell Liner**  
(not to size)

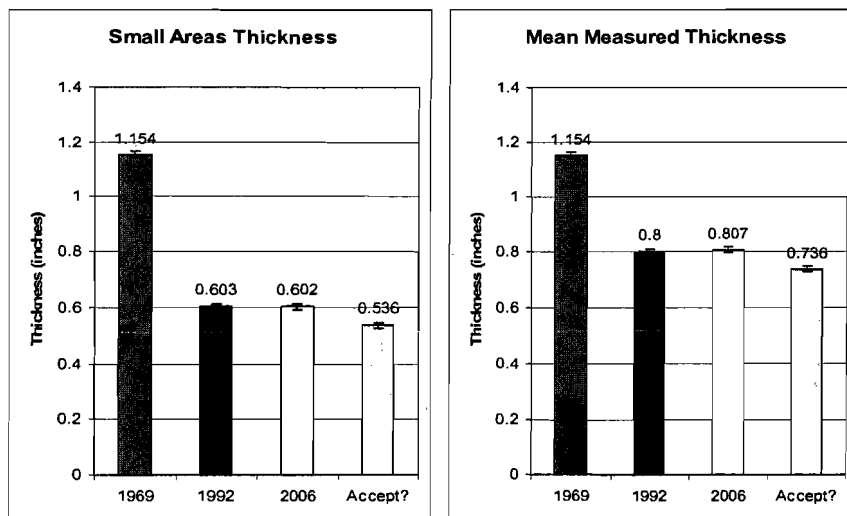
## Claimed Safety Margins Based on 6 By 6 Grids

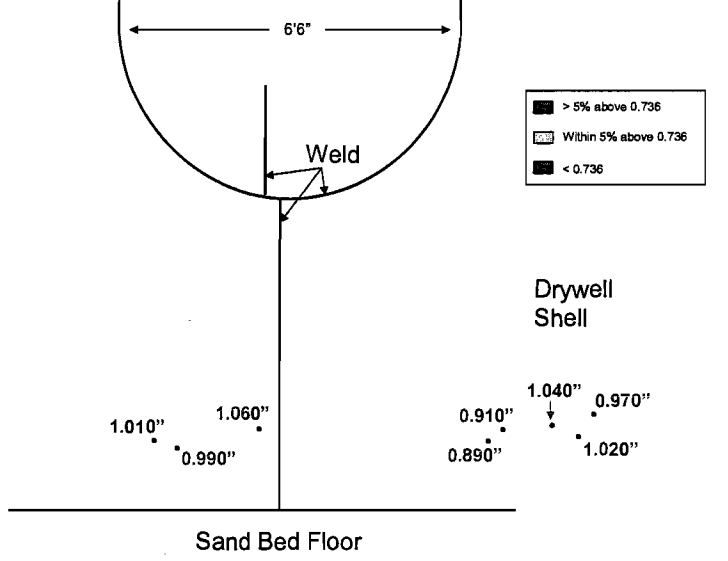
# 1992 External Spot Measurements Bay 5

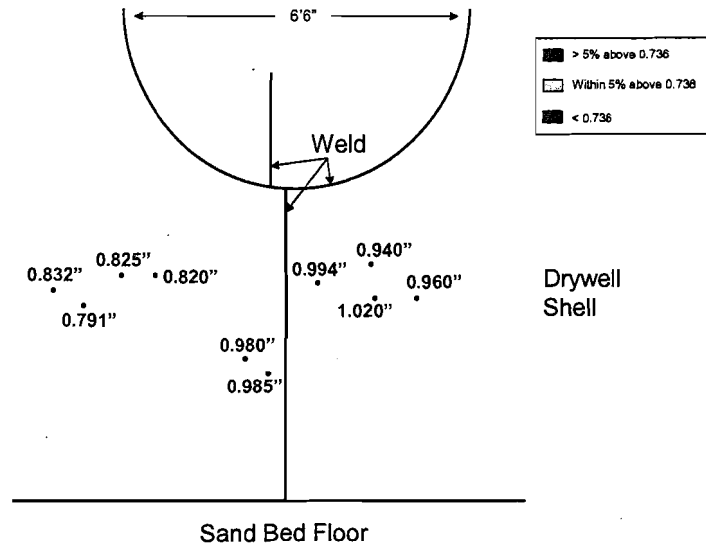
### 1992 External Spot Measurements Bay 9

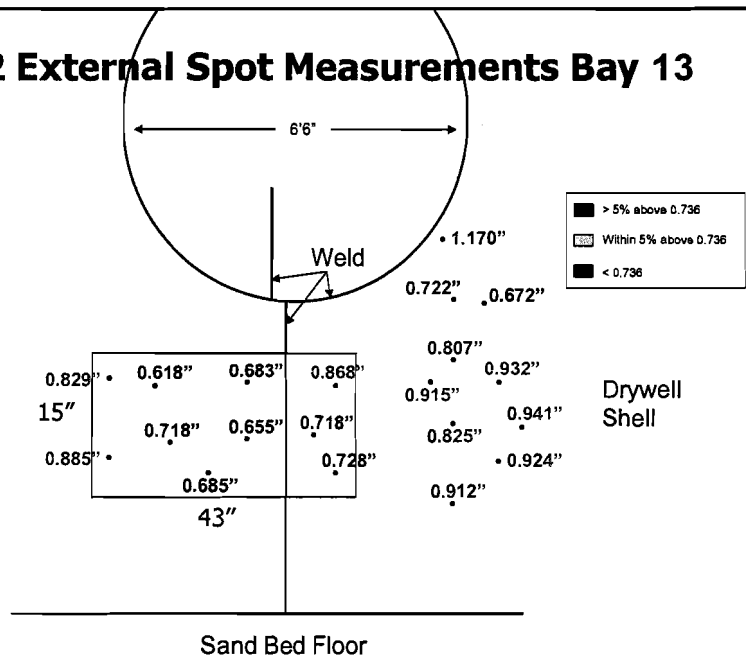
### 1992 External Spot Measurements Bay 13

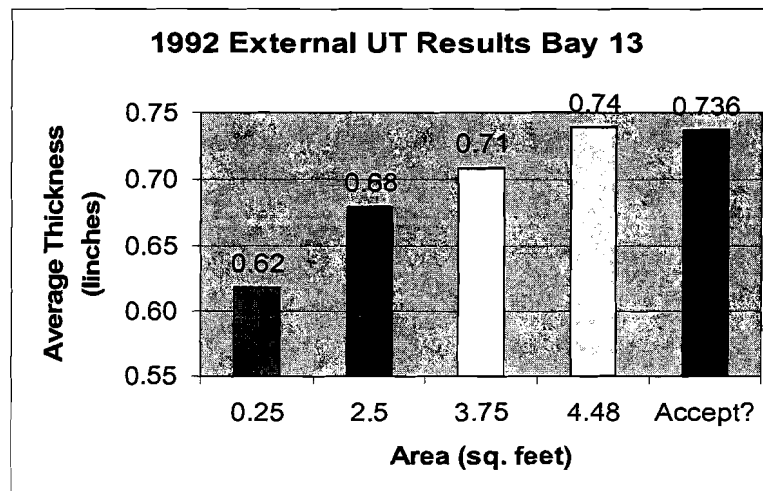
## Significant Thin Areas Existed in 1992

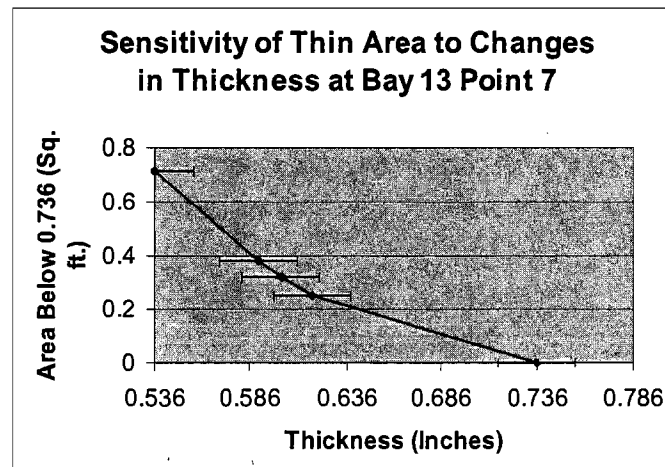
## Areas of Thin Regions Are Sensitive to Corrosion

- Incomplete results presented in an opaque way in ACRS information package
- Thinnest point measured decreased from 0.618 inches to 0.602 inches
- Results indicated general thinning of the drywell shell by up to 0.039 inches
- Likely that shell is thinner than it was in 1992
- Even 0.02 inches of corrosion would be significant because claimed margin was 0.064 inches and thin areas expand quickly with additional thinning

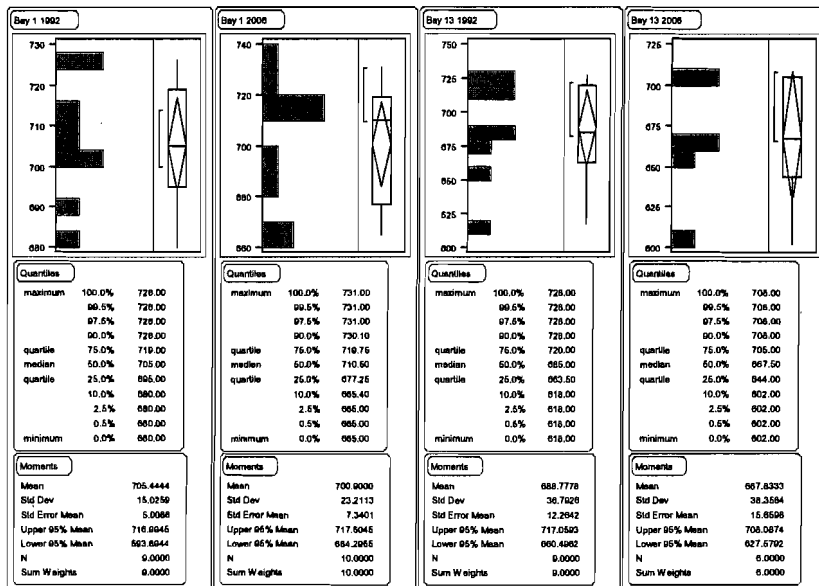
## 2006 External UT Results: Details

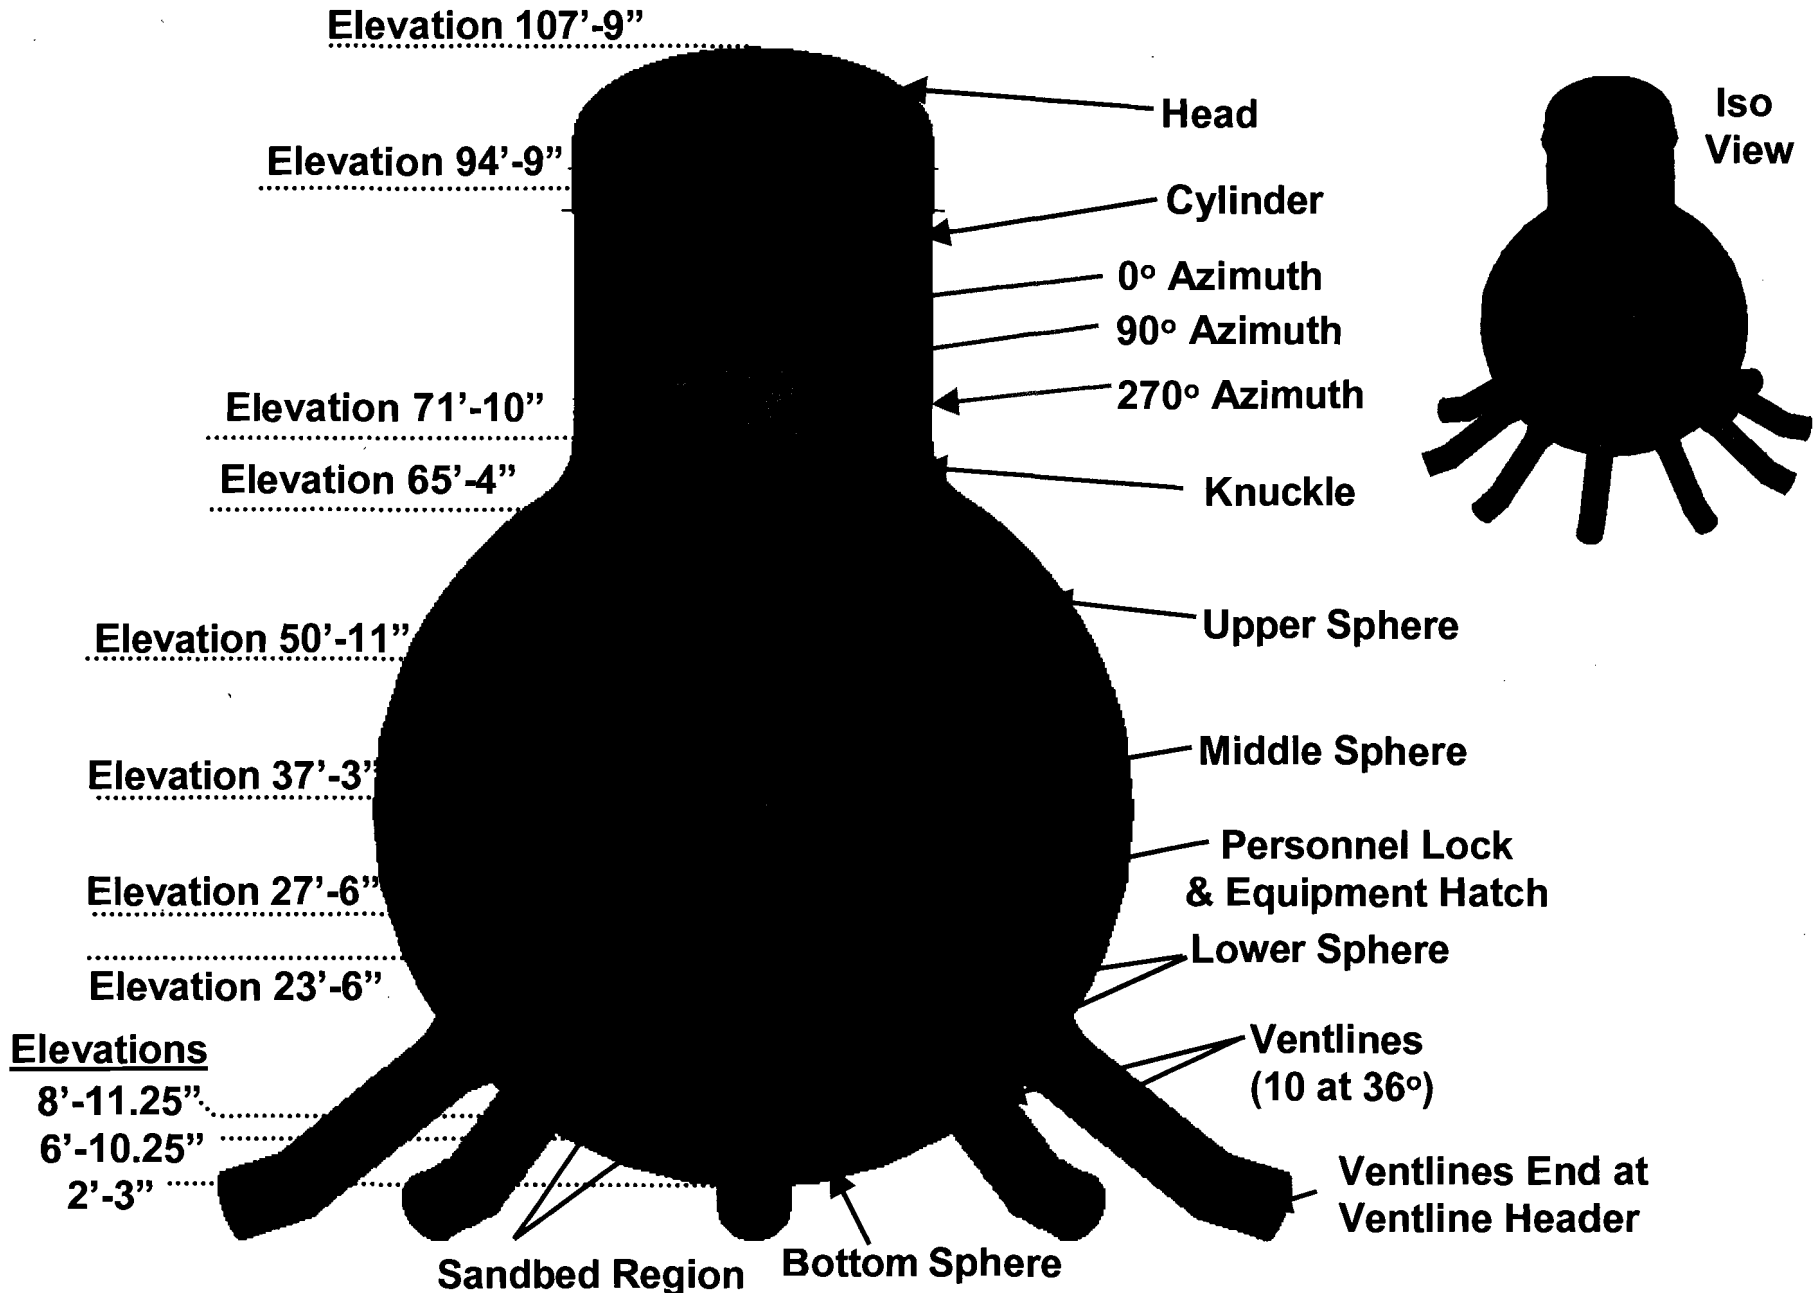
# Drywell Model – Elevations and Regions

- Wall thinning used to model degradation.
- Region by region averages used based on reported measurements.
- Localized thinning was modeled in Bay 1 and Bay 13

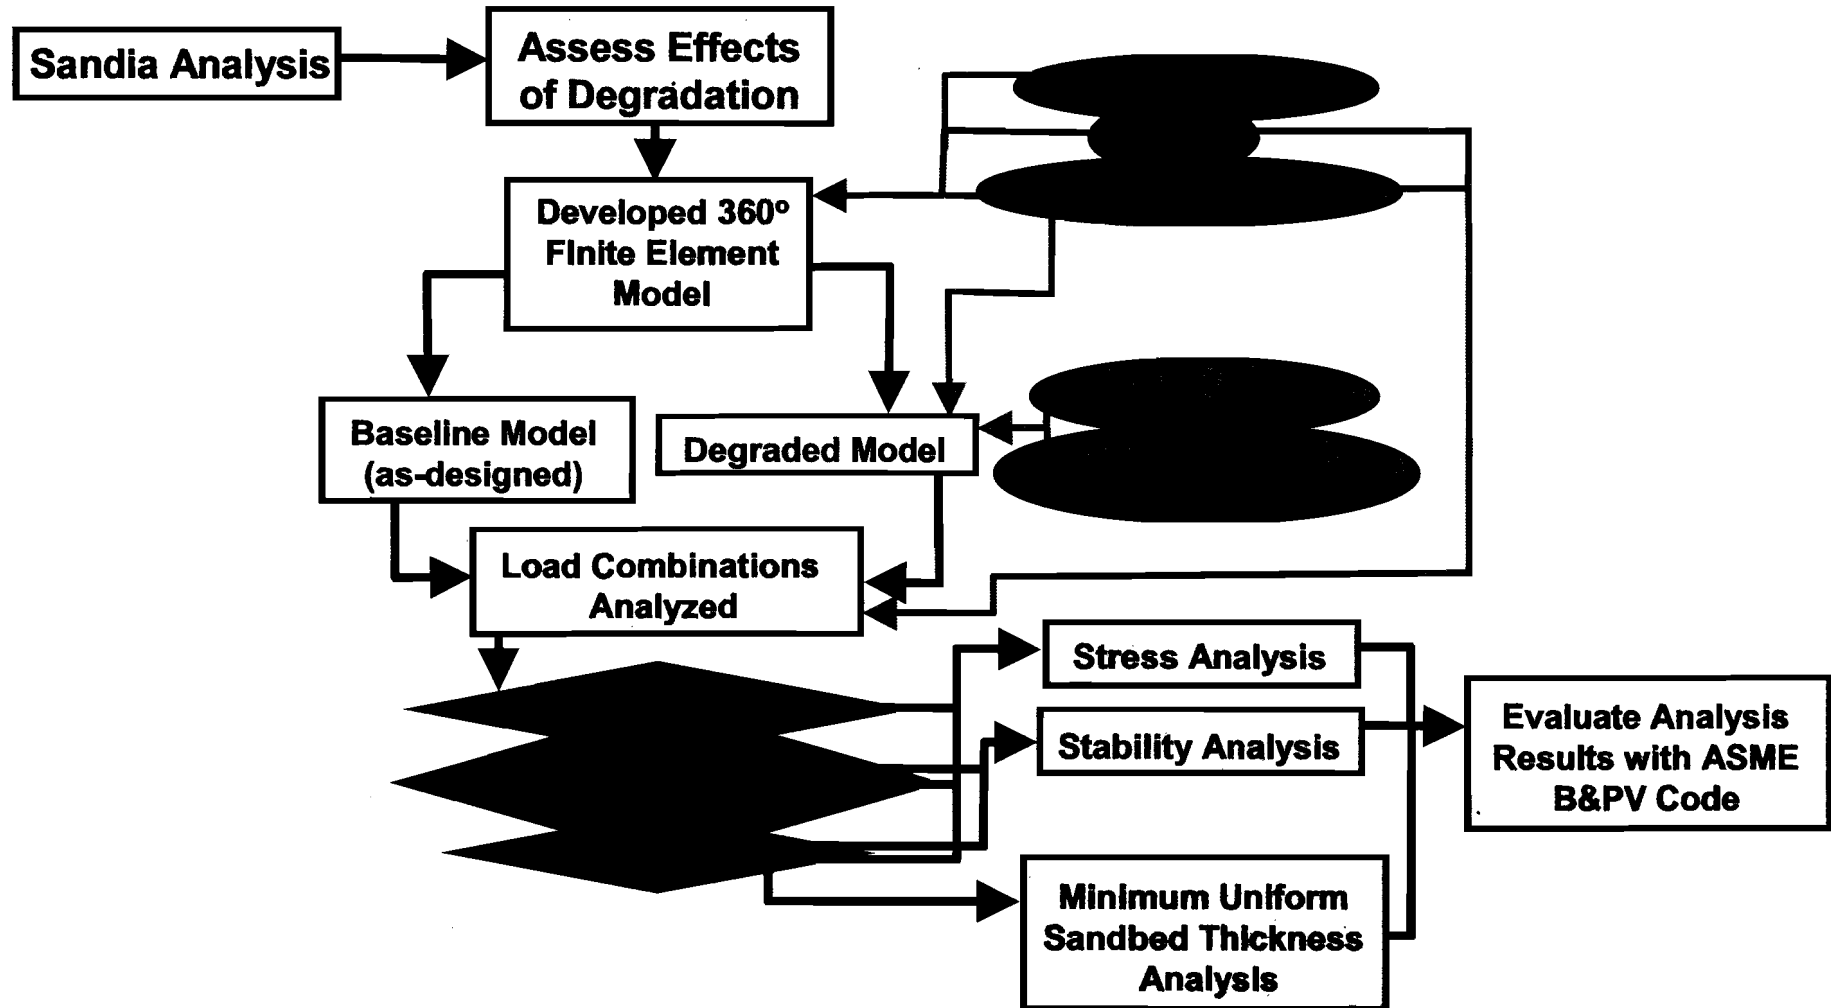
# Model and Analysis Development

- The intent of this study was to assess the ability of the degraded drywell shell to withstand the postulated loadings
- 360° model of drywell was used to study the spatial variation of the degradation
- Stress and stability analyses of the drywell for as-designed and degraded shell conditions for postulated loads

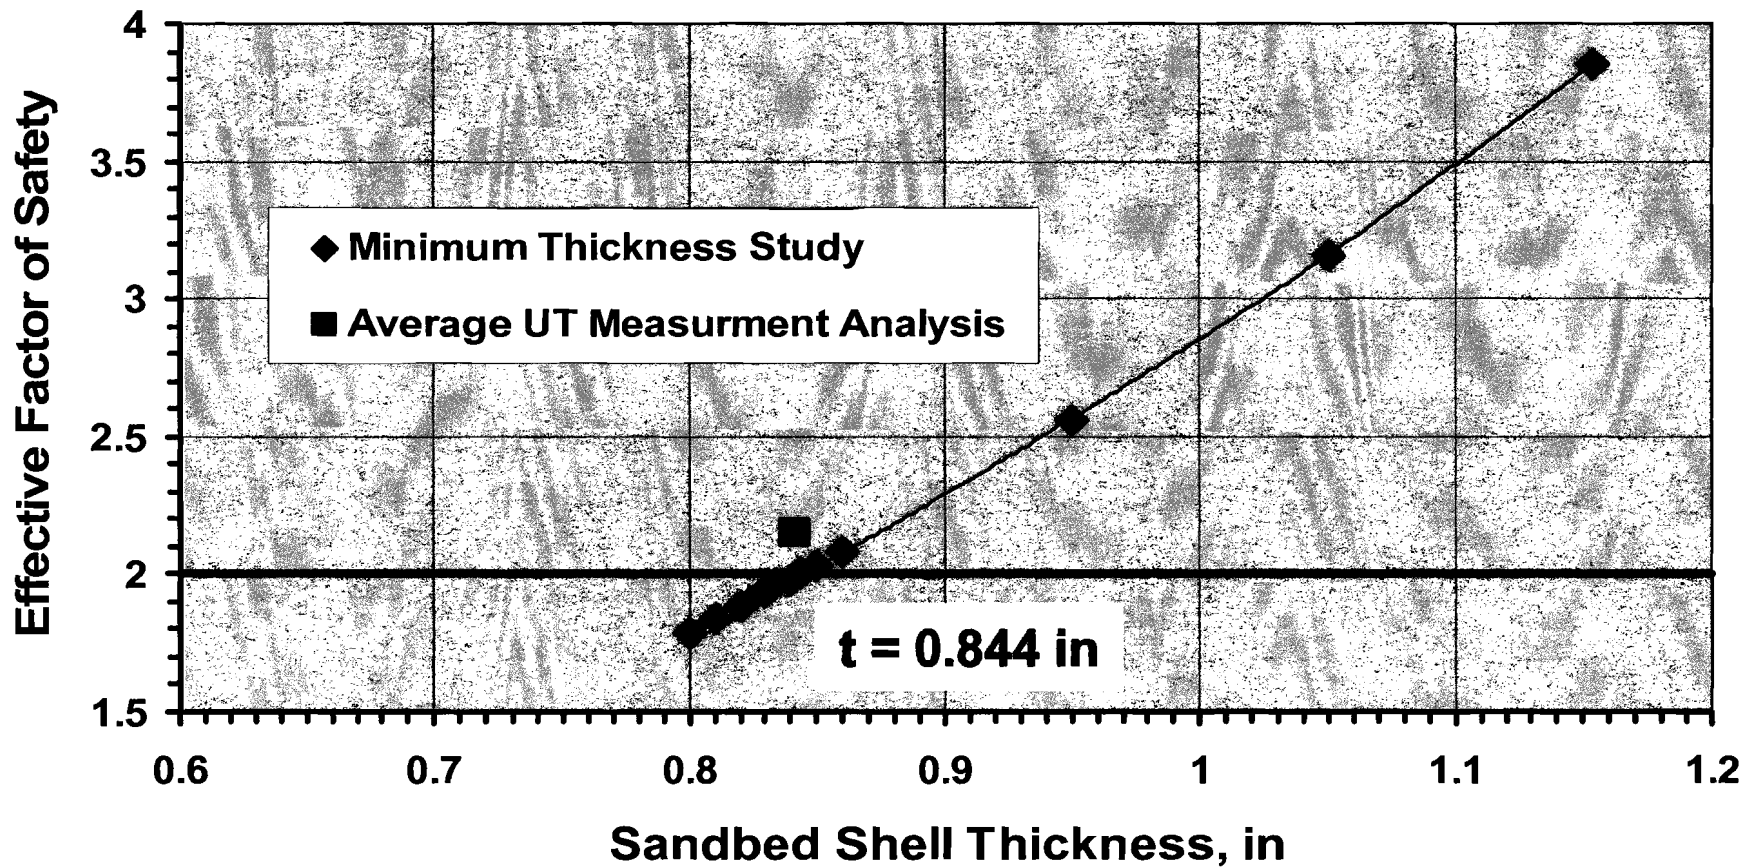
# Thicknesses Used in Lower Sphere

Sphere Equator – Elevation 37'-3"

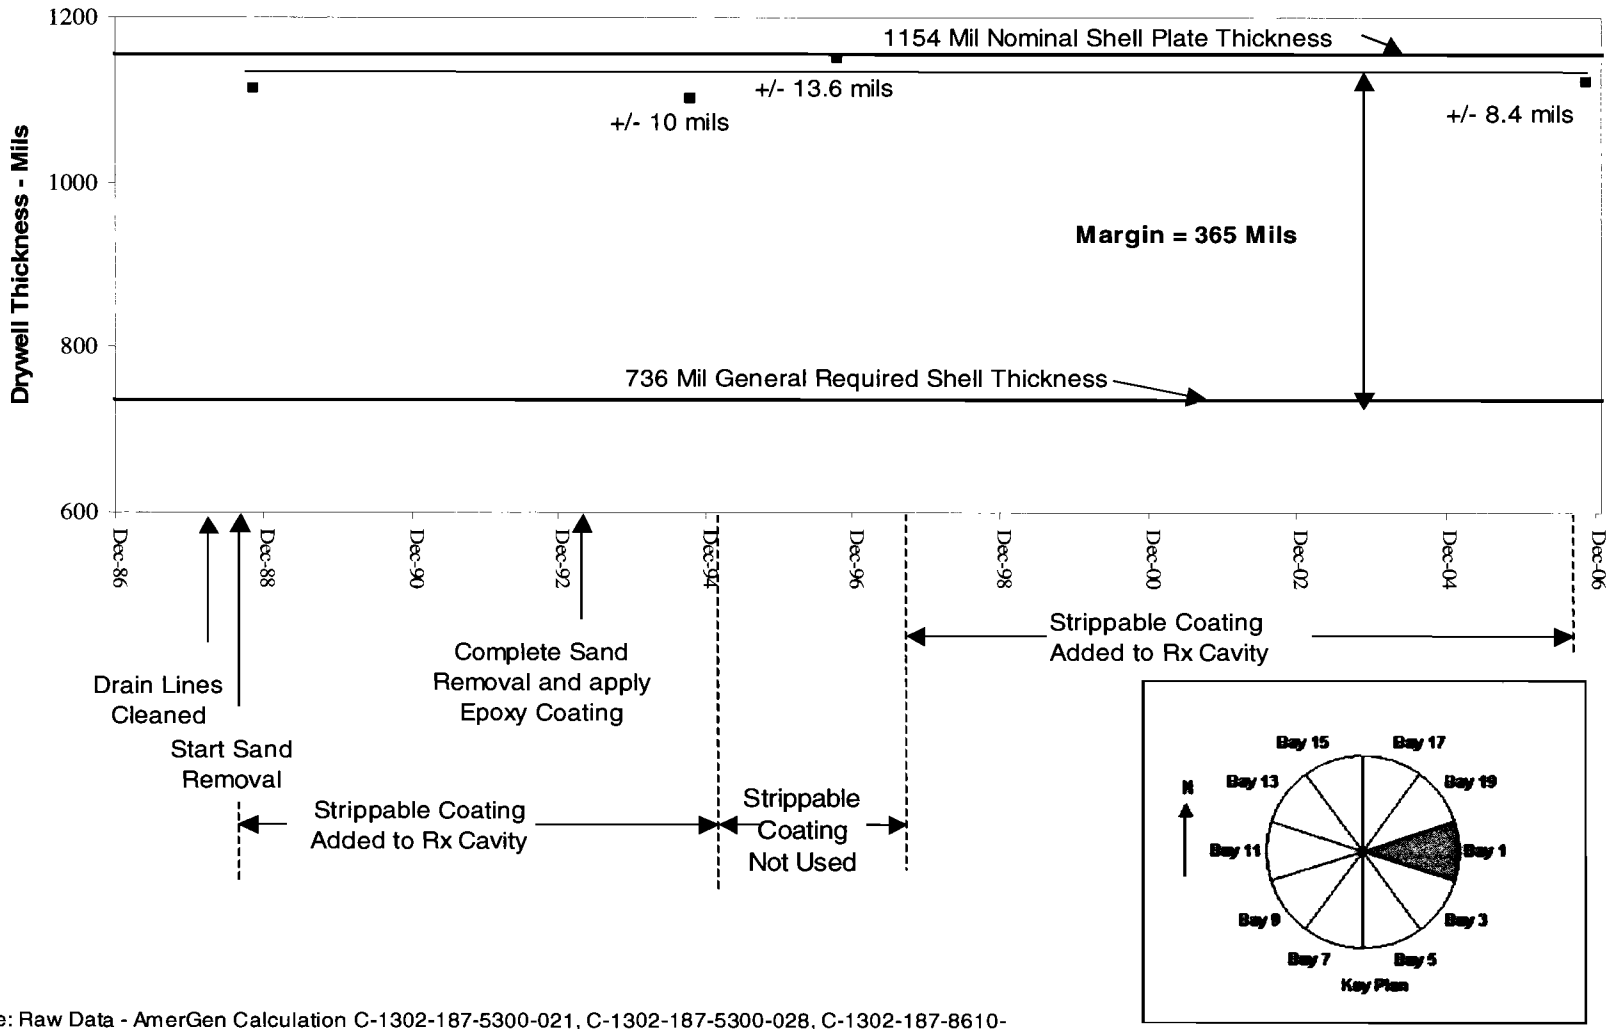
Source: Raw Data - AmerGen Calculation C-1302-187-5300-021, C-1302-187-5300-028, C-1302-187-8610-

**Figure 1. Sandbed Bay # 1D**

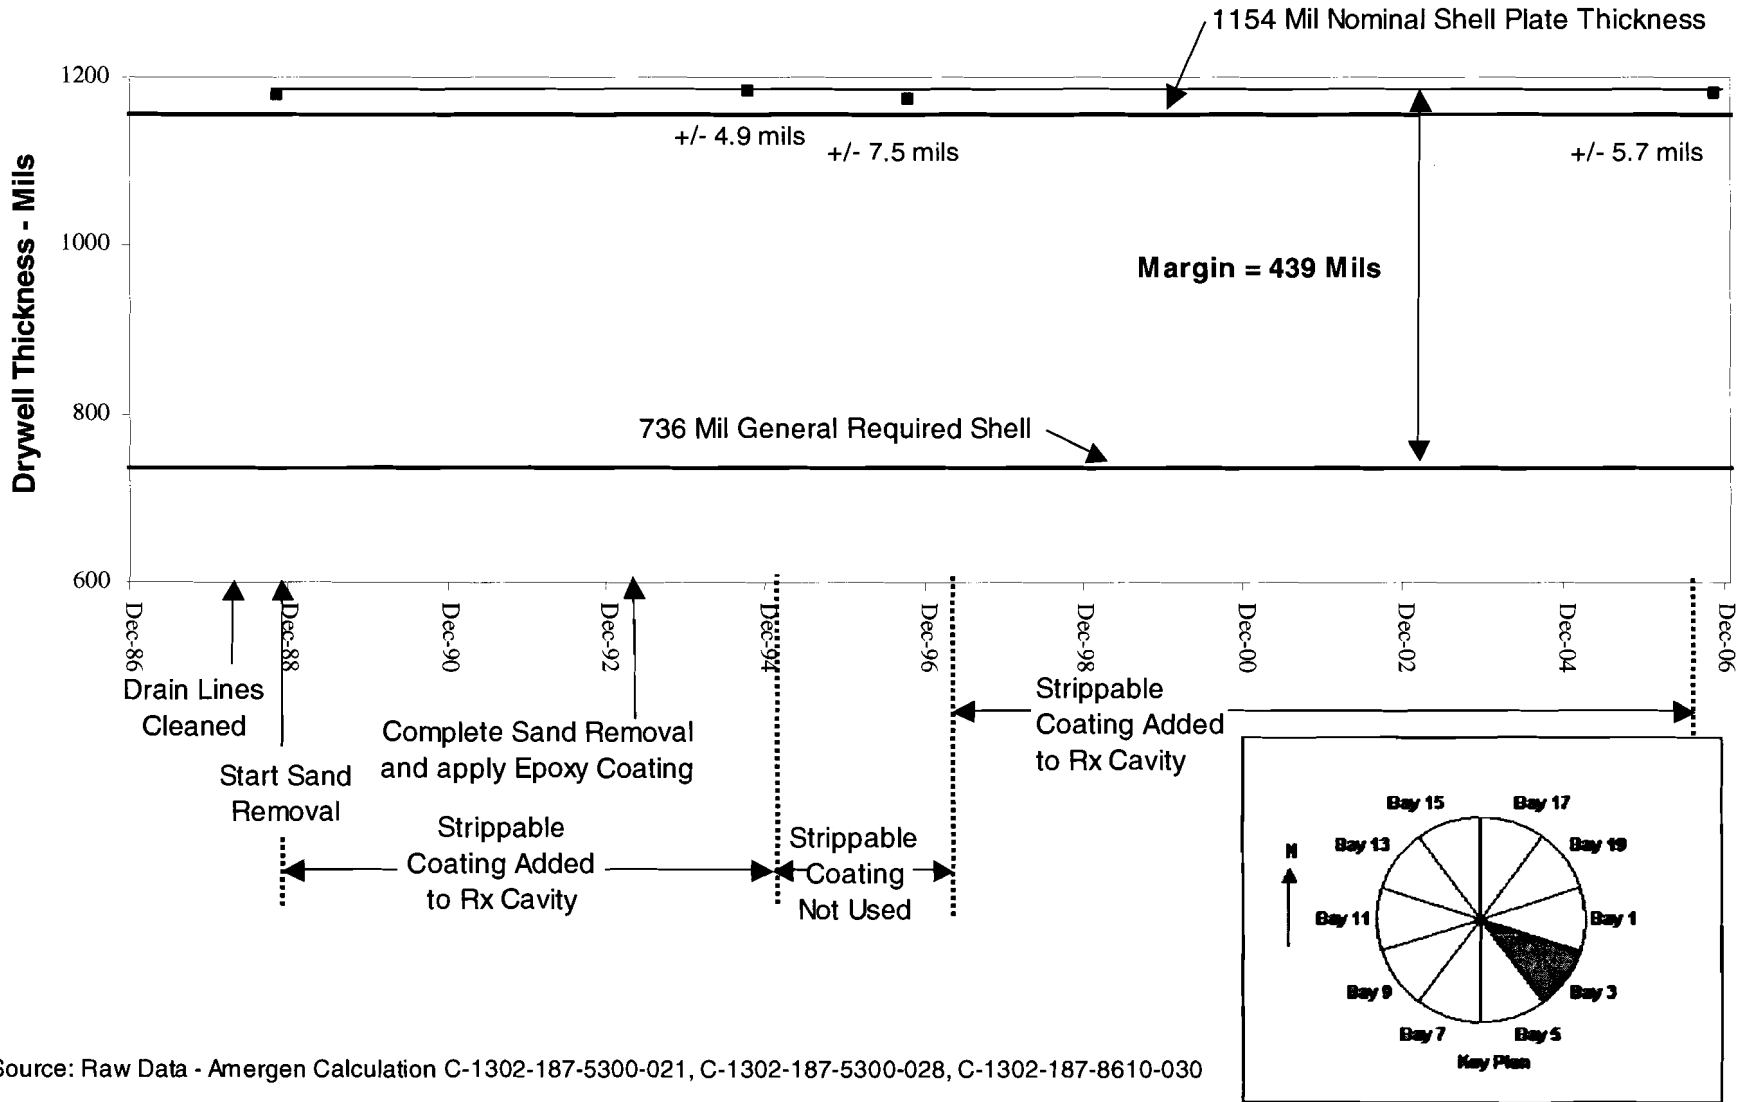
**Figure 2. Sandbed Bay #3D**

Source: Raw Data - Amergen Calculation C-1302-187-5300-021, C-1302-187-5300-028, C-1302-187-8610-030

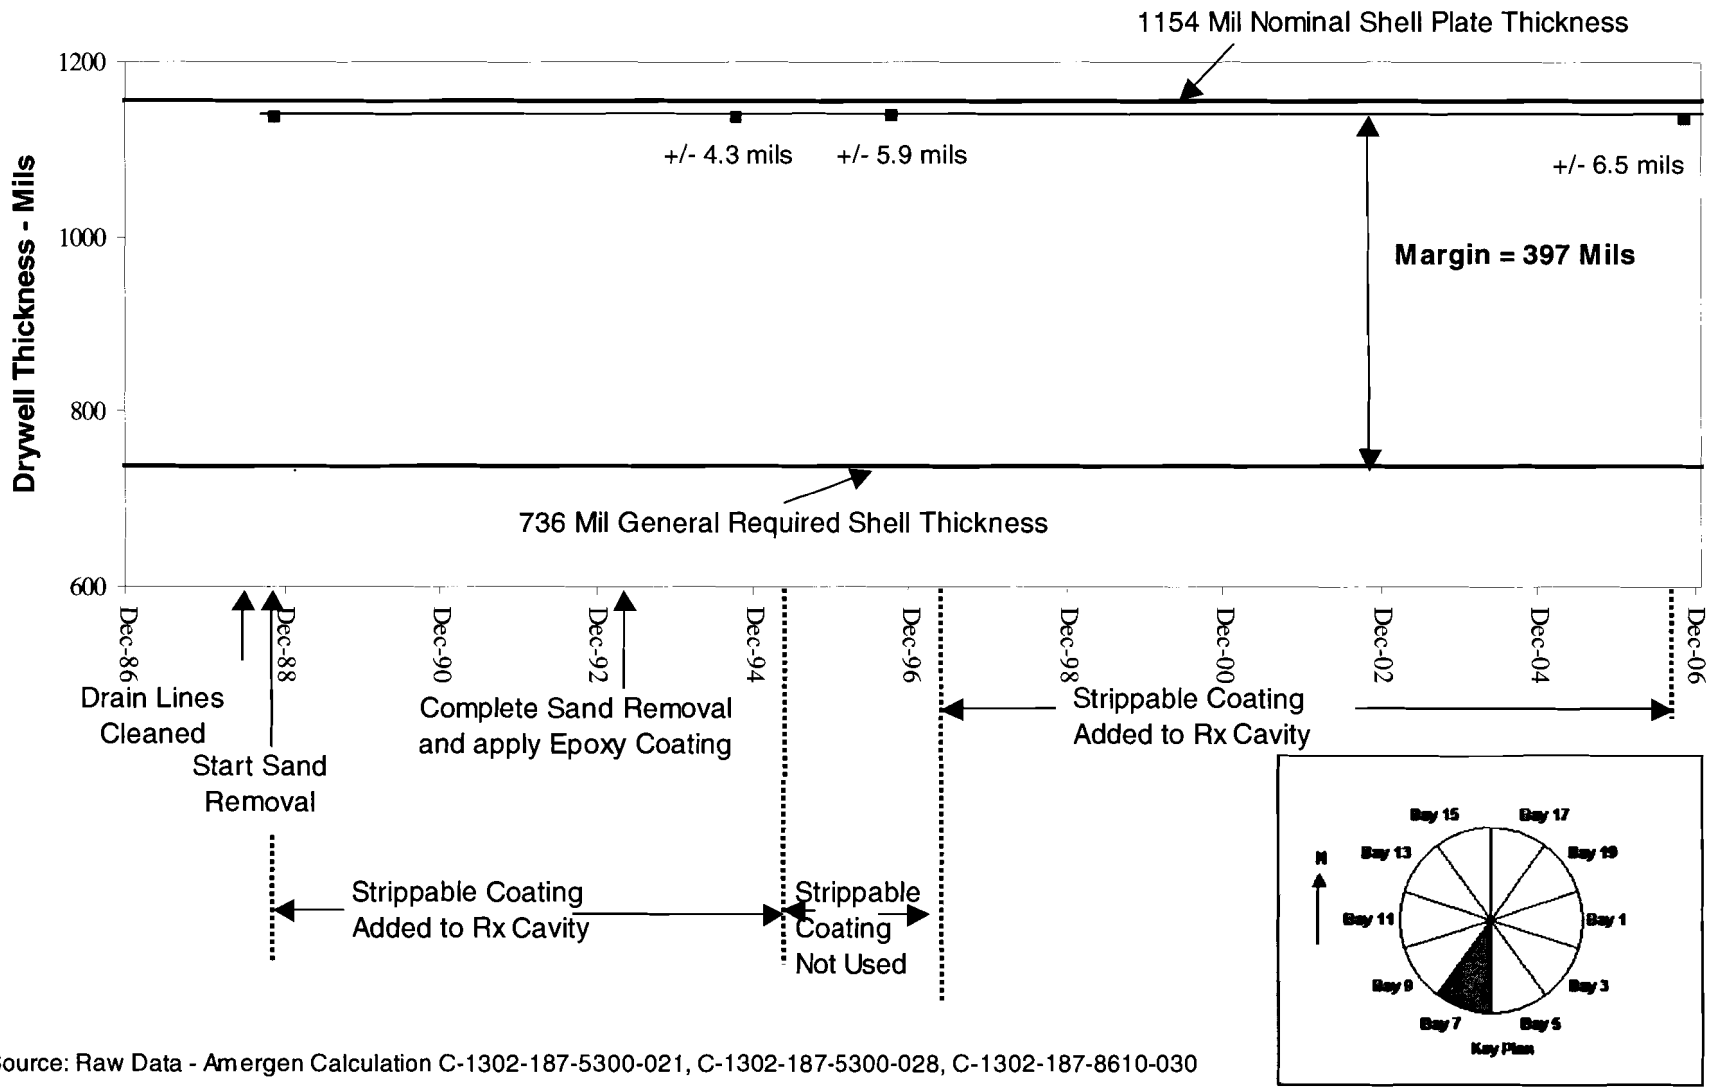
### Figure 4. Sandbed Bay # 7D

Source: Raw Data - Amergen Calculation C-1302-187-5300-021, C-1302-187-5300-028, C-1302-187-8610-030

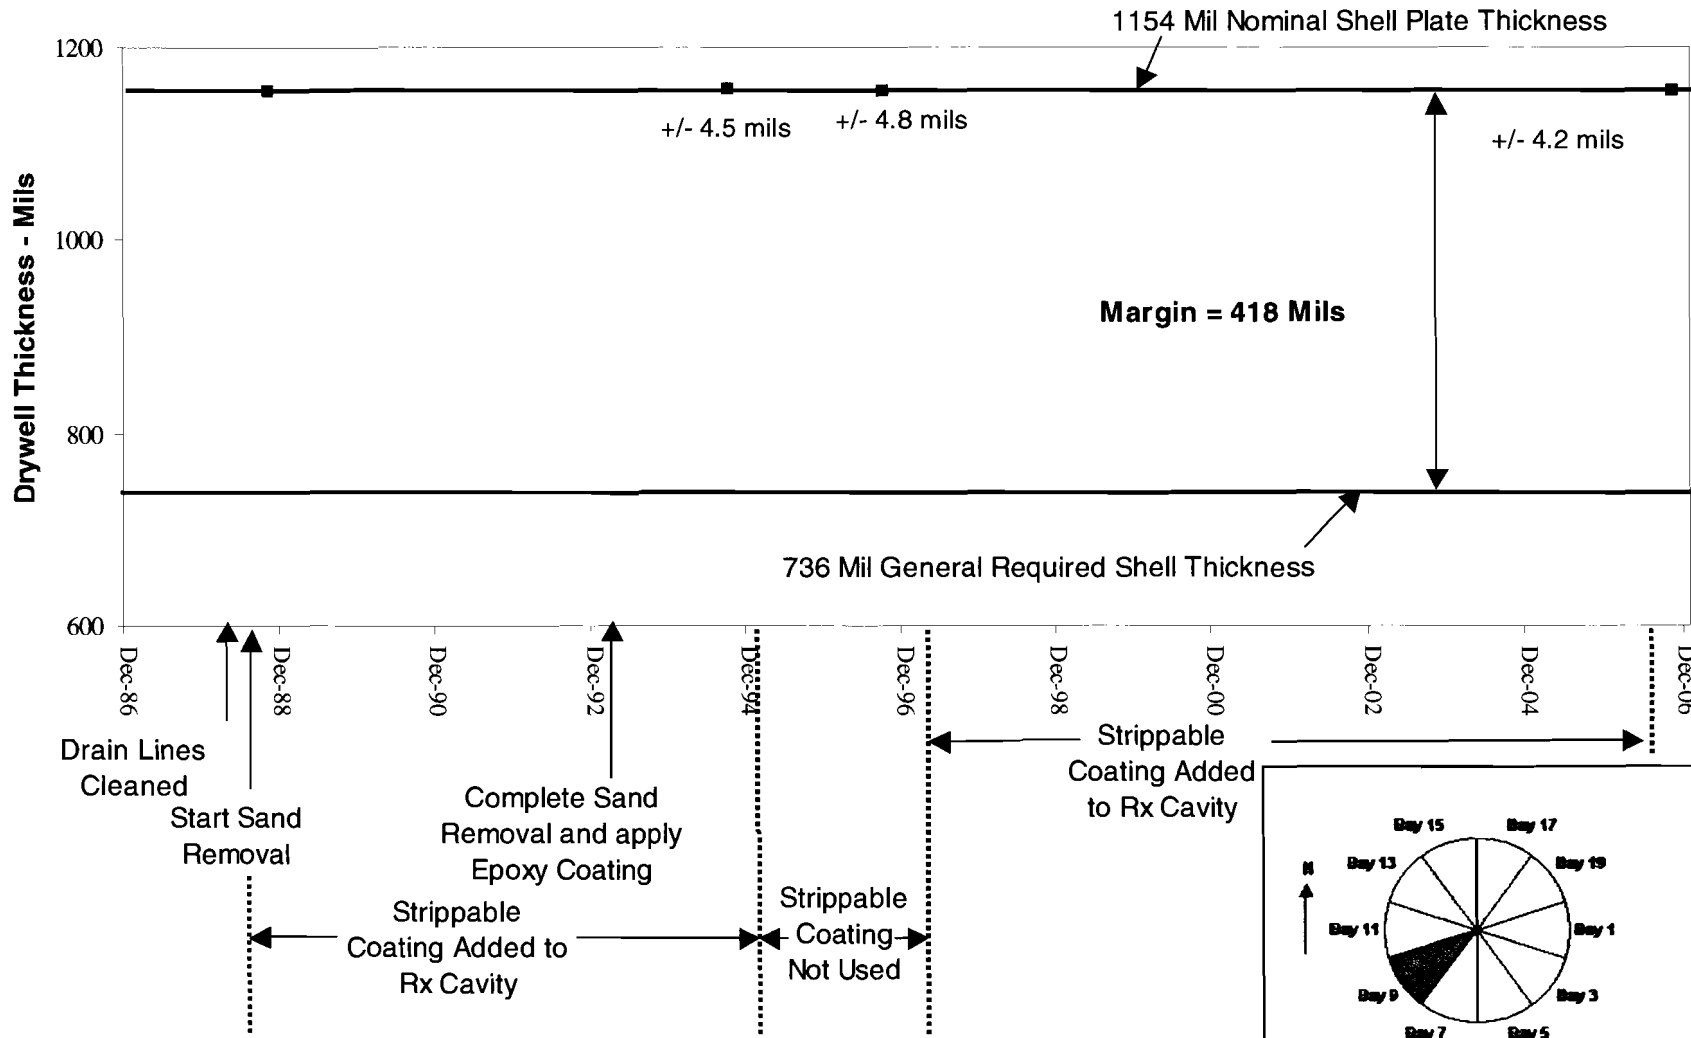
### Figure 5. Sandbed Bay # 9A

Source: Raw Data - Amergen Calculation C-1302-187-5300-021, C-1302-187-5300-028, C-1302-187-8610-030

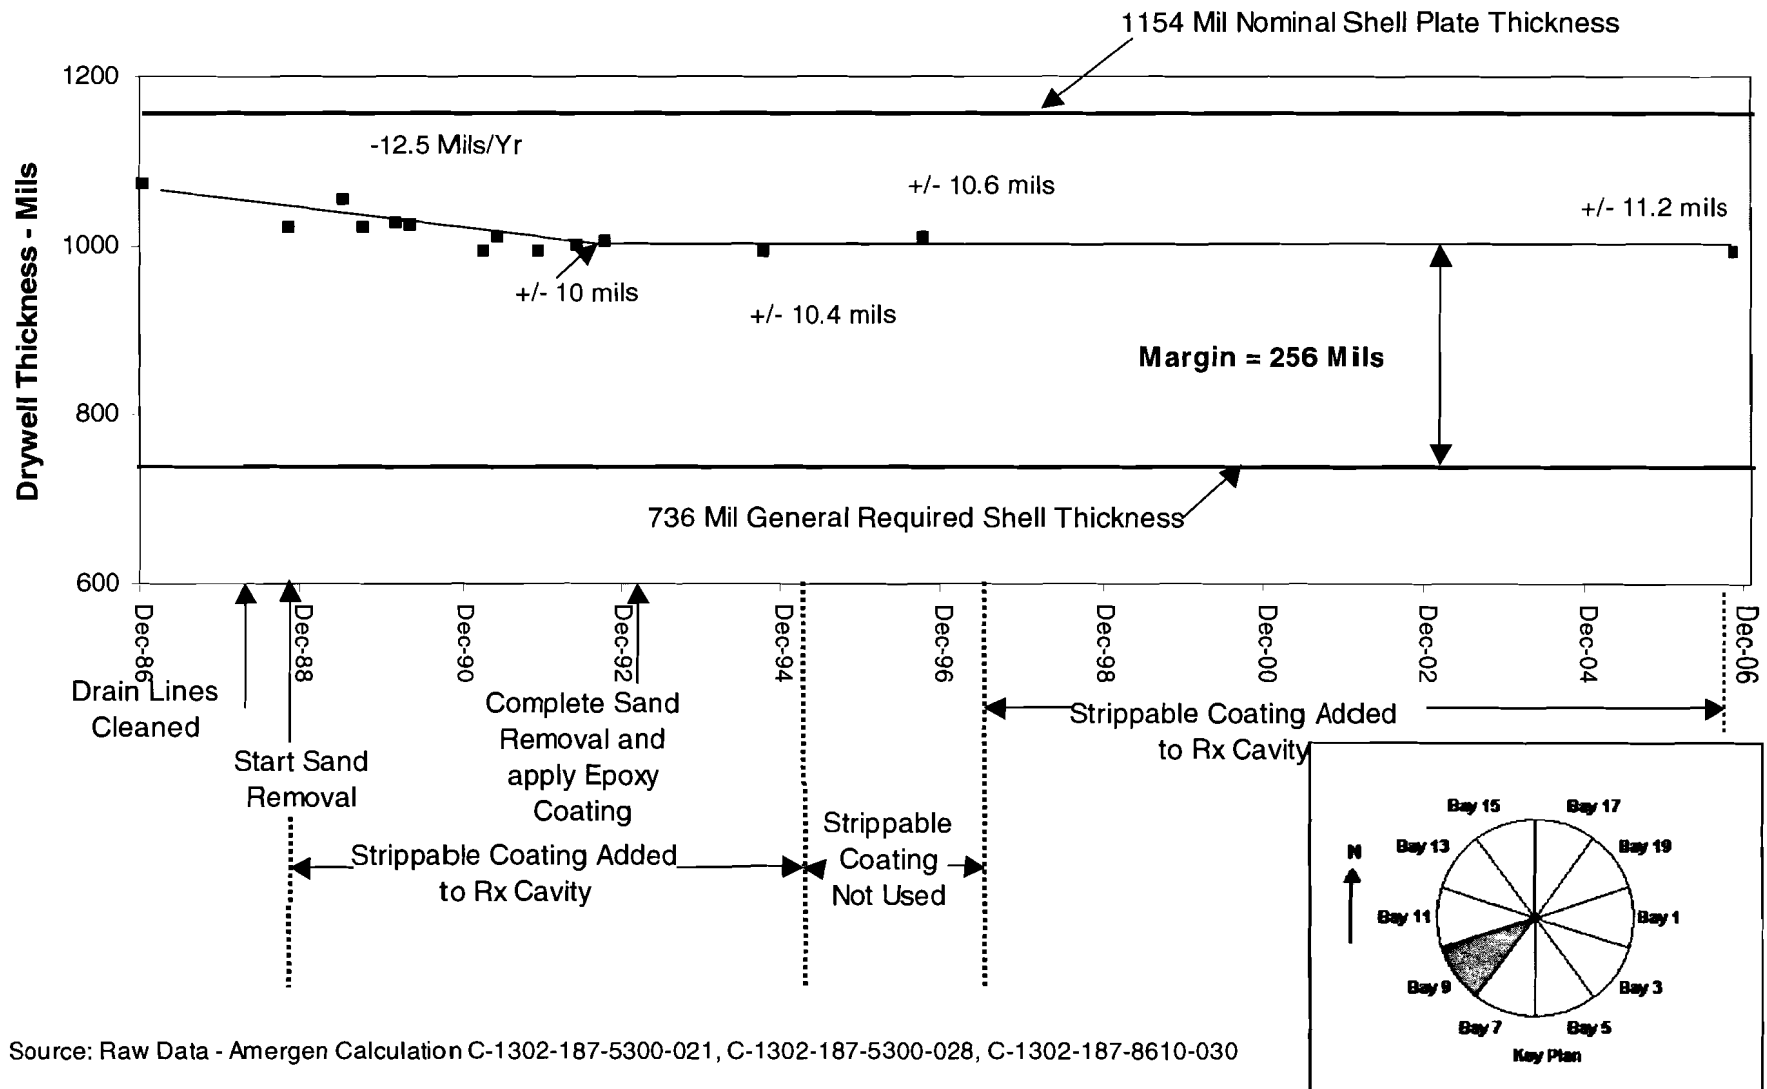
### Figure 6. Sandbed Bay # 9D

Source: Raw Data - Amergen Calculation C-1302-187-5300-021, C-1302-187-5300-028, C-1302-187-8610-030

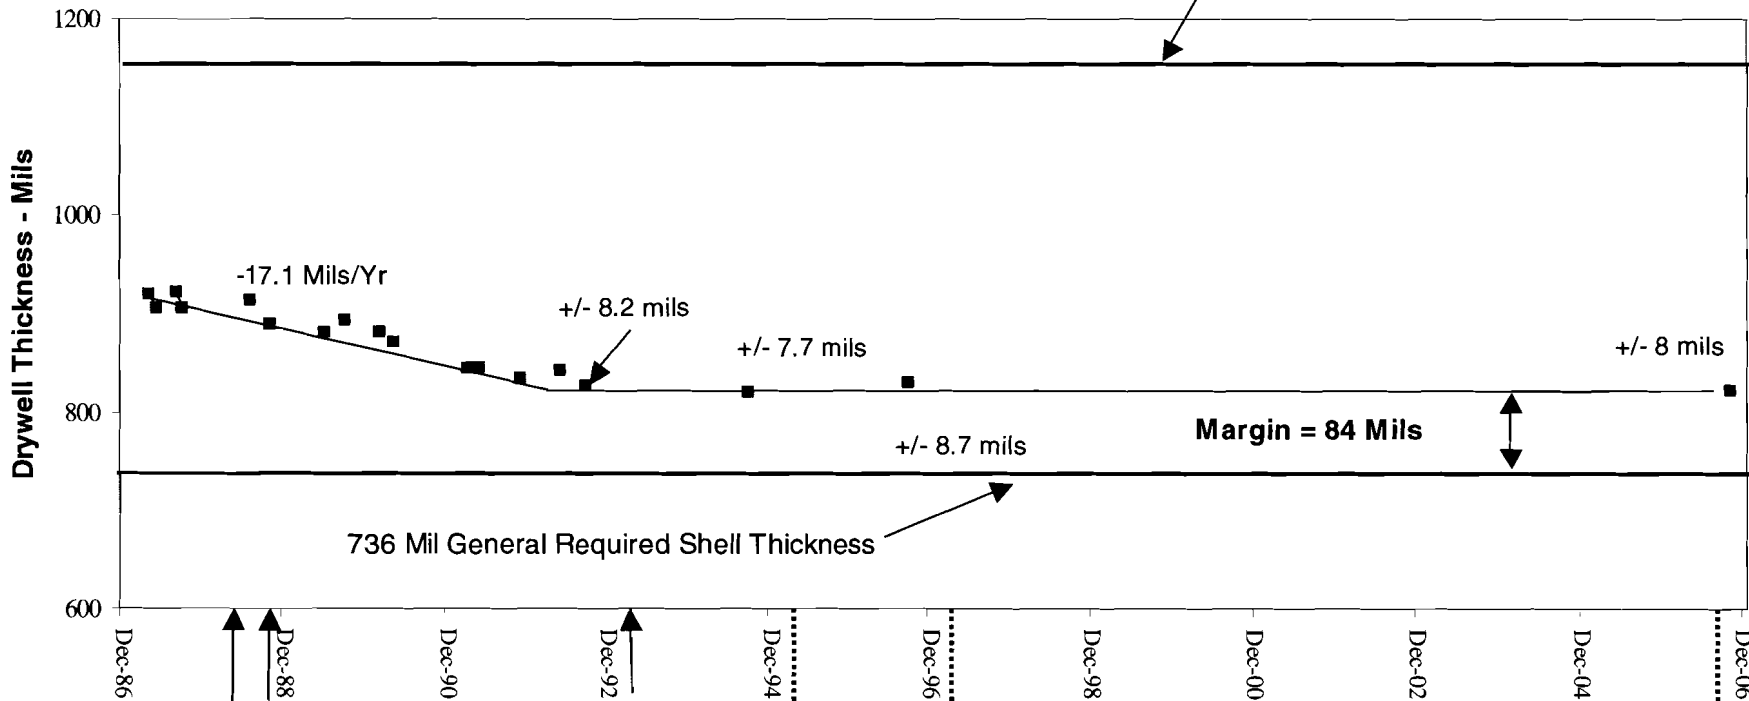
**Figure 7. Sandbed Bay #11A**

1154 Mil Nominal Shell Plate Thickness

Drain Lines Cleaned  
 Start Sand Removal  
 Complete Sand Removal and apply Epoxy Coating  
 Strippable Coating Added to Rx Cavity  
 Strippable Coating Not Used  
 Strippable Coating Added to Rx Cavity

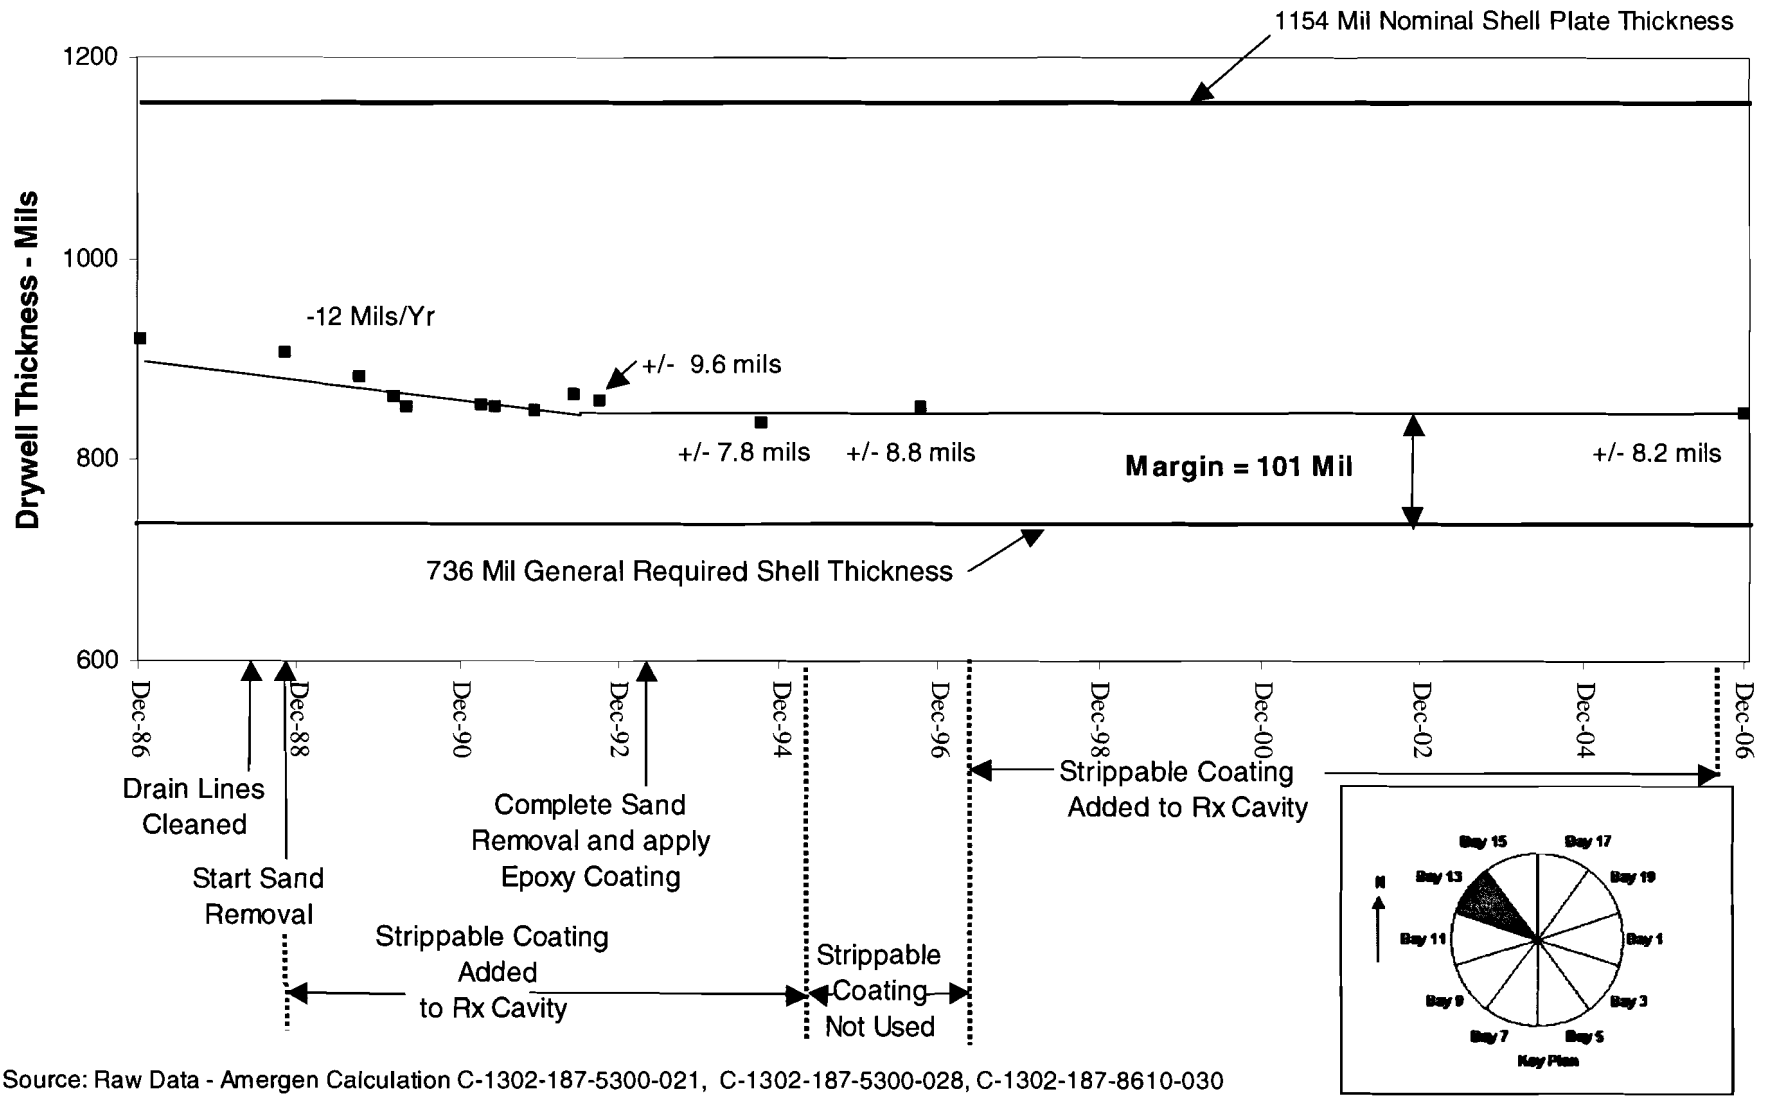
### Figure 10. Sandbed Bay #13A

Source: Raw Data - Amergen Calculation C-1302-187-5300-021, C-1302-187-5300-028, C-1302-187-8610-030
