SUBJECT: CERTIFICATION OF THE MINUTES OF THE ACRS SUBCOMMITTEE  
MEETING ON THE OYSTER CREEK GENERATING STATION LICENSE  
RENEWAL APPLICATION, JANUARY 18, 2007 - ROCKVILLE,  
MARYLAND

## Unresolved Problems With Drywell Corrosion

# **Structural Integrity Analysis of the Degraded Drywell Containment at Oyster Creek**

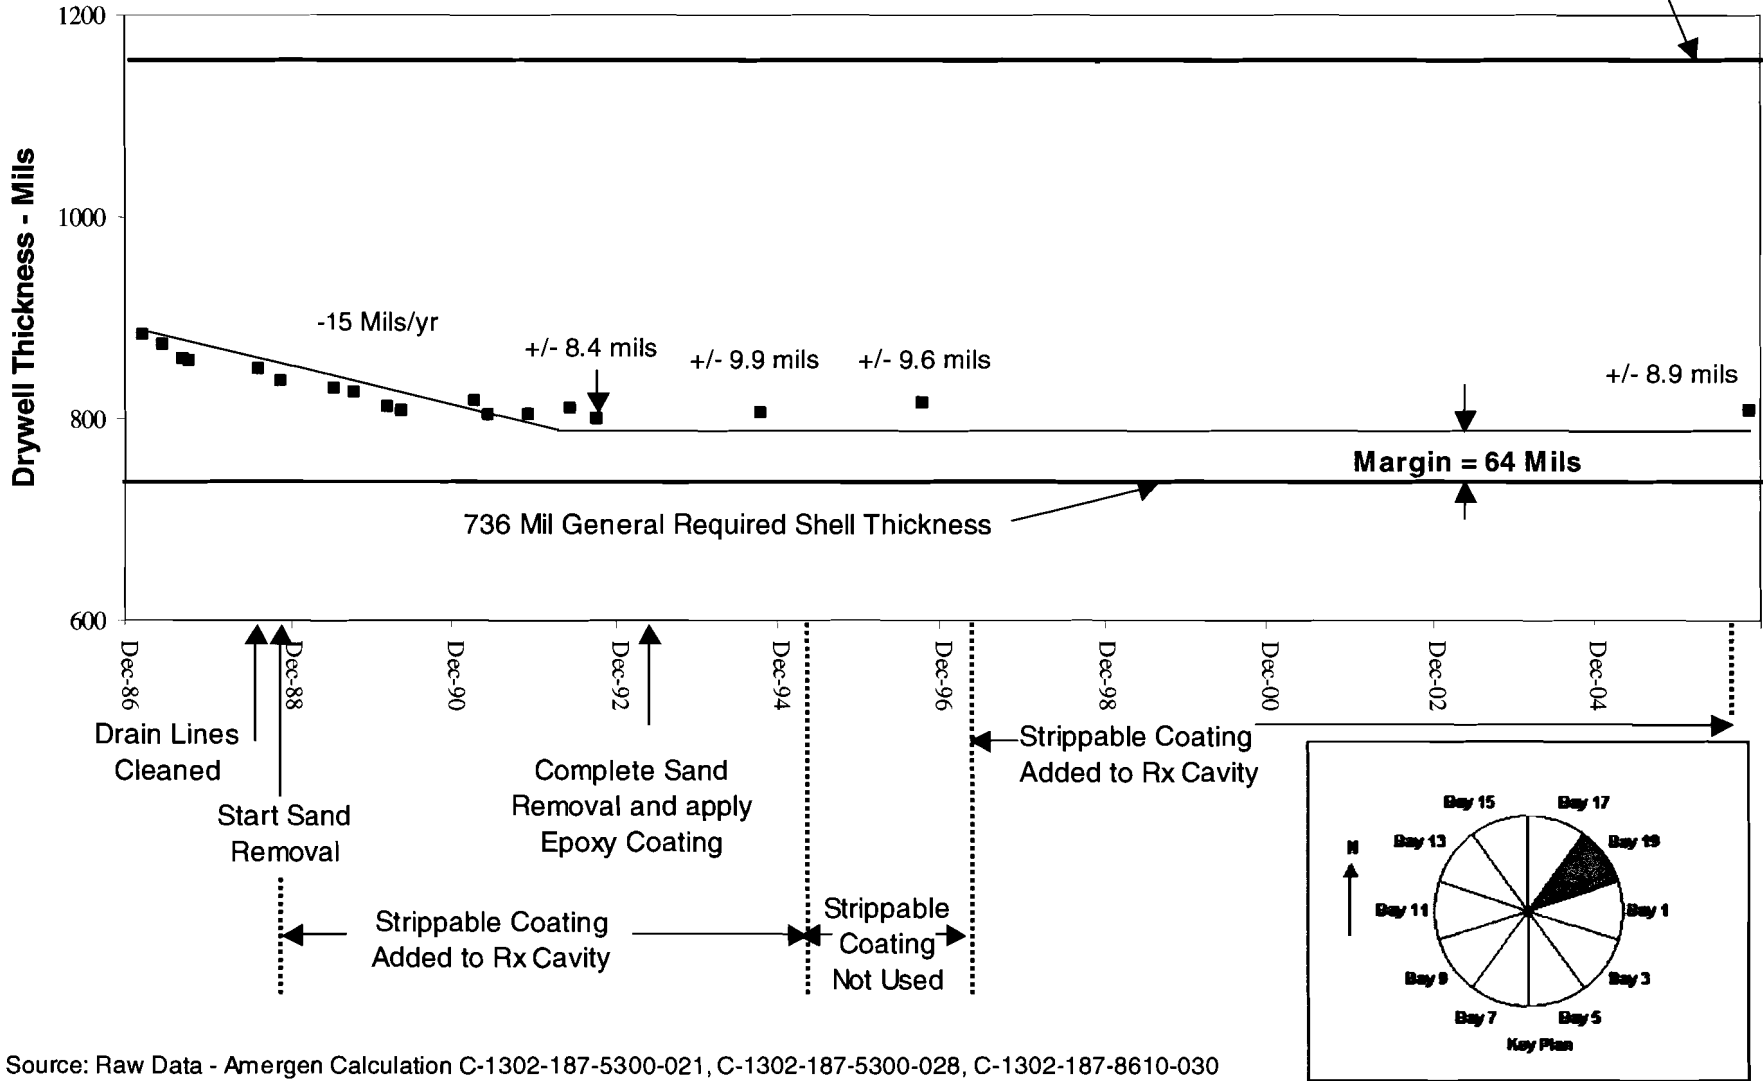
**Figure 21 Sandbed Bay # 19A**

Source: Raw Data - Amergen Calculation C-1302-187-5300-021, C-1302-187-5300-028, C-1302-187-8610-030

1154 Mil Nominal Shell Plate Thickness

### Figure 21 Sandbed Bay # 19A

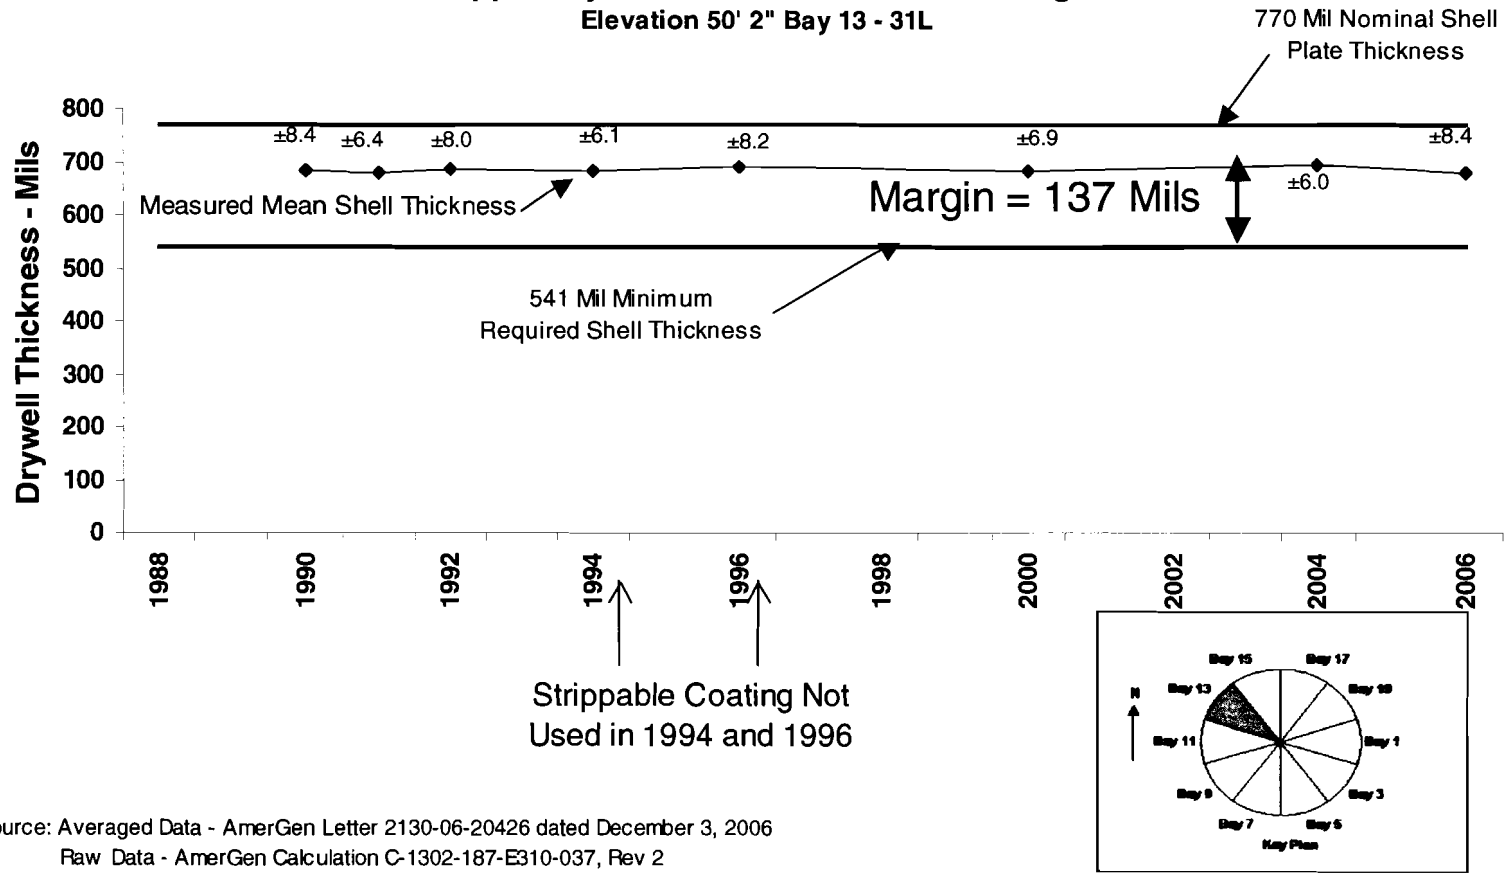
**5. Upper Drywell Corrosion Trend and Margin**  
 Elevation 50' 2" Bay 13 - 31L

Source: Averaged Data - AmerGen Letter 2130-06-20426 dated December 3, 2006  
 Raw Data - AmerGen Calculation C-1302-187-E310-037, Rev 2

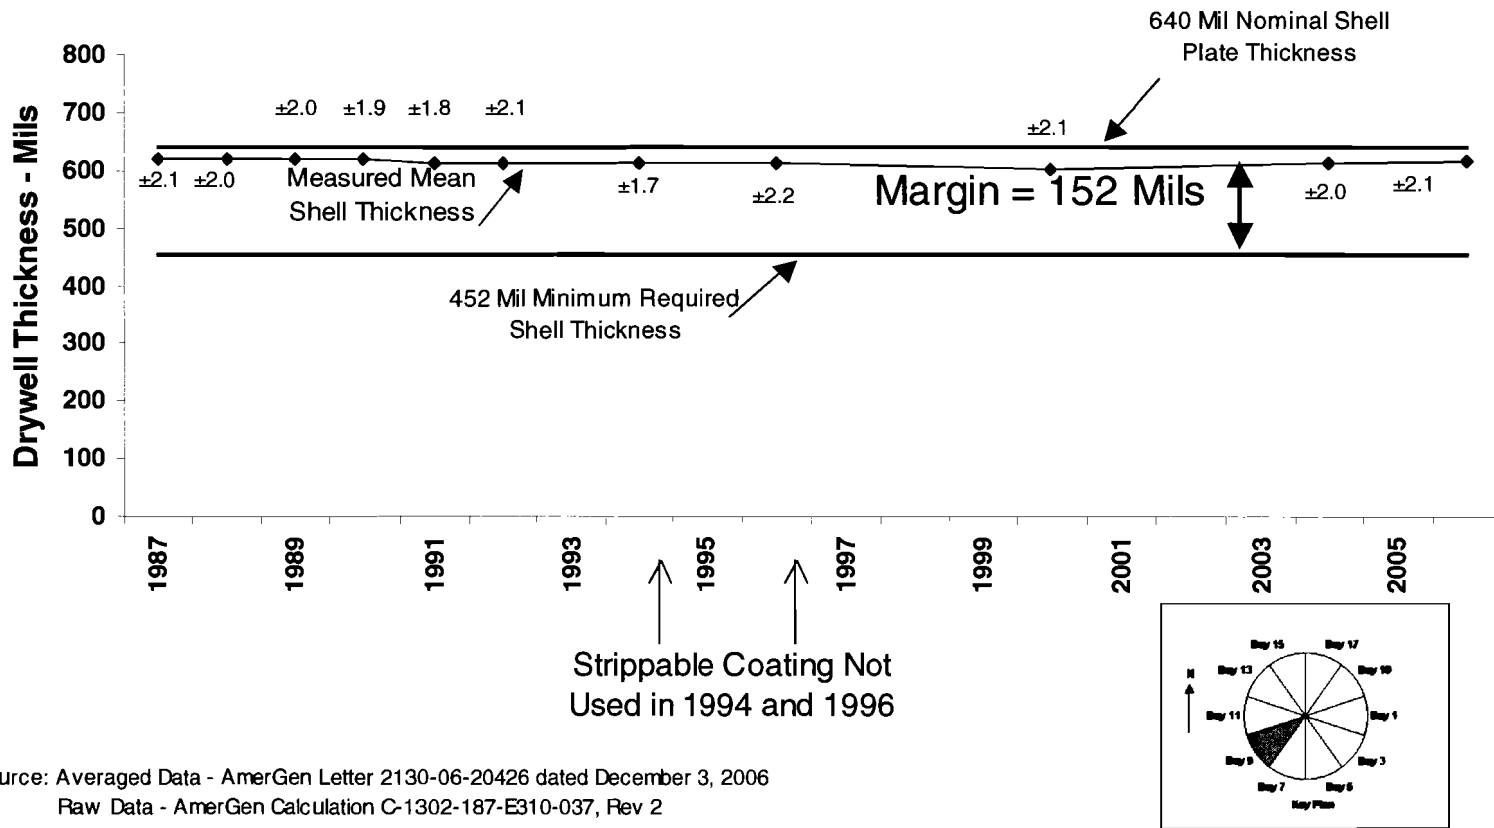
### 11. Upper Drywell Corrosion Trend and Margin

Elevation 87' 5" Bay 9 - 20

Source: Averaged Data - AmerGen Letter 2130-06-20426 dated December 3, 2006  
 Raw Data - AmerGen Calculation C-1302-187-E310-037, Rev 2

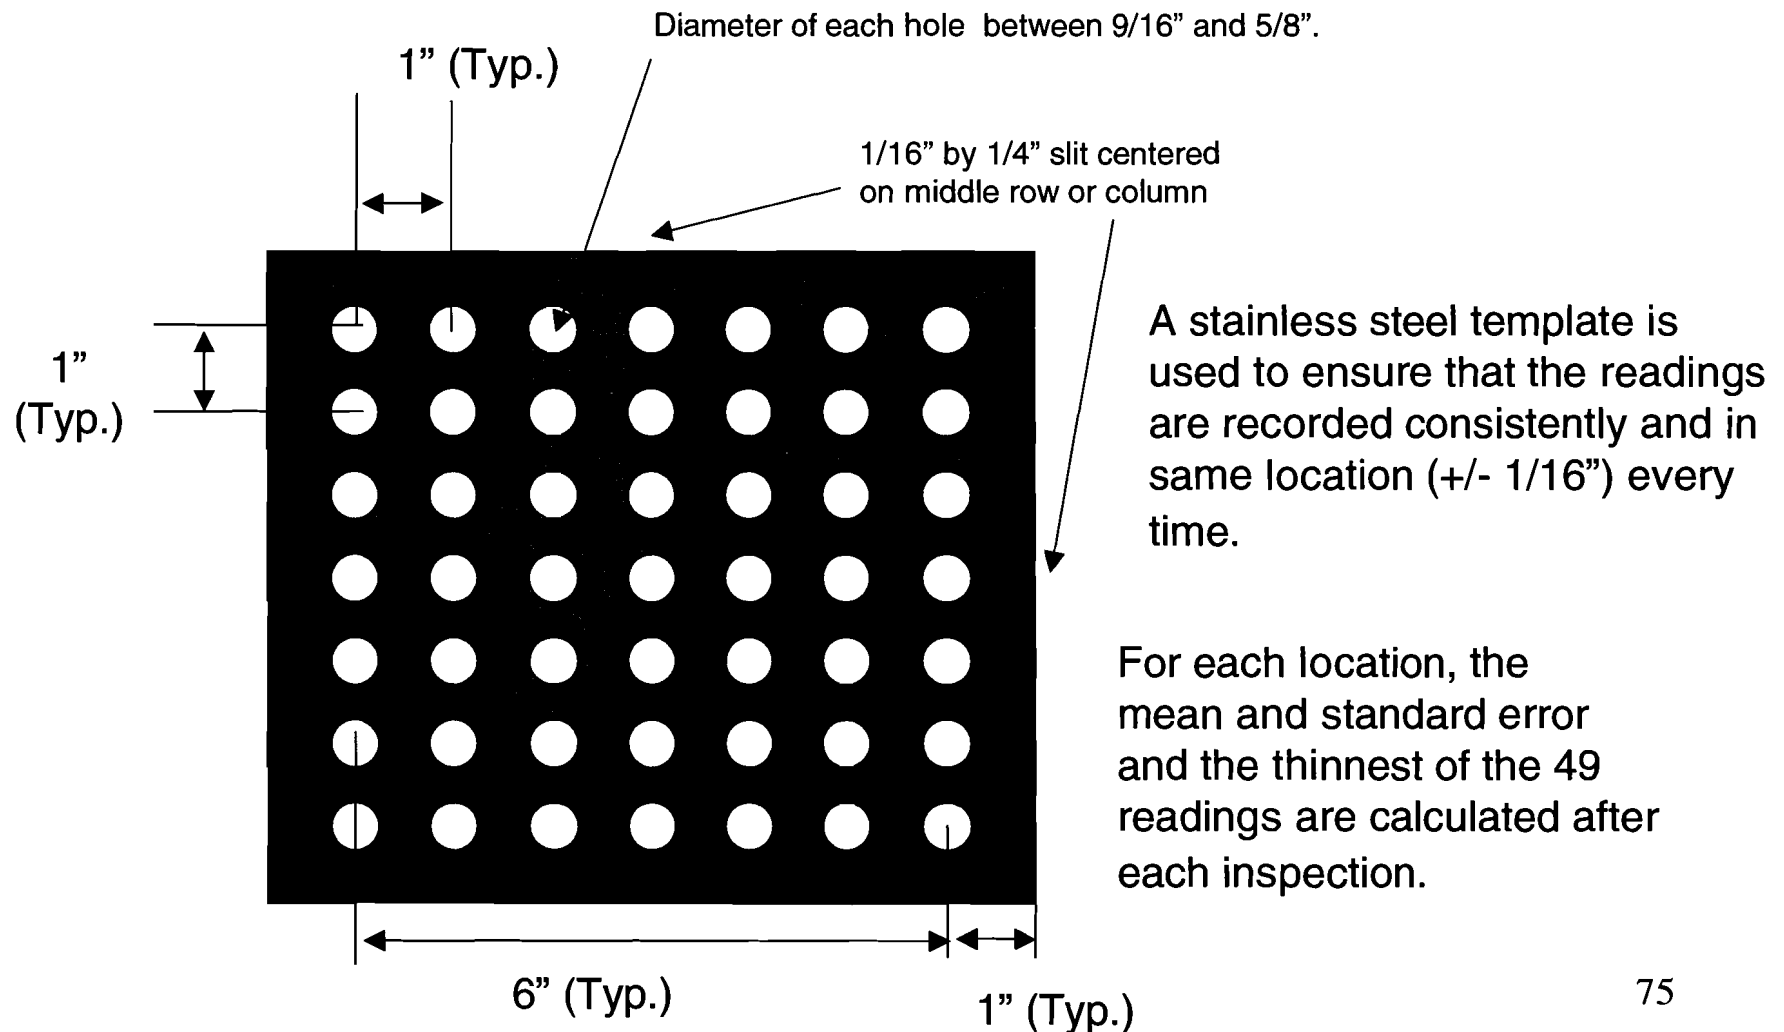
- Measurement locations are marked on the inside of the drywell shell
- Use a stainless steel template with 49 holes to align the UT probe
- UT probe placed perpendicular to the surface to consistently obtain lowest reading
- A protective grease is applied to the 6"x6" grid during operation, and removed to take UT measurements

49 UT readings are recorded over a 6" by 6" area.

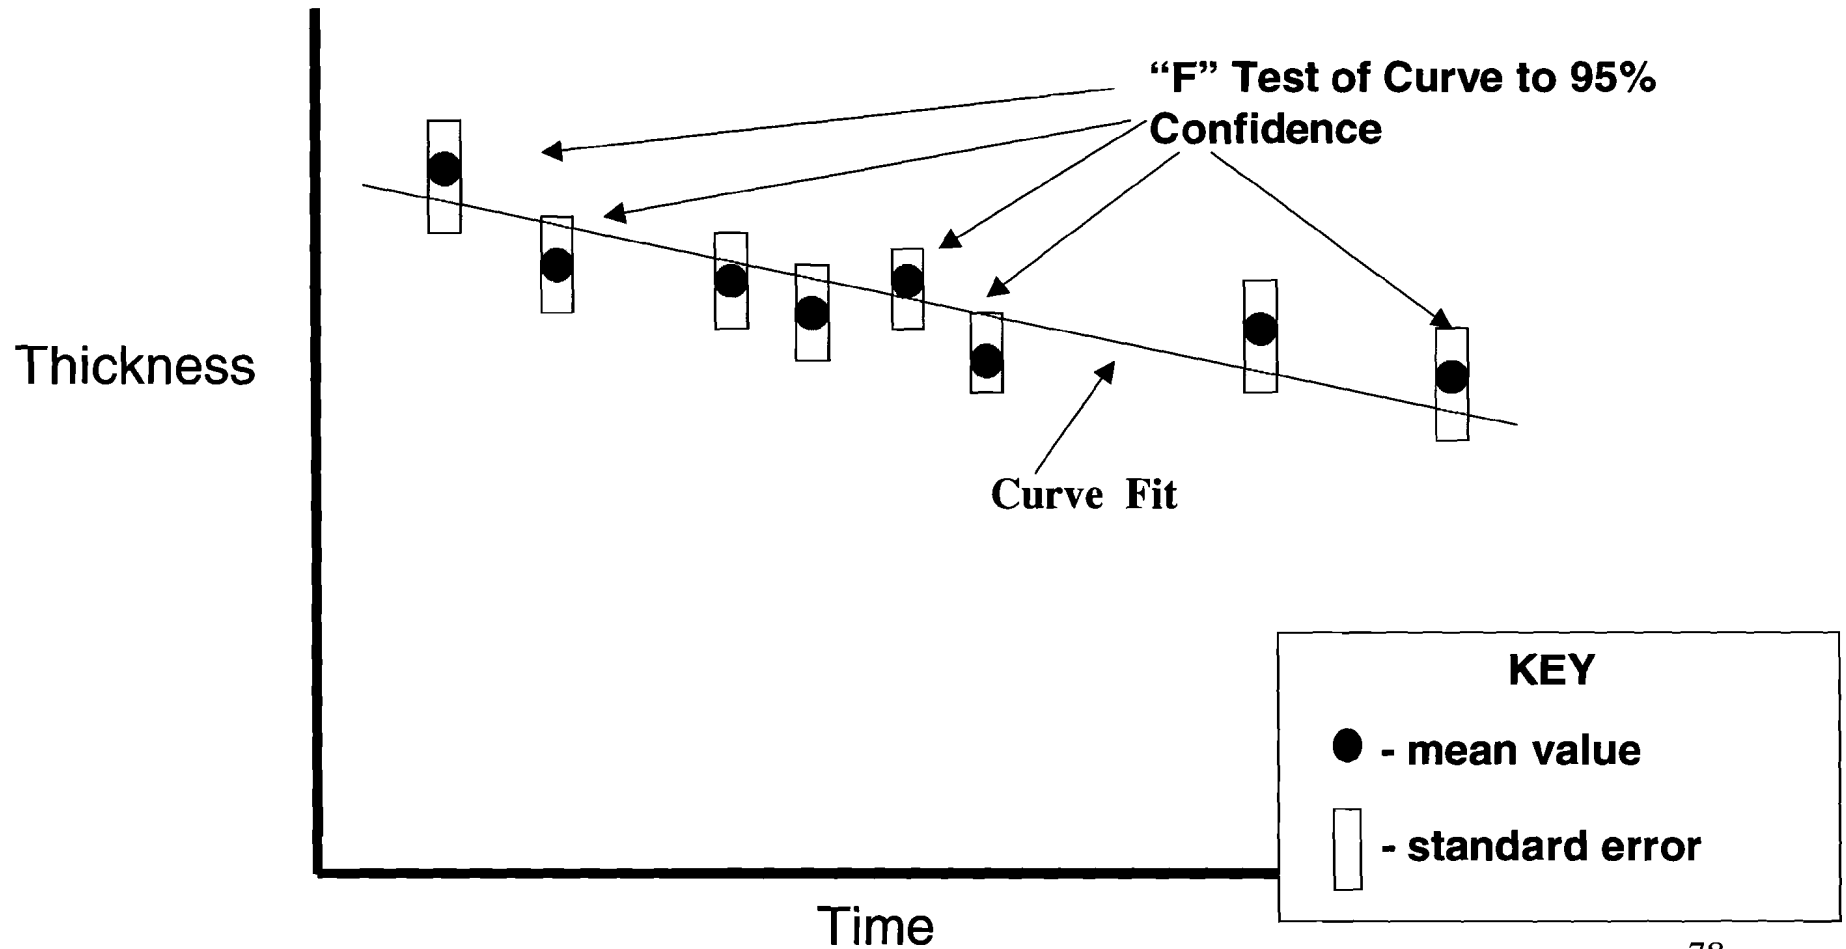
1) A curve fit based on the regression model is then developed.

2) The Corrosion "F" Test is performed to determine if the data meet the curve fit with 95% confidence.

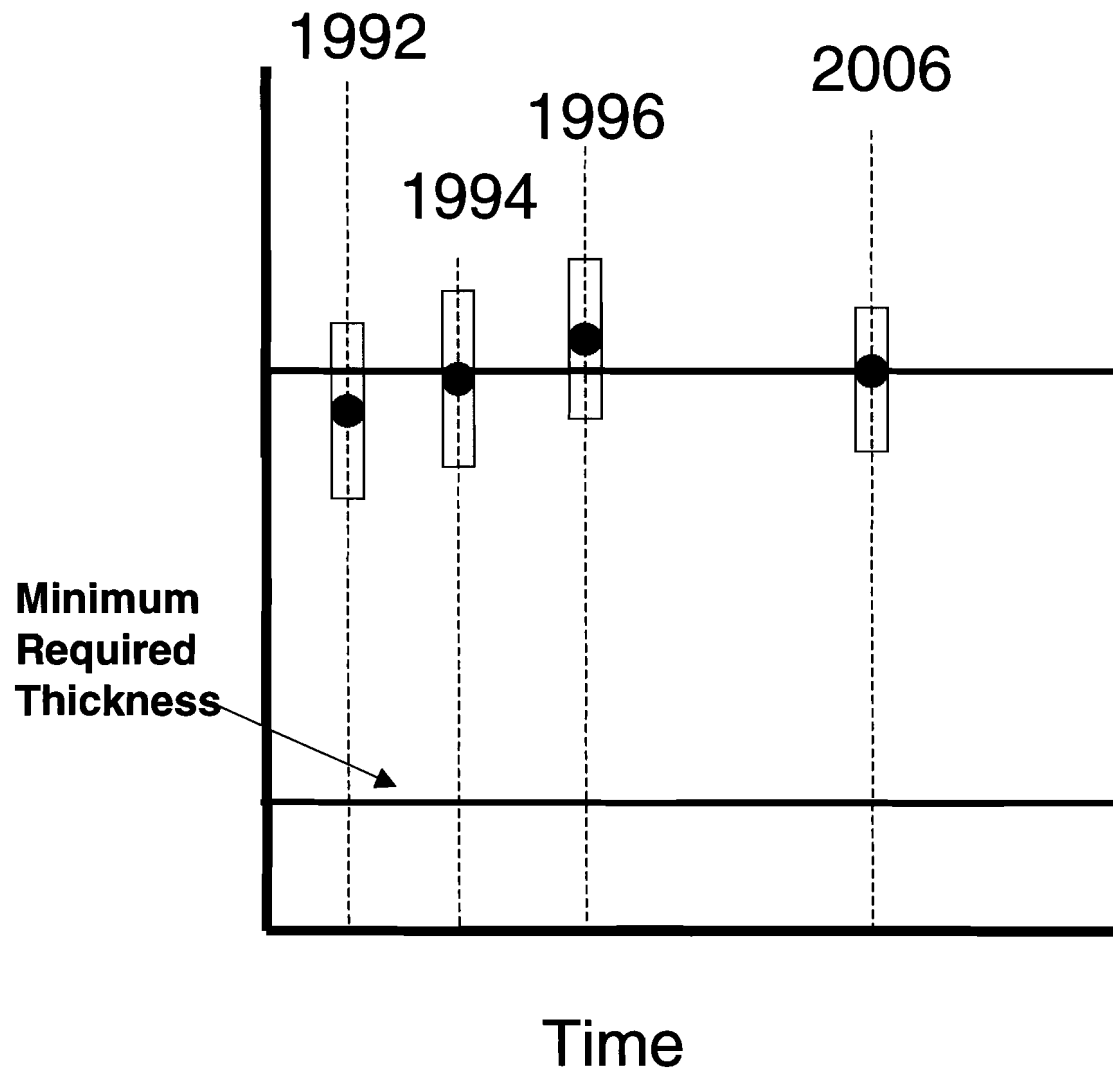
# 2006 Sand Bed Data Summary

In the case of the 2006 sand bed inspections, there are only 4 inspections per location with most standard errors between +/- 8 and +/-16 mils

There are not enough inspections to satisfy the Corrosion Test F test with 95% confidence.

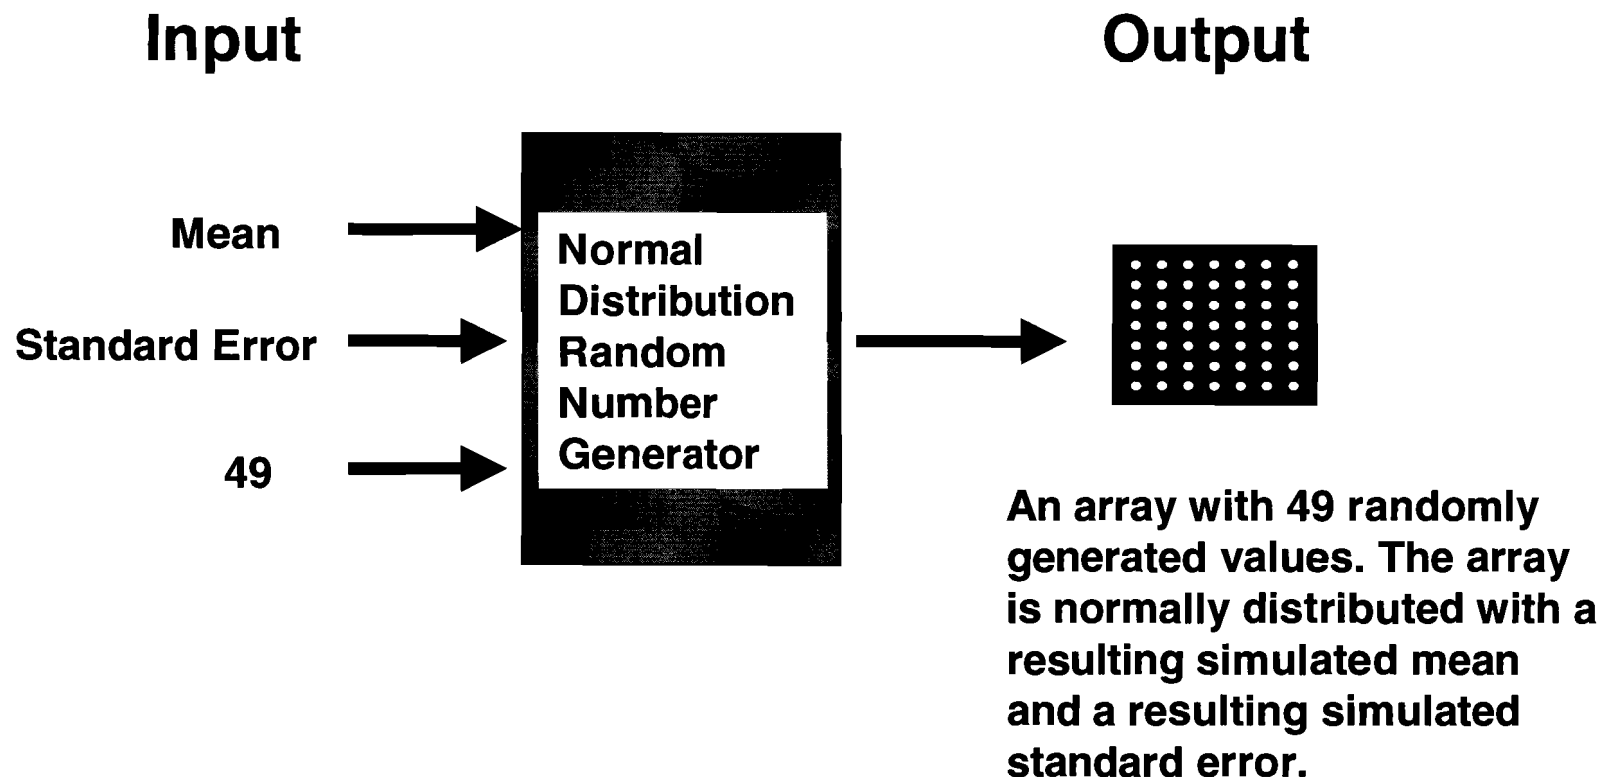
The simulation used a random number generator based on the normal distribution

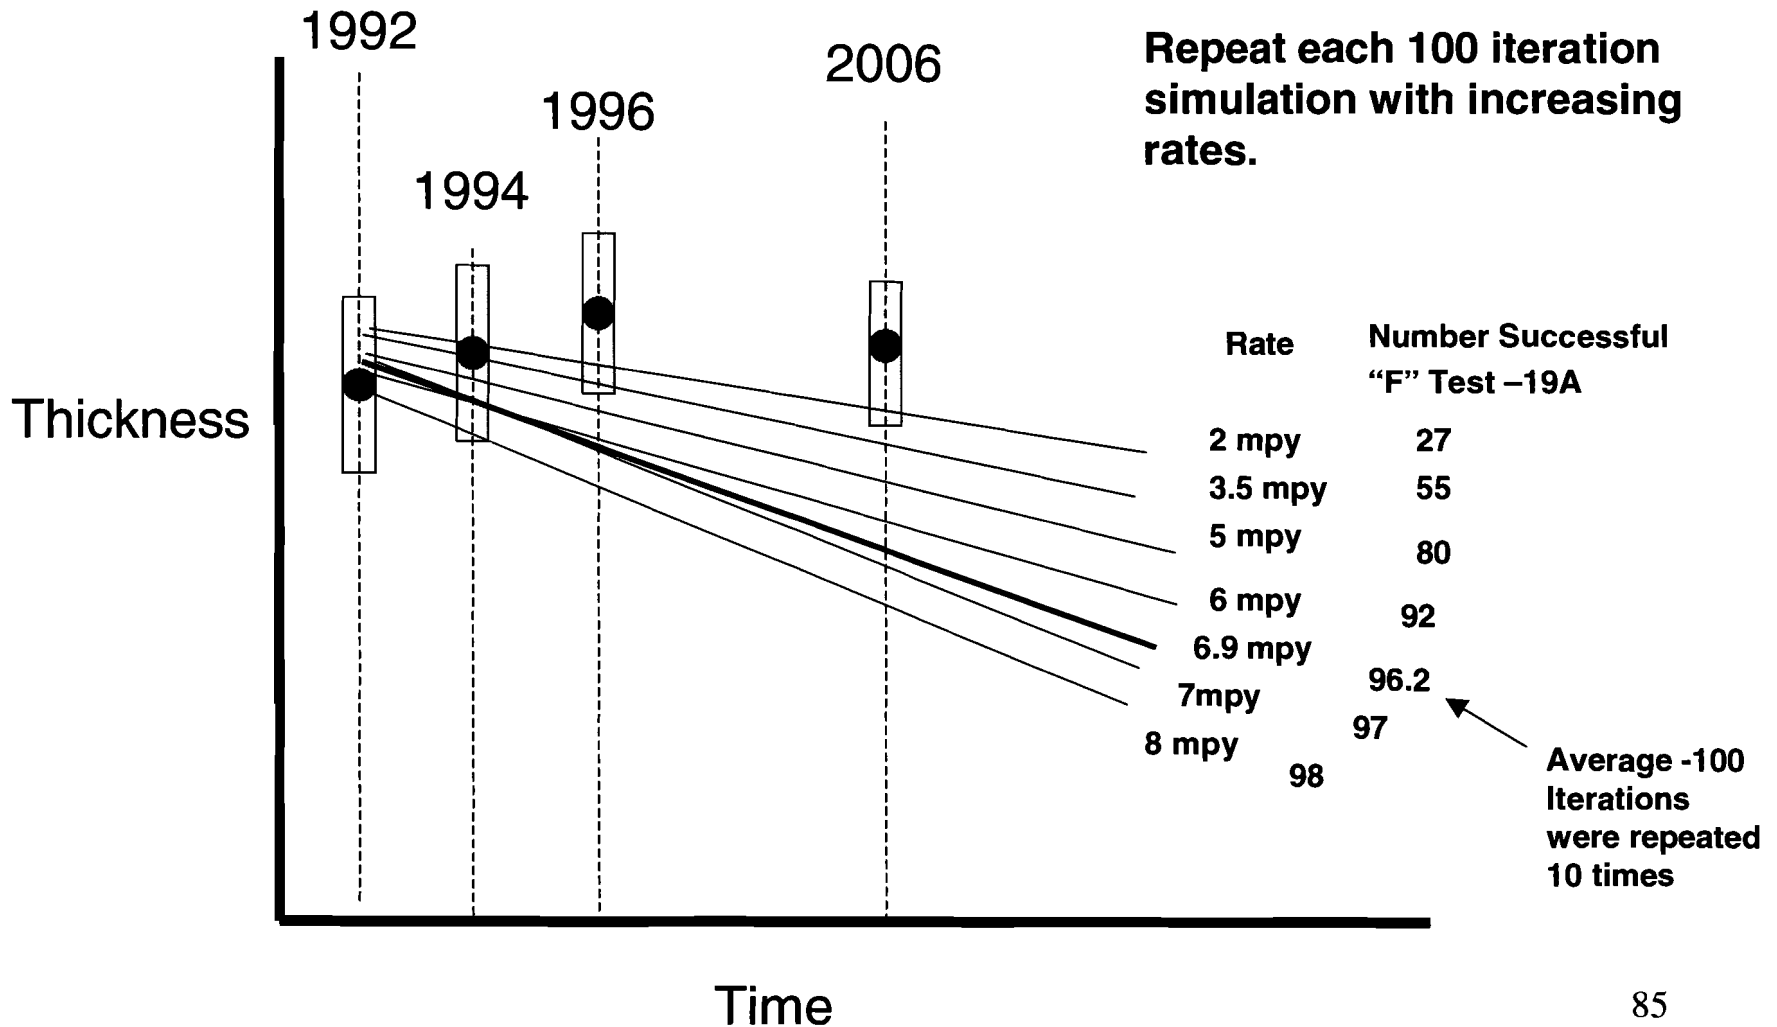
## Simulation – Minimum Observable Corrosion Rate

The minimum rate which consistently passes the Corrosion “F” Tests 95 out of 100 times is the Minimum Observable Corrosion Rate.
