UNITED STATES  
NUCLEAR REGULATORY COMMISSION  
ATOMIC SAFETY AND LICENSING BOARD

In the Matter of	)	
	)	
ENTERGY NUCLEAR VERMONT YANKEE, LLC	)	Docket No. 50-271-LR
and ENTERGY NUCLEAR OPERATIONS, INC.	)	ASLBP No. 06-849-03-LR
	)	
(Vermont Yankee Nuclear Power Station)	)

**TACKLING THE SINGLE-PHASE  
EROSION CORROSION ISSUE**

## TACKLING THE SINGLE-PHASE EROSION CORROSION ISSUE

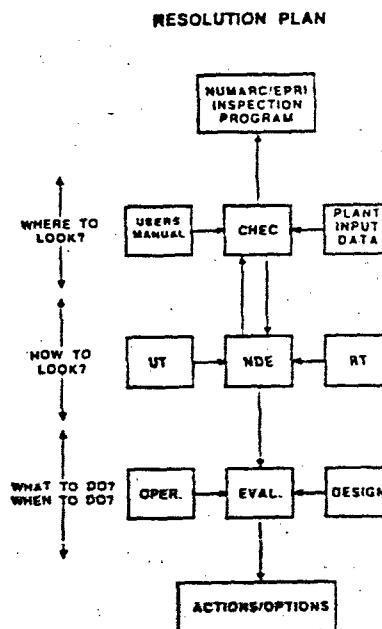
Figure 1--Inspection Plan.

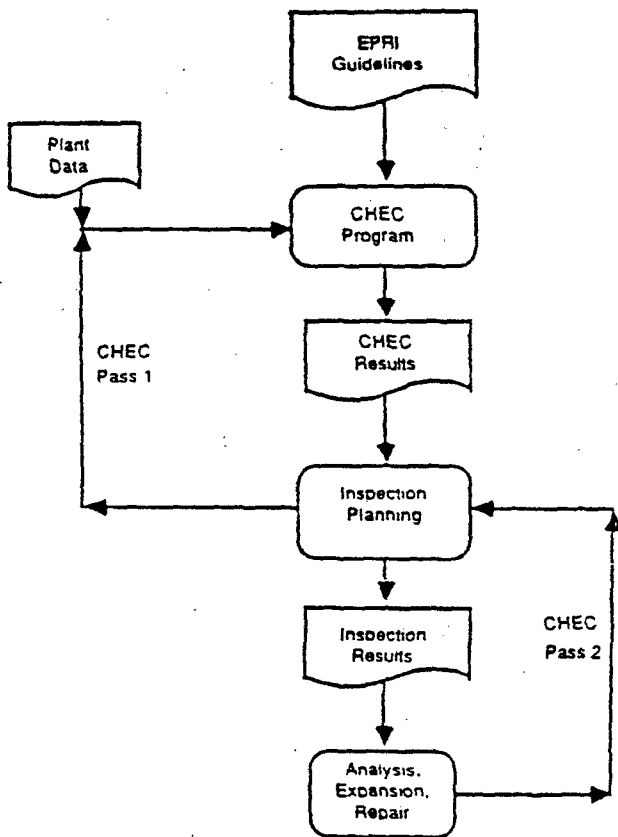
Figure 2--Planning with CHEC.

The CHEC code is designed to help utilities plan inspection programs to determine the extent of pipe thinning caused by erosion-corrosion (Figure 2). The program factors in available inspection data to make accurate predictions for a given plant. Information is provided to allow the development of a cost-effective inspection program. Other applications include:

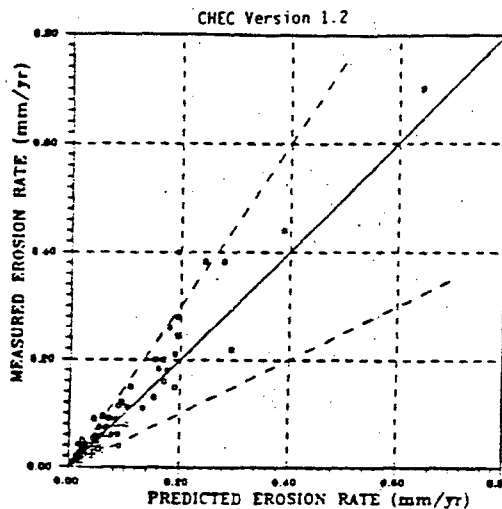
Figure 4--Comparison With Laboratory Data.

Figure 4 presents an overall comparison between CHEC predictions and laboratory data. This comparison shows that the model predicts the laboratory data well, particularly at high values of material removal.

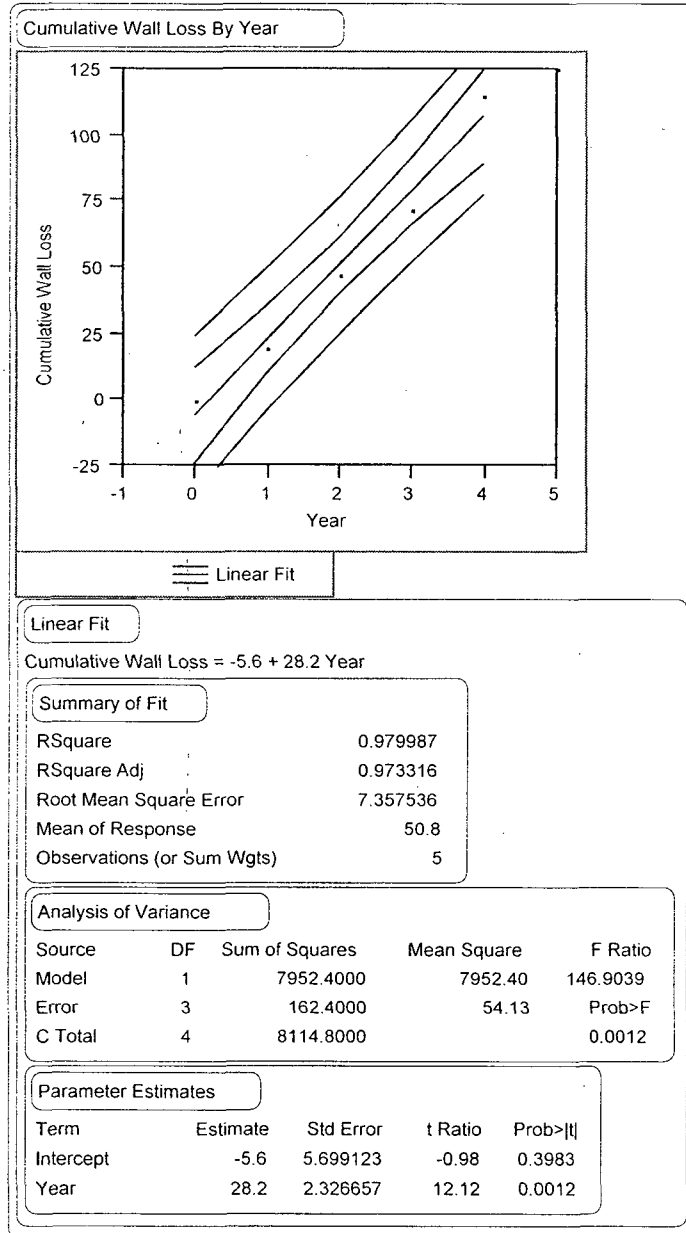
Elapsed Time [years]	Measured Wall Thickness [mils]	Cumulative Wall Thickness Loss [mils]	Corrosion Rate [mpy]
0	375	0	.
1	355	20	20.0
2	328	47	23.5
3	303	72	24.0
4	260	115	28.8
5	250	125	25.0
6	210	165	27.5
7	200	175	25.0
8	187	188	23.5
9	160	215	23.9

Figure 1  
 Statistical Evaluation of Corrosion Rate Using Data  
 From First Four Years

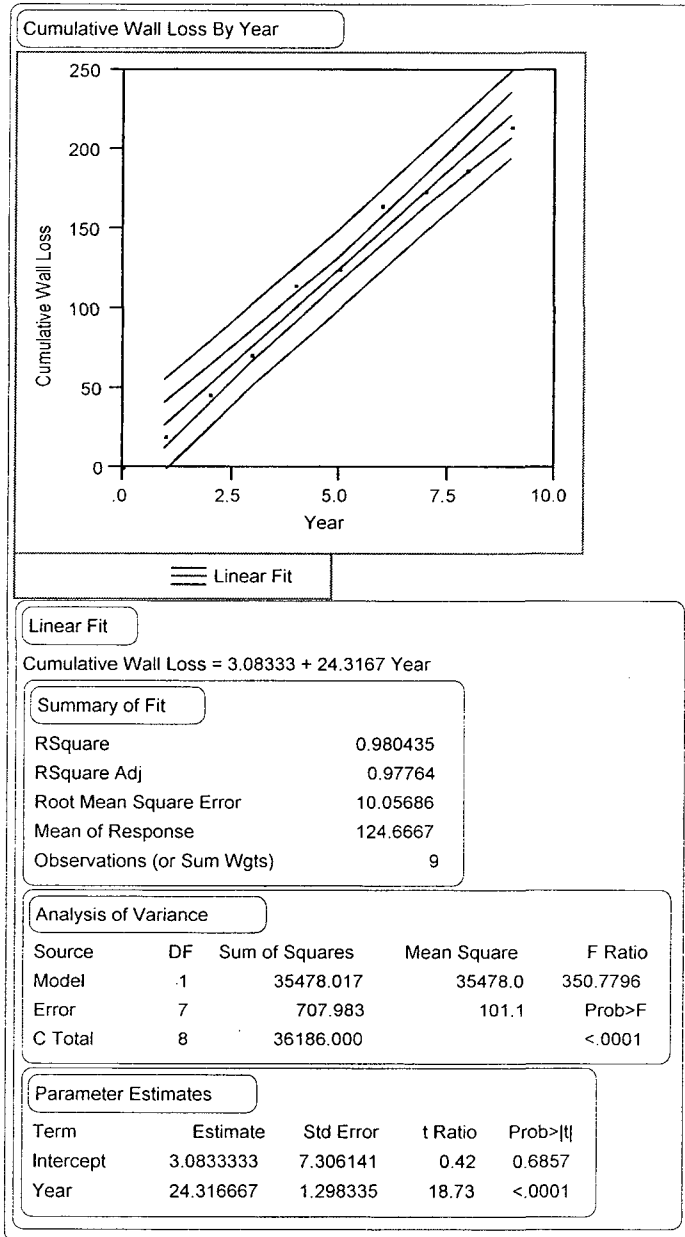
Figure 2  
 Statistical Evaluation of All Corrosion Rate Data  
 For All Nine Years of Measurements

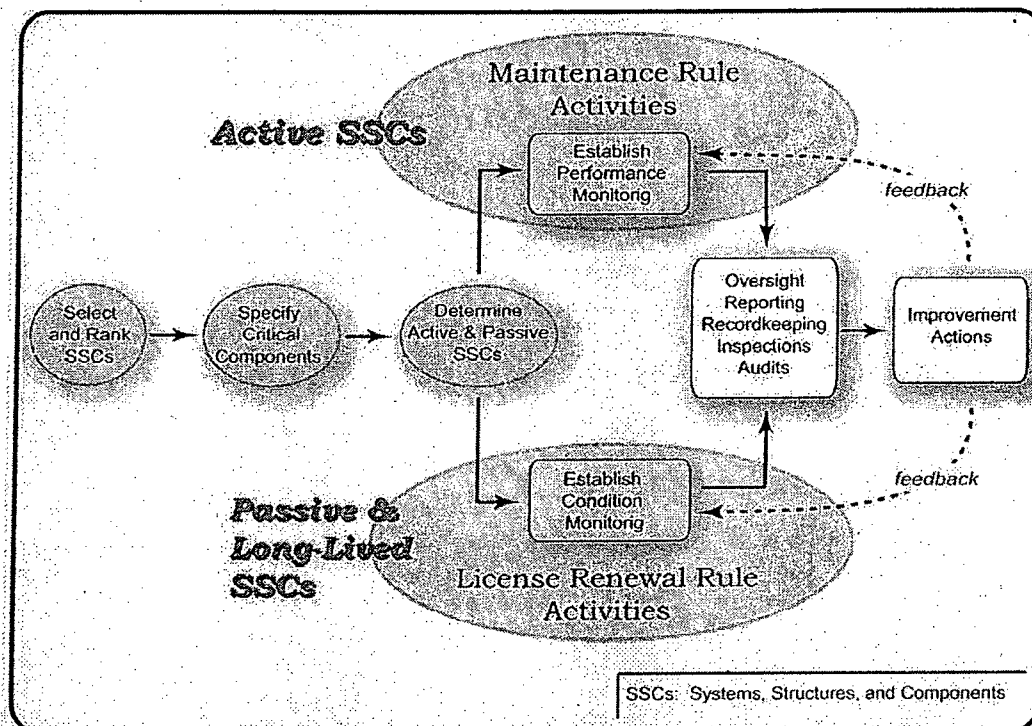
Figure 4: Relationship of Maintenance and License Renewal Rules

The relationship of the regulatory requirements for the Maintenance and License Renewal Rules is shown in Figure 4.

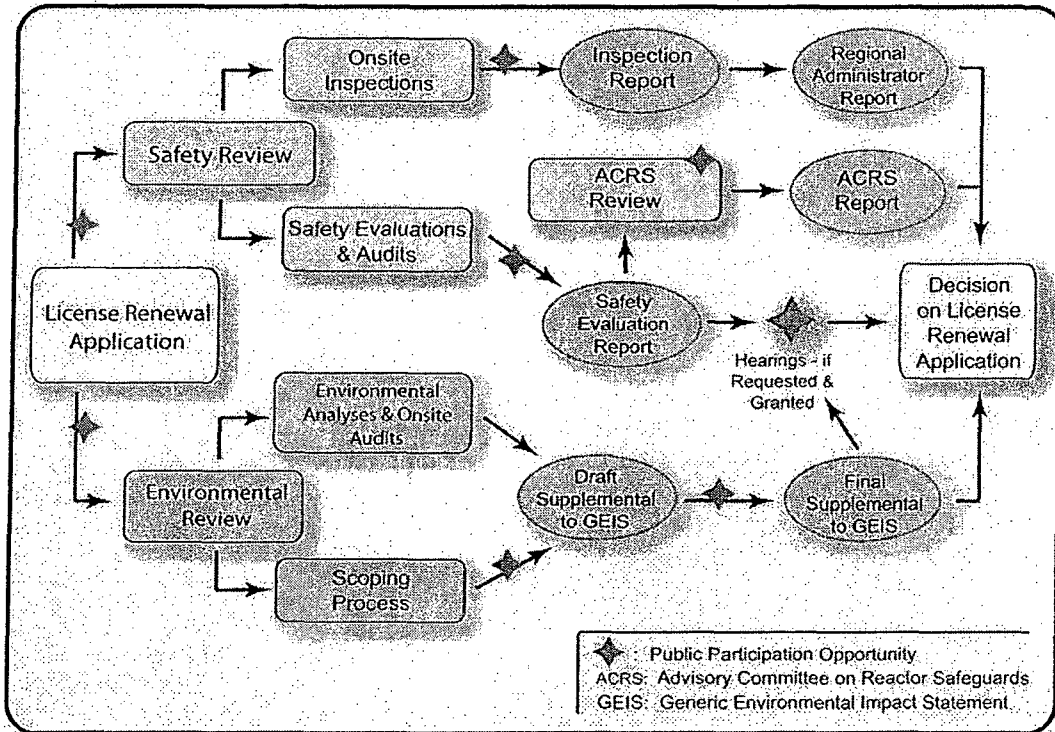
Figure 5: Simplified Flow Chart of the License Renewal Process (source: USNRC)

The license renewal review process (Figure 5) is intended to identify any additional actions that will be needed to maintain the functionality of the SSCs for the extended operation. The USNRC determined that the following can be excluded from the license renewal aging management review:

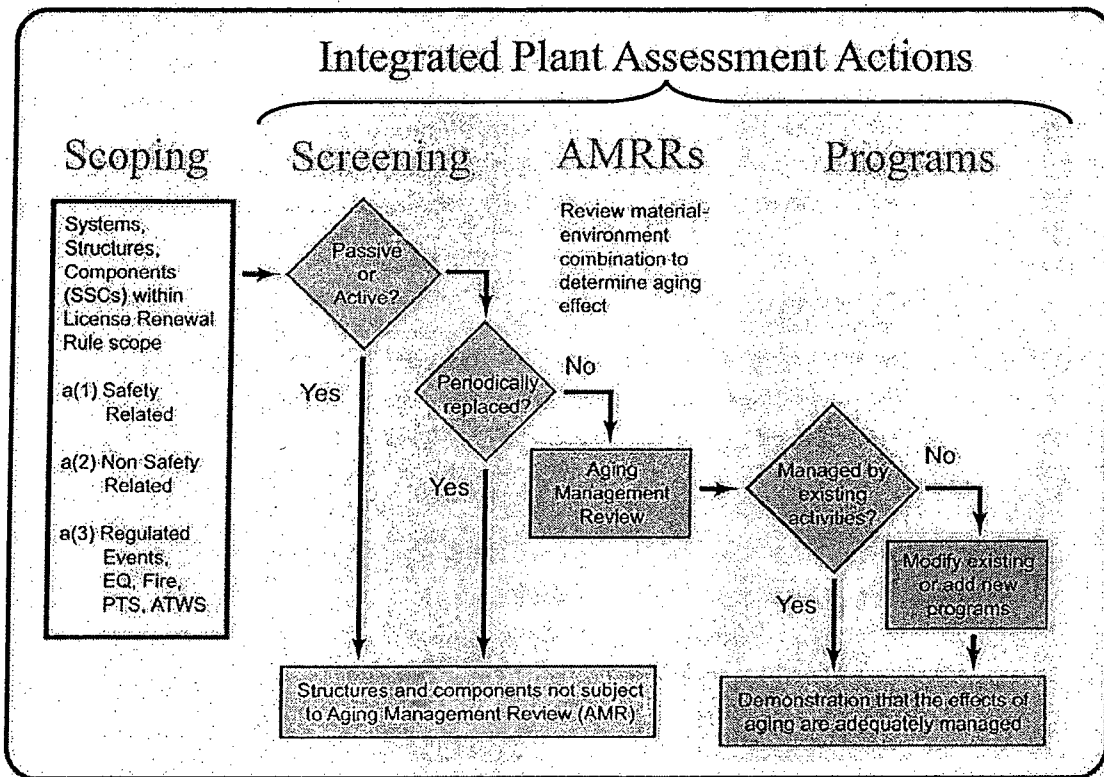
Figure 6: License Renewal Application Activities

The integrated plant assessment (IPA) is the core of the license renewal application (Figure 6). The purpose of the IPA is to demonstrate that the structures and components requiring aging management (within the scope of the Rule) have been identified and the effects of aging on their functionality will be managed to maintain an acceptable level of safety during extended operations
