**INQUIRY INTO THE
AUCKLAND POWER SUPPLY FAILURE
TECHNICAL REPORT - CABLE FAILURES**

The Ministerial Inquiry engaged Integral Energy Australia (IE) as technical consultants to prepare this report. IE was assisted in its task by TransGrid.

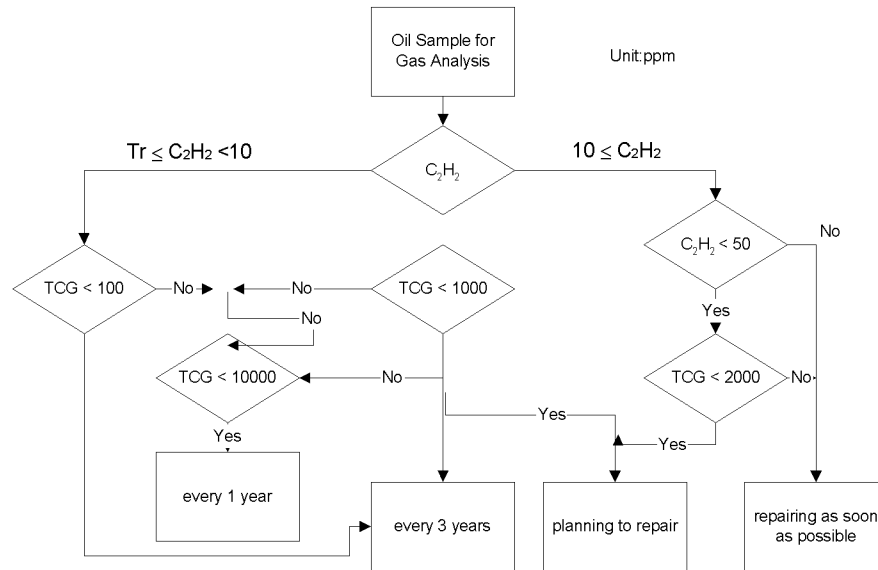
Figure 7 Flowchart of Inspection by Gas Analysis

In Figure 7 is presented the Japanese view in this regard highlighting the action to be taken when gas content level increases beyond acceptable limits.
