UNITED STATES
NUCLEAR REGULATORY COMMISSION
REGION IV
1600 EAST LAMAR BLVD
ARLINGTON, TEXAS 76011-4511

SUBJECT: WOLF CREEK NUCLEAR OPERATING CORPORATION – NRC AUGMENTED
INSPECTION TEAM REPORT 05000482/2012008

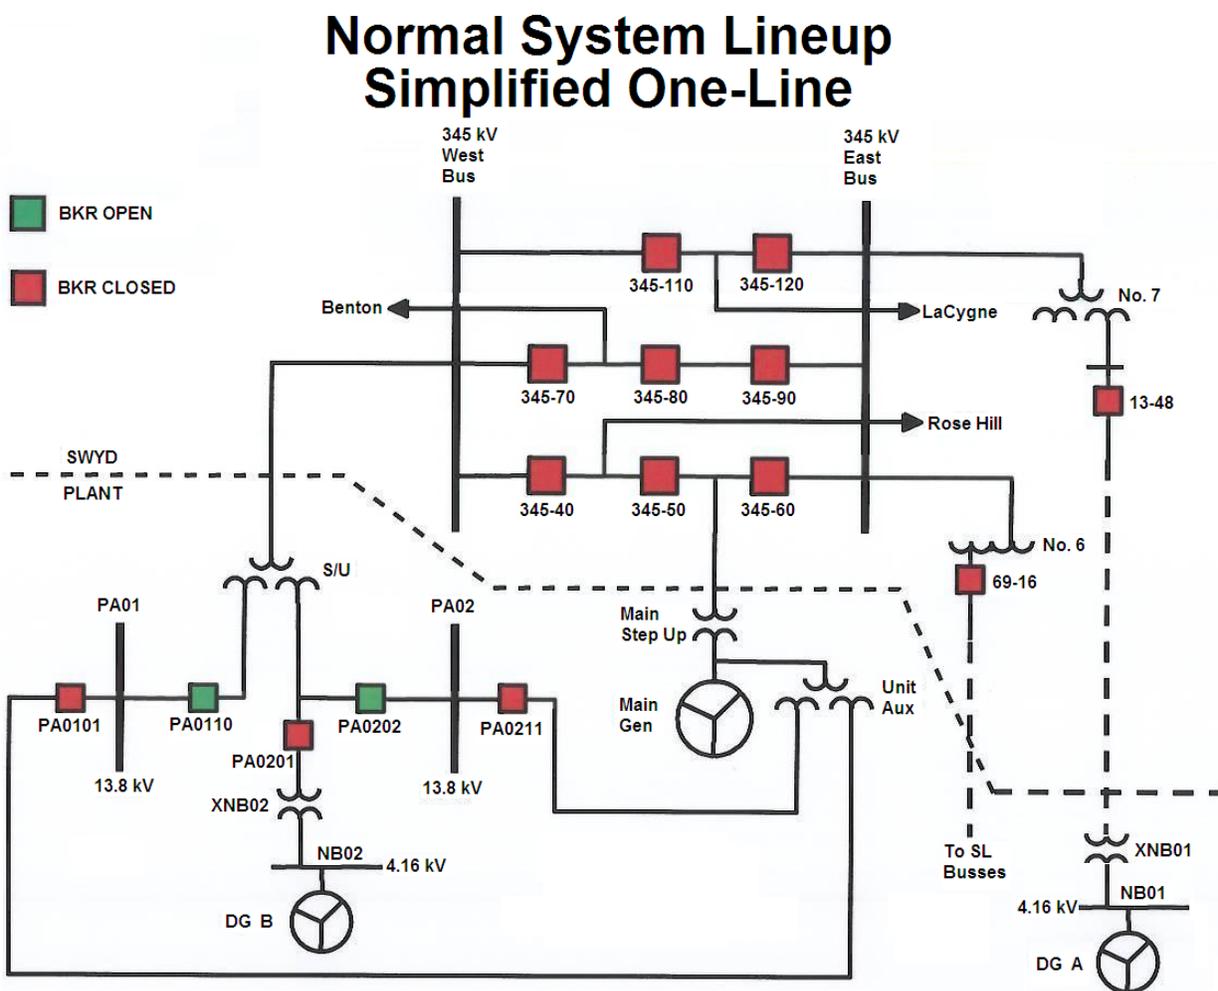
Figure-1, Wolf Creek Simplified Electrical Distribution

On January 13, 2012, at 2:02 p.m. CST, the site experienced a loss of offsite power (LOOP). The event resulted from two distinct faults. The first fault was on the C phase
