Reactor Oversight Process
Task Force FAQ Log
For the August 29, 2012
NRC Public Meeting

**NRC Response to
FAQ 12-01 (Withdrawn) re. Columbia DG3 Failure
For August 29, 2012 ROP WG Meeting**

Plant: Columbia Generating Station (CGS)

Performance Indicator: MS06

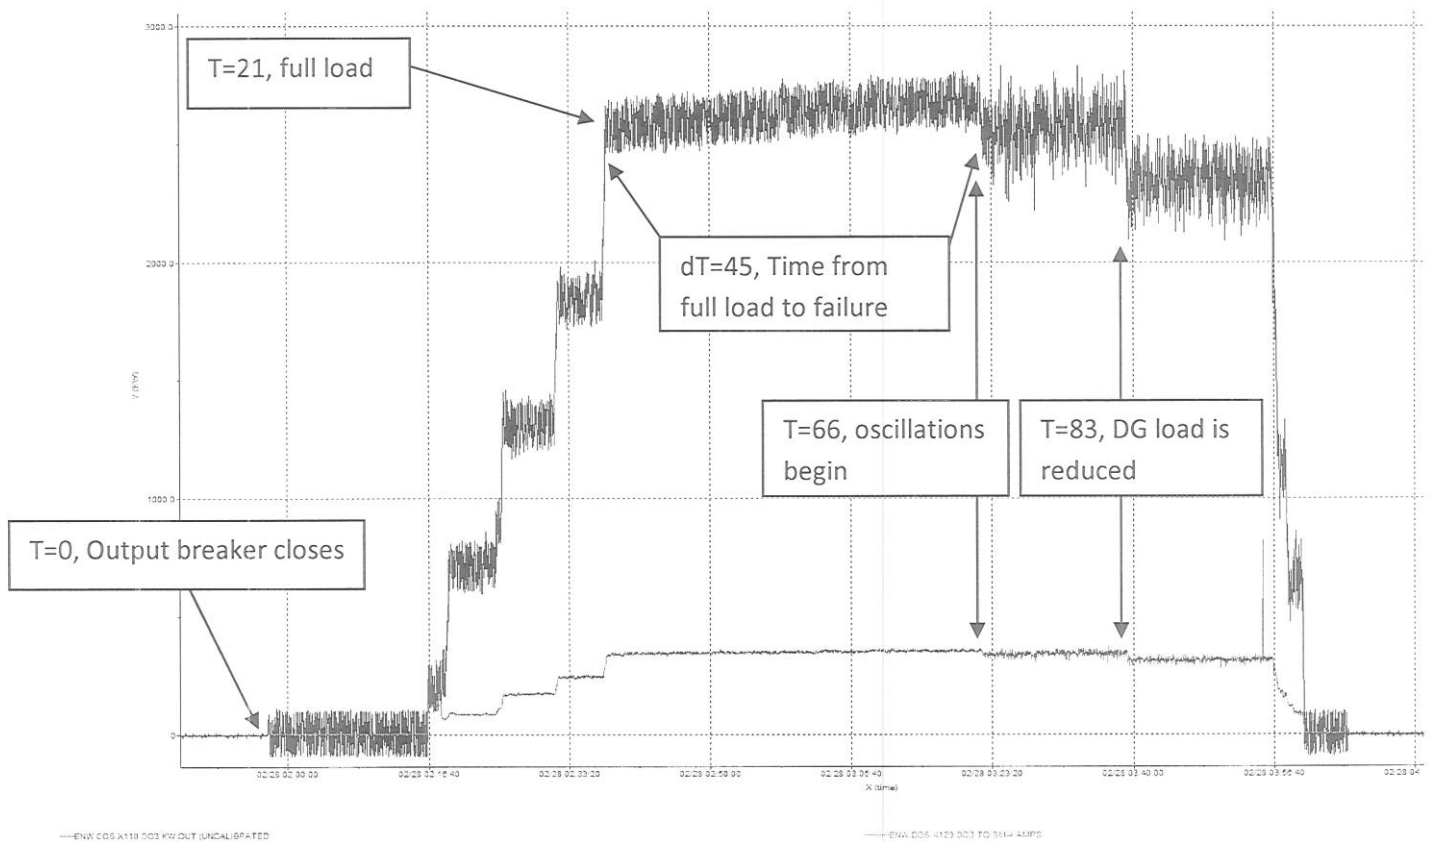
Figure 1, Load and current profile during DG3 Operation on 2/28/10

On February 28, 2010, CGS was testing an Emergency Diesel Generator (EDG). Refer to figure 1 for Load and Current trace of the subject event. The EDG successfully started, the EDG output breaker successfully closed (T = 0 minutes), the EDG successfully load sequenced up to fully loaded (T = 21 minutes), after 45 minutes the EDG experienced unexpected load oscillations of 350 kw (T = 66 minutes), after 17 minutes the load was lowered (T = 83 minutes) and the 350 kw oscillations were observed to continue another 16 minutes of operation until the EDG was unloaded (T = 99 minutes) and shut down.

CGS and the CGS NRC Senior Resident Inspector (SRI) do not agree that CGS properly reported the February 28, 2010 EDG failure. NEI 99-02 defines “EDG failure to load/run”. In part, it states: “Given that it has successfully started, a failure of the EDG output breaker to close, to successfully load sequence and to run/operate for **one hour** to perform its monitored functions.” The intent of this FAQ is to clarify that based on the guidance available at the time the start time for the “one hour” period begins once the EDG has completed its load sequence and is loaded (at T=21 and not at T=0 (as per figure 1)). Based on the response to FAQ Number 487, CGS understands that as of 1/1/2012 the “one hour” period begins at output breaker closure (T=0 per figure 1).

Because Figure 1 data is more reflective of an EDG failure-to-run for its mission time rather than a loading failure, the EDG failure at Columbia should have been reported as a failure-to-run.
