VSC-24 CoC Renewal Application  
Pre-Submittal Meeting #2

Rockville, MD  
August 21, 2012

- **Introductions**
  - Steve Sisley – Licensing/Regulatory Compliance Manager
  - James Hopf – Project Engineer
  - Suzanne Leblang – Entergy
- **Purpose of Meeting**
  - Discuss CoC Renewal Application for the VSC-24 Storage System
  - Focus on open items/questions from 1<sup>st</sup> NRC meeting on 1/19/12.
  - Obtain NRC feedback prior to submittal of CoC Renewal Application

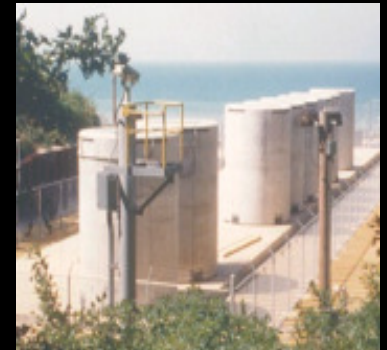
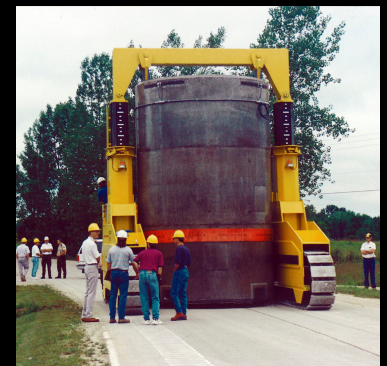
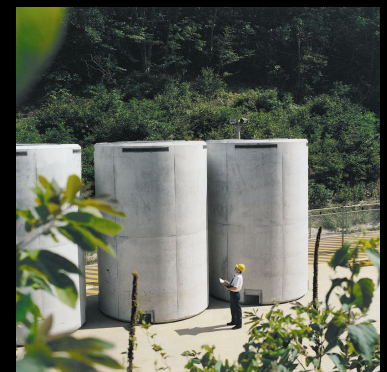
- 58 VSC-24 casks loaded and stored at three different ISFSIs between May 1993 and June 2003;
  - 18 casks at Palisades
  - 16 casks at Point Beach
  - 24 casks at ANO
- SNF assemblies stored in VSC-24 casks have low heat loads and low burnup.
  - Max. initial heat load of 58 loaded VSC-24 casks is  $< 15$  kW.
  - Highest burnup of all SNF assemblies in 58 loaded VSC-24 casks is  $< 42$  GWd/MTU.

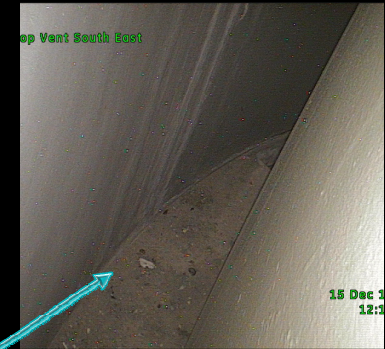
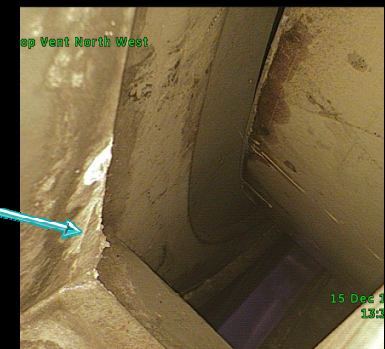
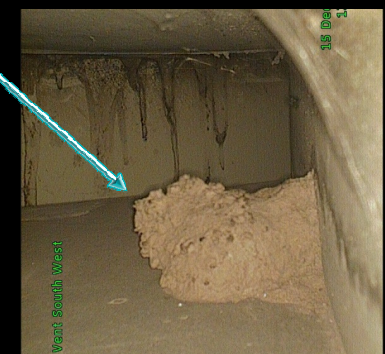
- VCC interior surface examinations
  - Condition of VCC ventilation paths
    - No significant blockage accumulation in inlet/outlet ducts and annulus
    - Small amount of debris (e.g., coating, dead insects) at bottom of VCC annulus
    - Small mineral deposits (e.g., stalactites) at entrance to VCC outlet vents
    - Small muddobber nest inside outlet vent of one VCC (removed)

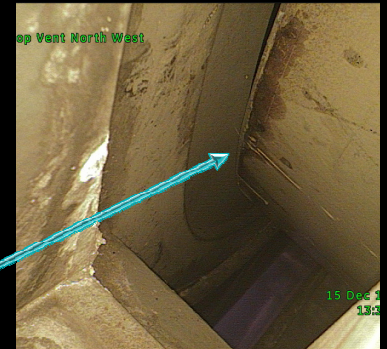
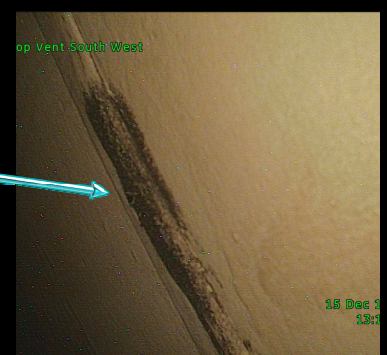
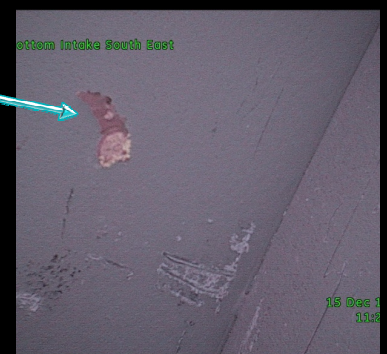
- VCC interior surface examinations (cont.)
  - Condition of MSB Shell and VCC liner and inlet/outlet duct surfaces
    - Coated steel surfaces in good condition
    - Discoloration of coating near top end of MSB shell
    - Small areas of corrosion (?) on MSB shell surface (< 0.045" allowance @ 15 yr)
    - VCC liner coating in excellent condition, few small areas of coating damage and corrosion

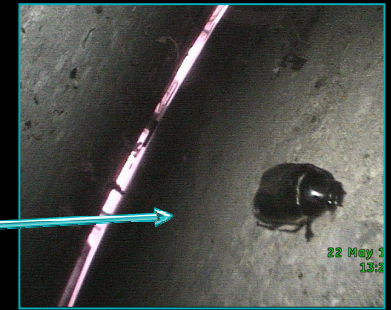
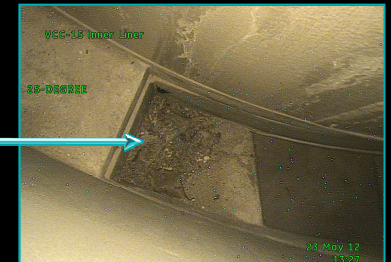
- Lead Cask Inspection Results
  - VCC bottom & underlying pad
    - Insects and some debris found
  - MSB shell, VCC liner & air ducts
    - No significant blockage, coating degradation or corrosion found (some debris/insects found)
  - VCC lid, MSB structural lid & closure weld
    - Some dust/dirt on MSB top end, but no significant coating degradation or corrosion
    - Coating scraped off in 2 areas when temporary shielding removed after inspection
      - No corrosion on exposed CS surfaces
      - Areas cleaned and recoated
  - VCC exterior concrete
    - Acceptable condition overall, 6 bug-holes found exceeding acceptance criteria (grout repair done)

- Lead Cask Inspection Plan
  - Palisades Cask No. VSC-15, May 21-24, 2012
    - Design configurations similar at all 3 sites
    - Environment conditions similar at all 3 sites
    - Palisades VSC-15 had highest heat load (14.7 kW)
    - 13 years in service (loaded June 1999)
    - Location on ISFSI pad provides good accessibility/visibility
  - Inspection scope
    - Remote visual examination of VCC bottom surface
    - Remote visual examination of VCC air flow passages
    - Direct visual examination of VCC cask lid, liner flange, and shield ring, and MSB structural lid and closure weld
    - Direct visual inspection of VCC exterior concrete surfaces
  - Concrete inspector: ASME, Section XI, Subsection IWL
  - Steel inspector: ASME, Section XI, Subsection IWE
